# Victoria Baths

Heritage Impact Assessment  
and DAS

January 2025

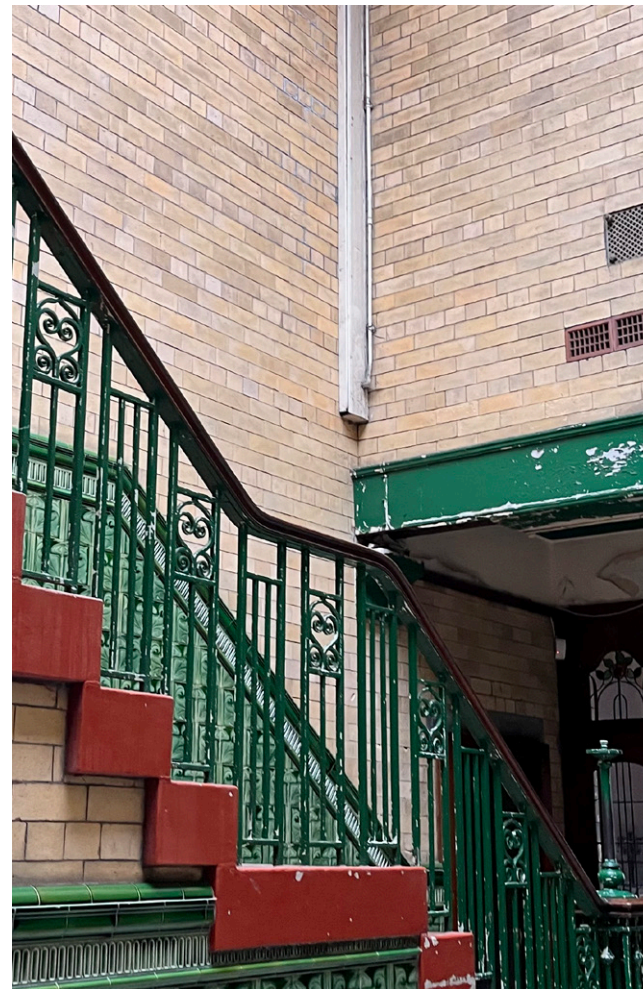
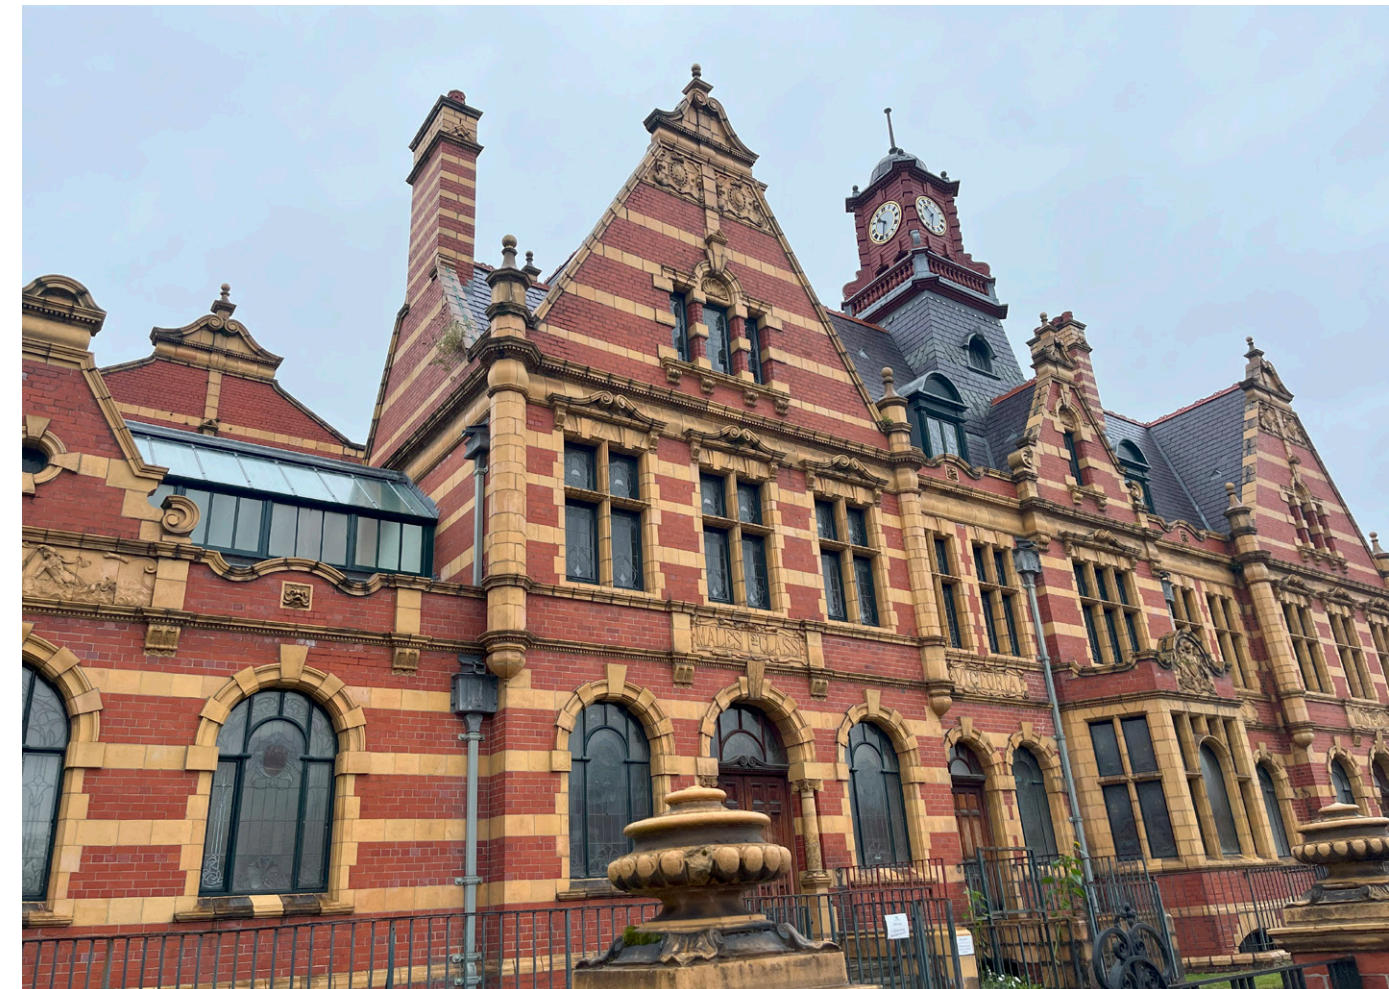
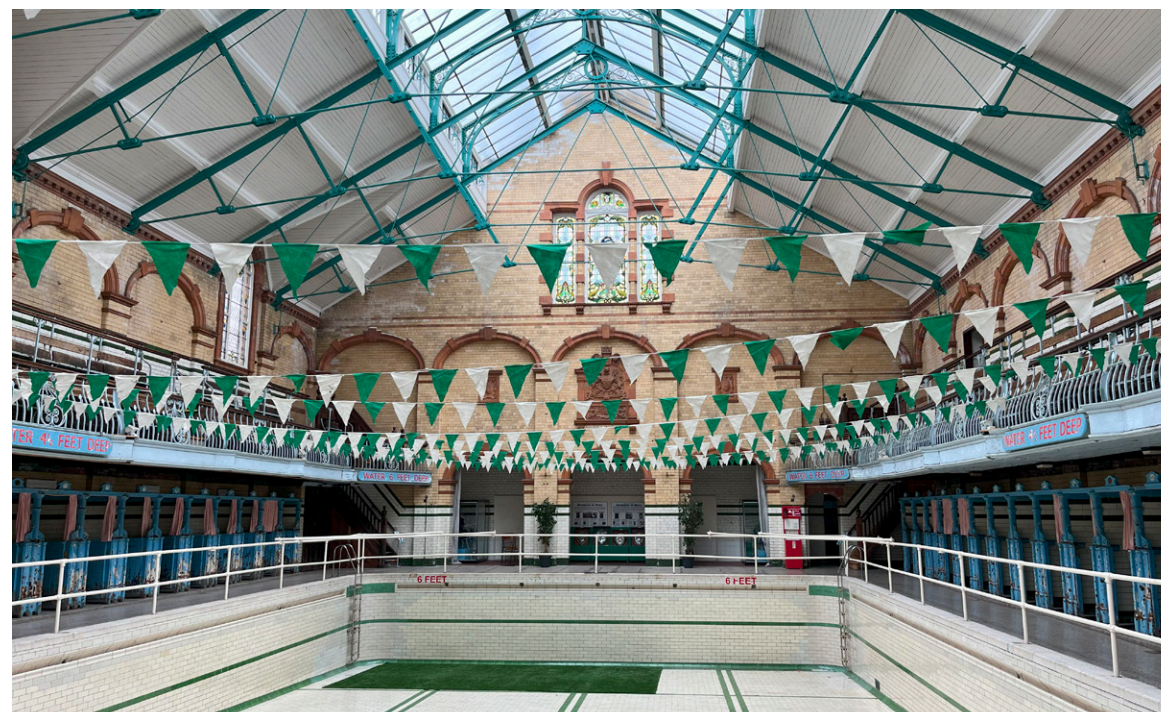
Figure 2 Victoria Baths - General Spaces

The pools are flanked by changing cubicles along the side walls and are overlooked by galleries that provide additional spectator seating. The basement level beneath the pools accommodates service areas, including plant rooms, filtration systems, and structural supports for the pool basins.

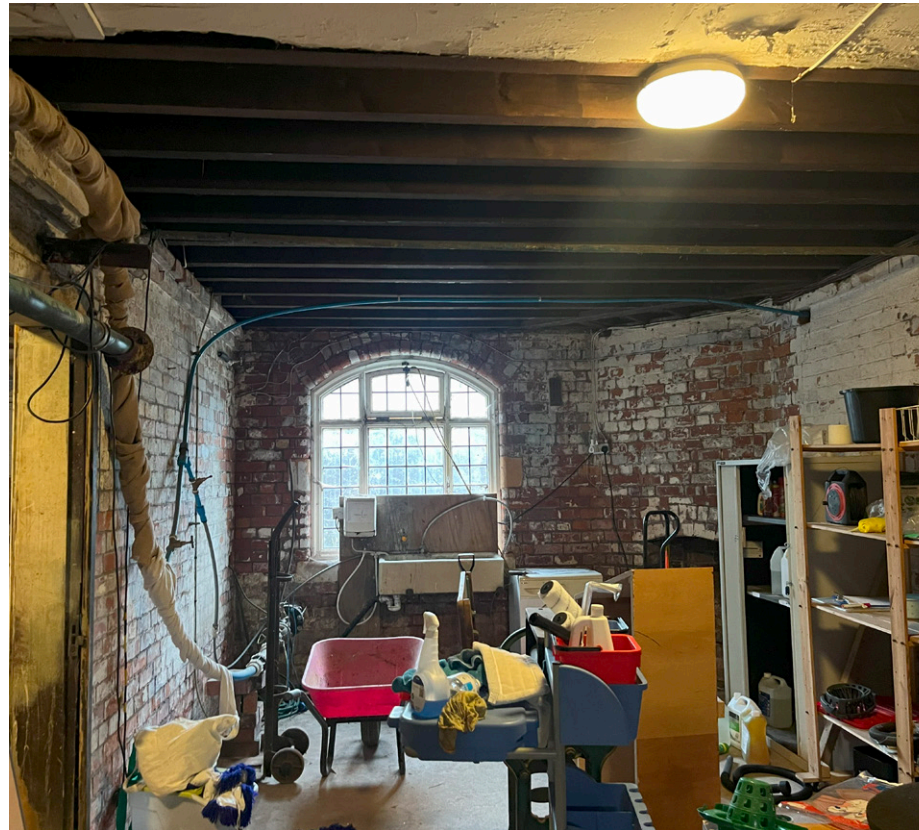
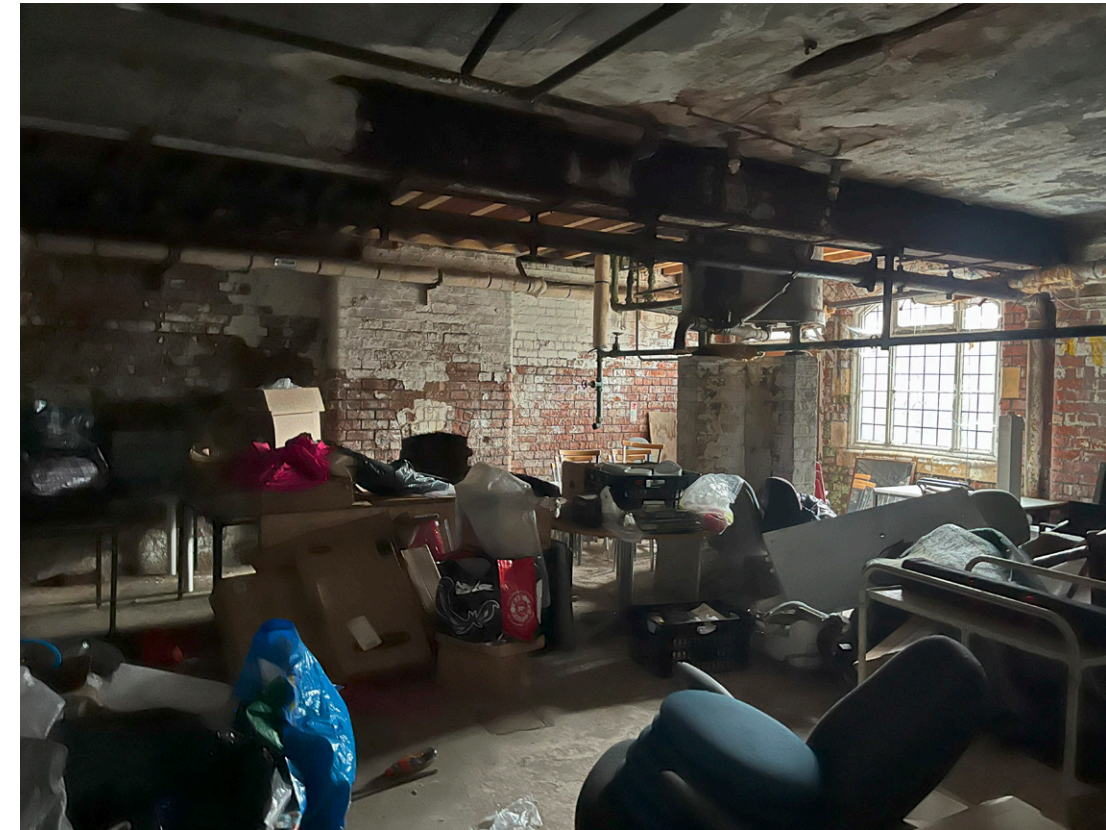
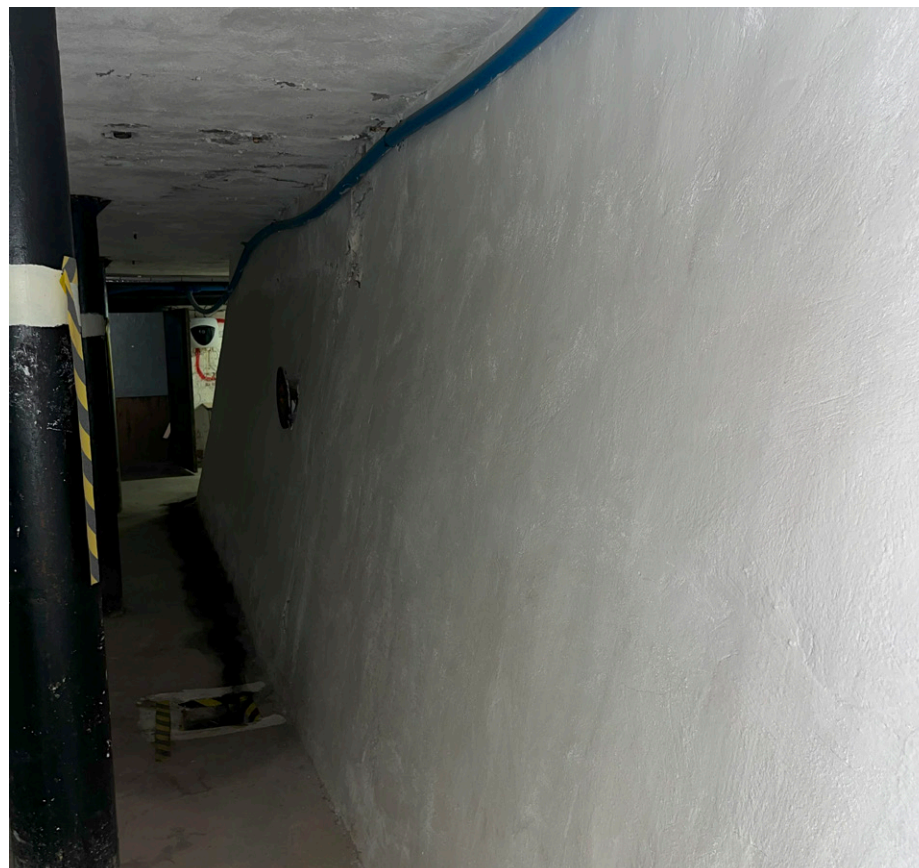
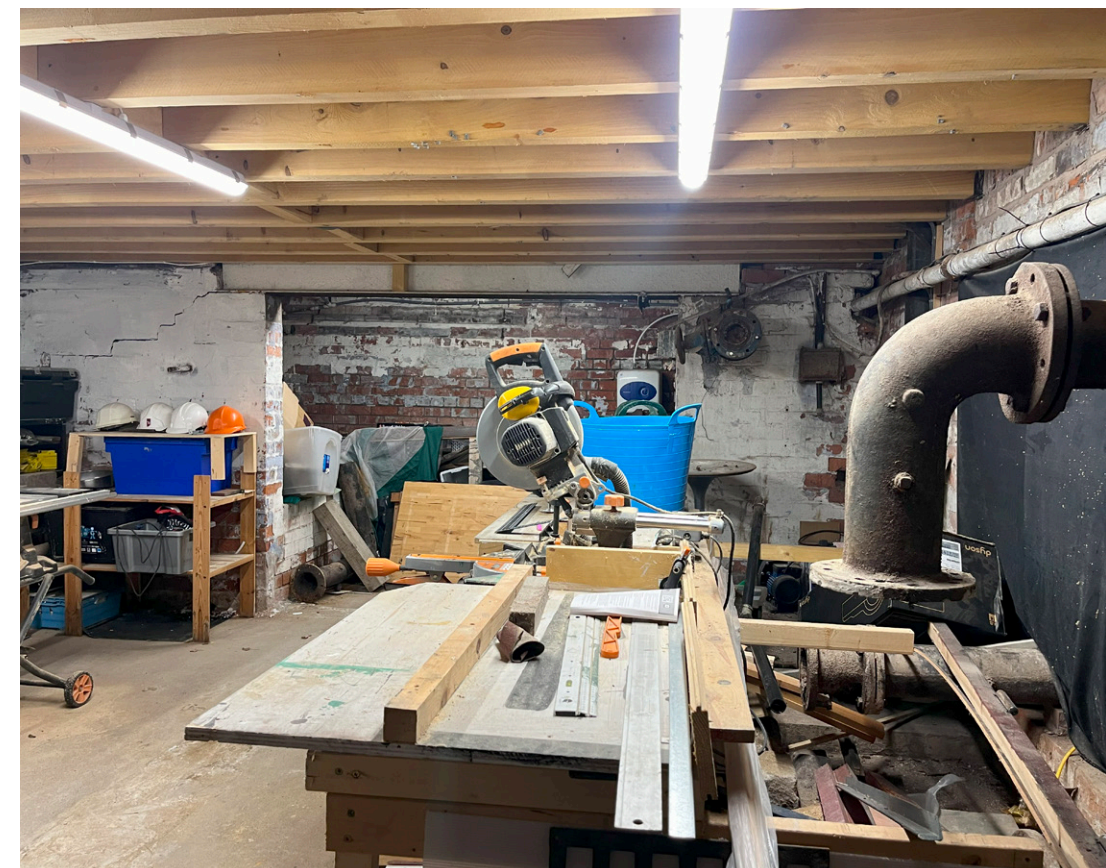
Figure 3 Below: Basement Spaces to be Subject to Asbestos Removal

The basement spaces have utilitarian finishes designed for functionality rather than decoration and lack the more ornate decoration and detailing of the upper floor public spaces. The exposed fairfaced common brickwork walls of the storage and plant spaces are painted in areas however are in poor condition with peeling paint. Areas of interest include historic fireplace openings and bullnose brick corners to fireplaces and to dividing room walls. Ceilings are a combination of the plastered underside of concrete 'filler joist' floors, as well as exposed timber joists, both recent and more historic.

The spaces are now largely filled within modern shelving, work benches and equipment, as well as a combination of more historic and modern pipework, plant and electrics.

The basement walls beneath the pools are also fairfaced common brickwork around the exterior of the building, the pool basins themselves made of concrete, exposed to the surrounding walkways.

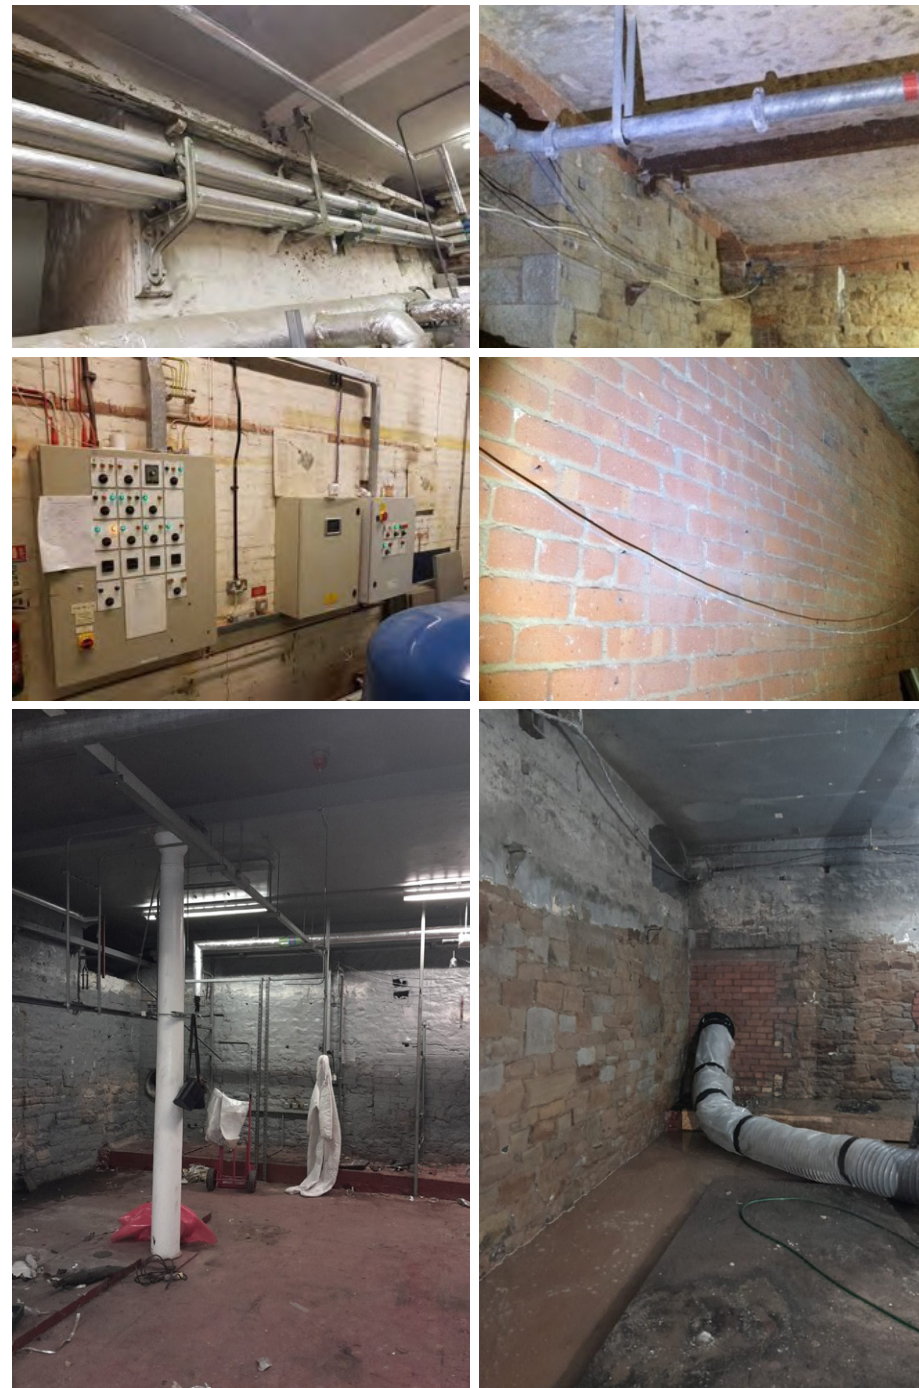
Pre-blast

Post-blast

Photographs of before and after the abrasive blast method was utilized at the Grade I Listed Harris Museum in Preston. Photographs by Weldlag Ltd.

The ‘abrasive blasting’ technique includes propelling aggregates at the surface, in this case paint-covered-walls. The velocity and aggregates used can be adjusted to reduce the risk of unwanted damage, and poses no vibration threat, to historic building fabric. This has proven successful many times including recently at the Grade I Listed Harris Museum in Preston where blasting was carried out by Weldlag Ltd, who intend to undertake the works at Victoria Baths.
