# Geo-Environmental Assessment Report

## Upper Brook Street, Manchester

Delta-Simons Project No: 101718.591891

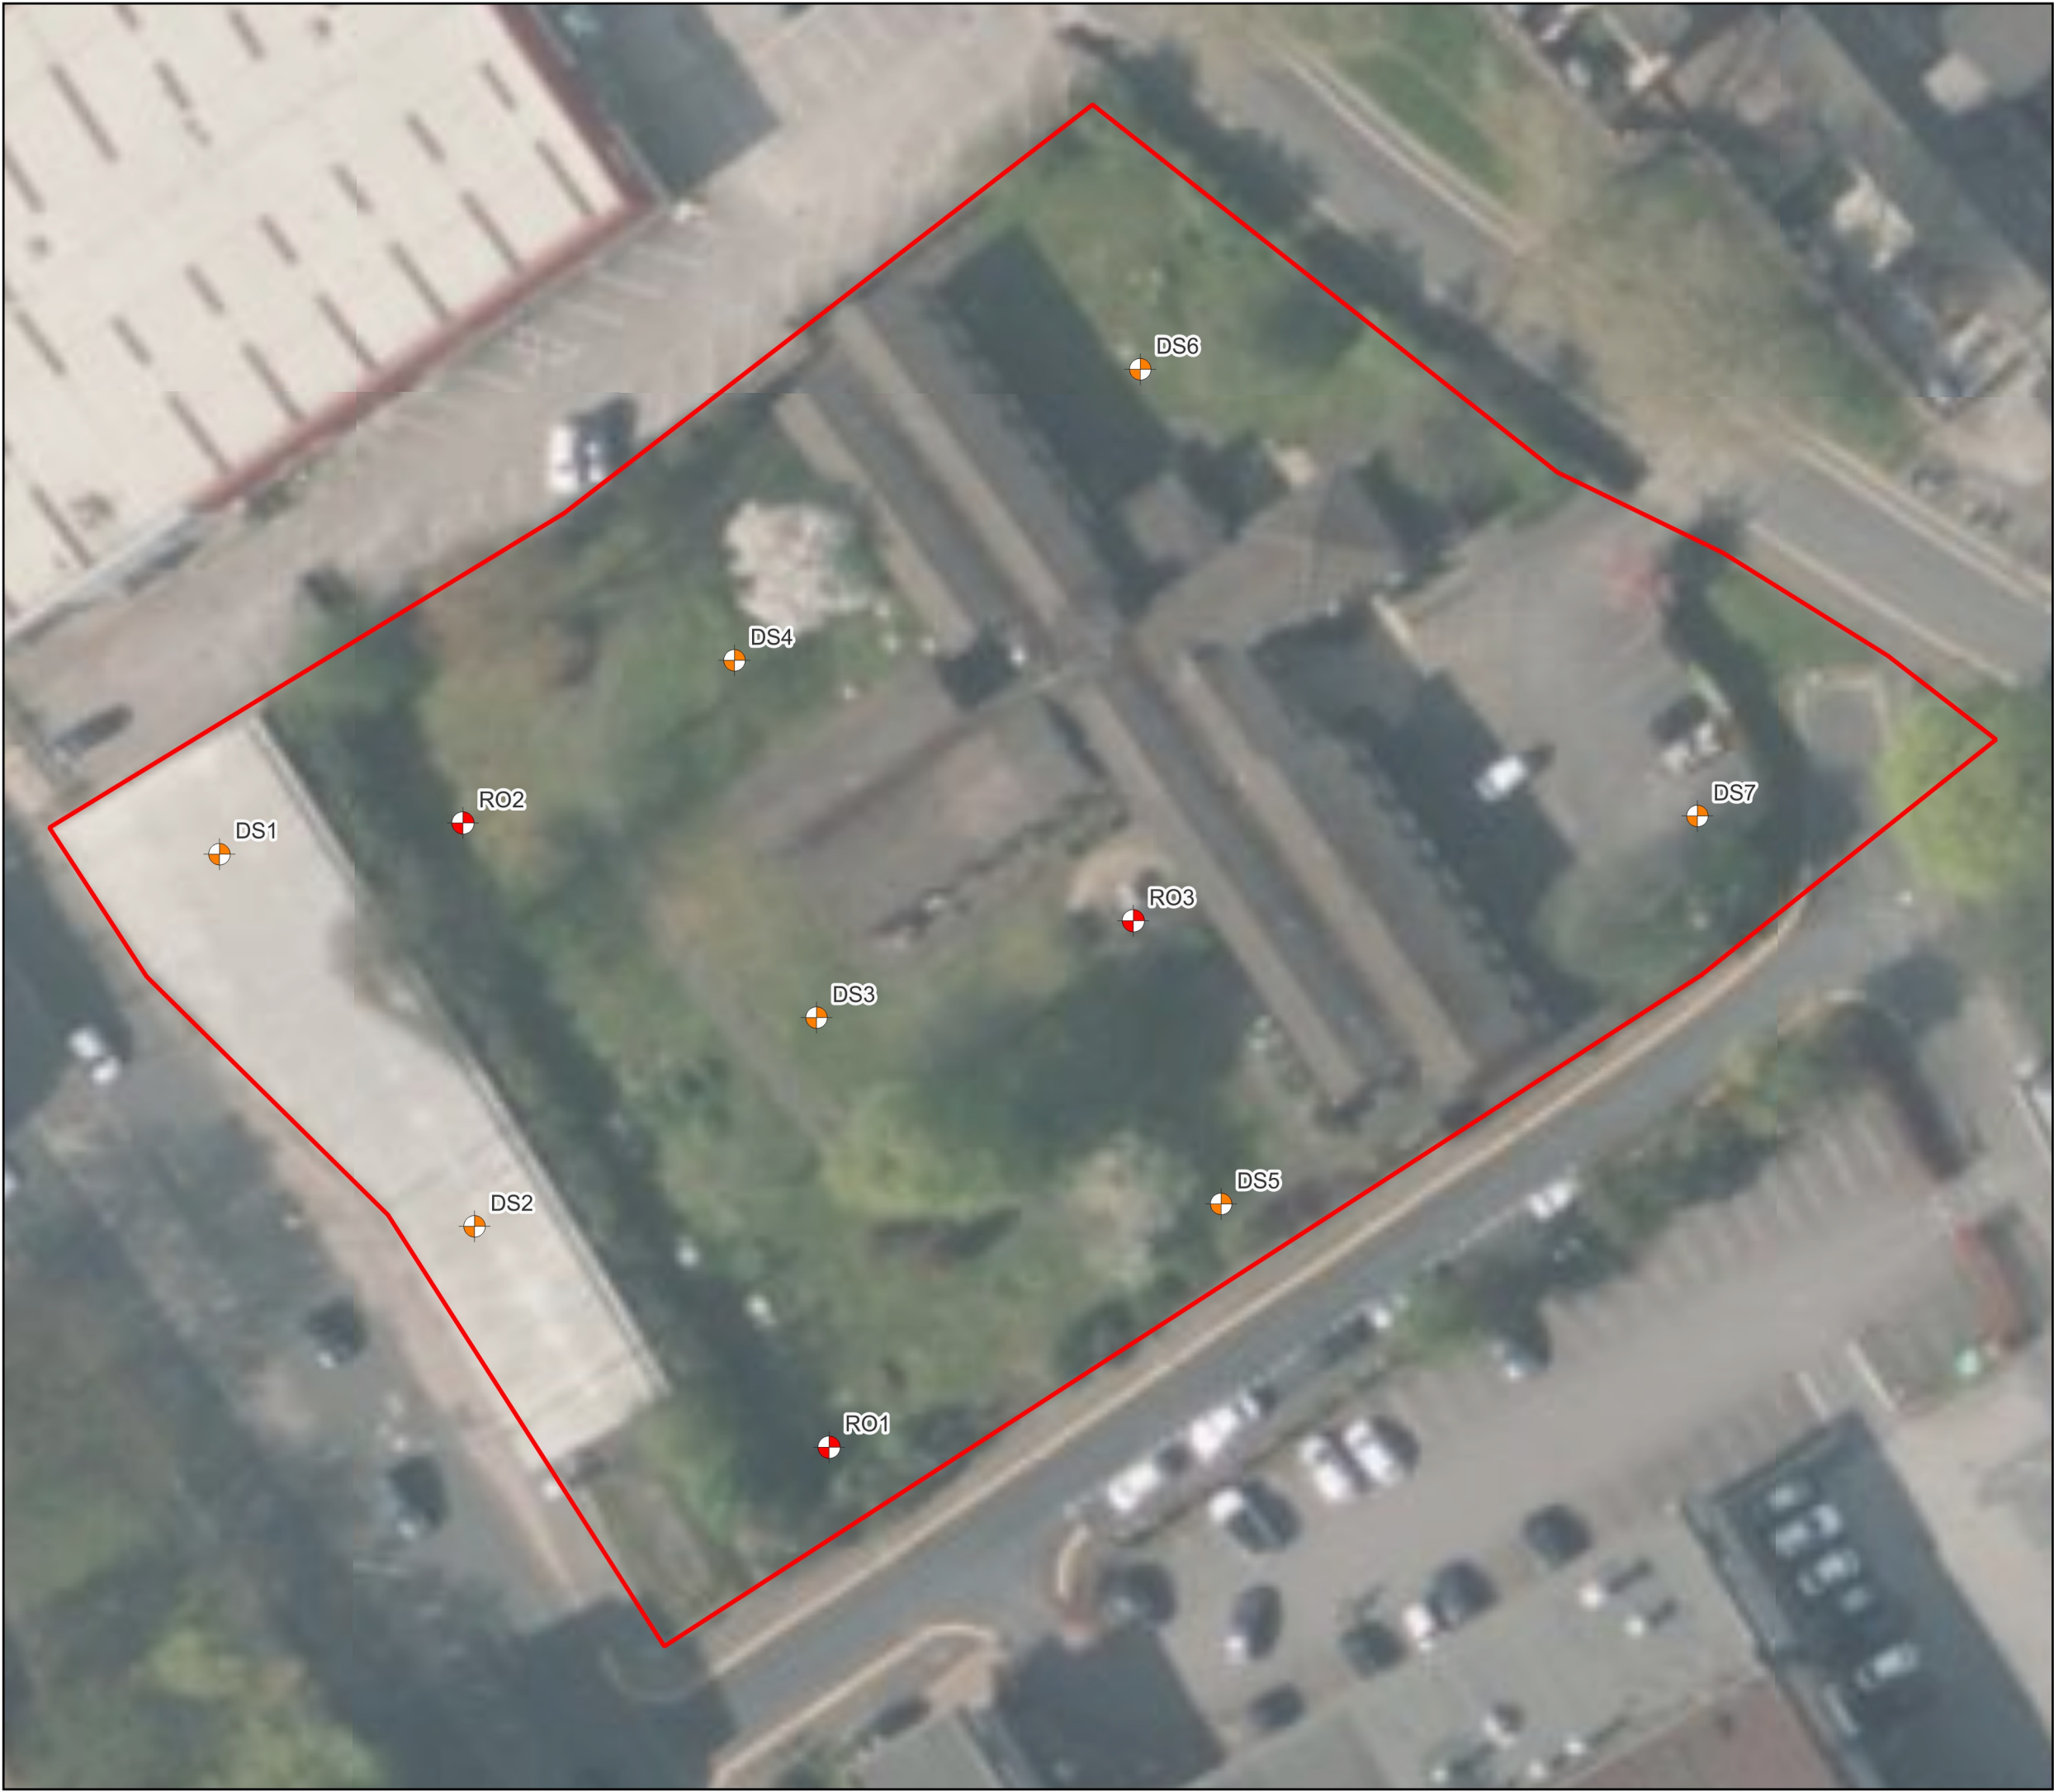
## Figure 2 - Exploratory Hole Location Plan

- Site Boundary
- Exploratory Hole Locations
  - DS - Dynamic Sampling
  - R - Rotary

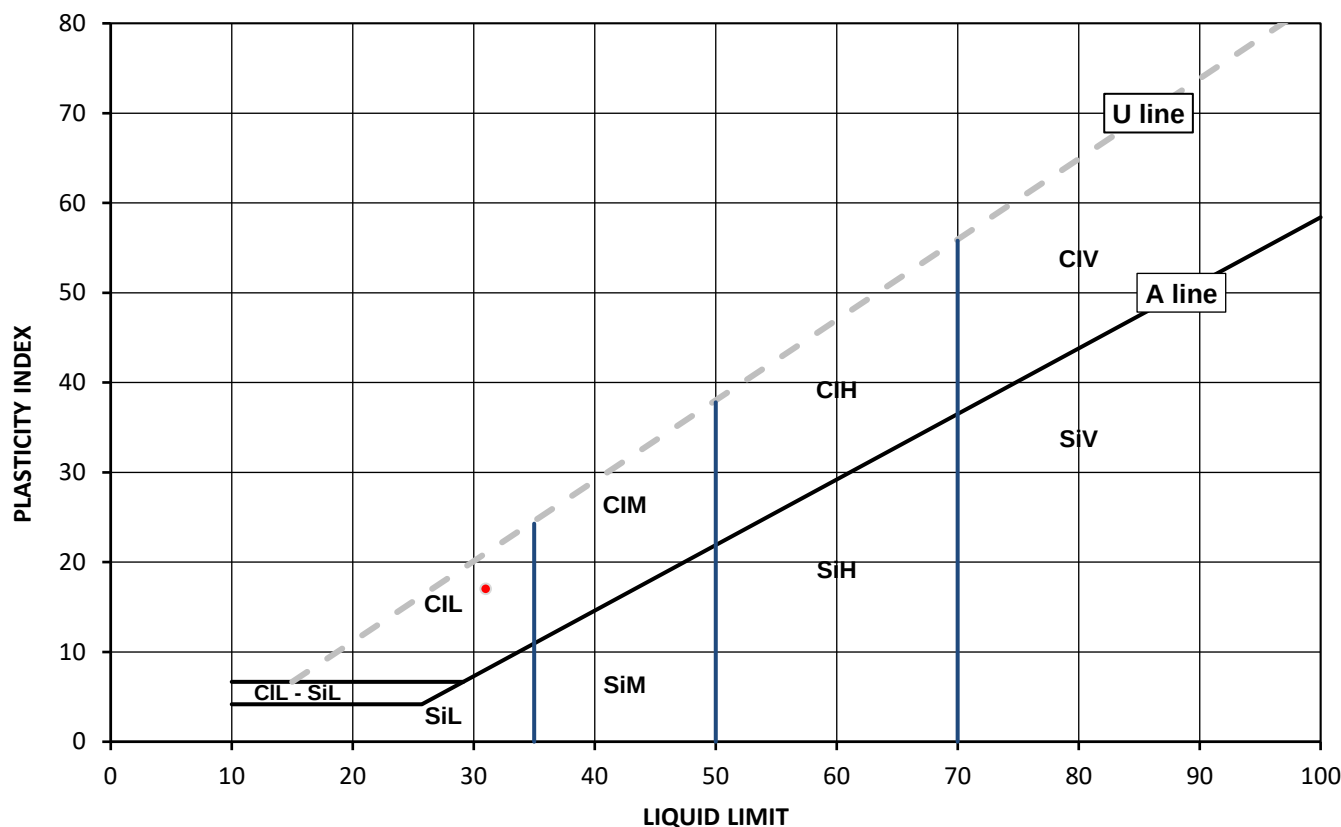
| As Received Water Content [ W ] % | Liquid Limit [ WL ] % | Plastic Limit [ Wp ] % | Plasticity Index [ Ip ] % | % Passing 425µm BS Test Sieve |
| 15 | 31 | 14 | 17 | 88 |

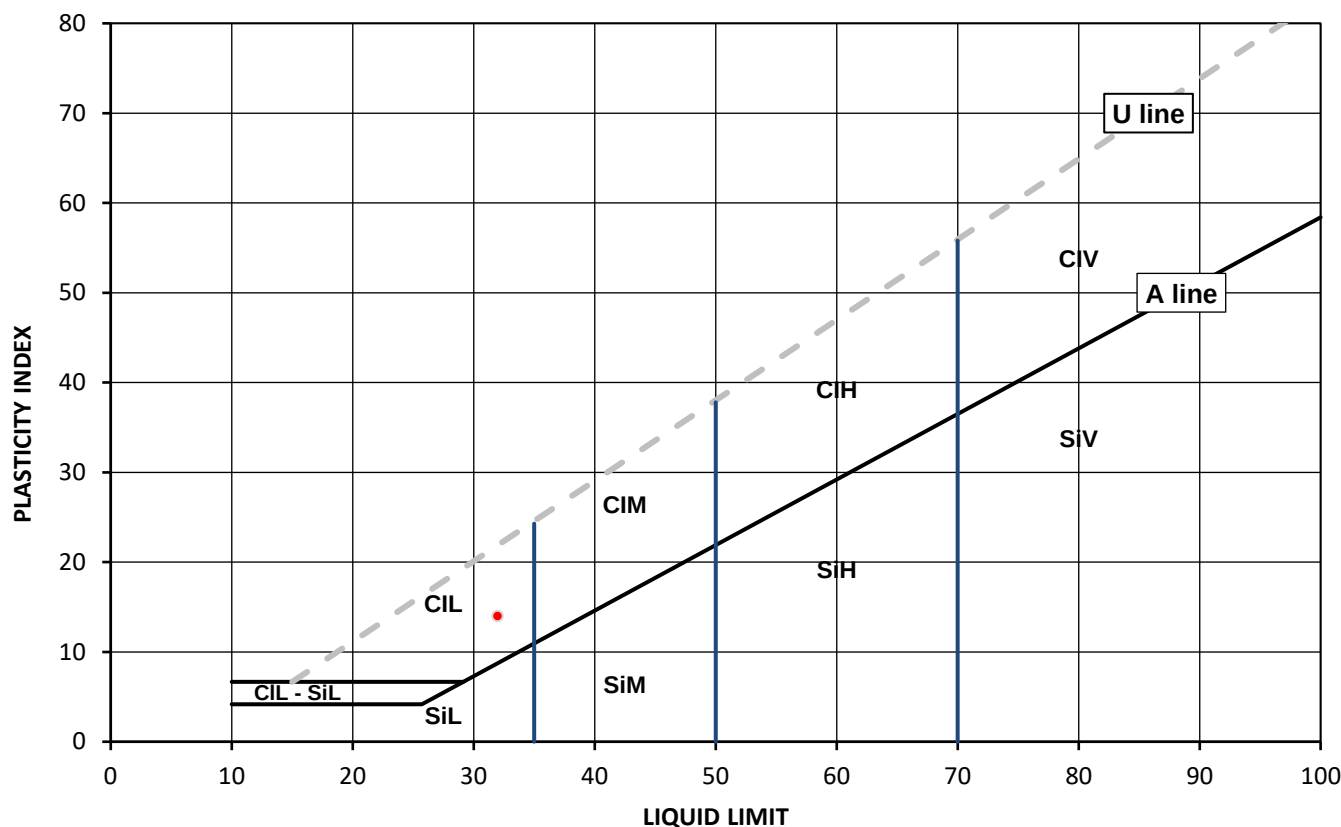
| As Received Water Content [ W ] % | Liquid Limit [ WL ] % | Plastic Limit [ Wp ] % | Plasticity Index [ Ip ] % | % Passing 425µm BS Test Sieve |
| 16 | 32 | 18 | 14 | 65 |

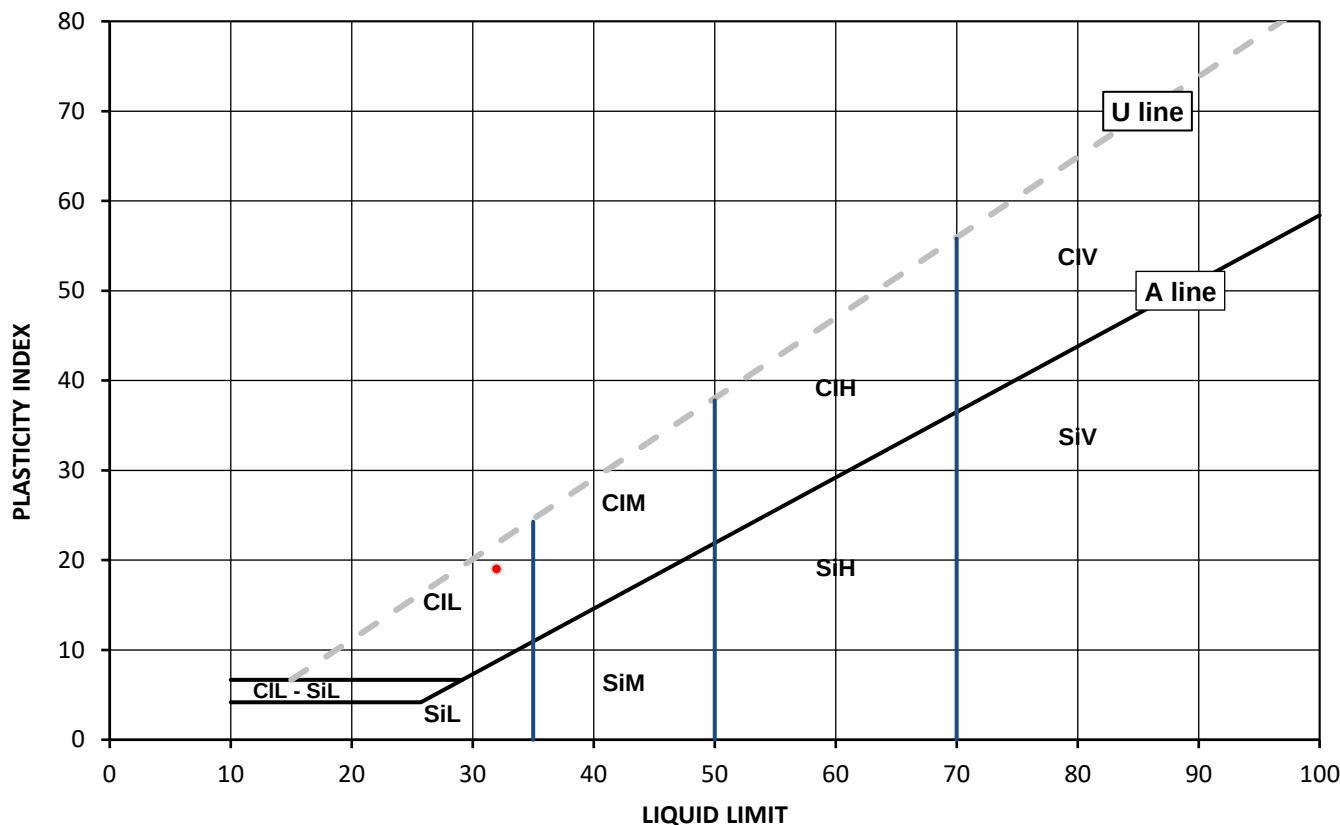
| As Received Water Content [ W ] % | Liquid Limit [ WL ] % | Plastic Limit [ Wp ] % | Plasticity Index [ Ip ] % | % Passing 425µm BS Test Sieve |
| 17 | 32 | 13 | 19 | 88 |

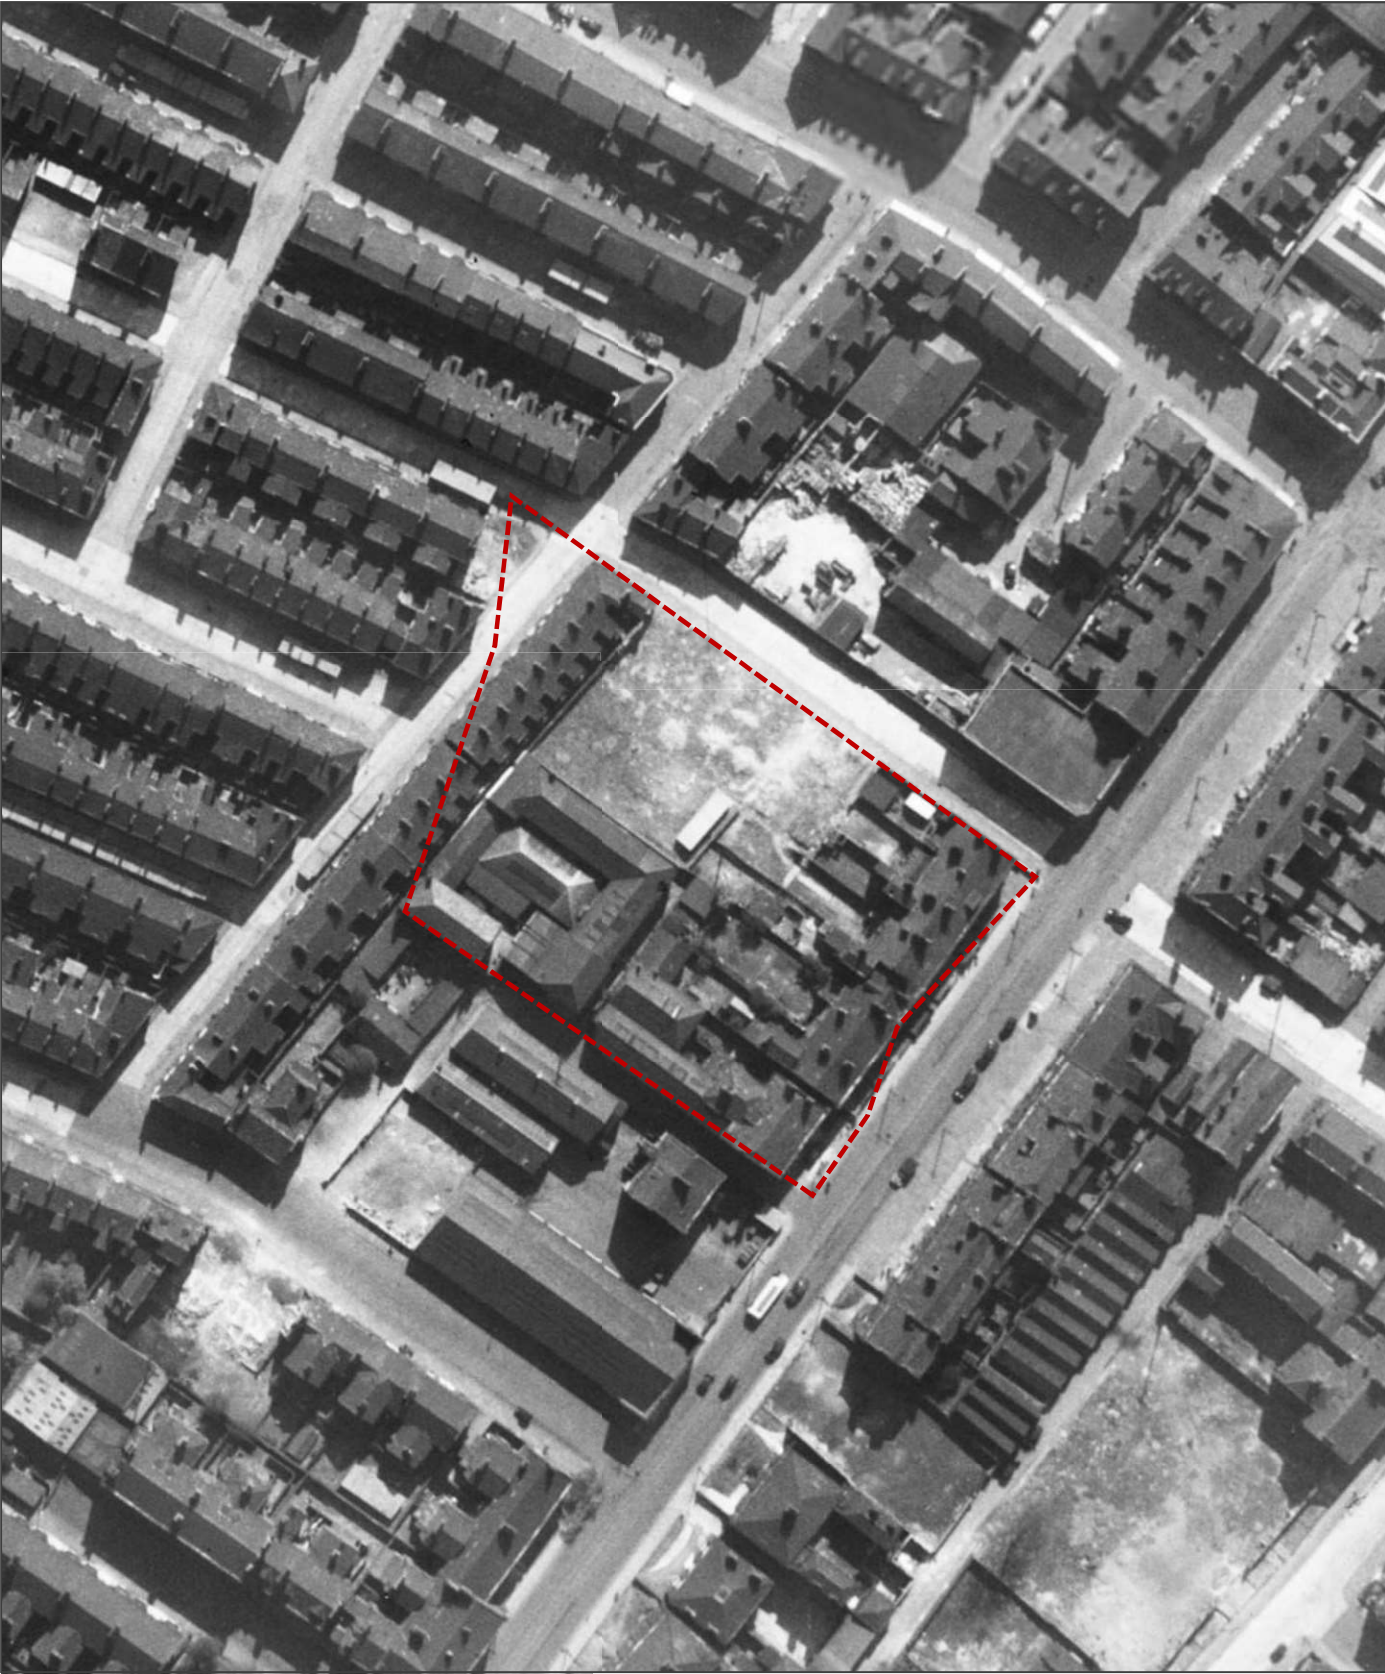
Figure: 05

Figure Title:  
Manchester Bomb and  
Damage Plot Map

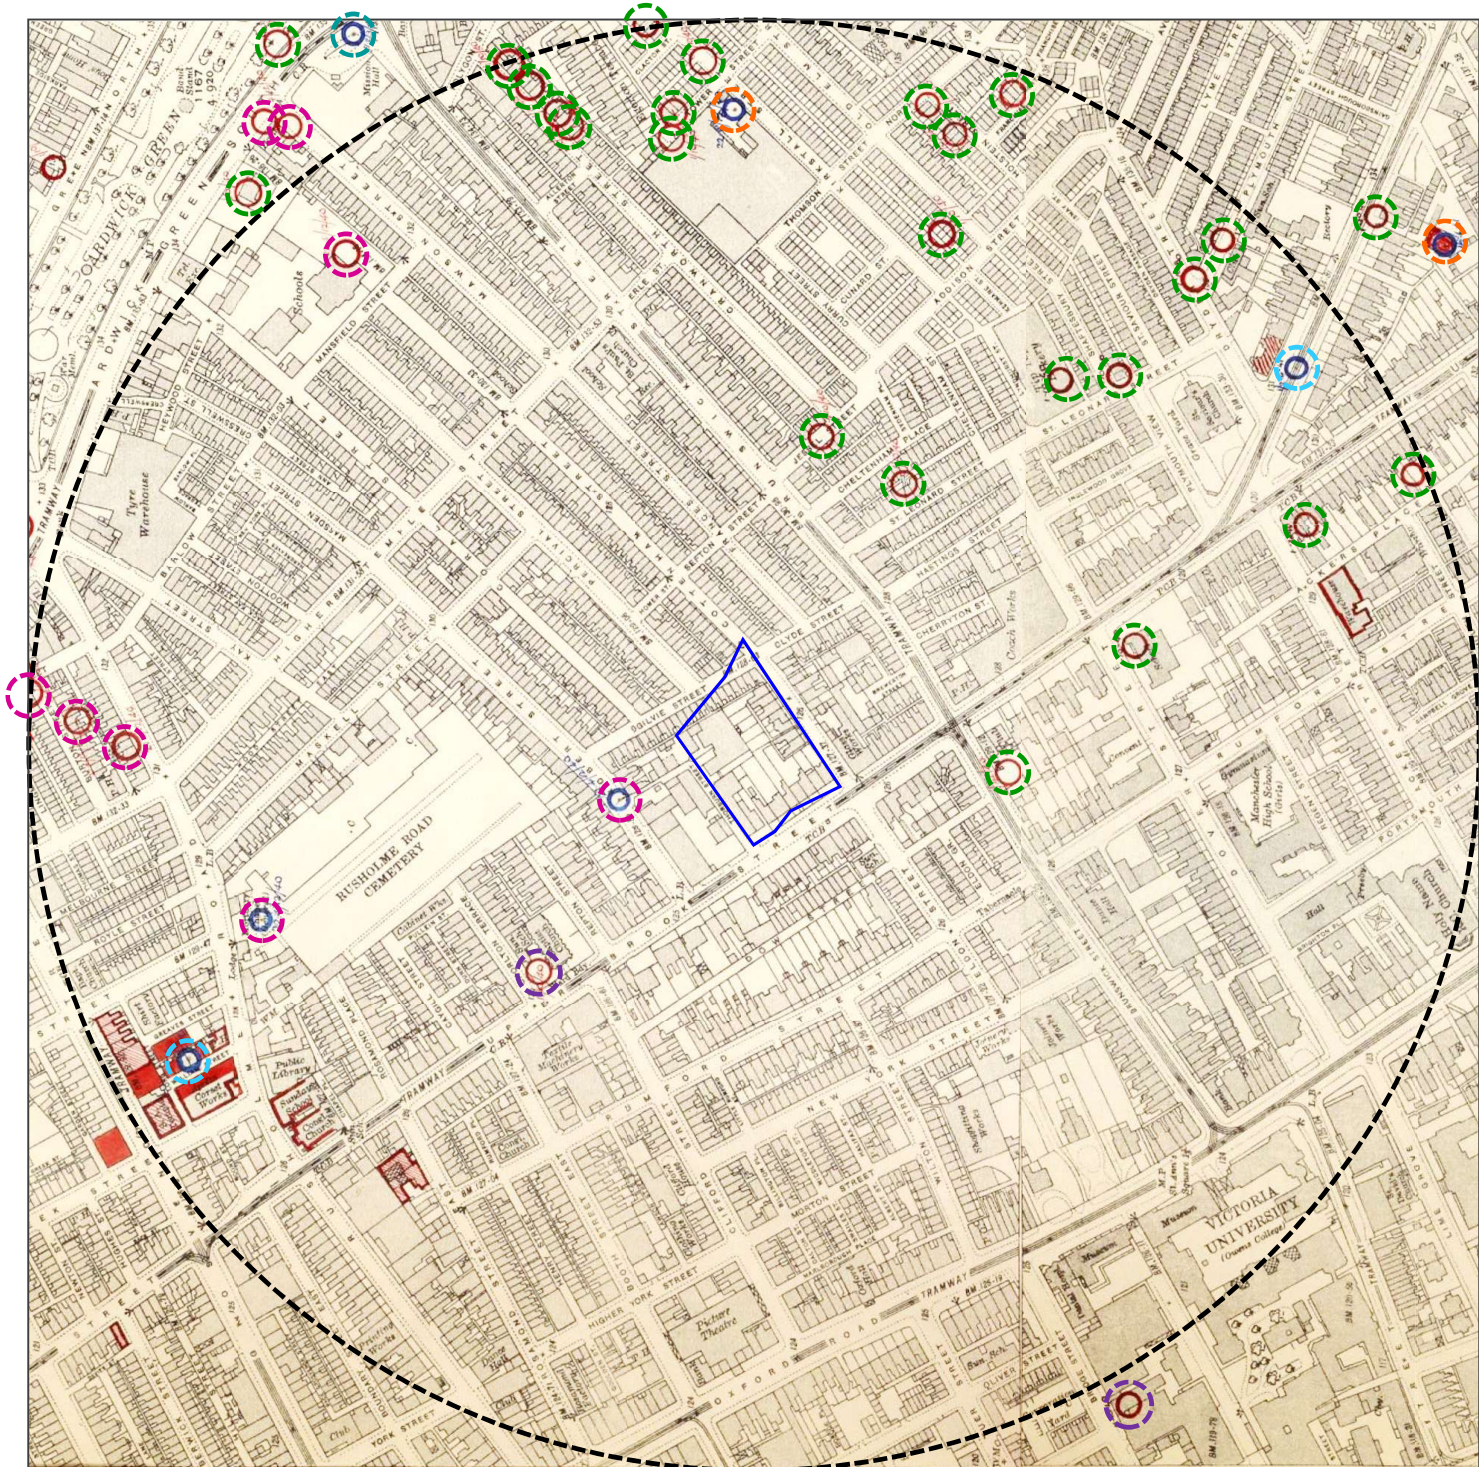
**Figure: 06**

**Figure Title:**  
Risk Map

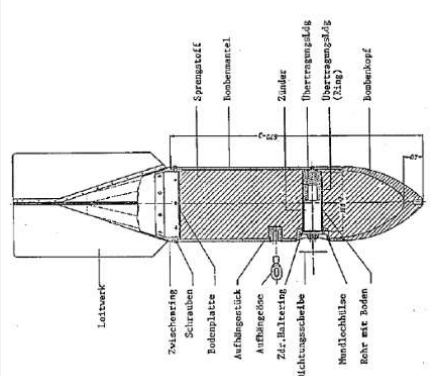
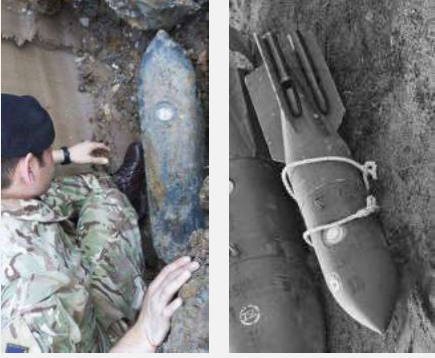
| Appearance: | Grey/green with yellow stripe on the tail unit |
| Variants: | Grades I, II and III. Body length / construction |

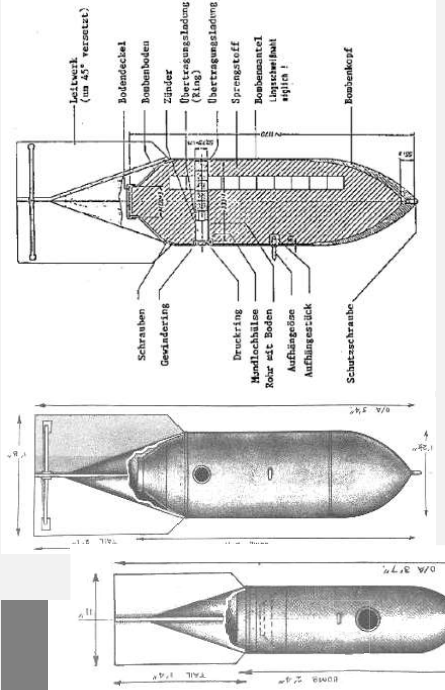
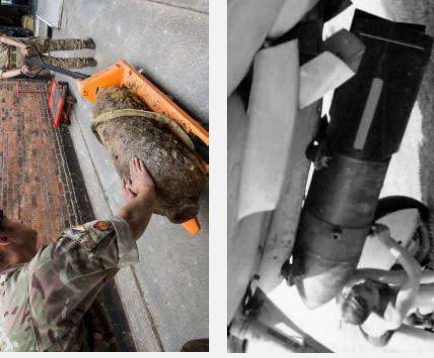
SC 250

| Bomb Weight: | 256kg (564lb) |
| Appearance: | Grey/green with yellow stripe on the tail unit |
| Variants: | Grades I and II. Body length and doubled fu |

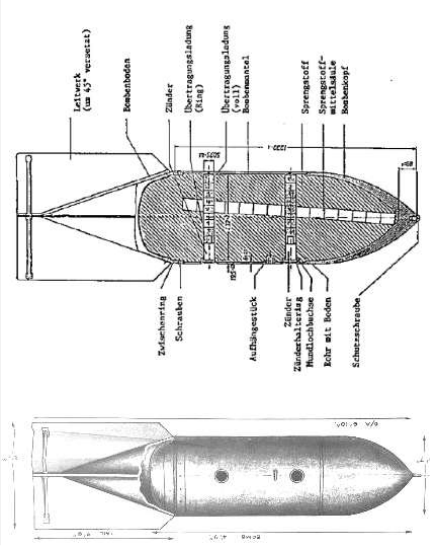
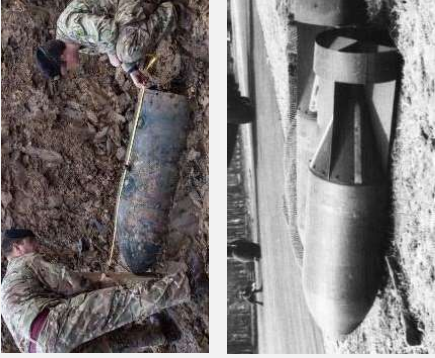
SC 500

| Bomb Weight: | 480 to 520kg (1,058 to 1,146lb) |
| Appearance: | Grey/green or buff with yellow stripe on the tail unit |
| Variants: | Grades I, II and III. Body length / construction |

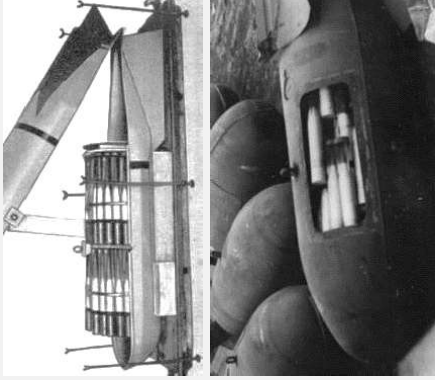
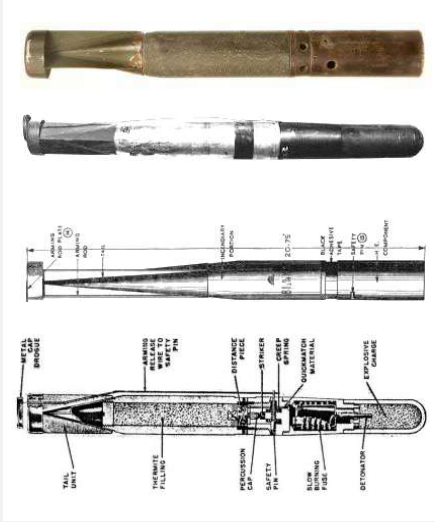
B2 Series Sub-Munition

| Bomb Weight: | 2.0 to 2.2kg (4.40 to 4.85lb) |
| Variants: | Two types; round nose or flat nose plus longer tail unit |
| Bomb Container: | Various sizes holding up to 372No. B2s. Usually mixed with B1s. |

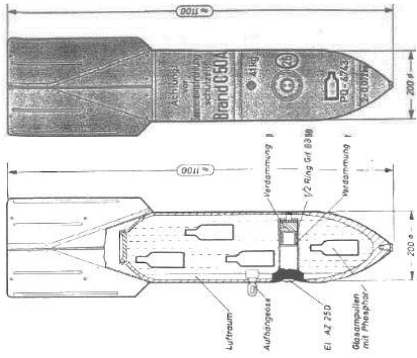
Brand C50 A

| Bomb Weight: | 41kg (75lb) |
| Appearance: | Grey or green body, red base, red band around the centre of the body |
| Variants: | C50 B (77% Phosphorus fill) |

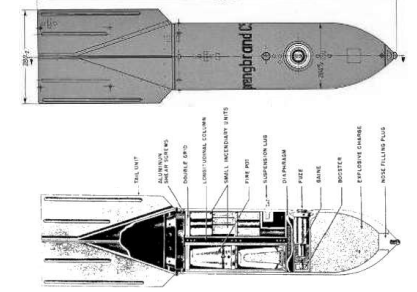
Sprengbrand C50 'Fire Pot'

| Bomb Weight: | 50kg (110lb) |
| Appearance: | Grey or green body, red or brown stenciling on body |
| Variants: | None |

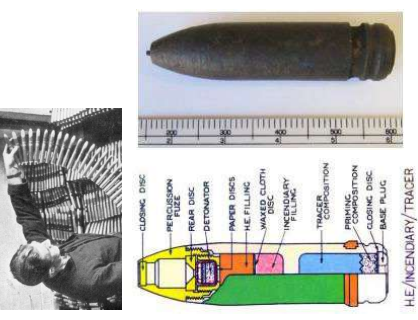
20mm Light AA Gun (WW2)

| Shell Weight: | 123g or 116g or 130g |
| Max Range: | 4,389m |
| Rate of Fire: | 250 to 450rpm |

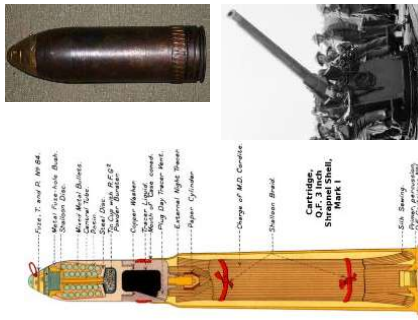
3 inch QF Heavy AA Gun (WW1)

| Shell Weight: | 5.7kg or 7.3kg |
| Max Range: | 6,700m |
| Rate of Fire: | 16 to 18rpm |

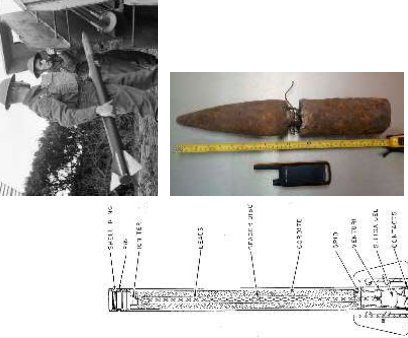
3-inch UP Rocket - Z Battery (WW2)

| Rocket Weight: | 24.5kg |
| Shell Appearance: | Pointed bronze or black nose |
| Max Range: | 6,770m |

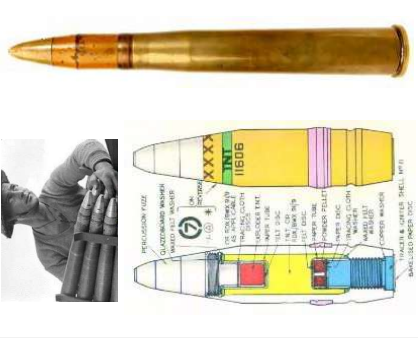
40mm Light AA Gun (WW2)

| Shell Weight: | 0.84kg |
| Max Range: | 7,160m |
| Rate of Fire: | 120rpm |

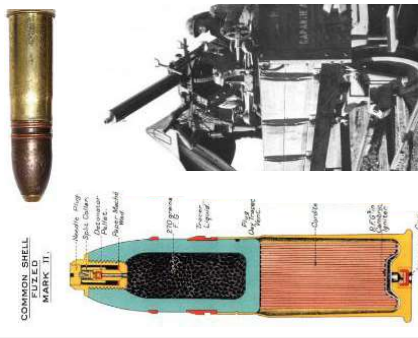
37mm Light AA Gun (WW1)

| Shell Weight: | 0.45kg |
| Max Range: | 4,110m |
| Rate of Fire: | 300rpm |
