# **Great Jones Street, Manchester**

## **Phase 1 Geo-Environmental Investigation**

For: Oslady Homes Ltd

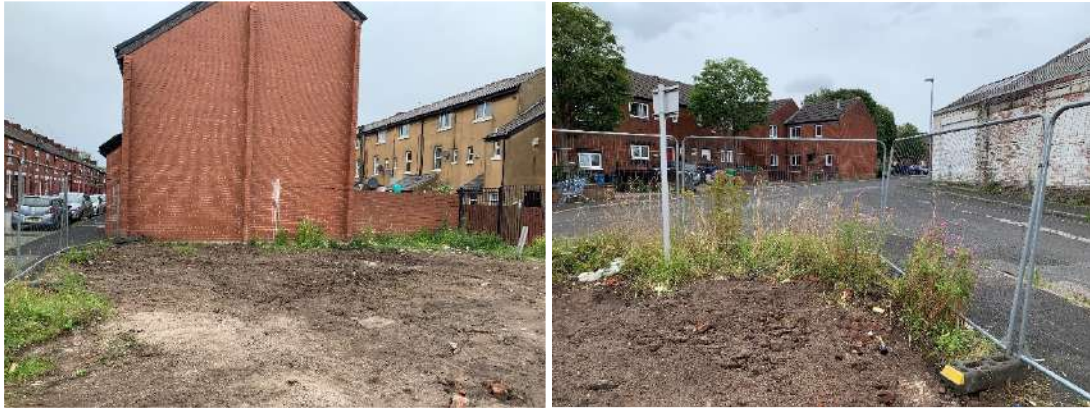
The site currently comprises a small, vacant parcel of land. The ground underfoot was noted to be semi-grassed Made Ground across the site. The site is bound by a residential property to the west, an alleyway to the north, Milne Close to the east and Great Jones Street to the south.

Figure 3: Photographs of the western site section (left) and eastern site section (right).

The topography across the site remains relatively consistent with levels in the north western site section at 56.76m AOD and levels in the southeastern corner at 57.14m AOD.

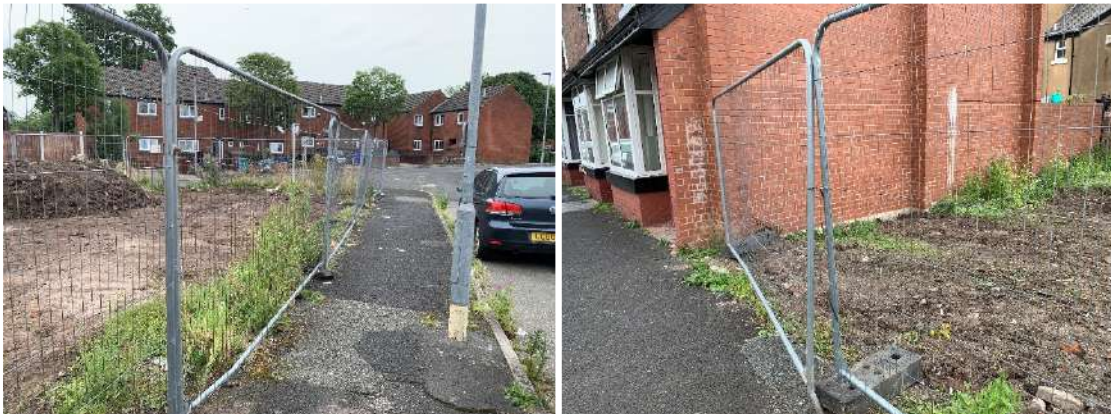
Figure 4: Photographs showing the southern boundary along Great Jones Street looking east (left) and west (right).

No evidence of overhead or underground services were noted on site. However, services were noted running beneath the pavements which bound the site. For example, water services are known to run parallel to the northern boundary, while electricity and gas services are known to run parallel to the southern boundary.

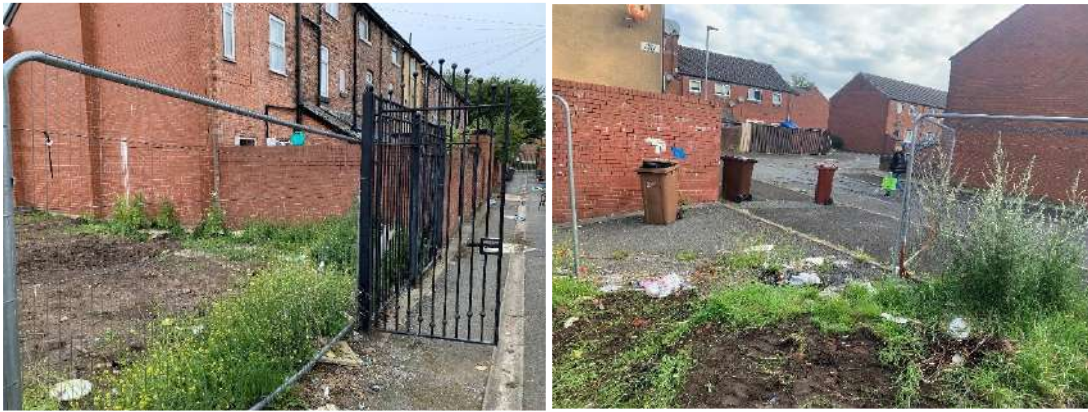
*Figure 5: Photographs showing the northwestern corner of the site (left) and the site access looking north towards Milne Close (right).*

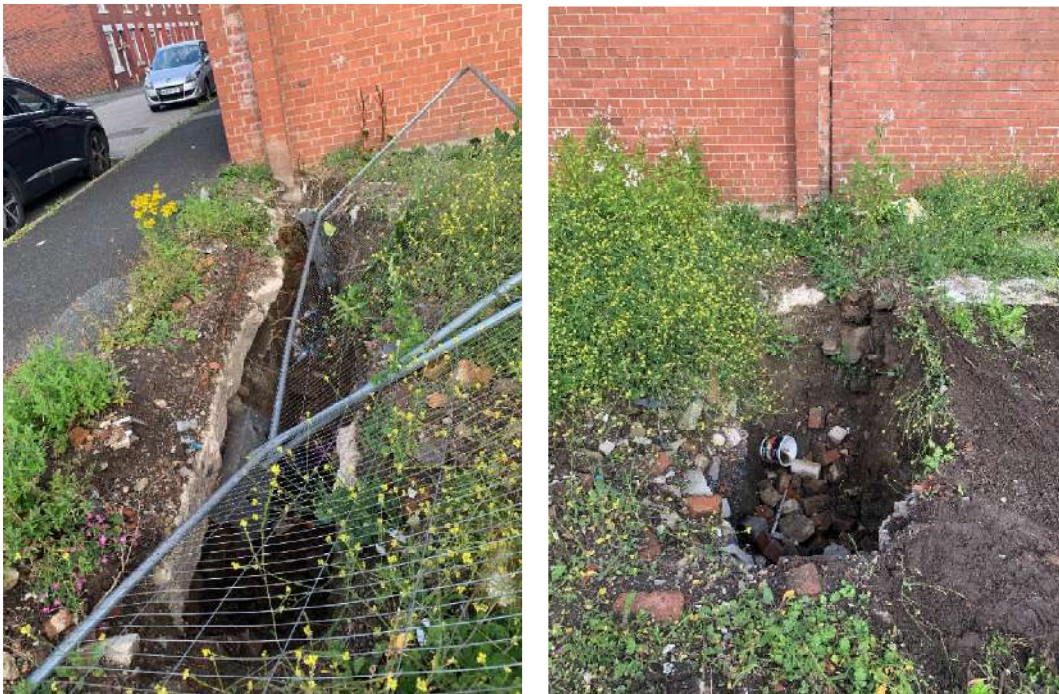
Two open holes were also noted on site. One adjacent to the southern boundary and the other in the western site section, both suspected former trial pits.

*Figure 6: Photographs showing open holes along the southern boundary (left) and in the western site section (right).*

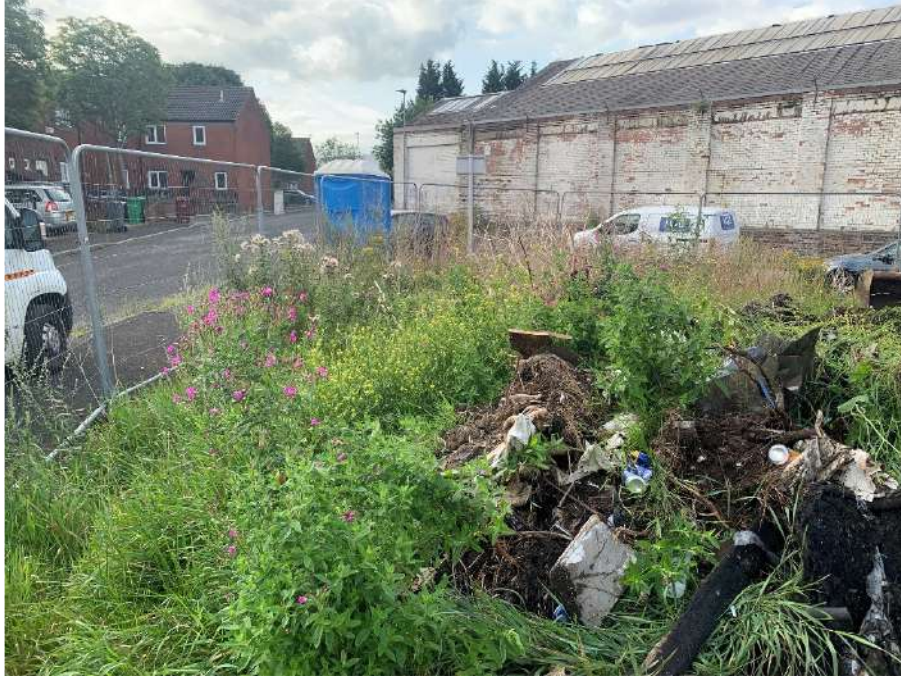
No evidence of contamination (i.e. spillages or leakages) or contaminative sources were identified. However, evidence of fly tipping was noted in the northeastern site section. The material primarily contained household waste.

Figure 2: Photograph showing the fly tipping in the northeastern site section.

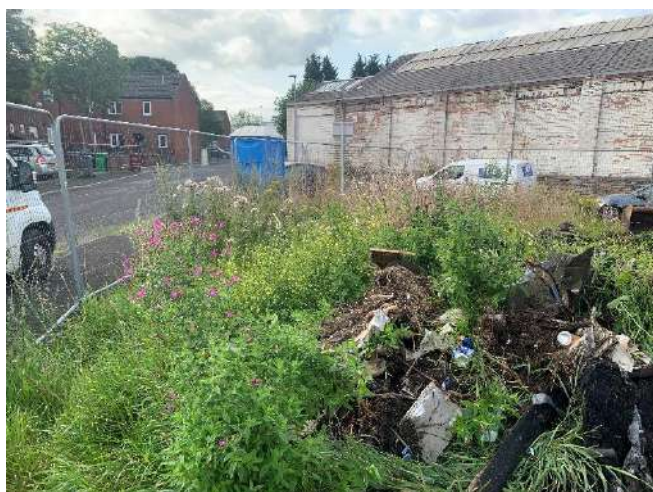
Figure 7 – Looking south east, showing the fly tipping on site.

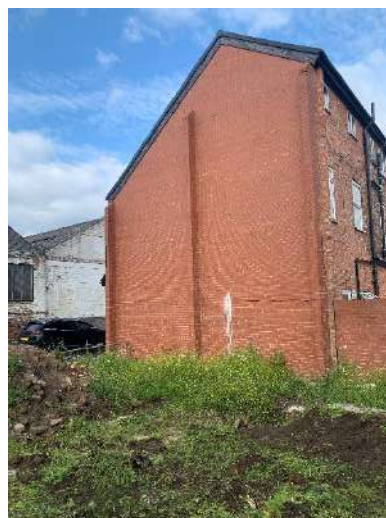
It should be noted that the western boundary of the site are existing buildings, therefore consideration is required for the impact of the proposed development on third party walls.

Figure 8 – Showing the hieght of the third party walls along the western boundary.

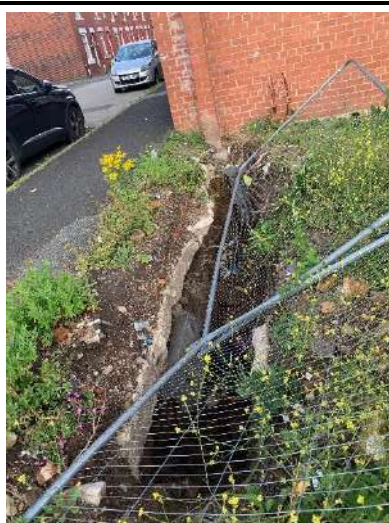
Figure 11 – Open hole running along the southern boundary.

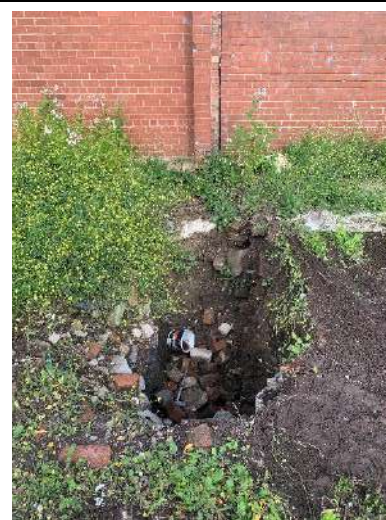
Figure 12 – Open hole in the western site section.
