# ARBORICULTURAL IMPLICATIONS ASSESSMENT

PROPOSED DEVELOPMENT

GREY MARE LANE  
MANCHESTER

Author: C. Salisbury  
Date: 02 March 2025  
Ref: TRE/GMLM/Rev E

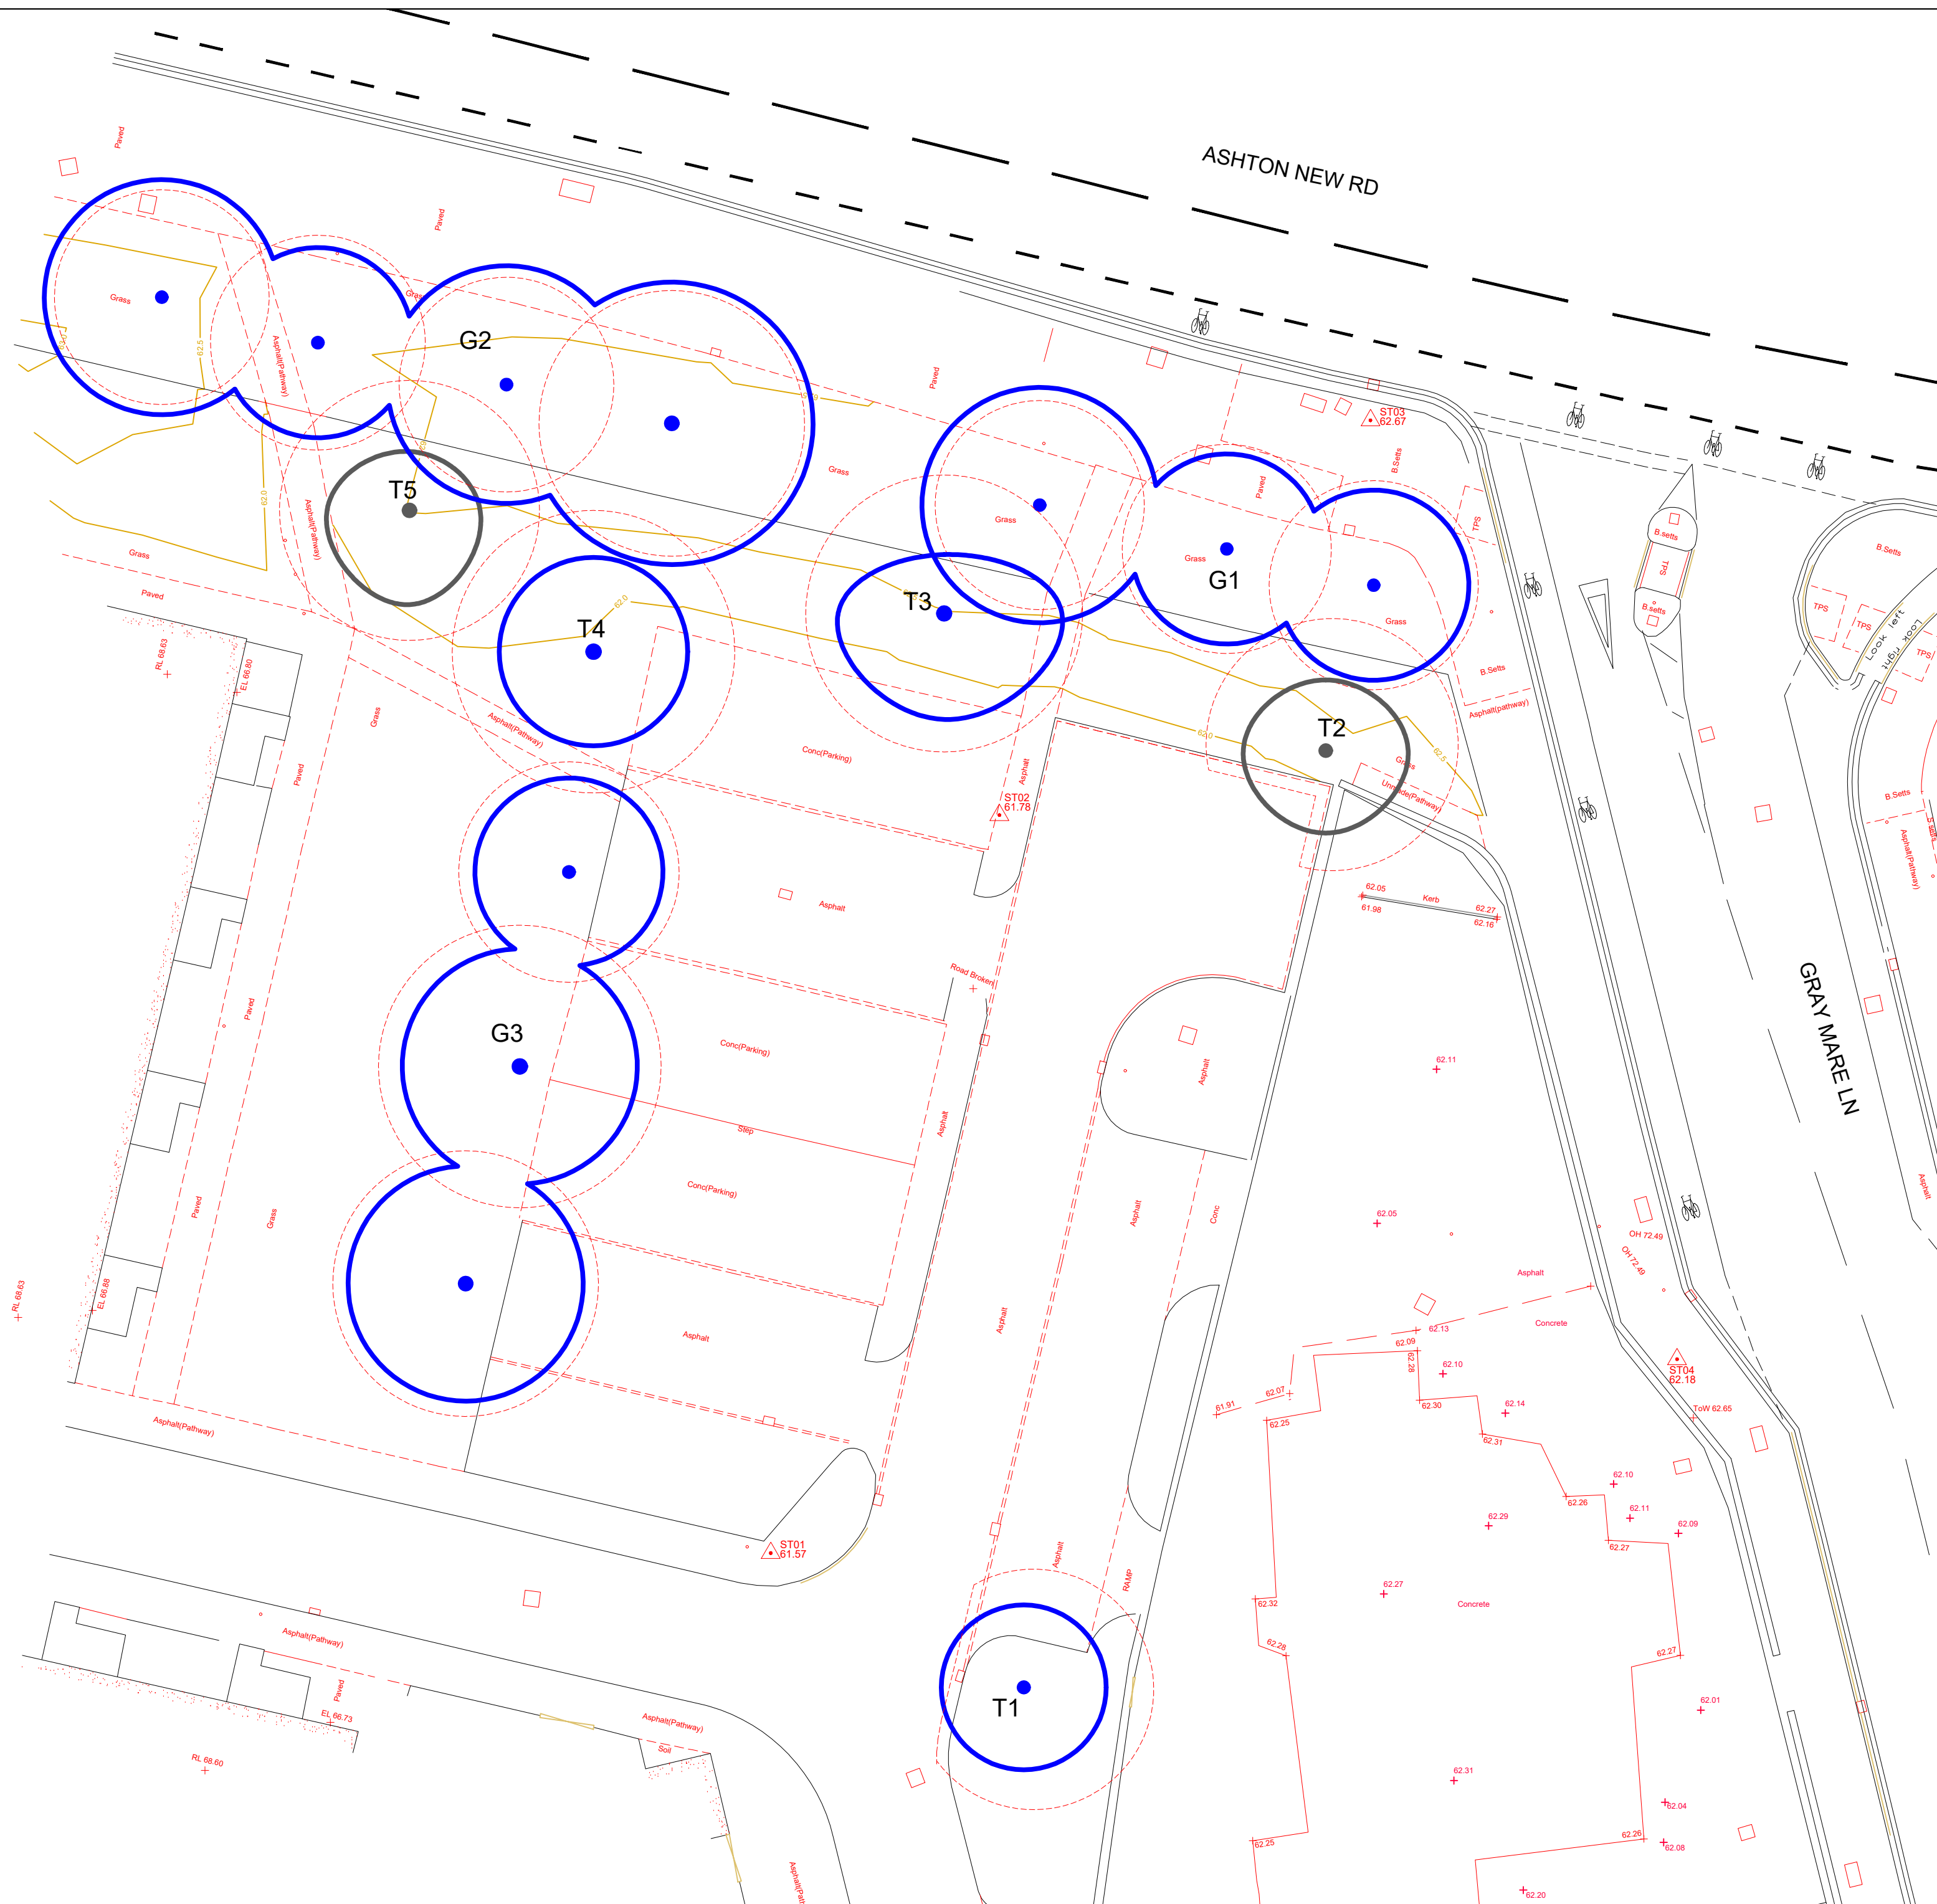
Drawing No:  
GMLM/BS/01

Drawing Title:  
BS5837 Plan

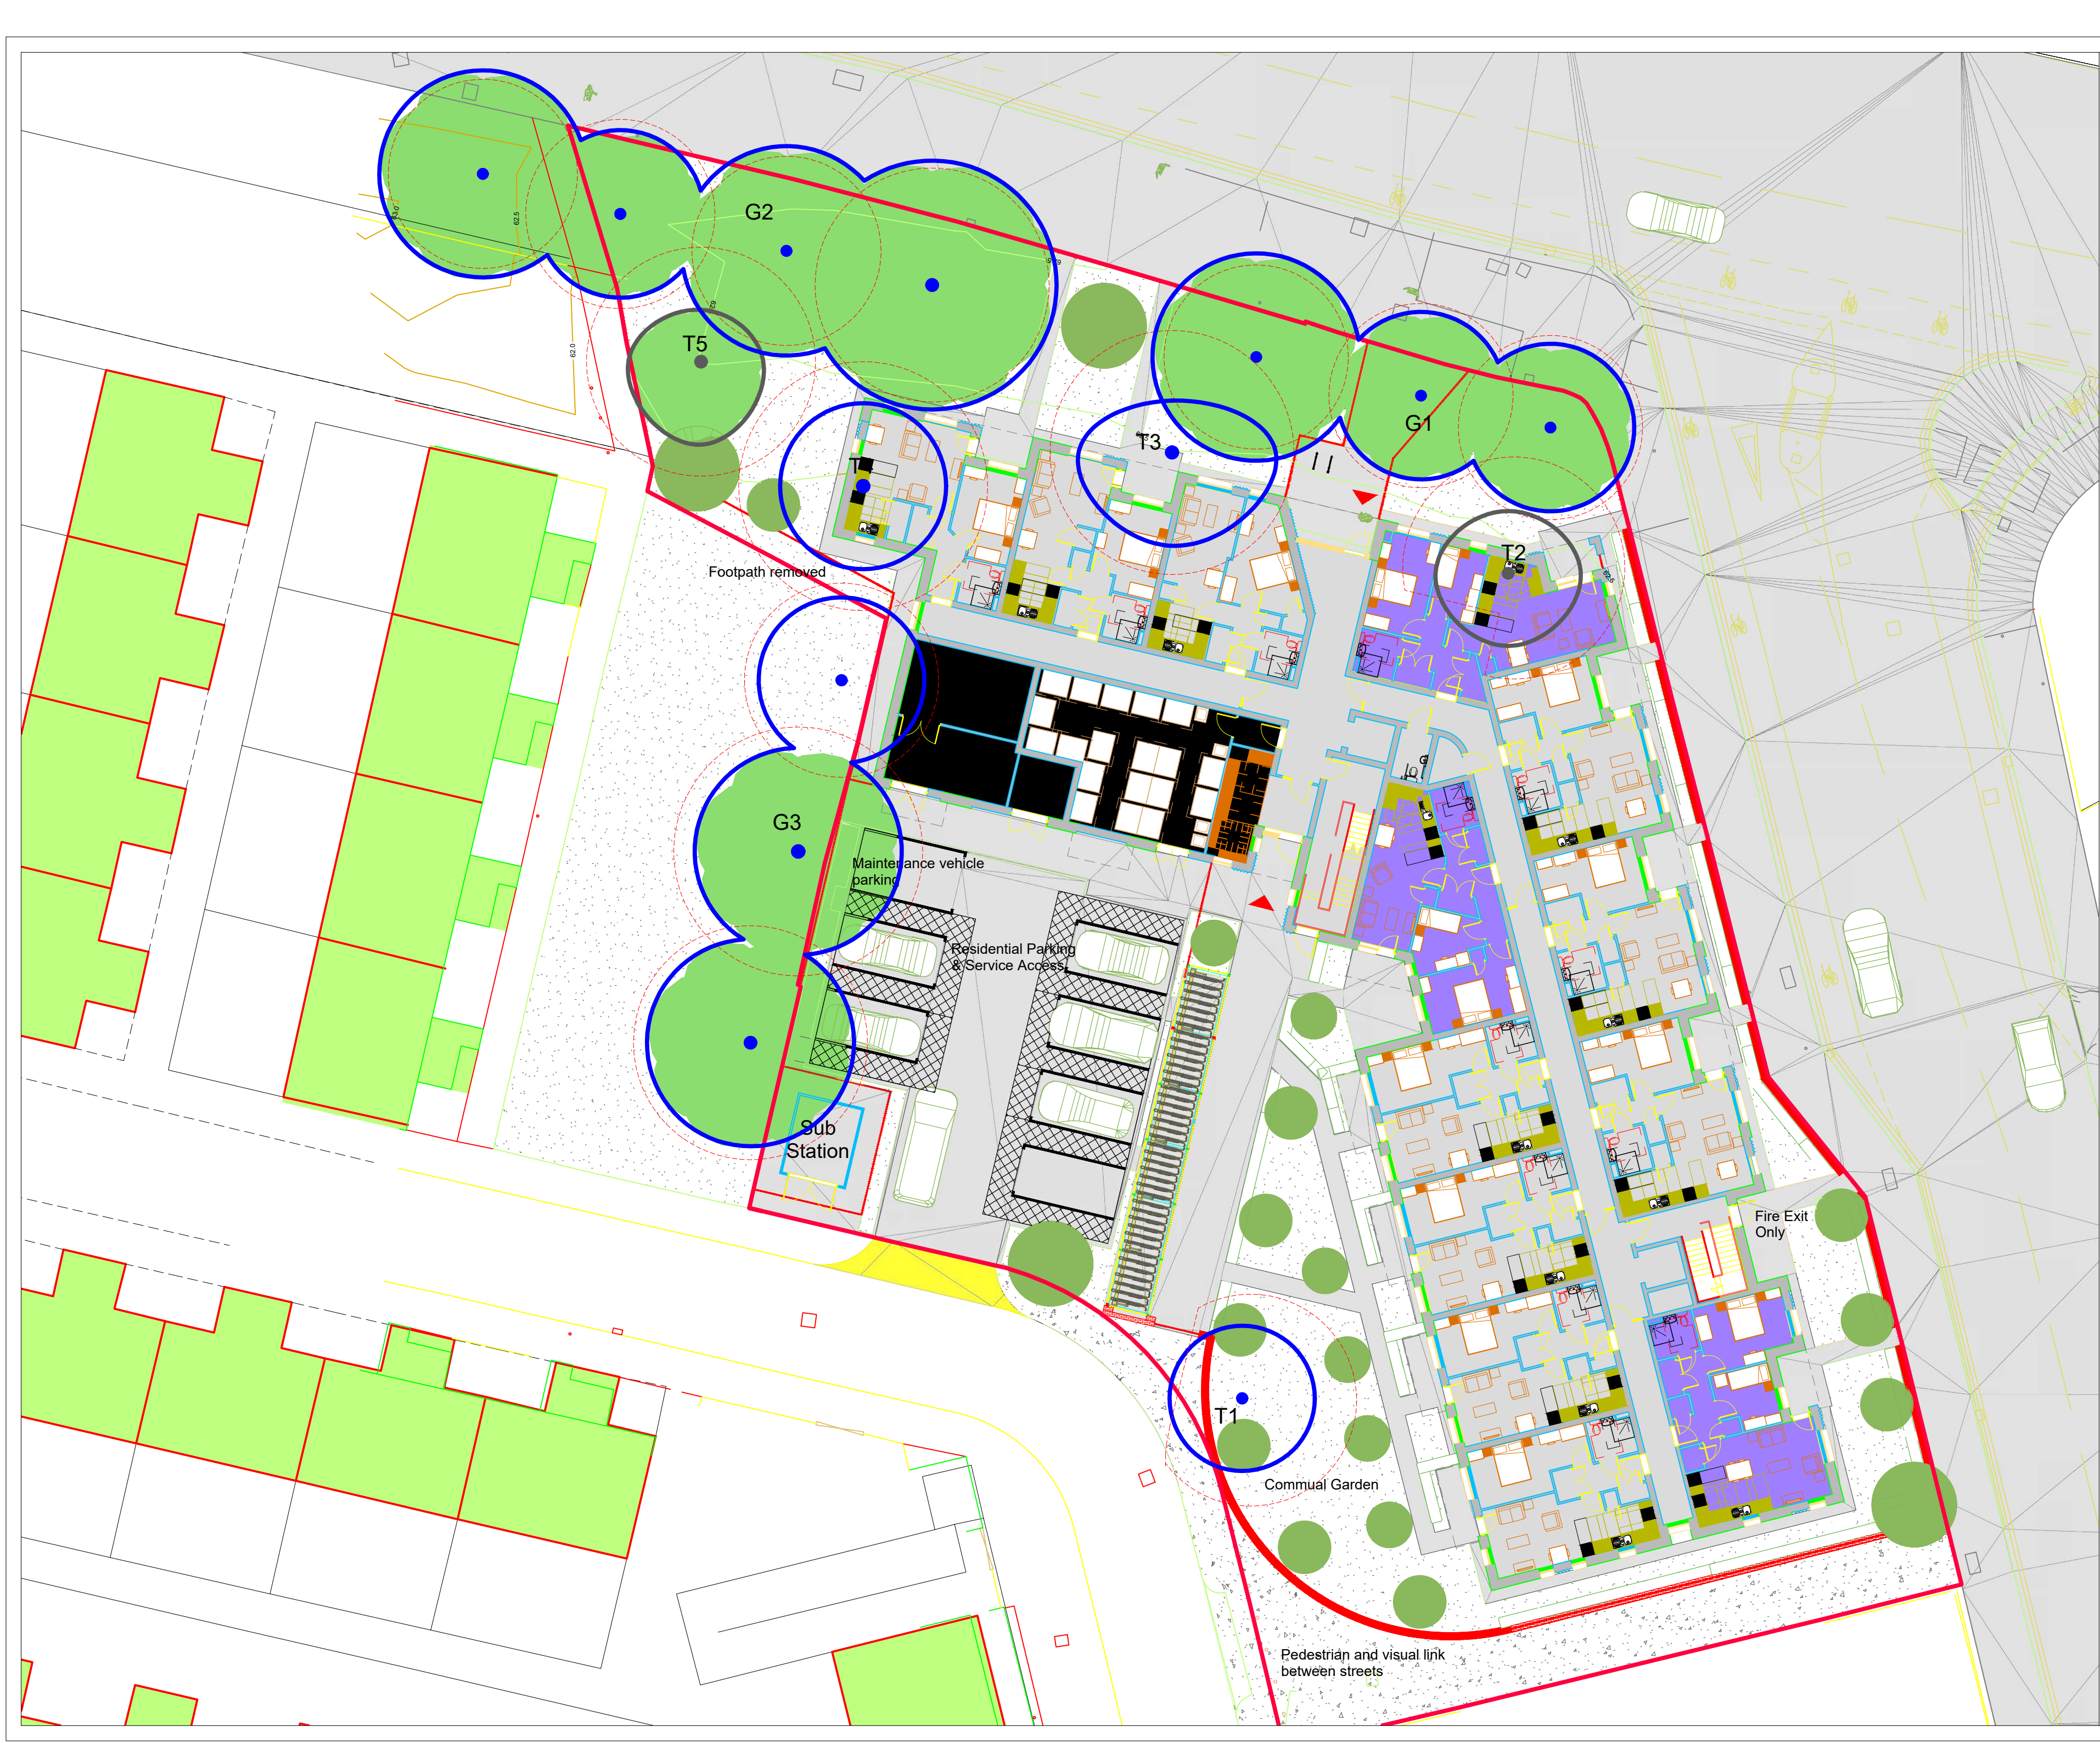
Drawing No:  
GMLM/AIS/01 Rev E

- 3.1 Due to the proposed development and its associated infrastructure there are a number of locations where the proposals are in close proximity to the trees surveyed. The Site Layout Plan within appendix three identifies the trees in relation to the proposed development.
- 3.2 In order to fully assess the impact of the proposals an Impact Table has been created detailing each tree, which shows the proximity of the associated works to the tree.
- 3.3 This can then be assessed in accordance with BS 5837:2012 to determine whether the development will have a detrimental impact on the health of each tree. Once this has been determined remedial measures can be detailed to reduce the impact the proposals will have on the treescape.

Drawing Title:  
AIS Plan
