## Ground Investigation Report

Proposed Mixed Use Development

Postal Street, Manchester

March 2025

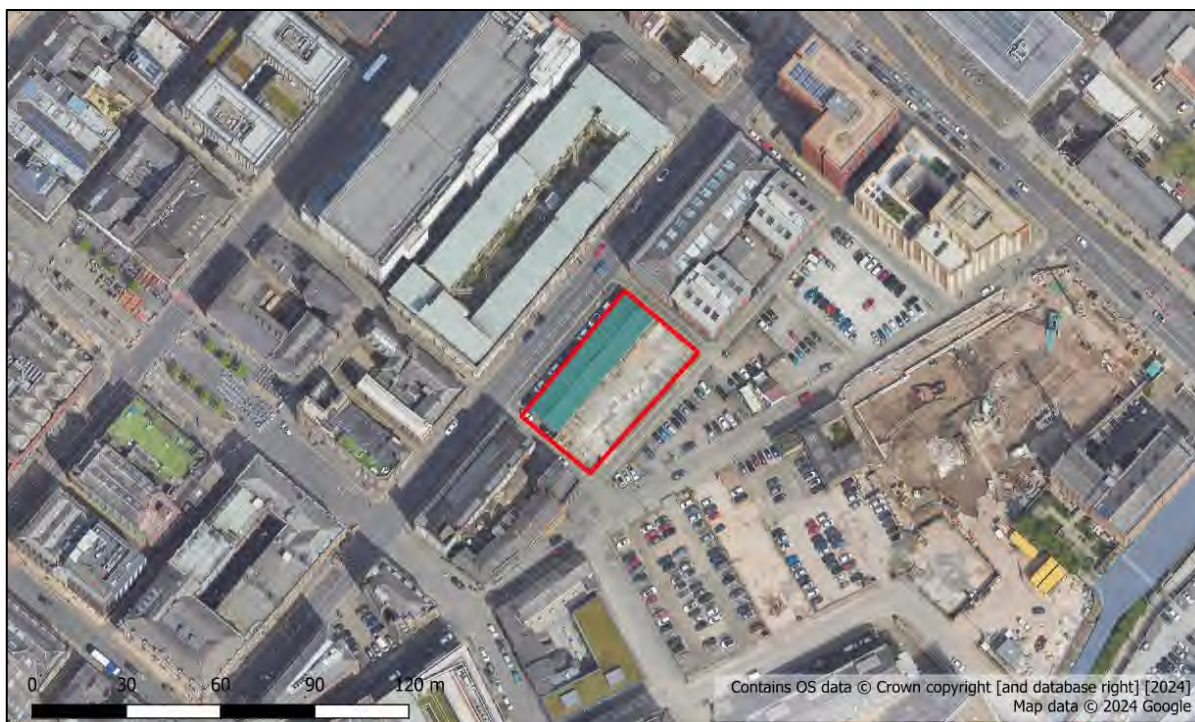
*Figure 2-A: Aerial photograph and approximate site boundary*

- 2.1.1 The proposed development lies within Manchester, approximately 0.6km northeast of the town centre. The post code for the site is M1 1EE, and the site is accessed from Dean Street which lies adjacent to the site's south-eastern boundary.
- 2.1.2 An aerial image showing the approximate site boundary is presented below, followed by a site layout summary. A site plan is provided within Appendix A.

- 2.1.3 The site is currently unoccupied and levelled, with demolition of relict above ground structures recently completed. Surfacing generally comprises of bare earth, with localised areas of hardstanding are present across entire site footprint. Site boundaries are formed by timber hoarding.
- 2.1.4 A selection of site photographs are presented below:

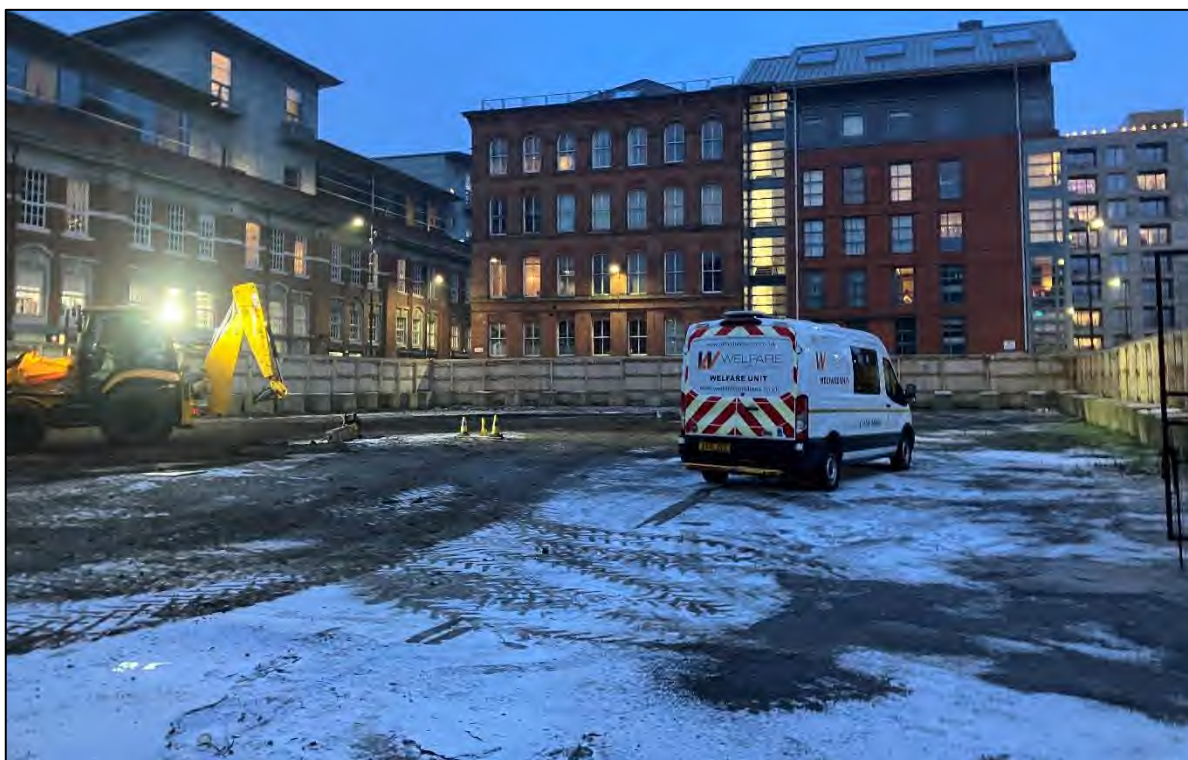
Figure 2-B: General view of the site, taken adjacent to the site entrance in the southeast facing north

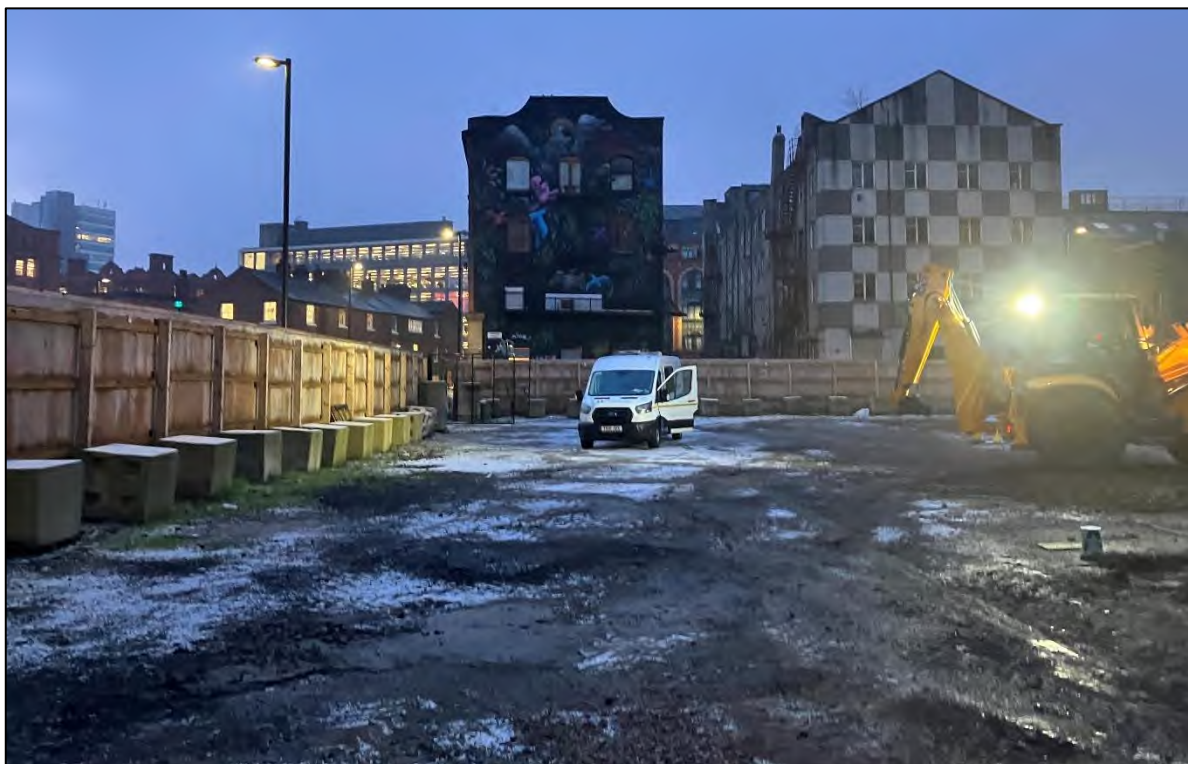
Figure 2-C: General view of the site, taken in the northeast of the site facing southwest

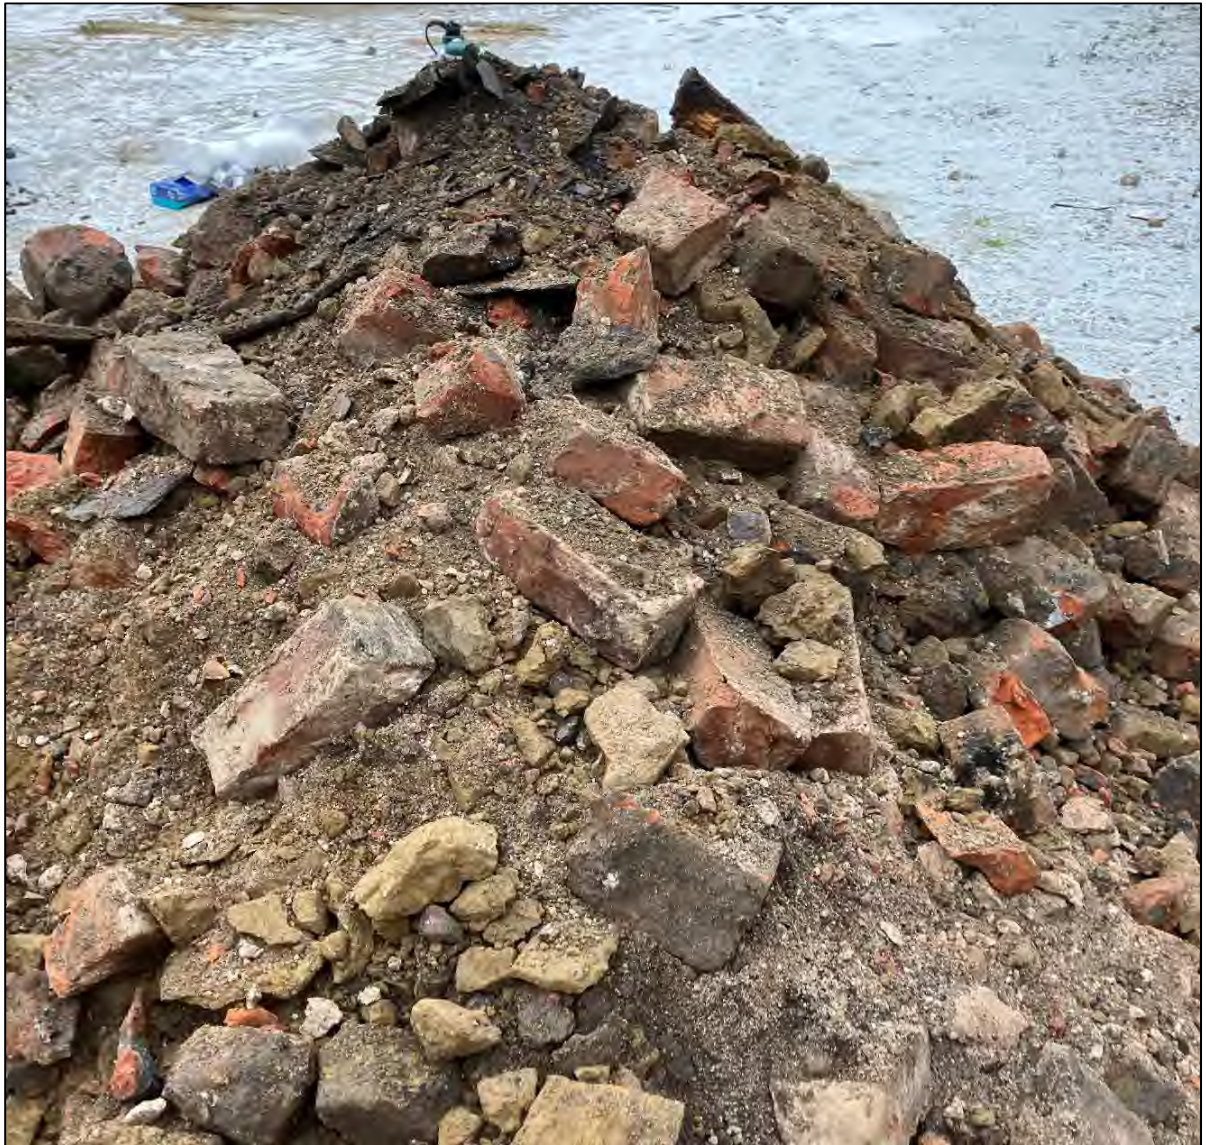
- 5.3.3 A photograph of the Made Ground deposits encountered during Soiltechnics 2025 investigations is presented below.

*Figure 5-A: Made Ground deposits encountered in TP02*

- 5.3.1 Made Ground was observed from ground level or underlying hardstanding where present. The base of the Made Ground was only proven in TP03 at 2.00m bgl in the northern corner of the site during 2025 investigations. All other positions terminated within the Made Ground to a maximum exploratory depth of 3.3m. During Curtins, 2022 investigations, Made Ground was encountered to depths between 2.1-3.5m bgl.
- 5.3.2 Made Ground was variable in composition, however generally comprised brown and black sandy gravel with cobbles of brick and concrete. Frequent metal, timber and plastic was also observed within Made Ground deposits.

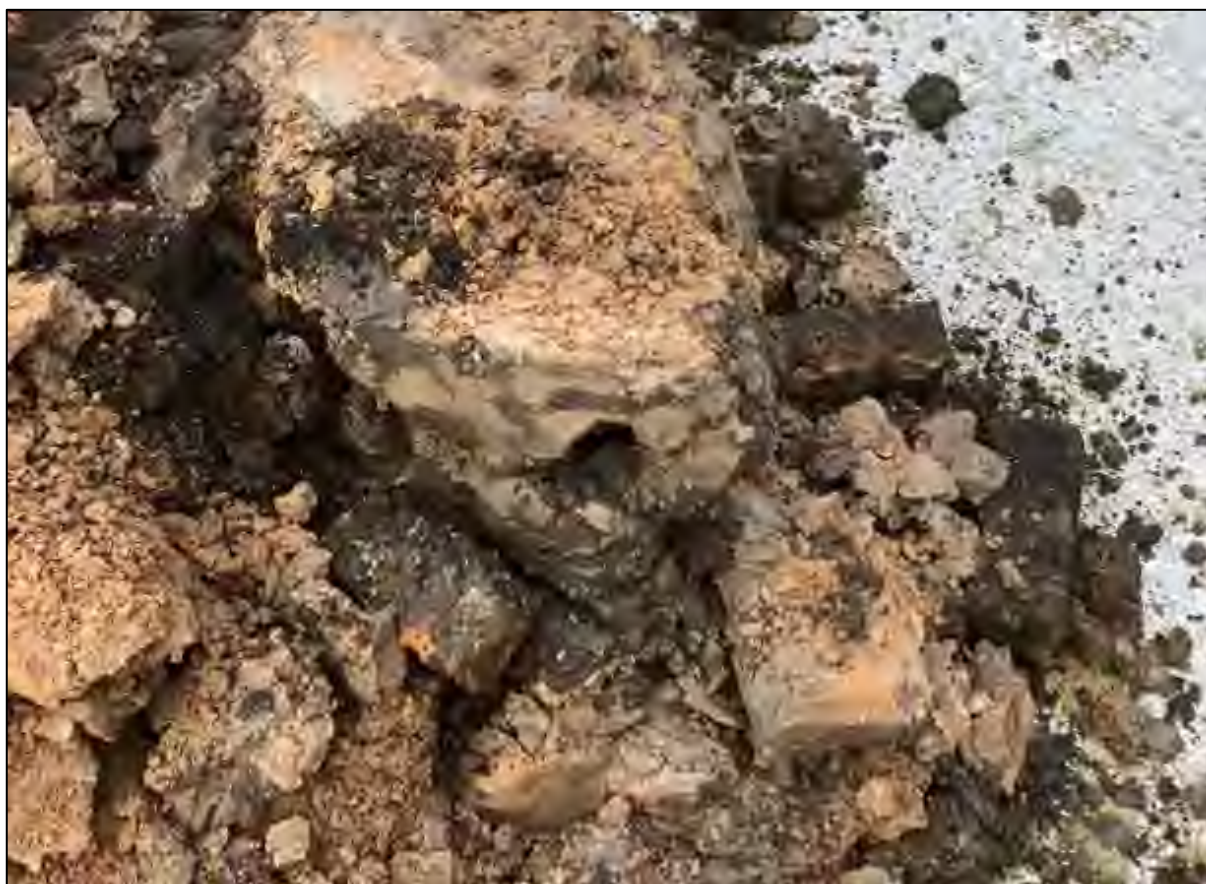
Figure 5-B: Devensian Till encountered at the base of TP03

- 5.4.1 Devensian Till was encountered underlying Made Ground deposits from 2.00m bgl in TP03 only comprising firm, orangish brown mottled grey gravelly clay.
- 5.4.2 During Curtins 2022 investigations, Till comprised firm to stiff gravelly clay with bands of sandy clayey gravel and clayey sand to depths of 22.90m to 23.80m bgl.
- 5.4.3 A photograph of the cohesive Devensian Till encountered during Soiltechnics 2025 investigations is presented below.

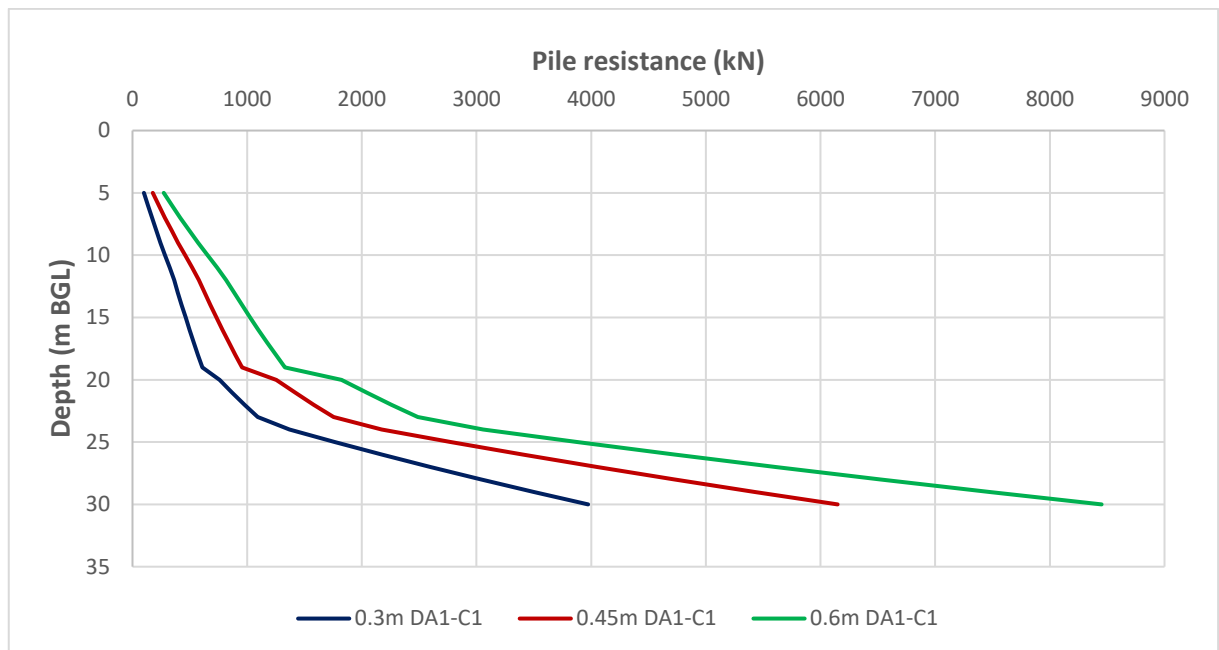
- 6.8.11 The variation of single pile resistance in relation to pile toe level is presented below for three different pile diameters. It should be noted that the resistance of a single pile is reduced in the vicinity of other piles. Accordingly, detailed design of the piled foundation arrangement should take into account spacing between piles and pile group effects.

Figure 6-A: Pile resistance of a single pile versus pile depth – Combination 1

- 6.8.10 We have also considered groundwater at 15.5m bgl as a worst case within the Devensian Till/Chester Formation aquifer (assumed in connectivity).

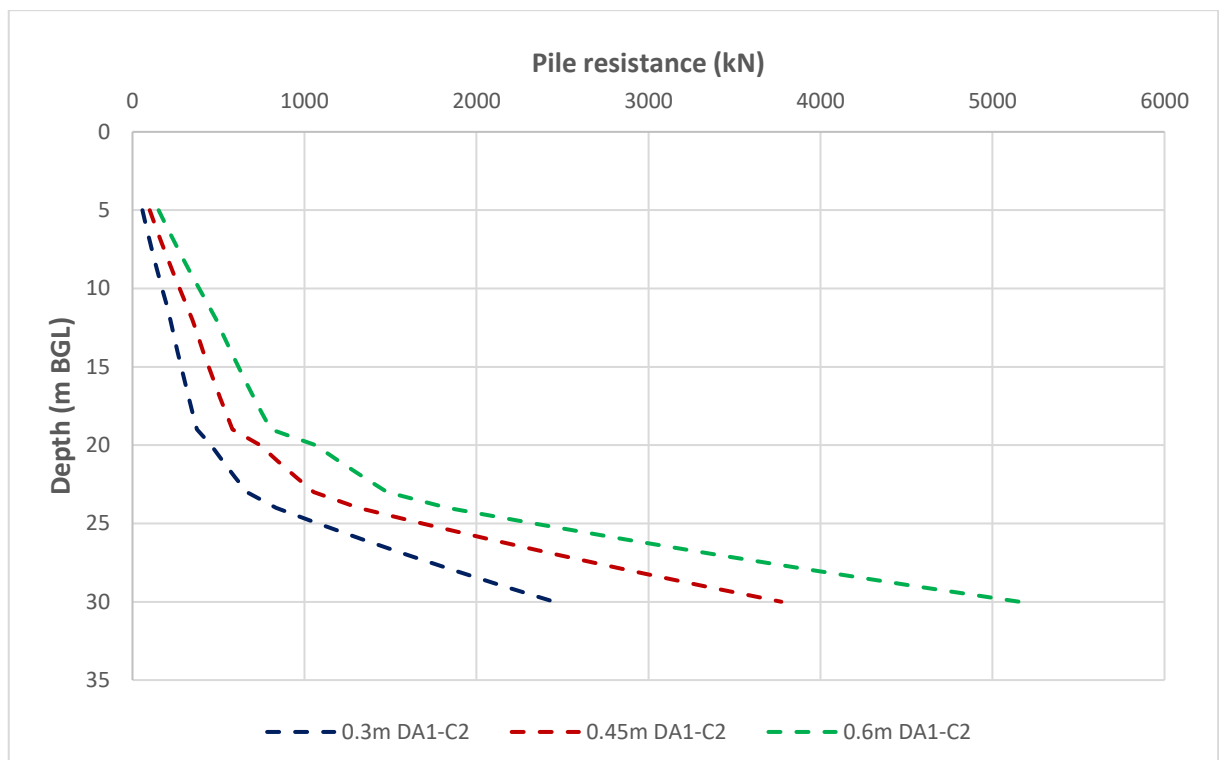
Figure 6-B: Pile resistance of a single pile versus pile depth – Combination 2

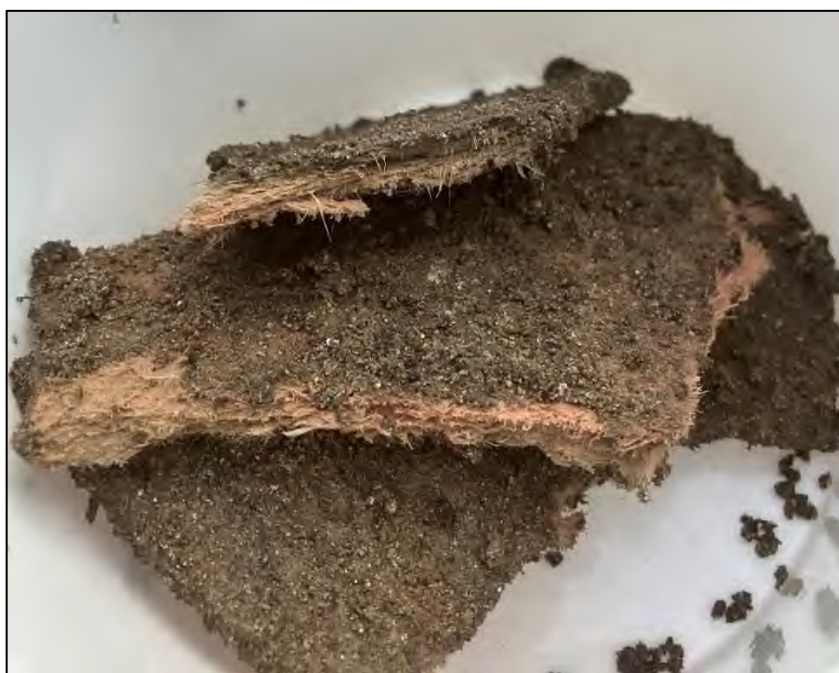
- 7.2.1 A suspected fragment of ACM (bound cement) was observed within Made Ground soils from TP01 at a depth of 3.1m bgl (see Figure 7-A below).

*Figure 7-A: Suspected ACM observed within Made Ground deposits from TP01*

- 7.2.2 As asbestos was already highlighted as a pollutant linkage within the previous Curtins report, no amendments to the previous conceptual site model (CSM) are required.
- 7.2.3 Other than the above, fieldwork observations on the potential for contamination and the underlying ground conditions did not identify any new contaminant sources or significant pathway alterations to the anticipated ground model. Therefore, no potential contaminant linkages (PCL) additions or amendments are required to be made to the CSM at this stage.

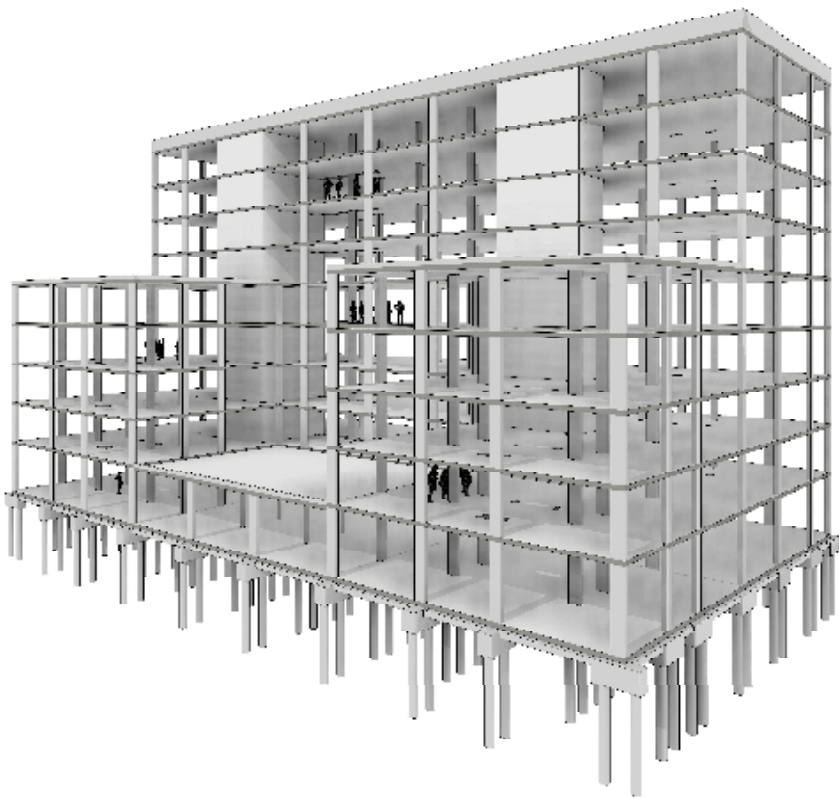
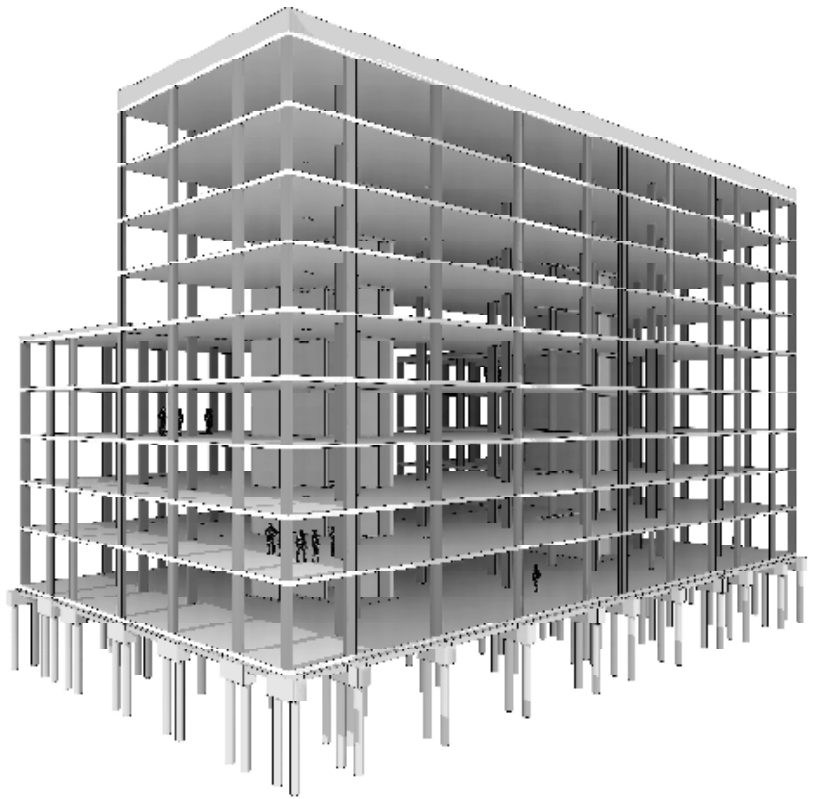
Structural Frame Isometrics

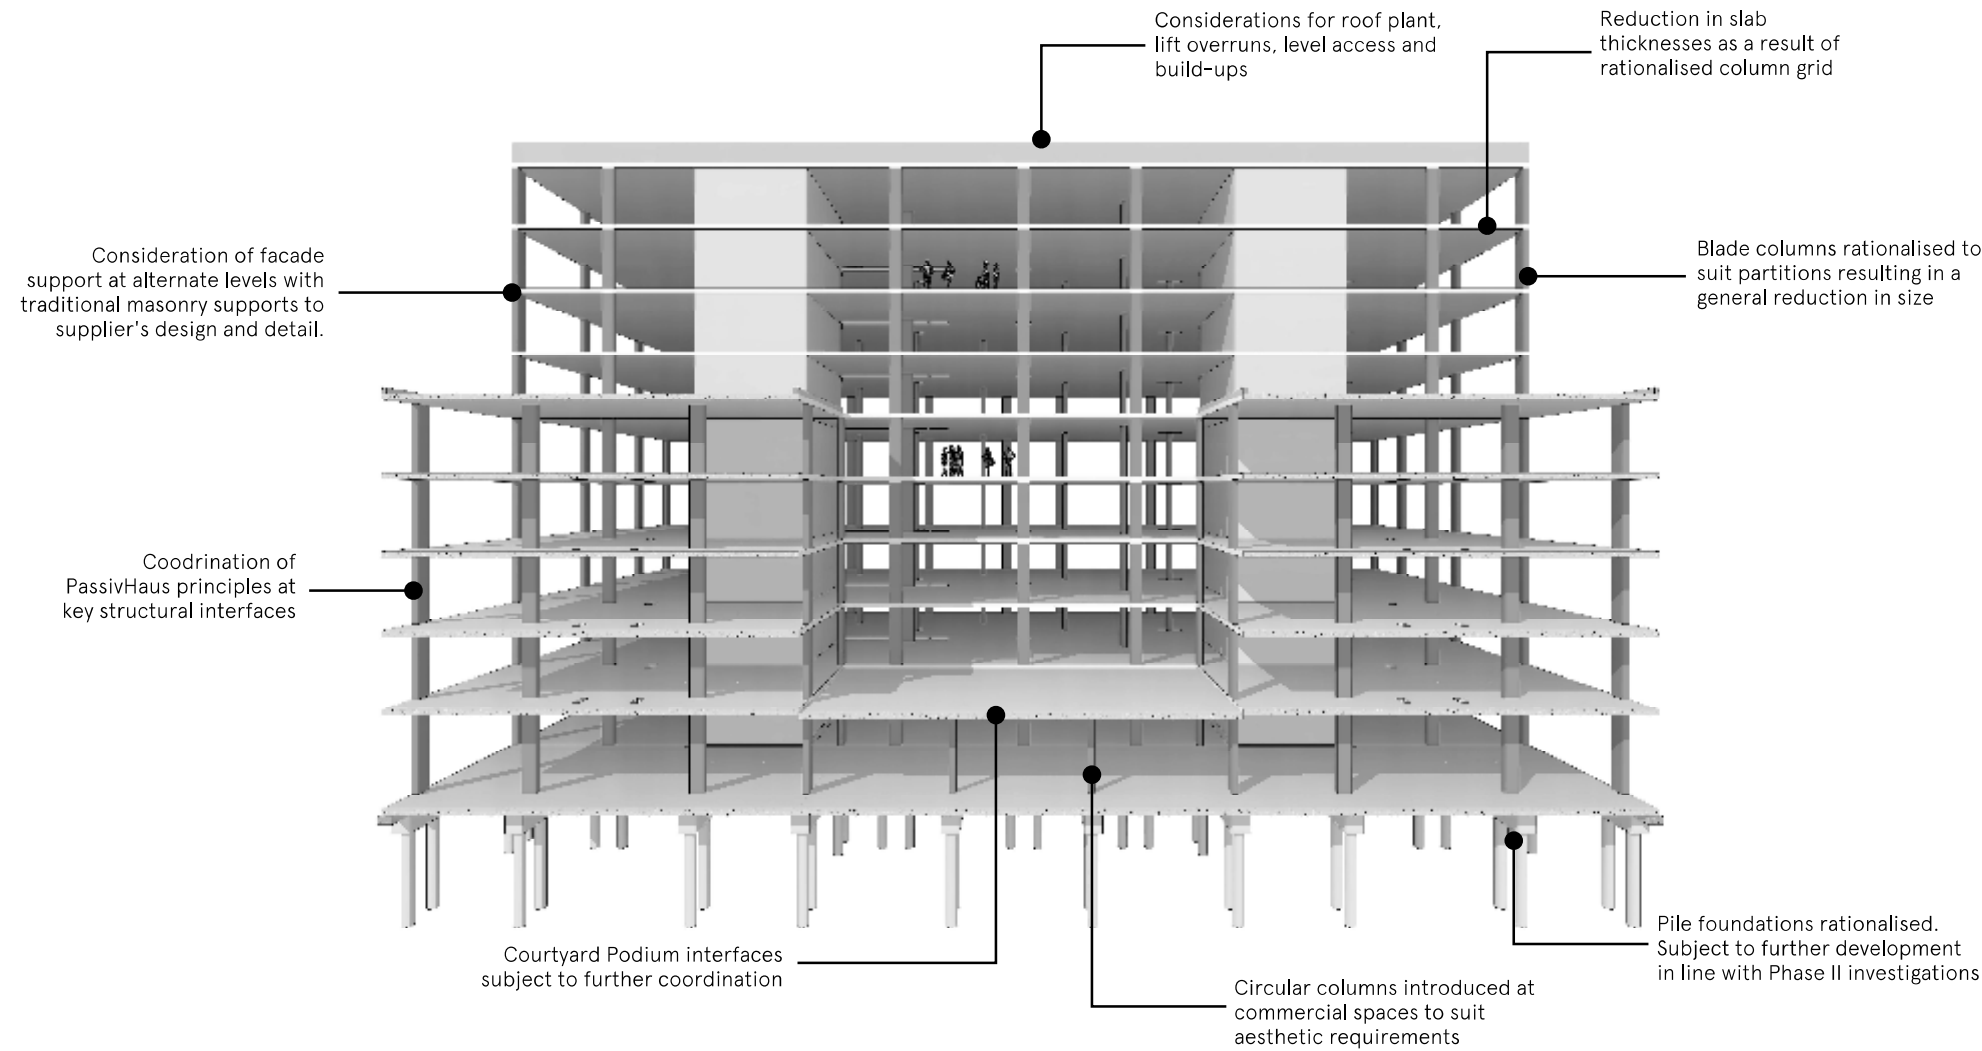
Proposed Postal Street Structural Frame

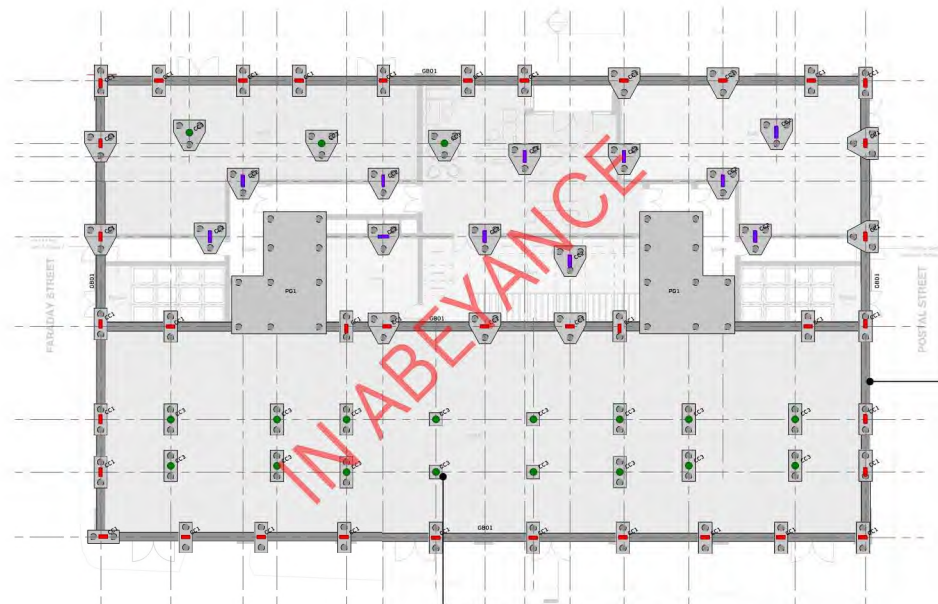
FOUNDATION PLAN  
1:200

Ground beams support low level masonry facade & restrain pile caps. Allow for additional internal ground beams subject to confirmation of slab steps

Allow for moment heads/additional ground beams for internal pile cap restraints

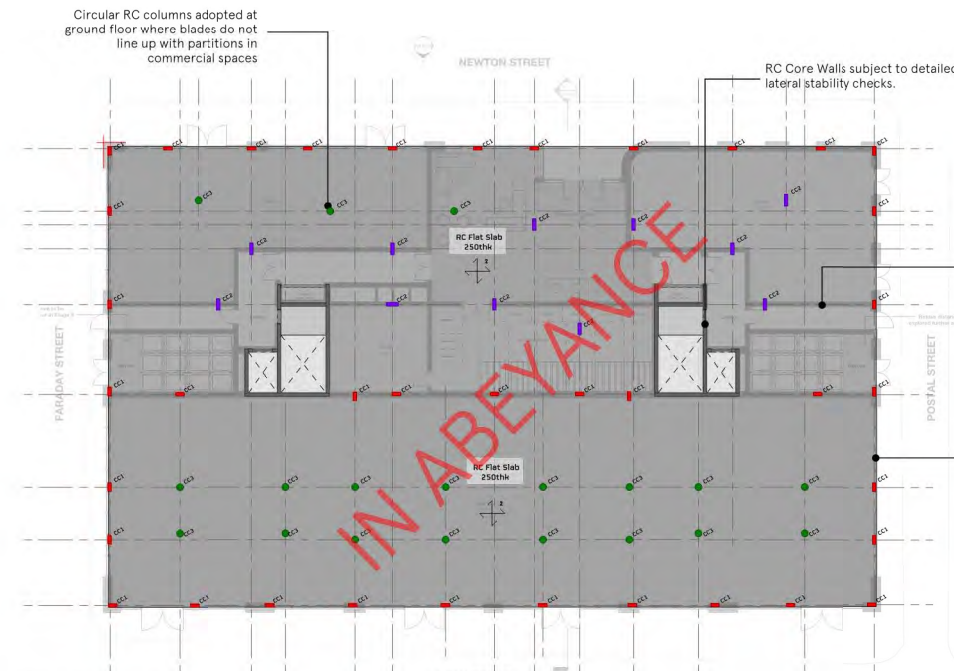
GROUND FLOOR PLAN  
1:200

Circular RC columns adopted at ground floor where blades do not line up with partitions in commercial spaces

Allow for additional ground beams to suit slab steps subject to final depths

Facade assumed to be supported at ground, 1st and every other floor with traditional masonry supports to supplier's design and detail.

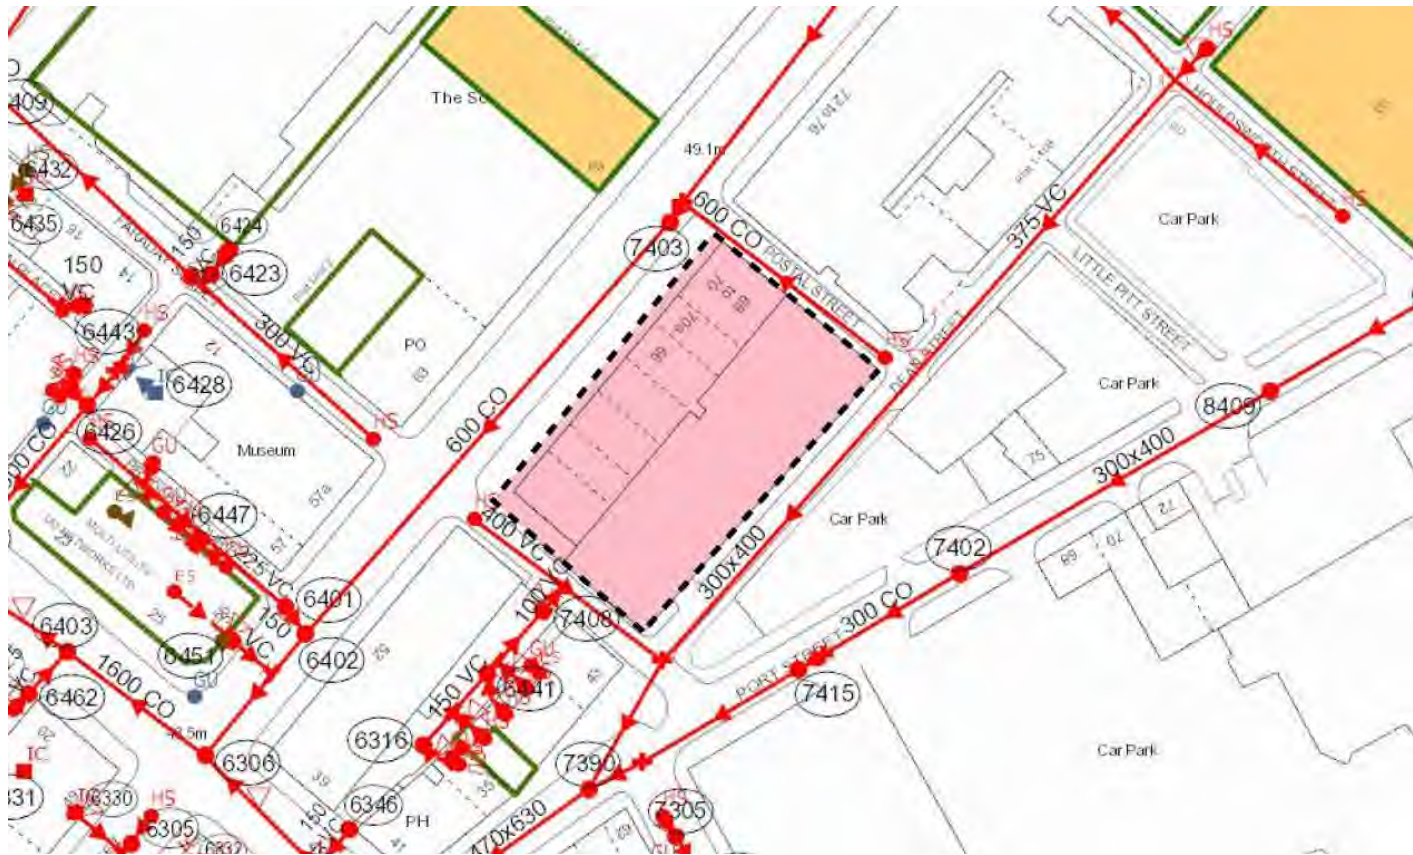
United Utilities Asset Map Extract

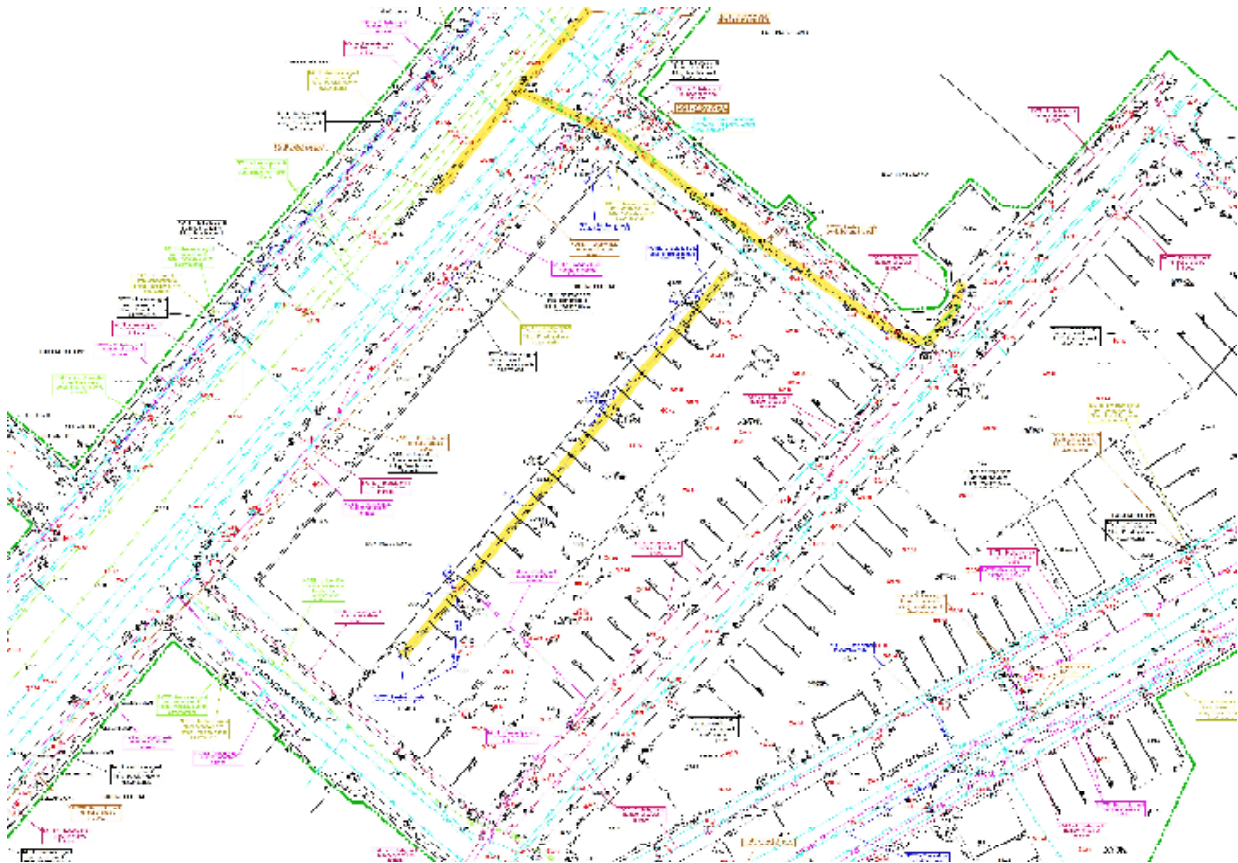
GPR Survey Extract Highlighting Private Drainage

It is unlikely that any of the existing system will be retained. However, the existing outfall should be re-used if deemed to be in a suitable location and level in relation to the proposed development.

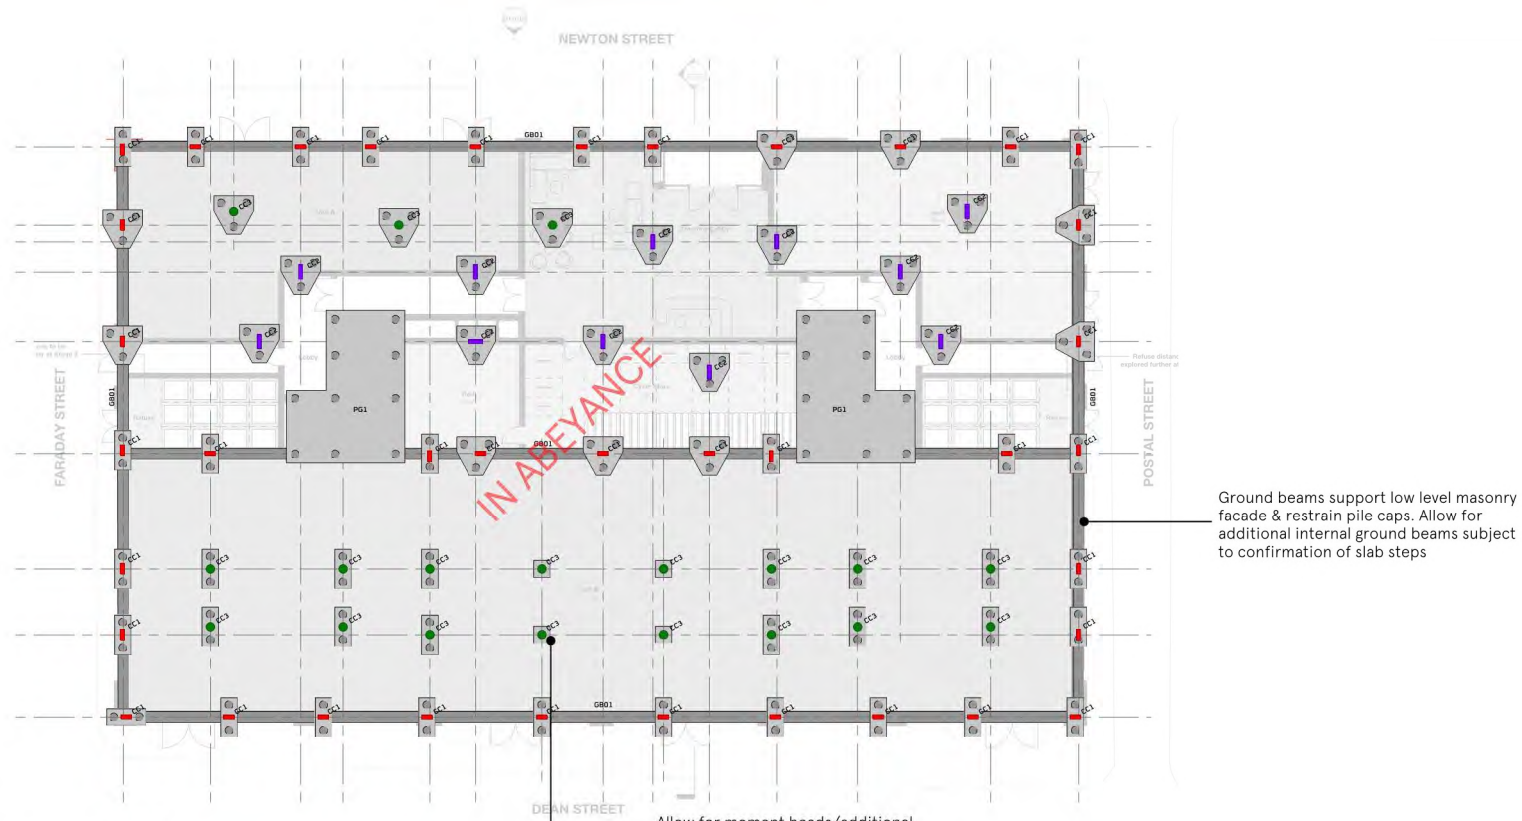
FOUNDATION PLAN  
1:200

NOTE:  
FOUNDATION & PILE LAYOUTS ARE INDICATIVE AND SUBJECT  
TO COORDINATION WITH PHASE II SITE INVESTIGATION  
RESULTS IN THE NEXT RIBA DESIGN STAGE

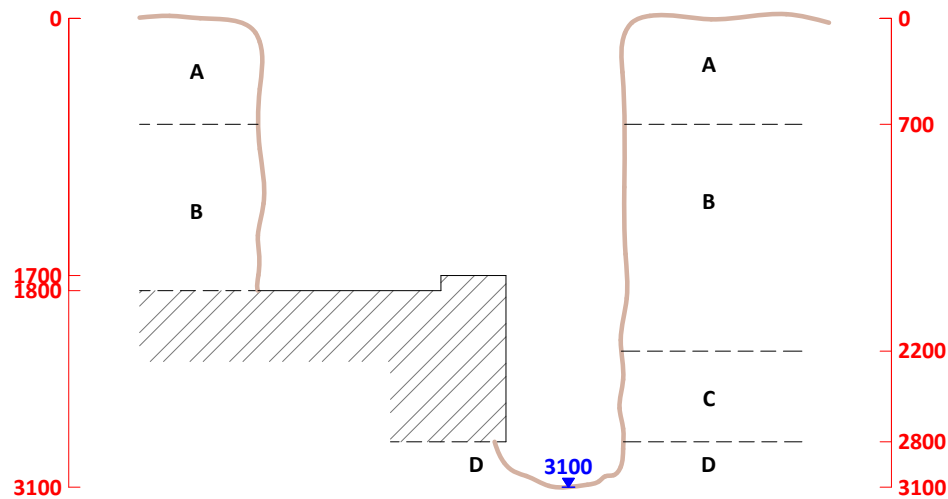
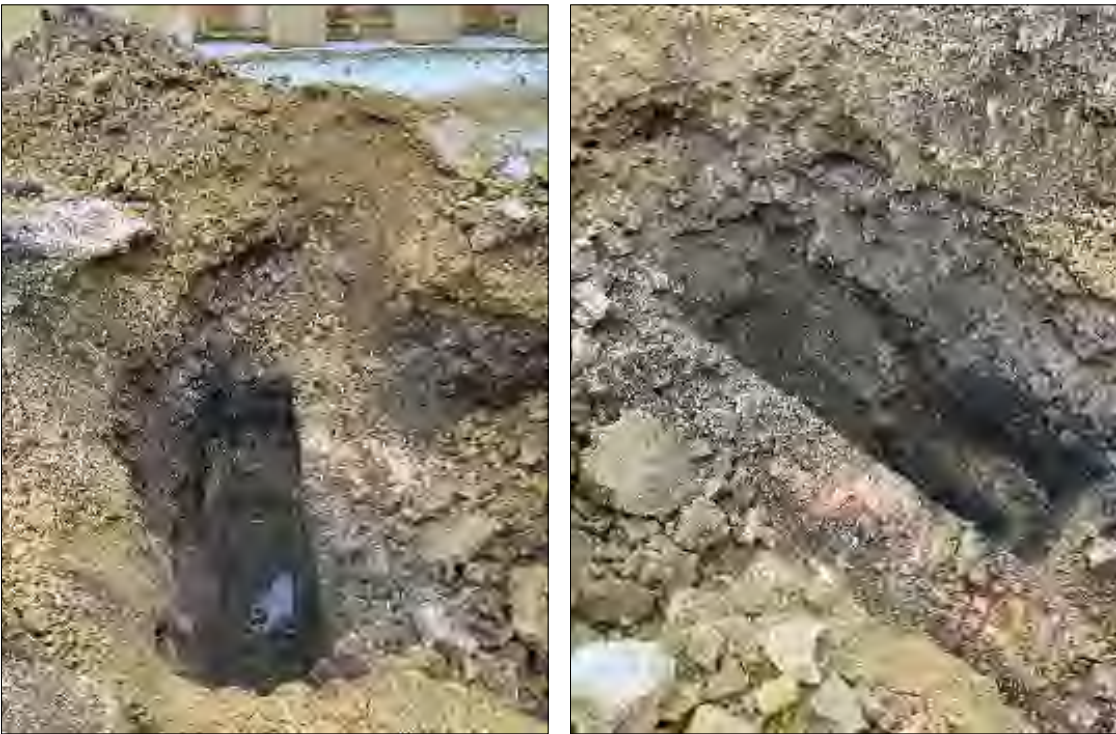
- A. Orangish brown slightly gravelly fine to coarse SAND with a medium cobble content of subangular sandstone, concrete and brick. Gravel is fine to coarse angular to subrounded sandstone, concrete, brick and slate. (MADE GROUND)

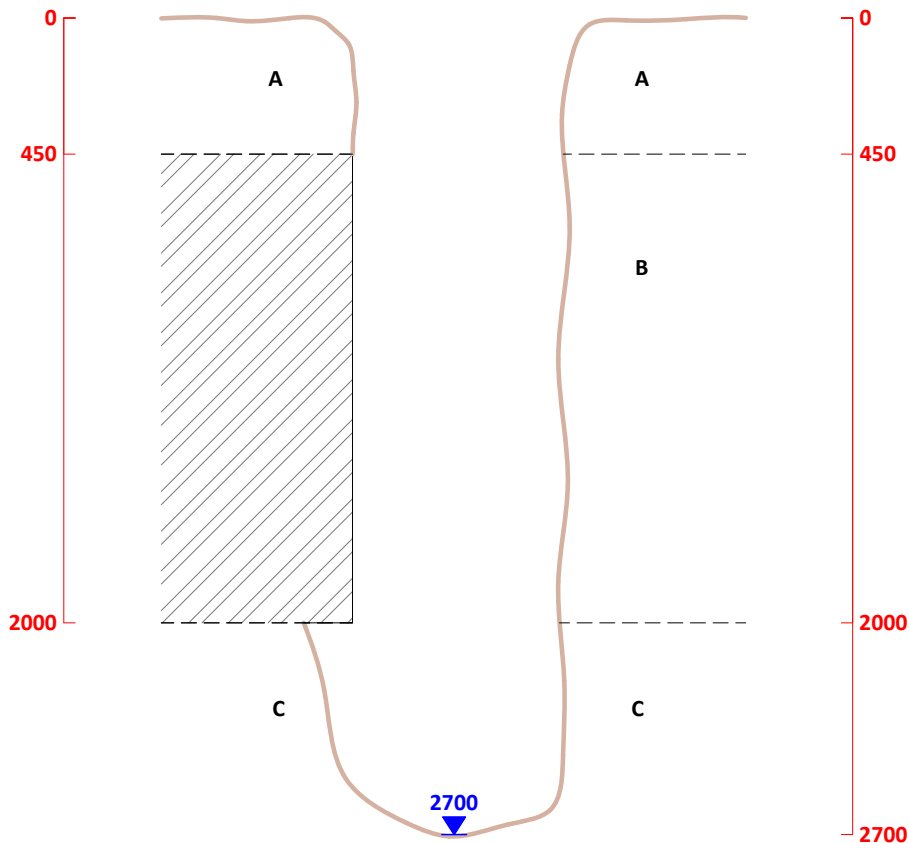
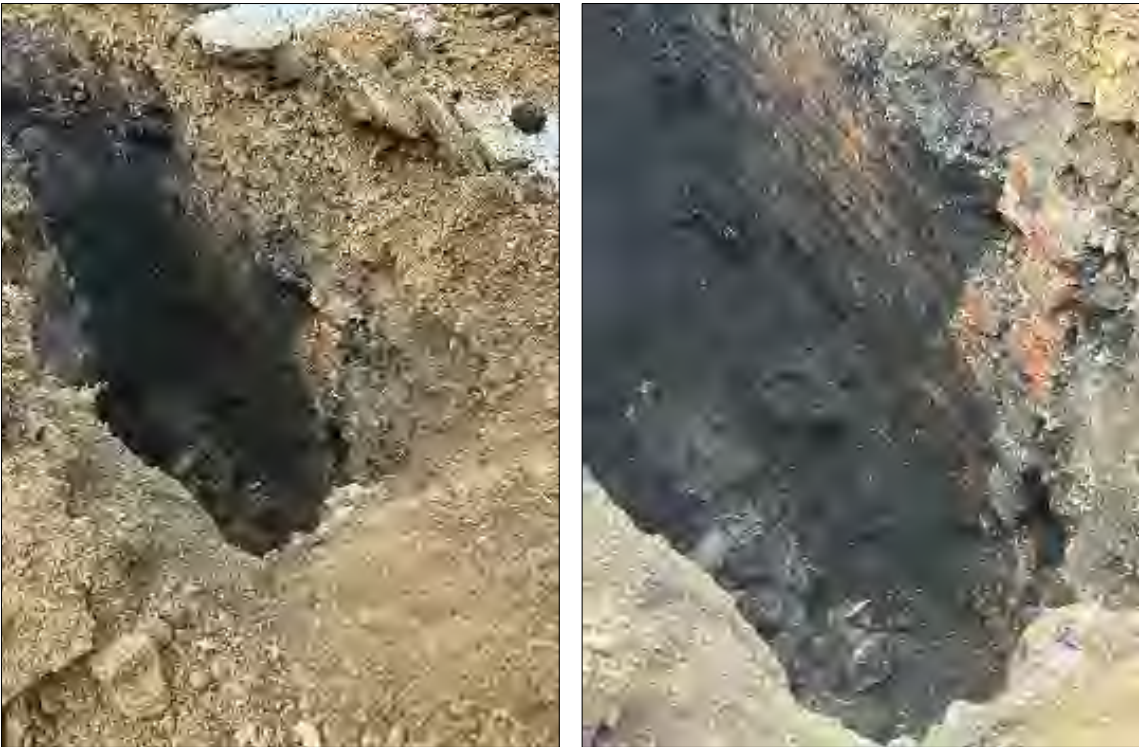
- A. Orangish brown slightly gravelly fine to coarse SAND with a medium cobble content of subangular sandstone, concrete and brick. Gravel is fine to coarse angular to subrounded sandstone, concrete, brick and slate. (MADE GROUND)
- B. Black very gravelly fine to coarse SAND with a high cobble content of angular concrete, brick, whole bricks and masonry sections. Gravel is fine to coarse angular to subrounded slate, brick, clinker, concrete and ceramic. Occassional glass, metal and plastic. (MADE GROUND)
- C. Firm orangish brown mottled grey CLAY with occassional bands of slightly gravelly slightly sandy CLAY. Gravel is fine to medium sandstone. (DEVANSIAN TILL)

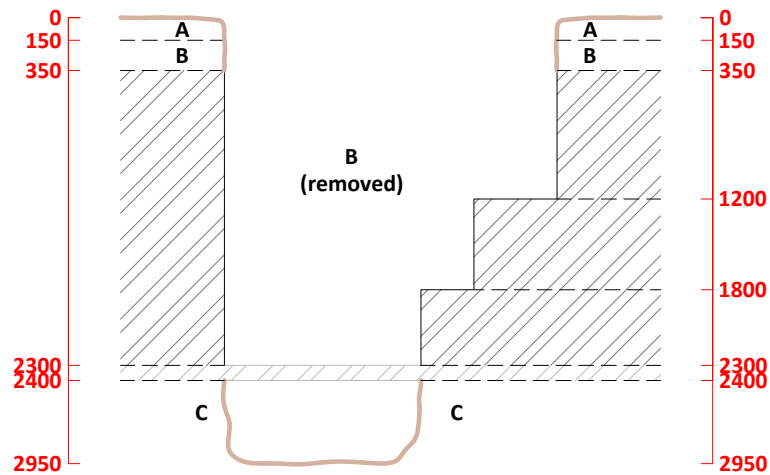
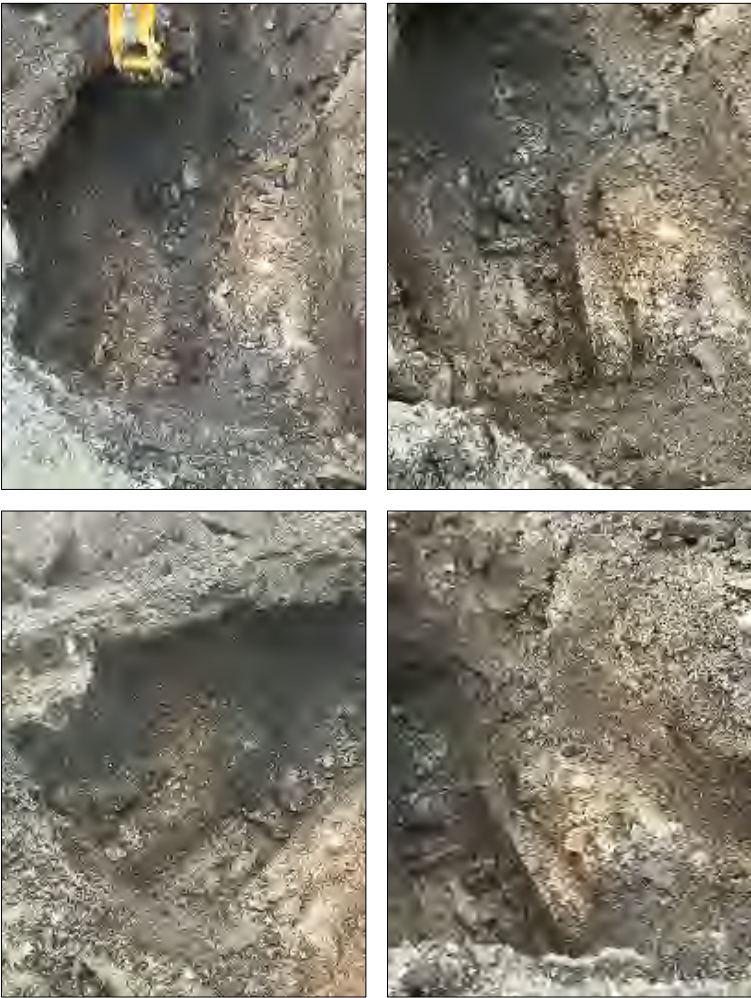
- A. ASPHALT
- B. Black very gravelly fine to coarse SAND with a high cobble content of angular concrete, brick, whole bricks and masonry sections. Gravel is fine to coarse angular to subrounded slate, brick, clinker, concrete and ceramic. Occassional glass, metal and plastic. (MADE GROUND)
- C. Firm grey mottled orangish brown slightly gravelly CLAY. Gravel is fine to medium subangular sandstone. (DEVENSIAN TILL)
