## Ground Investigation Report

Proposed Mixed Use Development

Postal Street, Manchester

March 2025

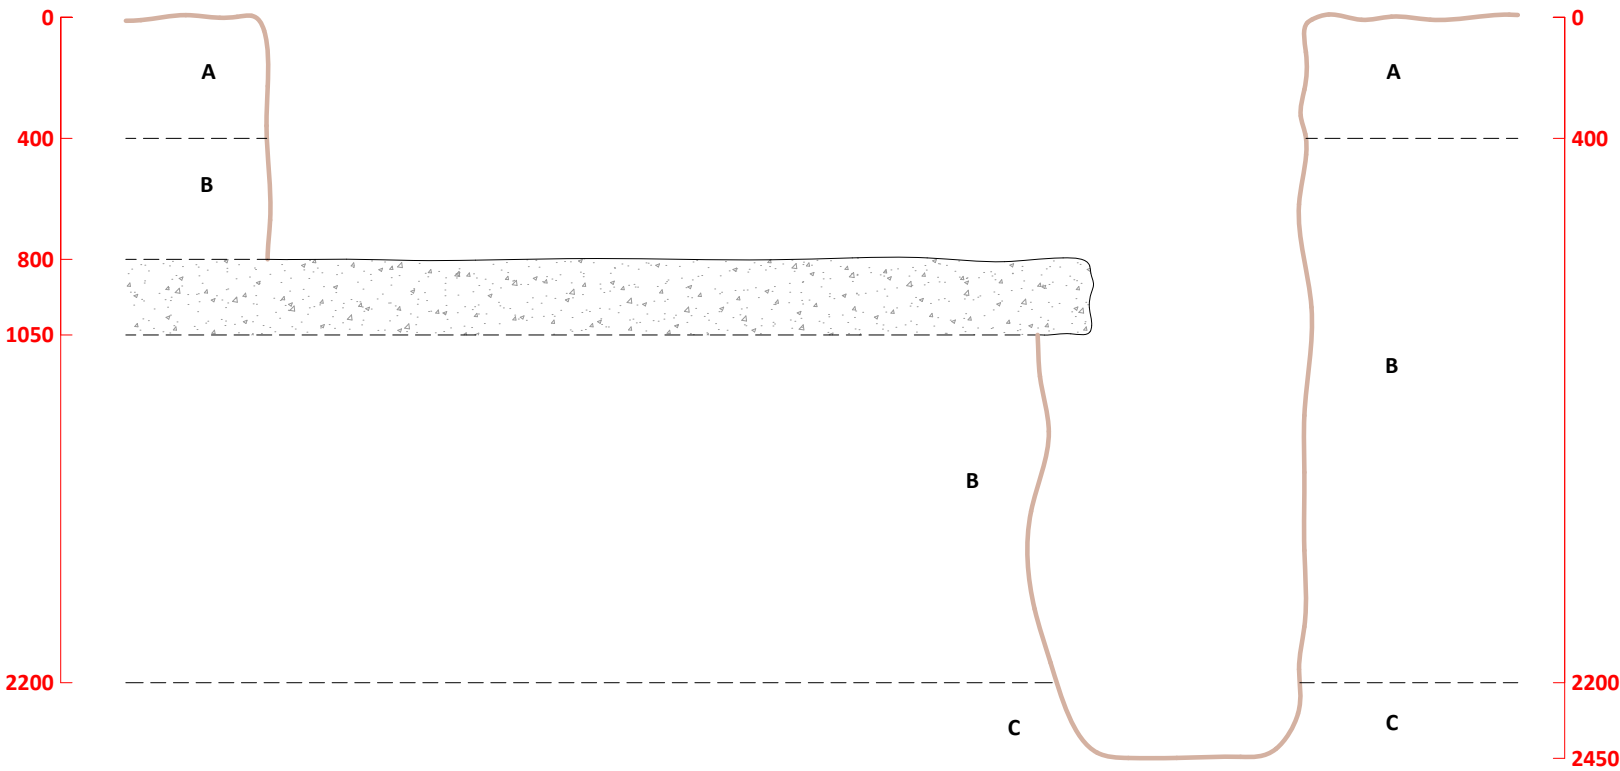
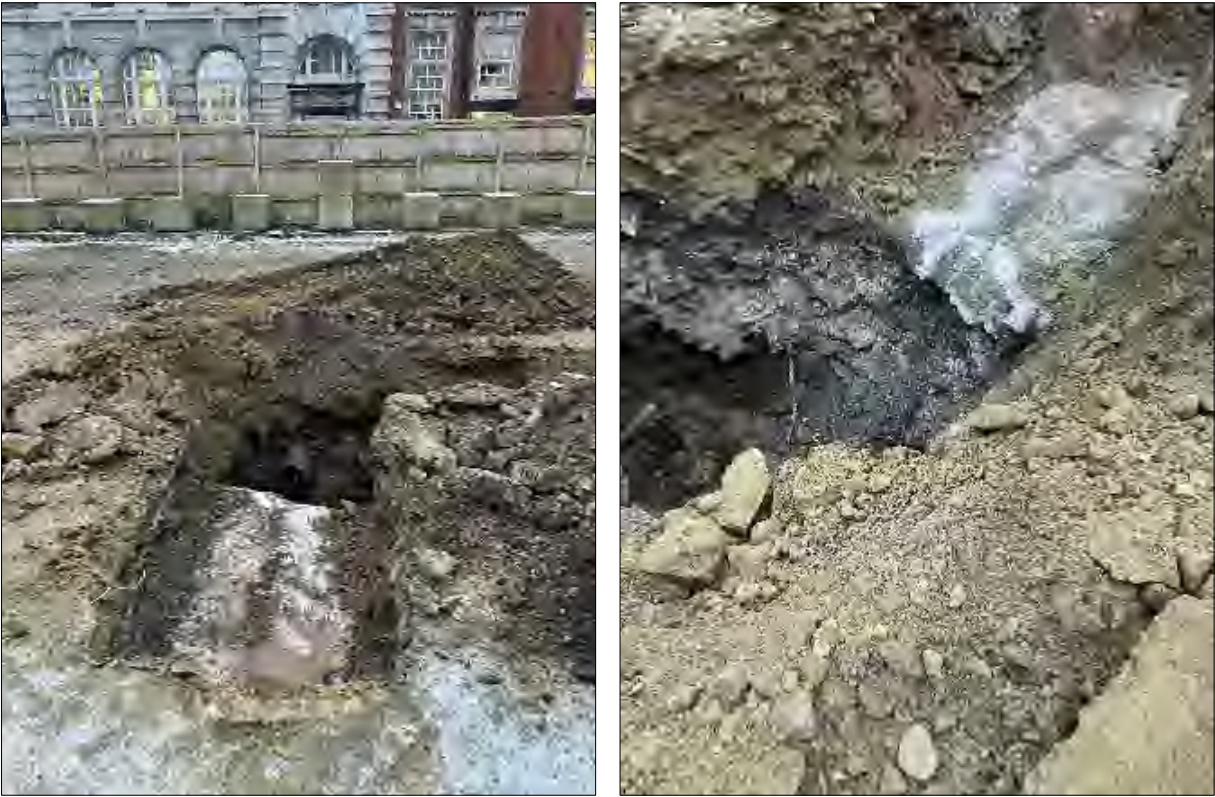
- A. Orangish brown slightly gravelly fine to coarse SAND with a medium cobble content of subangular sandstone, concrete and brick. Gravel is fine to coarse angular to subrounded sandstone, concrete, brick and slate. (MADE GROUND)
- B. Brown sandy fine to coarse GRAVEL with a high cobble content of subangular concrete, brick, and whole bricks. Gravel is fine to coarse angular to subrounded sandstone, concrete, brick and plastic. Frequent timber, metal and plastic. (MADE GROUND)
- C. Brown slightly clayey very sandy fine to coarse GRAVEL with a high cobble content of subangular concrete, brick and whole bricks and occasional boulder sized pockets of brown slightly gravelly CLAY. Gravel is fine to coarse angular to subrounded sandstone, concrete, brick, clinker and slate. (MADE GROUND)
