# Geo-Environmental Investigation & Assessment

**Ferrous – Phoenix II**

| <b>Report Title:</b> | <b>Ferrous – Phoenix II<br/>Geo-environmental Investigation and Assessment</b> |
| <b>Report Reference:</b> | <b>9861G-WML-XX-ZZ RP-G-0002</b> |

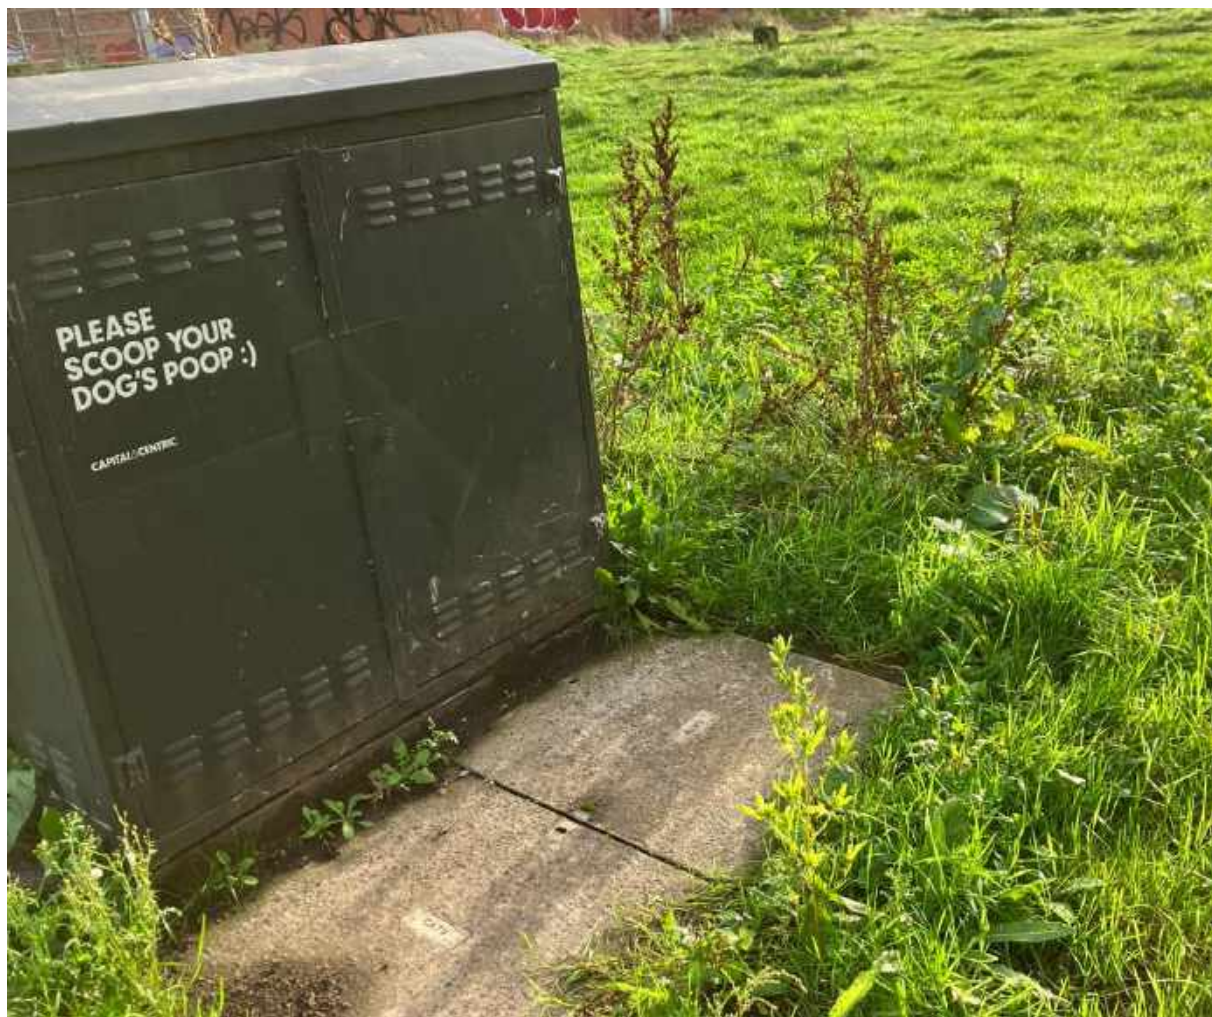
Photograph 5 – Broadband junction box located near the western boundary.

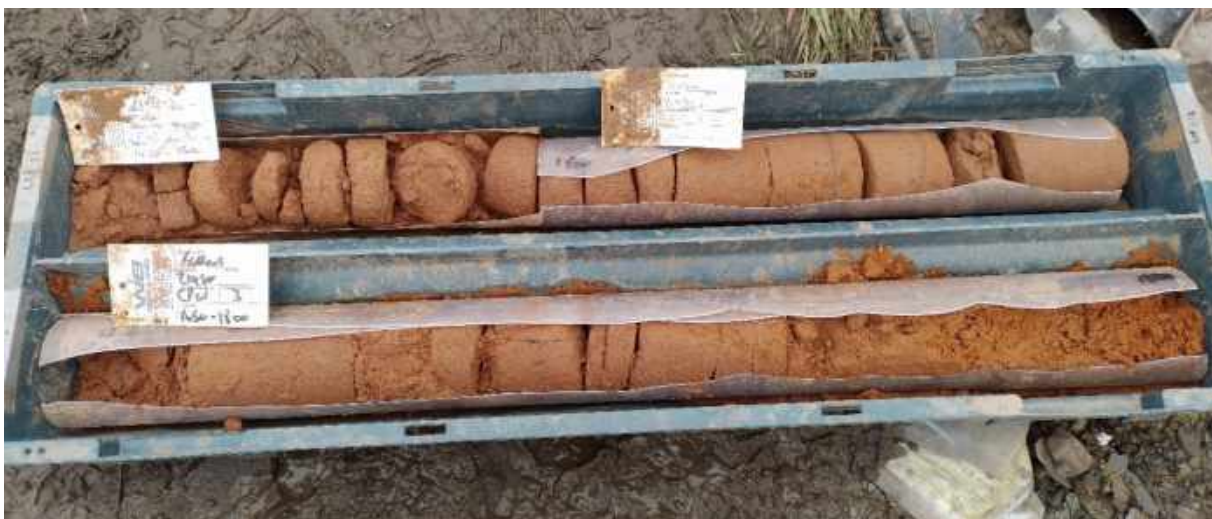
Photograph 6 – CP01 rotary core runs 1, 2 and 3.

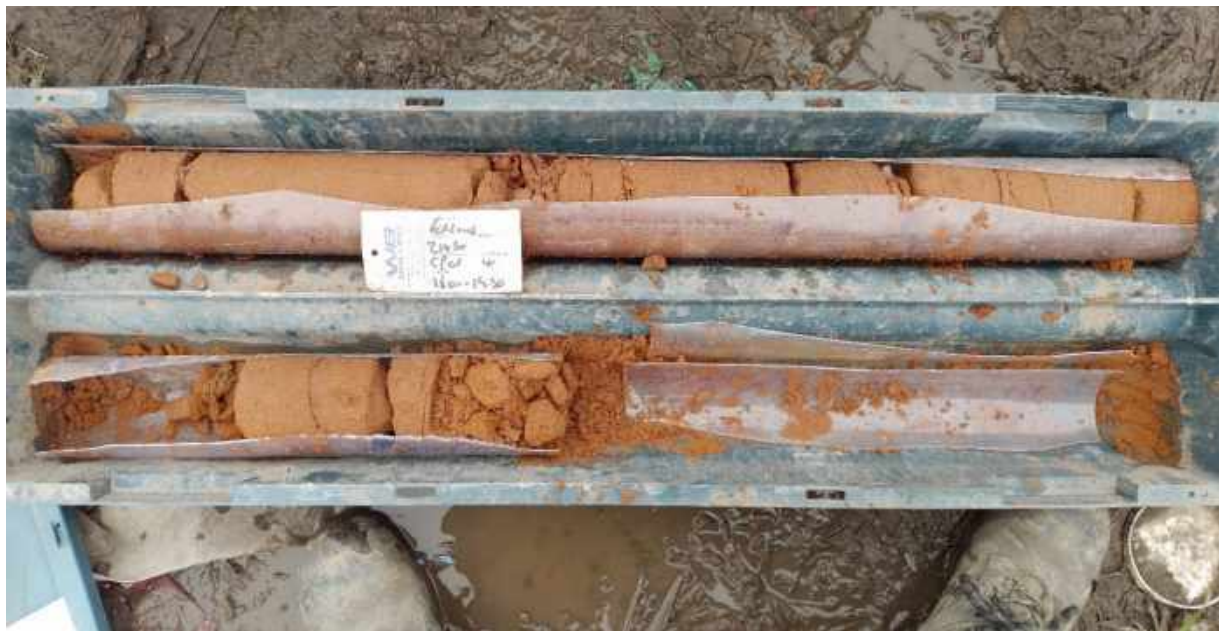
Photograph 7 – CP01 Rotary core run 4.

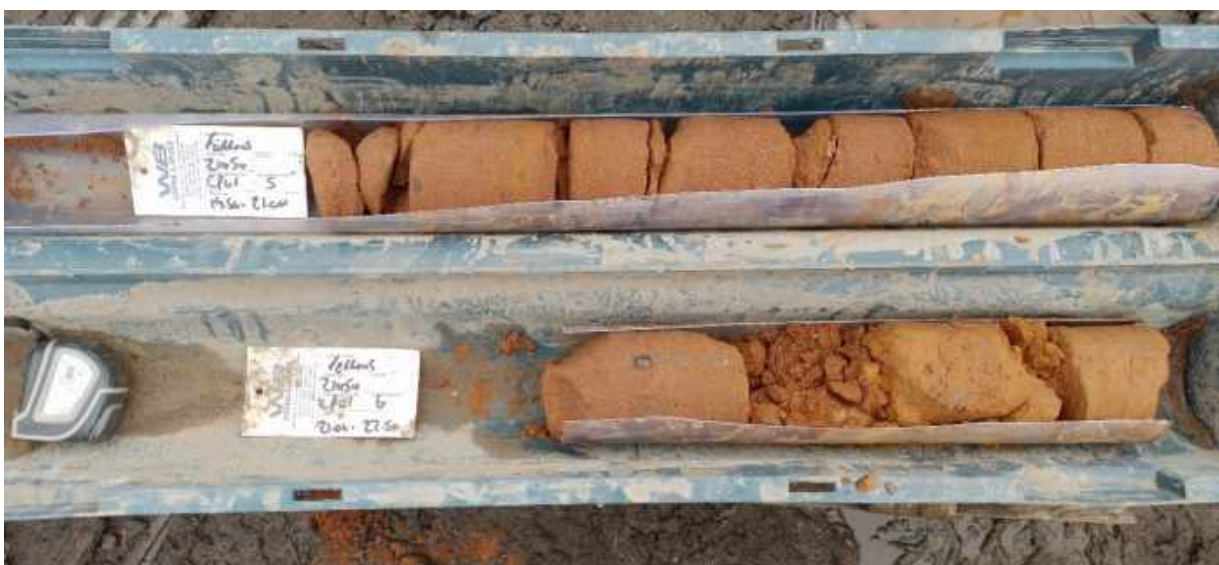
Photograph 8 – CP01 Rotary core runs 5 and 6.

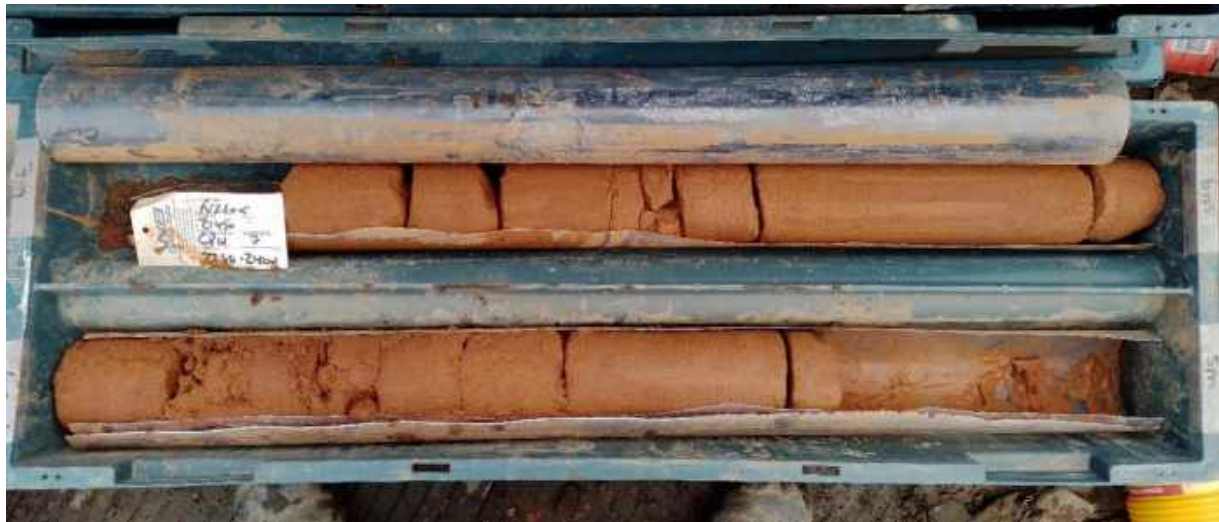
Photograph 9 – CP01 Rotary core run 7

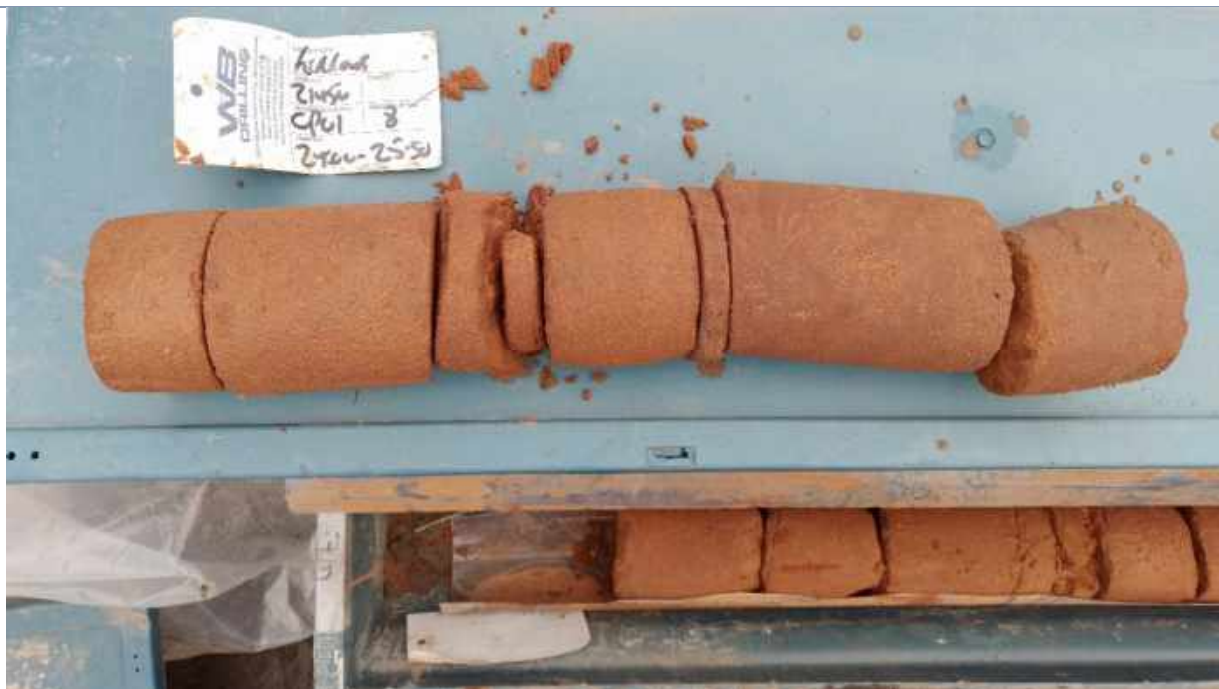
Photograph 10 – CP01 Rotary core run 8

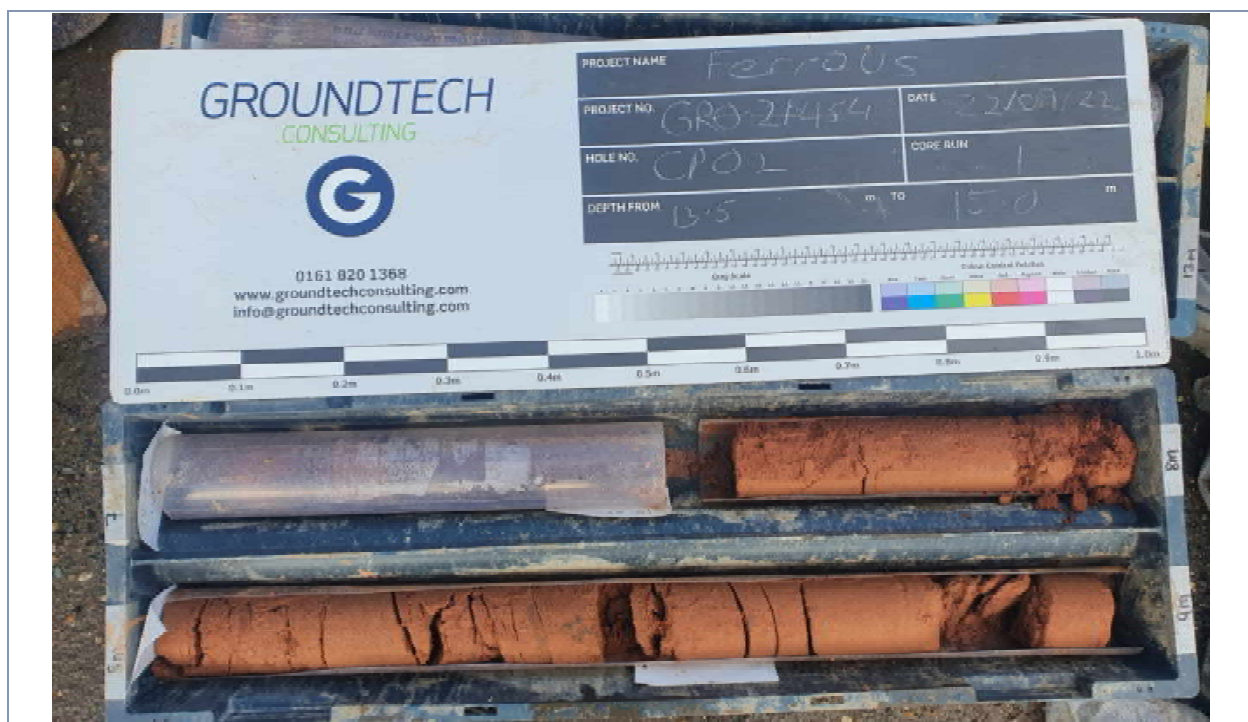
Photograph 11 – CP02 Rotary core run 1.

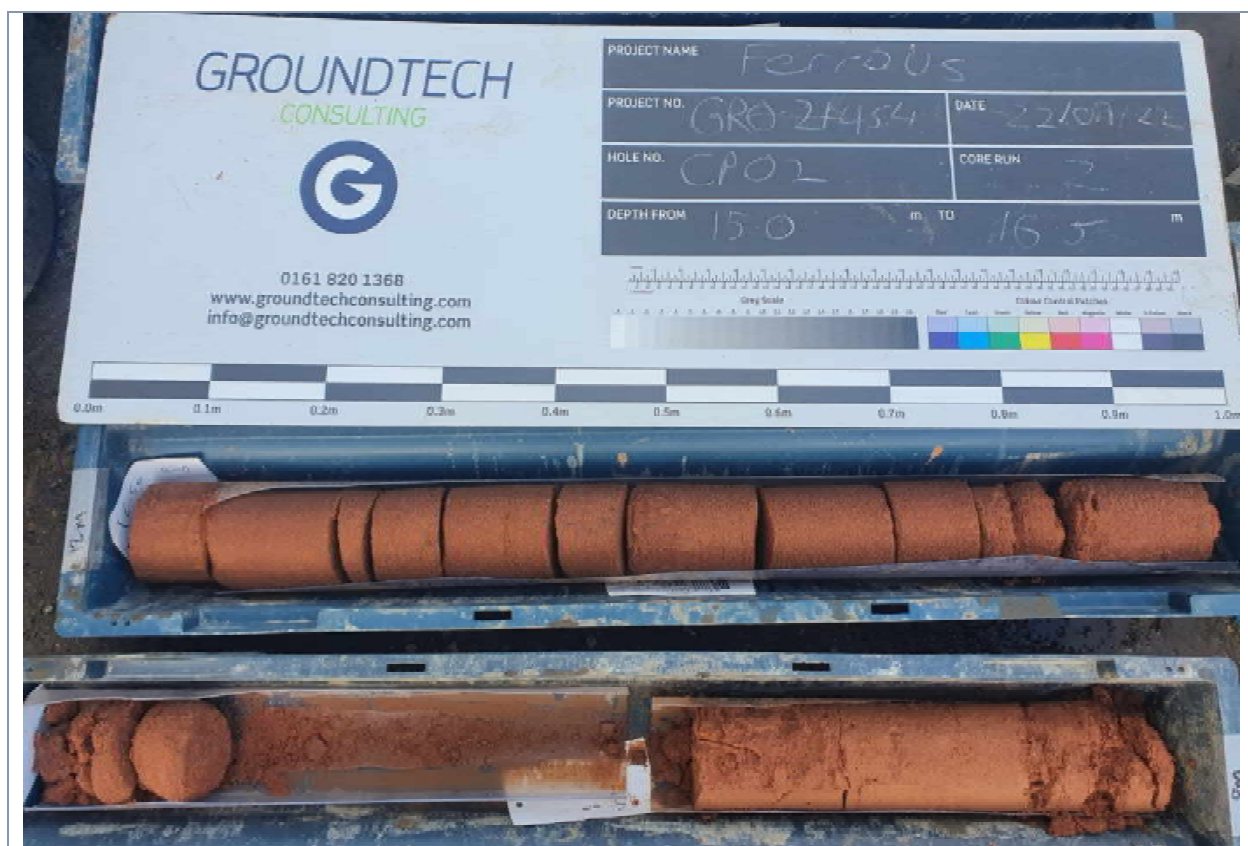
Photograph 12 – CP02 Rotary core run 2.

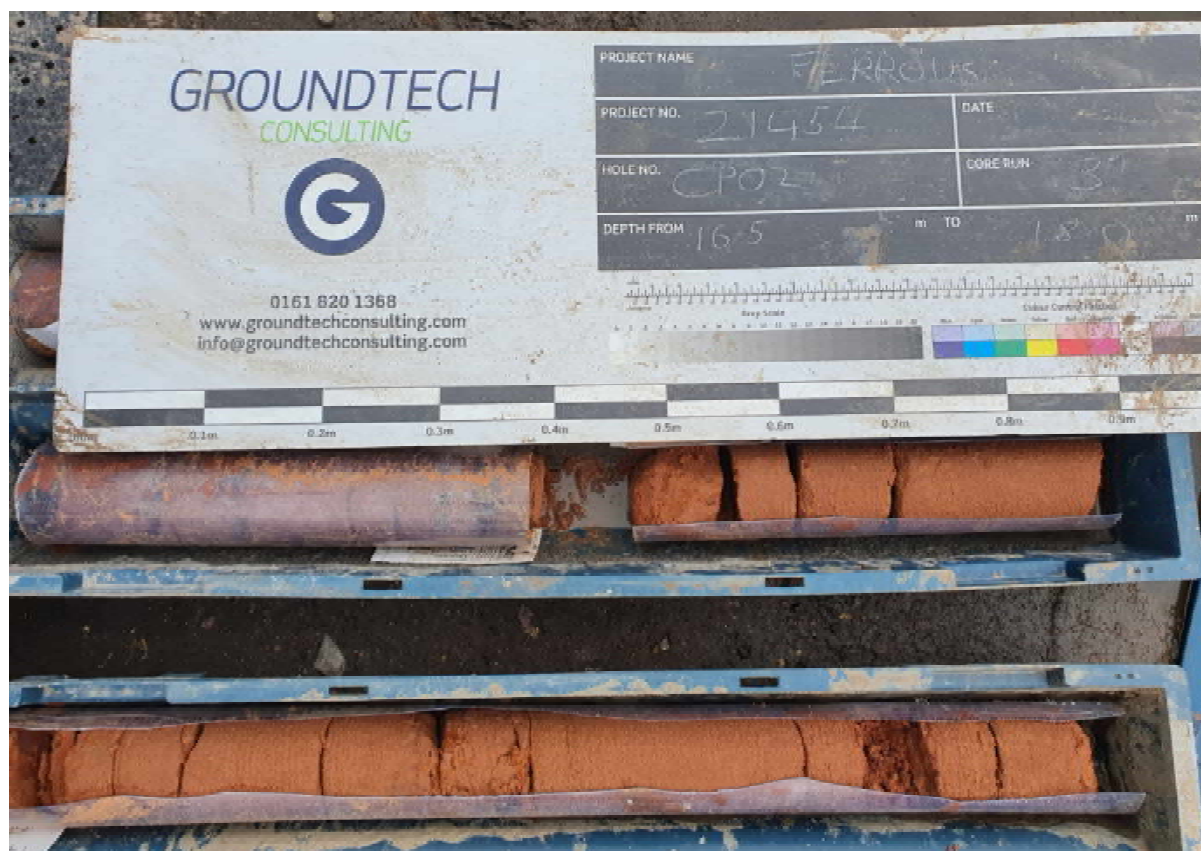
Photograph 13 – CP02 Rotary core run 3.

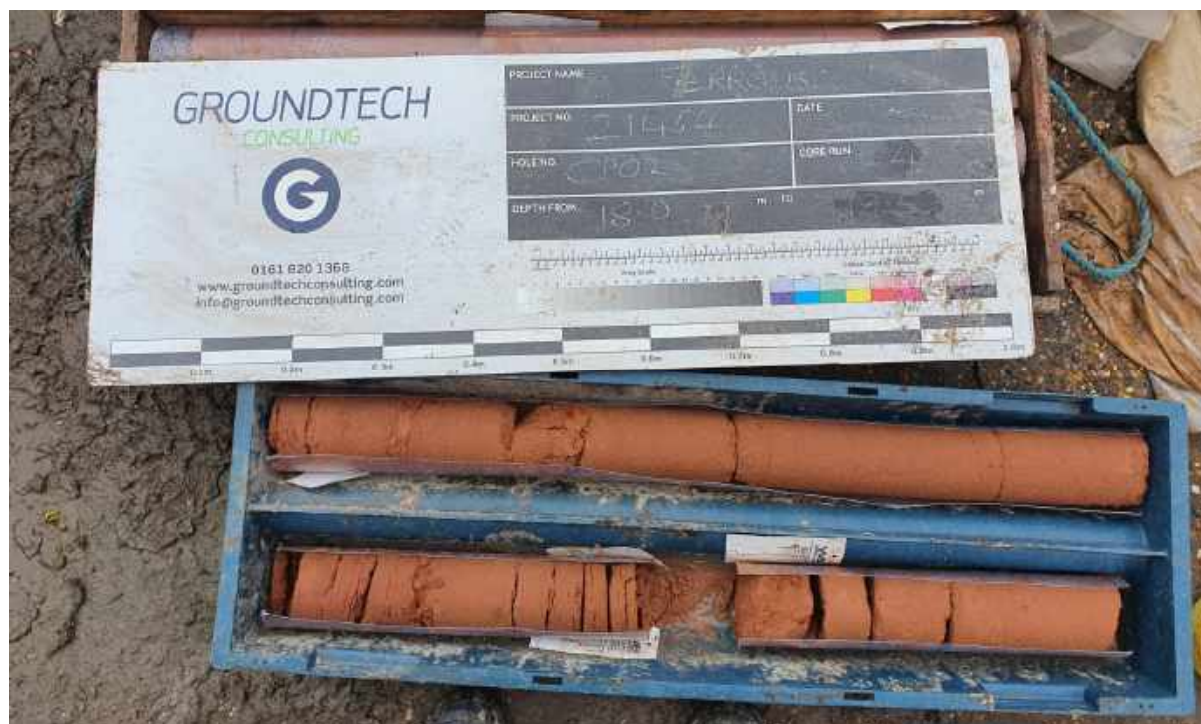
Photograph 14 – CP02 Rotary core run 4.

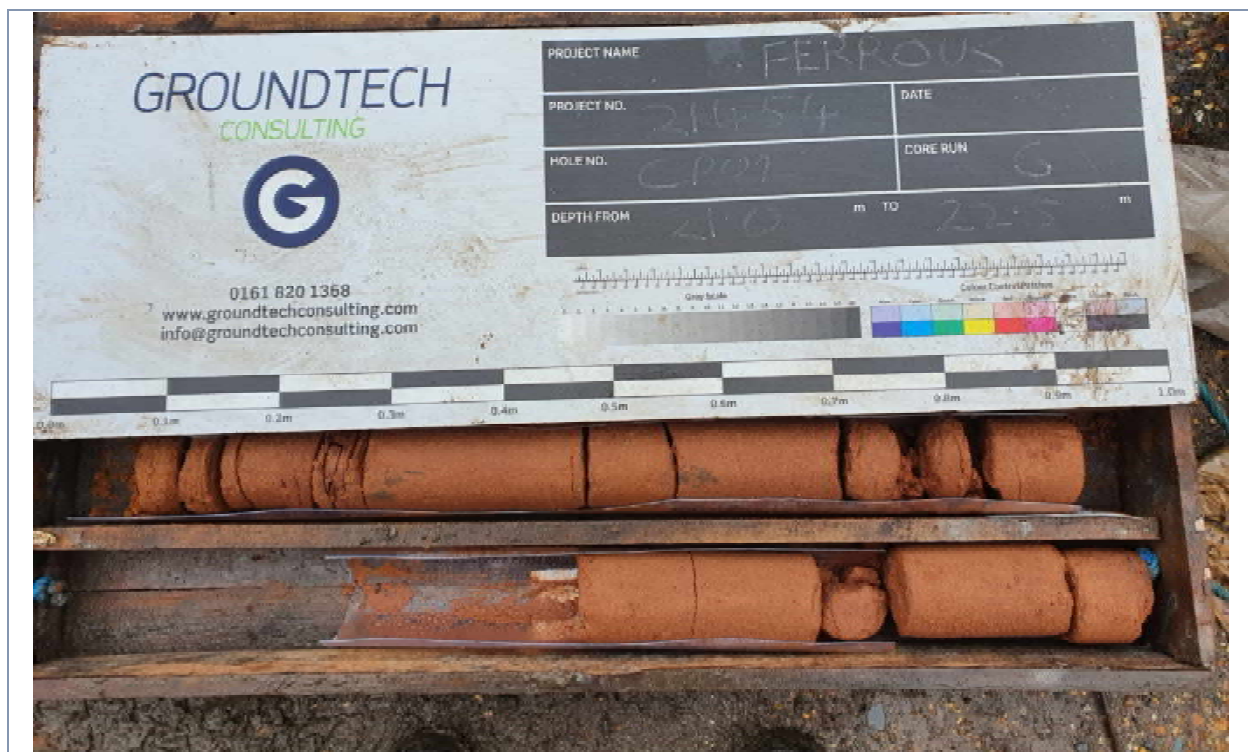
Photograph 16 – CP02 Rotary core run 6.

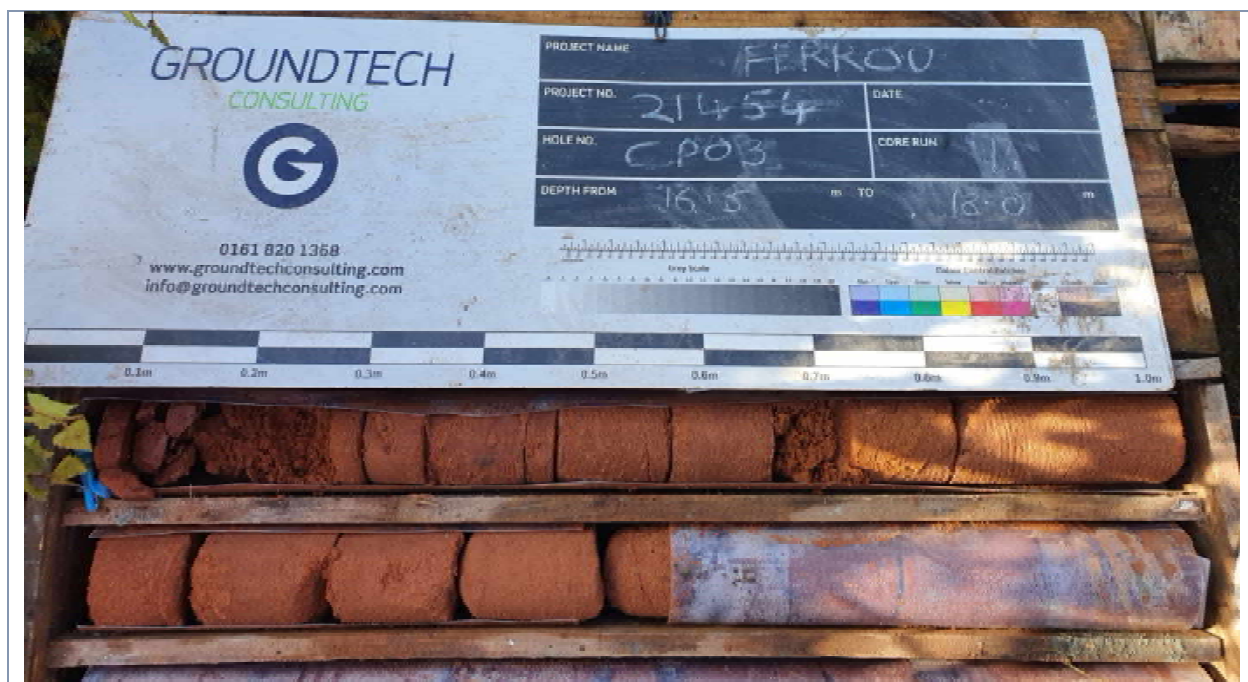
Photograph 17 – CP03 Rotary core run 1.

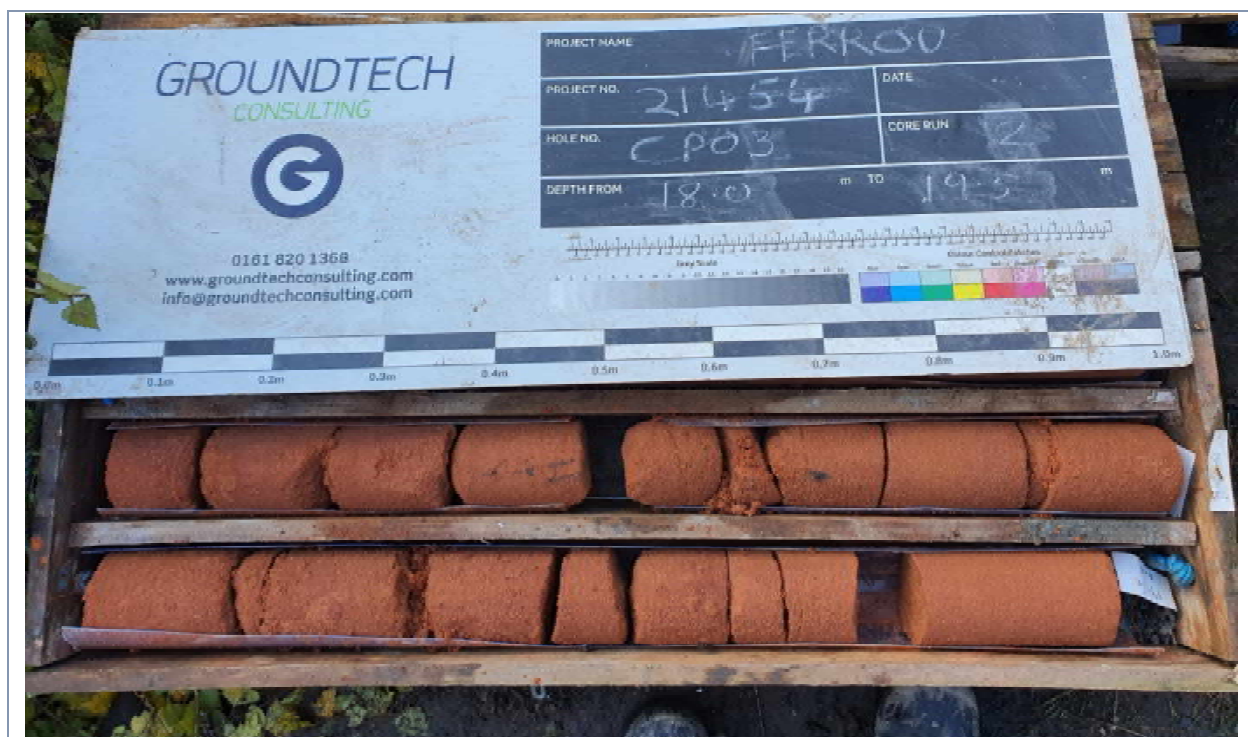
Photograph 18 – CP03 Rotary core run 2

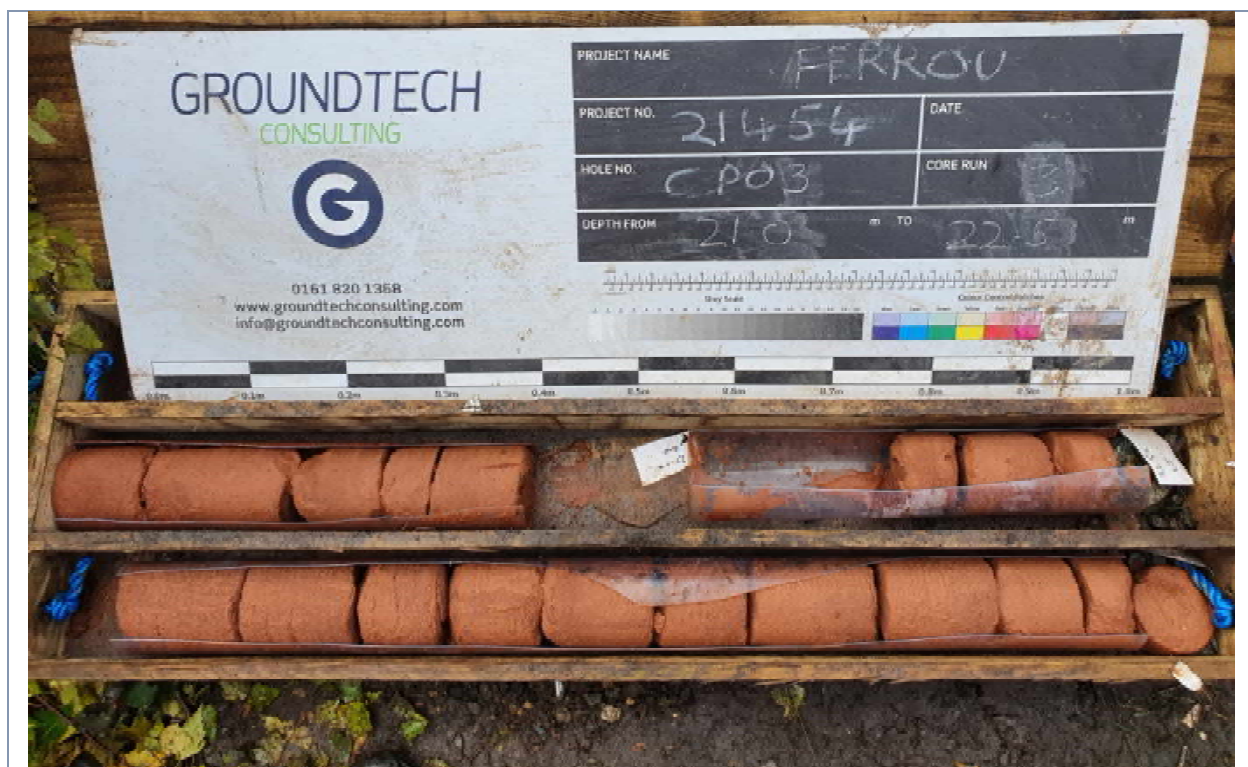
Photograph 19 – CP03 Rotary core run 3.

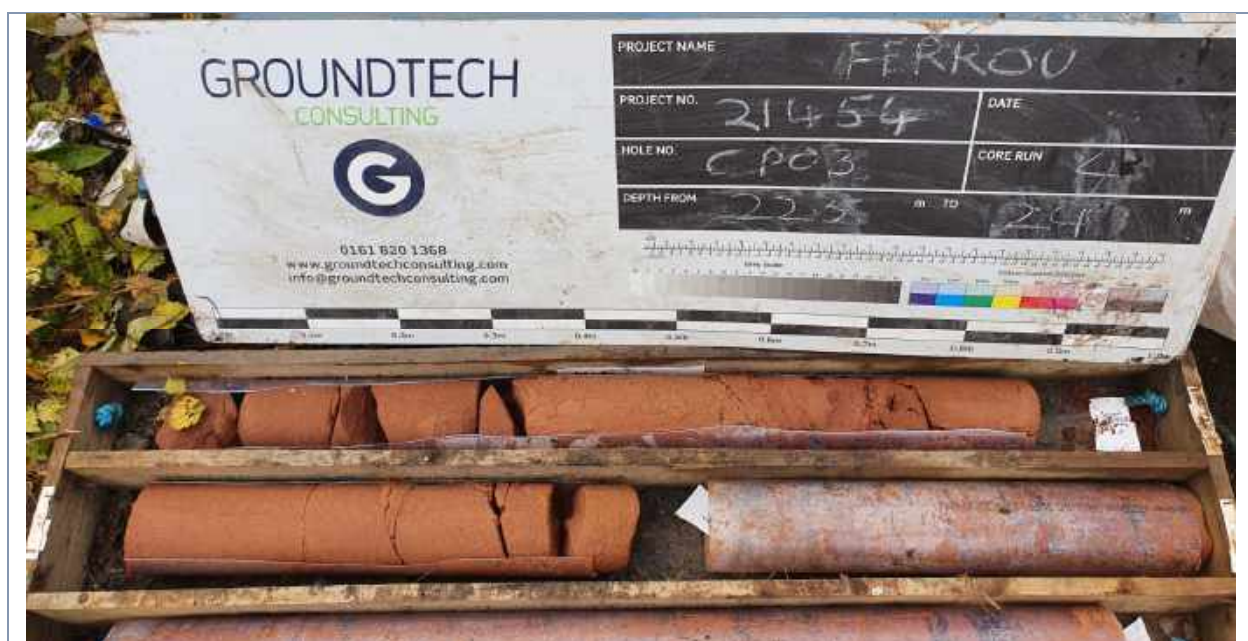
Photograph 20 – CP03 Rotary core run 4

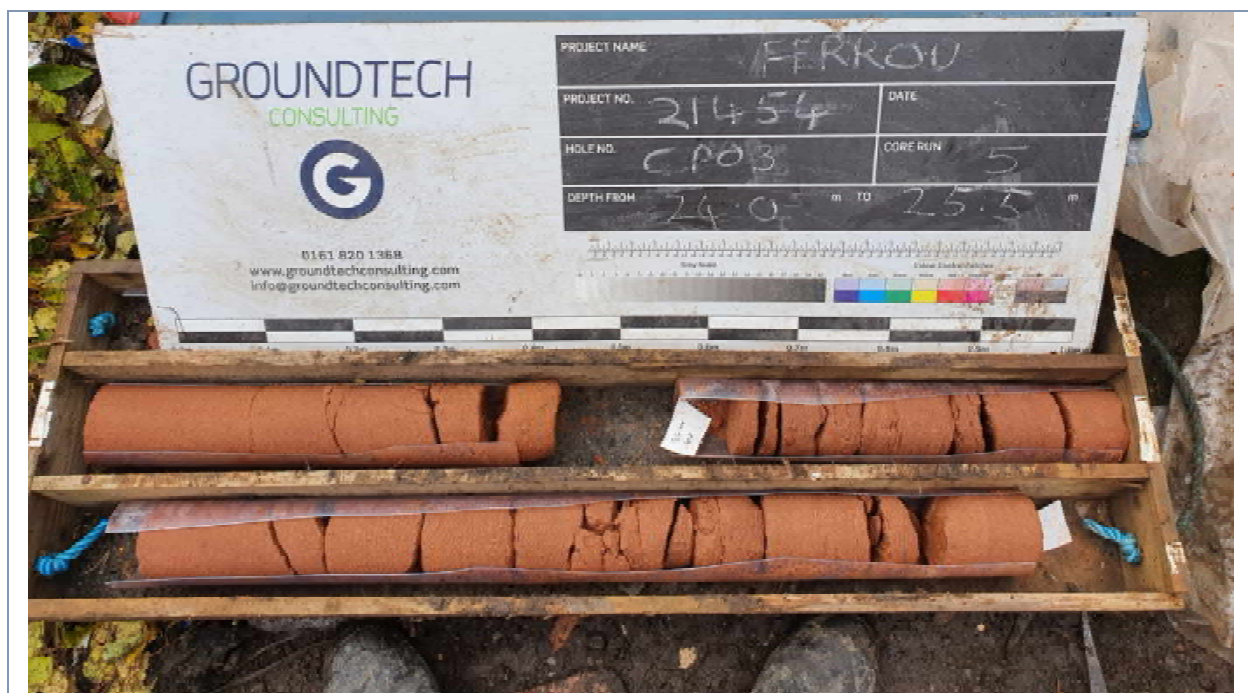
Photograph 21 – CP03 Rotary core run 5.

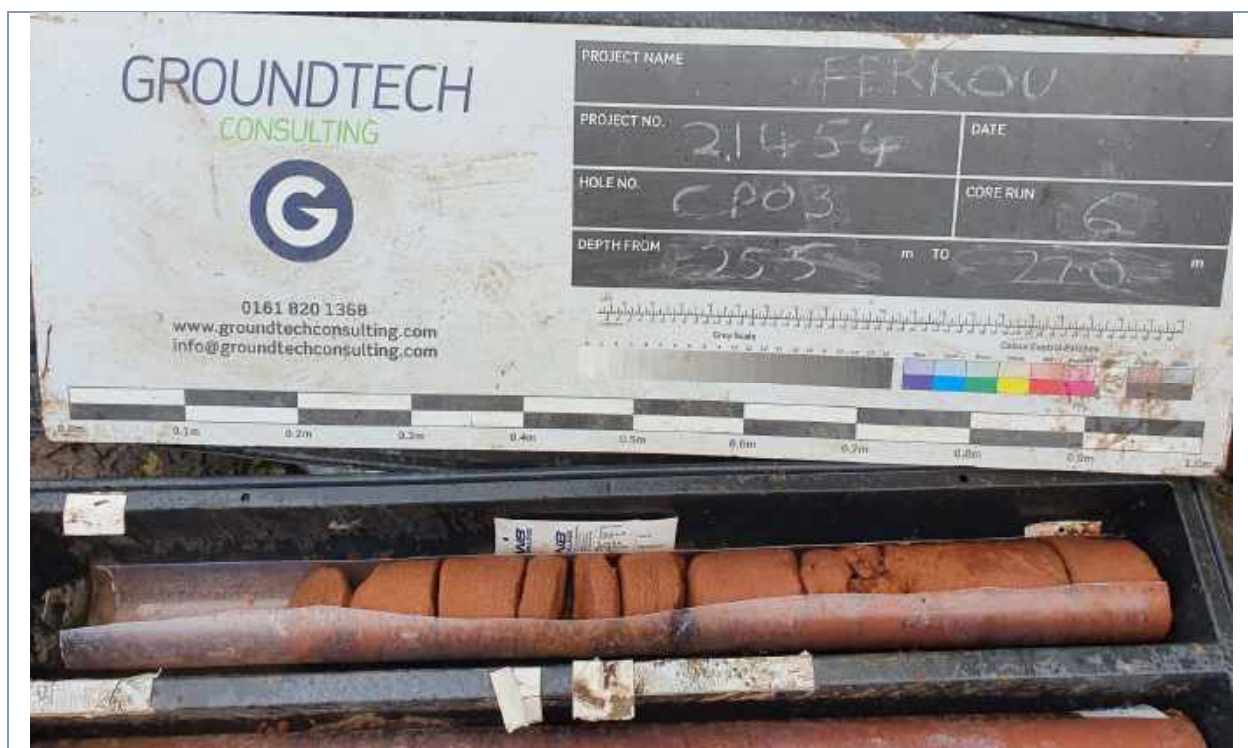
Photograph 22 – CP03 Rotary core run 6

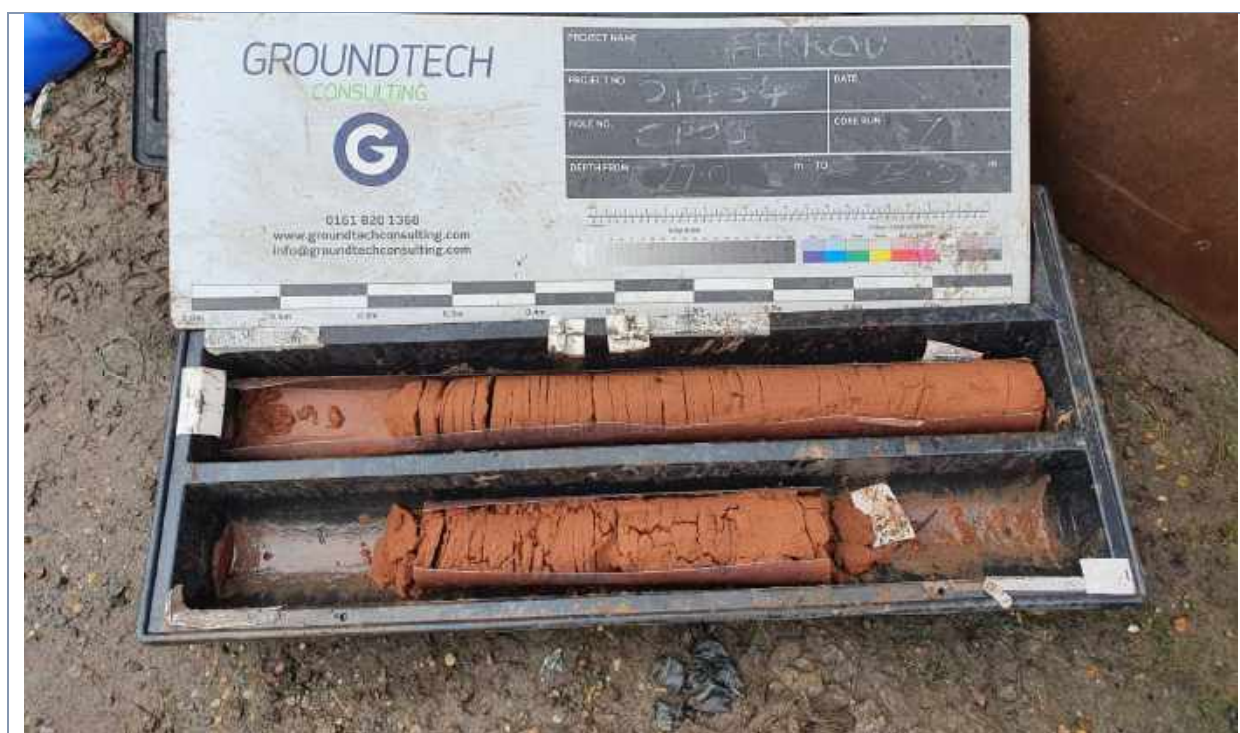
Photograph 23 – CP03 Rotary core run 7

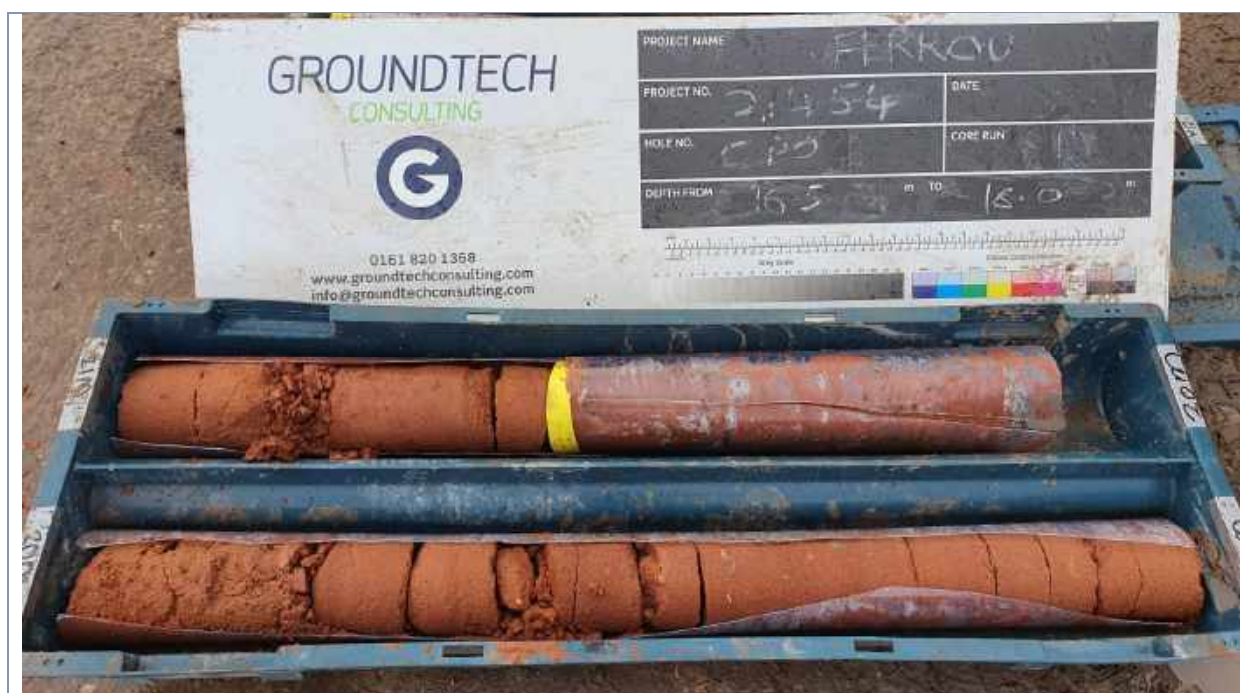
Photograph 24 – CP04 Rotary core run 1

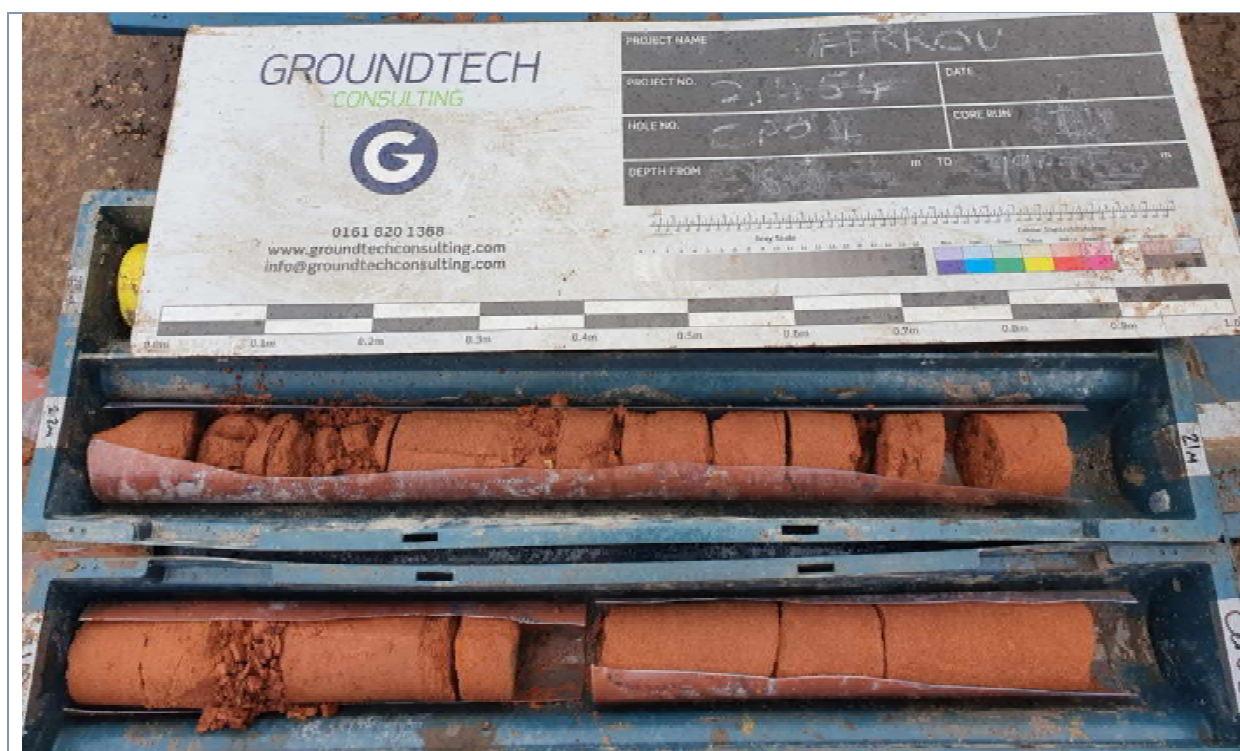
Photograph 25 – CP04 Rotary core run 2.

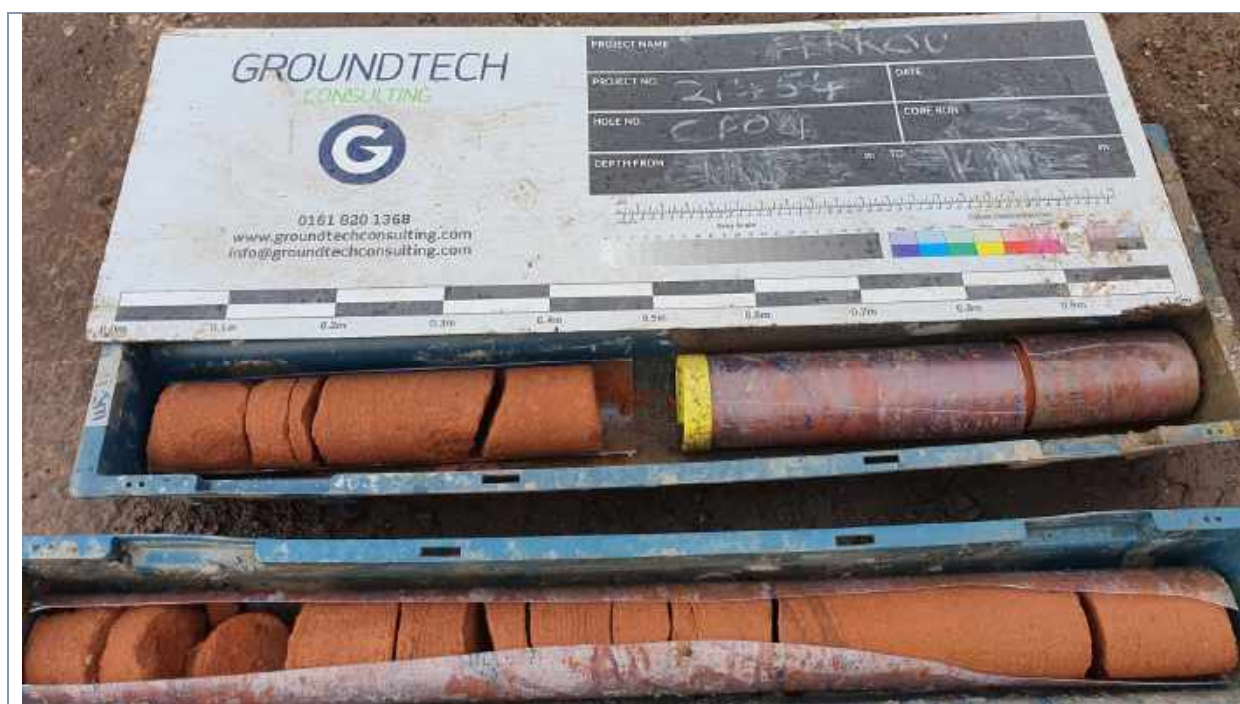
Photograph 26 – CP04 Rotary core run 3.

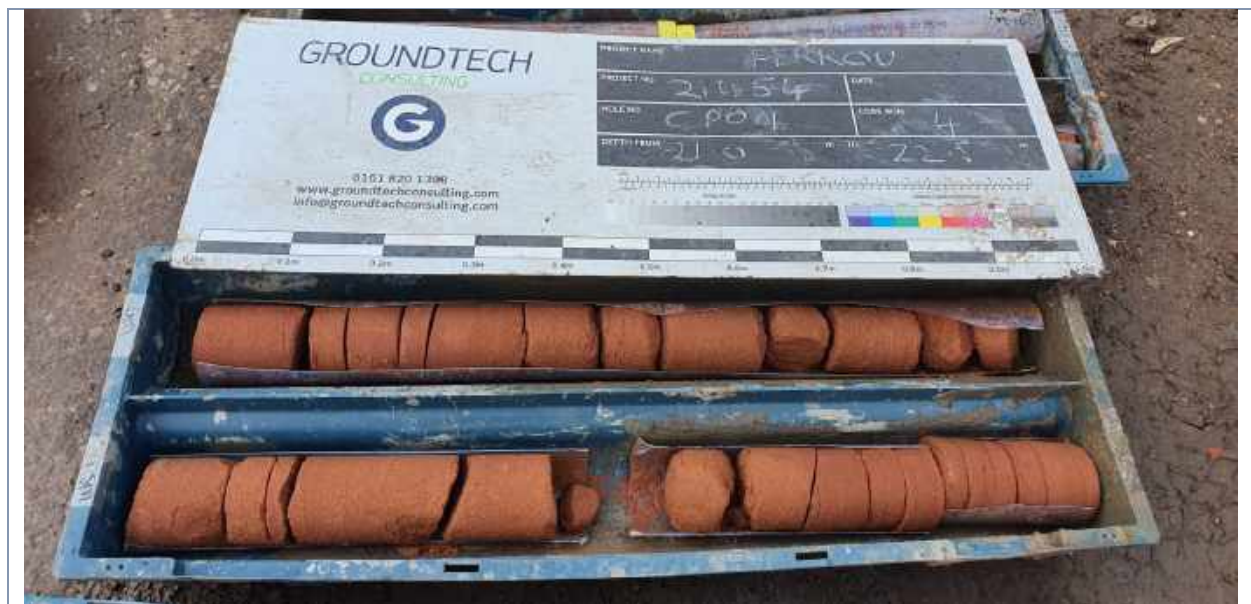
Photograph 27 – CP04 Rotary core run 4

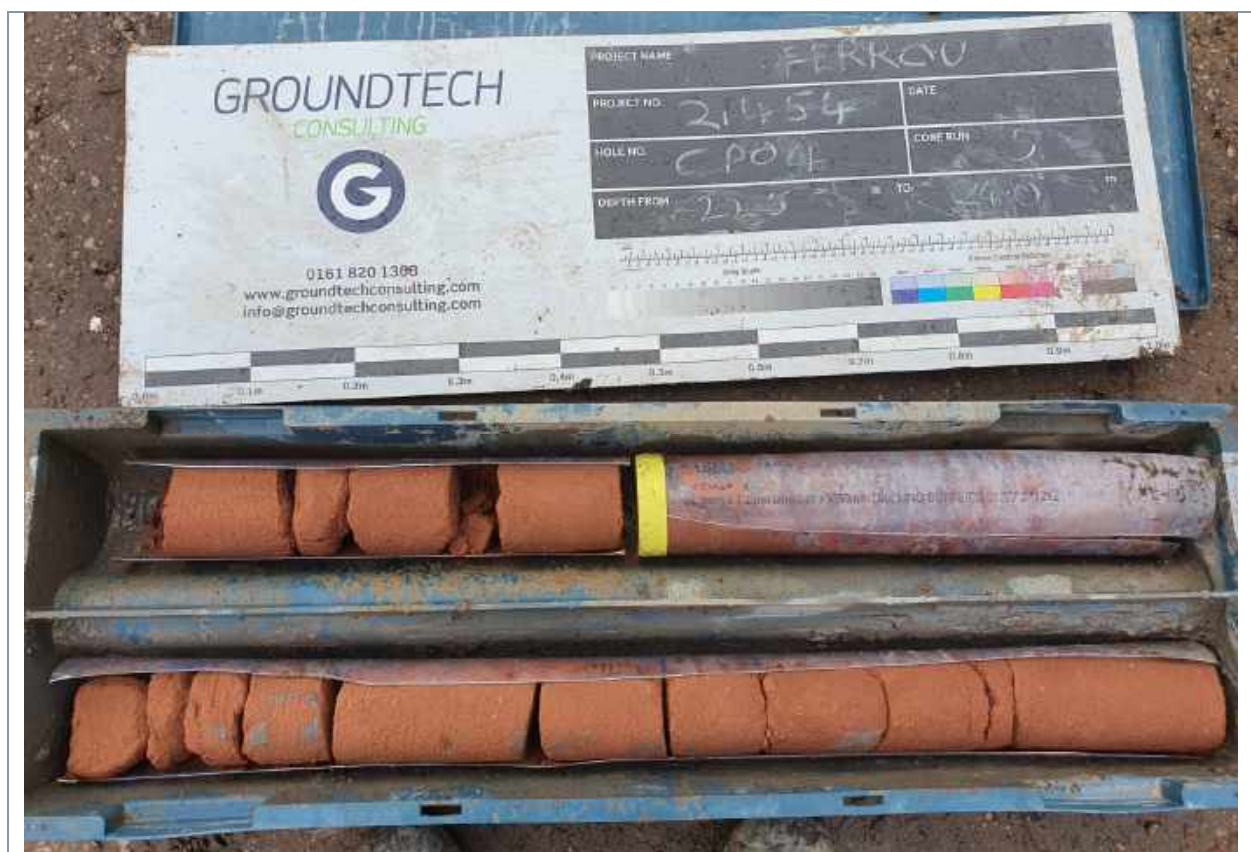
Photograph 28 – CP04 Rotary core run 5

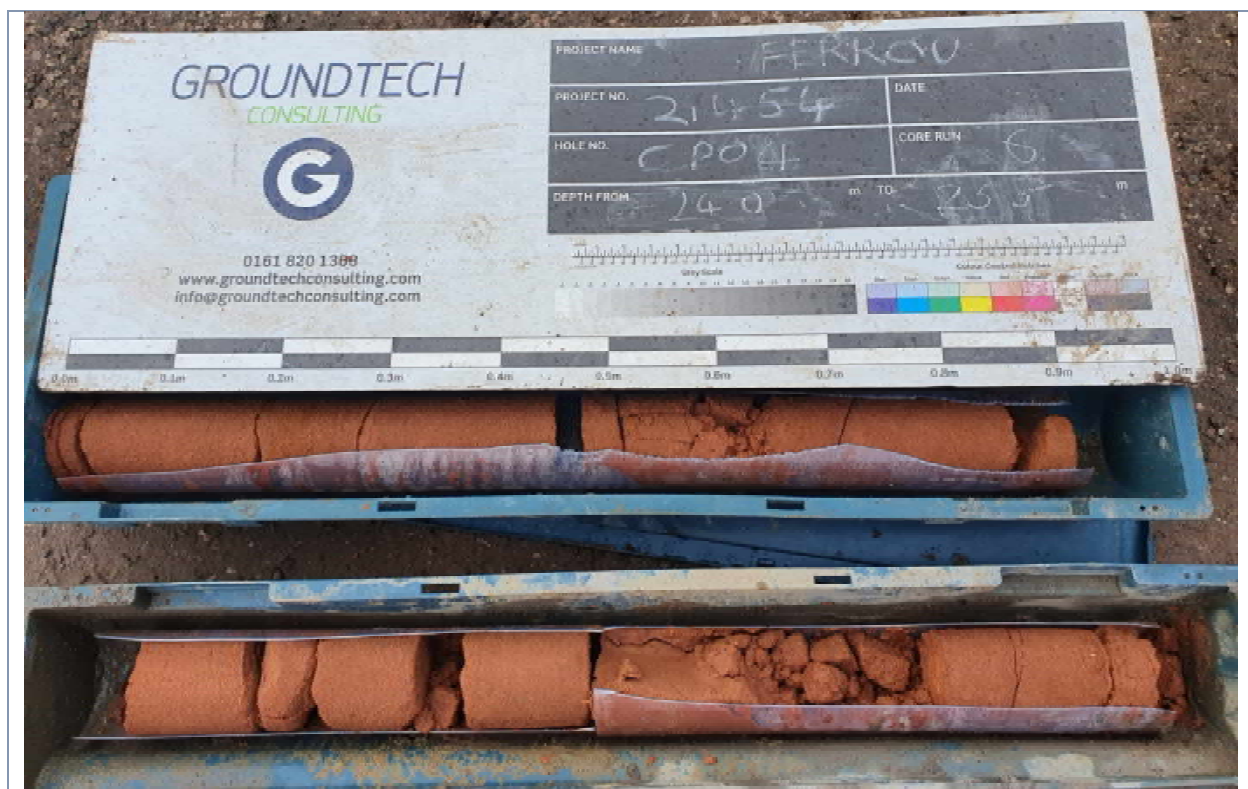
Photograph 29 – CP04 Rotary core run 6

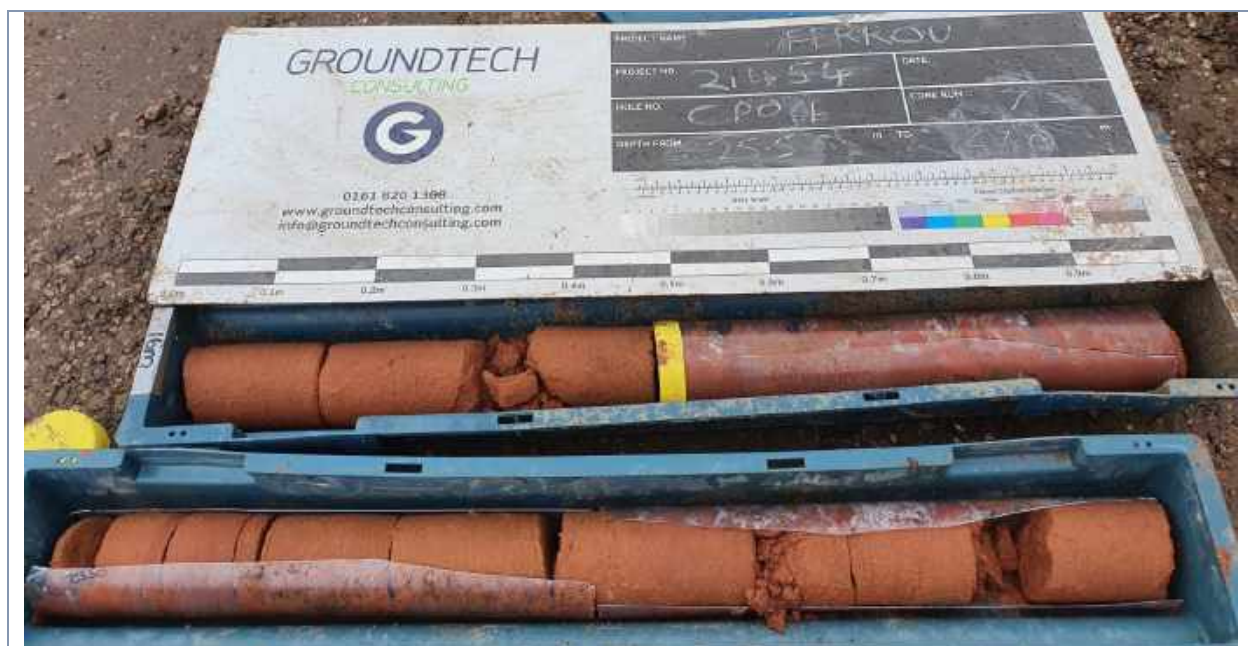
Photograph 30 – CP04 Rotary core run 7

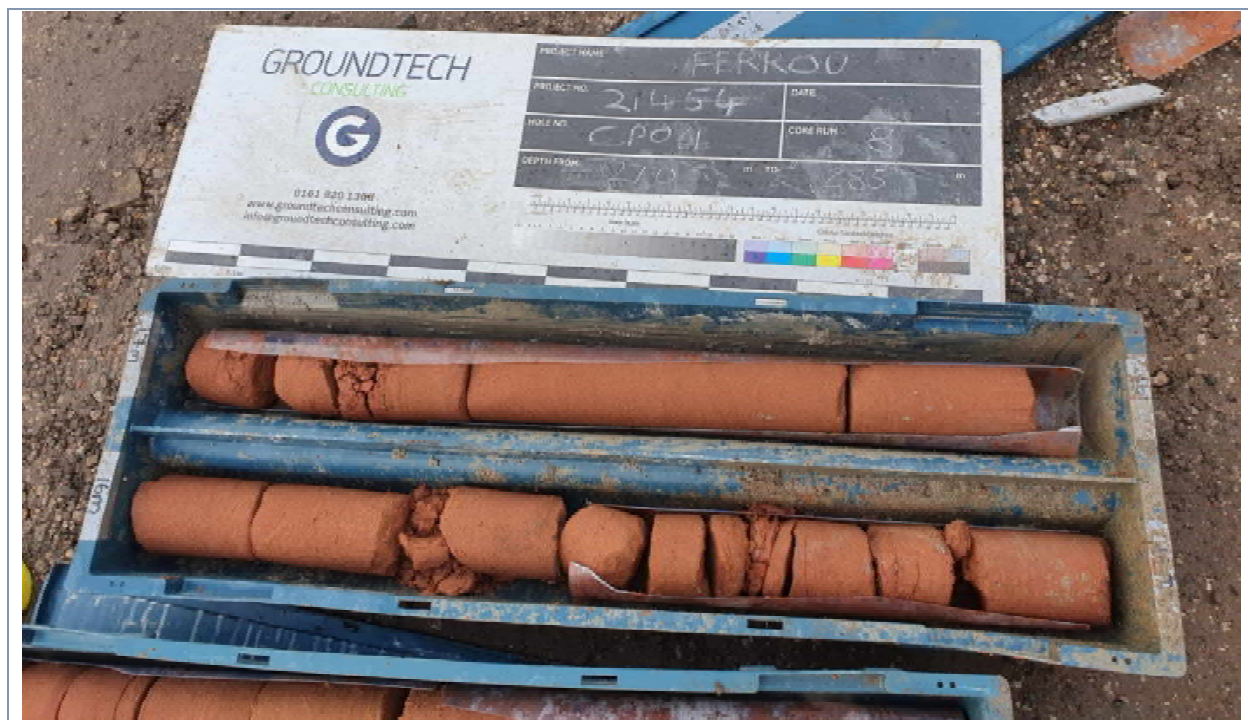
Photograph 31 – CP04 Rotary core run 8
