# PRELIMINARY ROOST ASSESSMENT

**140 Great Ancoats Street**  
Manchester  
M4 6DU

| <b>Date:</b> | 10/08/2023 | | | |

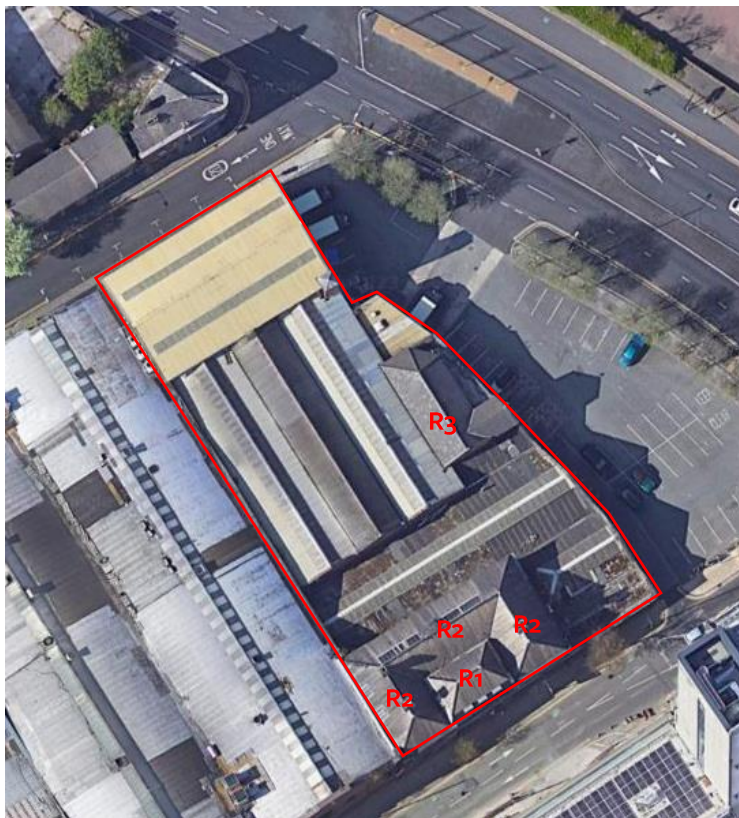
**Figure 2 – Roof locations**

The site's external structure featured a complex mosaic of longstanding historic commercial buildings and a large warehouse, all fully adjoined to form a single structure. Two independently pitched rooves, one located along the southern boundary (R1) with the other wrapping around the first (R2), were present atop three storeys, their loft voids accessible internally. The majority of the site comprised long pitched rooves of single layered, corrugated, transparent material, likely plastic, and featured no loft voids, nor any potential to support a roost. Another length of pitched roof was present along the eastern border of the structure (R3), also featuring an accessible loft void. A large warehouse was present at the northwestern corner of the site, which also featured a single layered pitched roof, with no loft void and no suitability for habitation by bats. Figure 2 shows the location of all accessible loft voids.

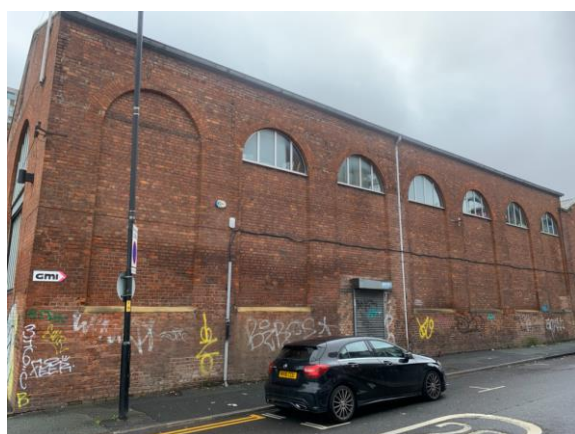
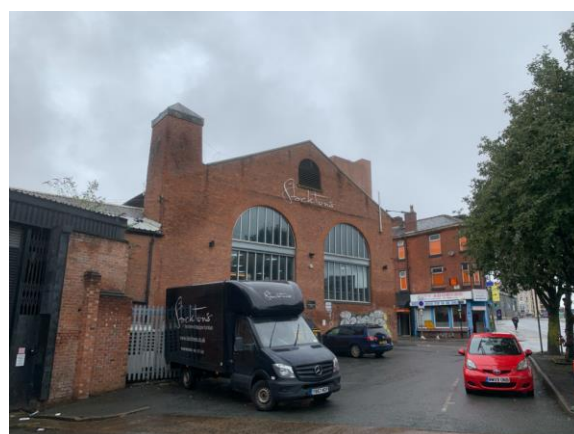
The northern & northeastern aspects of the site featured a well-sealed brick exterior with a pitched roof. A large grate was located at each gable end which was noted as a potential entrance into the loft void, however after following internal inspection both grates were found to be closed off (See Section 3.2.2). The roof consisted single layered corrugated material with no potential PRFs following internal inspection. A turret was located at the eastern corner of the roof, also well sealed with no visible PRFs. The area was assessed as featuring negligible potential to support a bat roost.

**Picture 1 – Northern aspect**

**Picture 2 – Northeastern corner aspect**

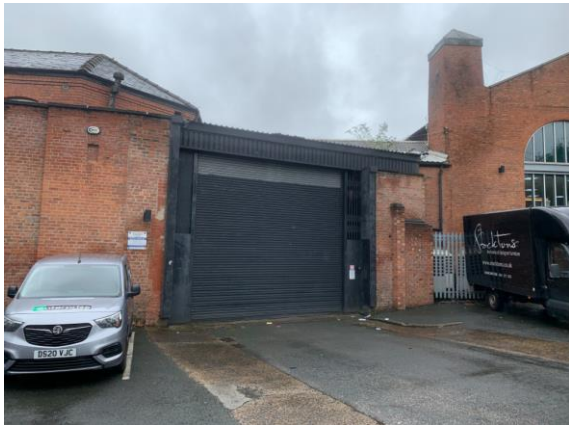
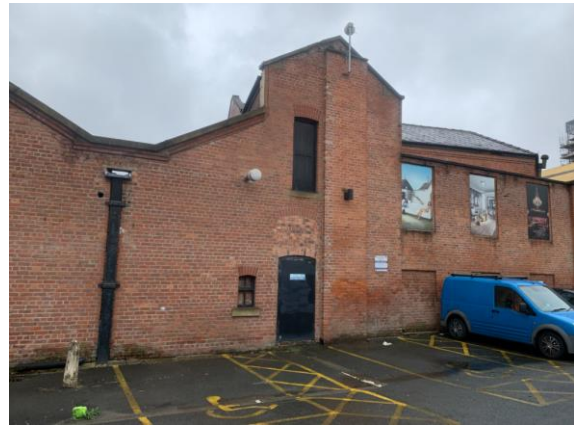
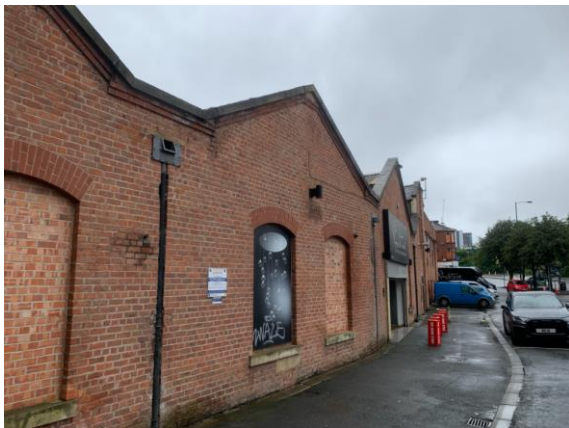
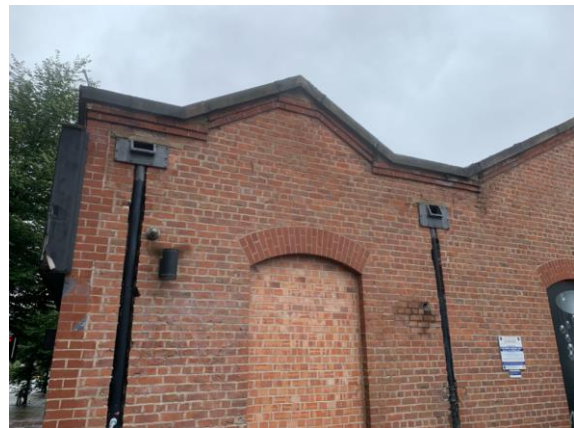
The eastern façade was furthermore well sealed across its extent, featuring as a gable end for multiple pitched rooves across the site. This area was generally single storey, with one area (R3) raising up a second story and featuring a loft void. No PRFs were identified across the extent.

**Picture 3 – Eastern aspect & shutter gate**

**Picture 4 – Eastern aspect & pitched roof**

**Picture 5 – Eastern aspect**

**Picture 6 – Southeastern corner aspect**

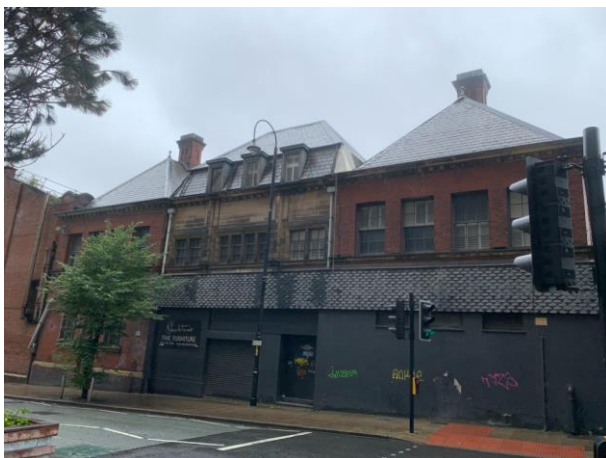
The southern aspect of the site was the most complex, featuring two pitched rooves with hipped ends and slate tiling, one roof partially encircling the other. Although all the tiling was observed well sealed, on the southern extent one hip cover was almost entirely removed, leaving large gaps into cavities between the tiling and inner roof insulation along its extent and serving as a large suitable PRF. Along the northern extent of these rooftops a dilapidated dormer was present, featuring a grate which served as a suitable PRF.

**Picture 7 – Southern extent featuring R1 & R2**

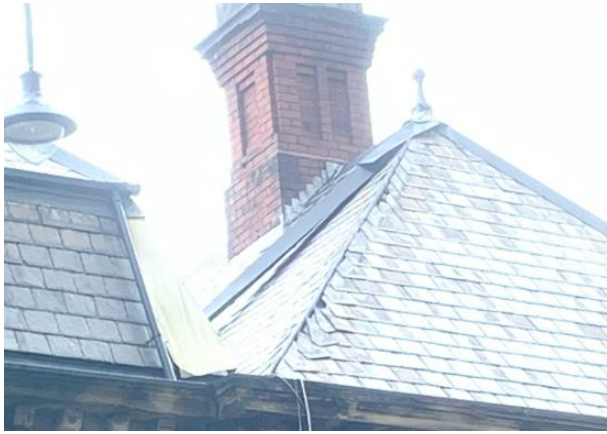
**Picture 9 – Lifted hip cover**

The site was assessed as having **low** potential to support a bat roost due to the PRFs present along R1 and R2.

A minimum of one dusk emergence or dawn re-entry survey is to be undertaken on site to confirm presence or likely absence of roosting bats. All surveys should be undertaken in accordance with the current BCT guidance (Collins, 2016).

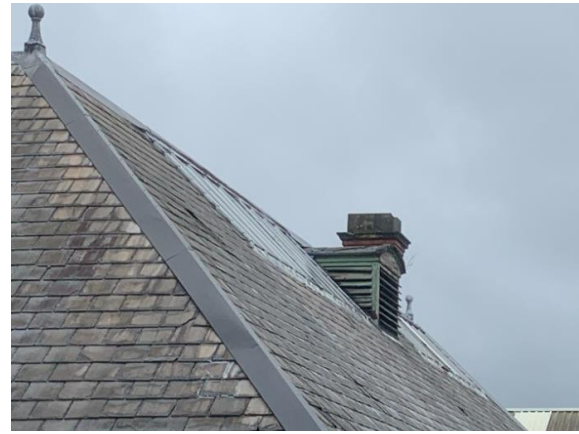
**Picture 10 – Dilapidated dormer**

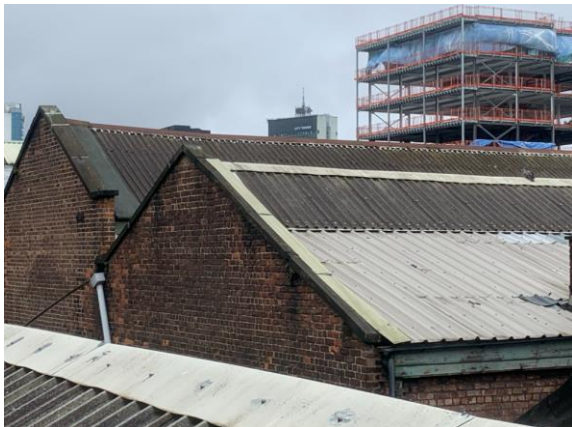
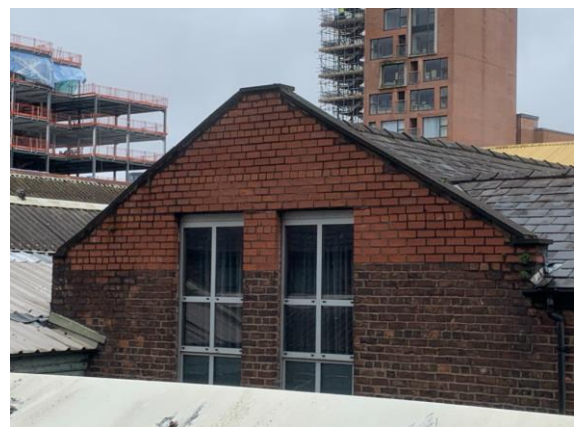
The central rooftop was accessible by surveyors and comprised of a mosaic of pitched roofs of single layer corrugated material, covering open plan commercial space beneath and featuring negligible suitability for roosting within (See Section 3.2.2.). Where brick walls were present, they were well sealed and did not feature suitable PRFs.

**Picture 11 – Central pitched roofs**

**Picture 12 – Gable end of R3**

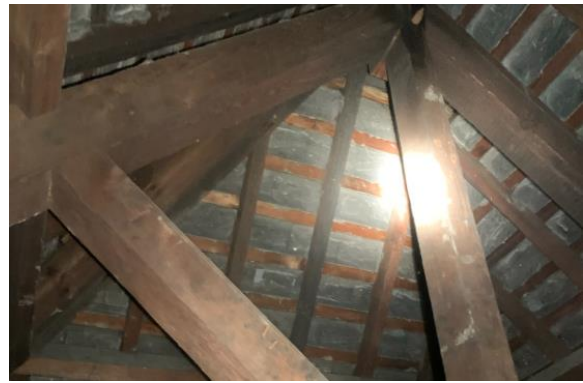
R1's loft void was well sealed from within apart from slight light spill entering the cavity from the eaves. No tears in the internal insulation were present, and the void was assessed as providing negligible potential to support a roost.

**Picture 13 – Light spill within R1**

**Picture 14 – Well sealed internals of R1**

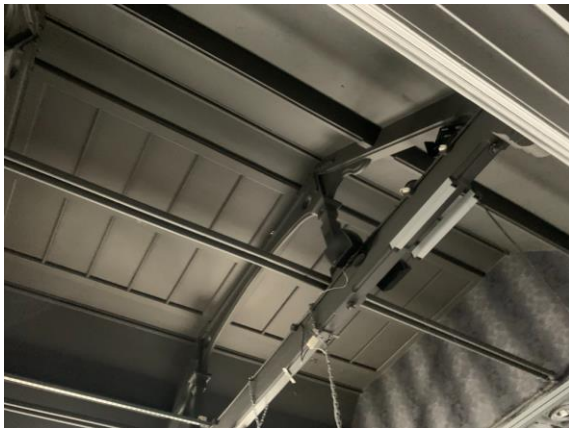
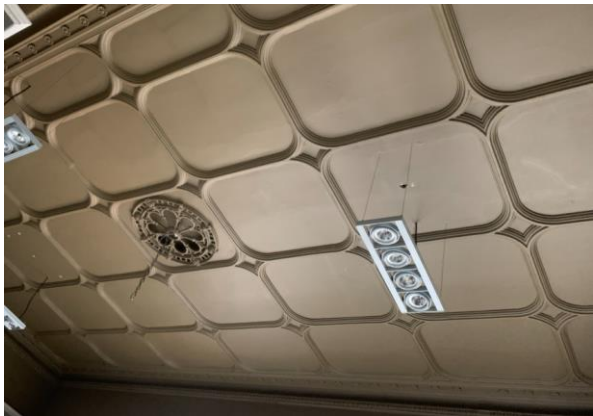
**Picture 15 – R2**

R2's loft voids served as publicly accessible showrooms and were fully sealed from within, featuring negligible potential to support a roost.

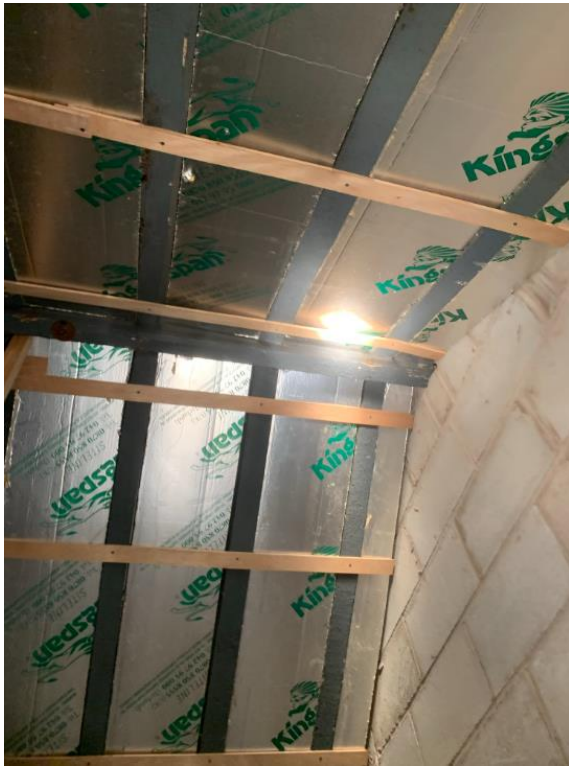
**Picture 17 – R3**

R3's loft void was similarly well sealed, featuring no light spill.

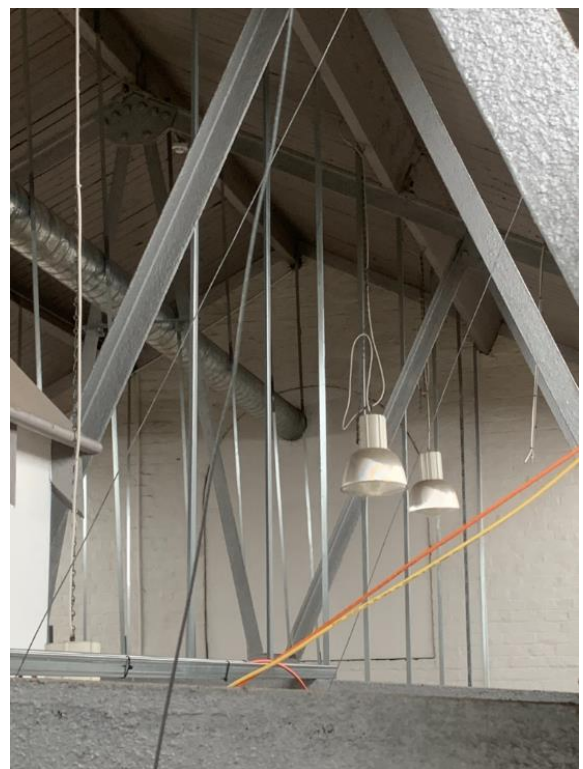
All of the central roof spaces, along with the large warehouse space to the north, were open plan with the public access and warehouse floors beneath and consisted of single corrugated sheet material which provided no small crevices for bat species to roost within. All these areas were assessed as providing negligible potential to support a roost.

**Picture 17 – Example of central roof space**

**Picture 18 – Northern warehouse roof space**
