# Geo-Environmental Investigation Report

Lidl, 440 Hollinwood Avenue, Moston, Manchester

**Client:** Lidl Great Britain Limited  
**Project:** Lidl, 440 Hollinwood Avenue, Moston, Manchester  
**Title:** Geo-Environmental Investigation Report  
**Report Ref:** 24-1990-P-R2  
**Status:** Final  
**Date:** November 2024

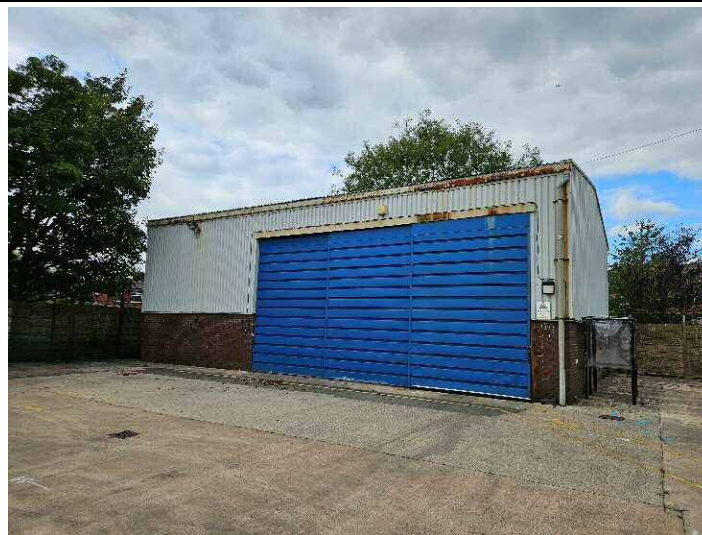
Photograph 4 – Former vehicle maintenance building.

The western area of the site is predominantly covered with concrete hardstanding. A former vehicle repair building is also located in the north-western corner of the site. We understand from anecdotal evidence that this was more recently used for storage and warehousing. There were former, above ground fuel storage tanks (AGST's) located immediately to the east of the small building; comprising a 20,000-litre diesel tank and along the northern boundary a 4000-litre liquid petroleum gas tank, however these have since been removed. There is however a newer AGST located adjacent to the western elevation of the main warehouse building comprising a 10,000-litre diesel tank within an Enviro Cube, with AdBlue tanks also present.

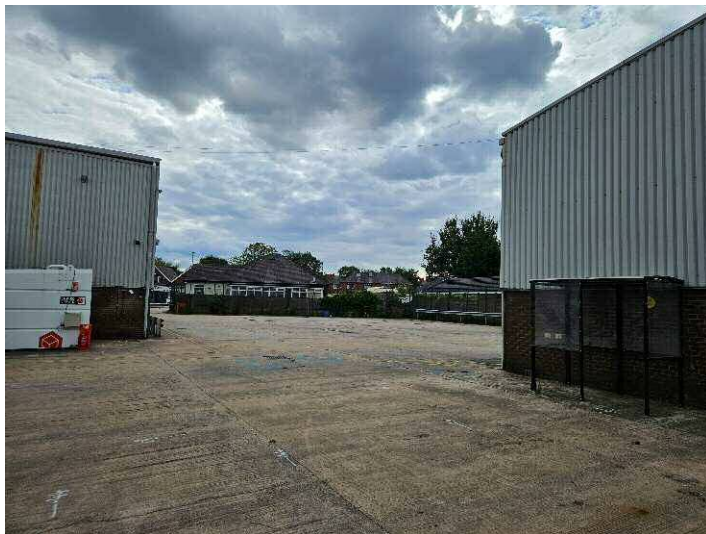
Photograph 5 – Present above ground fuel tank in left of image. Former above ground fuel tank in location of shelter.

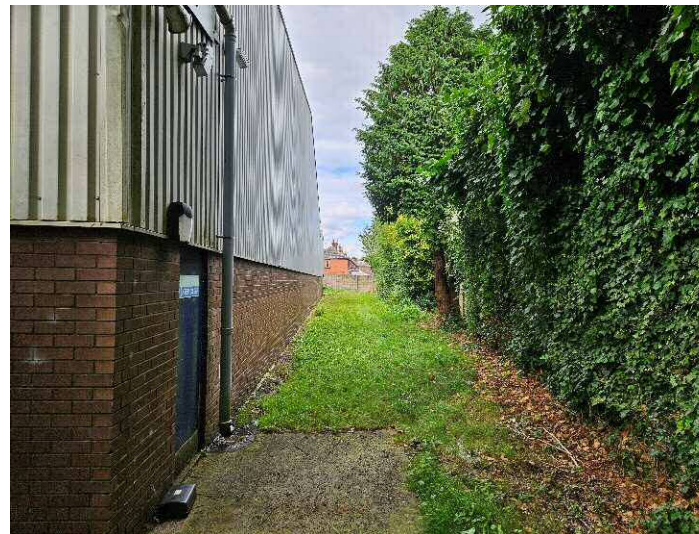
Photograph 6 – Area of landscaping along eastern border.

Some vegetation is present around the boundary of the site, with an area of landscaping along the eastern boundary and the eastern half of the northern boundary. The majority of the mature trees found on site are located along the eastern boundary.

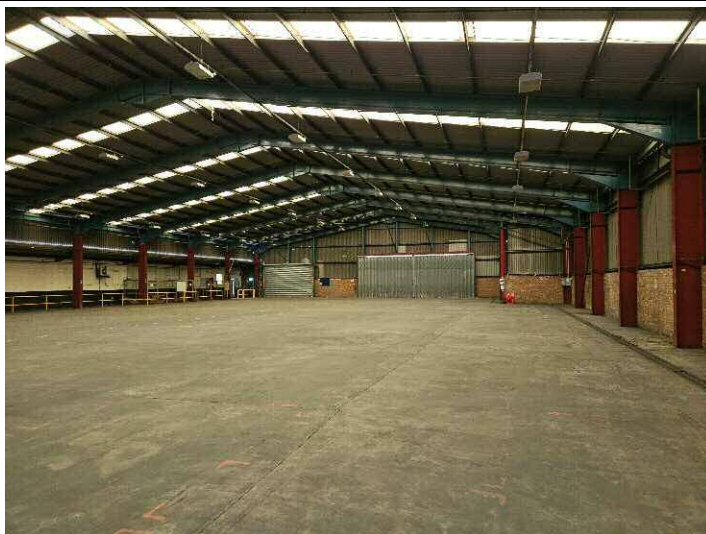
Photograph 7 – The southern warehouse.

Piles are recommended as the underlying natural strata is deemed too soft and variable for conventional foundations. The brickwork of the current warehouse buildings has also been observed to have some significant cracks and many replacement areas throughout. It is likely that this building has not been piled and the damage has been caused by either differential settling or soil heave due to the boundary trees.

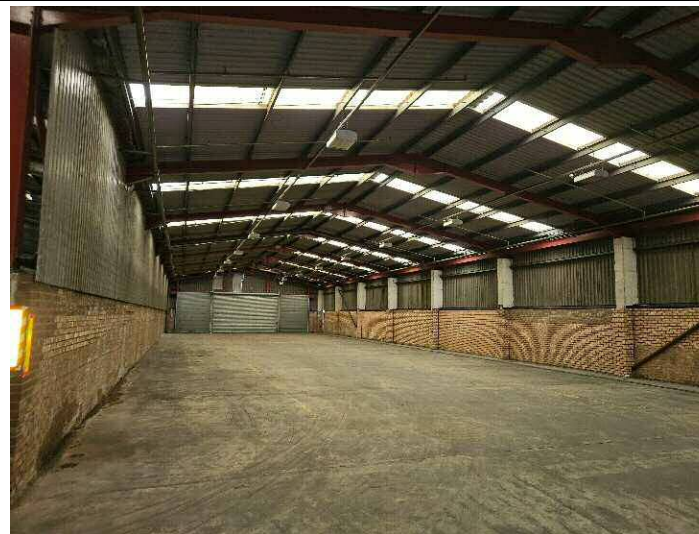
Photograph 8 – The northern warehouse.

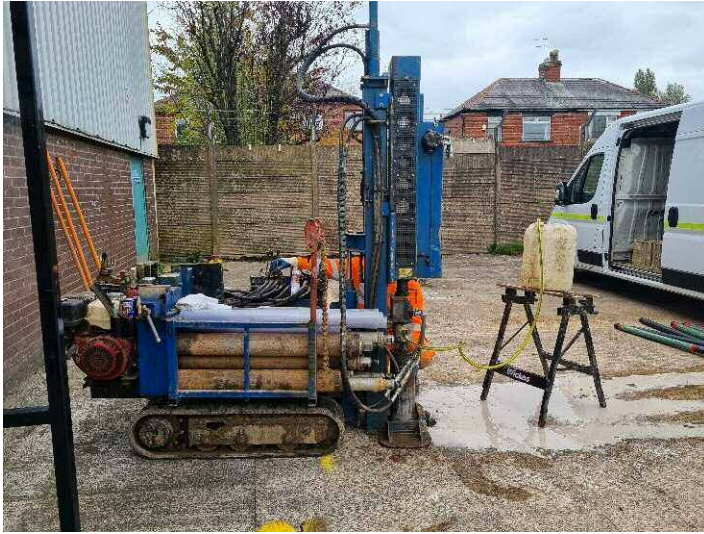
Photograph 9 – Location and drilling of borehole WS01.

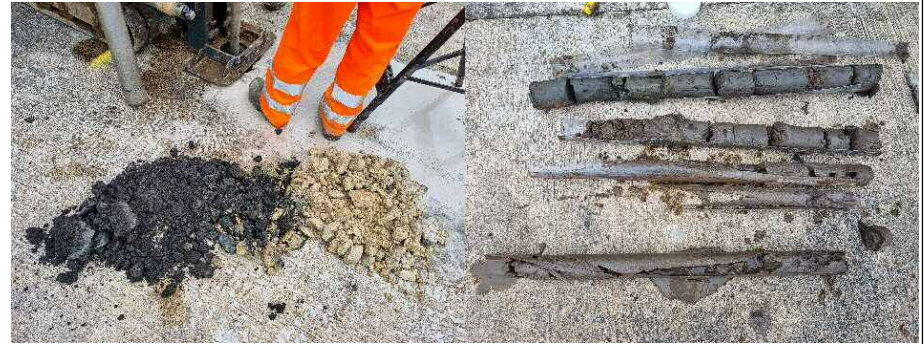
Photograph 10 – The hand dug pit excavated material and core recovery for WS01.

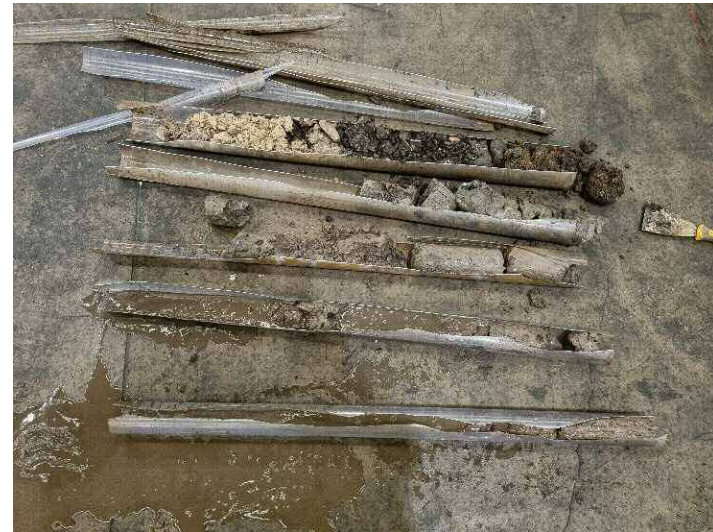
Photograph 12 – Core recovery of borehole WS07.

One sample recorded elevated PAHs as well as a positive detection of asbestos containing materials (ACM), with a quantification of 0.132%. This sample (WS07 at 0.60m bgl) is located beneath the proposed building footprint within a layer of Made Ground found between 0.50m and 0.70m bgl. The

affected Made Ground is a thin layer, which will likely be stripped during the formation of the foundations. Due to its asbestos content, it will likely require a Hazardous Waste classification. The extent of the affected material is unknown, it is recommended that this area is delineated either pre or post demolition works. Given the nature of the Made Ground, it may be the case that asbestos is present elsewhere on site.
