# SUNLIGHT HOUSE

DESIGN AND ACCESS STATEMENT  
GROUND AND BASEMENT WORKS

This document accompanies the listed building and planning application for the refurbishment of the ground and basement at Sunlight House, Manchester, M3 3HP. Works comprise of Landlord improvements ahead of future tenant fit outs, including the demolition of non-original walls, structural repairs to concrete slabs, repairs to cornices and installation of decorative louvres to shopfronts.

February 2025

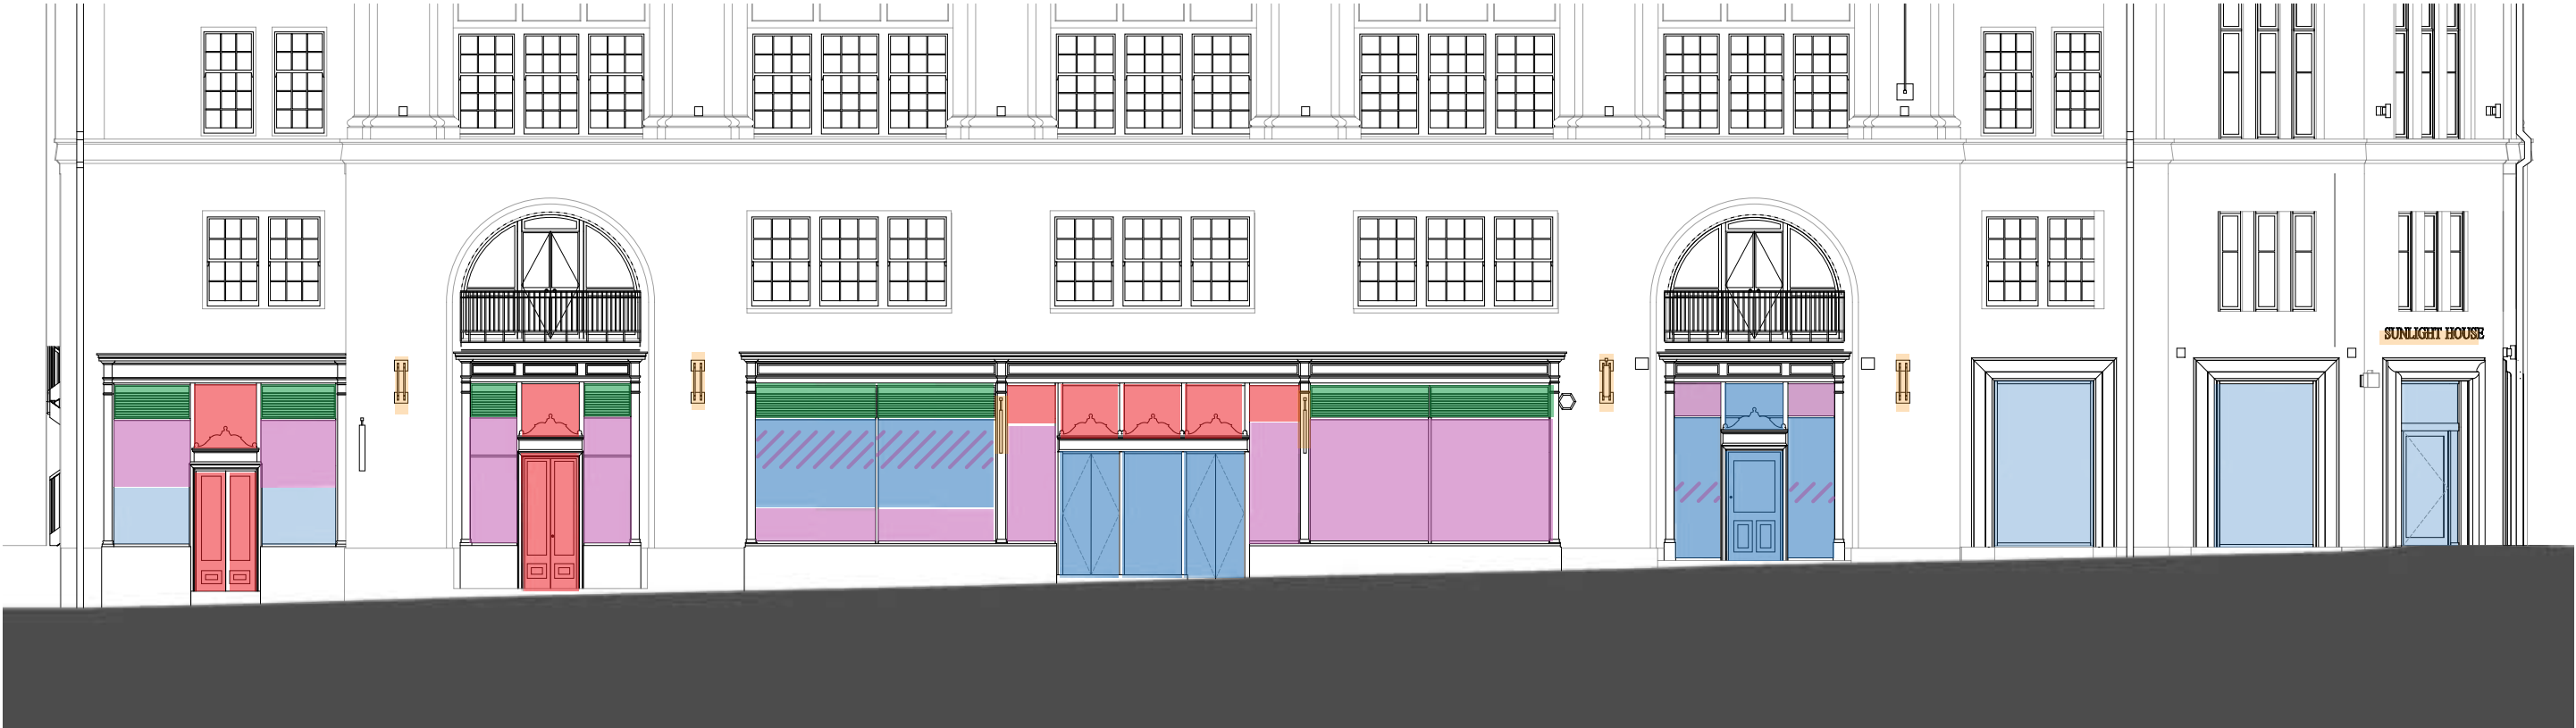
① EXISTING SOUTH ELEVATION - QUAY STREET

EXISTING ELEVATION APPRAISAL

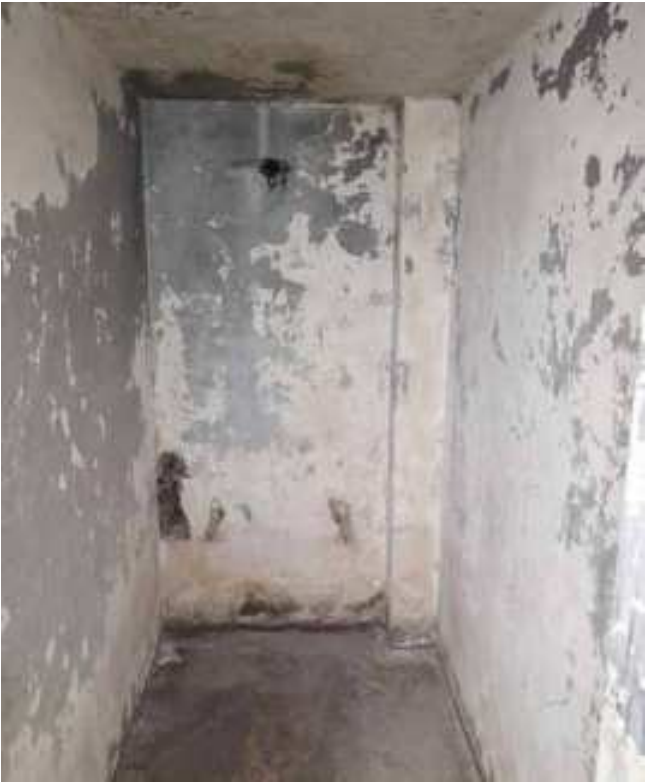
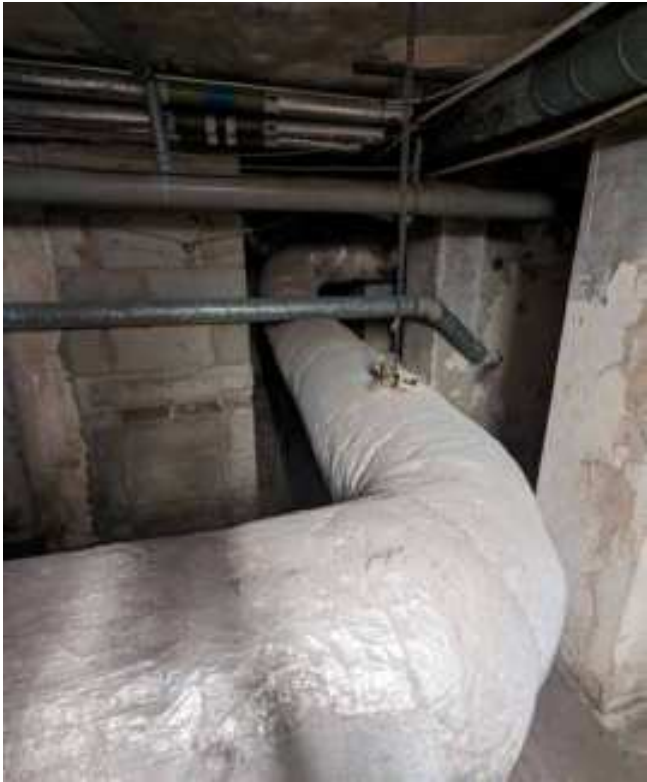
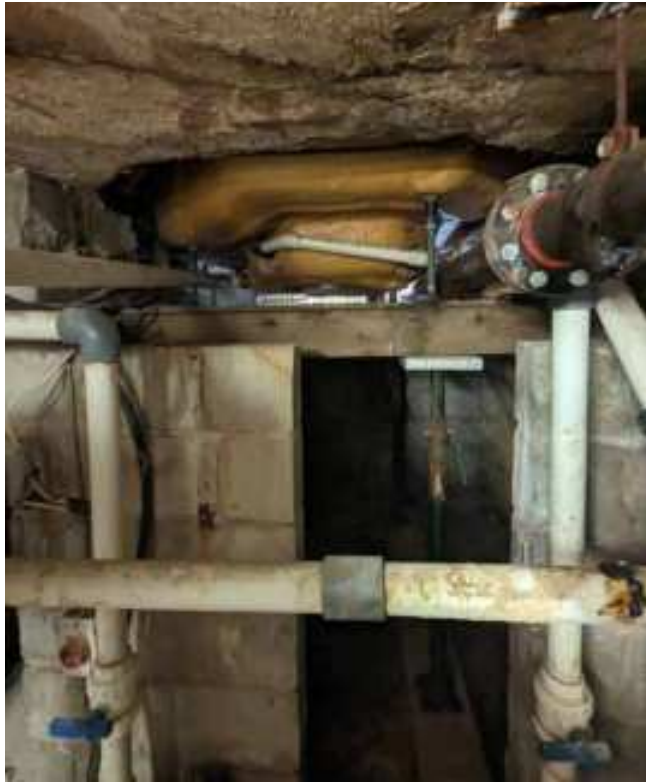
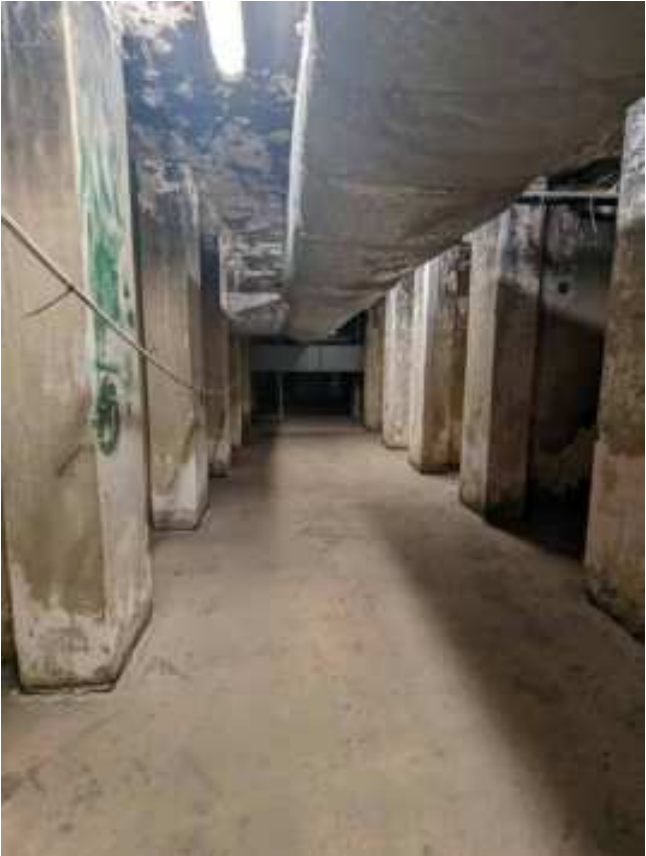
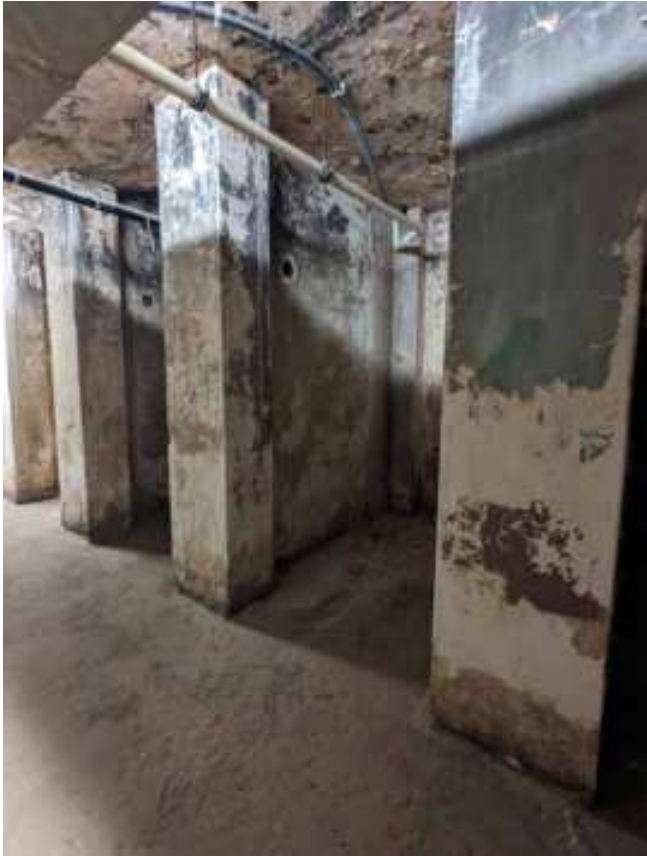
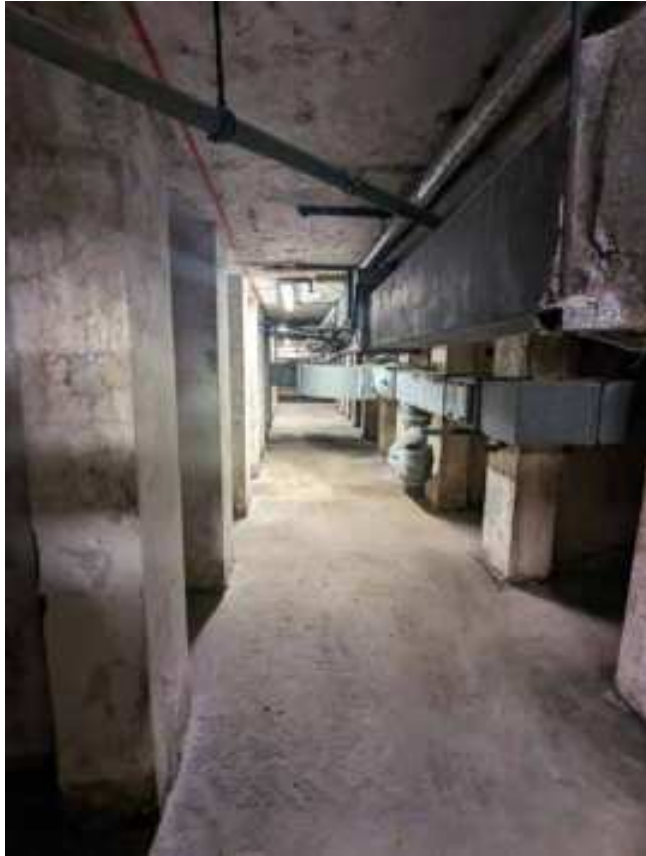
**BASEMENT**  
OLD CHANGING AREA + PLANT

- 1. Large area of older changing rooms (along little quay street) maintained for future generations but difficult to activate in current use due to condition, headheight and no opportunity for level access through historic install of basement mezzanine level and lift/stair configuration.
- 2. The area near Atkinson Street will be maintained to provide exemplary end of journey facilities for entire building with direct access from Atkinson Street through the existing stair which will be increased to meet regulation minimum width. This section of works is provided within a separate listed building application.
- 3. Area used mostly for varies services and MEP equipment serving the main office floors and the Basement tenant.

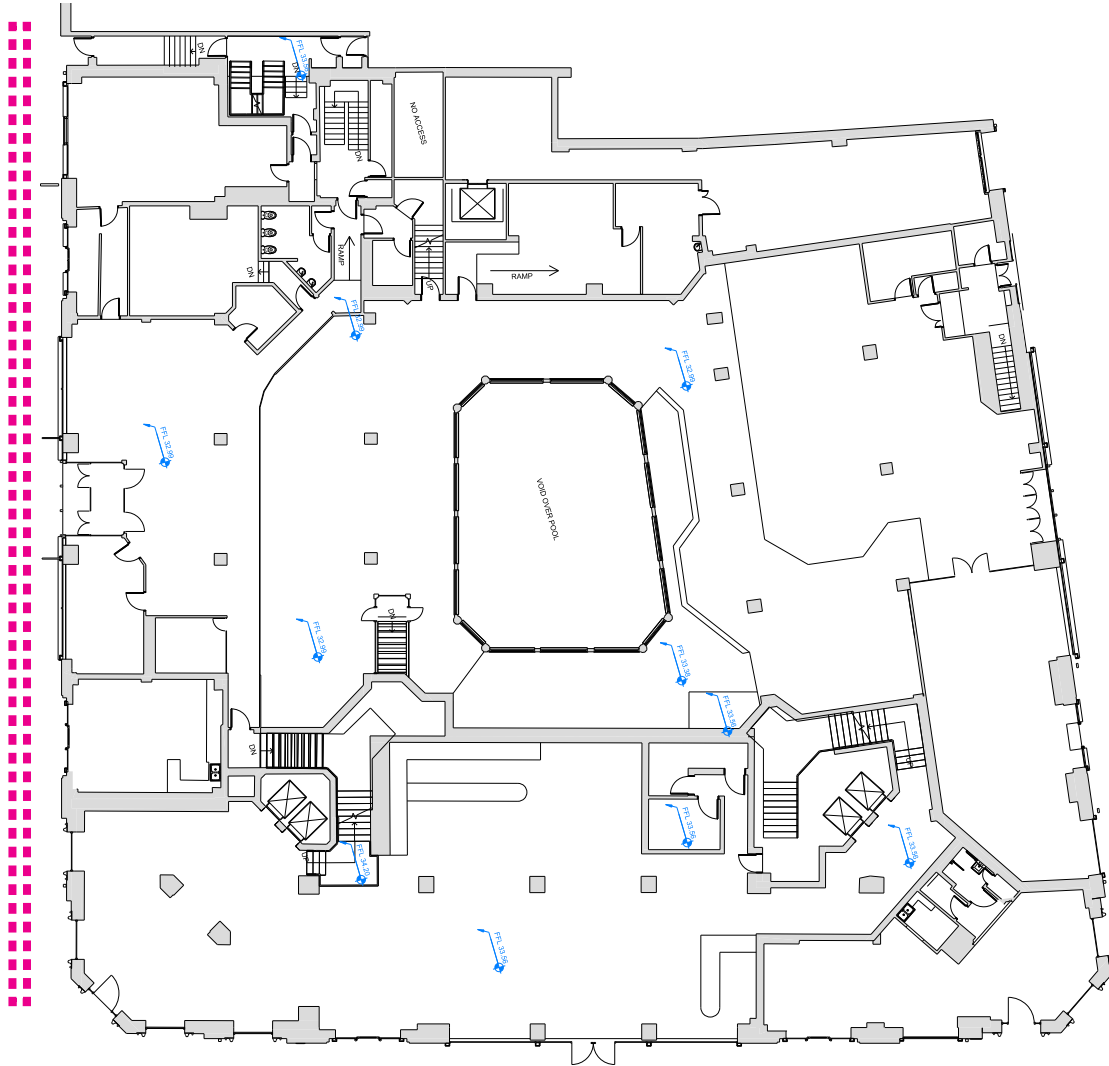
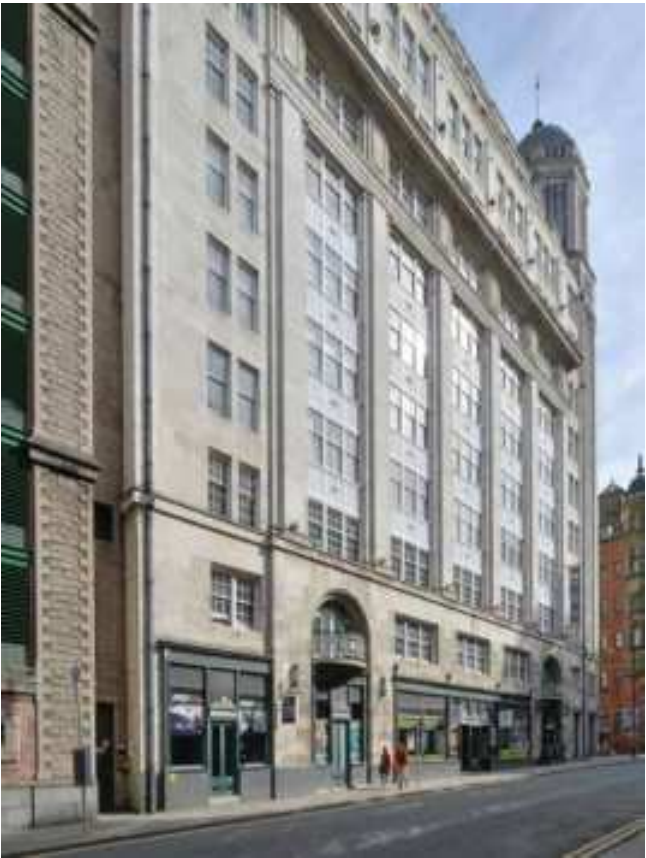
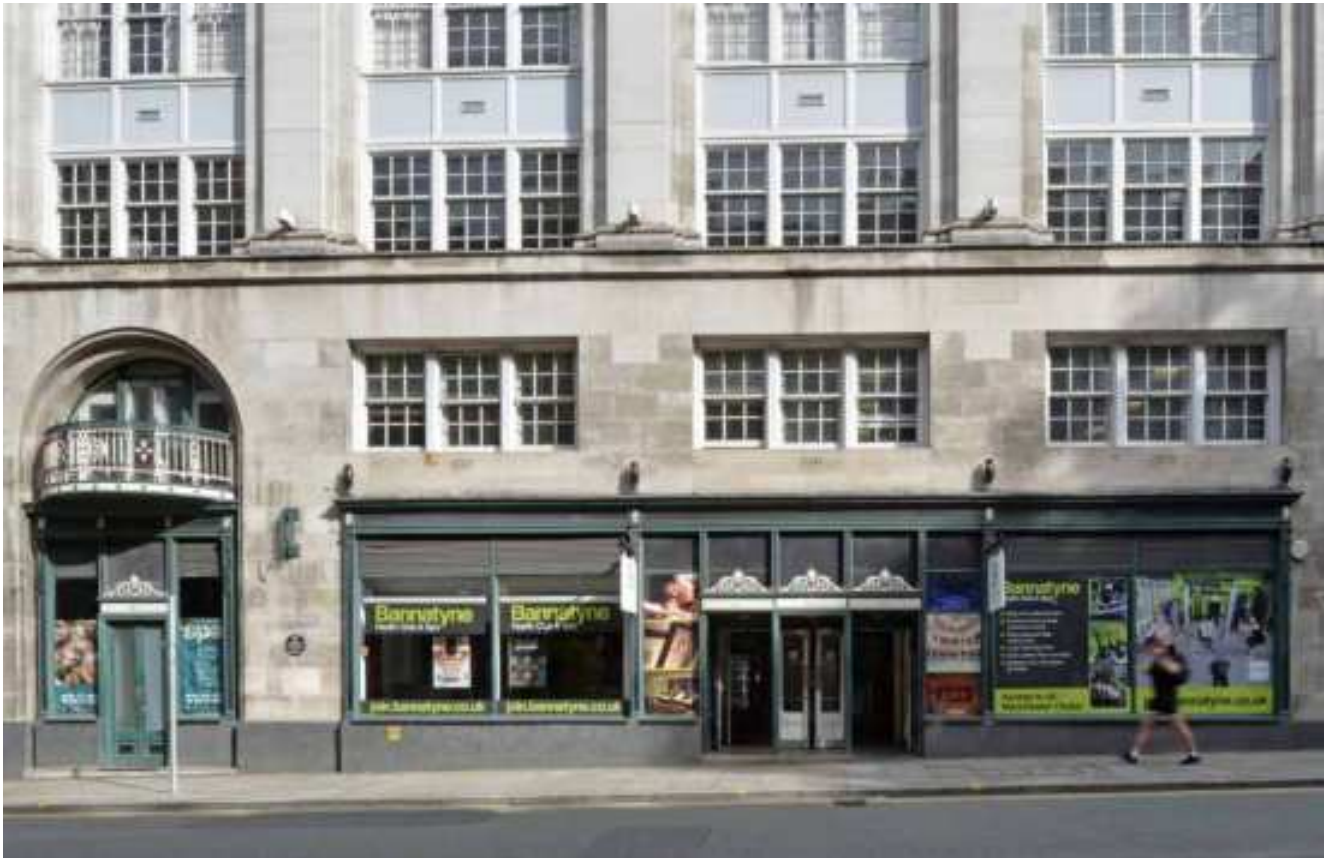
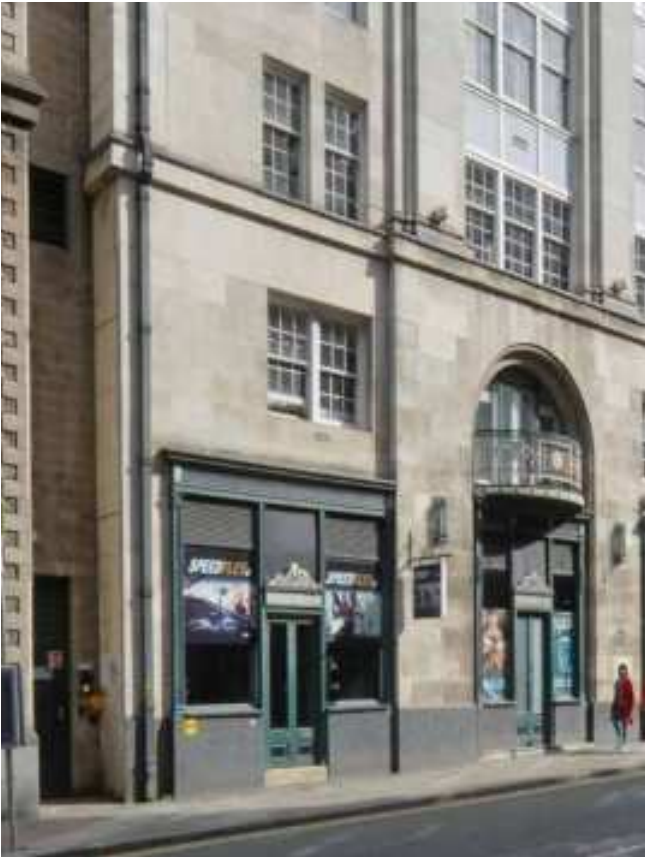
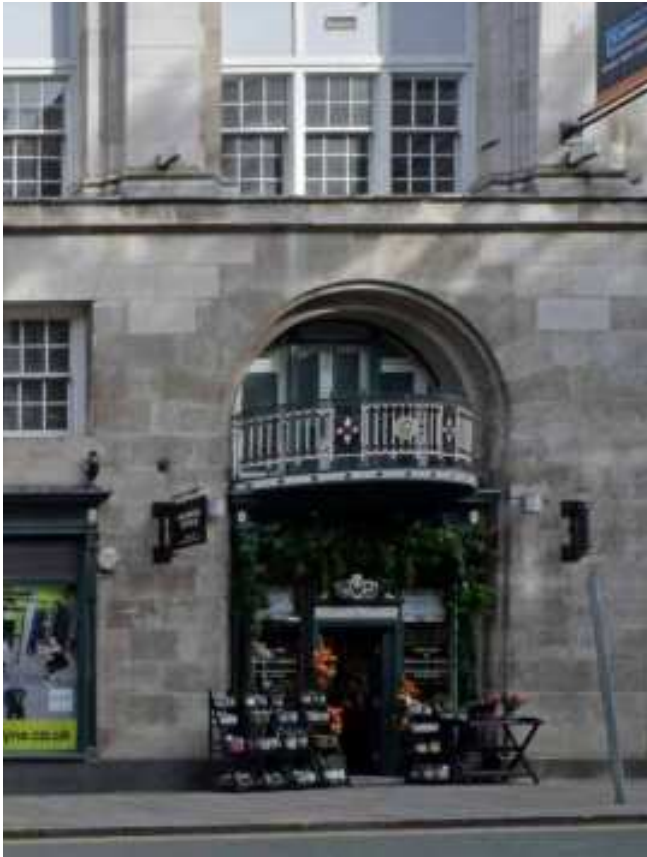
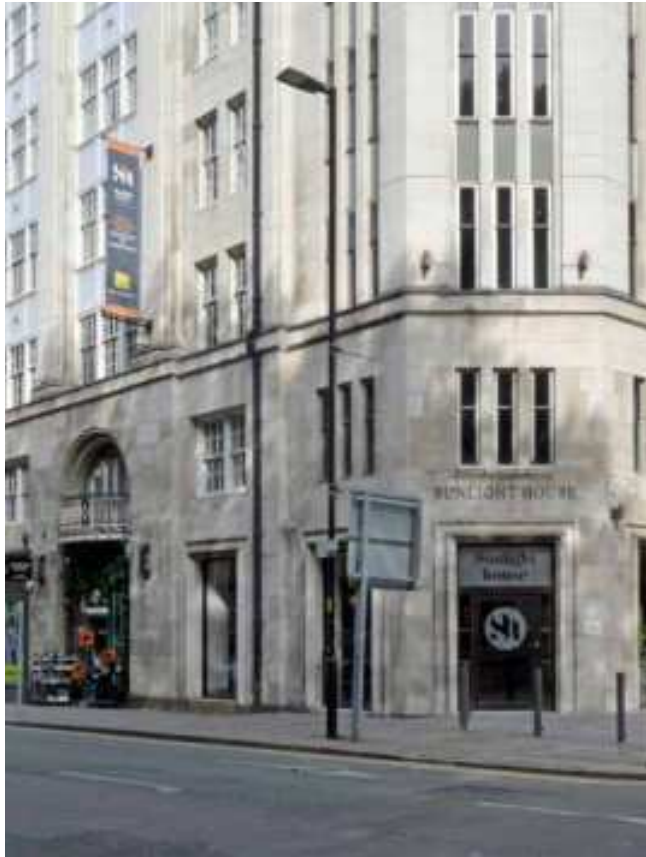
PHOTO APPRAISAL | JUNE 2023 | QUAY STREET

GROUND  
EXTERNAL - QUAY STREET

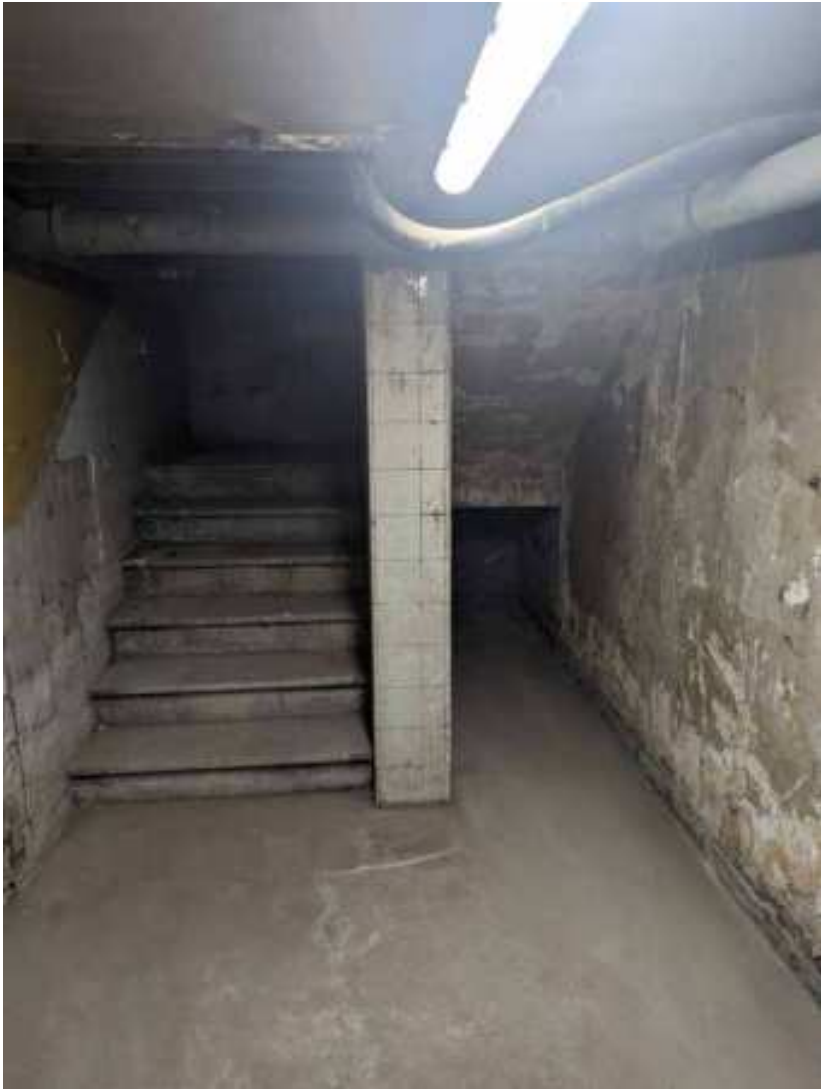
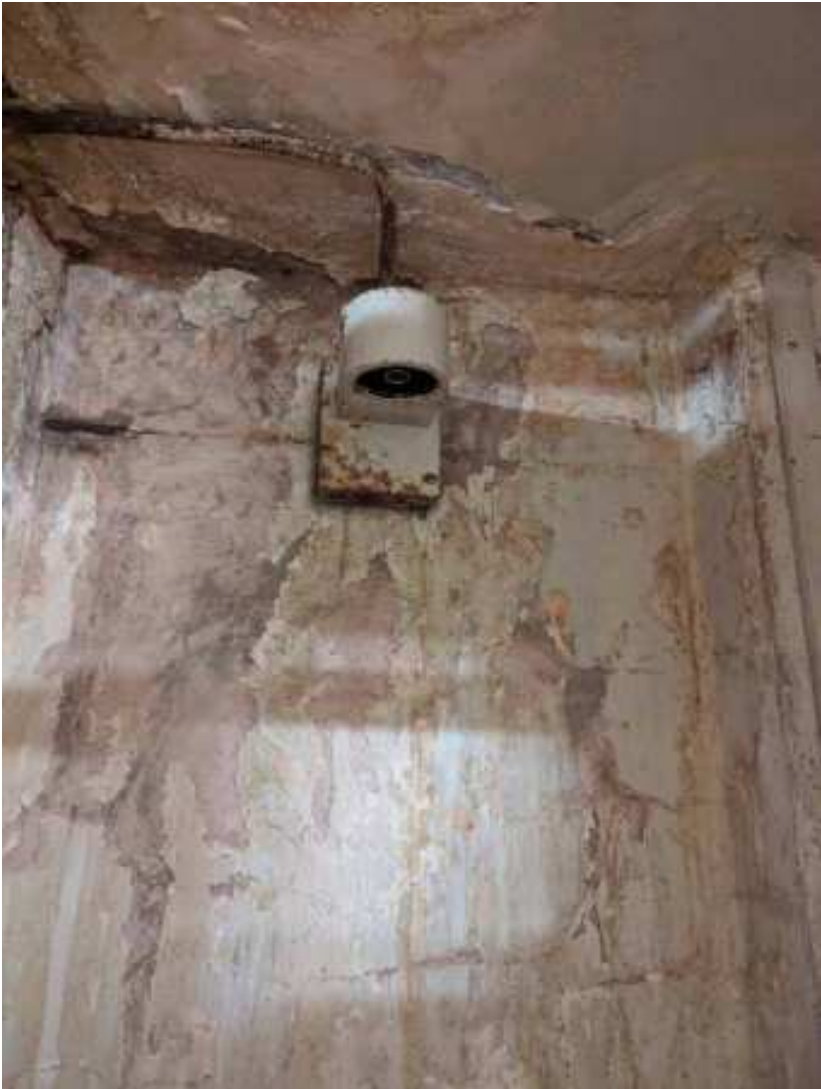
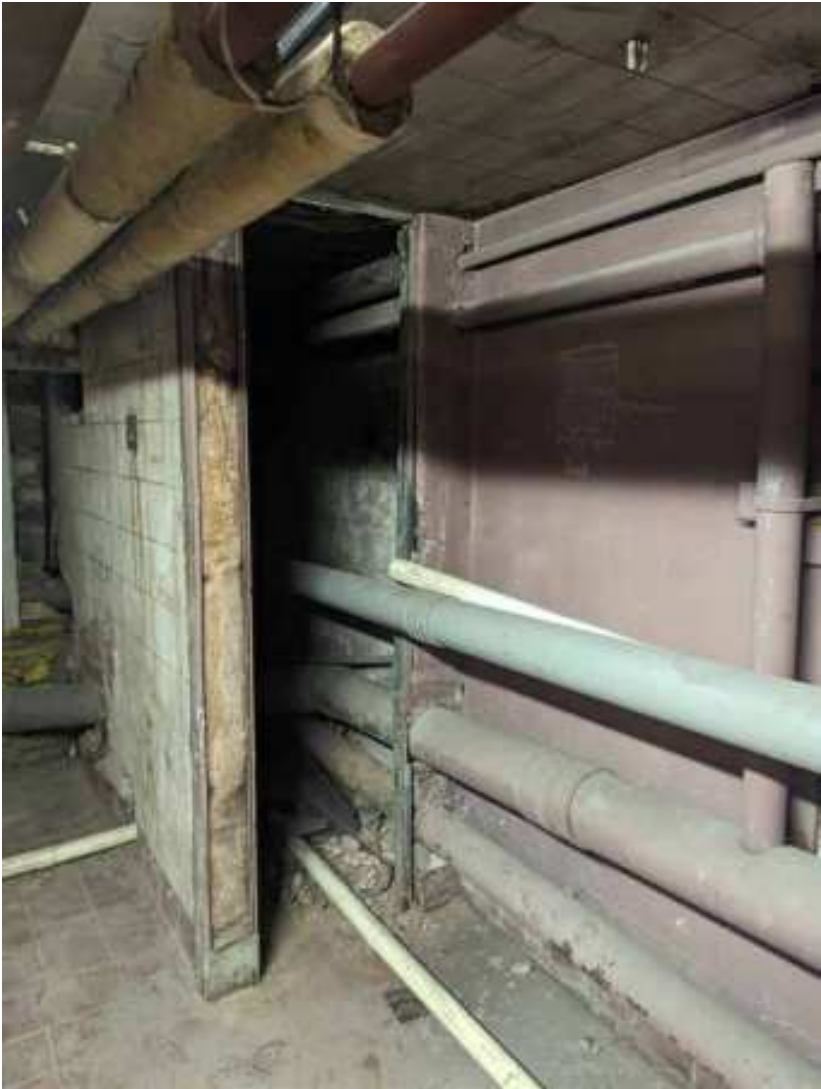
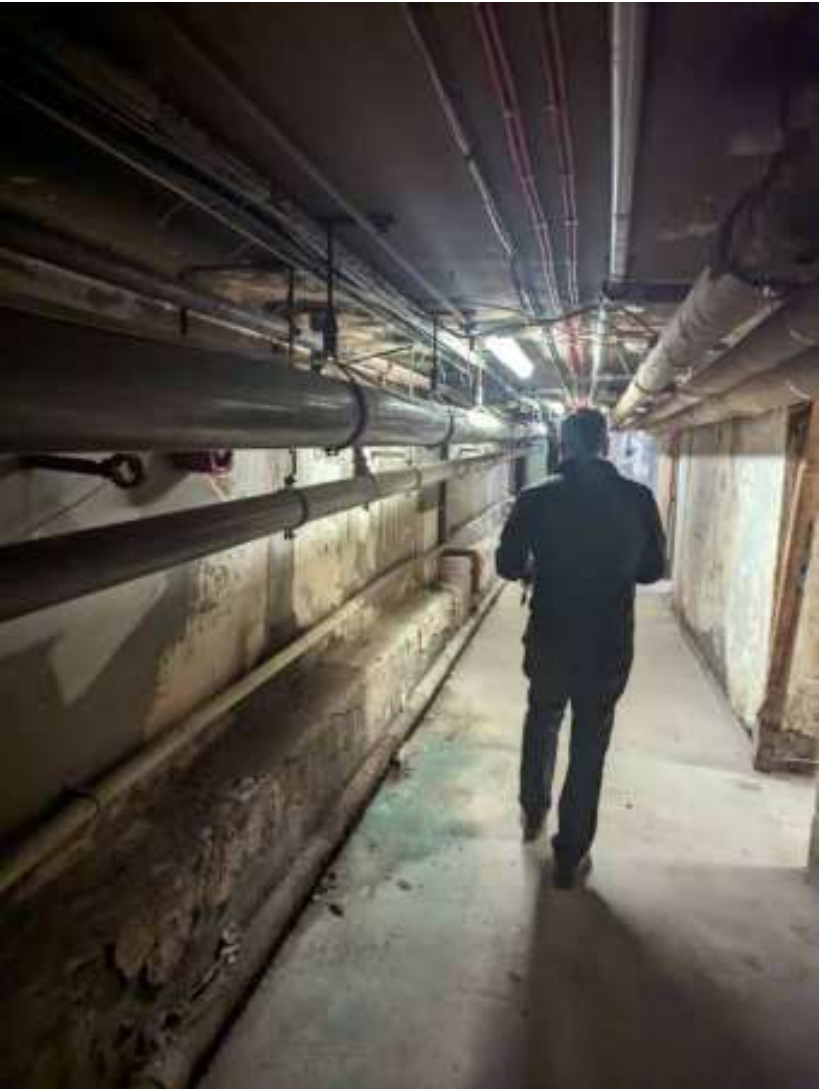
**BASEMENT**  
KEY INTERVENTIONS | CONDITION

STRUCTURAL REPAIRS TO  
EXISTING SLAB WHERE  
REQUIRED.

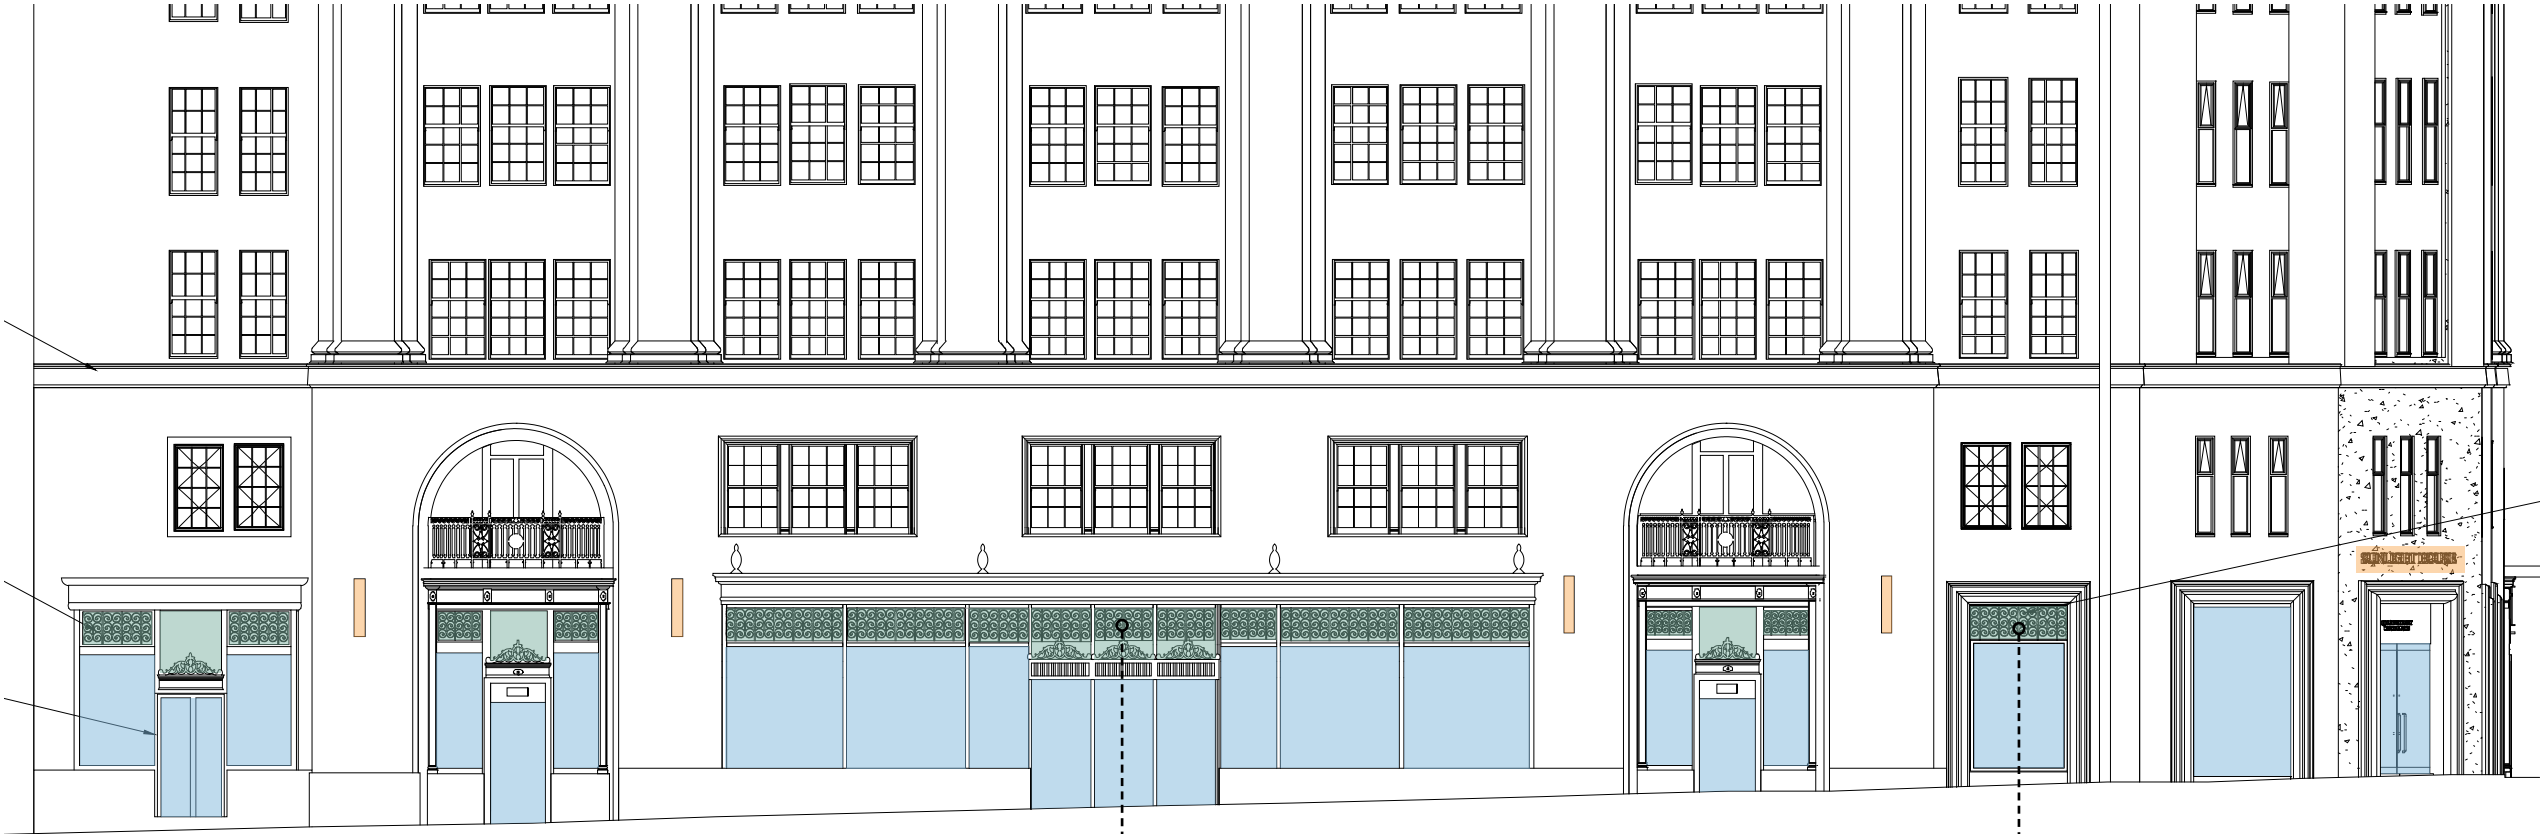
Indicative glazing advertising/branding. Each incoming tenant will likely have their own signage requirements subject to use that will have to be dealt with under their own applications. Proposals for lighting and signage not included as a part of this application. New decorative window louvres in keeping with the historic building providing sufficient coverage to the louvre beyond, all while meeting required free air area.

PROPOSED NEW LOUVRE  
DECORATIVE FOR VENTILATION  
REQUIREMENTS

THIS WINDOW NEW DECORATIVE  
LOUVRE & GLAZING PROVIDED IN  
SEPERATE PLANNING CONDITION

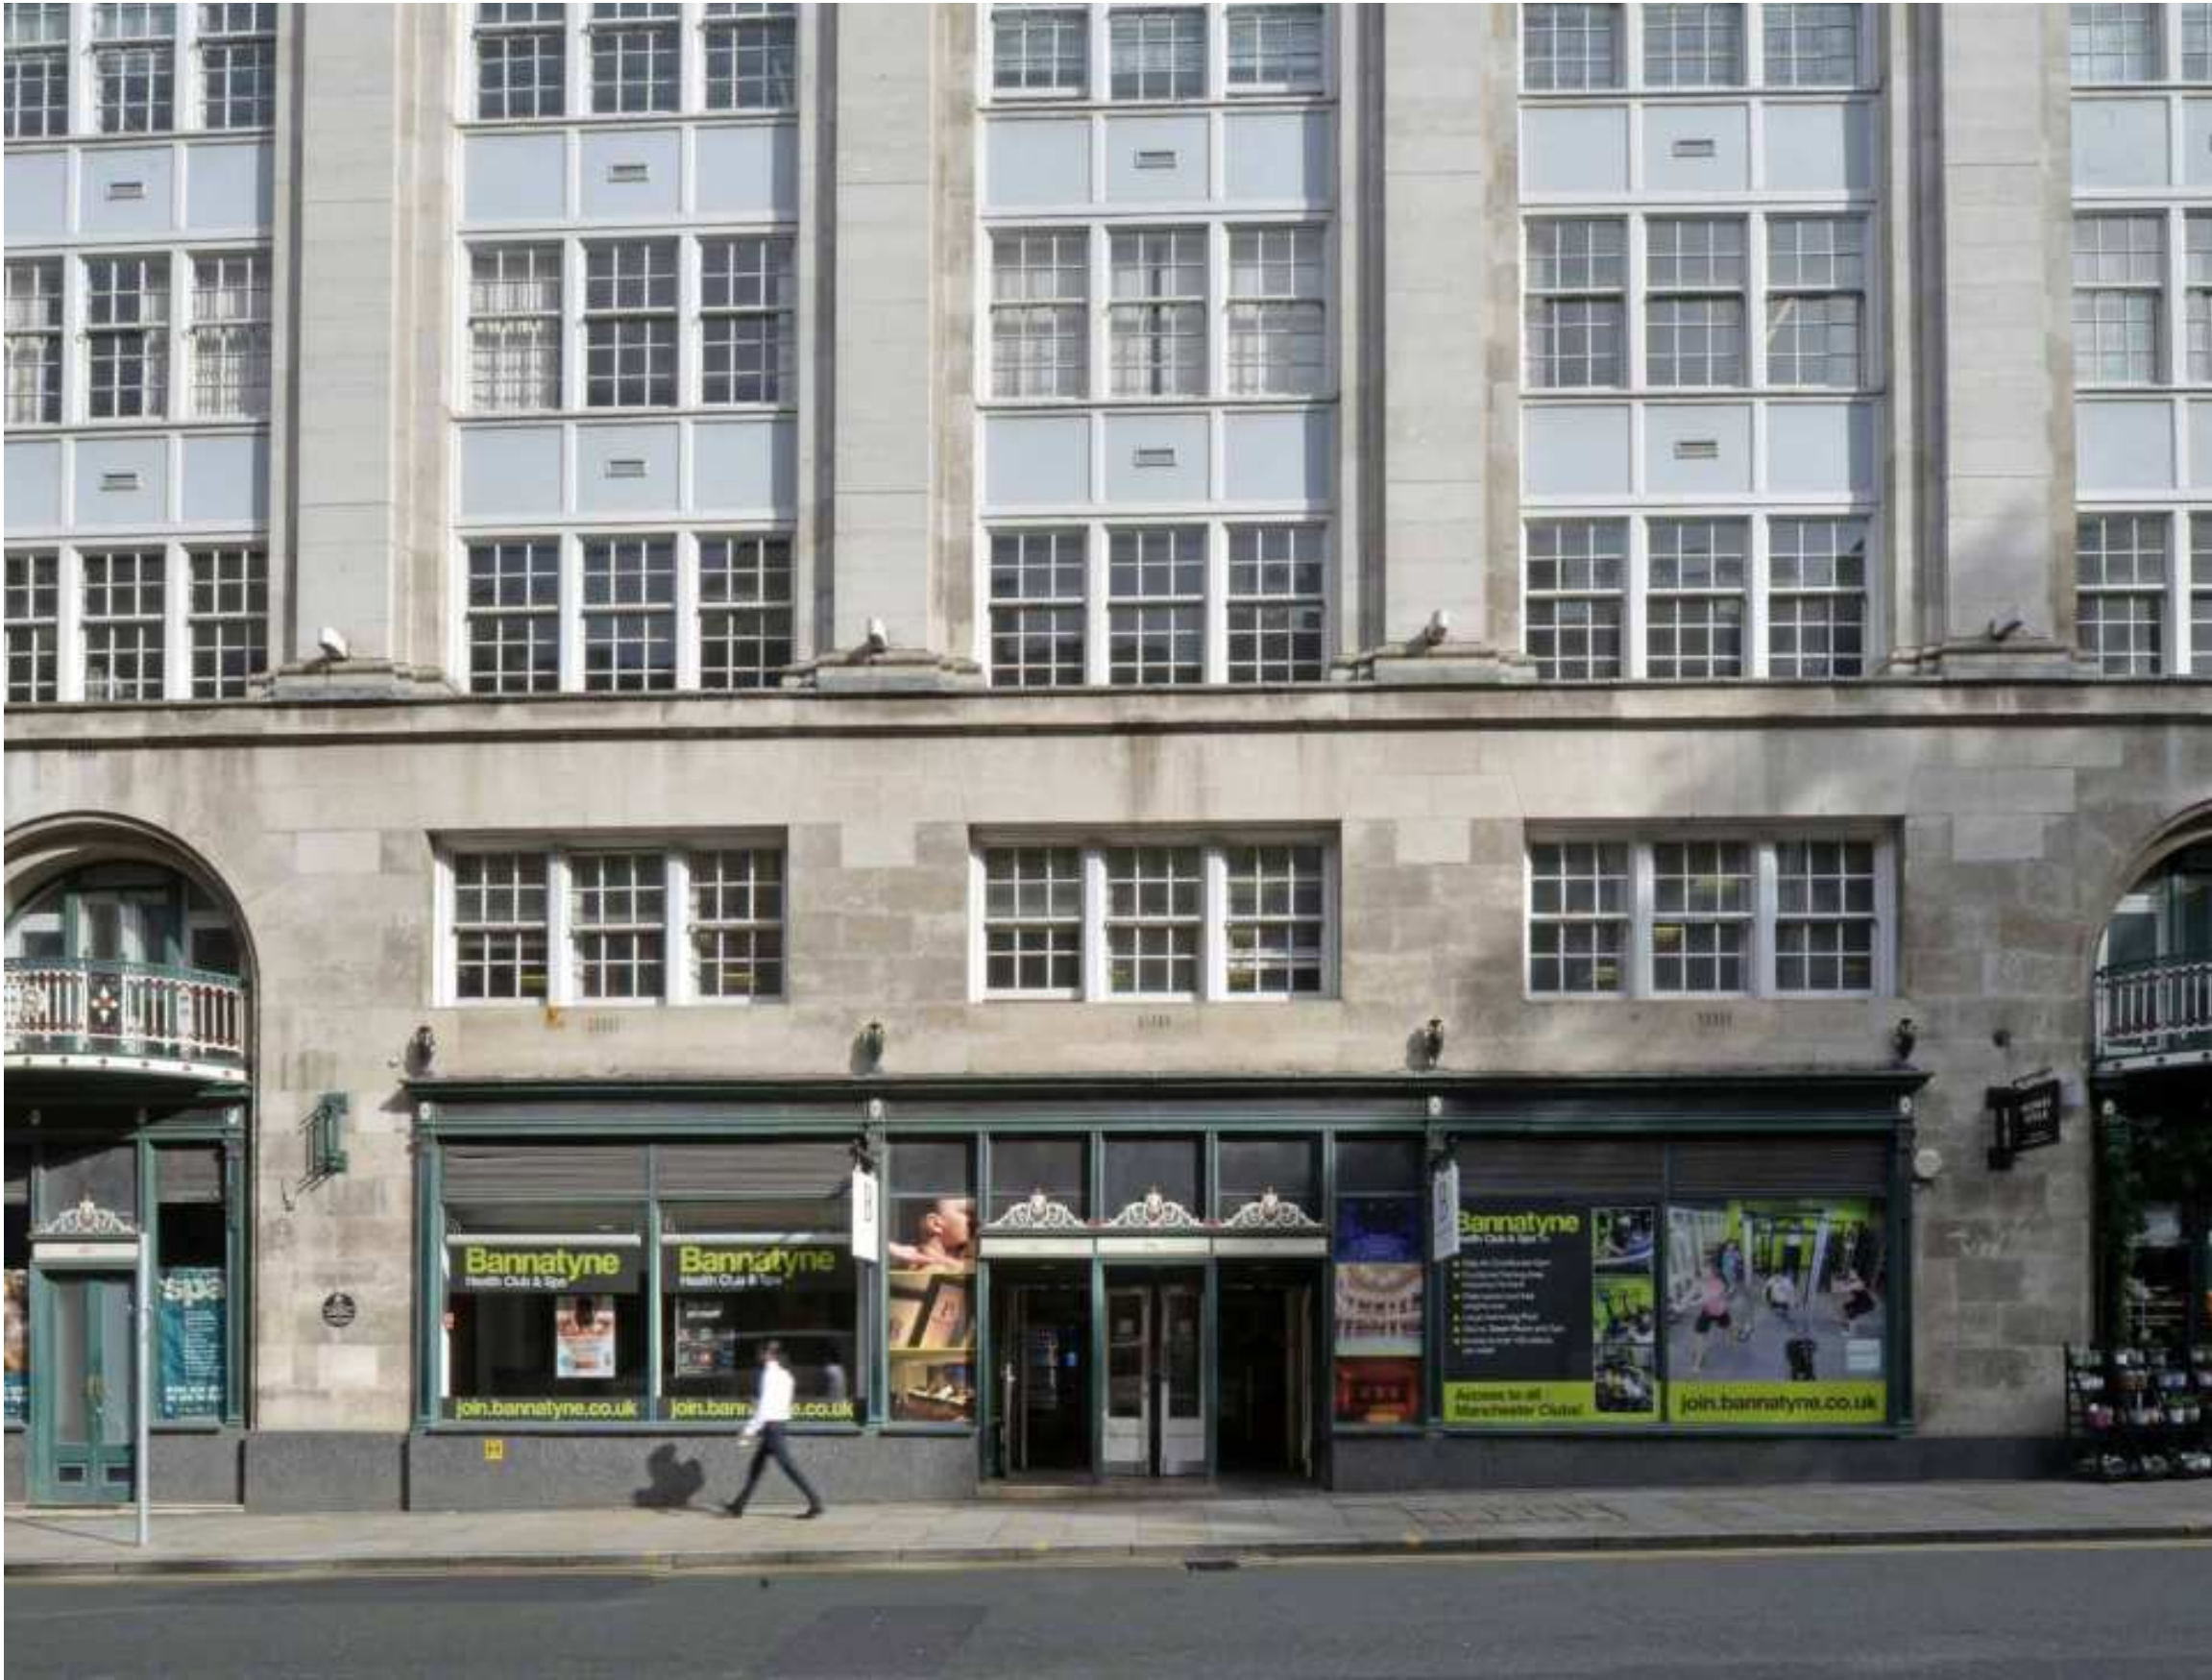
The historic shop fronts to Quay Street and Atkinson Street have largely remained intact over the years, much of the original detailing and colour remains evident on site. The internal arrangements and heavy branded advertisement vinyls have however detracted from their design. Many of the access doors are no longer in use and in some instances blocked entirely as 'escape only' fire doors.

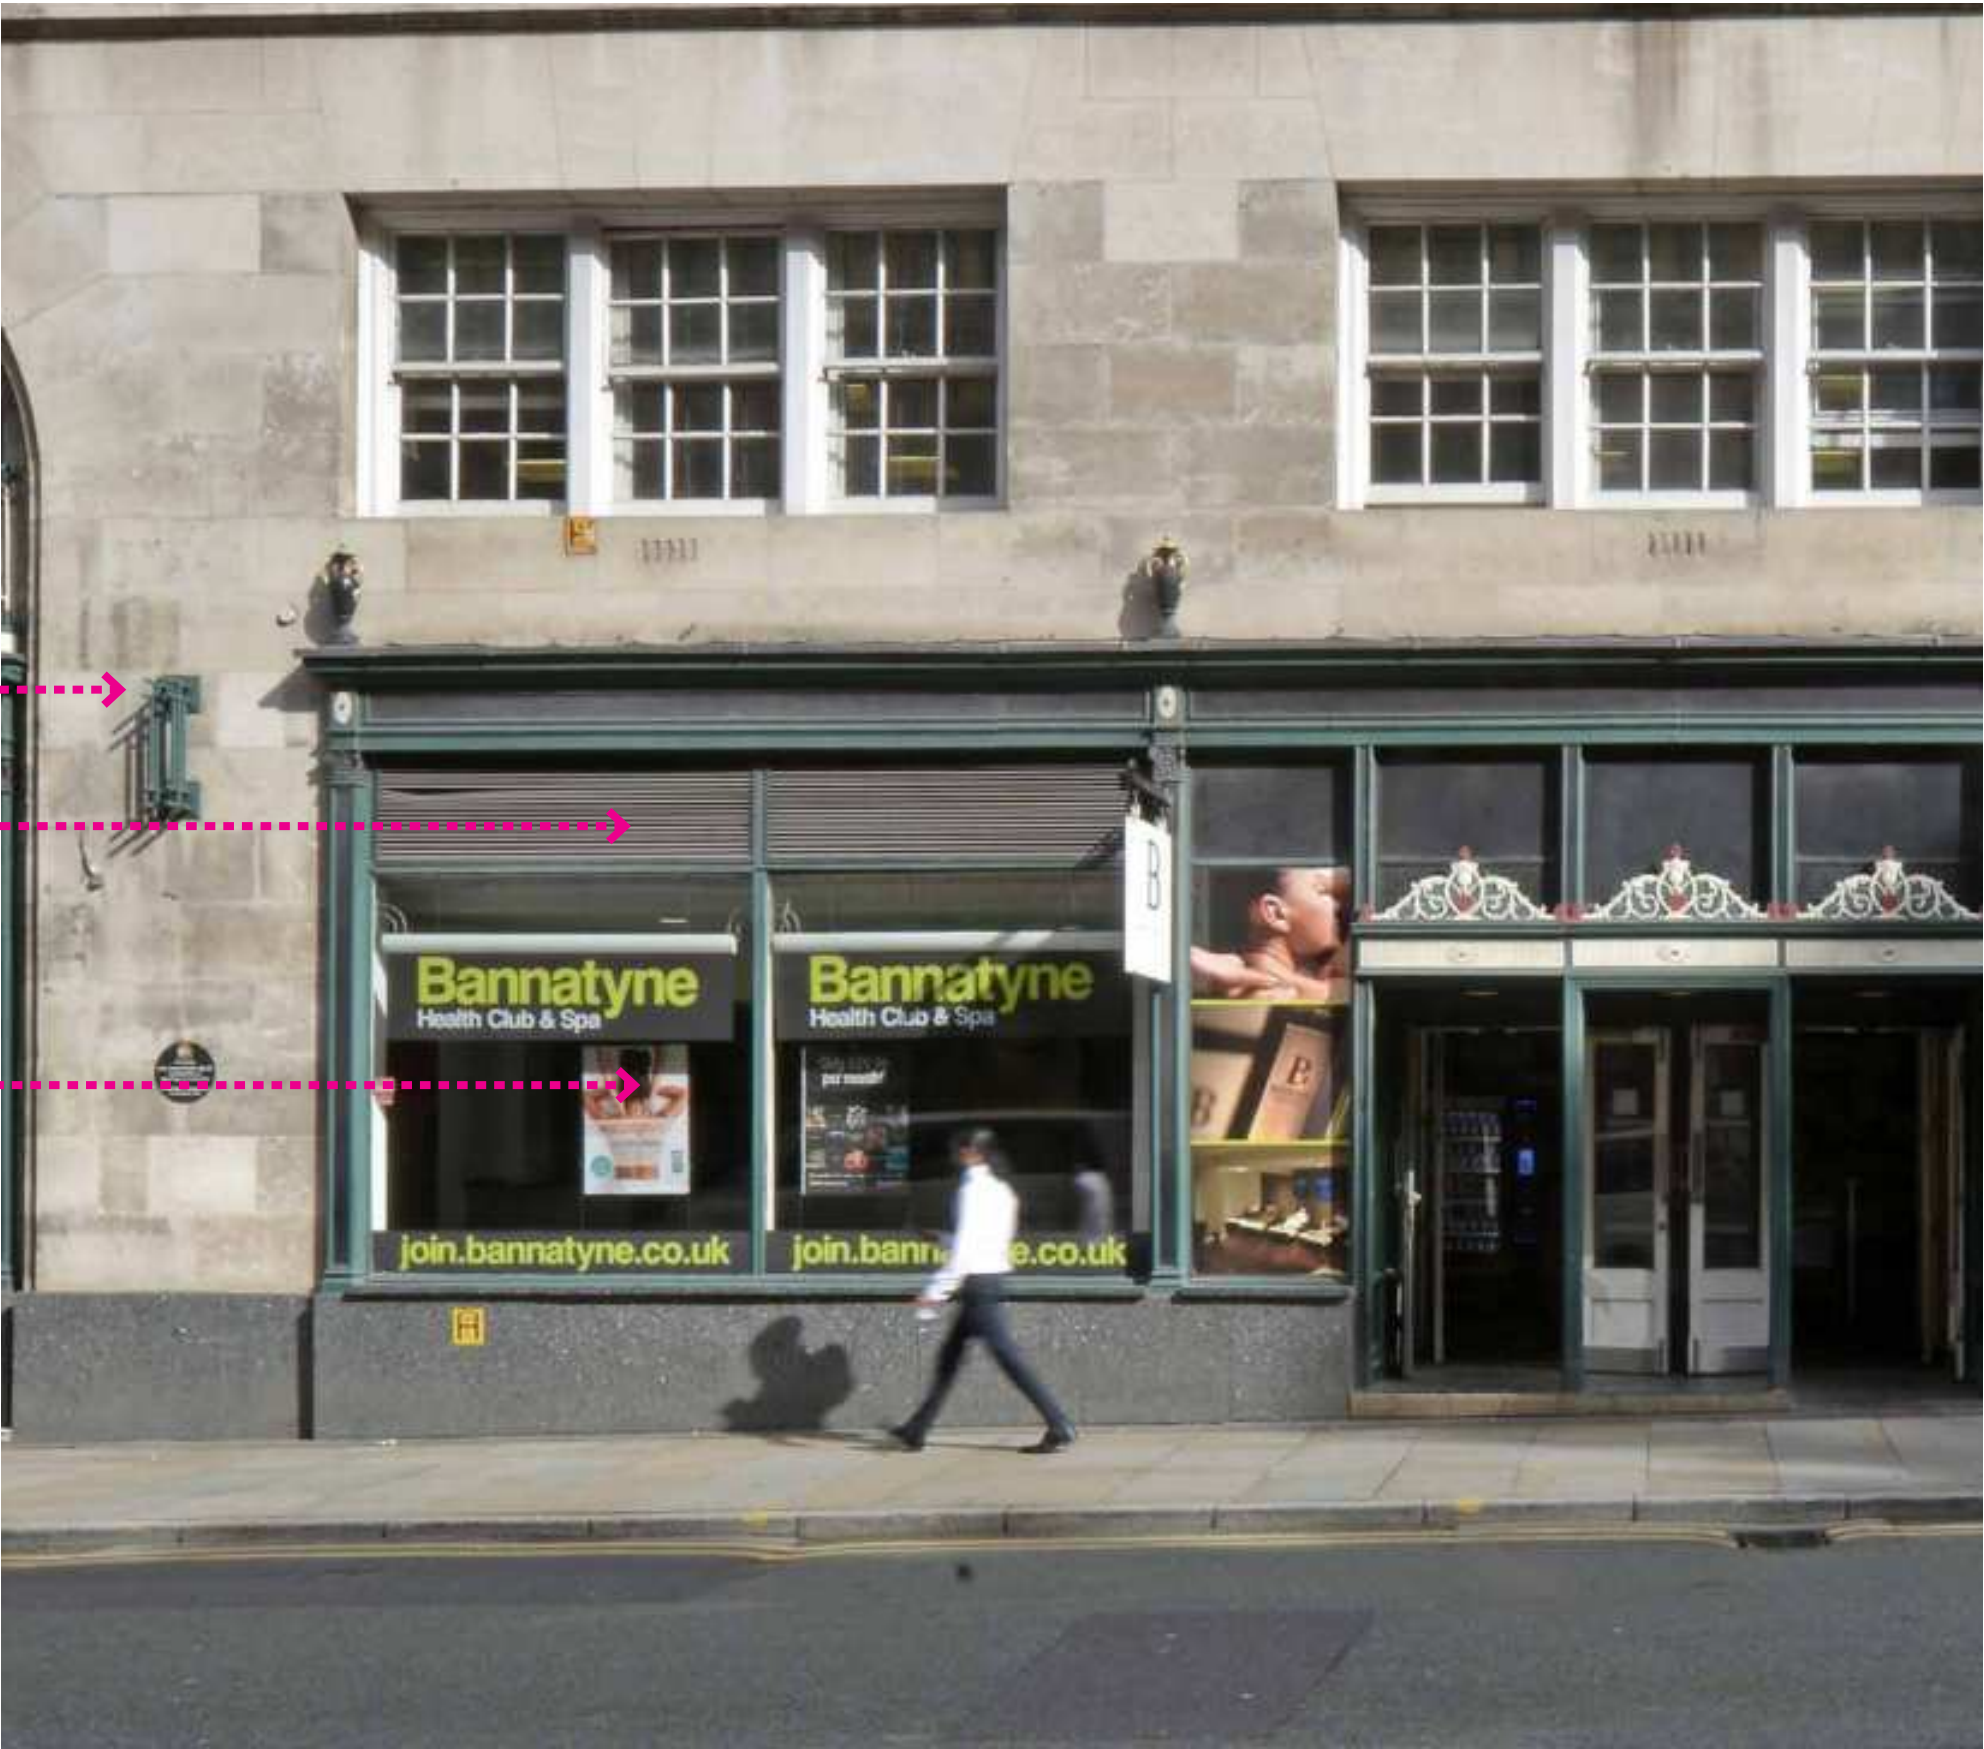
FACADE REFURBISHMENT PRINCIPLES

UTILISING OF HISTORIC SIGNAGE BRACKETS FOR TENANT SIGNAGE

VENTILATION LOUVRES UPGRADED TO CONTEMPORARY AND SUBTLE DECORATIVE HERITAGE DESIGN TO TIE IN WITH THE REDECORATED HISTORIC SHOPFRONT

VINYL ADVERTISING SIGNAGE REMOVED TO PROVIDE MORE FREE AREA OF GLAZING INTO GROUND FLOOR SPACE
