# SUNLIGHT HOUSE

DESIGN AND ACCESS STATEMENT  
GROUND AND BASEMENT WORKS

This document accompanies the listed building and planning application for the refurbishment of the ground and basement at Sunlight House, Manchester, M3 3HP. Works comprise of Landlord improvements ahead of future tenant fit outs, including the demolition of non-original walls, structural repairs to concrete slabs, repairs to cornices and installation of decorative louvres to shopfronts.

February 2025

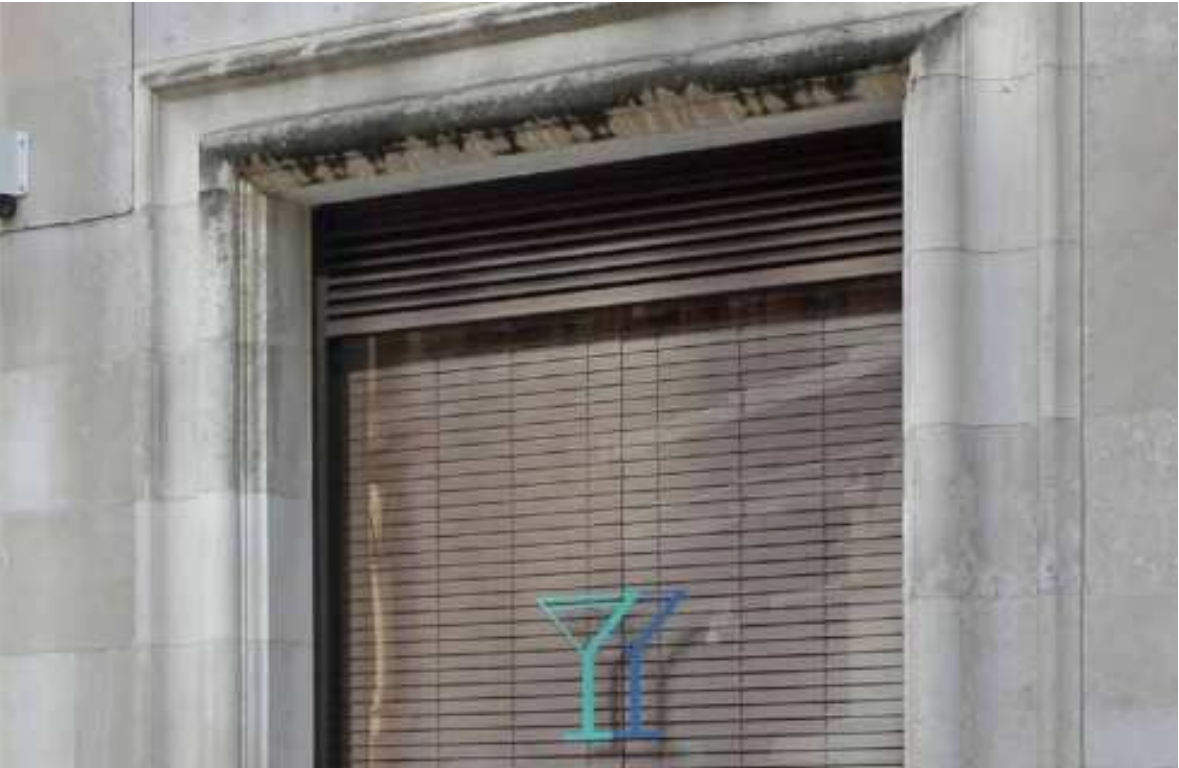
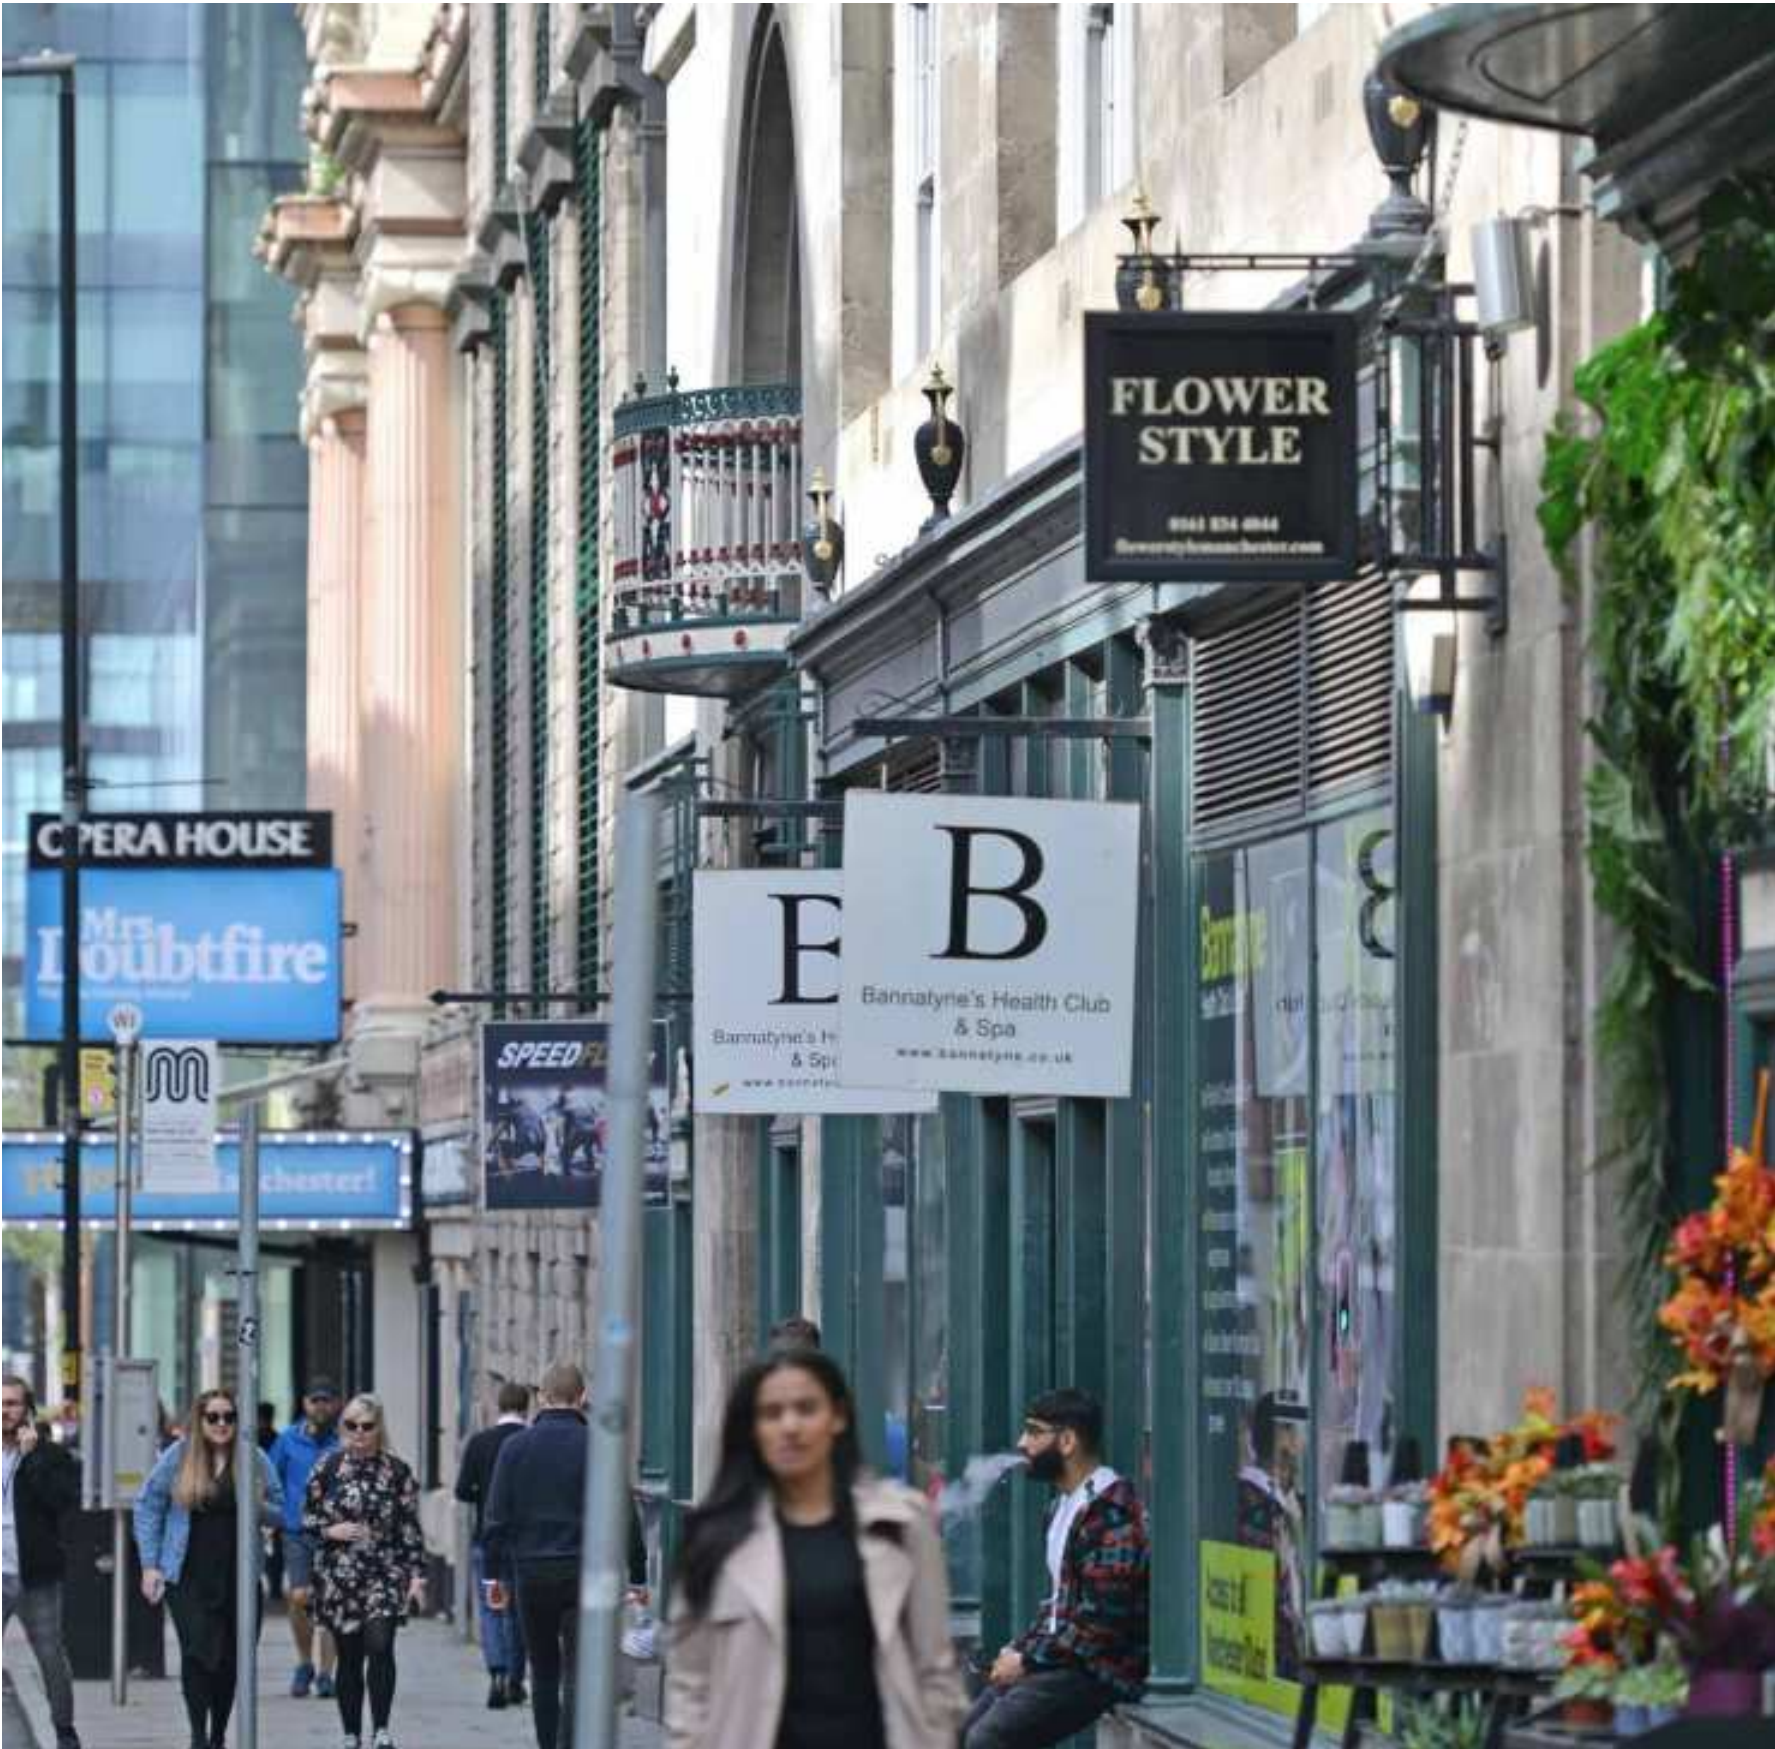
The louvres themselves are inoffensive in design and align with the existing framing. We would look to keep them as subtle - with a contemporary replacement to improve performance. Its important to note that building consent reference 139279/LO/2024 has previously been granted for a decorative louvre to serve the reception cafe space. The principles applied here will inform the remainder of the facade.

Below - well designed louvre integrated into the building on Atkinson Street as benchmark.

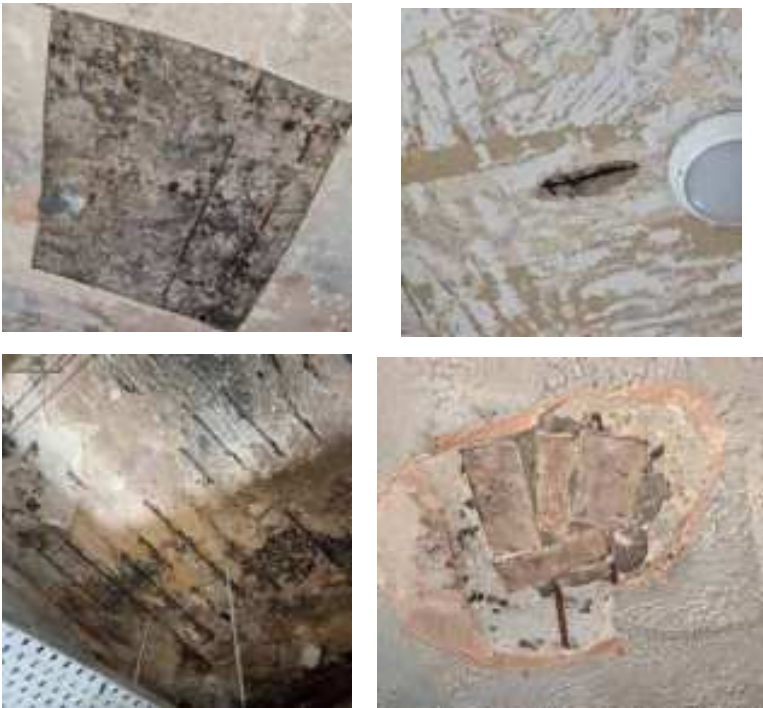
- Concrete repair to protect reinforcement from further degradation
- In majority of basement and basement mezzanine area
- Greater cover (min. 20mm) to achieve minimum durability requirement for internal environment

Concrete slab with insufficient cover should be reinstated with sufficient cover to meet minimum durability requirement and fire protection as per the modern standard. See typical repair detail 02.

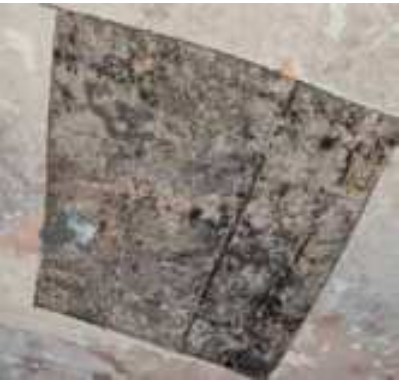
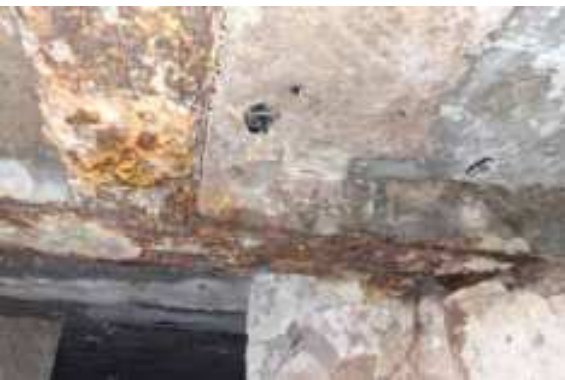
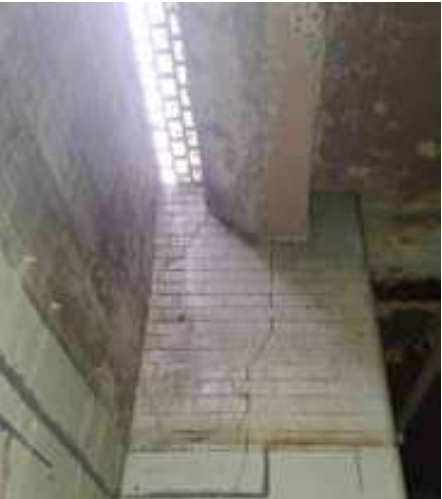
Figure 6 – Exemplary site photos of key conditions: concrete slab exposure, steel beam corrosion, cracking on surface

The next sections of this report look in more detail at key conditions discovered within the existing basement. Summary of basement condition is illustrated on the right. The following key conditions are covered in this report:

- Section 3.2 Concrete Slab Cover and Condition
- Section 3.3 Structural Steelwork Condition
- Section 3.4 Observed Cracking

In multiple locations, reinforcement bars are exposed and exhibit corrosion on the surface. Concrete covers to the reinforcement bars are observed to be zero to maximum 10mm, suggesting the existing concrete slab has insufficient cover to protect reinforcement bars from internal environment exposure and from fire, causing further degradation without remedial works.

In multiple locations, the bottom of encased steel beams are exposed and is observed to be moderately to heavily corroded. The corrosion reduces the section size of steel beam that results in reduction of its strength. In some locations, especially at the basement barrel area and corridor of retained changing rooms, steel beams are heavily corroded to a degree that very limited section is left to resist floor load above.

Generally along the building perimeter, the vertical columns and buttresses have visible cracks on the surfaces. Whilst the observed cracks may only present on the surfaces, i.e. render or tiles clad at the front of structural elements, if the crack is also present within structural elements, this indicates the structural elements are subjected to overstressing and requires further strengthening.

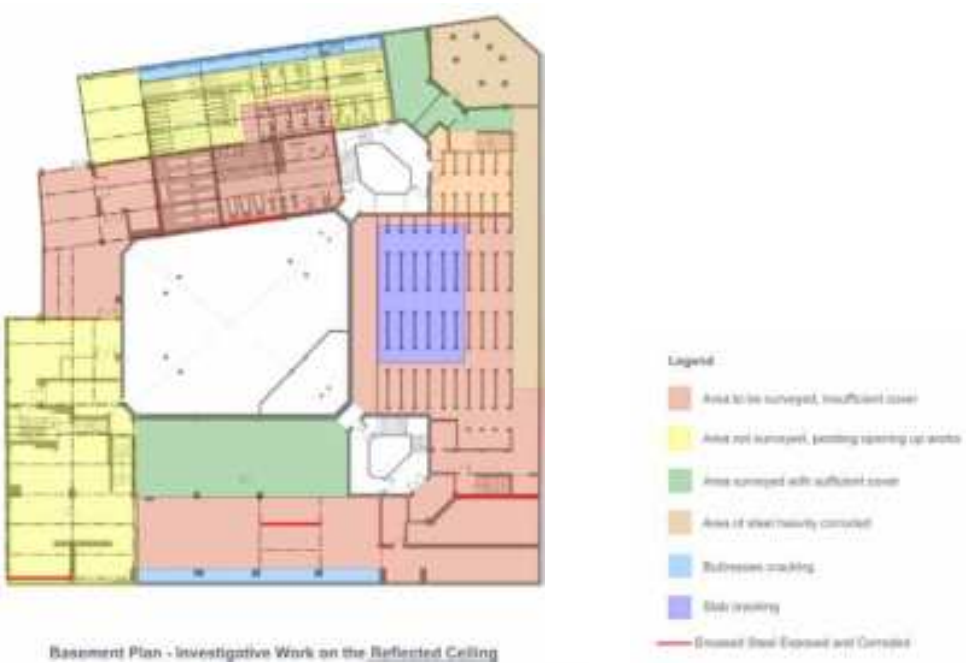
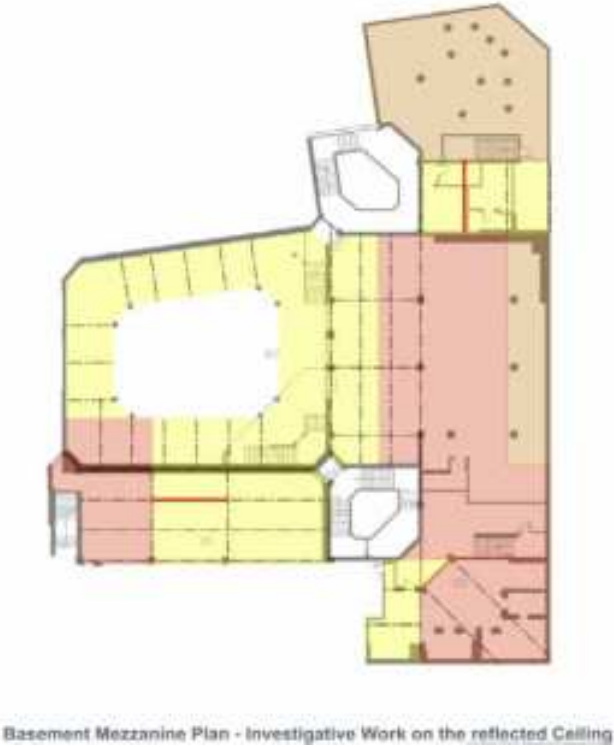
Figure 7 - Summary Key Plan of Site Condition

General condition of the basement was previously outlined in the Stage 2 report. In summary, based on the GBG intrusive survey results and previous site inspections, the inspections found evidence of water ingress in a number of locations and significant steelwork corrosion. Concrete slab in general was discovered to have insufficient cover to protect embedded reinforcement from further degradation.

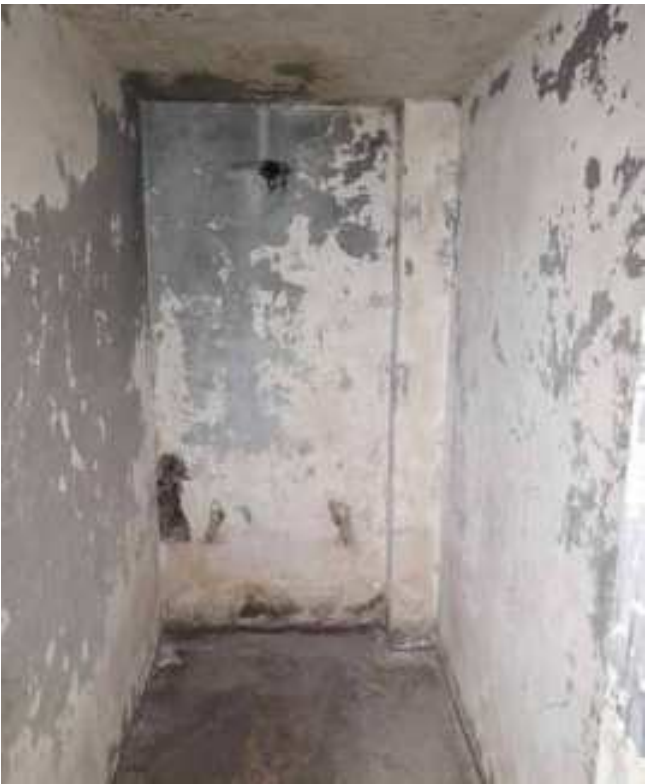
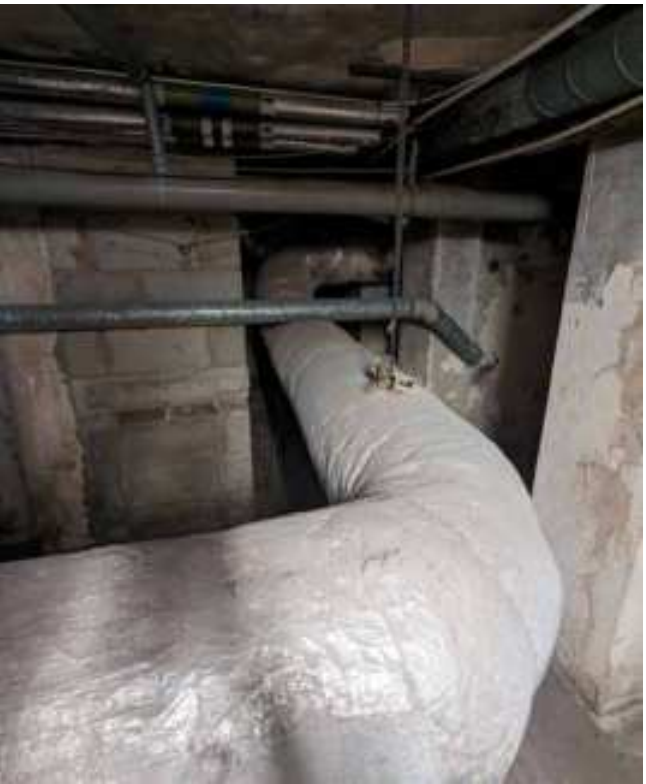
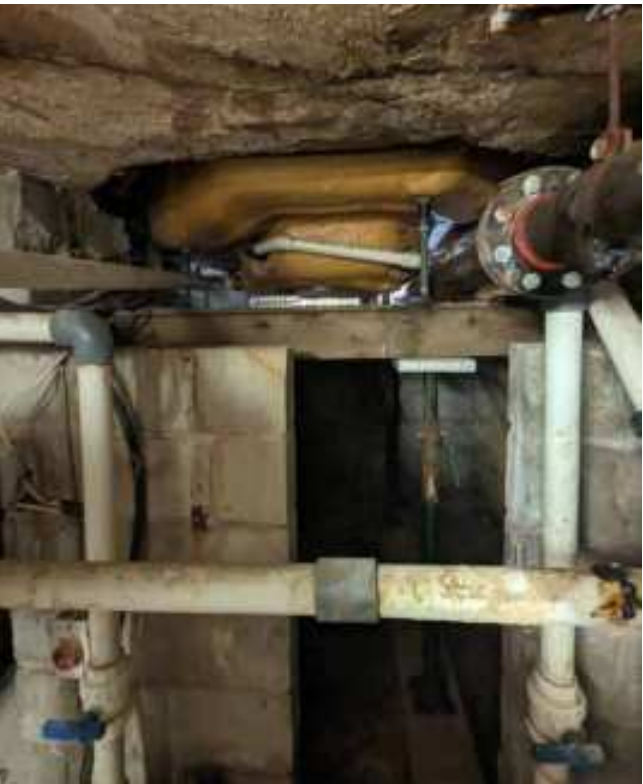
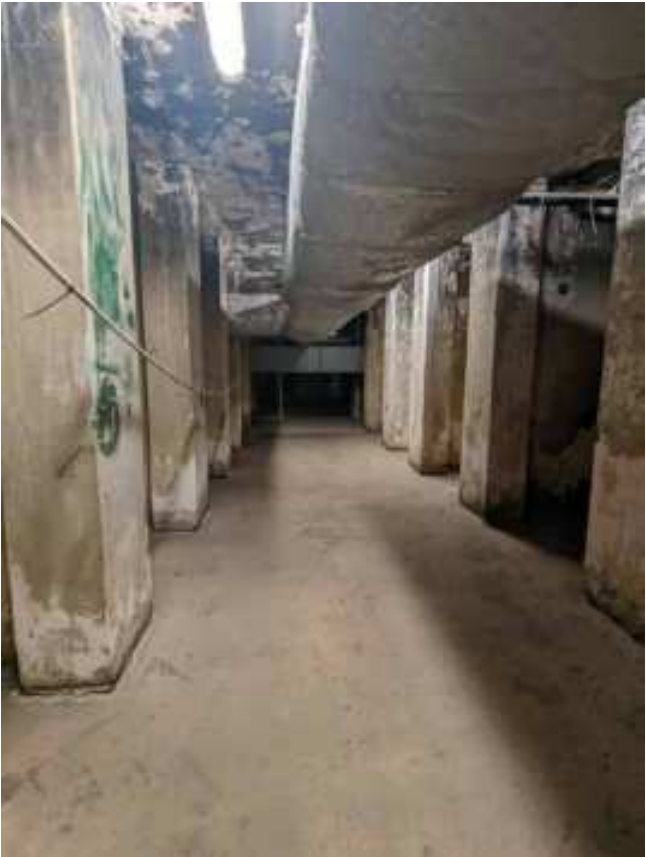
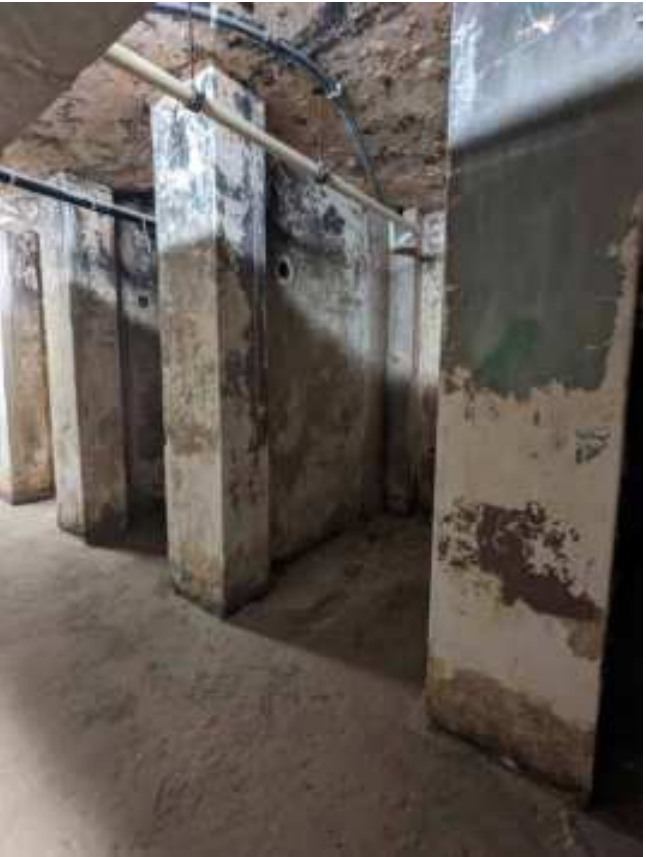
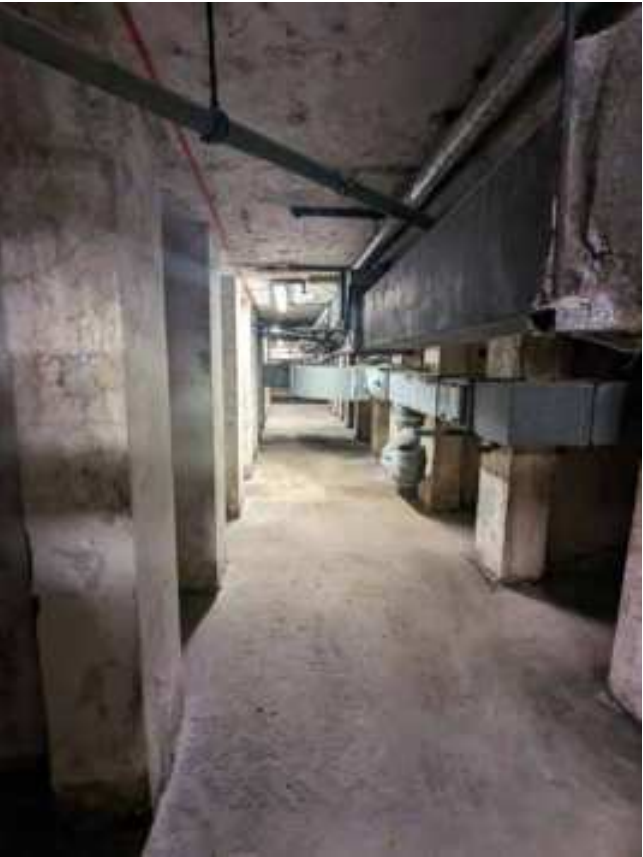
In addition new lighting and emergency services added, a large area of the existing changing rooms on basement level will be preserved for future generations as we recognise their heritage significance. However, activating the space for current use presents challenges due to its condition.

- 1. Limited ceiling height.
- 2. Lack of opportunity to provide access.

This is a result of the original historic installation, which includes a basement mezzanine level and a lift/stair configuration that restricts accessibility.

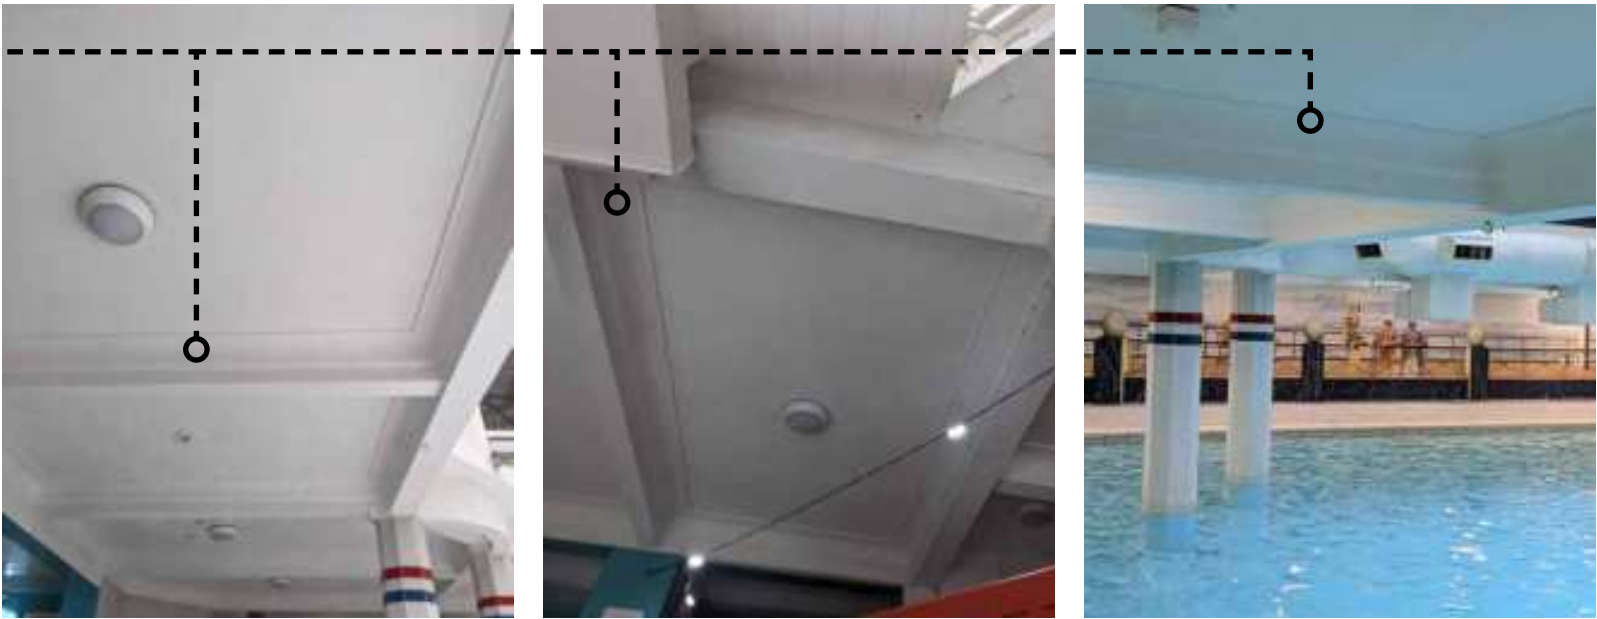
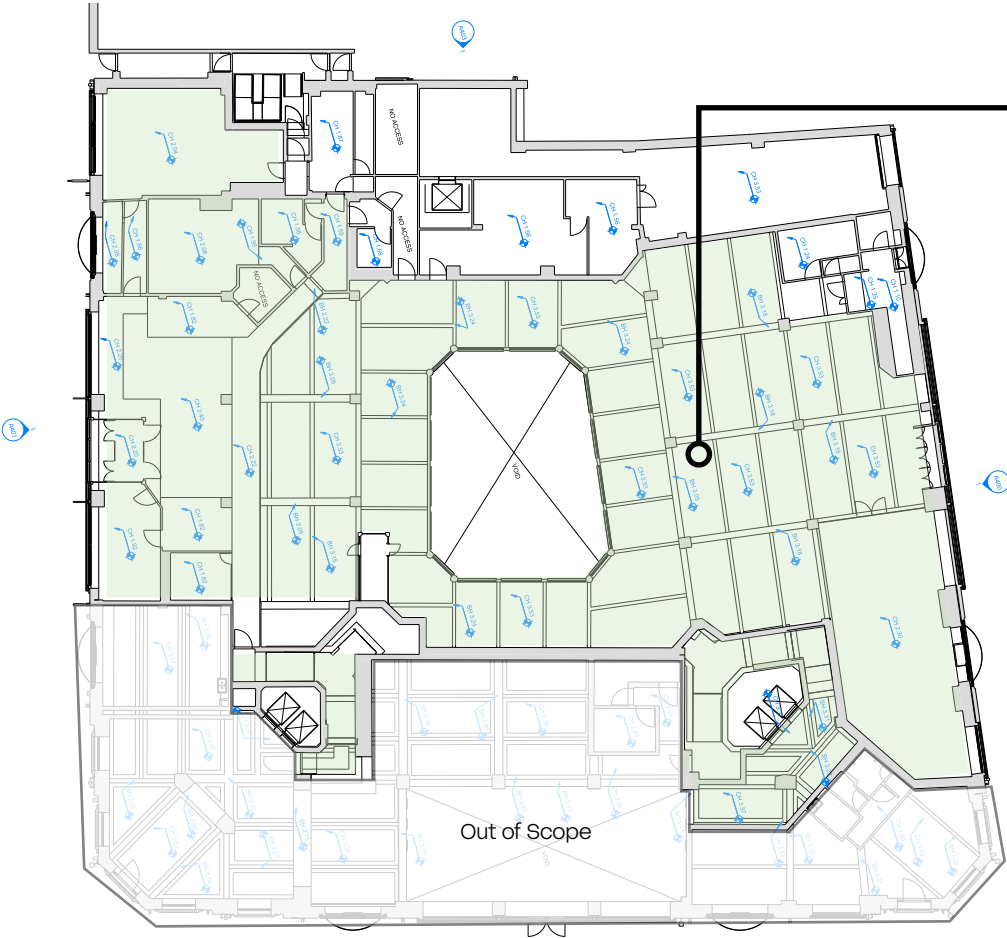
GROUND RCP

Example of cornice that we propose to replace with like for like if damaged in structural strengthening process

Green hatch indicates expected location of cornice proposed to be replaced, like for like if removal is required for structural upgrade

Where cornice is missing or damaged we will carefully repair the affected section, starting approximately 100mm either side of the area. The original cementitious build up will be repaired using Fosroc to ensure longevity of the repair. The decorative elements will then be repaired using fibrous plaster to match the approved sample on site.

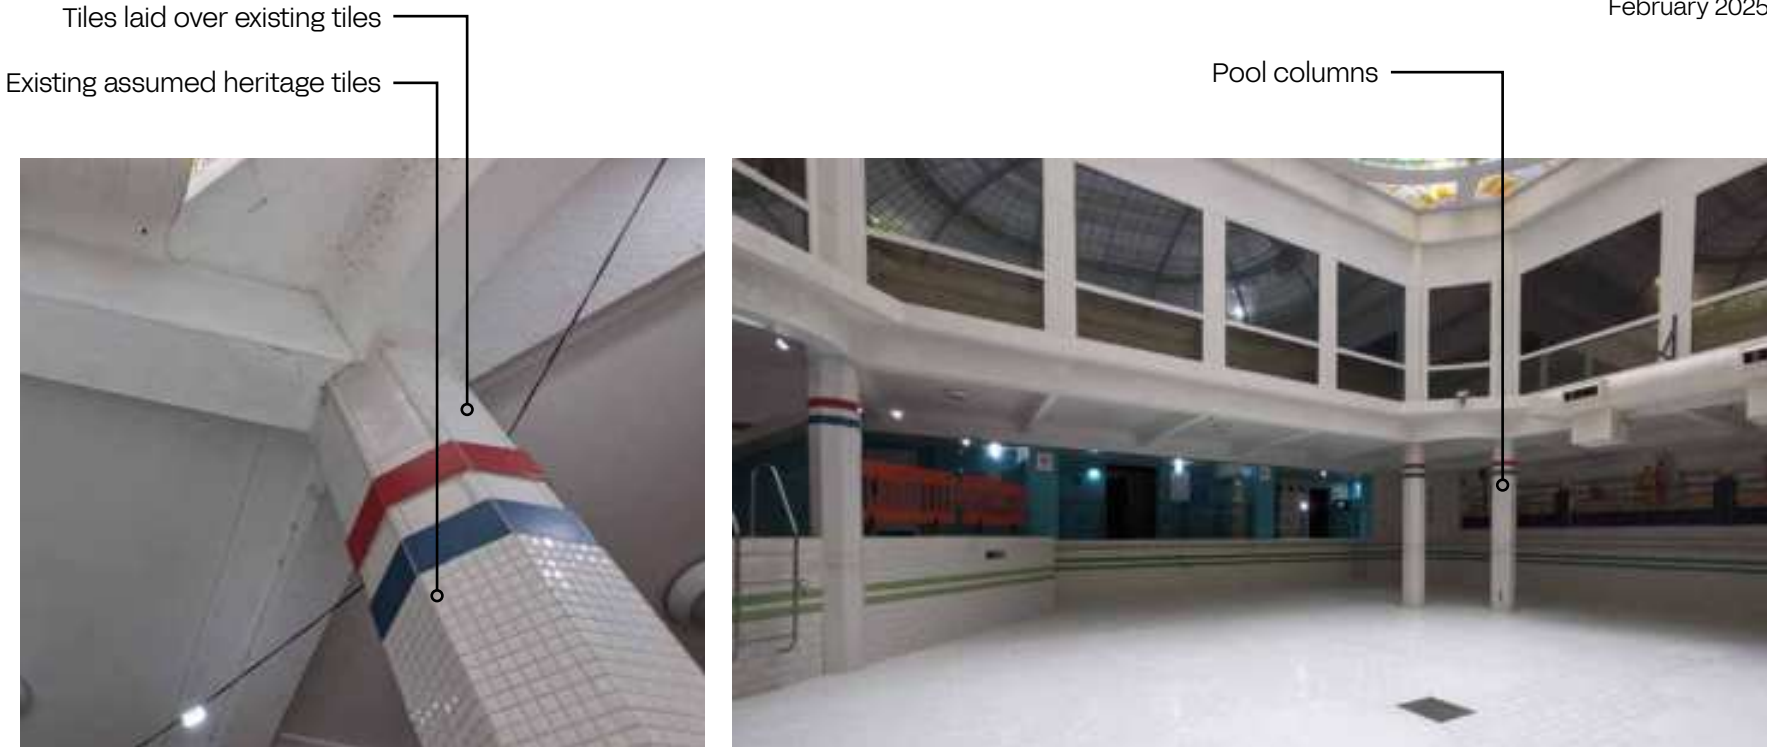
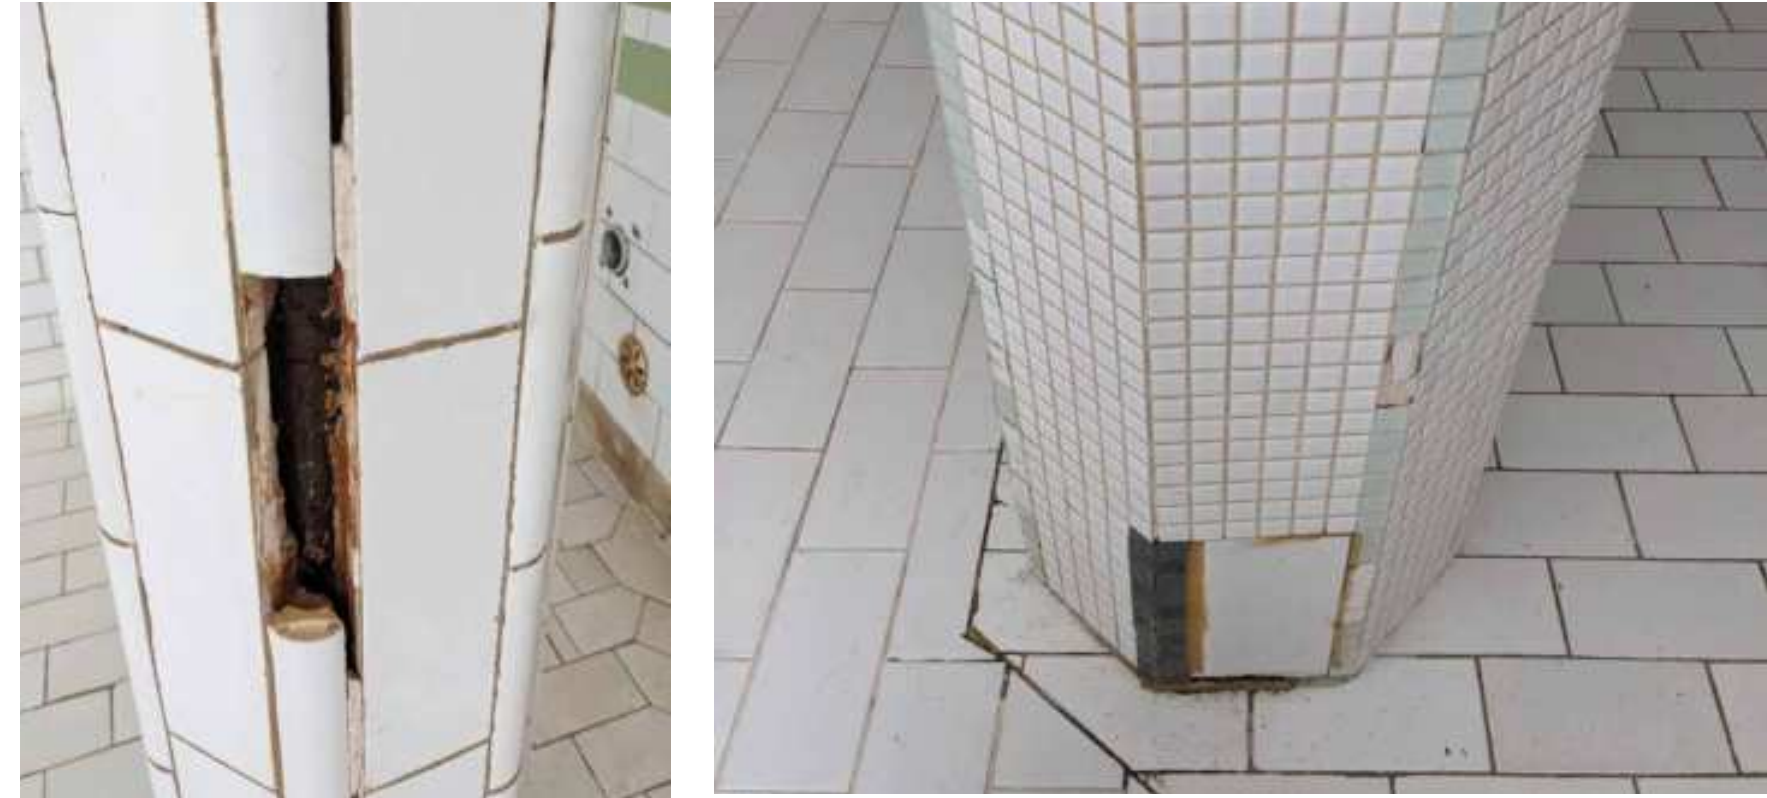
TILES TO POOL COLUMNS OPTIONS

Eckersley O’Callaghan’s proposed structural upgrades for the columns will be carefully designed to preserve the historically significant pool columns and their decorative tiling while ensuring necessary structural improvements. Refer to Eckersley O’Callaghan structural engineer information on existing pool column investigative works.

Currently there are two layers of tiles covering the existing pool columns. We acknowledge the importance of protecting these historical tiles. The structural integrity of the columns needs to be investigated - In order to do this a small portion of tiles will need to be removed. The first layer of tiles are of heritage significance and the tiles ontop are laid at a later date, we believe in the late 1900s when the pool was installed. The tiled columns and pool tiles have been sitting in water for a number of years it is likely that there is a decent amount of corrosion. Refer to structural engineer for further information.

If structural engineers recommend the existing columns and their concrete encasement to be upgraded, then we propose to work with MCC to put forward a number of options that both address the structural integrity for future generations and retain as much of the existing historical tiles as possible.

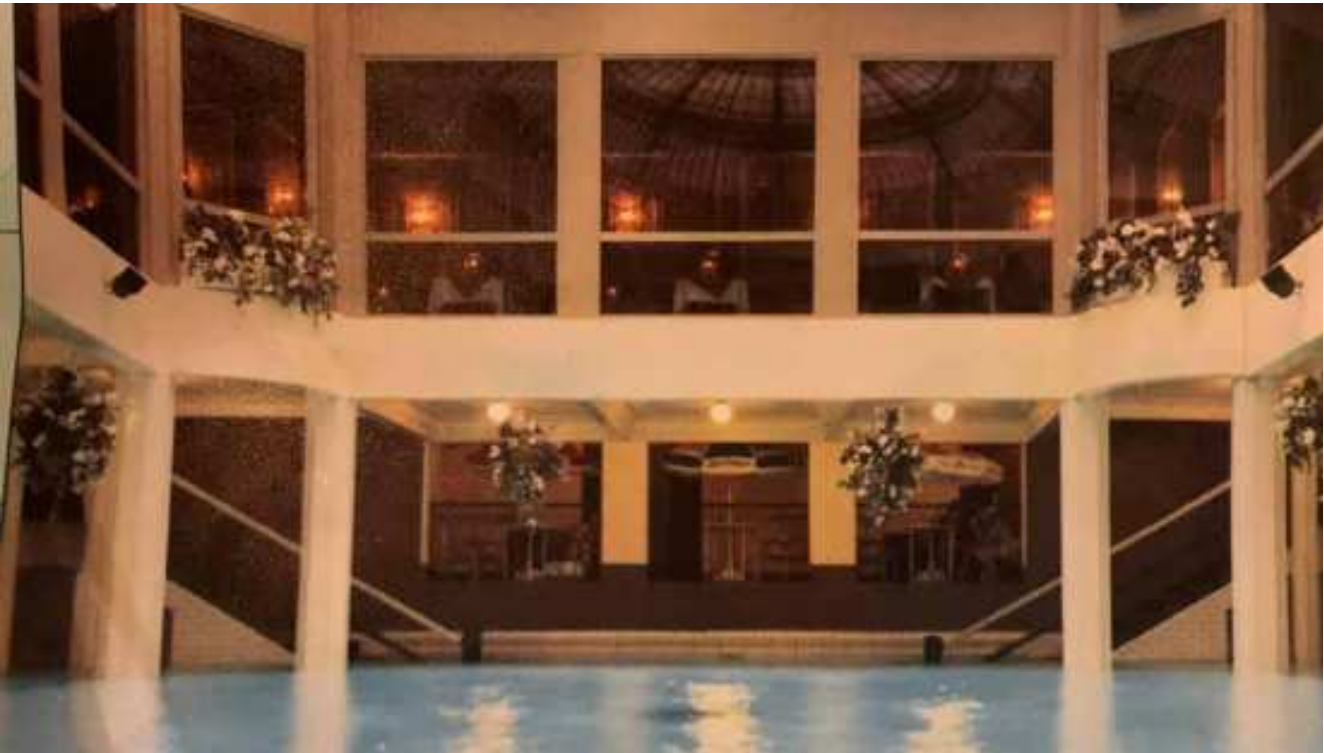
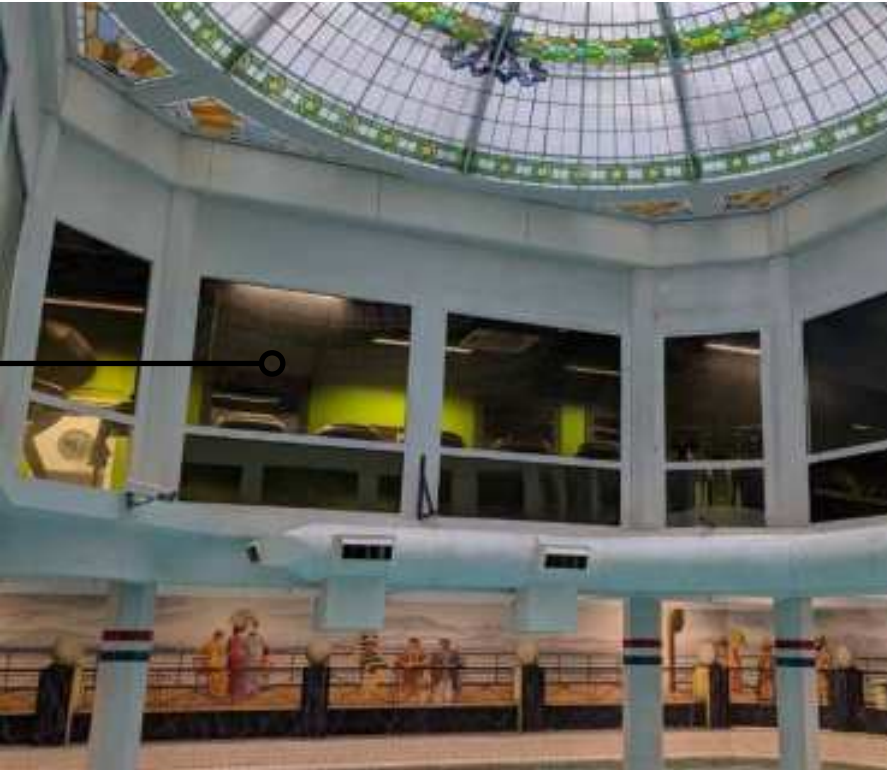
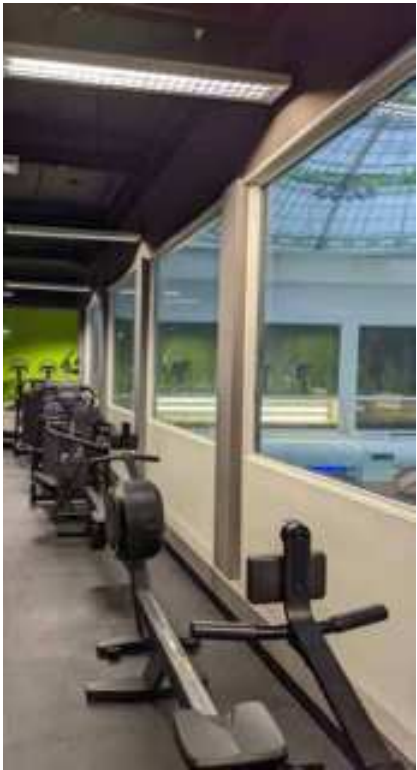
GROUND FLOOR PLAN

The existing full-height glazing along the perimeter of the ground-level separates the double-height pool area from the adjacent gym and provides a view of the lower level.

Therefore, we propose to remove the glazing and open up the space to create a connection between the building's lower levels. A temporary balustrade will be installed, allowing future tenants to replace in future.

Green area indicates existing glazing
