# **Great Jones Street, Manchester**

## **Phase 2 Geo-Environmental Investigation**

For: Oslady Homes Ltd

Ref: 4015-02  
Job: 4015  
Rev: -  
By: TP

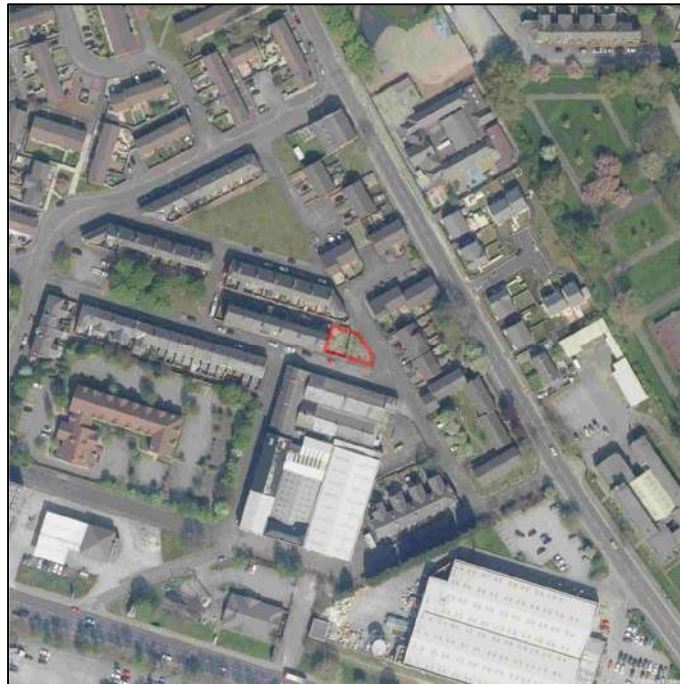
The site currently comprises an open parcel of land. The site is bound by residential properties to the north and the west, Milne Close to the east and Great Jones Street to the south. Access to the site is off Great Jones Street. An aerial photo of the site is included below and a Site Location Plan is contained in Appendix 2.

*Figure 1: Aerial image of the site dated May 2019.*

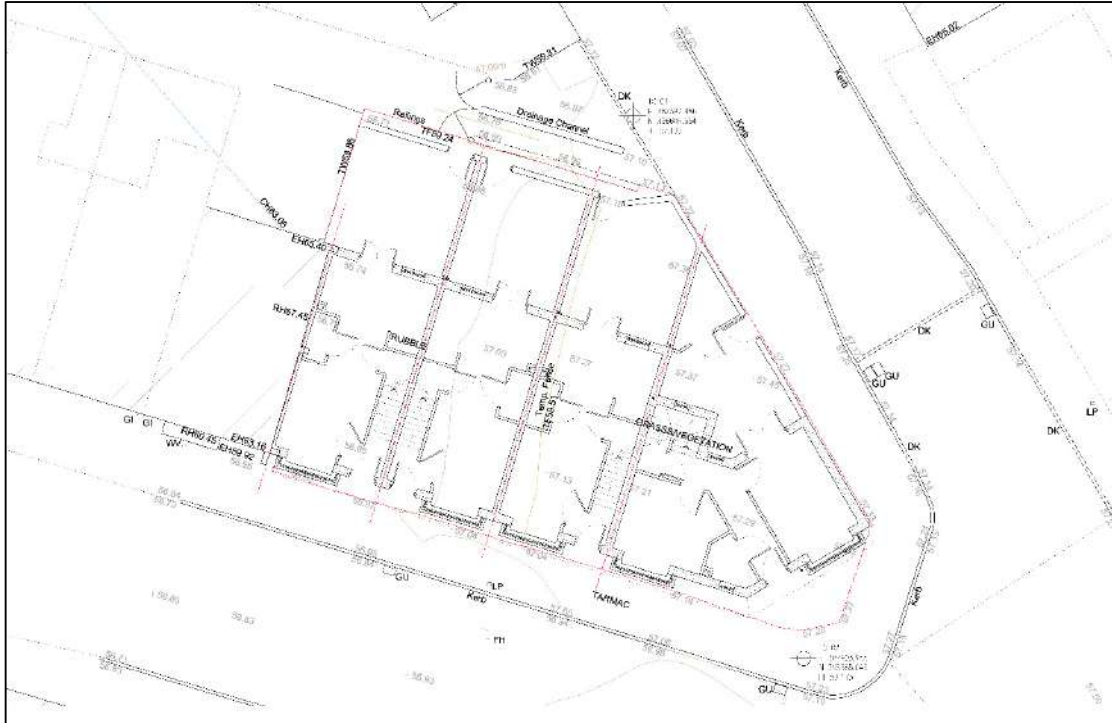
This Phase 2 Geo-Environmental Investigation Report is to be used for submission to the Local Authority as part of a planning application. It is the Client's intention to develop the site into 4 No. terraced dwellings (mixed 2 and 3 -storey) with associated private gardens as shown in Figure 2, below.

Figure 2: Extract from the proposed development plan.

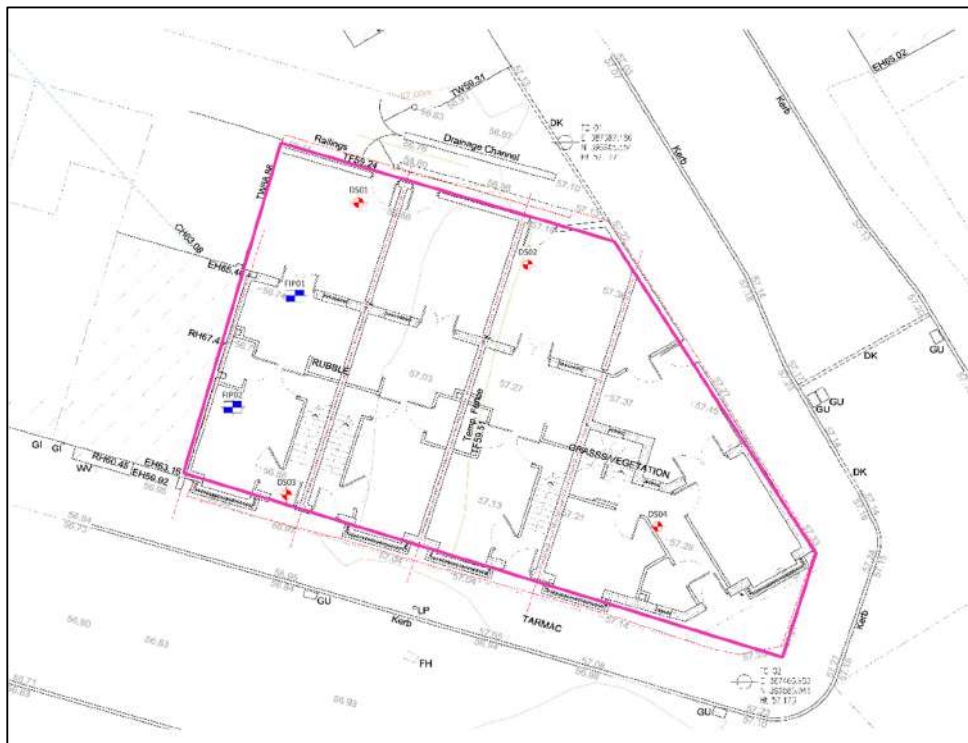
Figure 3: Extract from the Exploratory Hole Location Plan.

An Exploratory Hole Location Plan, contained within Appendix 2, indicates the location of the foundation inspection pits and dynamic sample boreholes as shown by the below extract.

The locations of the foundation inspection pits are shown on the exploratory hole location plan in Appendix 2 and foundation inspection pit logs and photographs are contained in Appendix 3.

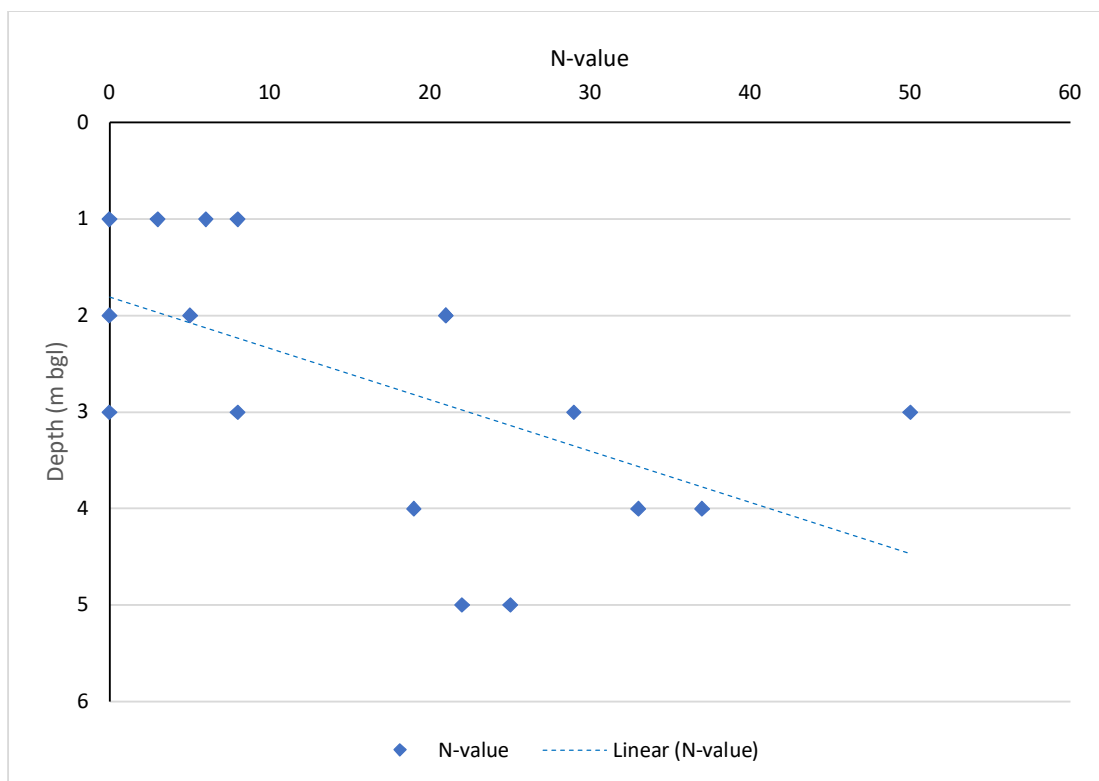
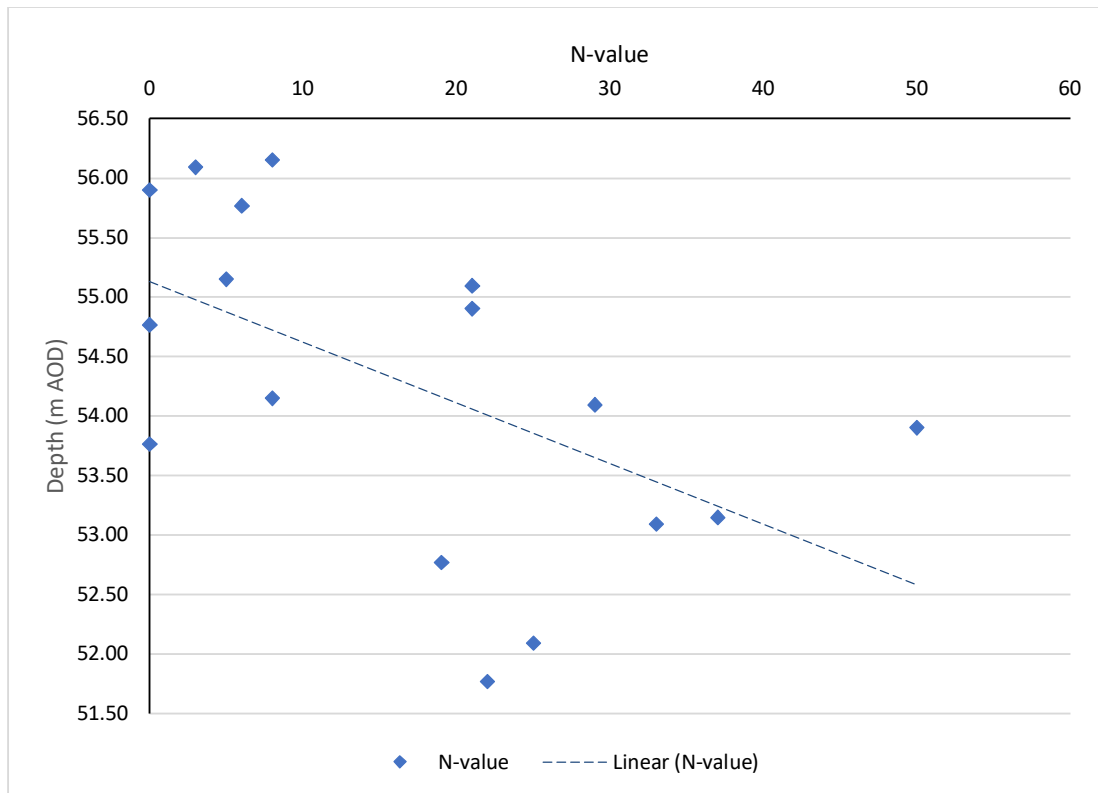
Standard penetration tests (SPTs) were undertaken at regular 1.00m intervals during the construction of the dynamic sampling boreholes. The following scatter graph shows that there was a positive correlation between increasing N-value with depth.

SPT results are included on the dynamic sample borehole logs presented in Appendix 4.

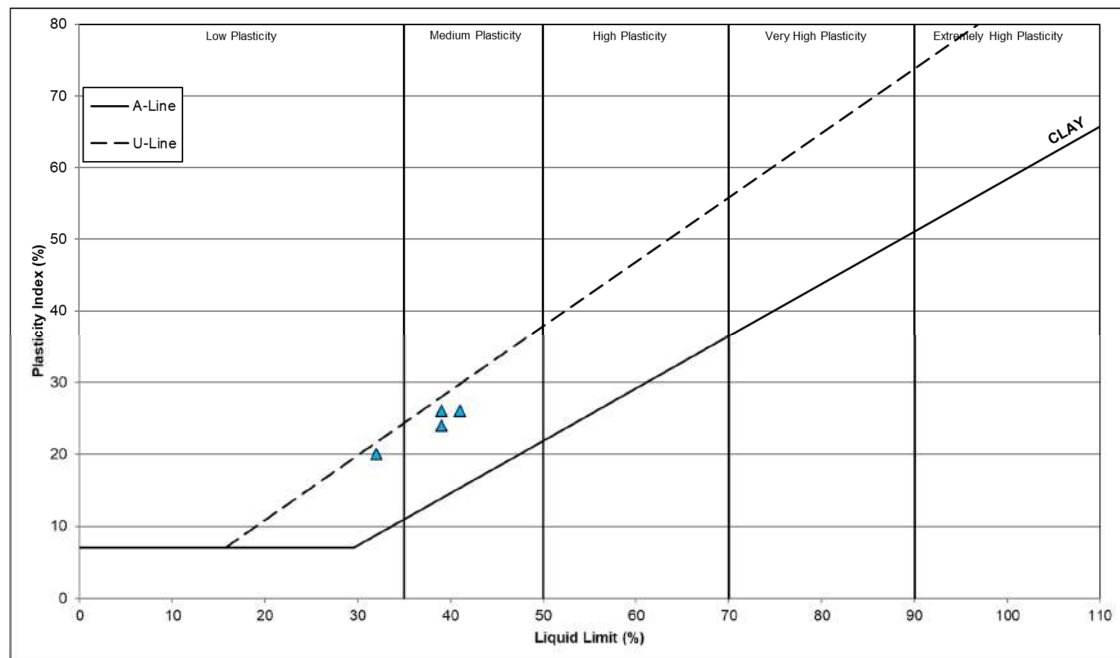
The Atterberg Limit tests indicate that the Made Ground is generally of medium plasticity and the Glacial Till is of low to medium plasticity in-line with BS14688 Part 2.

The Made Ground is generally of medium volume change potential and the Glacial Till is generally of low volume change potential in-line with NHBC Chapter 4.2 guidance.

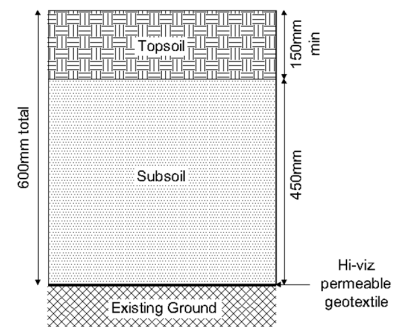
1. Excavate to 600mm bgl in private gardens (300mm in soft landscaping areas).
2. A 600mm clean cover system is recommended to be added to the proposed private gardens (300mm in soft landscaping areas). This is to consist of:
  - No less than 150mm and no more than 300mm suitable topsoil, underlain by;
  - Suitable subsoil to a total (topsoil + subsoil) depth of 600mm (300mm in areas of soft landscaping), underlain by;
  - A high vis geotextile marker
  - Validate in line with the below strategy.

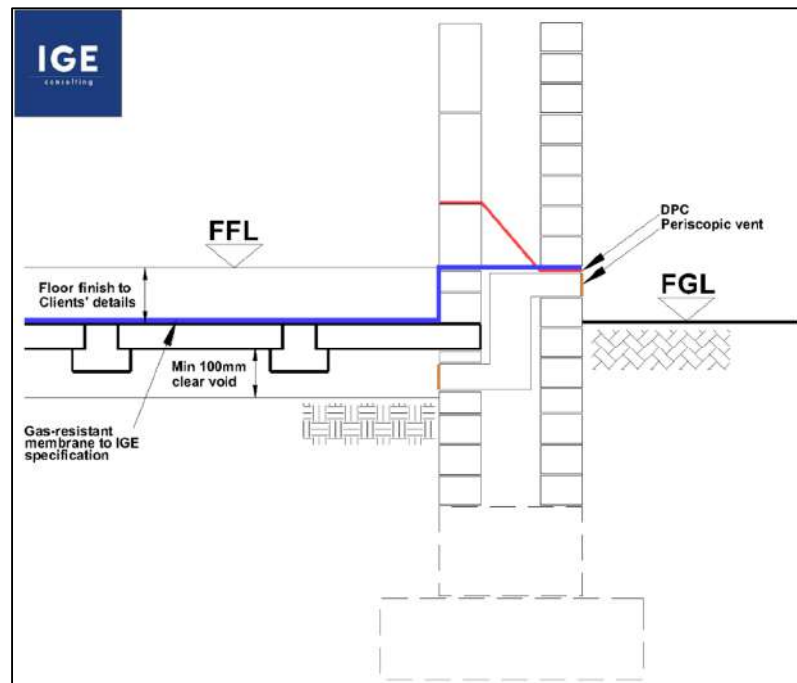
Figure 4: Edge detail including periscopic vents (brown) and location of ground gas-resistant membrane (blue). This drawing is not to scale. Use detailed dimensions only.

Adequate ventilation through internal obstructions to be installed in line with above recommendations. Joints between sheets of gas membrane should be lapped (minimum overlap of 150mm) and taped between sheets with appropriate double-sided tape in accordance with the manufacturer's recommendations.

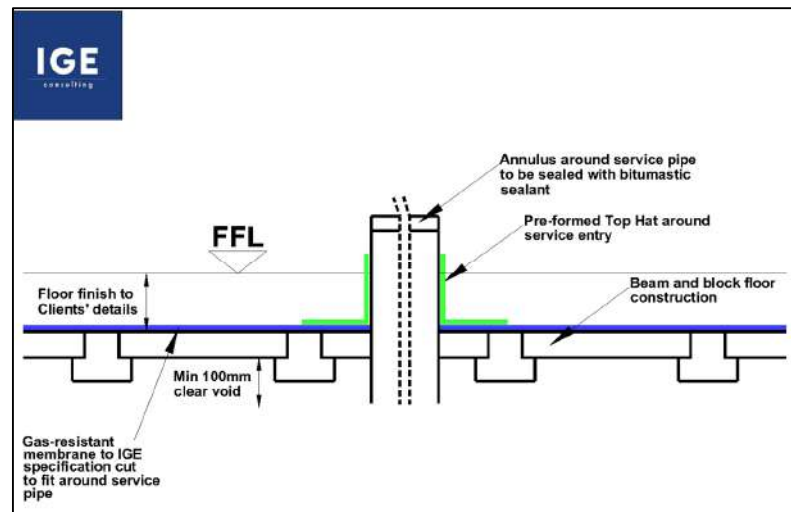
Figure 5: Service entry detail including pre-formed top hat (green) and location of ground gas-resistant membrane (blue). This drawing is not to scale. Use detailed dimensions only.
