Ground Gas Addendum Report  
Kenyon Lane, Failsworth

Reference:16-717-R2  
Date: November 2023

## GROUND GAS ADDENDUM REPORT

Kenyon Lane  
Moston  
Manchester  
M9 4PF

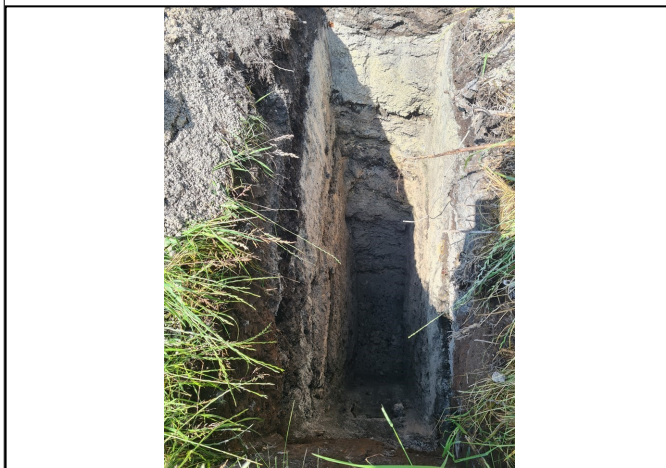
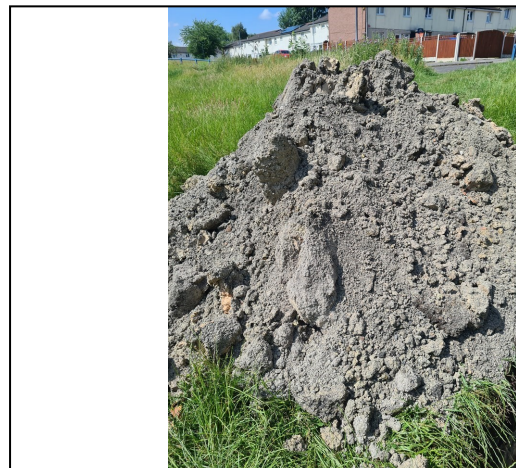
Trial Pit 101

Remarks: 1. Complete. 2. Depth of Made Ground unproven.

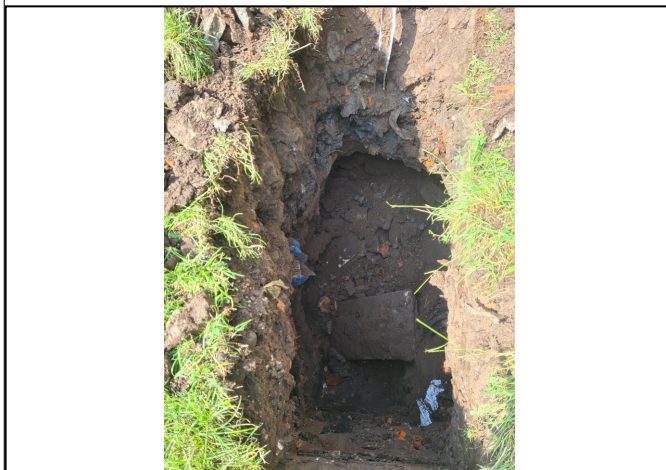
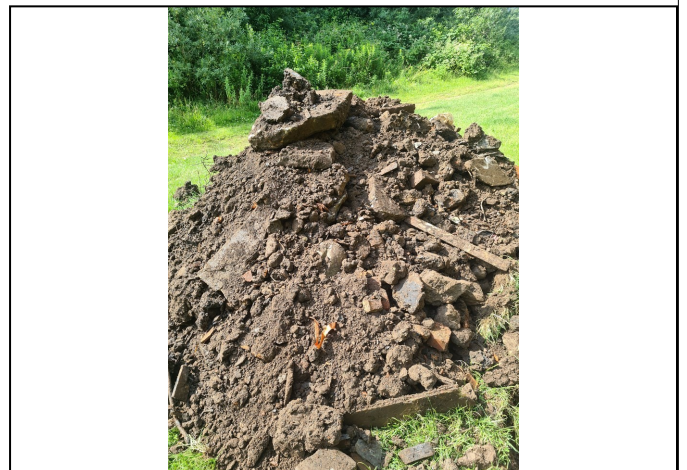
Trial Pit 103

Remarks: 1. Terminated at 2.50 m bgl due to large concrete blocks restricting excavation. 2. Slight organic odour encountered within Made Ground.

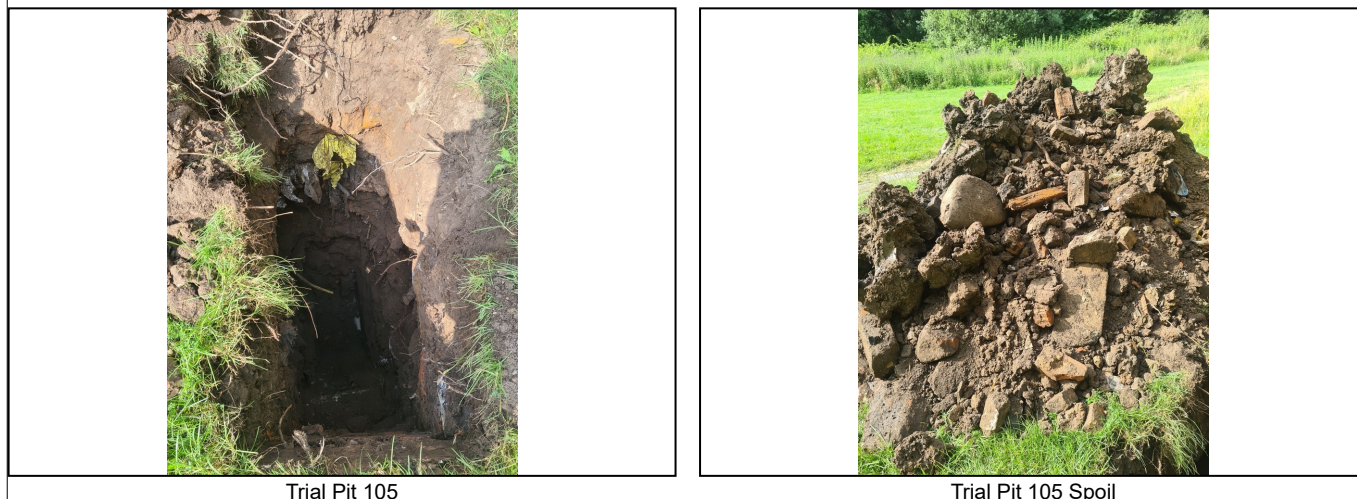
Remarks: 1. Complete. 2. Frequent concrete flagstones encountered to 2.00 m bgl. 3 Depth of Made Ground unproven.

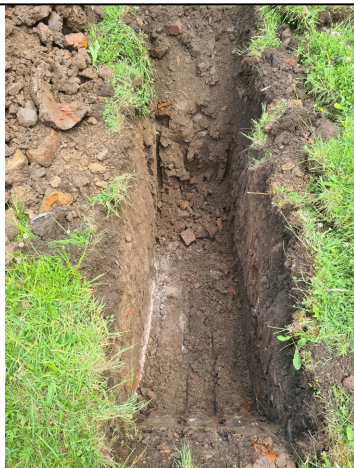
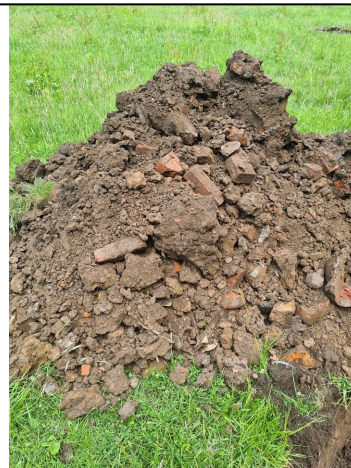
Trial Pit 109

Remarks: 1. Terminated at 1.20 m bgl due to concrete slab.
