Postal Street  
Manchester

Archaeological Desk-Based Assessment

March 2025

| <b>Document Number:</b> | BWB-ZZ-XX-RP-LH-0001_Archaeological Desk-Based Assessment |

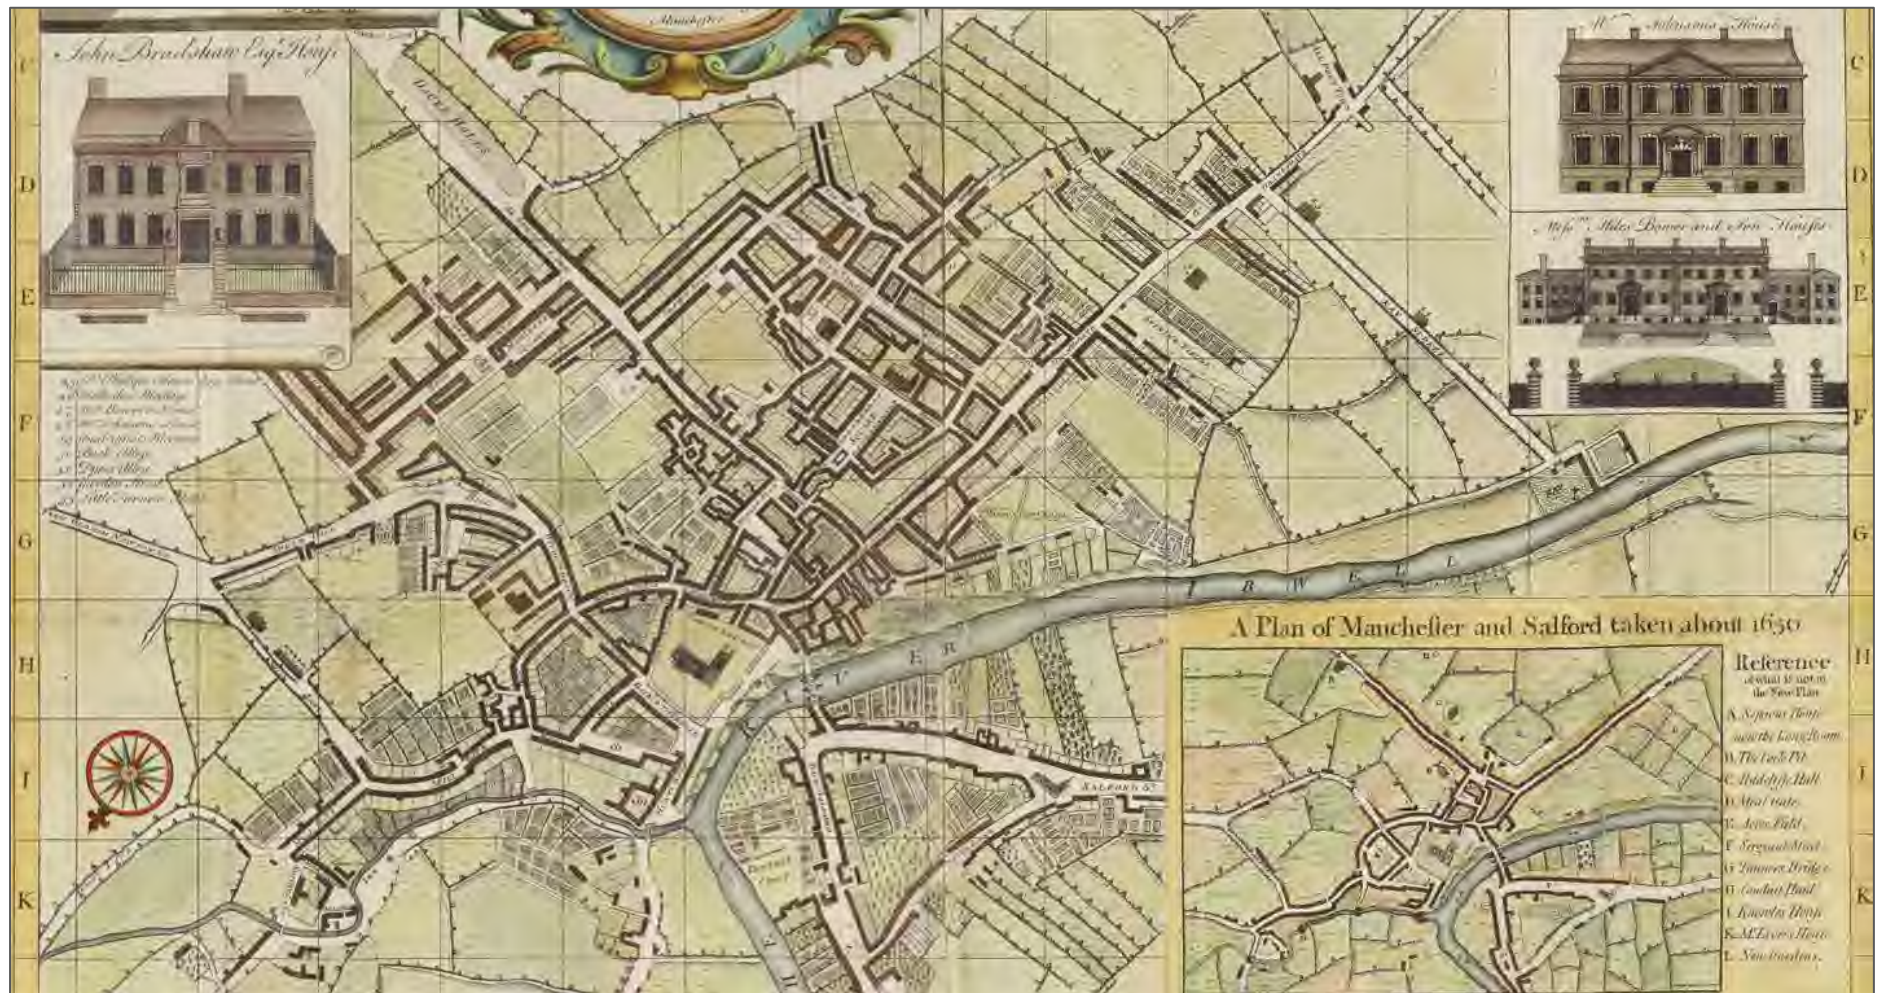
Plate 1: Plan of the Towns of Manchester & Salford (1750)

- 5.37 The 1750 Plan of the Towns of Manchester & Salford (**Appendix 4, Plate 1**), and the attached 1650 plan, show the land to the east of the centre of Manchester comprising fields. Although the Site itself is not shown, it is likely that this too lay within fields at this time.

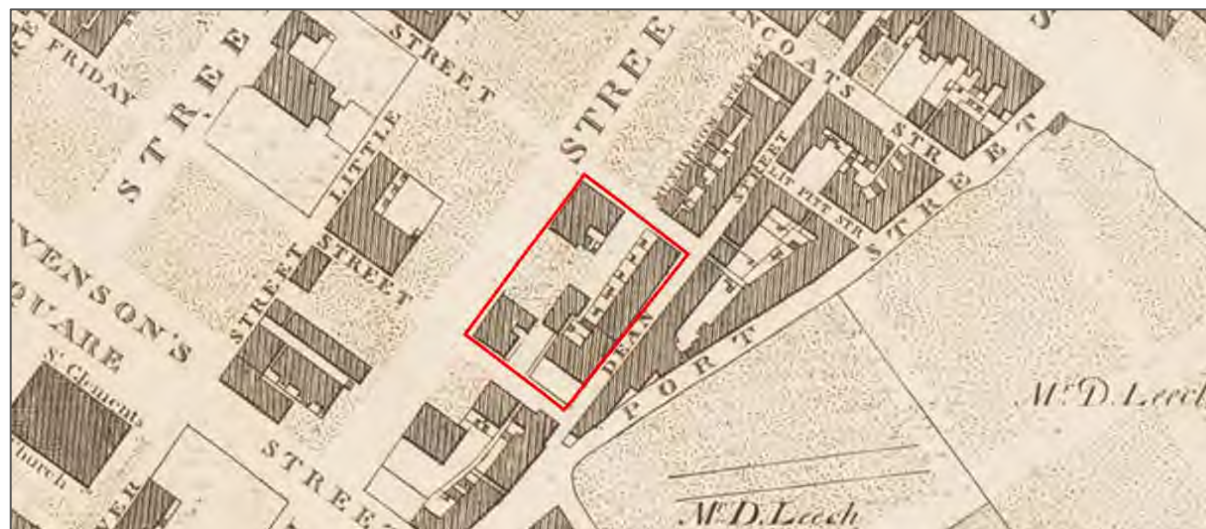
Plate 2: Green & Thornton's Plan of Manchester and Salford (1794)

- 5.38 Green & Thornton's 1794 Plan of Manchester and Salford (**Appendix 4, Plate 2**) shows the rectangular layout of the Site. What is now Postal Street to the Site's north-east was *Warwick Street* at this time, and Faraday Street to the south-west was *Friday Street*. The Site contained several buildings, including a row of terraced houses with outhouses to the rear on Dean Street. Two larger buildings are depicted in the northern and western corners of the Site, although these are not labelled. The Site lay near the eastern extent of the urban core of Manchester at this time, with apparently empty plots situated to its east beyond Port Street.

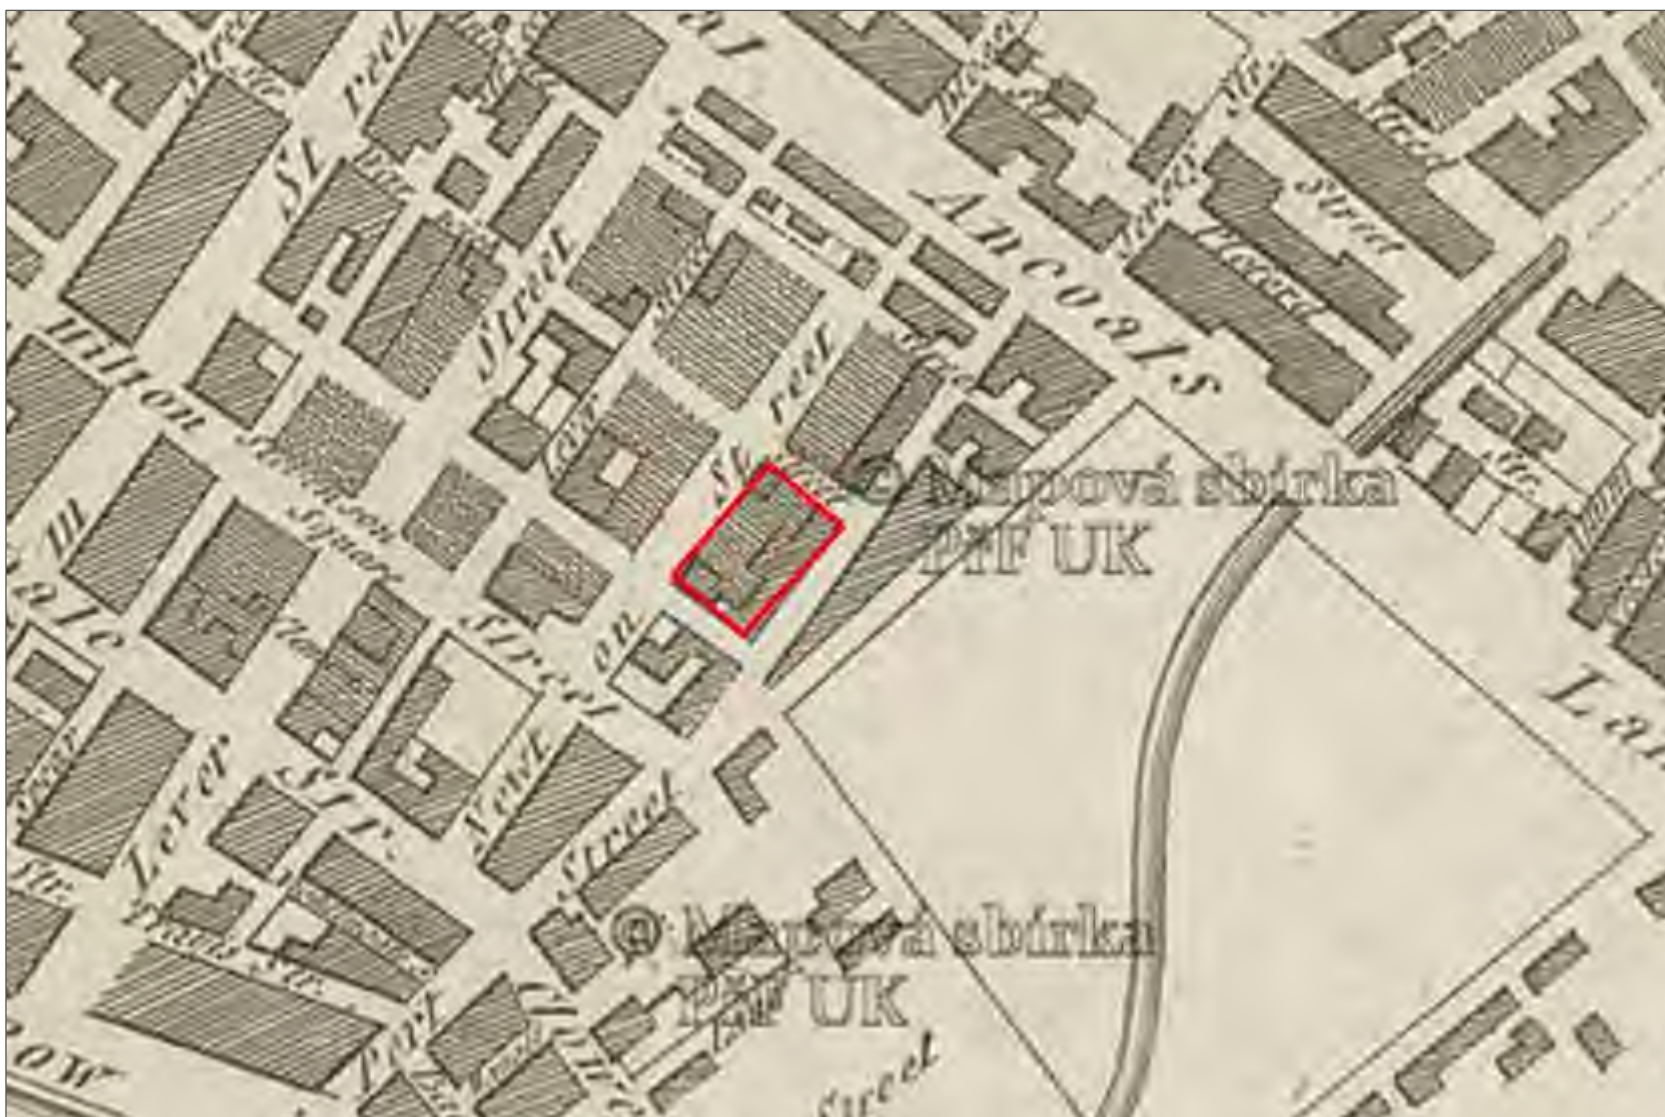
Plate 3: Plan von Manchester und Saalford in England (1810)

- 5.39 The 1810 German city map of Manchester and Salford (**Appendix 4, Plate 3**) depicts the Site in broadly the same layout although in less detail.

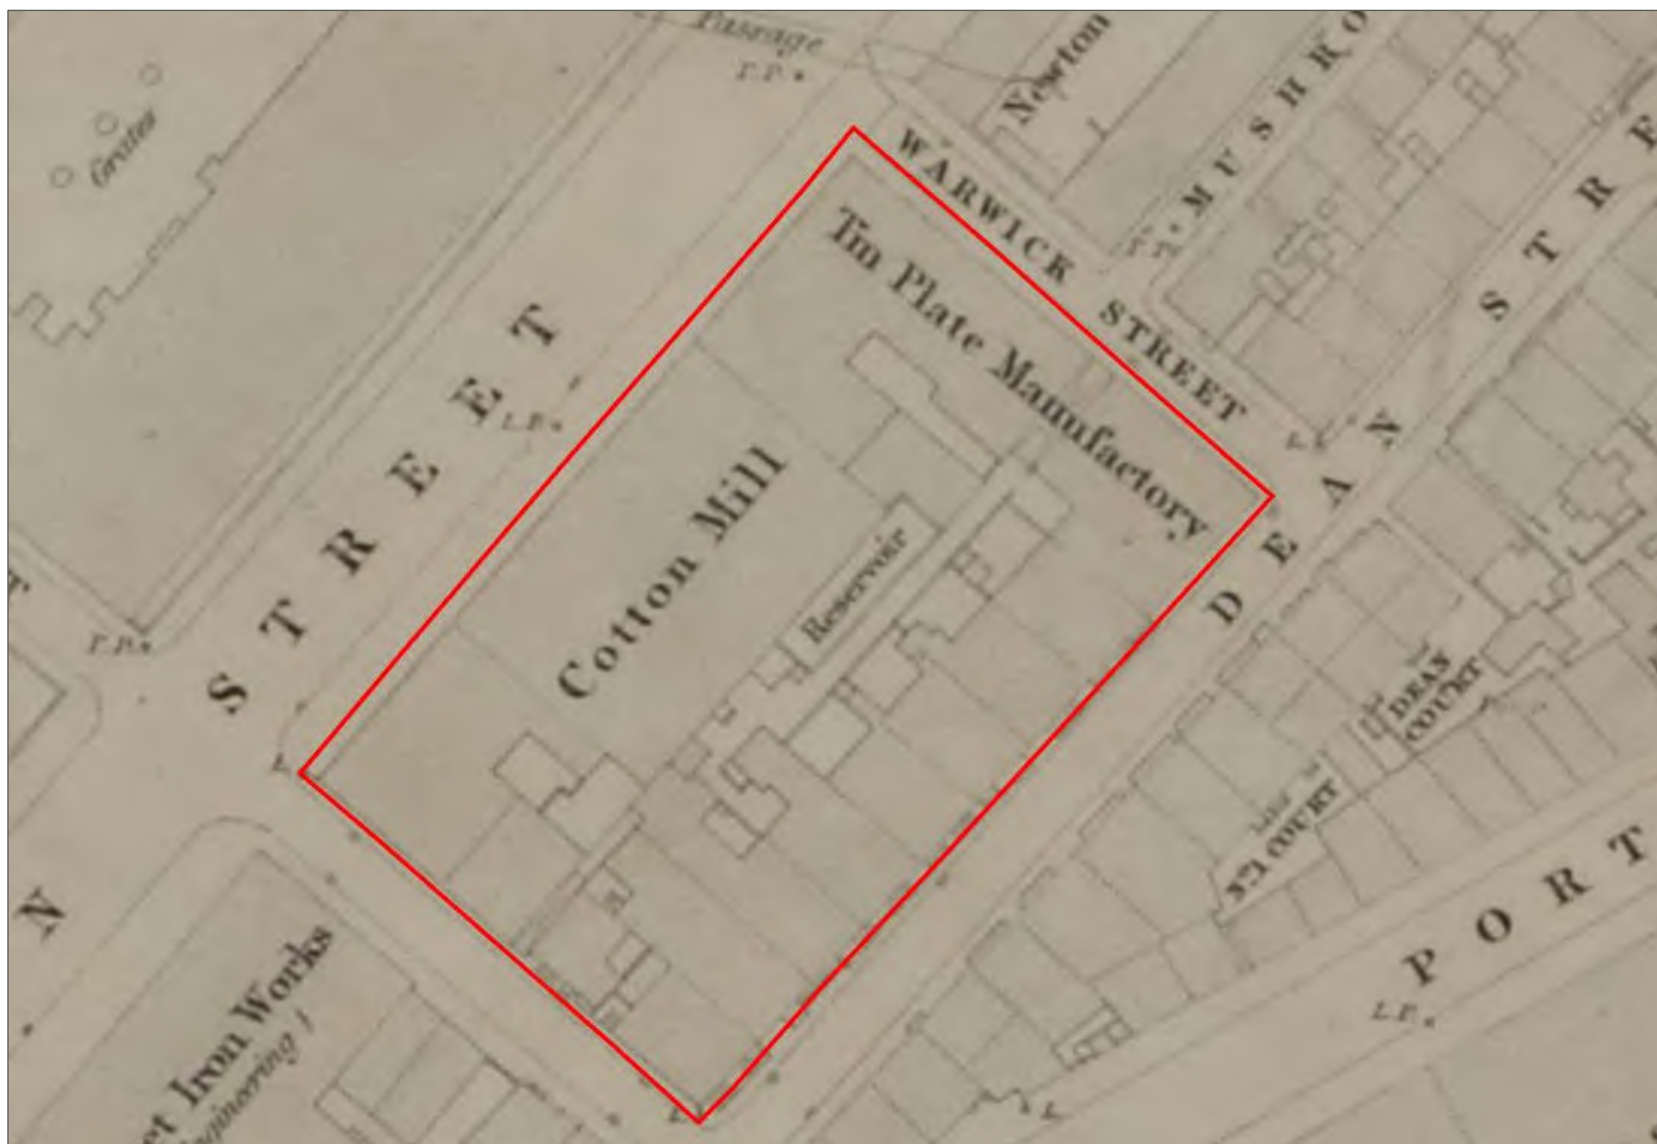
Plate 4: Manchester and Salford 1:10,560 OS plan (1851)

- 5.40 The 1851 1:10,560 Ordnance Survey (OS) plan (**Appendix 4, Plate 4**) is more detailed and shows the Site now includes industrial buildings, including a *Cotton Mill* and *Tin Plate Manufactory*. A rectangular reservoir is also labelled in the centre of the Site. Terraced housing still lined the south-eastern side of the Site off Dean Street. Other industrial

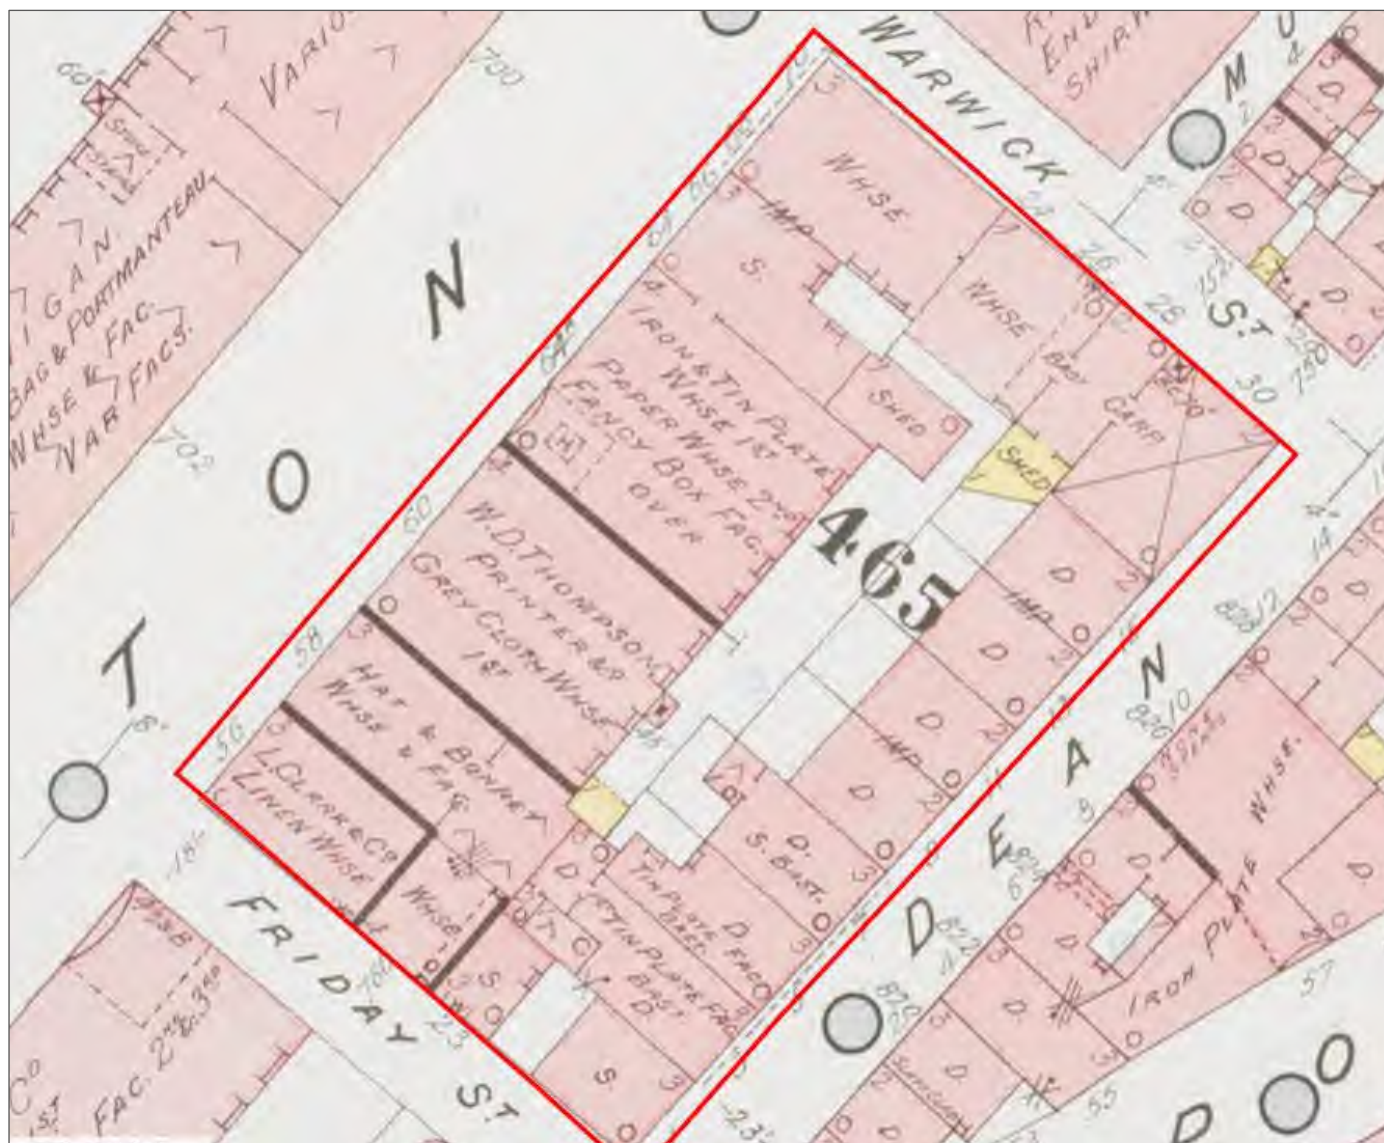
Plate 5: Goad's Insurance Plan of the City of Manchester Vol. II: sheet 31 (1888)

- 5.41 Goad's Insurance Plan of the City of Manchester of 1888 (**Appendix 4, Plate 5**) depicts the Site in detail. On the north-western side, fronting onto Newton Street lay *Iron & Tin Plate Warehouses*, a *Paper Warehouse*, *Fancy Box Factory*, *W. D. Thompson Printer & Co.*, *Grey Cloth Warehouse*, *Hat & Bonnet Warehouse and Factory* and *L. Clarke & Co. Linen Warehouse*. Warehouses lay along the north-eastern side of the Site fronting onto Warwick Street. A *Tin Plate Factory* was located in the southern part of the Site off Dean Street. A row of terraced houses fronted onto Dean Street. Three shops are depicted within the Site, two in the southern corner and one on the north-western boundary. Two sheds are also labelled in the yard area in the centre of the Site.

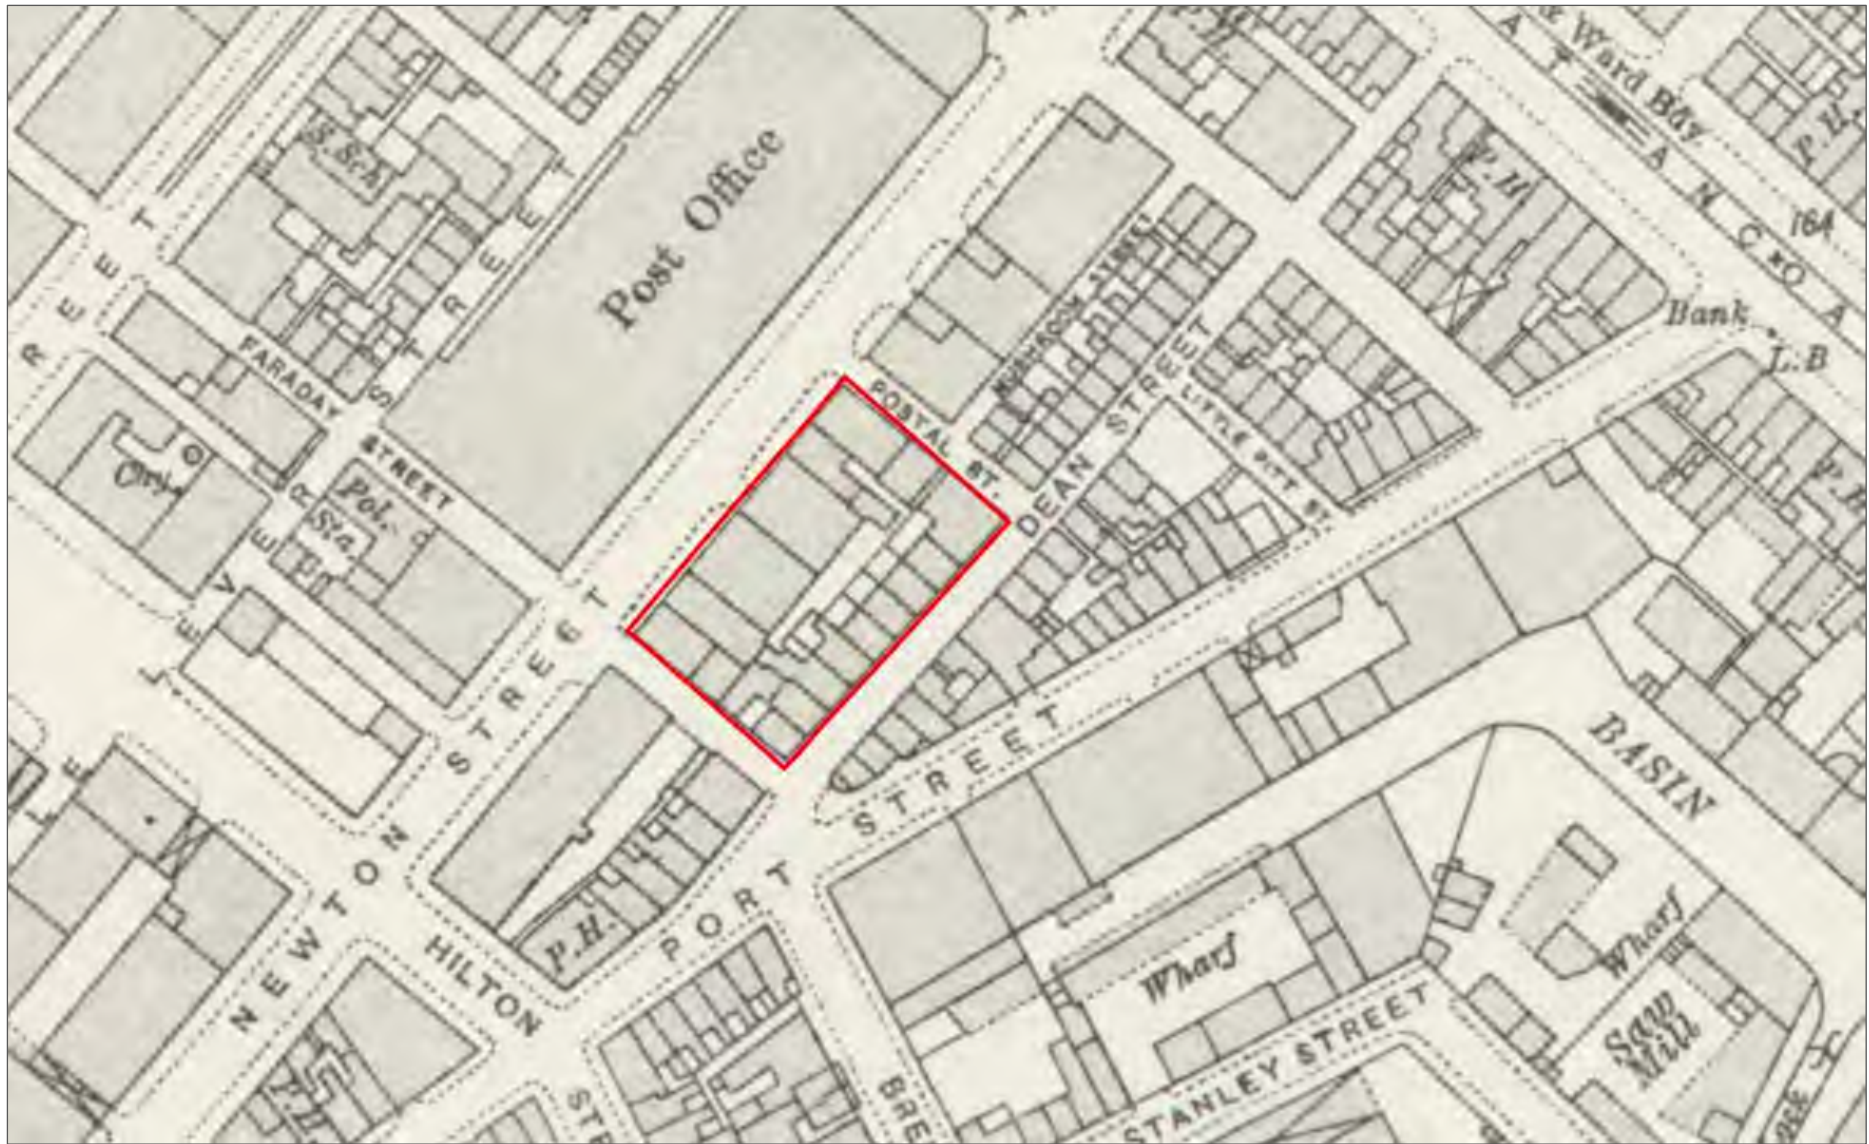
Plate 7: Lancashire CIV.7 25-inch OS plan (1922)

- 5.42 The Site layout remains the same on the 1893 25-inch OS plan (**Appendix 4, Plate 6**), although none of the buildings are labelled.
- 5.43 Aside from the demolition of several small outbuildings in the central yard area of the Site, no change is shown within the Site on the 1922 25-inch OS plan (**Appendix 4, Plate 7**). The industrial buildings to the north-west outside of the Site on Newton Street had been demolished and replaced with a post office. Warwick Street has become Postal Street.

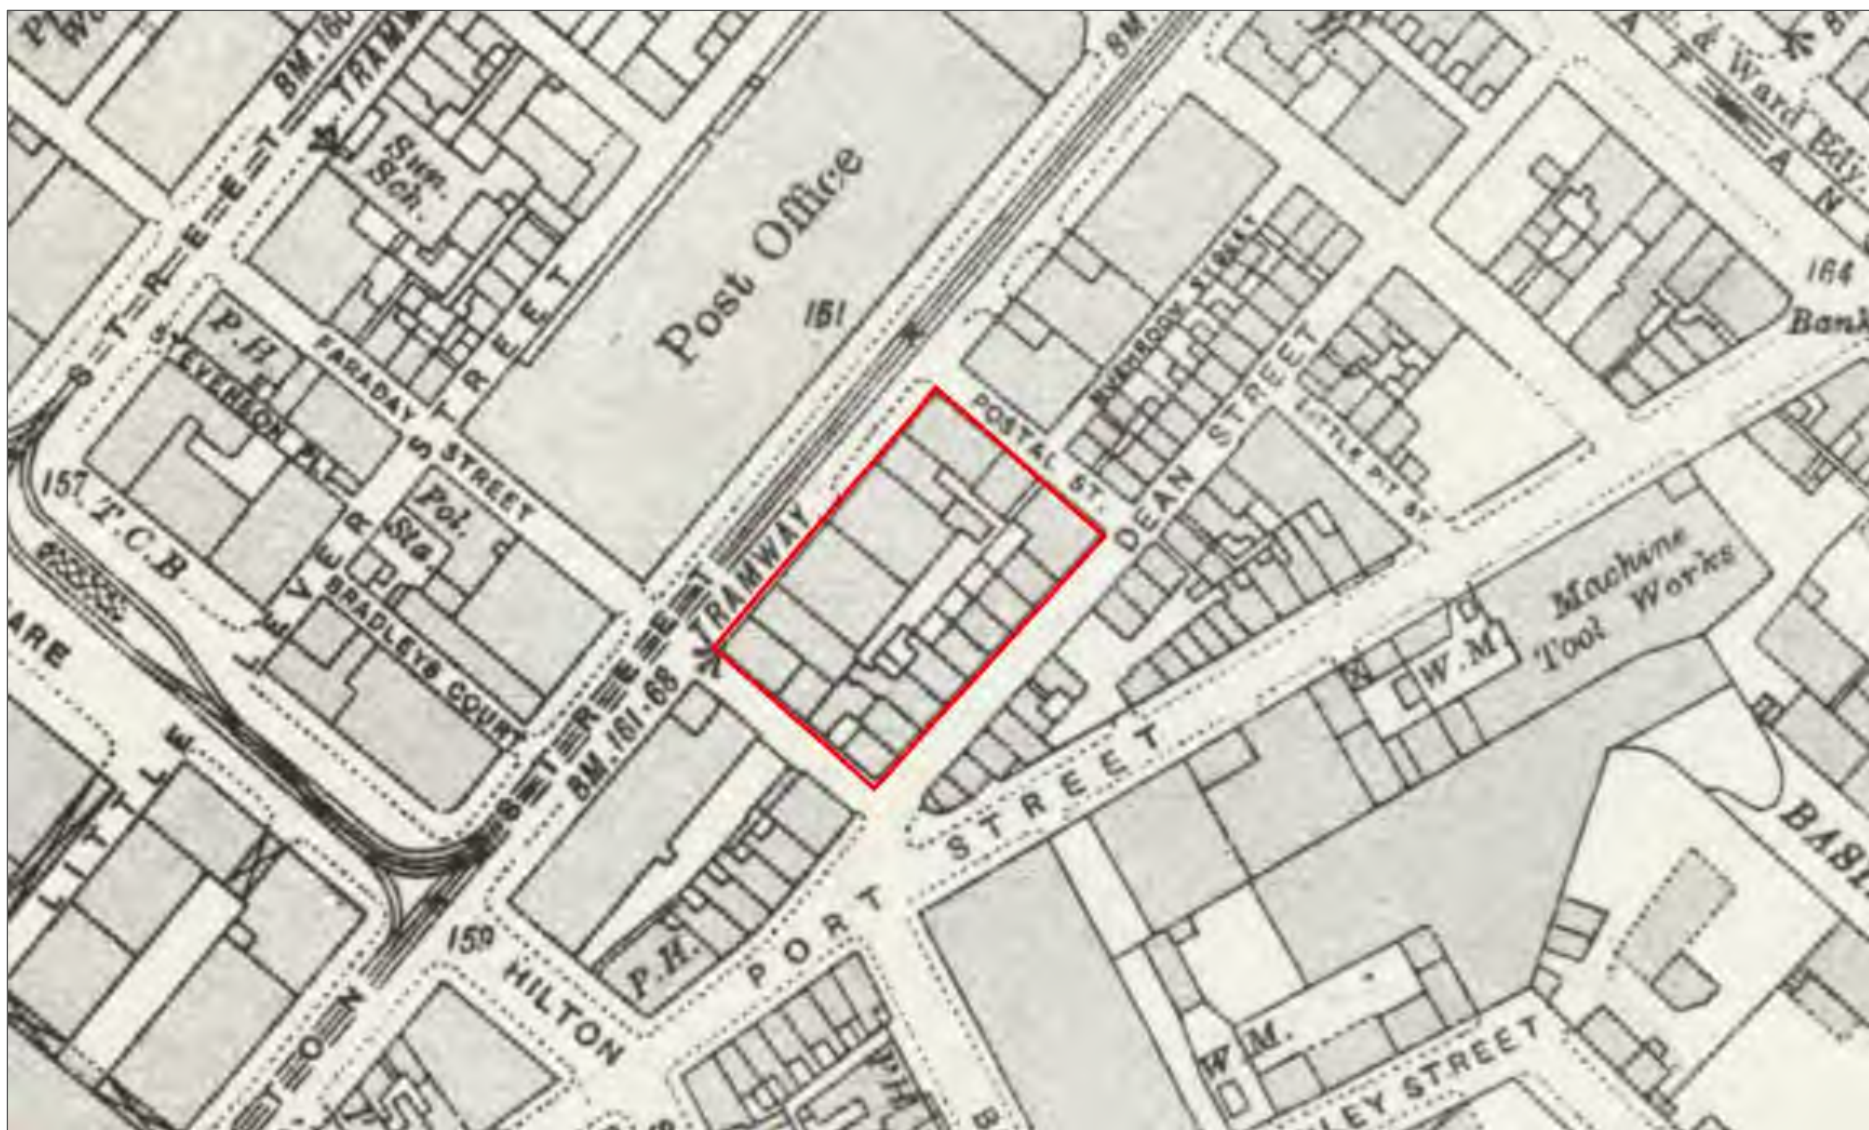
Plate 8: Lancashire CIV.7 25-inch OS plan (1934)

- 5.44 No change within the Site is shown on the 1934 25-inch OS plan (**Appendix 4, Plate 8**). A tramway had been constructed by this time, which ran along Newton Street to the north-west of the Site.

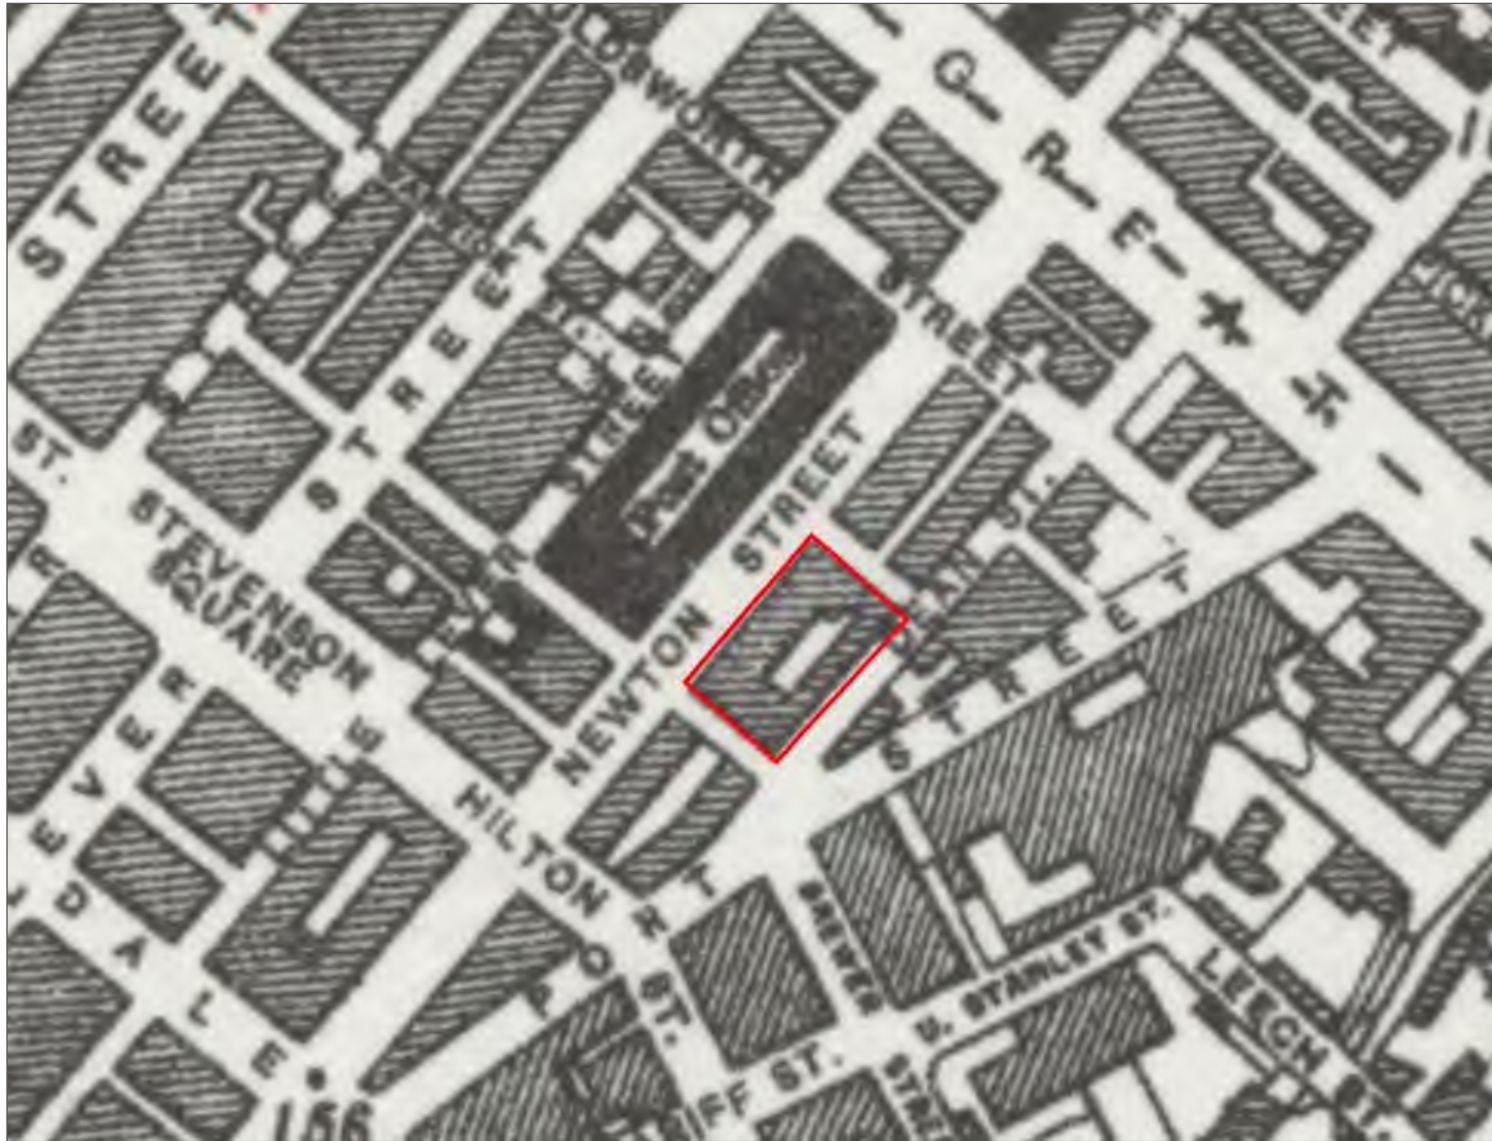
Plate 9: Lancashire Sheet CIV.NE 6-inch OS plan (c. 1947)

- 5.45 Though less detailed, the c. 1947 6-inch OS plan (**Appendix 4, Plate 9**) shows that the buildings on Site remained standing.
- 5.46 Demolition of residential properties on the south-eastern boundary of the Site had taken place by 1969. By 1985, all buildings on the southern and eastern boundary had been demolished, leaving two large buildings remaining on the western boundary. One of these was labelled an 'Arabesque House'. By 2000, the south-eastern half of the Site was in use as a car park. The commercial units have now been demolished as of 2024.

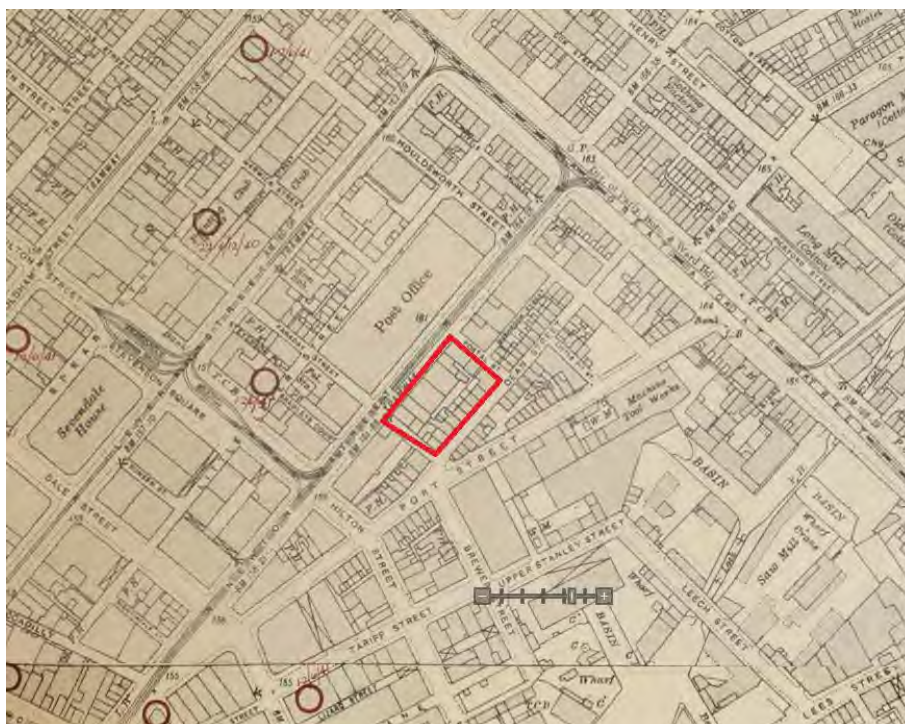
**Figure 2.6:** Site boundary shown in red.

Analysis of historical bomb mapping from the University of Manchester (Figure 2.6) shows that less than 74m west from the site a fire bomb (red circle) had hit and damaged a building in June 1941 (Ref. 5).
