## Remediation Strategy

Stockport Road

Manchester

**Report A2951/24/RMS/V**

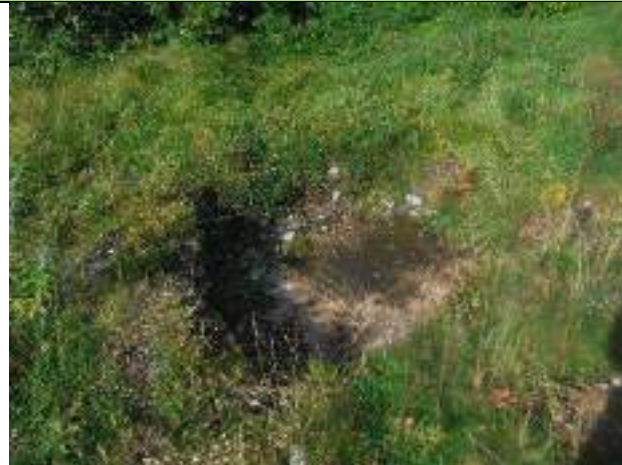
**P5:** Long grasses and sporadic weeds occupy the north and eastern parts of the site
