# Phase II Geoenvironmental Site Assessment

Site: Grey Mare Lane – Site 1

Reference: 16-908-R2-1

Date: June 24

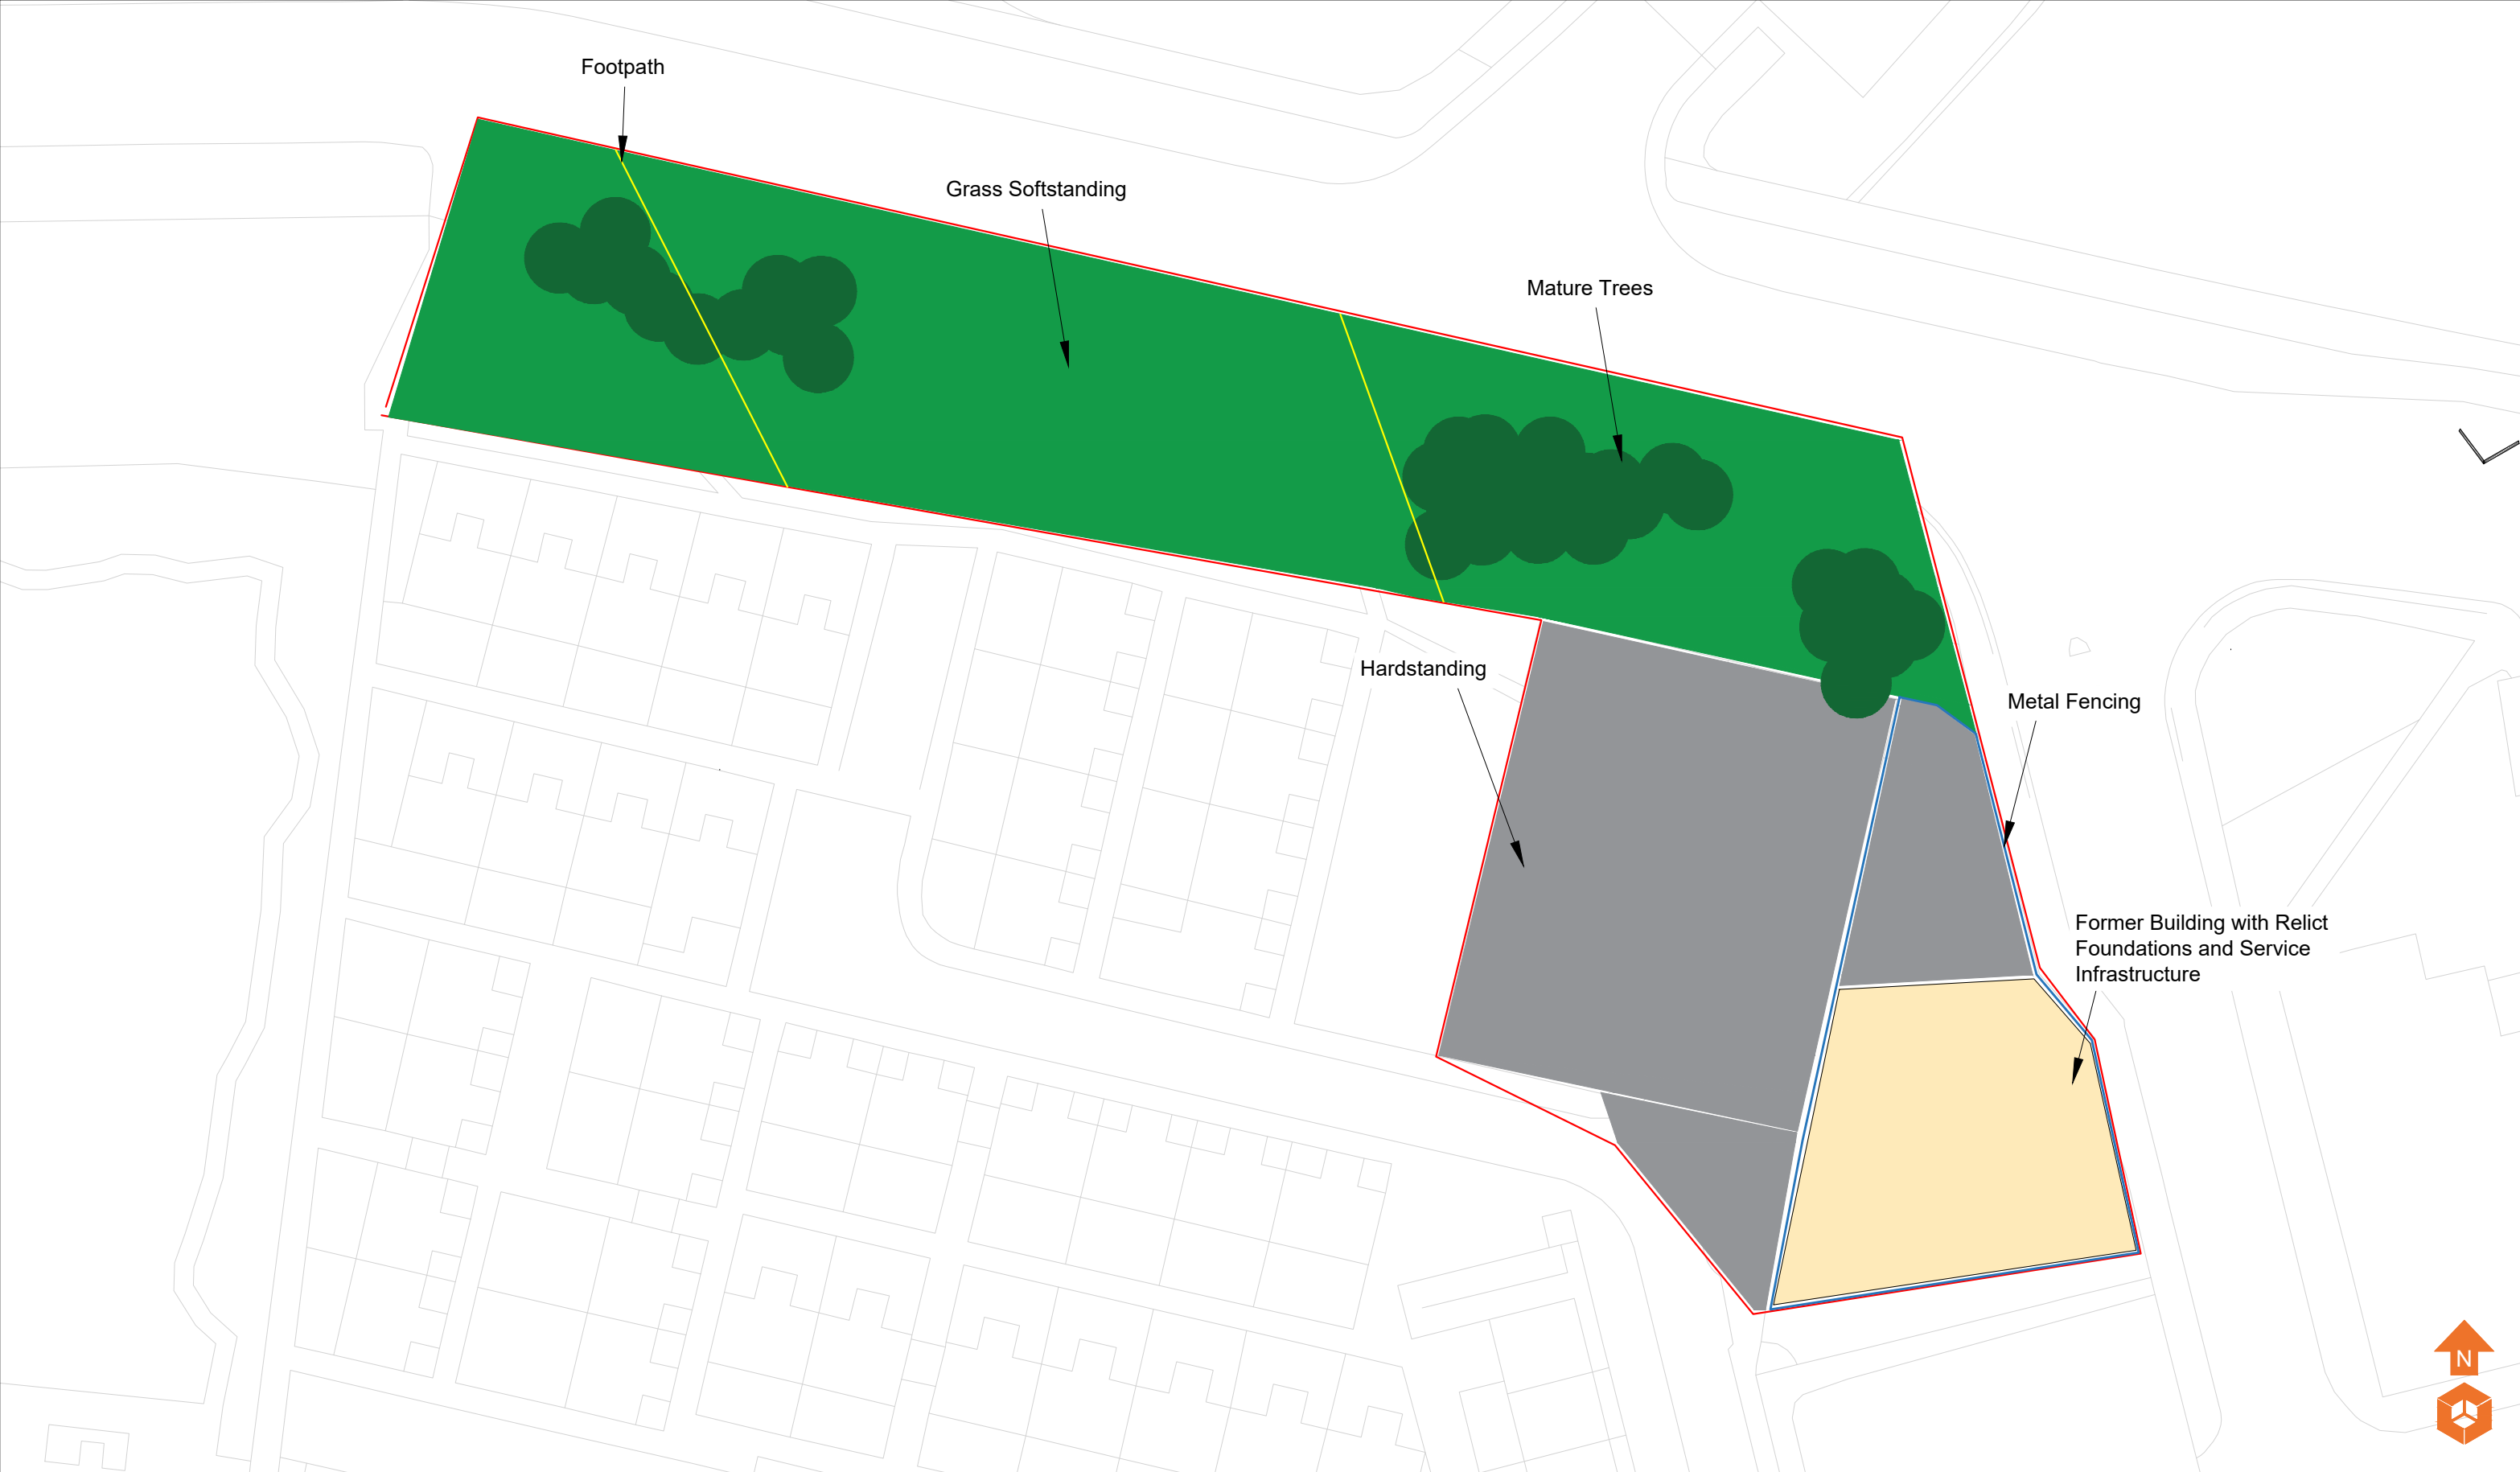
- Site Features
- Asphalt Hardstanding
  - Grass Softstanding
  - Mature Trees
  - Metal Fencing
  - Former Building with Relict Foundations and Service Infrastructures
  - Footpaths

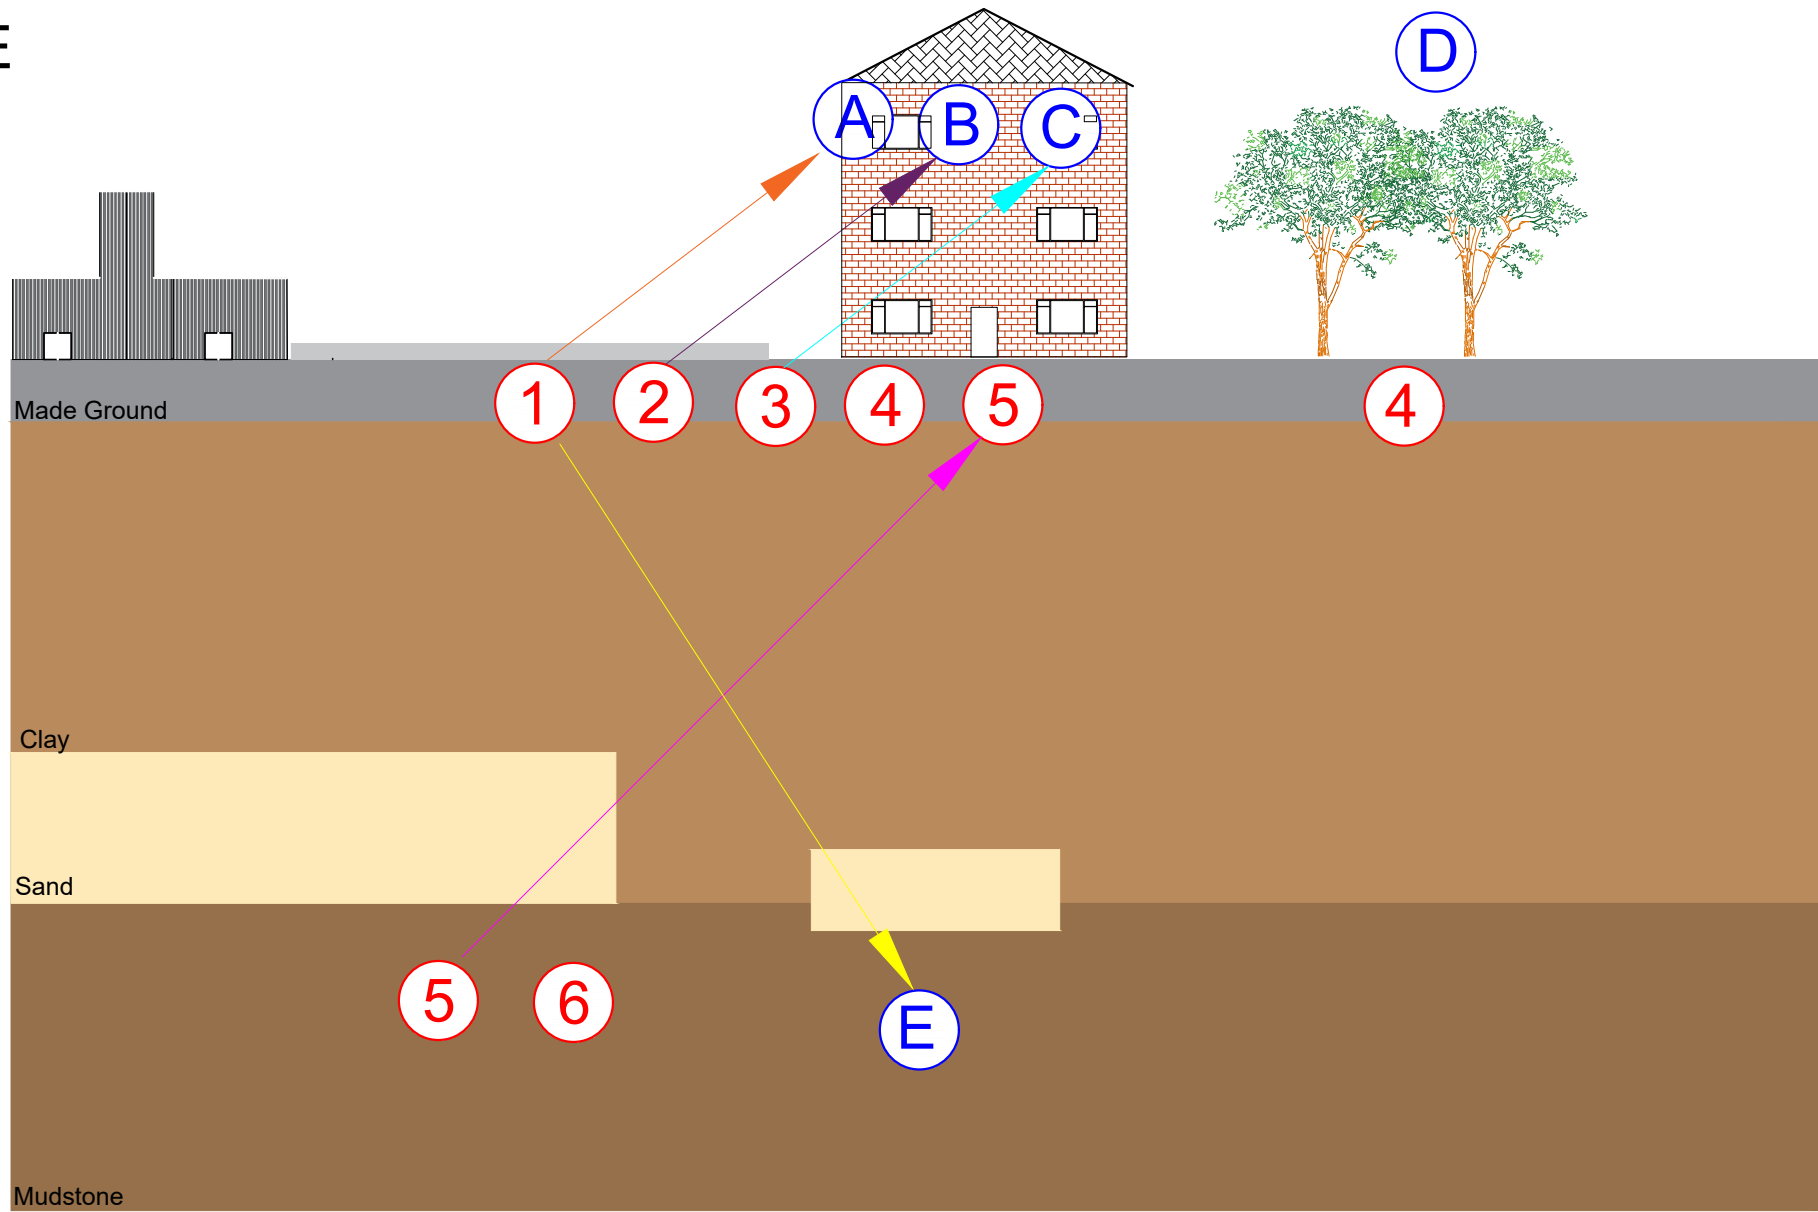
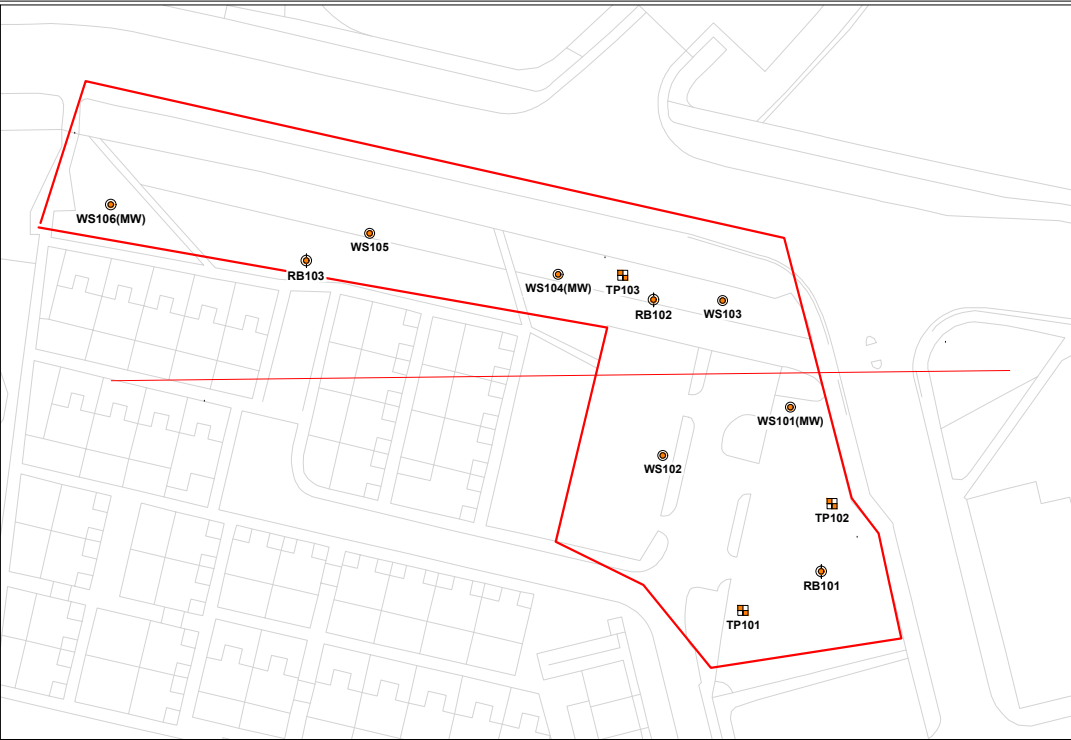
Geology Key

- Made Ground
- Clay
- Sand
- Mudstone

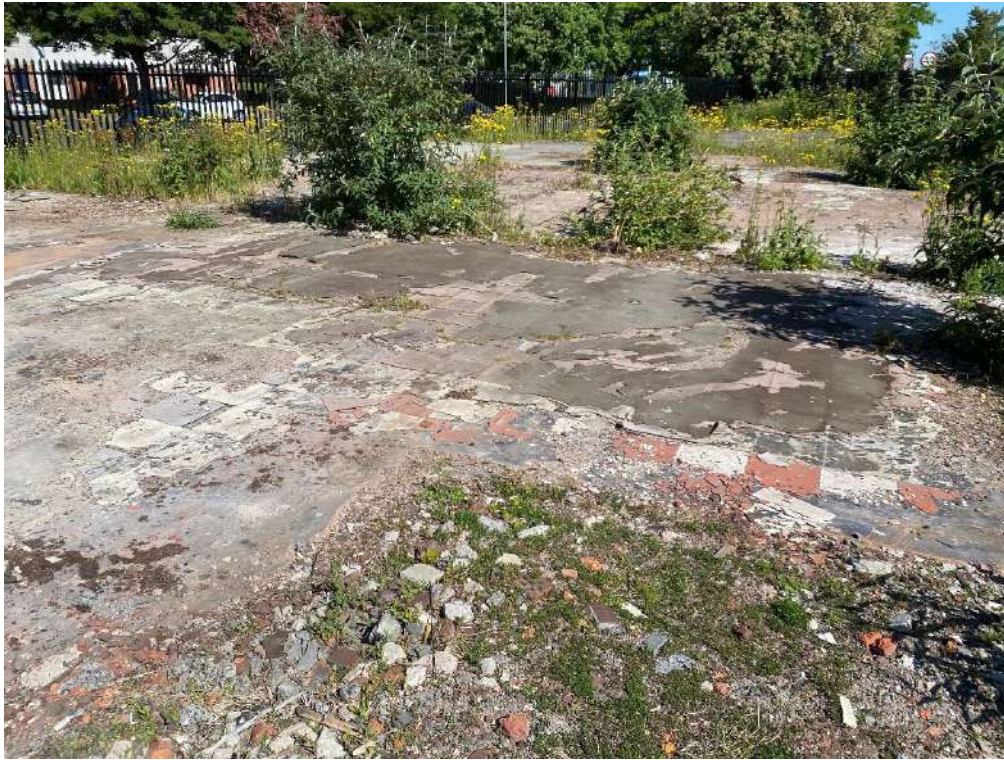
**PLATE 1**      **CENTRAL SECTOR – RELICT FOUNDATIONS AND SLAB**

| <b>Underground Obstructions &amp; Subterranean hazards</b> | <p>Across the site, notable concrete obstructions have been discovered within the Made Ground. These findings suggest the presence of remnants from previous buildings.</p> <p>As part of the process of creating a suitable platform for development, all subterranean obstructions will need to be excavated and removed beneath new structures and infrastructure. This will facilitate the construction of the proposed plots with a piled foundation solution as intended.</p> |
