# Geo-Environmental Investigation & Assessment

St Vincent's, Loreto College

| <b>Report Title:</b> | <b>St Vincent's, Expansion Project<br/>Geo-environmental Investigation and Assessment</b> |
| <b>Report Reference:</b> | <b>10939G-WML-XX-ZZ RP-G-0005B</b> |

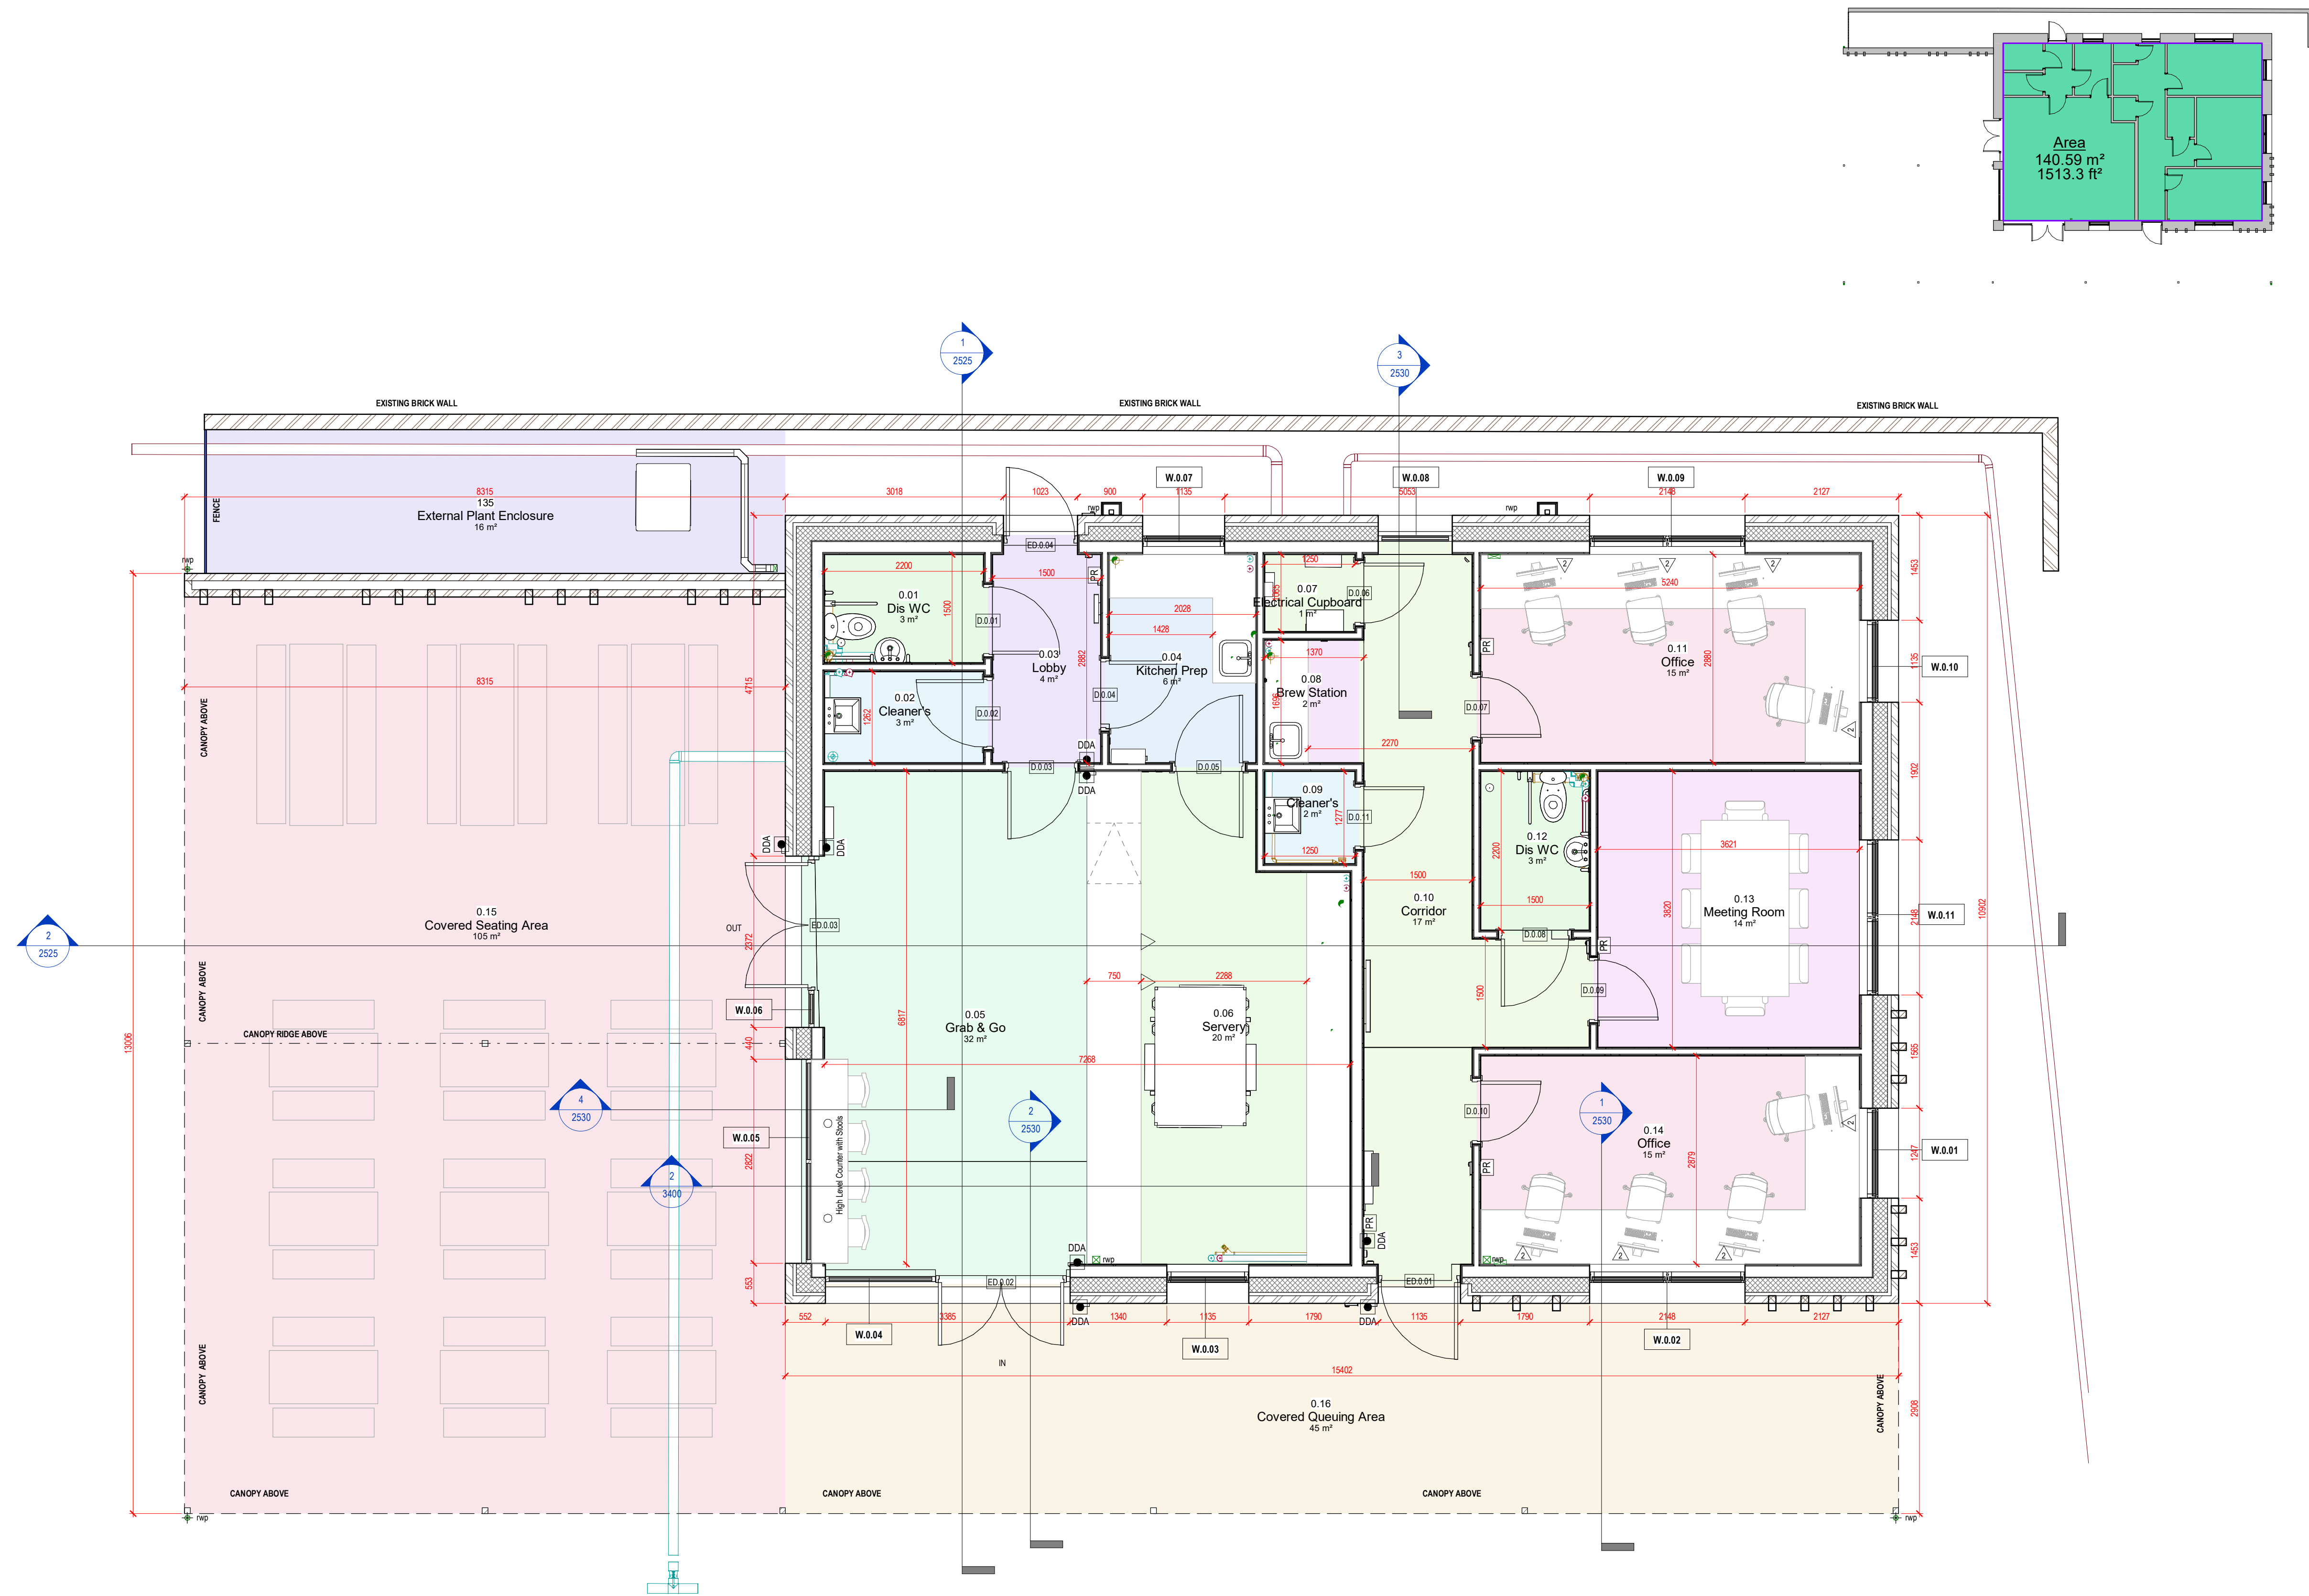
1 Proposed GA Plan  
1:50

- 1.2 The project consists of demolition of the existing St Vincent's building and construction of a new low-rise college structure located to the west of the E&K Building. The structure is to be used as a kitchen with servery, offices and a meeting room.
- 1.3 External areas are anticipated to comprise hardstanding for pedestrian access and potentially localised soft landscaping.
- 1.4 The proposed location plan and elevations by 10architect, referenced LCVL-10A-V9-00-DR-A-9004\_T1 and LCVL-10A-V2-XX-DR-A-2540\_T1, is presented in Appendix 01.

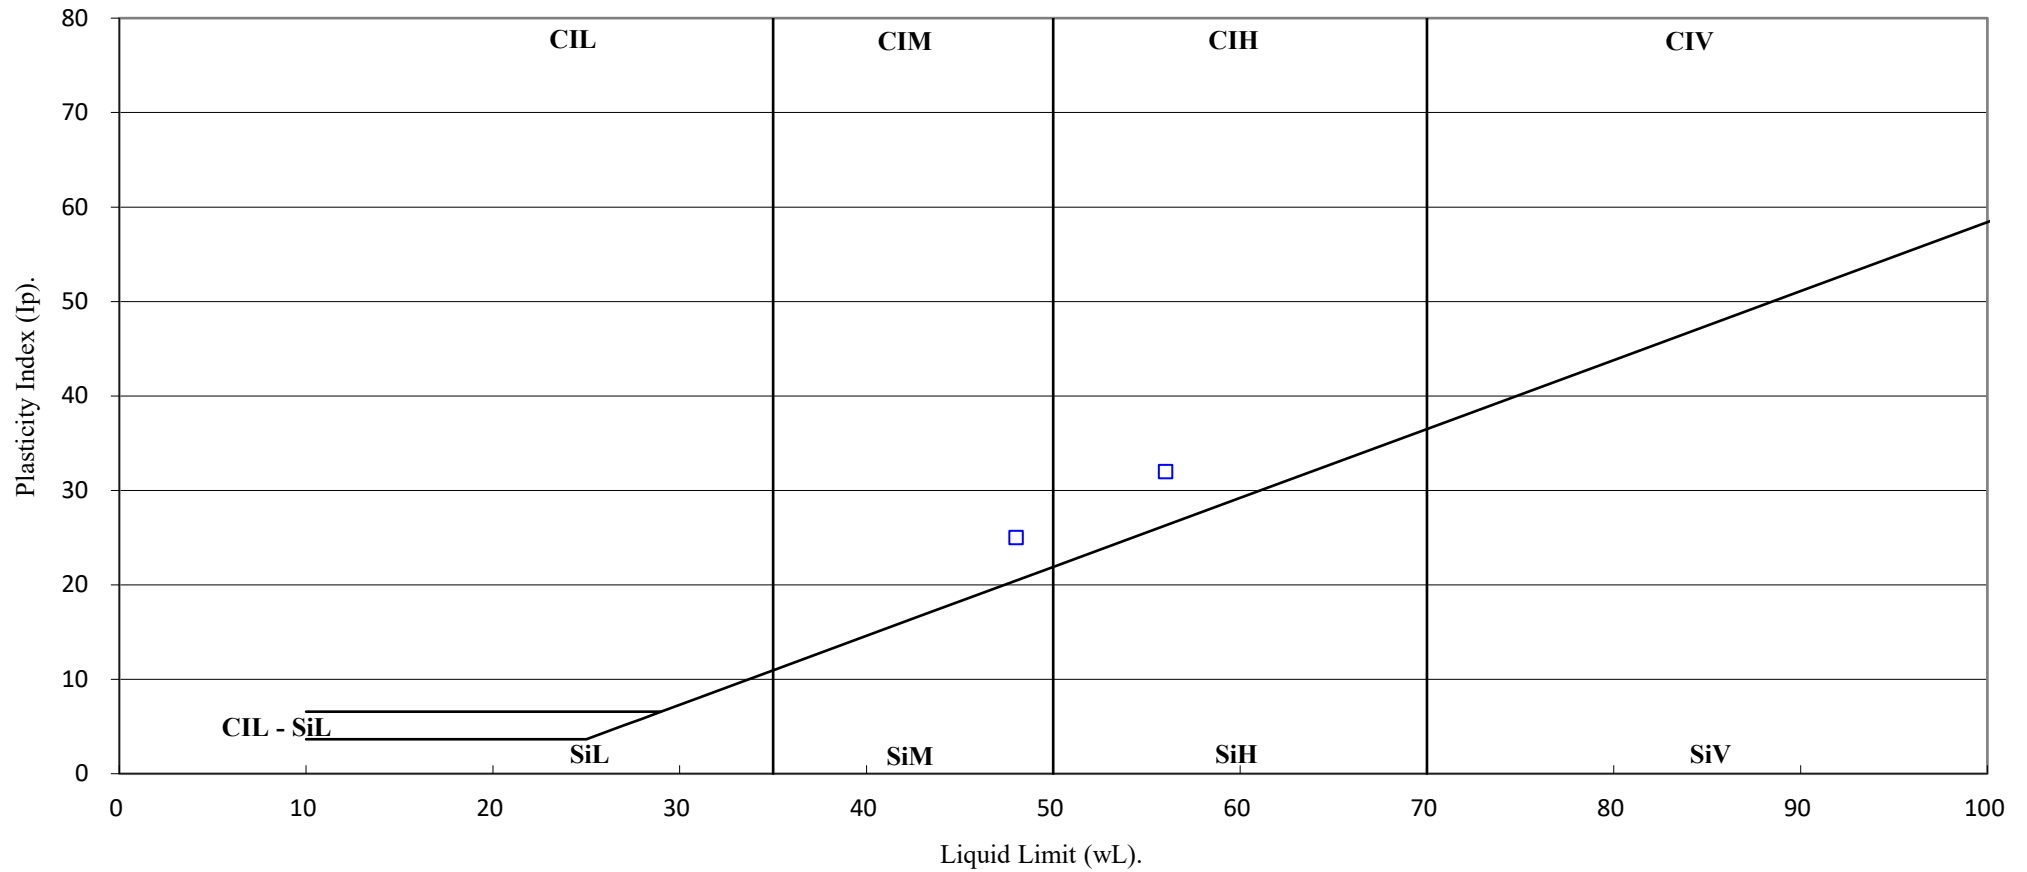
# PLASTICITY CHART

BS EN ISO 14688-2:2017 Clause 4.4

- 4.9 Geotechnical soils testing has been scheduled on selected samples for the following:
- Natural moisture content
  - Liquid and Plastic limits.
- 4.10 The results of the geotechnical testing are presented in Appendix 03.
