# Phase I and II Geoenvironmental Site Assessment

Site: Crabtree Lane, Manchester

Reference: 17-548-R1

Date: April 24

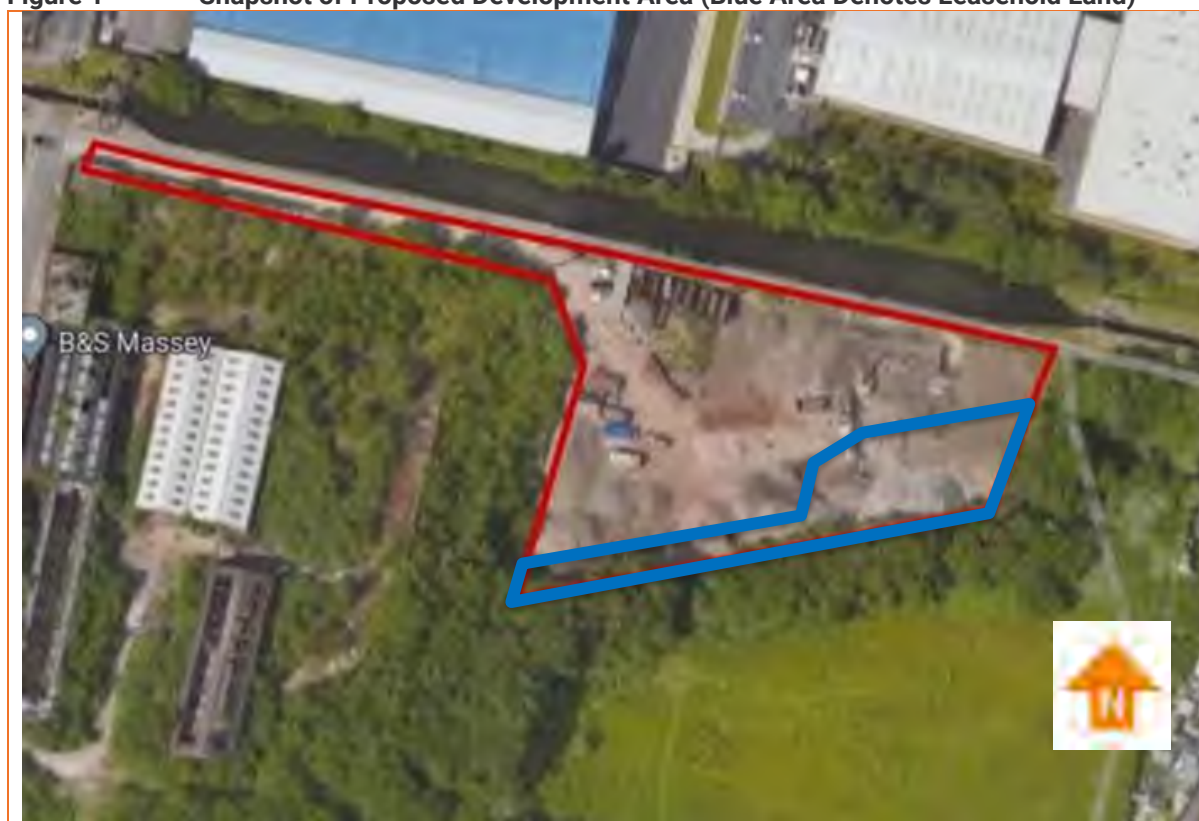
**Figure 1** Snapshot of Proposed Development Area (Blue Area Denotes Leasehold Land)

A snapshot of the proposed development area is indicated in Figure 1.

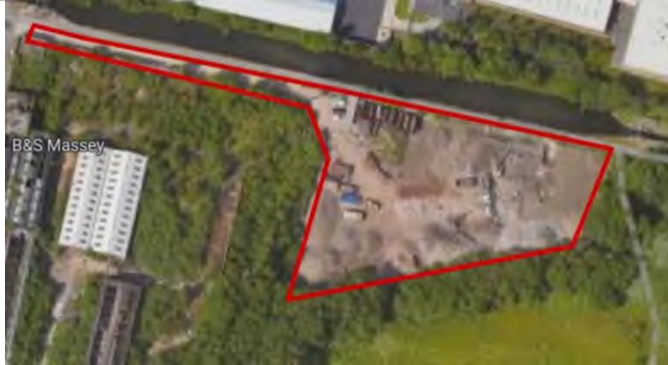
| FEATURE | DESCRIPTION | PHOTOGRAPHIC EVIDENCE |
|---|---|---|
| <b>Occupancy/Use</b> | <p>The subject site is an irregular-shaped parcel of land located east of Crabtree Lane and currently occupied by a service yard.</p> <p>The site is currently being cleared with stockpiled material being screened and crushed.</p> | |

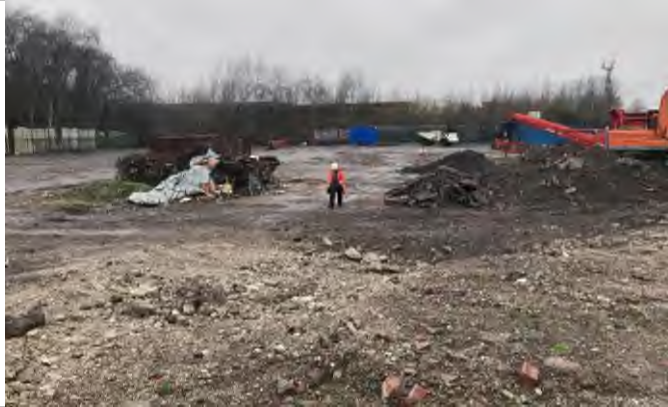
| FEATURE | DESCRIPTION | PHOTOGRAPHIC EVIDENCE |
|---|---|---|
| <b>Structures</b> | <p>There are no permanent structures on site though brick walls form the northern perimeter of the site.</p> | |

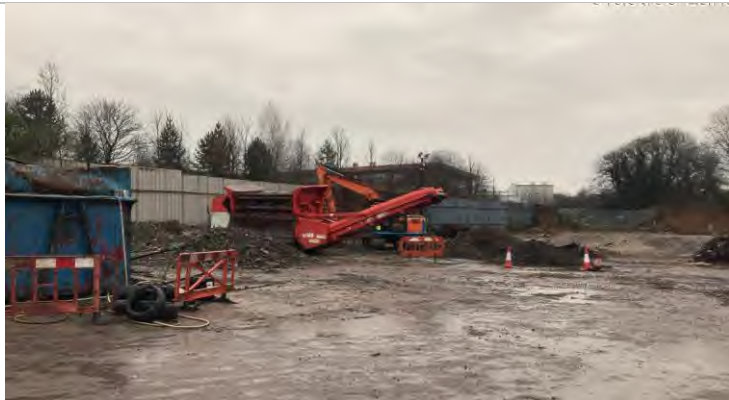
| FEATURE | DESCRIPTION | PHOTOGRAPHIC EVIDENCE |
|---|---|---|
| <b>Slope</b> | The site is topographically level though a small area of raised slab is present in the northeast of the site. There are mounds of materials on the site which are currently being processed for removal. | |

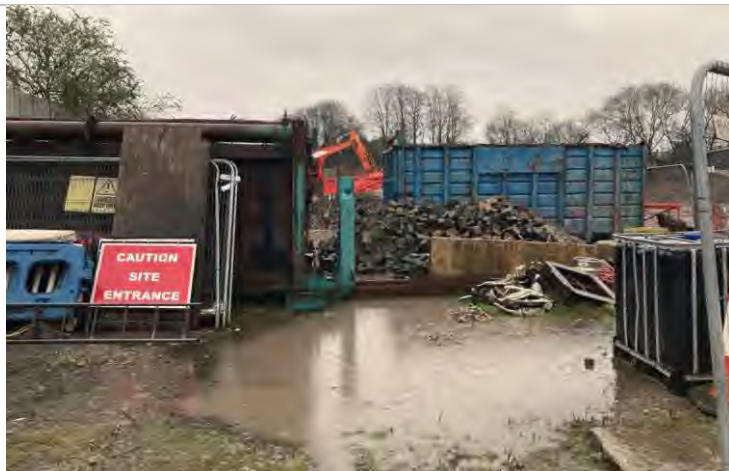
| FEATURE | DESCRIPTION | PHOTOGRAPHIC EVIDENCE |
|---|---|---|
| <b>Hazardous Material Storage</b> | <p>No above-ground storage tanks (ASTs) or underground storage tanks (USTs) were observed during the preliminary desk-based walkover.</p> <p>Temporary diesel storage and skips containing waste materials are currently present associated with the site clearance works.</p> | |

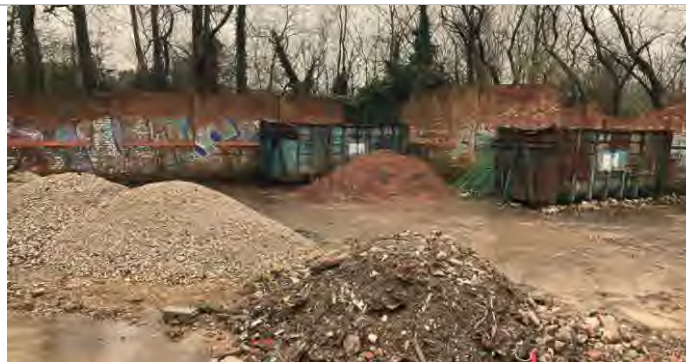
| FEATURE | DESCRIPTION | PHOTOGRAPHIC EVIDENCE |
|---|---|---|
| <b>Waste Storage</b> | There are currently skips stored on the site that relate to the site clearance operations being completed. | |

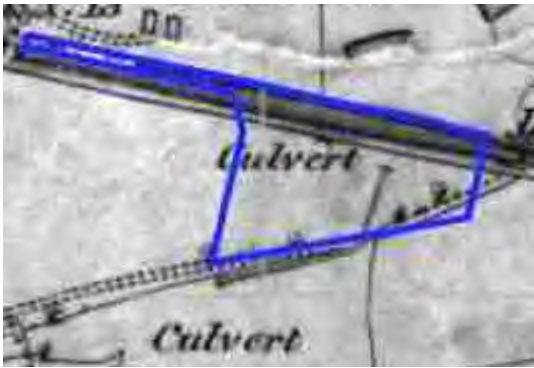
| Table 5<br>MAP<br>EDITION | Historical Development<br>HISTORICAL LAND USE | HISTORICAL MAP EXCERPT |
|---|---|---|
| <p>1848<br/>1:10,560</p> | <p>The site is recorded as undeveloped land. However, there is a culvert present.</p> | |

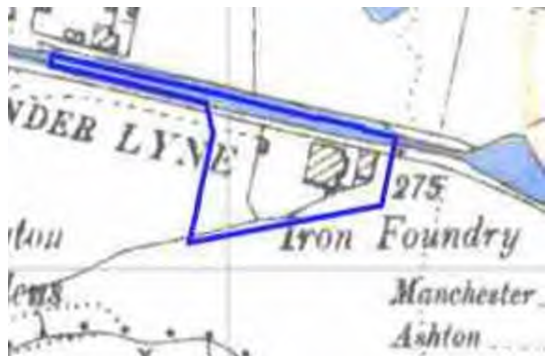
| Table 5<br>MAP<br>EDITION | Historical Development<br>HISTORICAL LAND USE | HISTORICAL MAP EXCERPT |
|---|---|---|
| <p>1890-1892<br/>1:10,560</p> | <p>An Iron Foundry is recorded on the site comprising two buildings in the west.</p> | |

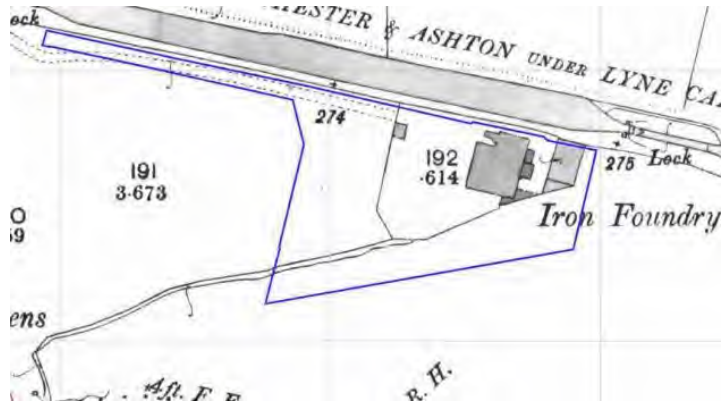
| MAP EDITION | HISTORICAL LAND USE | HISTORICAL MAP EXCERPT |
|---|---|---|
| <p>1893<br/>1:2,500</p> | <p>The earliest large-scale mapping provides a greater detailed insight into the Iron Foundry. The map also suggests that an open watercourse may have been present in the southwest though the culvert is no longer marked.</p> | |

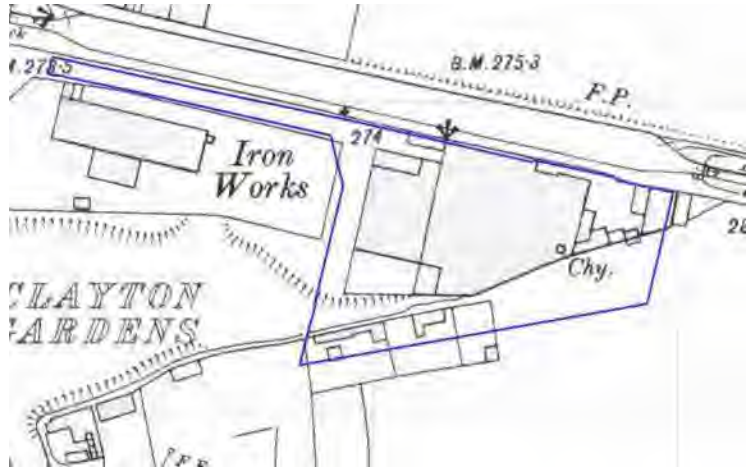
| MAP EDITION | HISTORICAL LAND USE | HISTORICAL MAP EXCERPT |
|---|---|---|
| <p>1908<br/>1:2,500</p> | <p>The iron works have expanded and there is now a chimney detailed in the central eastern sector of the site. Markings also suggest that the site levels have been raised with a slope marked in the southwest.</p> | |

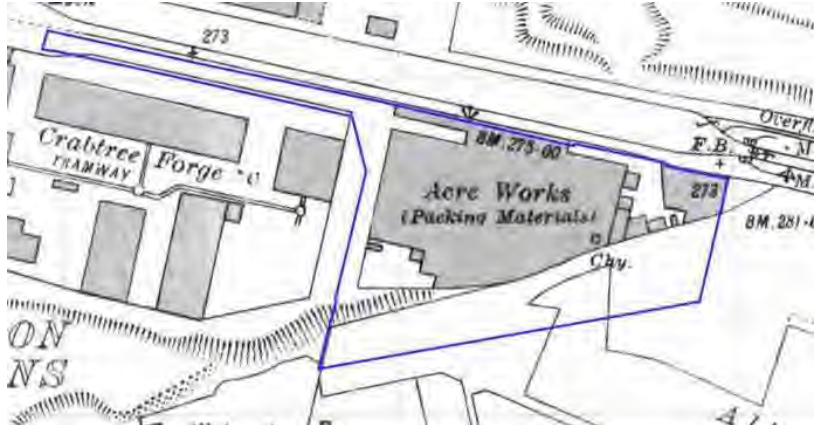
| MAP EDITION | HISTORICAL LAND USE | HISTORICAL MAP EXCERPT |
|---|---|---|
| <p>1932-1933<br/>1:2,500</p> | <p>The site's layout remains the same but is has now been relabelled Acre Works (Packing Materials). The watercourse is no longer recorded with markings suggesting it has been covered or infilled.</p> | |

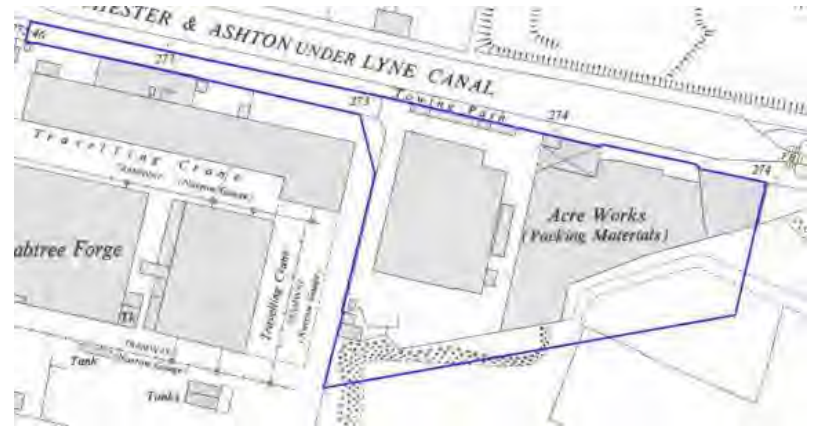
| MAP EDITION | HISTORICAL LAND USE | HISTORICAL MAP EXCERPT |
|---|---|---|
| <p>1949-1950<br/>1:1,250</p> | <p>The site remains the same. However, the more detailed mapping demonstrates that the site has multiple buildings as opposed to one large building which is detailed in the smaller scale mapping.</p> <p>A refuse heap is also present in the south of the site but is considered to be predominantly located to the south.</p> | |

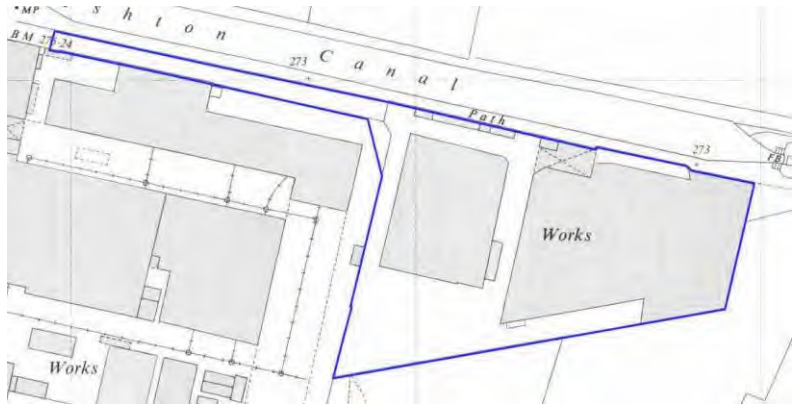
| MAP EDITION | HISTORICAL LAND USE | HISTORICAL MAP EXCERPT |
|---|---|---|
| <p>1964-1968<br/>1:1,250</p> | <p>The site remains unchanged but has been detailed as an unspecified works.</p> <p>There is no longer a refuse heap present in the south of the site.</p> | |

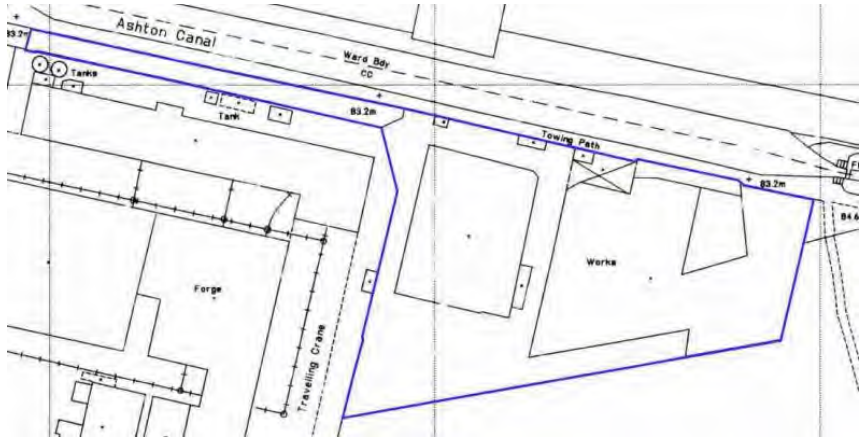
| MAP EDITION | HISTORICAL LAND USE | HISTORICAL MAP EXCERPT |
|---|---|---|
| <p>1992-1994<br/>1:1,250</p> | <p>There are no significant changes recorded when compared with the previous map.</p> | |

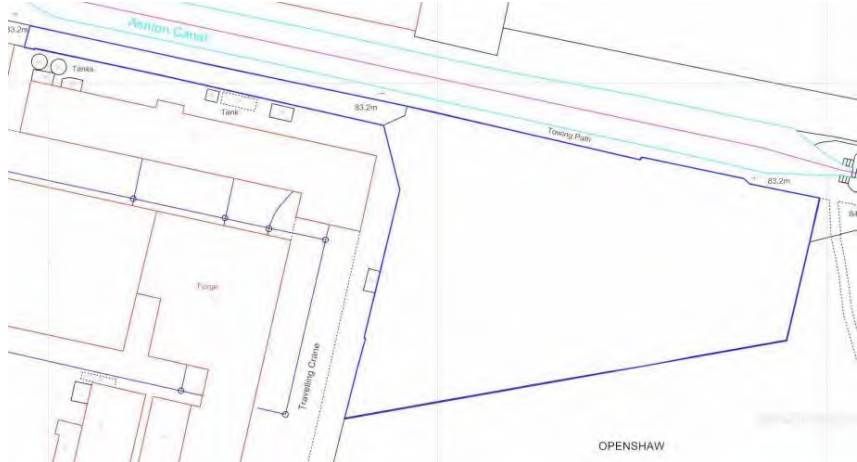
| MAP EDITION | HISTORICAL LAND USE | HISTORICAL MAP EXCERPT |
|---|---|---|
| <p><b>2003</b><br/><b>1:1,250</b></p> | <p>The unspecified works has been demolished and the site is vacant land with no structures recorded on it.</p> | |

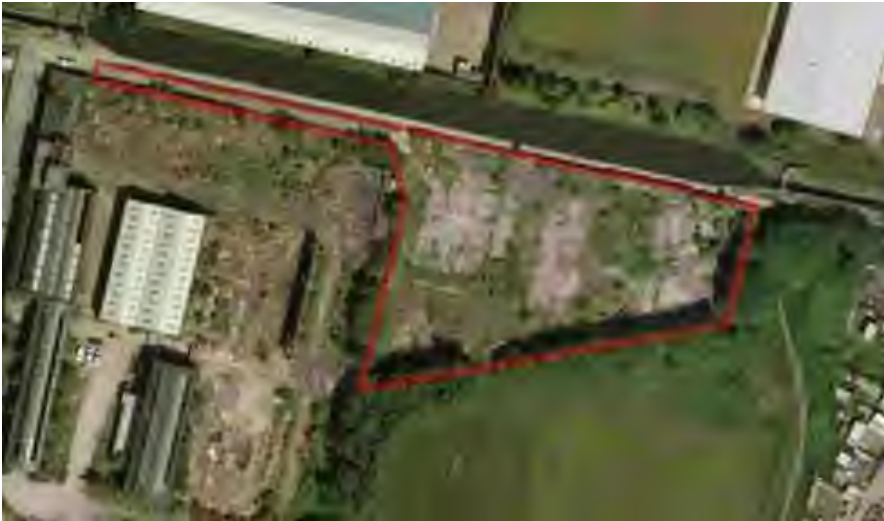
| MAP EDITION | HISTORICAL LAND USE | HISTORICAL MAP EXCERPT |
|---|---|---|
| <p><b>2009</b><br/><b>Satellite Imagery</b></p> | <p>There are no significant changes when compared with the previous map.</p> | |

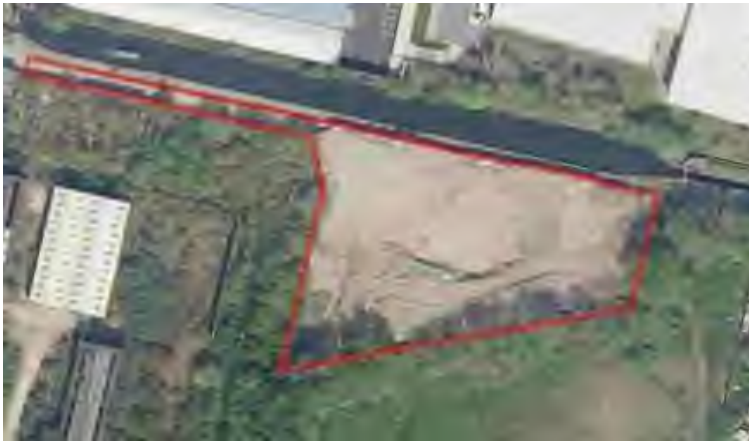
| MAP EDITION | HISTORICAL LAND USE | HISTORICAL MAP EXCERPT |
|---|---|---|
| 2019<br>Satellite<br>Imagery | The rough scrub vegetation has been cleared from site. | |

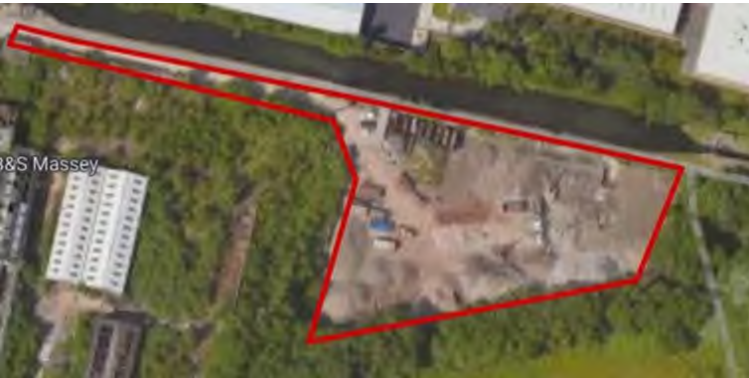
| MAP EDITION | HISTORICAL LAND USE | HISTORICAL MAP EXCERPT |
|---|---|---|
| 2024<br>Satellite<br>Imagery | The site is occupied by a service yard.<br><br>Site activities at the service yard include the loading and unloading of materials and the storage of these materials. | |

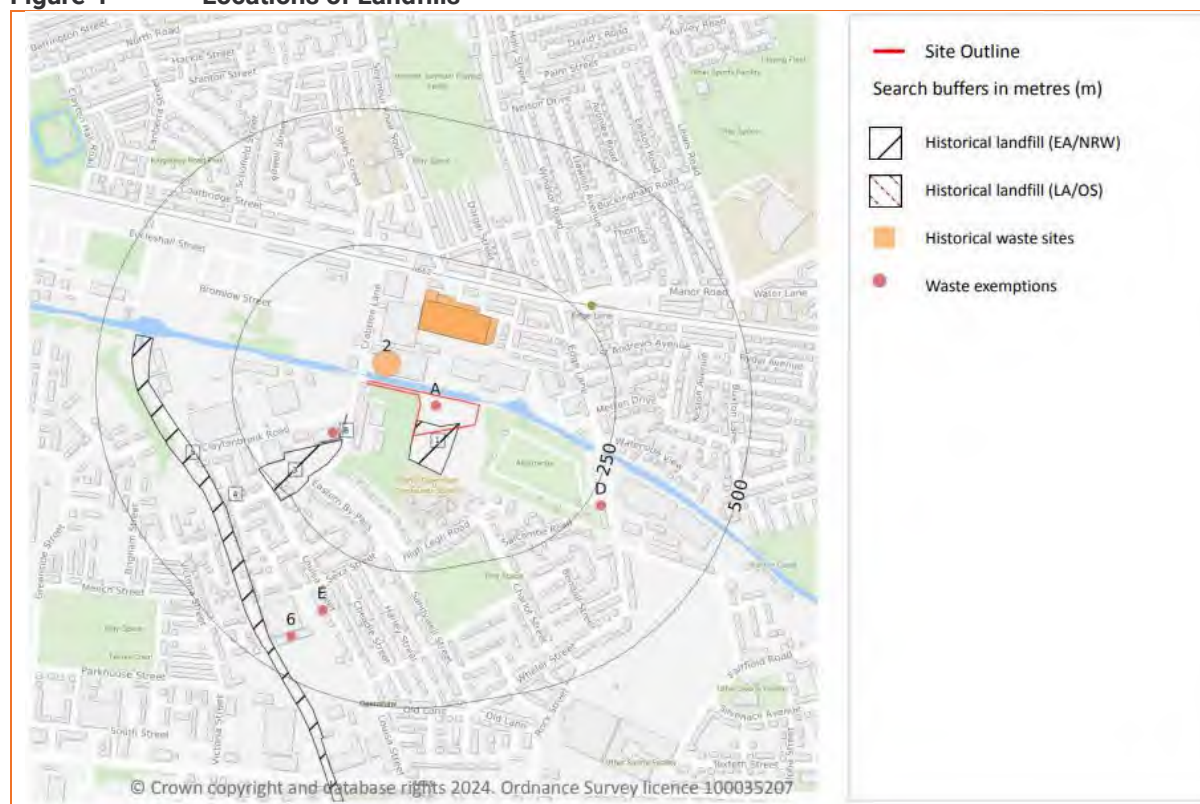
**Figure 4 Locations of Landfills**

The Crabtree Forge and Clayton Industrial Estate landfill sites are recorded as a historical landfill and pre-date the Control or Pollution Act (COPA) and current environmental permitting requirements.

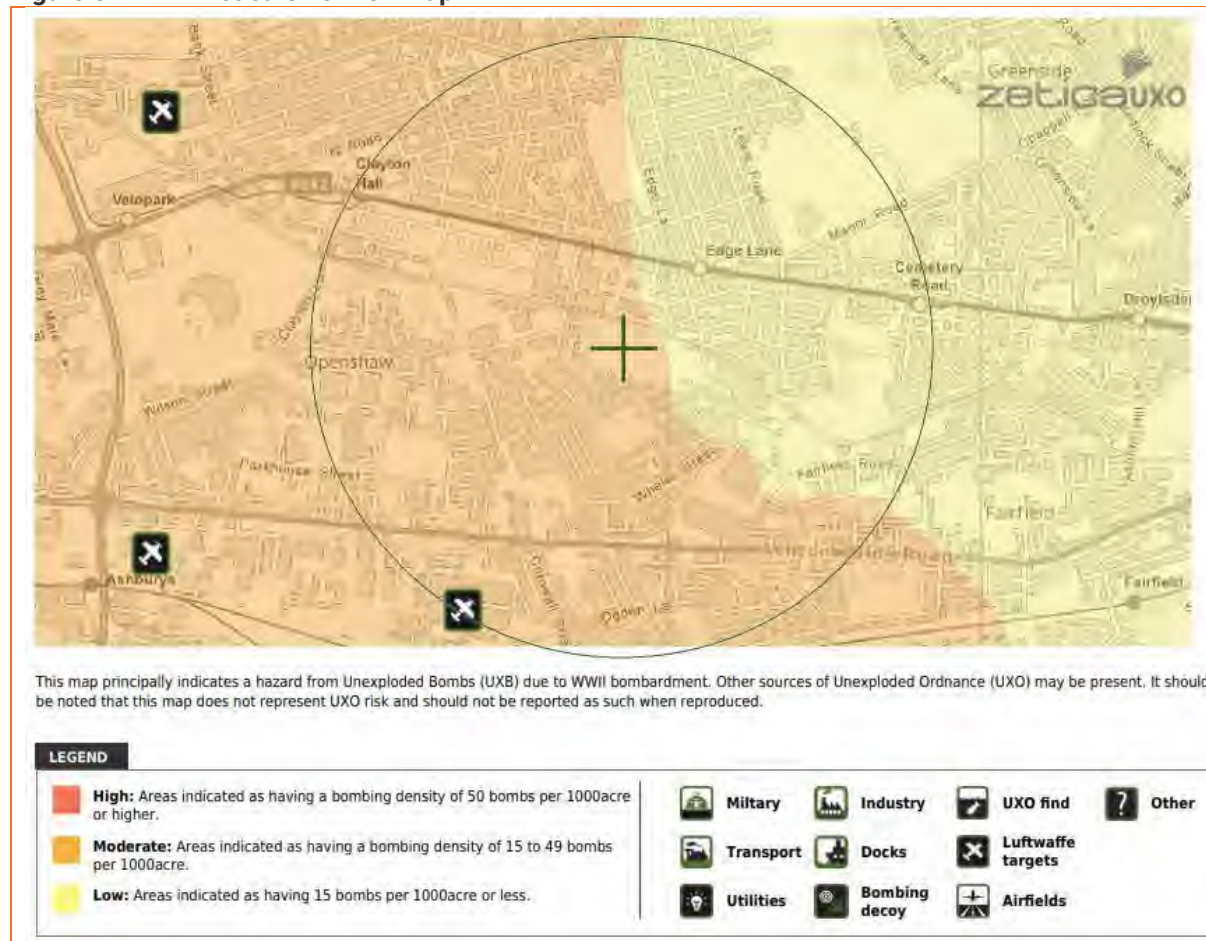
Figure 5 Zetica UXO Risk Map

The regional unexploded bomb risk map from Zetica (2014) indicates that the Site is in an area of moderate risk from possible unexploded ordnance (UXO) resulting from the Second World War. The Zetica UXO Risk Map is presented in Figure 5.

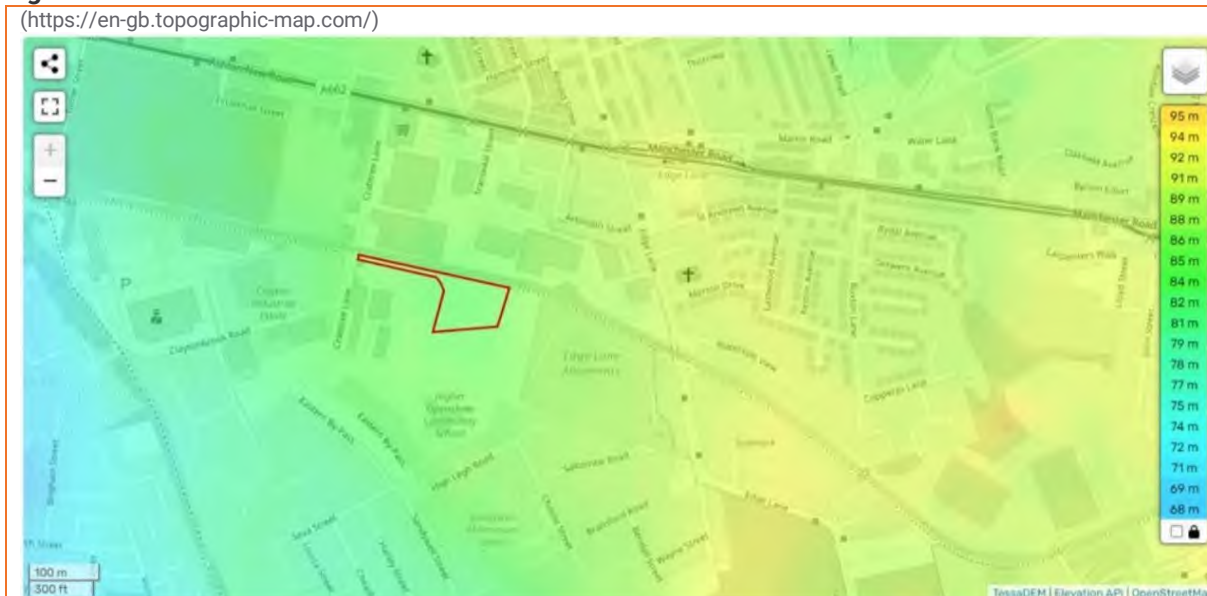
**Figure 6** Surface Lidar Data

The LIDAR imagery shown in Figure 6 shows topography within the local area context.

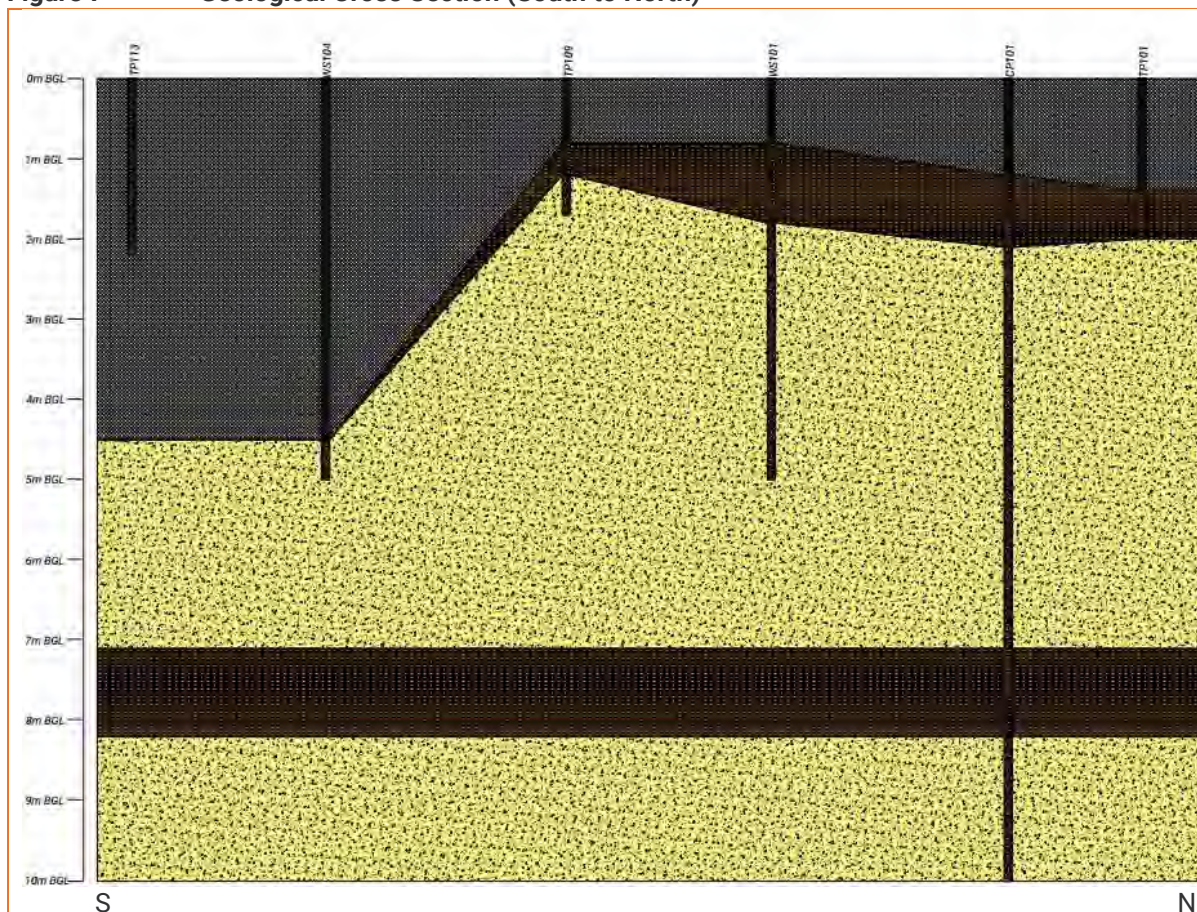
**Figure 7** Geological Cross Section (South to North)

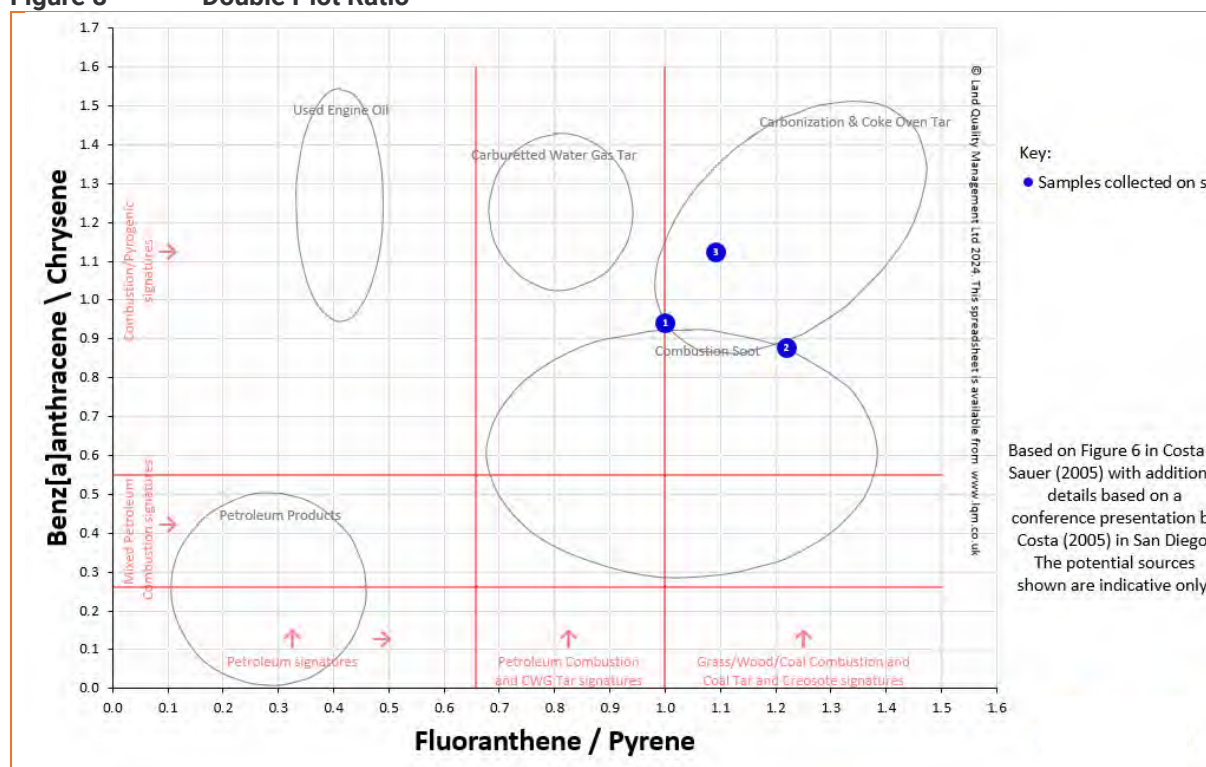
**Figure 8 Double Plot Ratio**

The double plot ratio indicates that the recorded PAH in samples from TP102 and WS104 are a result of combustion soot with ash noted in the soil descriptions. The sample from TP111 may be a result of carbonization with the soil description noting the presence of asphalt which may be the source. It should therefore be considered that other exceedances of these PAH compounds may be recorded in locations where ash and asphalt are noted.

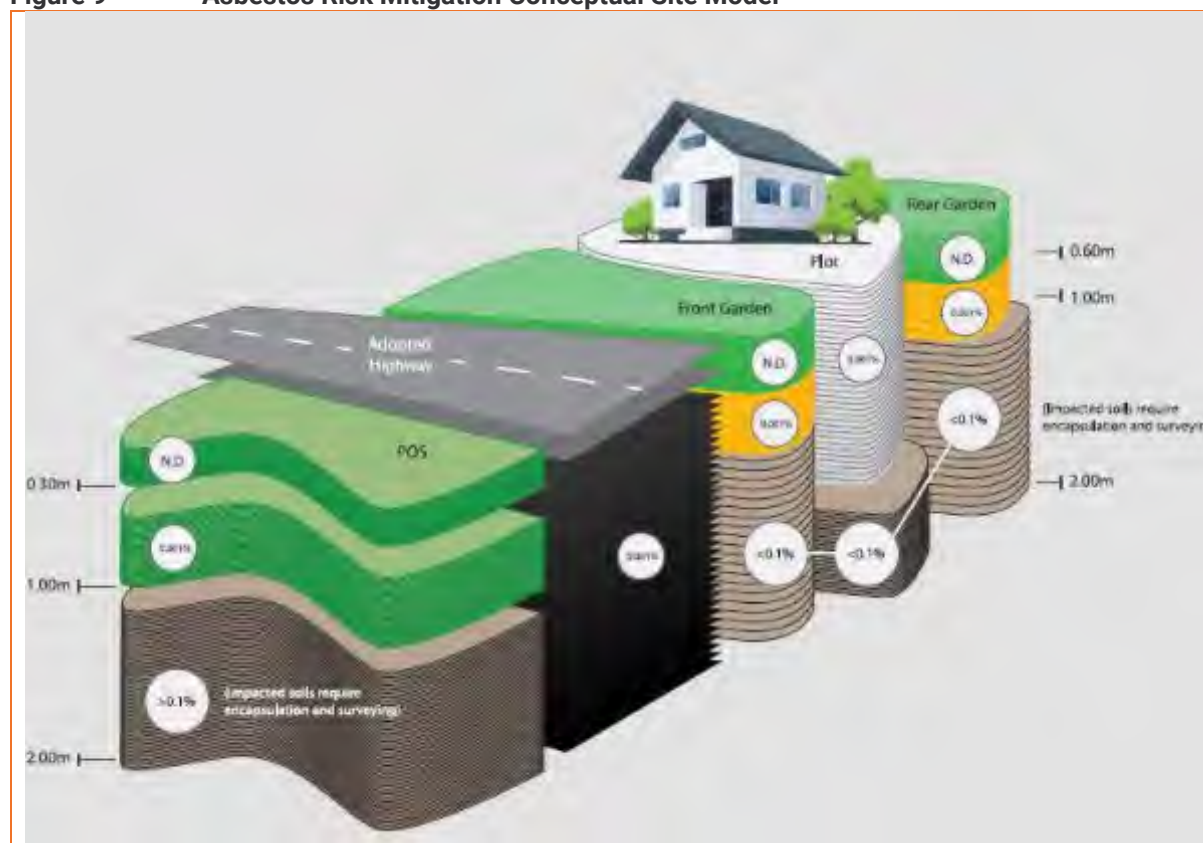
**Figure 9 Asbestos Risk Mitigation Conceptual Site Model**

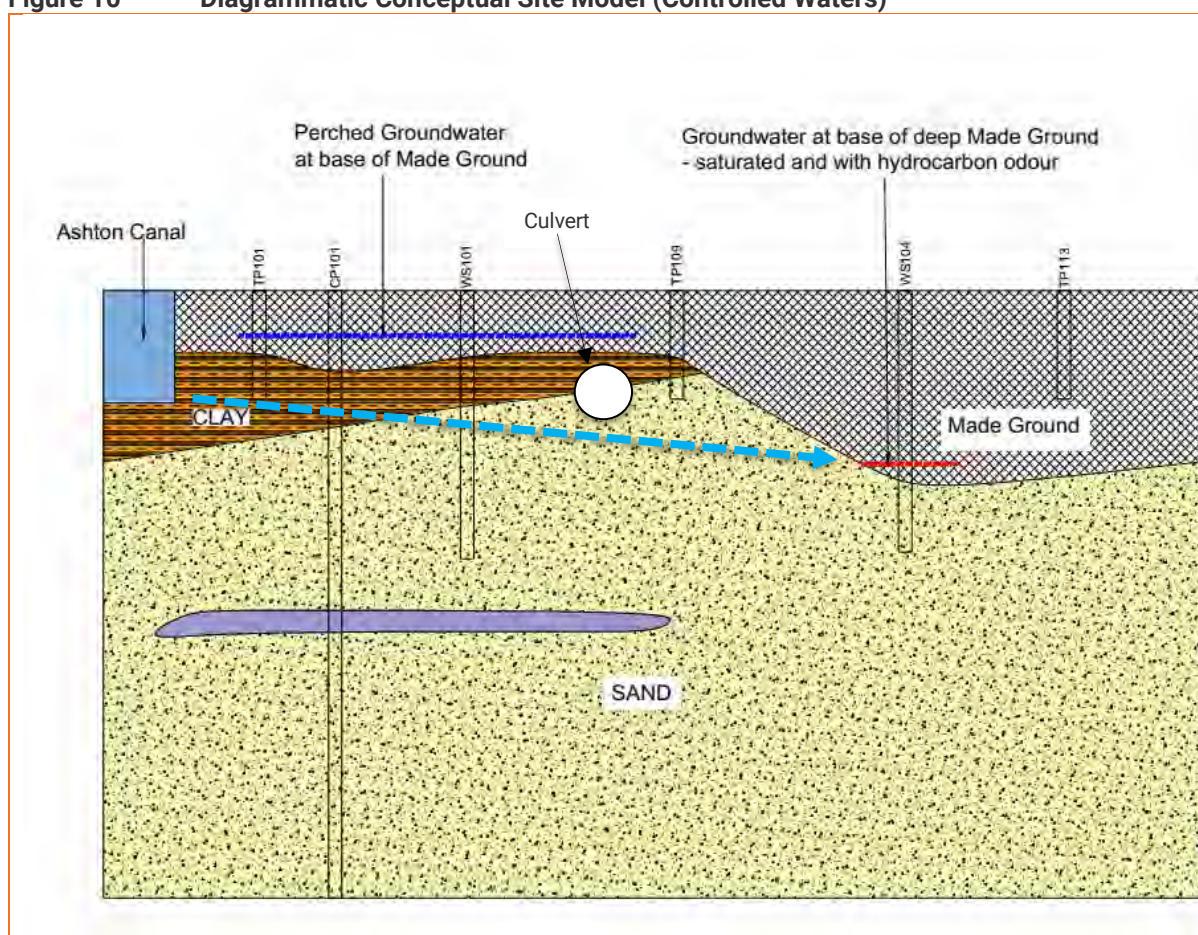
**Figure 10** Diagrammatic Conceptual Site Model (Controlled Waters)

The Tier 2 assessment in line with LCRM (2023) has included a comparison of leachate analysis from samples of the Made Ground and groundwater samples to drinking water standards (DWS) and environmental quality standards (EQS).

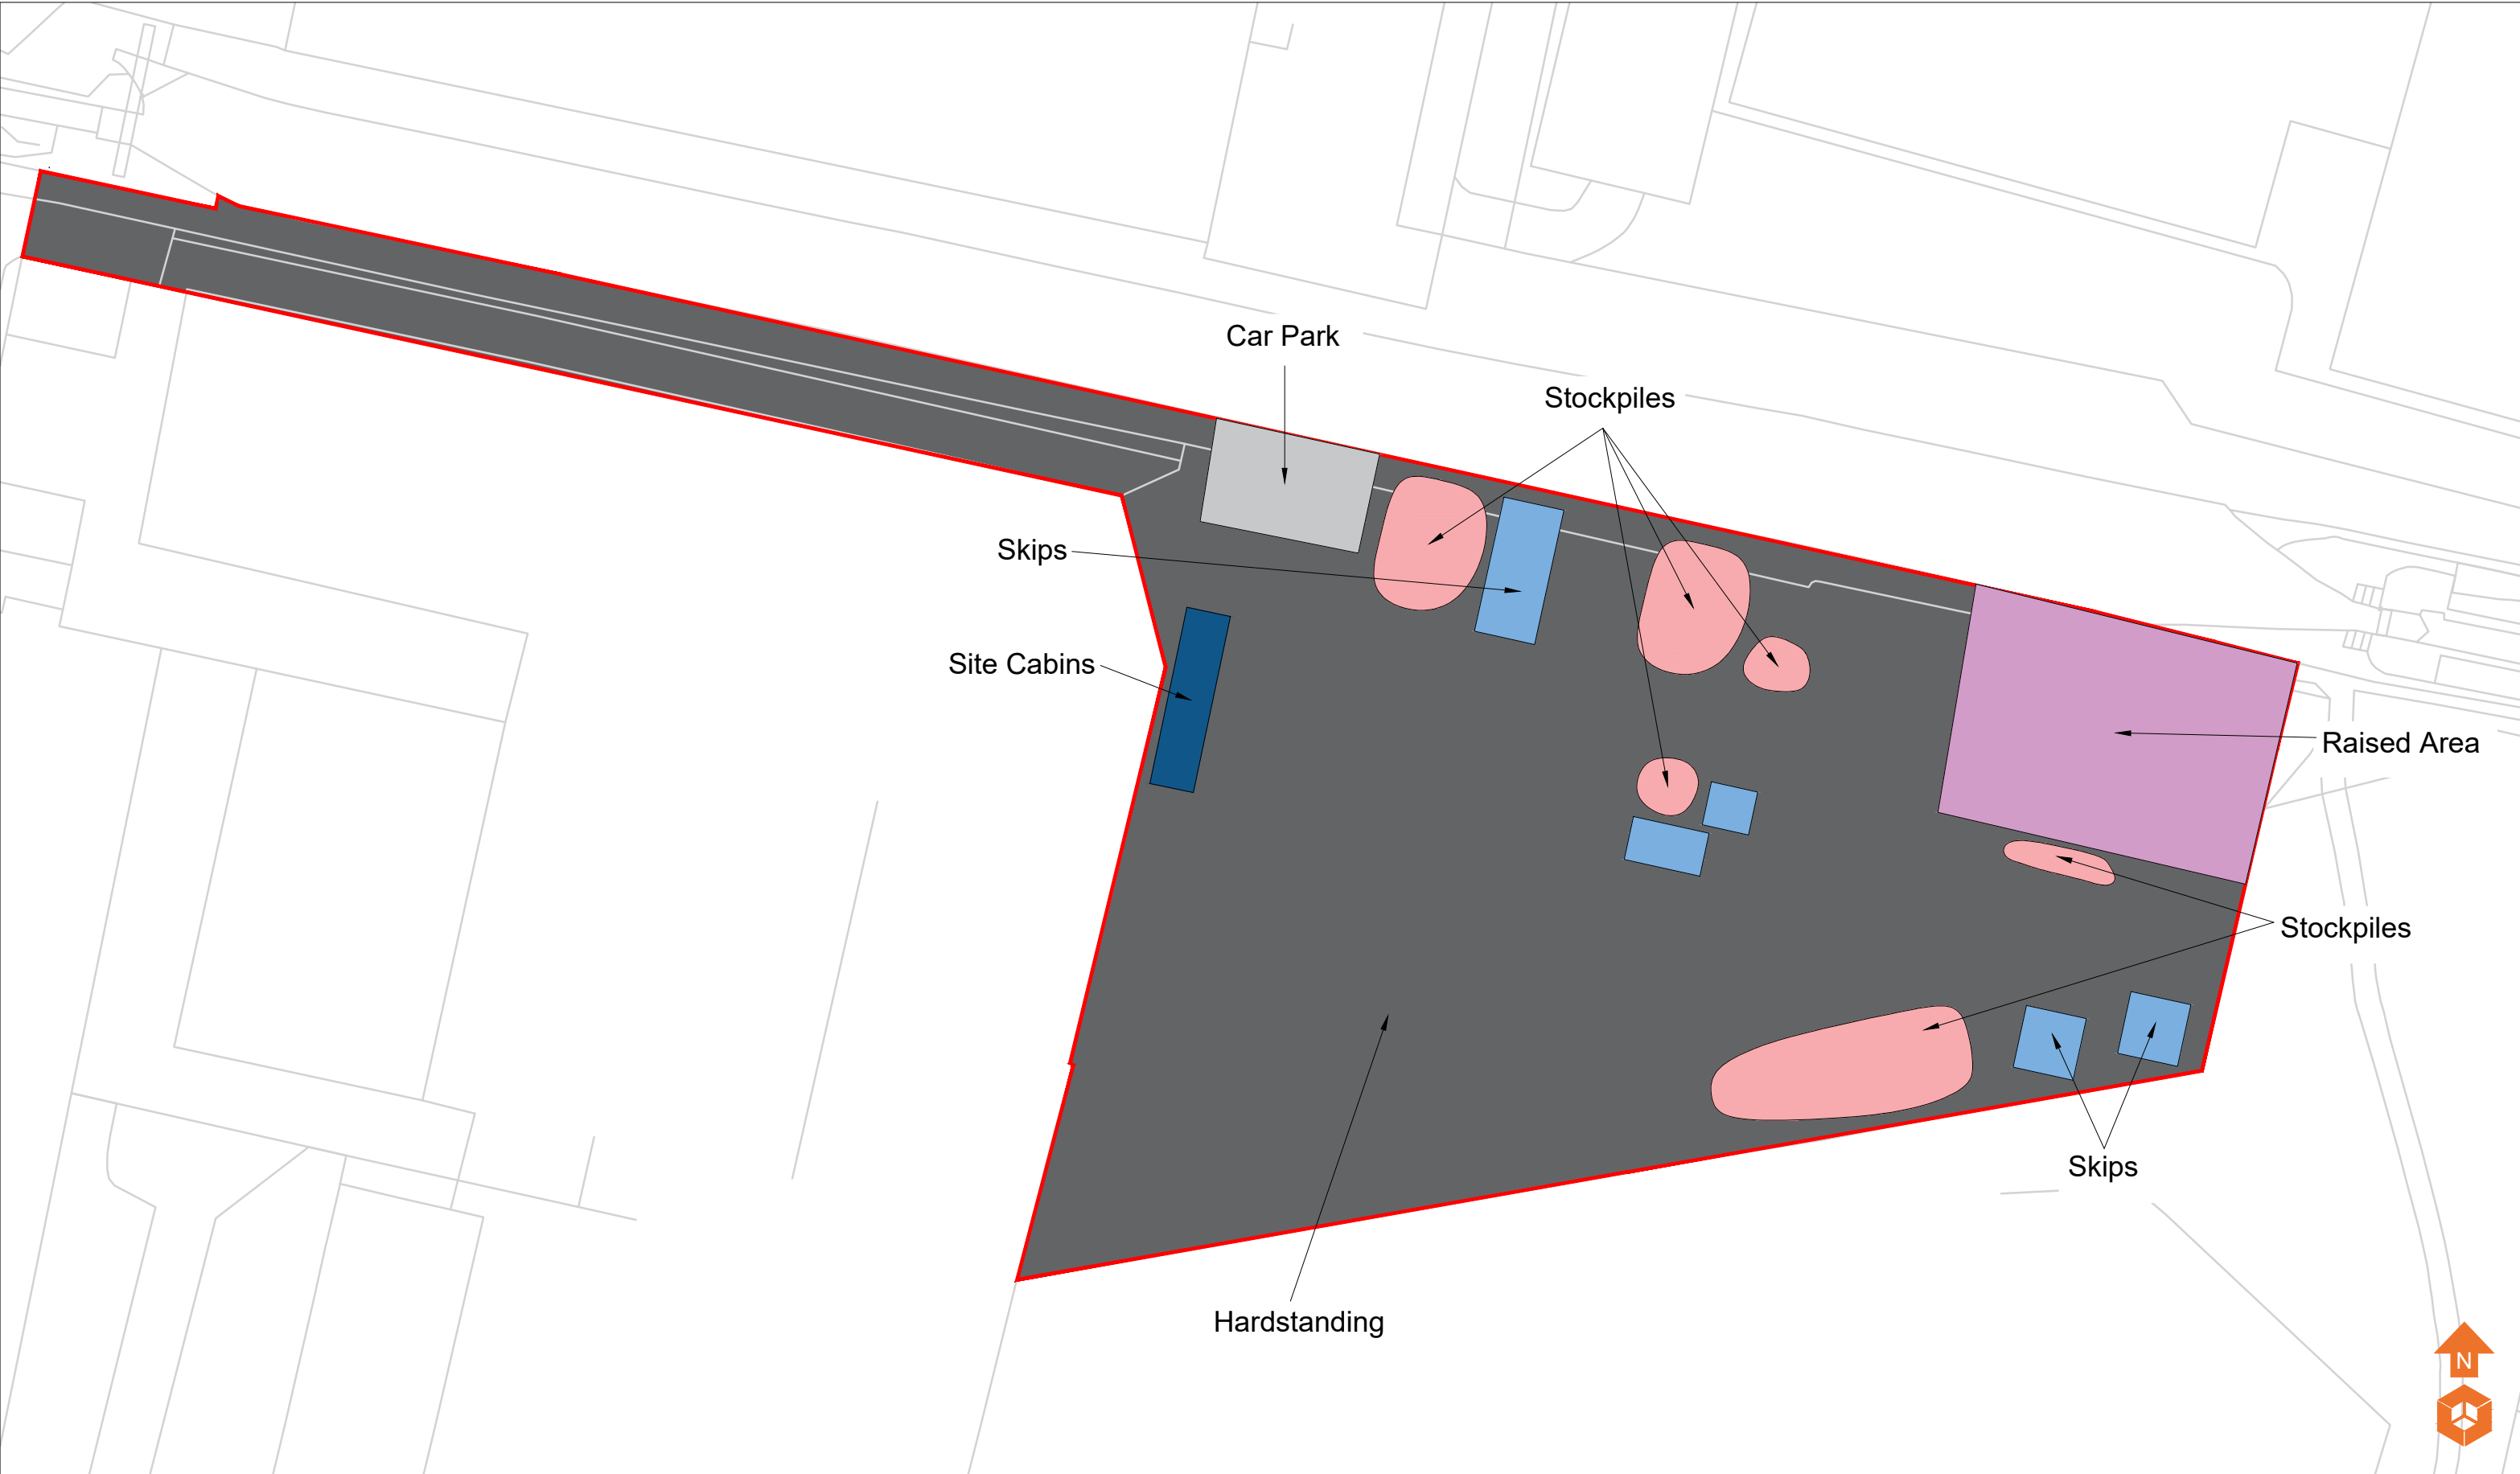
Site Features

- Hard Standing
- Car Park
- Site Cabins
- Stockpiles
- Skips
- Raised Area

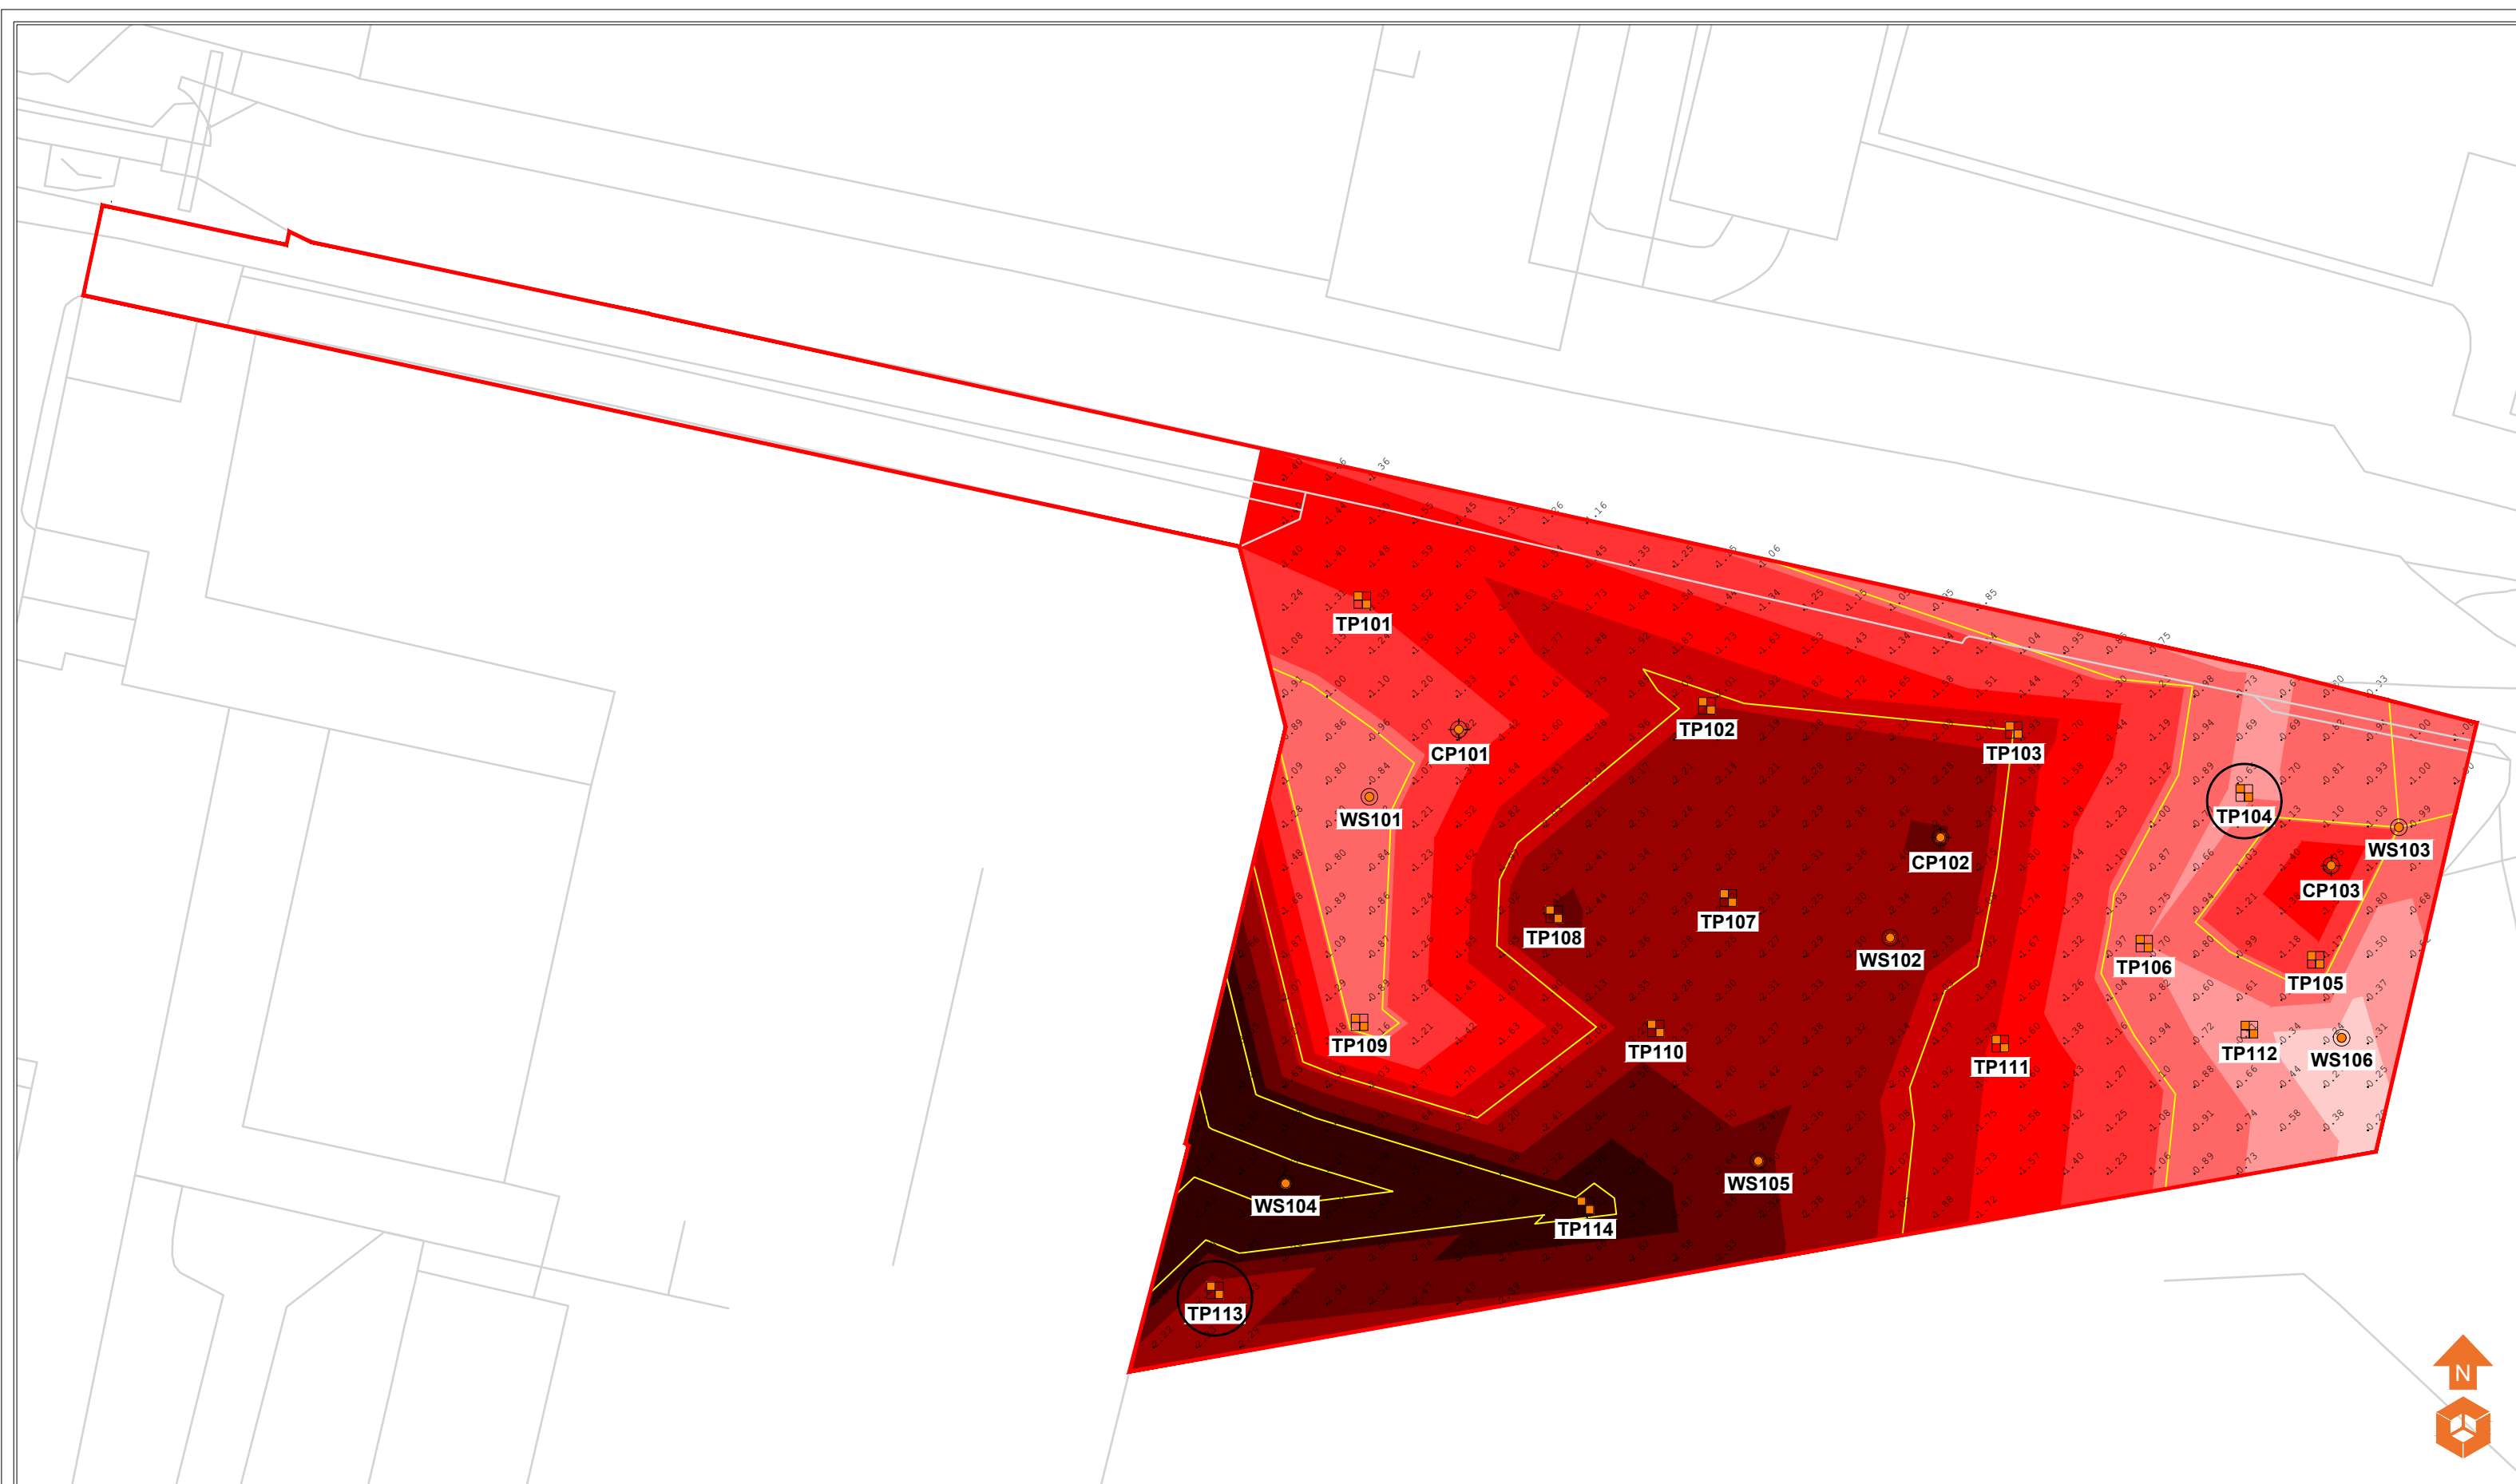
Location Symbols

- Approximate Window Sample Probehole Location (E3P Location March 2024)
- Approximate Trial Pit Location (E3P Location March 2024)
- Approximate Cable Percussive Borehole Location (E3P Location March 2024)
- Base of Made Ground Not Encountered
