# Phase I and II Geoenvironmental Site Assessment

Site: Crabtree Lane, Manchester

Reference: 17-548-R1

Date: April 24

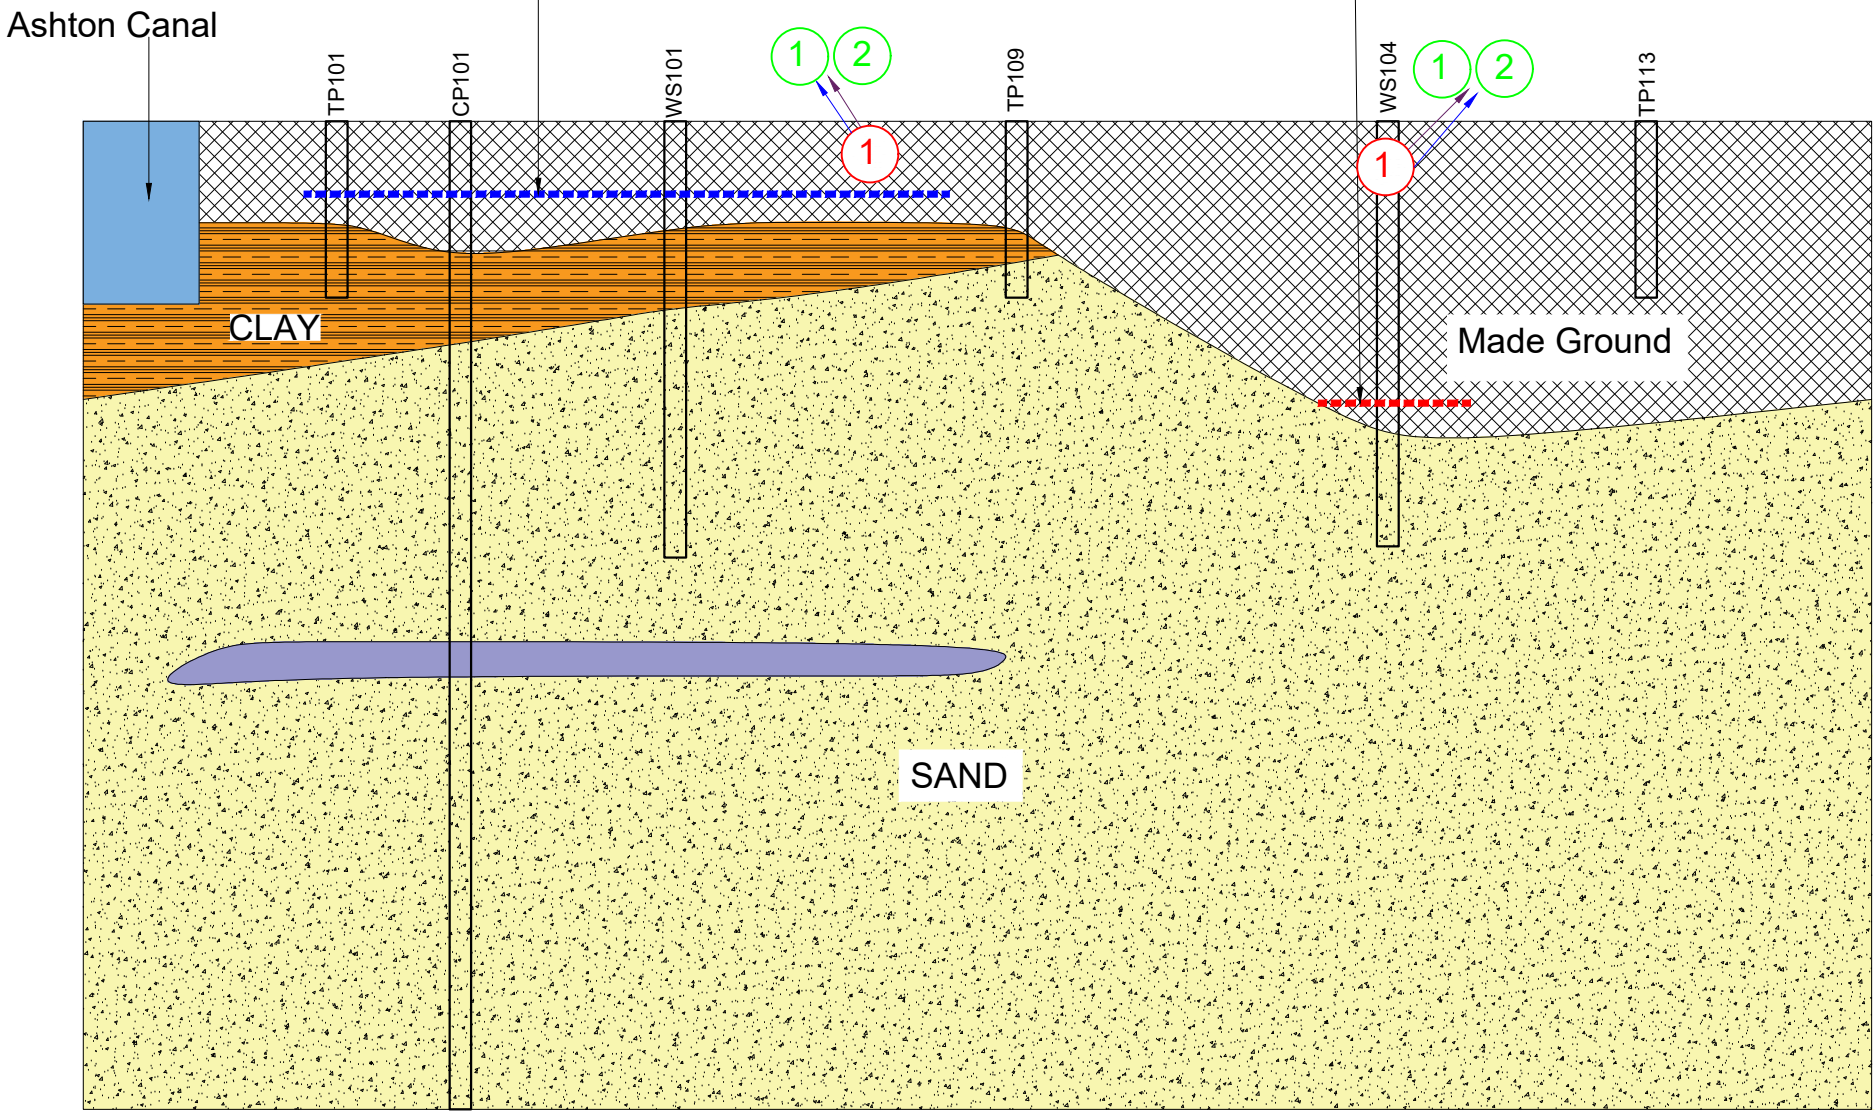
Groundwater at base of deep Made Ground  
- saturated and with hydrocarbon odour

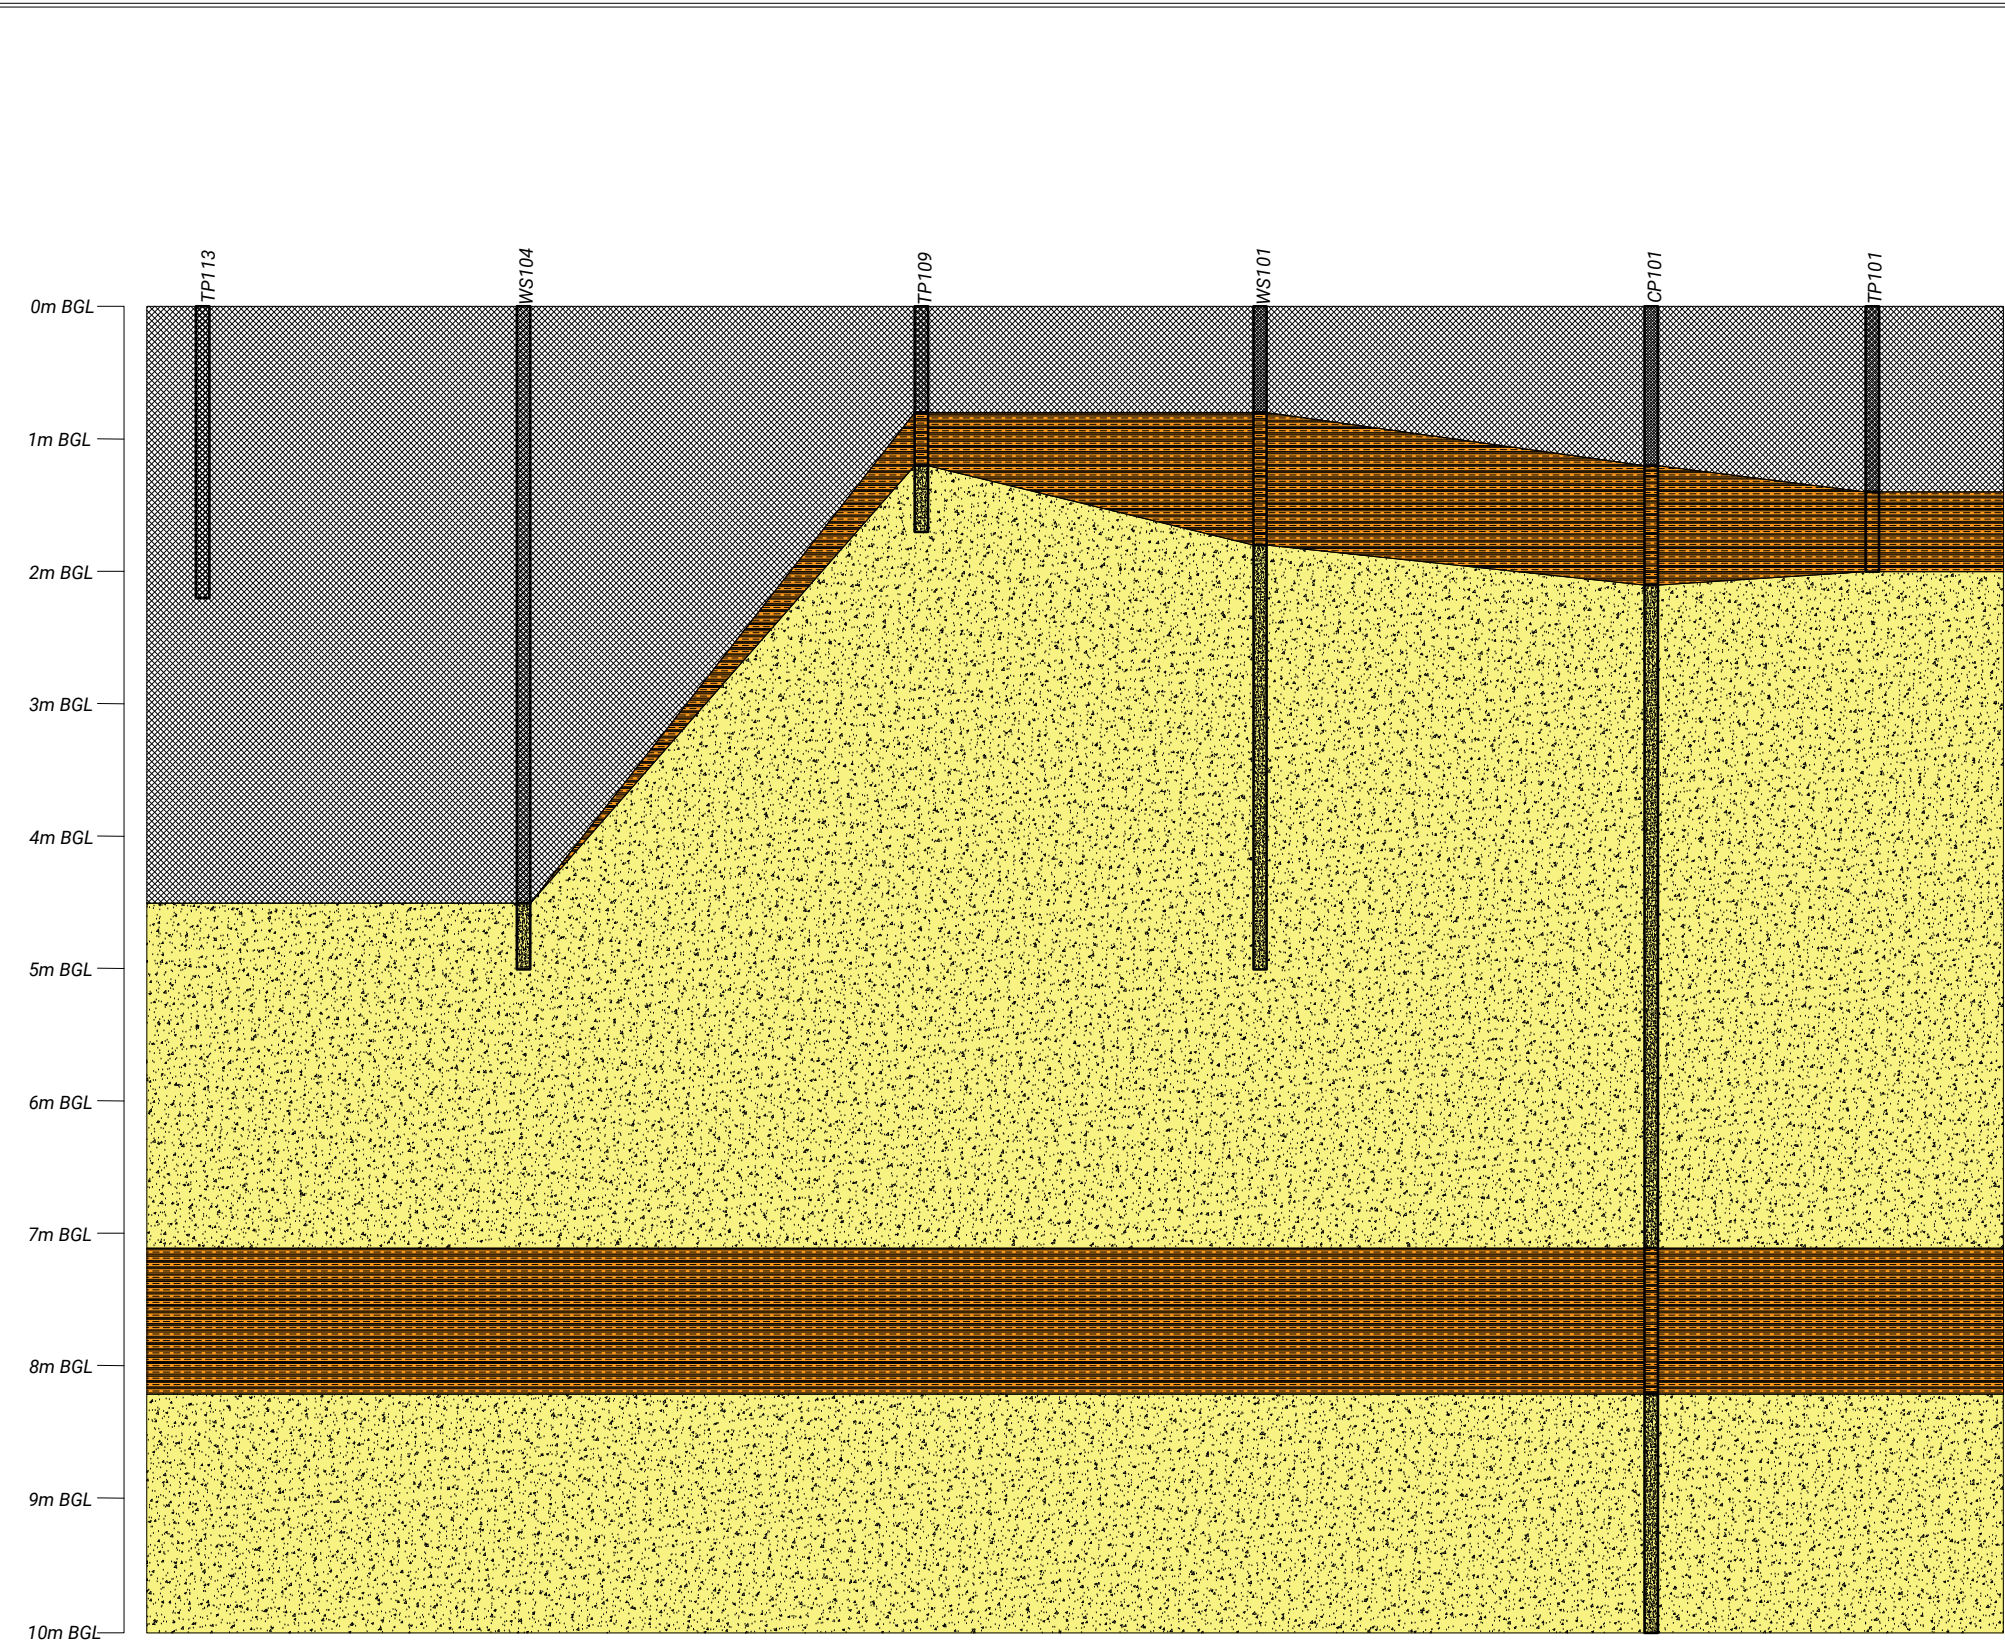
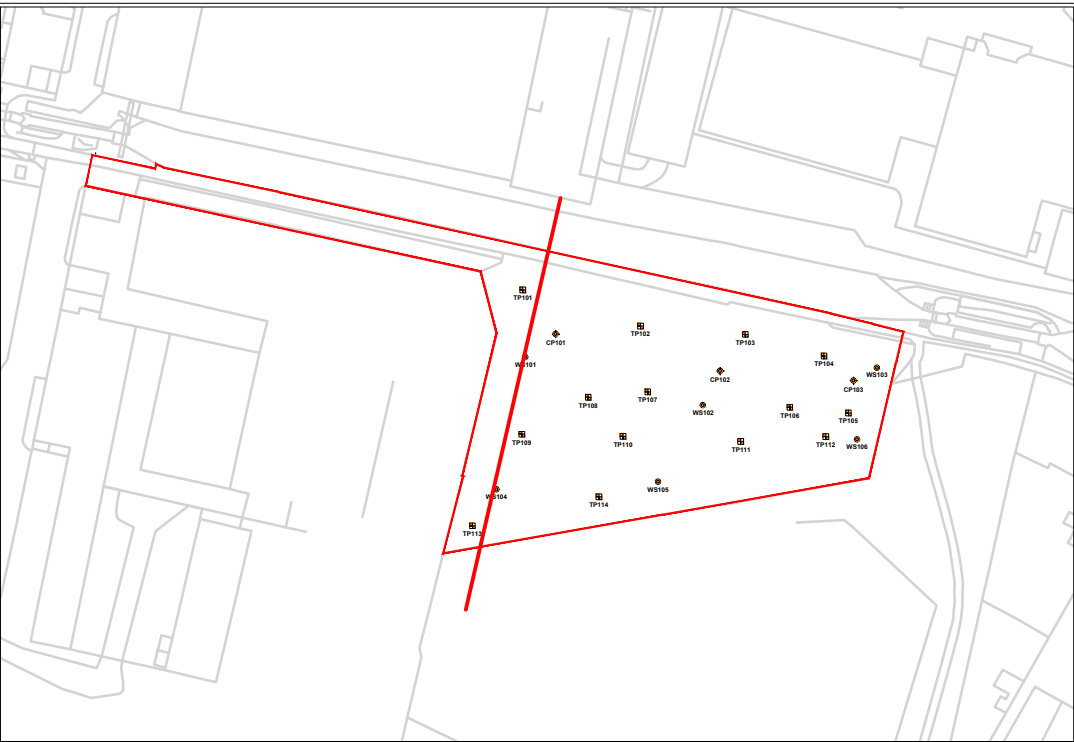
| <div>Geology Key</div> <div><div></div> Made Ground</div> <div><div></div> Clay</div> <div><div></div> Sand</div> | | | | | | | Notes: | | Client:<br><br>Connell Brothers | | Job No:<br><br>17-548 | Date:<br><br>22.04.2024 | <div></div> <div>Environmental Engineering Partnership Ltd<br/>Taylor Road, Trafford Park<br/>Urmston, Manchester, M41 7JQ<br/>Tel: 0161 707 9612<br/>E-mail: info@e3p.co.uk<br/>Website: www.e3p.co.uk</div> | |

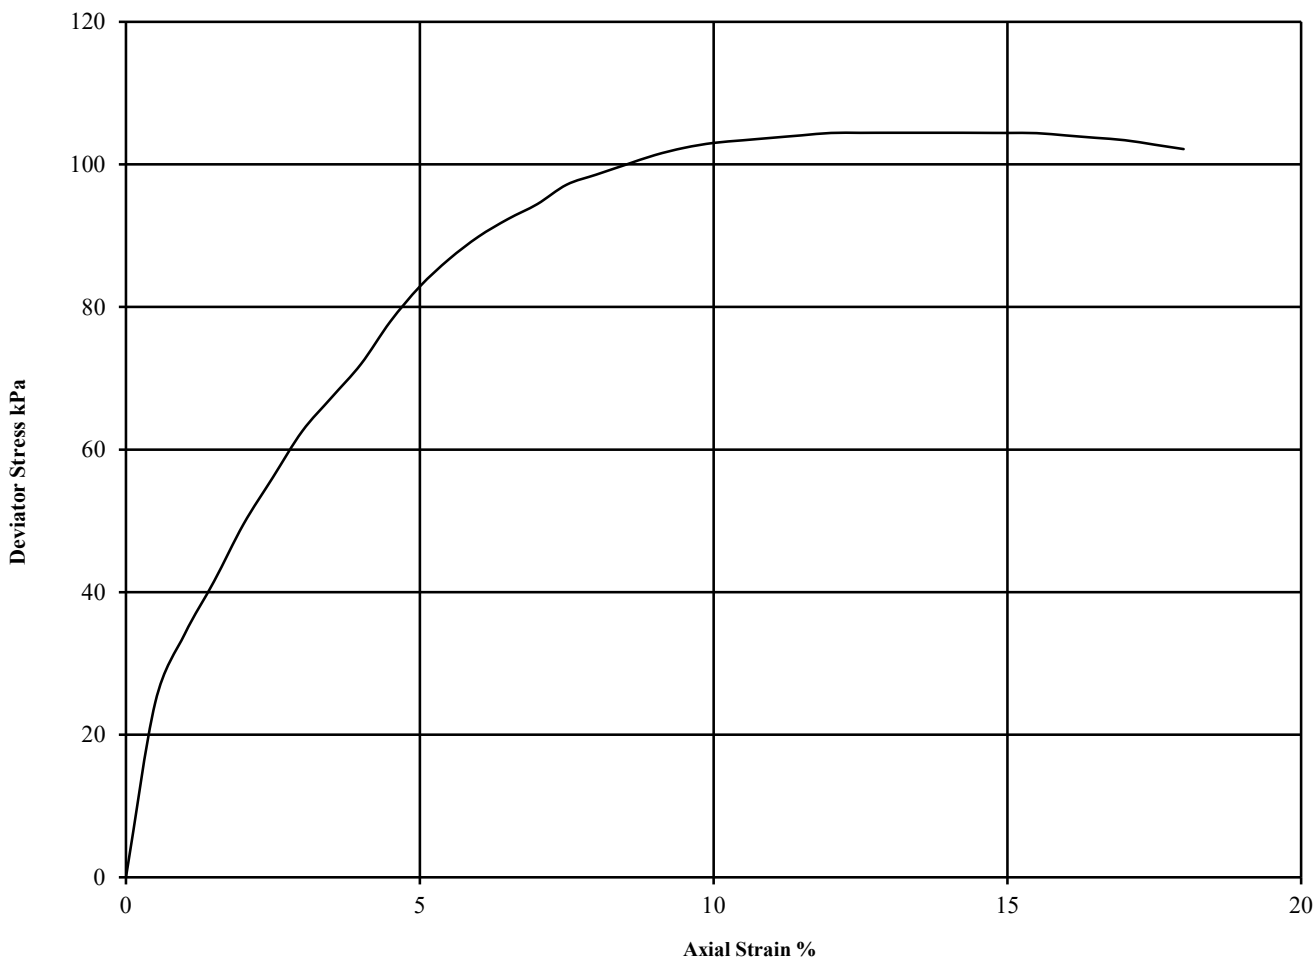
Sample Number: WS106 Base Depth (m): 1.00

| Diameter (mm): | | 80 | Height (mm): | | 160 | Test: | UU Single Stage | | Remarks: |
| Specimen | Moisture Content (%) | Bulk Density (Mg/m <sup>3</sup> ) | Dry Density (Mg/m <sup>3</sup> ) | Cell Pressure (kPa) | Corr. Max. Deviator Stress (kPa) | Shear Strength Cu (kPa) | Failure Strain (%) | Mode of Failure | Undisturbed Sample<br>Sample taken from top of tube<br>Rate of strain = 2 %/min<br>Latex Membrane used 0.2 mm thick,<br>Correction applied 0.43<br>See summary of soil descriptions |

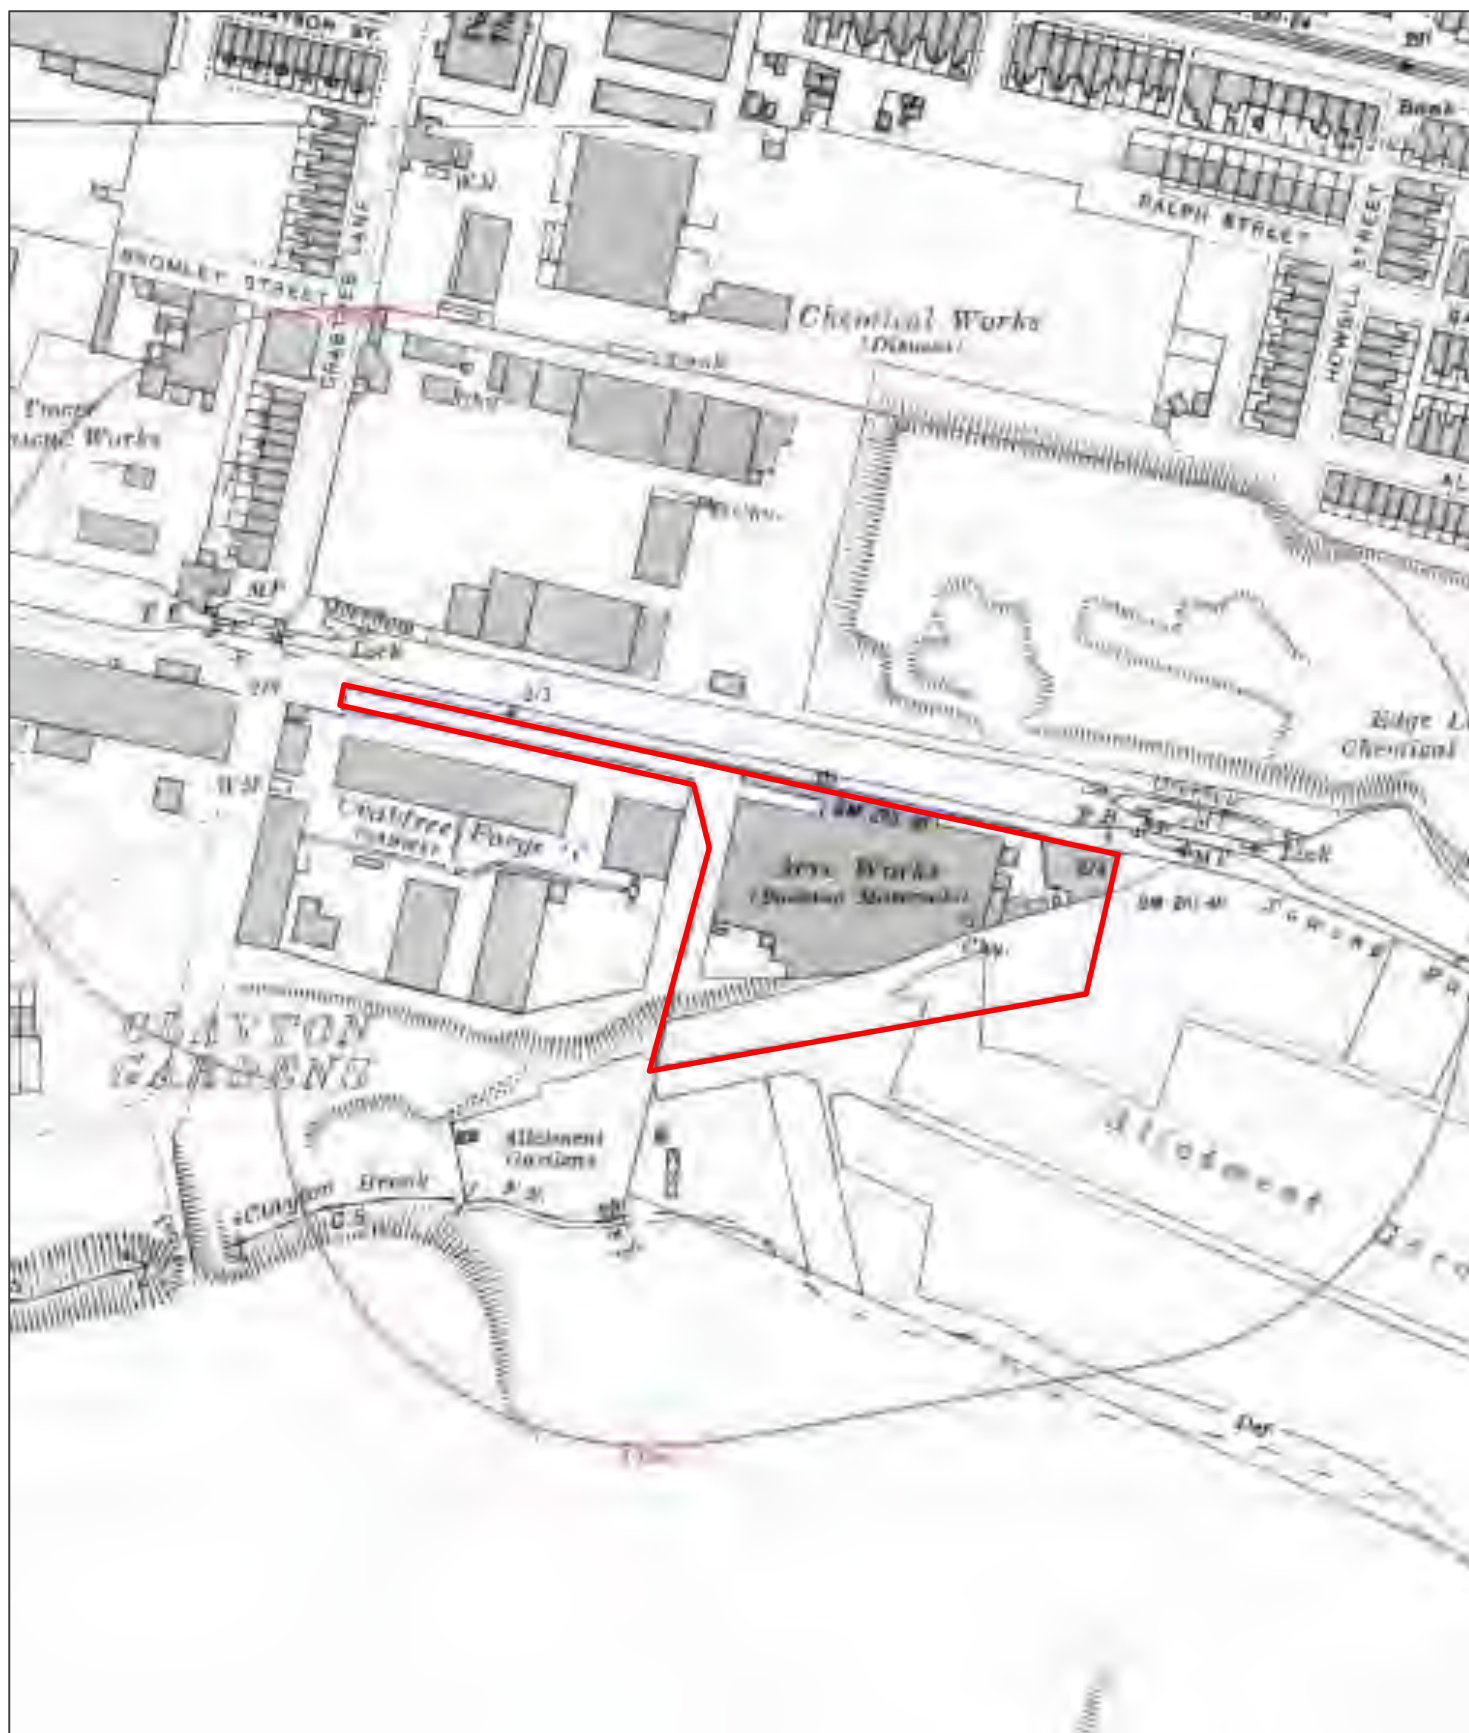
FIGURE: 4.1

| Pre-WWII | 1932-1933 | 1:2,500 | <b>FIGURE 4.1:</b> The works on Site is now labelled 'Acre Works (Packing Materials)'. The structures in the south of the Site have also been cleared. Edge Lane Chemical Works is now present adjacent to the Site across the canal to the north. |

Historical OS Mapping – 1932 - 1933

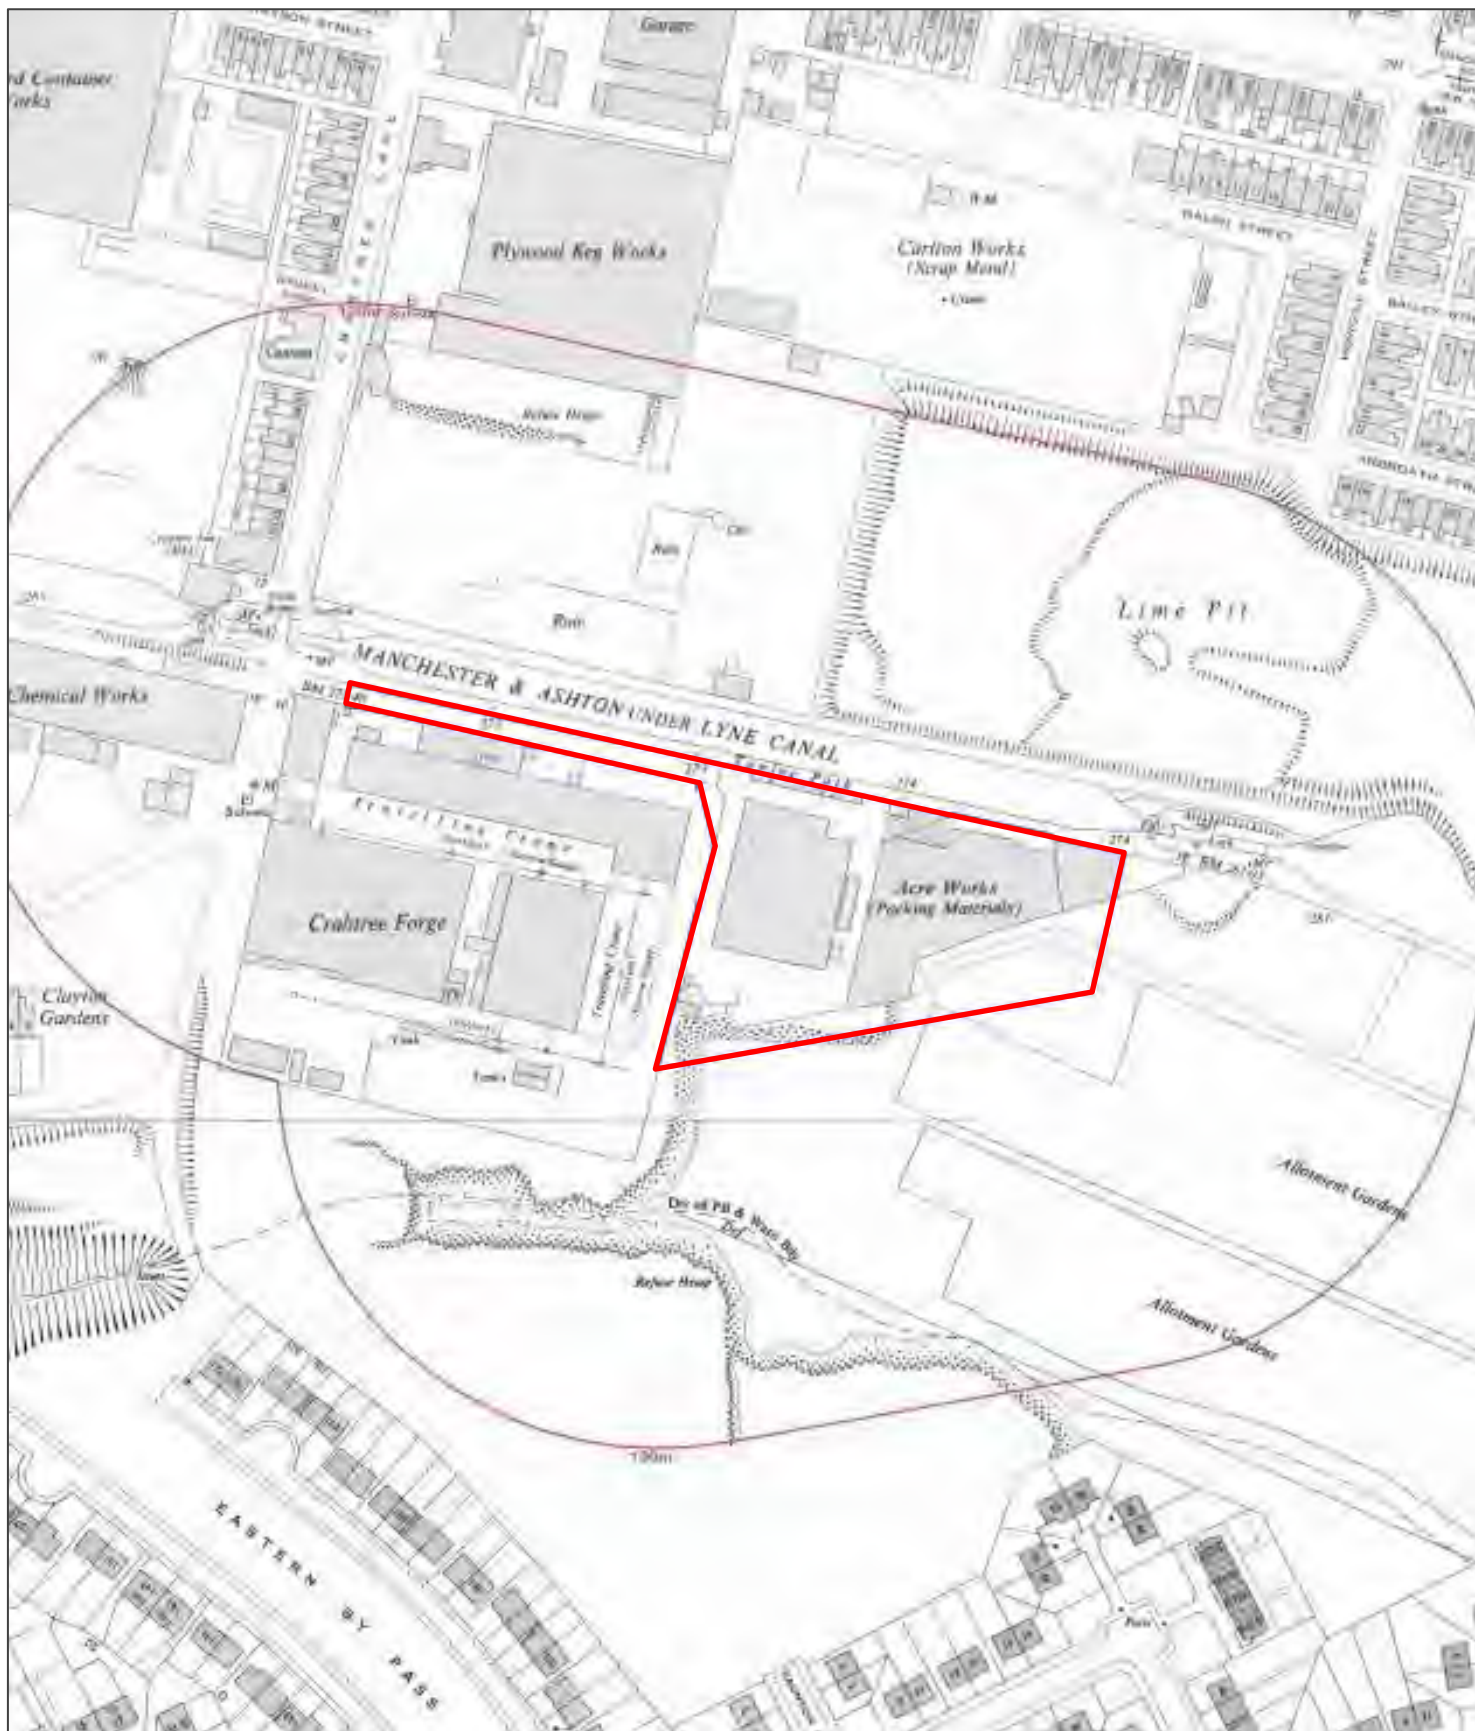
FIGURE: 4.2

| Post-WWII | 1949-1950 | 1:1,250 | <b>FIGURE 4.2:</b> The large structure on Site is no longer present, and two smaller structures are in its place.<br>Two ruins are labelled approximately 30m north of the Site on the adjacent side of the canal. |

Historical OS Mapping - 1949

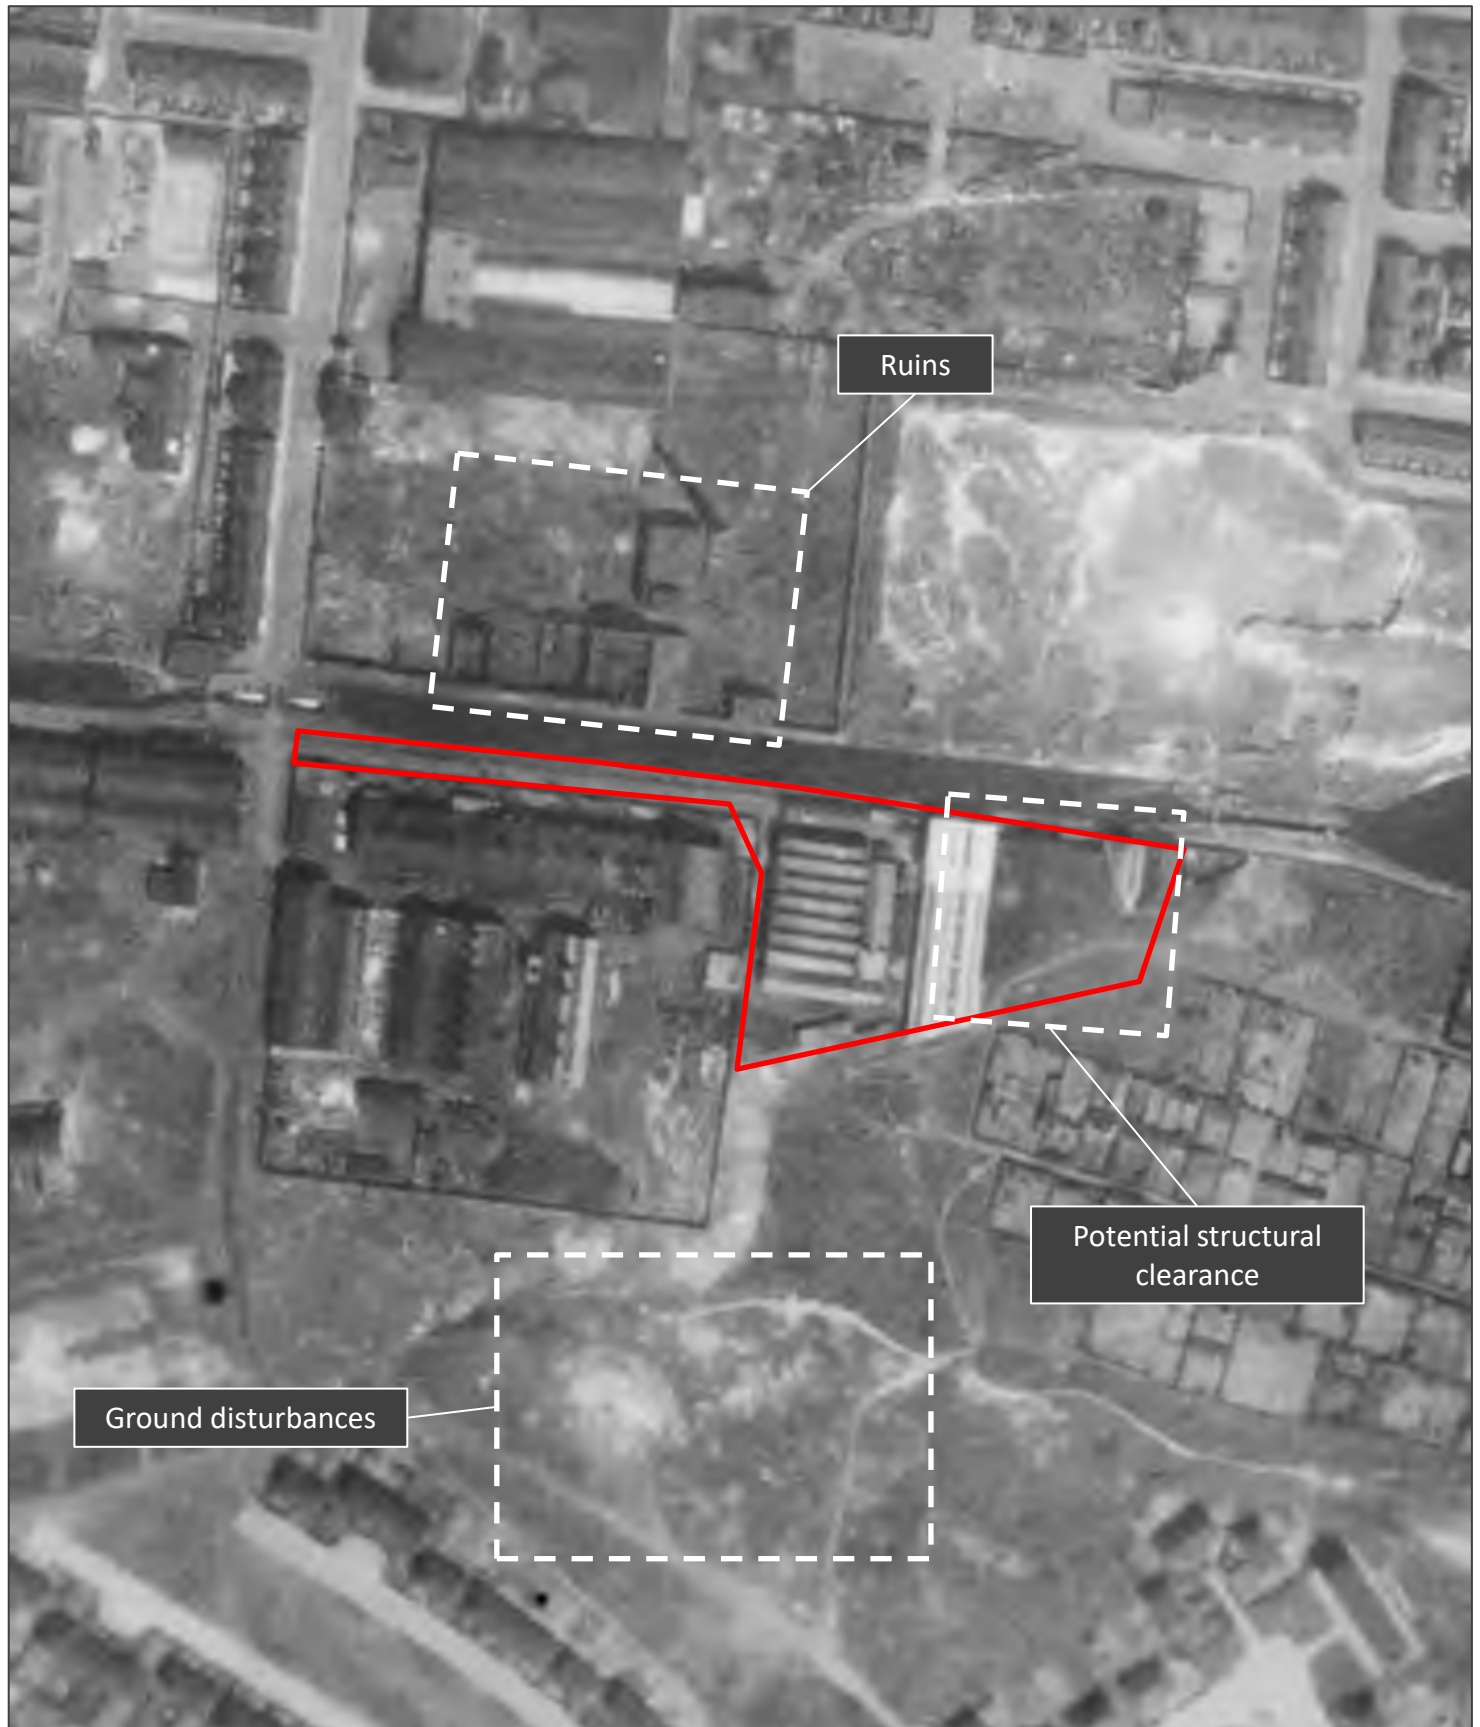
FIGURE: 5

| Period | Photo Date | Review |
|---|---|---|
| Post-WWII | 16 <sup>th</sup> May 1948 | <p><b>FIGURE 5:</b> This vertical image displays the Site approximately three years after the end of WWII.</p> <p>The structures on Site do not match the layout displayed in pre-WWII OS mapping; however, the westerly structure does not show any immediately obvious evidence of bomb damage such as light-coloured roofing, indicating repairs. Such evidence is visible to the structure in the centre of the Site, however.</p> <p>An area of open ground is present in the east of the Site; this is possibly an area of structural clearance given the change in Site composition between this image and pre-WWII OS mapping.</p> <p>Ruins are visible approximately 30m north of the Site, while the Crabtree Foundry directly west of the Site appears to have survived the war largely externally structurally intact, although a small area of clearance appears to be visible in the south of the foundry.</p> <p>An area of ground disturbance is visible approximately 90m south of the Site. Whilst it is not possible to confirm their exact cause, these are potentially indicative of bomb damage.</p> |

Historical Aerial Photography – 16<sup>th</sup> May 1948

- As briefly discussed above, analysis of post-WWII aerial photography indicates that the Site experienced significant bomb damage during WWII; this is somewhat corroborative of the bomb damage mapping, although the extent of the damage differs. The single large pre-WWII industrial structure is no longer present, with two smaller structures and an area of open ground present in its place. The structure in the centre of the Site in particular looks newly built in the photography; this change in the Site's composition indicates that the original pre-WWII structure sustained substantial bomb damage during WWII. The structure in the east of the Site does not show any immediately obvious signs of bomb damage, however, is likely also newly built. It is not possible to confirm the exact date that the composition of the Site changed; however, given the recorded bomb strike on Site, it is thought likely this occurred as a response to bomb damage during WWII. Further damage is visible 30m north of the Site, where multiple structures have been severely damaged, leaving ruins in their place.

- One 'fire bomb' is recorded within the Site boundary.
- A further four 'fire bombs' are recorded within an approximate 500m radius of the Site.
- The large industrial structure on site has been hatched red, indicating that it experienced moderate damage. This appears to have been cleared at some point during the war as indicated by post-WWII aerial photography (see **FIGURE 5**).

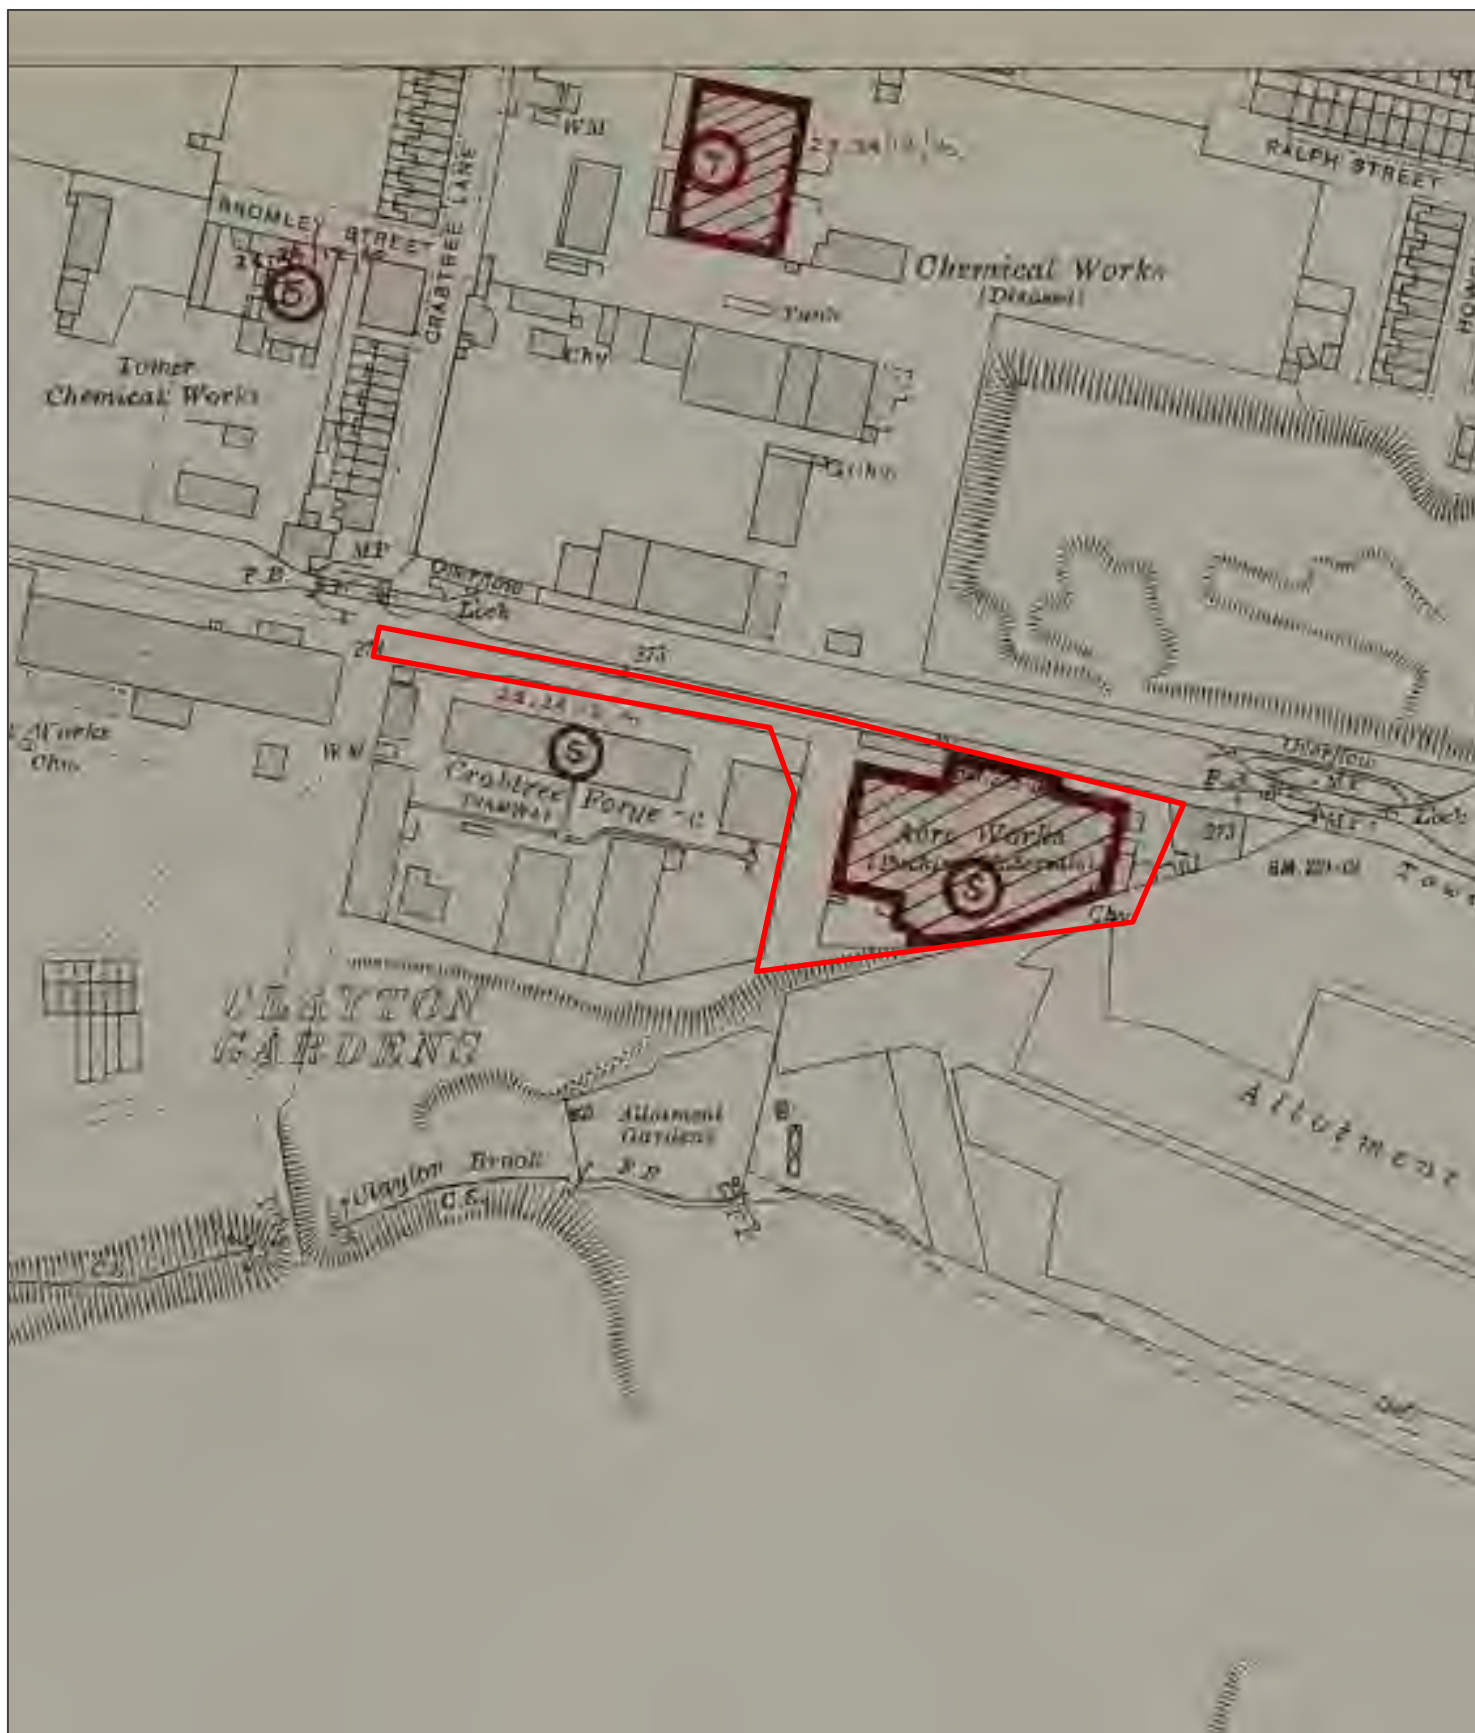
FIGURE: 6

Manchester Bomb Plot & Damage Map: 1940 - 1941

- Indeed, one 'fire bomb' is recorded within the Site boundary on a bomb plot and damage map for Manchester, with a further four within an approximate 500m radius. The large industrial structure on Site is hatched in red in this source, indicating that it experienced moderate bomb damage during WWII. At some point during WWII, however, this building appears to have been cleared, as evidenced by post-WWII aerial photography dated 1948. It is unlikely that the single fire bomb recorded would have caused significant enough damage for the structure to be cleared. It must be noted that the consulted record sets are not comprehensive, and it is possible that additional, unrecorded, bomb strikes occurred in the vicinity to which this damage could be attributed. This is evidenced by the ruins visible approximately 30m north of the Site in post-WWII OS mapping and aerial photography; this significant damage cannot be attributed to any recorded bomb strikes.

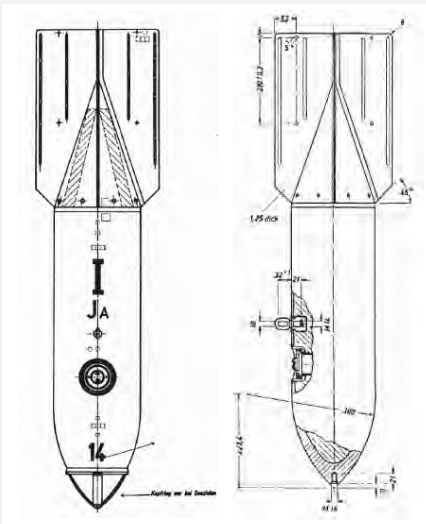
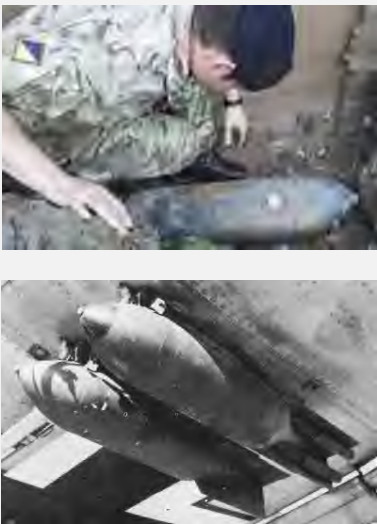
SC 50

**Bomb Weight:** 40-54kg (110-119lb)  
**Explosive Weight:** 25kg (55lb)  
**Filling:** TNT, Amatol or Trialen  
**Charge/Weight Ratio:** 46%  
**Fuse Type:** Electrical impact fuse or mechanical delayed action fuse  
**Body Dimensions:** 1,100mm length x 200mm diameter  
**Appearance:** Bomb body and tail painted grey/green with a yellow stripe on the tail unit. Steel construction.  
**Variants:** 8 x variants. Additional fittings: Kopfring nose for limited penetration and Stabbo nose for dive-bombing.

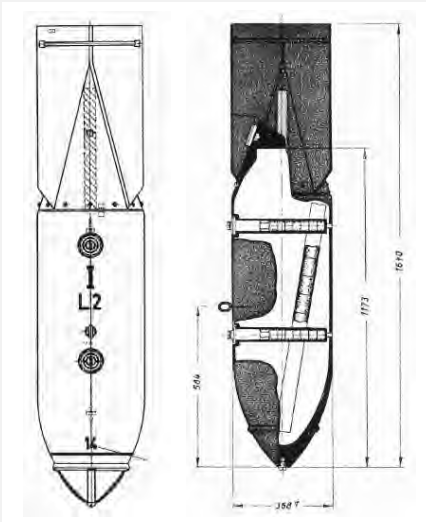
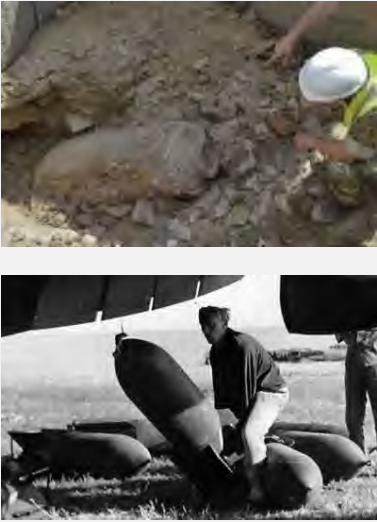
SC 250

**Bomb Weight:** 245-256kg (540-564lb)  
**Explosive Weight:** 125-130kg (276-287lb)  
**Filling:** TNT, Amatol and Trialen mix  
**Charge/Weight Ratio:** 44%  
**Fuse Type:** 1 or 2 electrical impact fuse(s) or mechanical delayed action fuse(s)  
**Body Dimensions:** 1,173mm length x 368mm diameter  
**Appearance:** Bomb body and tail painted grey/green with a yellow stripe on the tail unit. Steel construction.  
**Variants:** 8 x variants. Kopfring nose for limited penetration. Stabbo nose for dive-bombing.

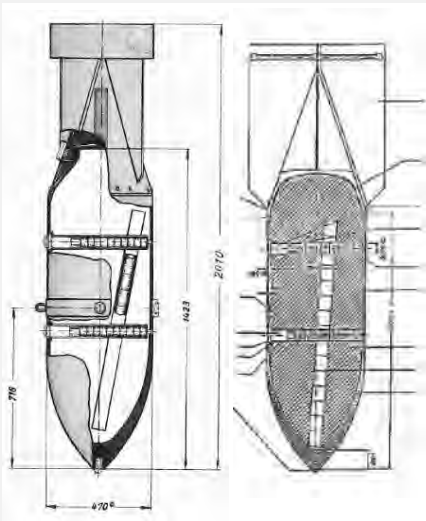
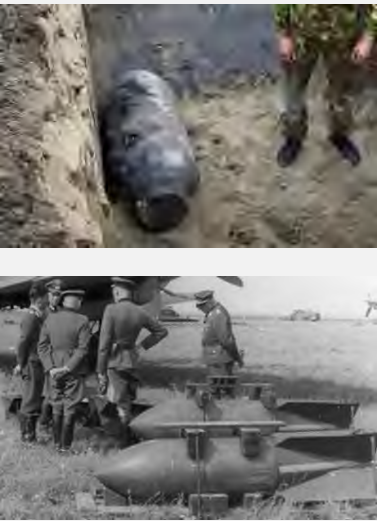
SC 500

**Bomb Weight:** 480-520kg (1,058-1,146lb)  
**Explosive Weight:** 220kg (485lb)  
**Filling:** TNT, Amatol and Trialen mix  
**Charge/Weight Ratio:** 44%  
**Fuse Type:** 2 electrical impact fuses or mechanical delayed action fuses  
**Body Dimensions:** 1,423mm length x 470mm diameter  
**Appearance:** Bomb body and tail painted grey/green or buff with a yellow stripe on the tail unit. Steel construction.  
**Variants:** 3 x variants. Kopfring nose for limited penetration.

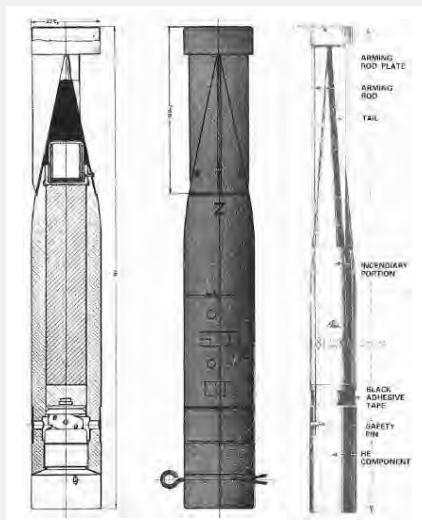
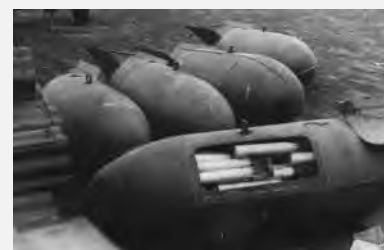
## B-1E Sub-Munition

| <b>Bomb Weight:</b> | 1-1.3kg (2.2-2.87lb) |
| <b>Variants:</b> | Most common variant: B 2EZ (2kg) included a small HE charge |
| <b>Remarks:</b> | Drop containers varied in size. The smallest cluster bomb held 36 x B-1Es and the largest 620 x B-1Es. |

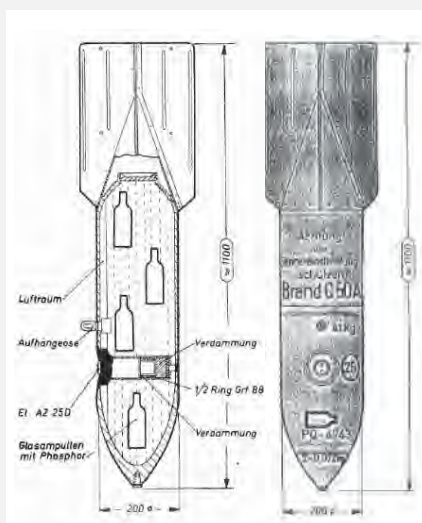
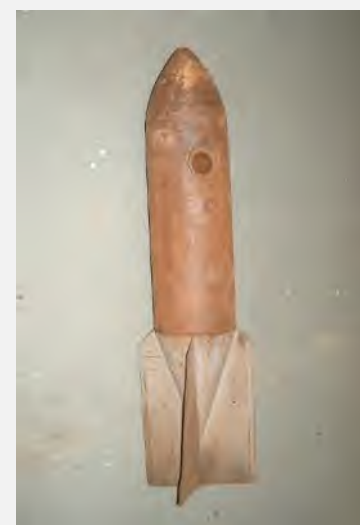
## Brand C50

| <b>Bomb Weight:</b> | 41kg (90.4lb) |
| <b>Appearance:</b> | bomb body and tail painted grey or green with the rear of the bomb painted red and a red band around the centre of the body. |
| <b>Variants:</b> | C 50 B: 77% White Phos fill<br>C 250 A: 87.7% Petroleum, 11.7% Polystyrene, 0.5% White Phos (185kg version) |

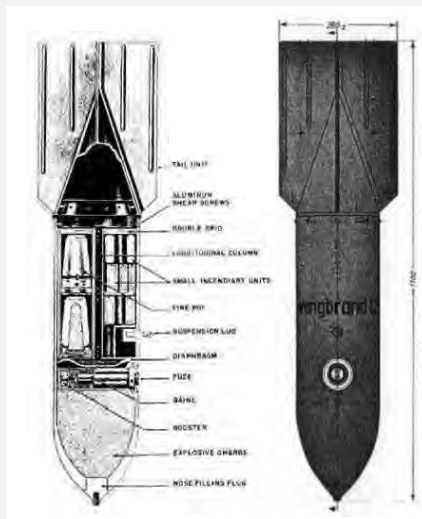
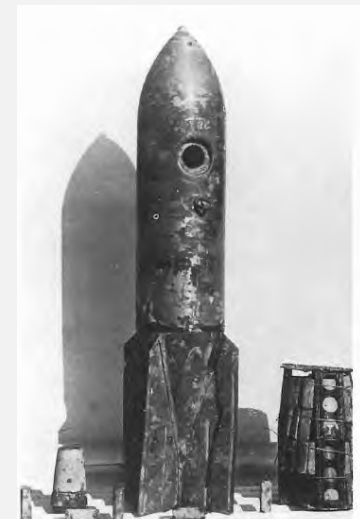
| <b>Appearance:</b> | Bomb body and tail painted grey/green or pale blue with red base plug and red or green incendiary markings. Steel construction. |
| <b>Operation:</b> | A charge blows off the base plate, firing a plume of incendiary mixture 100 yds. Approx 1 second later the HE charge detonates. |

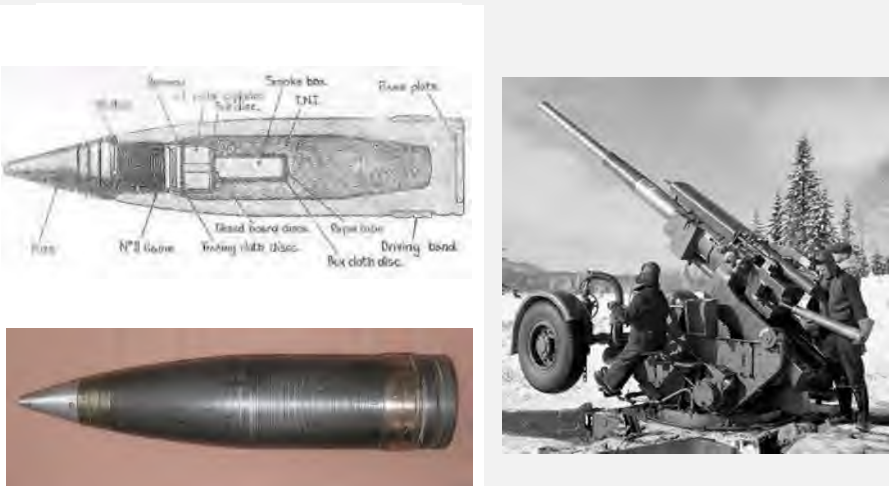
**Ceiling:** 9,000 - 18,000m

**Variants:** HE or shrapnel shells.  
Note, the 4.5" gun was also used in an HAA role throughout the UK.
