# Phase I and II Geoenvironmental Site Assessment

Site: Crabtree Lane, Manchester

Reference: 17-548-R1

Date: April 24

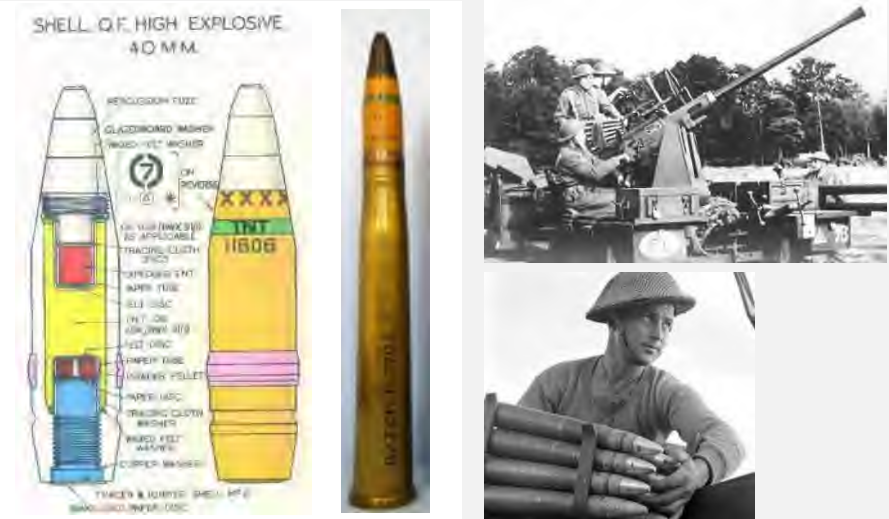
### LAA Battery - 40mm Bofors Shell

**Shell Weight:** 0.84kg

**Ceiling:** 7,000m

**Variants:** HE or AP shells. Both with rear tracer compartment

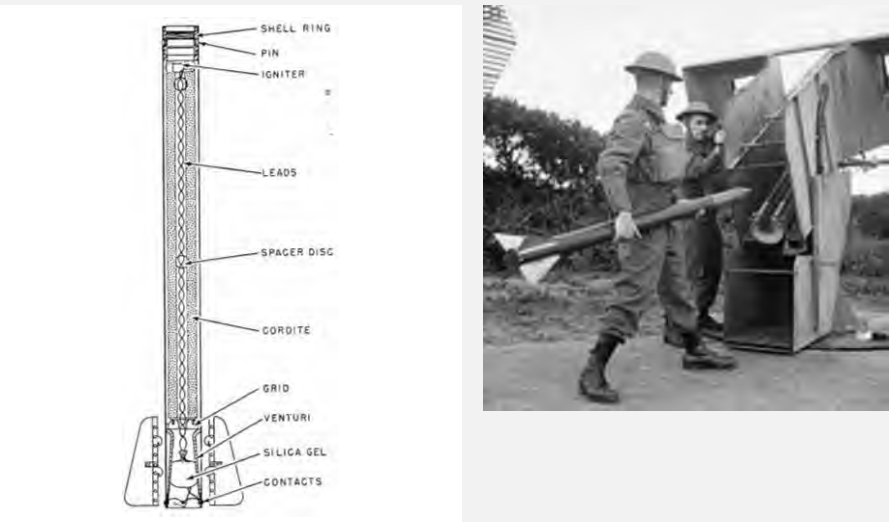
### Z Battery - 3" U.P Rocket

**Rocket Weight:** 24.5kg

**Ceiling:** 6,770m

**Operation:** Fired from single, tandem and (later) 36 x rail launchers (Z Batteries). Limited use throughout the UK.
