## Photographic Strip Out Schedule

52 Princess St, Manchester M1 6JX

February 2025

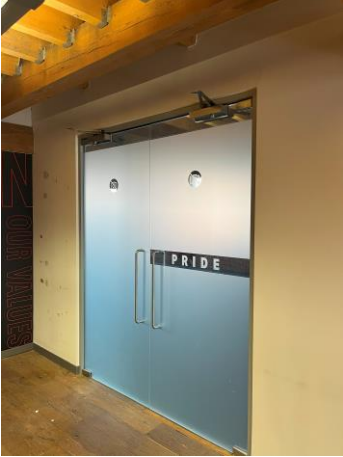
| Photograph Number | Photograph Description | Photograph |
|---|---|---|
| 1. | Glass doors adjacent to reception within existing partition to be removed prior to removal of partition wall. Please see method 5 above for removal methodology. | |

1. Prior to the removal of all partitions. Doors, skirtings, worktops, pegboards and accessories affixed to the existing partitions will be removed and disposed of off-site.
2. Carefully rake out sealants to the head and perimeter of all partition walls using a blunt filler knife.
3. Carefully remove existing plasterboard from the centre of the plasterboard working upwards and downwards from the centre to prevent pry bar damage against the existing flooring and soffit timbers. Clear all waste from site.
4. Carry out works to carefully saw through and remove studs from head and base tracks and clear all waste from site.
5. Using a manual method, carry out works to carefully remove nails from head and base tracks and clear all waste from site.
6. Clear all debris from resultant apertures and leave all apertures in situ unfilled.

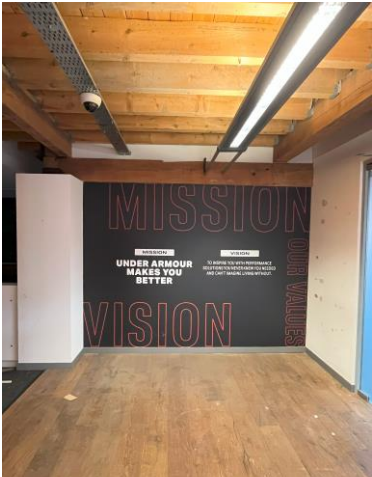
| Photograph Number | Photograph Description | Photograph |
|---|---|---|
| 2. | Stud partition to be removed adjacent to the main reception. Please see method 5 above for removal methodology. | |

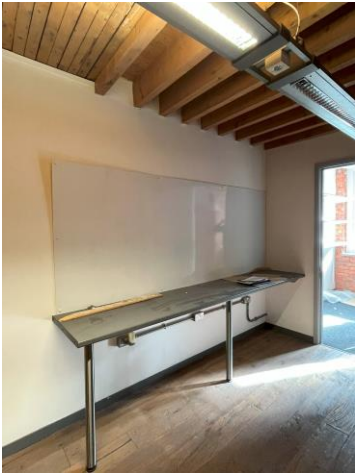
| Photograph Number | Photograph Description | Photograph |
|---|---|---|
| 3. | Stud partition to be removed adjacent to the main reception. Please see method 5 above for removal methodology. | |

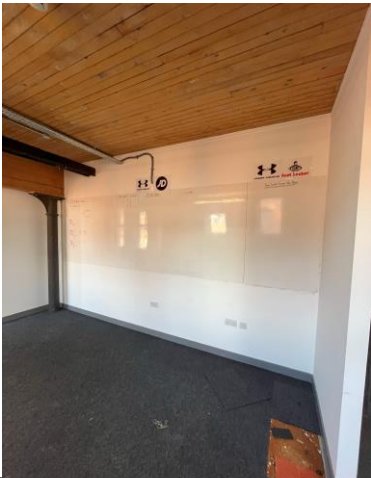
| Photograph Number | Photograph Description | Photograph |
|---|---|---|
| 7. | Stud partition to be removed behind the main reception. Please see method 5 above for removal methodology. | |

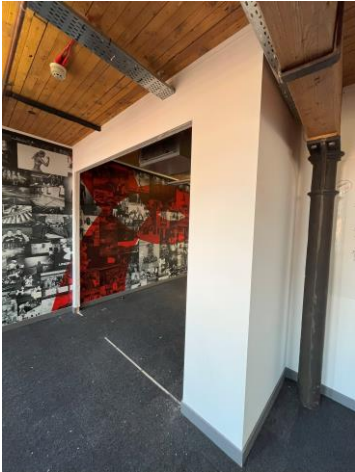
| Photograph Number | Photograph Description | Photograph |
|---|---|---|
| 8. | Stud partition to be removed behind the main reception. Please see method 5 above for removal methodology. | |

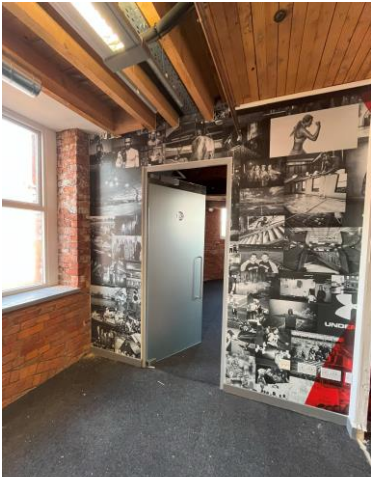
| Photograph Number | Photograph Description | Photograph |
|---|---|---|
| 9. | Stud partition to be removed behind the main reception. Please see method 5 above for removal methodology. | |

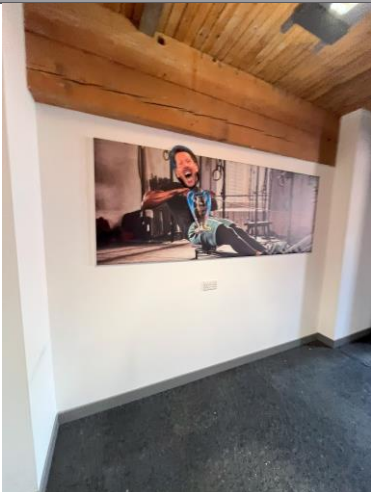
| Photograph Number | Photograph Description | Photograph |
|---|---|---|
| 10. | Stud partition to be removed behind the main reception. Please see method 5 above for removal methodology. | |

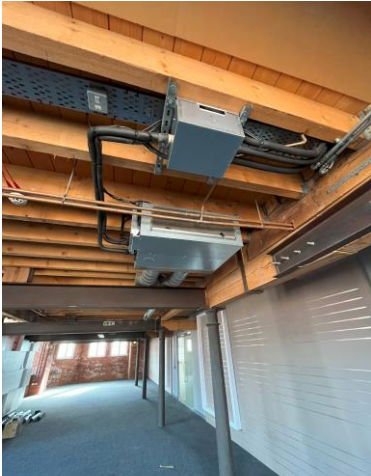
| Photograph Number | Photograph Description | Photograph |
|---|---|---|
| 11. | M&E installations, pipework and cable management are to be removed. Please see method 9 above for removal methodology. | |

1. Isolate building services. Carefully disconnect all flow / return pipework, air handling units, lighting and smoke detection including all cabling and cut back to source.
2. Carefully remove mechanical and electrical equipment, ductwork and cable trays from Unistrut and clear from site.
3. Carefully unscrew and dismantle Unistrut installations in their entirety and clear from site.
4. Carefully unscrew all fixings.
5. Clear all debris from resultant apertures and leave all apertures in situ unfilled.

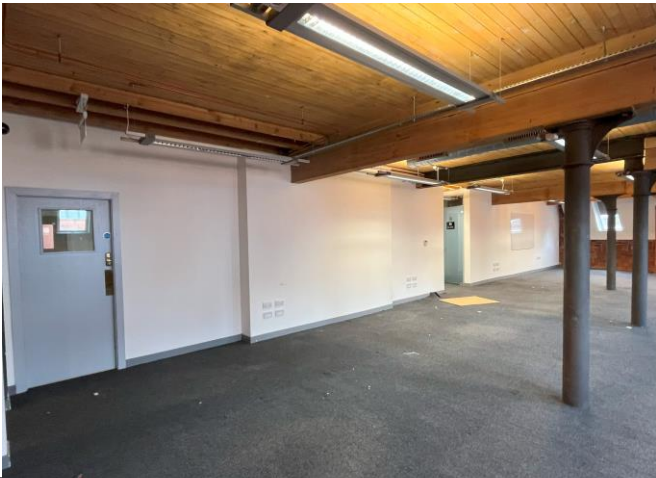
| Photograph Number | Photograph Description | Photograph |
|---|---|---|
| 13. | Stud partition to the main office space. Please see method 5 above for removal methodology. | |

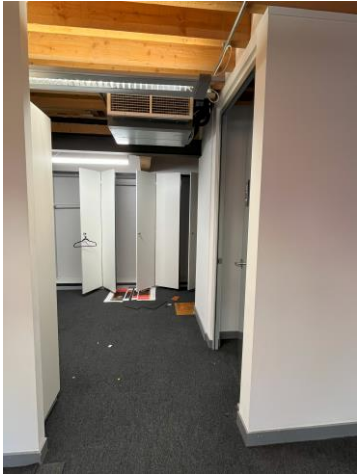
| Photograph Number | Photograph Description | Photograph |
|---|---|---|
| 14. | Stud partition to former storage area. Please see method 5 above for removal methodology. | |

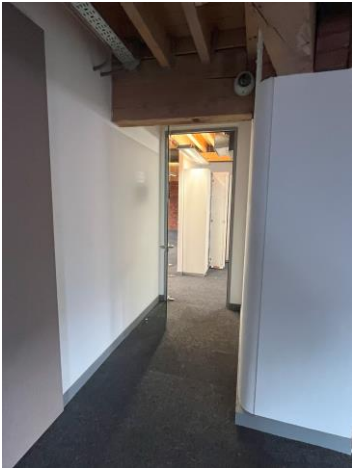
| Photograph Number | Photograph Description | Photograph |
|---|---|---|
| 15. | Stud partition to former storage area. Please see method 5 above for removal methodology. | |

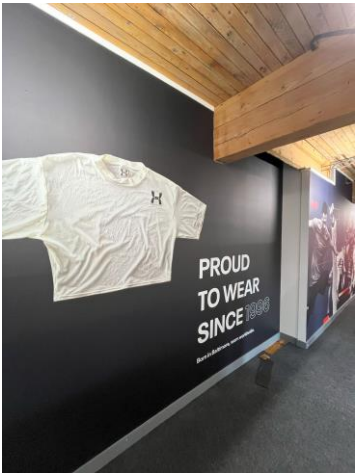
| Photograph Number | Photograph Description | Photograph |
|---|---|---|
| 19. | Stud partition to former storage area. Please see method 5 above for removal methodology. | |

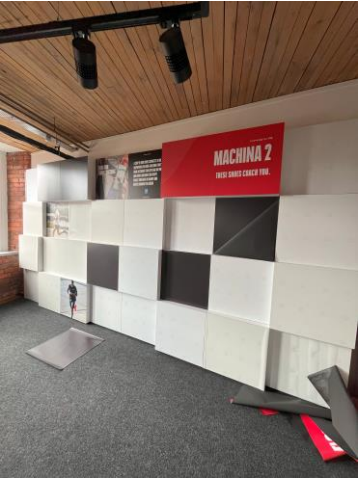
| Photograph Number | Photograph Description | Photograph |
|---|---|---|
| 20. | Fixed furniture to display room to be removed. Please see method 7 above for removal methodology. | |

1. Carefully dismantle furniture down to base track and clear all waste from site.
2. Carefully unscrew base track and clear all waste from site.
3. Clear all debris from resultant fixing apertures and leave all apertures in situ unfilled.

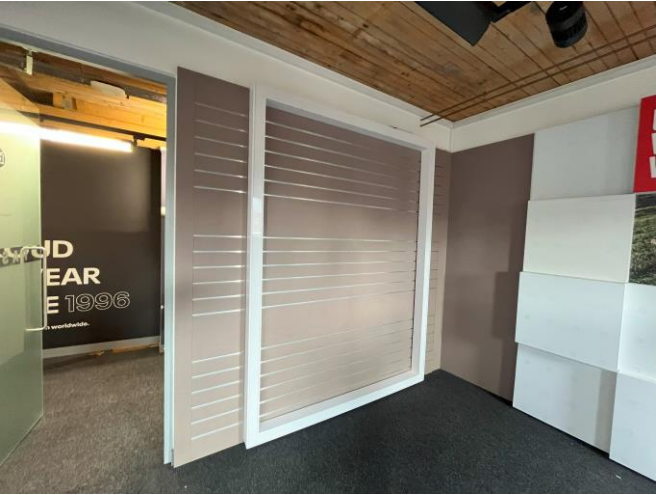
| Photograph Number | Photograph Description | Photograph |
|---|---|---|
| 21. | Stud partition to former office area. Please see method 5 above for removal methodology. | |

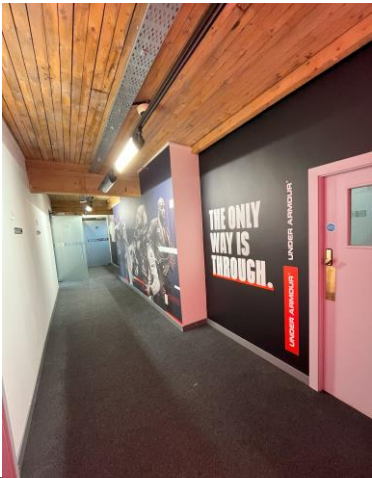
| Photograph Number | Photograph Description | Photograph |
|---|---|---|
| 22. | Stud partition to former office area.<br>Please see method 5 above for removal methodology. | |

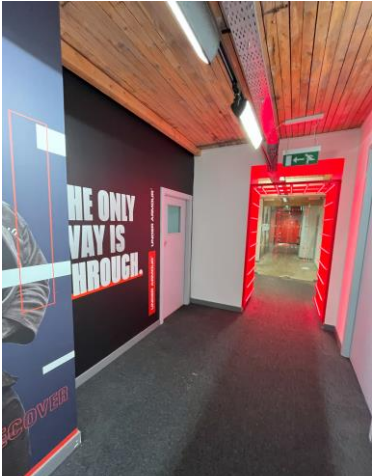
| Photograph Number | Photograph Description | Photograph |
|---|---|---|
| 23. | Stud partition to former office area.<br>Please see method 5 above for removal methodology. | |

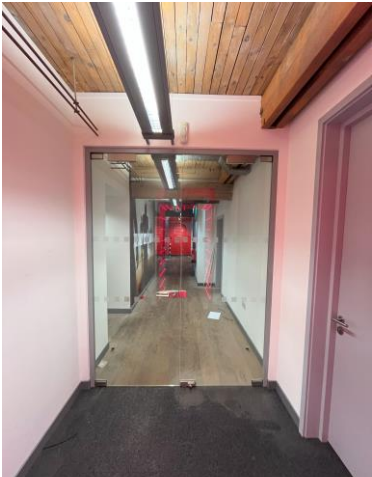
| Photograph Number | Photograph Description | Photograph |
|---|---|---|
| 24. | Stud partition to former office area.<br>Please see method 5 above for removal methodology. | |

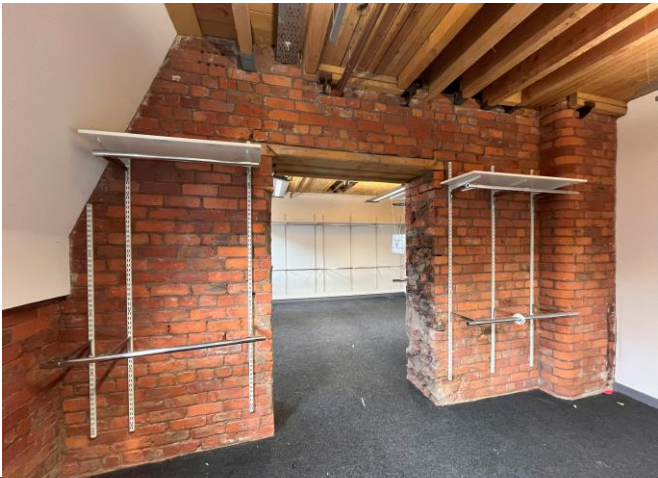
| Photograph Number | Photograph Description | Photograph |
|---|---|---|
| 28. | Remove fixed wall shelving from former display area. Please see method 9 above for removal methodology. | A photograph showing a section of a brick wall. Two white metal shelves are mounted on the wall with silver brackets. The wall is made of red bricks, and the ceiling above has exposed wooden beams. The floor is dark grey. |

1. Carefully unscrew all existing metal wall tracks from masonry walls and clear from site.
2. Carefully unscrew all fixings and clear from site.
3. Clear all debris from resultant apertures and leave all apertures in situ unfilled.

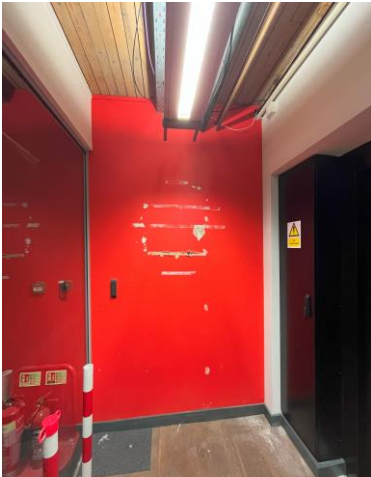
| Photograph Number | Photograph Description | Photograph |
|---|---|---|
| 30. | | A photograph of a red wall in a hallway. The wall has some white markings or graffiti. To the left, there is a fire extinguisher and a red and white striped safety pole. To the right, there is a black door with a yellow warning sign. The floor is made of light-colored wooden planks. |

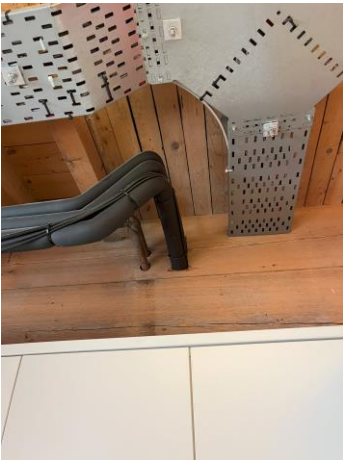
| Photograph Number | Photograph Description | Photograph |
|---|---|---|
| 34. | There are several instances throughout the floorplate where the existing timbers have been haphazardly notched for building services. | |

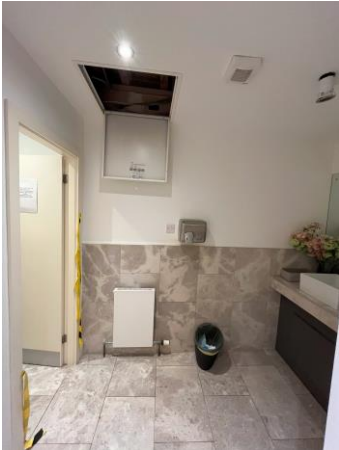
| Photograph Number | Photograph Description | Photograph |
|---|---|---|
| 35. | Ceramic floor tiles to WC to be removed. Please see method 3 above for removal methodology. | |

1. Carry out works to carefully degROUT and lift ceramic tile in one operation using a blunt implement taking care not to damage the floor substrate.
2. Clear off all tile adhesive and prepare floor substrate to receive new ceramic tiles floor coverings.
