Phase I Geoenvironmental Site Assessment  
Former Burnage Cricket Club, Manchester

Reference: 16-953-R1-2  
Date: February 2025

Former Burnage Cricket Club,  
Manchester,  
M19 1AL

Prepared for:  
**VIEWS**

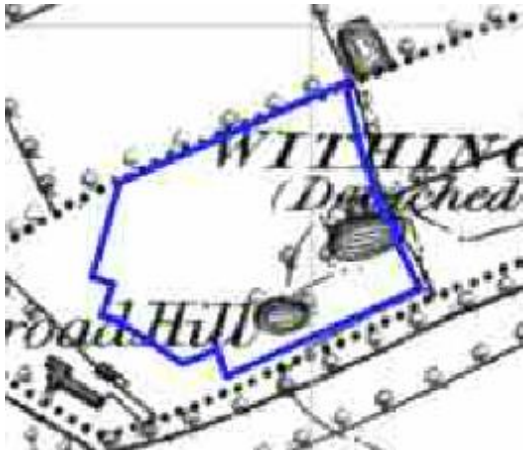
| MAP EDITION | HISTORICAL LAND USE | HISTORICAL MAP EXCERPT |
|---|---|---|
| <b>1849</b><br><b>1:10,560</b> | The site is part of an agricultural field and includes two ponds in the south and east of the site. | |

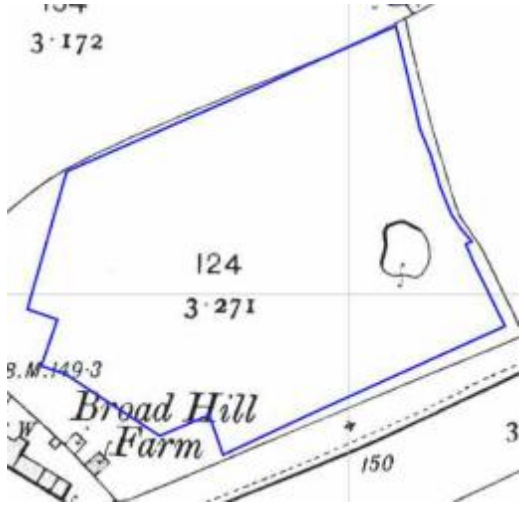
| MAP EDITION | HISTORICAL LAND USE | HISTORICAL MAP EXCERPT |
|---|---|---|
| <p><b>1907</b><br/><b>1:2,500</b></p> | <p>The remaining pond has been decreased in size and the trees are no longer marked and assumed to be removed from site.</p> | <p>This map excerpt shows a large area labeled '124' with a scale of '3:271'. A small pond is visible in the upper right corner. The area is labeled 'Broad Hill Farm' and 'S.M. 149.3'. A scale bar indicates 150 units.</p> |

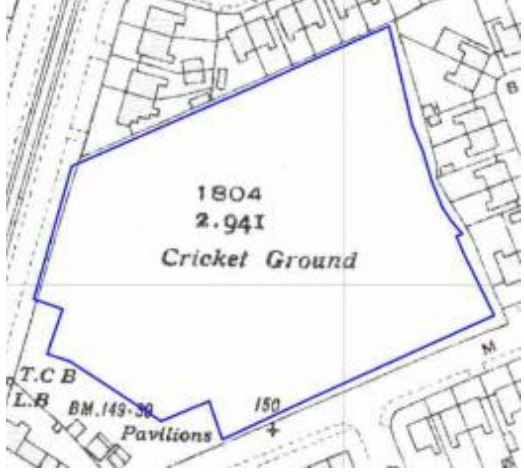
| MAP EDITION | HISTORICAL LAND USE | HISTORICAL MAP EXCERPT |
|---|---|---|
| <p><b>1934</b><br/><b>1:2,500</b></p> | <p>The remaining pond had been infilled. A cricket ground is marked on site. Given no structures are marked this likely comprises a cricket pitch only.</p> | <p>This map excerpt shows the area labeled '1804' with a scale of '2:941'. The area is labeled 'Cricket Ground' and 'Pavilions'. A scale bar indicates 150 units. The area is also labeled 'T.C.B.' and 'L.B. B.M. 149.30'.</p> |

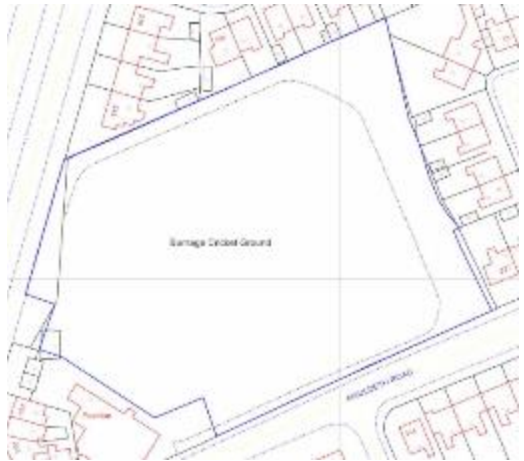
| MAP EDITION | HISTORICAL LAND USE | HISTORICAL MAP EXCERPT |
|---|---|---|
| <p><b>2003</b><br/><b>1:1,250</b></p> | <p>No changes are recorded.</p> | |

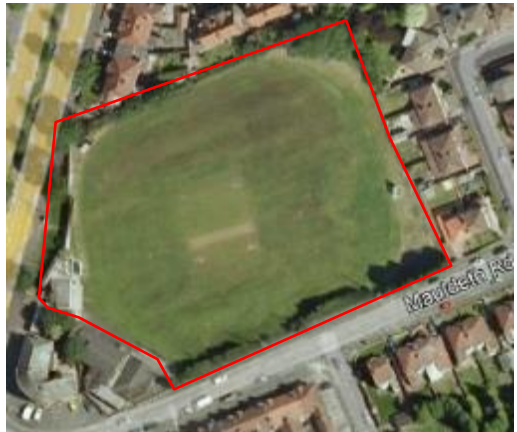
| MAP EDITION | HISTORICAL LAND USE | HISTORICAL MAP EXCERPT |
|---|---|---|
| <p><b>2009</b><br/><b>Google Earth imagery</b></p> | <p>No significant changes are recorded.</p> <p>First aerial images show the site to comprise a cricket pitch only.</p> | |

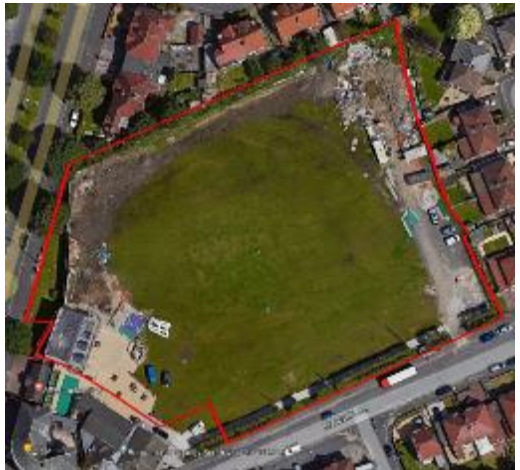
| MAP EDITION | HISTORICAL LAND USE | HISTORICAL MAP EXCERPT |
|---|---|---|
| <p><b>2016</b><br/><b>Google Earth imagery</b></p> | <p>The small structure in the west of the site has been demolished and a larger structure (three storey apartment building) has been constructed in its place. Additionally, the sports club has extended with the addition of hardstanding and foundations of a new structure in the west of the site.</p> <p>A gravel car park/storage area has been constructed in the east and northwest of site, assumed to be a temporary storage area of building materials associated with construction in the west.</p> | |

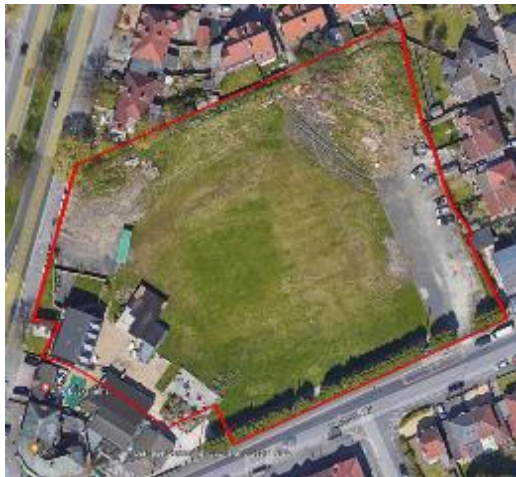
| MAP EDITION | HISTORICAL LAND USE | HISTORICAL MAP EXCERPT |
|---|---|---|
| <b>2021</b><br><b>Google Earth imagery</b> | <p>The building has been constructed in the west of the site.</p> <p>The gravel car park remains, however, the material storage area is no longer noted now construction has been completed.</p> <p>A decking area has been constructed in the southwest of the site.</p> <p>A shipping container is present in the north west.</p> | |

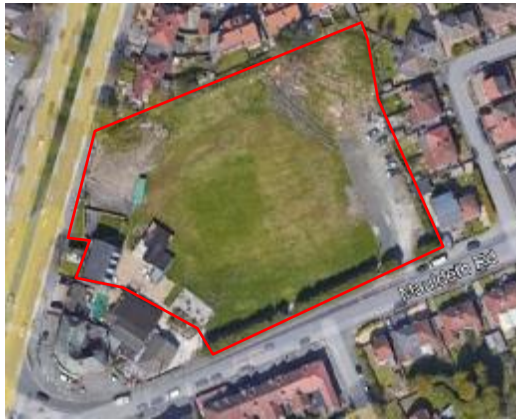
| MAP EDITION | HISTORICAL LAND USE | HISTORICAL MAP EXCERPT |
|---|---|---|
| <b>2023</b><br><b>Google Earth imagery</b> | <p>No changes are recorded.</p> | |

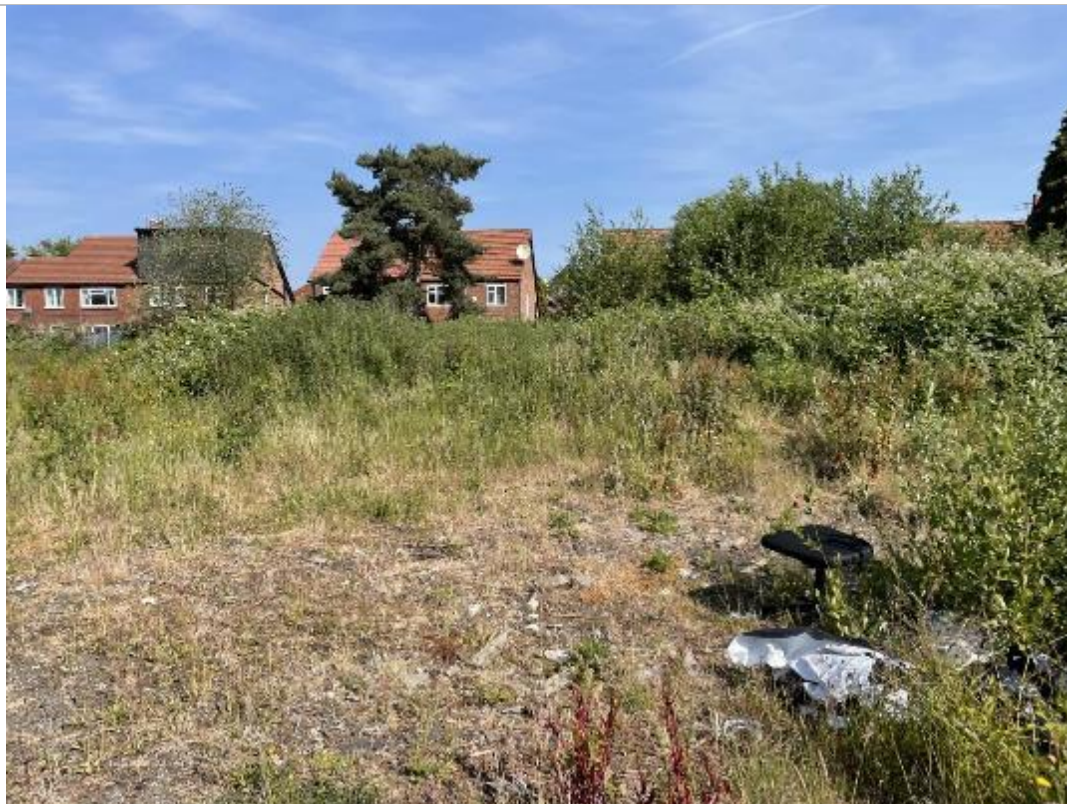
PLATE 1      DENSE VEGETATION IN NORTH EAST

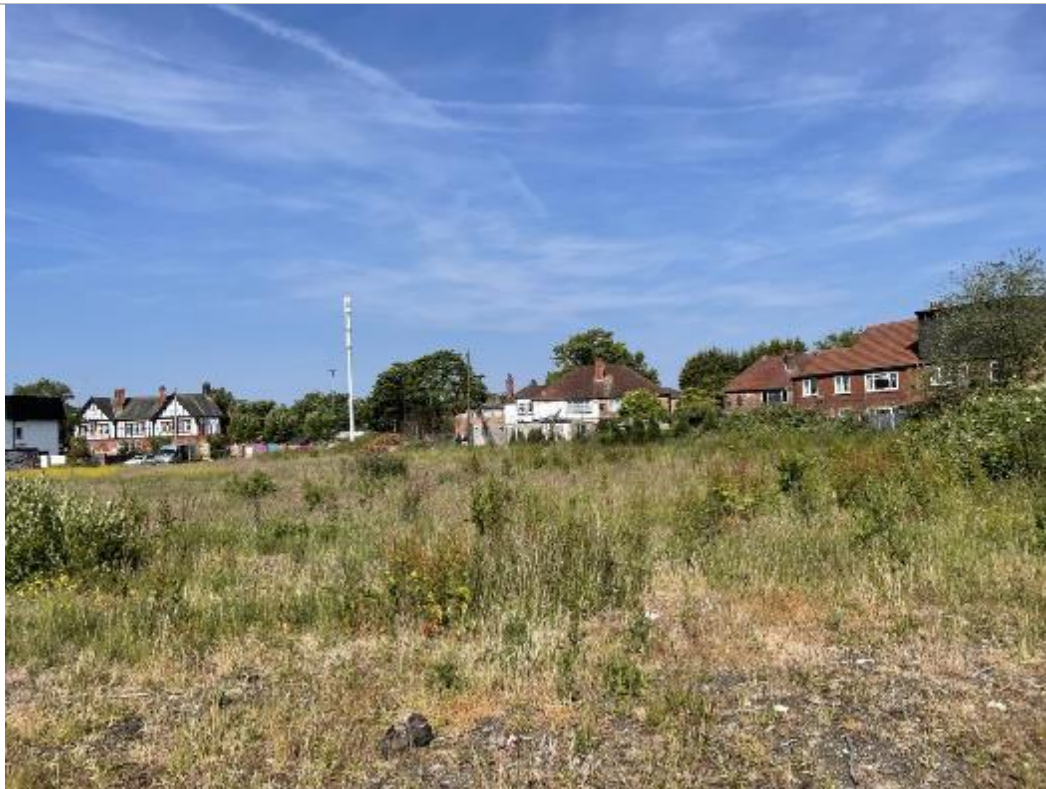
PLATE 3 GRAVEL CAR PARK AND ACCESS TO MAULDETH ROAD IN SOUTH EAST

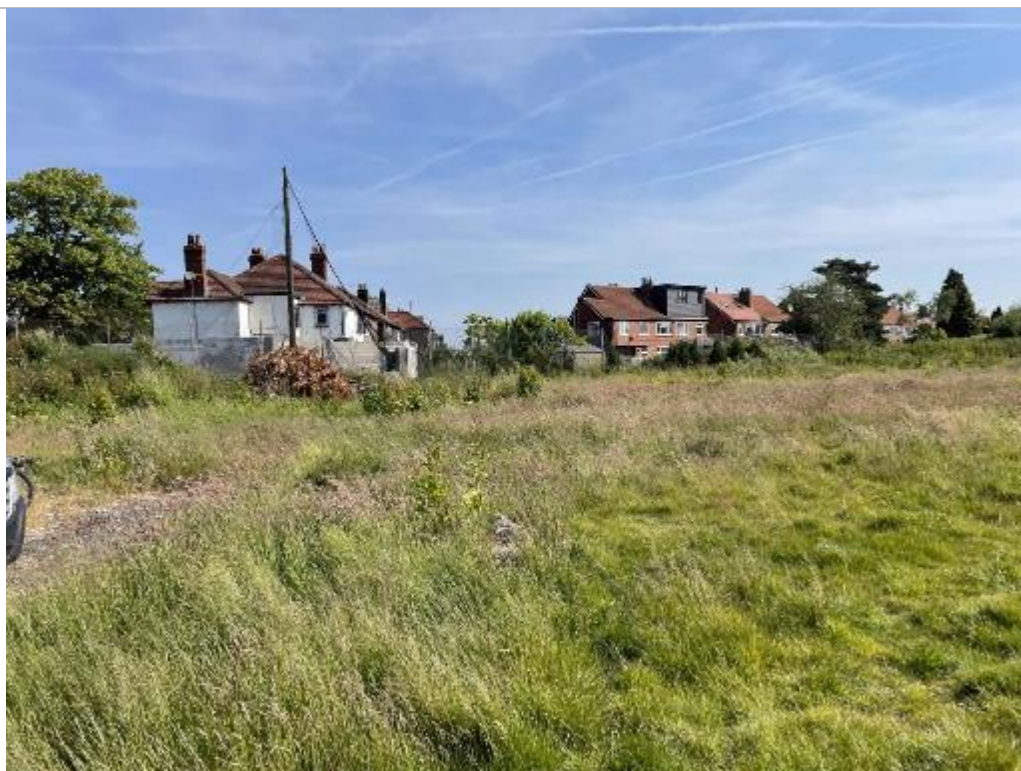
PLATE 5      TIMBER STRUCTURE AND DOMESTIC WASTE IN CENTRAL WEST

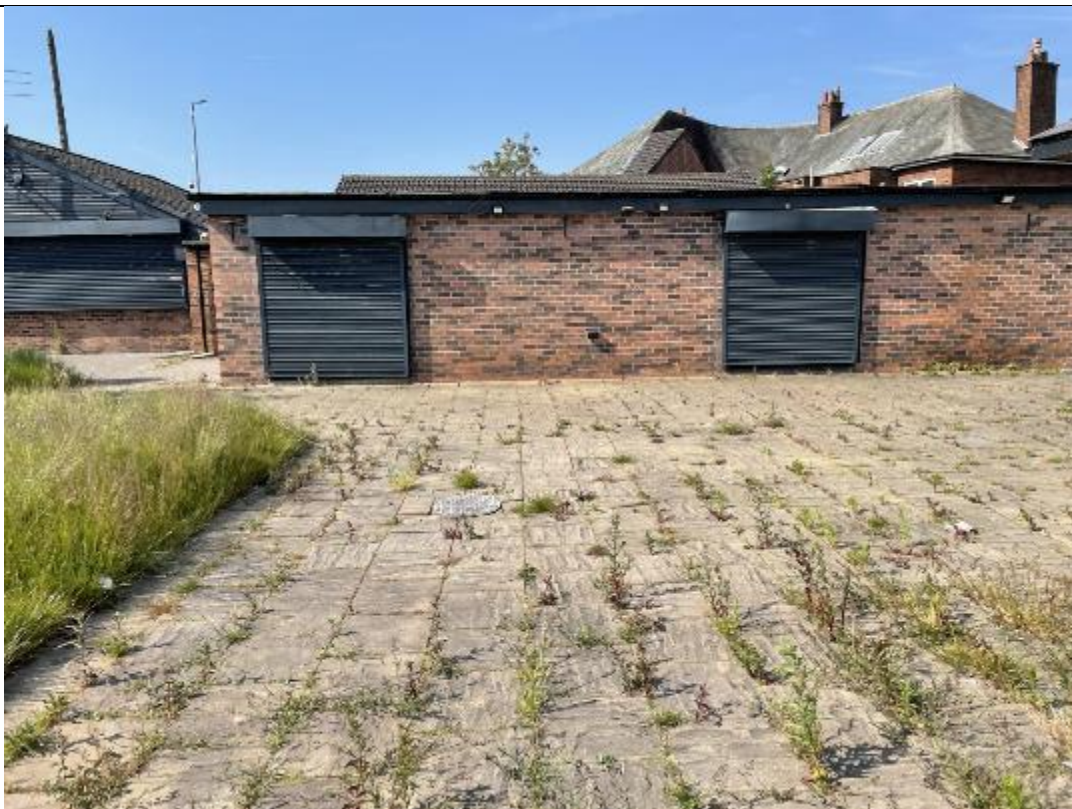
PLATE 6      HARDTAND AREA IN WEST

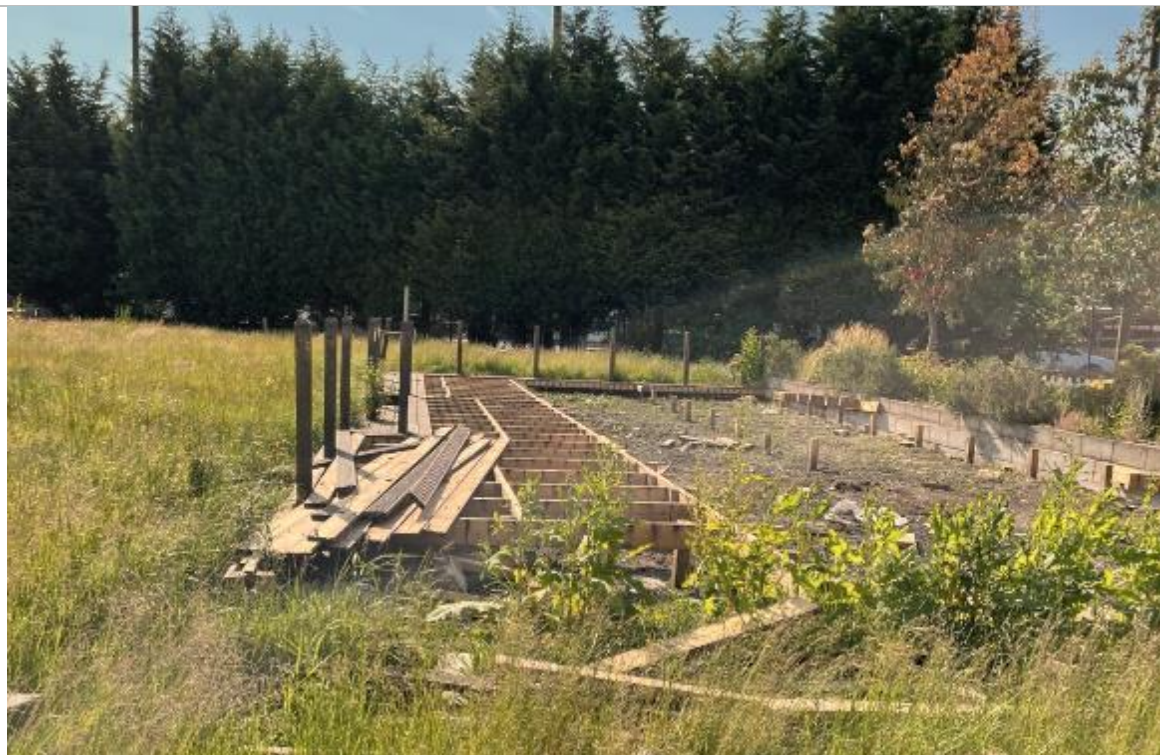
PLATE 7      PARTIALLY DISMANTLED DECKING AND CONFIERS IN SOUTH WEST

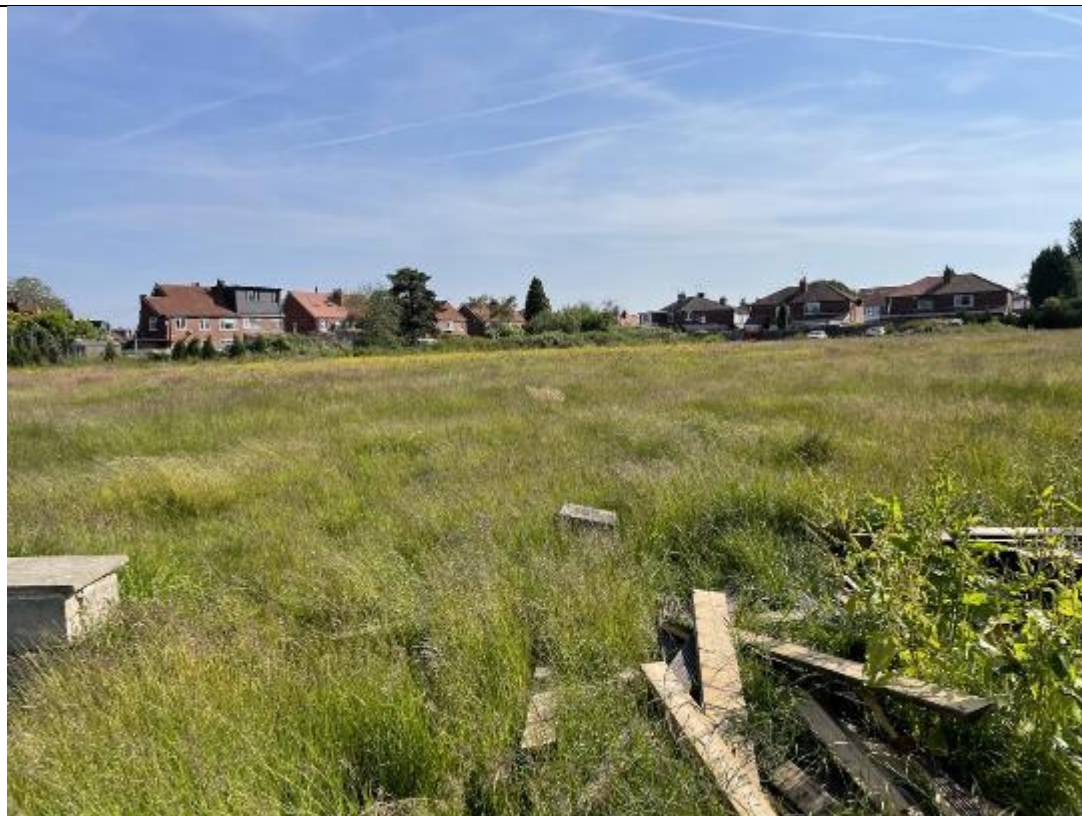
PLATE 7      TIMBER STRUCTURE AT CENTRAL WEST OF SITE

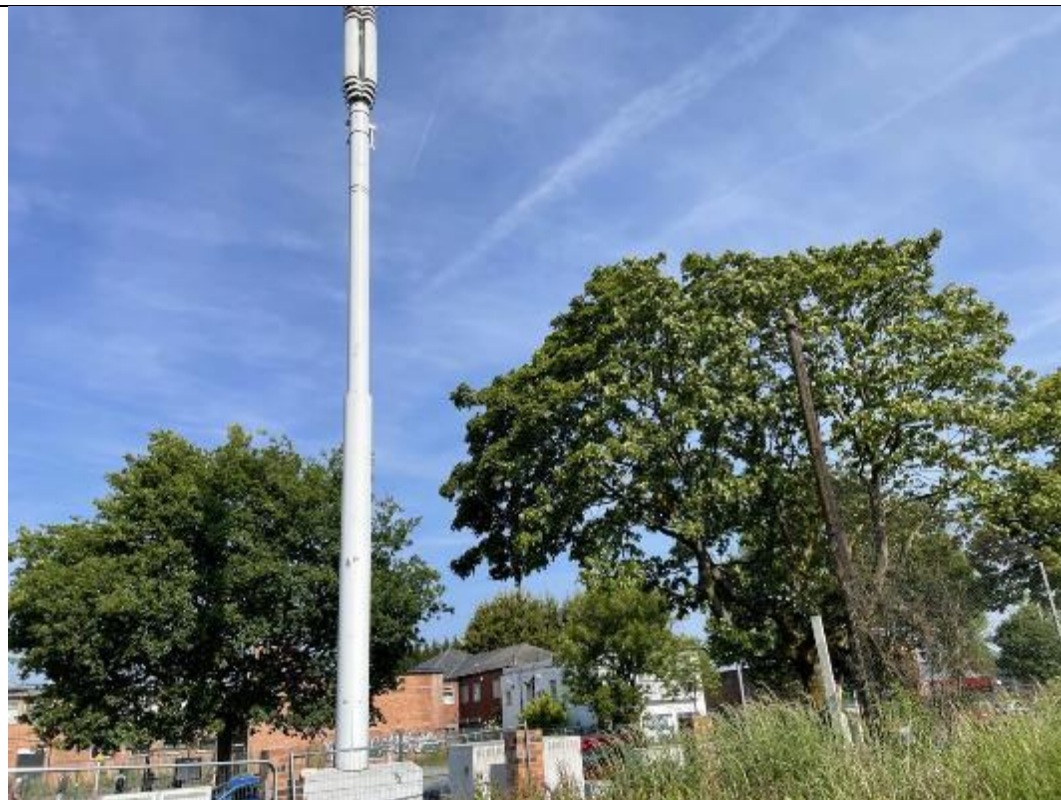
PLATE 8      TELECOMMUNICATIONS MAST ADJACENT TO WESTERN BOUNDARY
