# North Manchester General Hospital

## Ground Conditions Desk Study and Ground Investigation Report

*For Manchester University NHS Foundation  
Trust*

*Doc ref:* 32425-HYD-XX-XX-RP-GE-1001

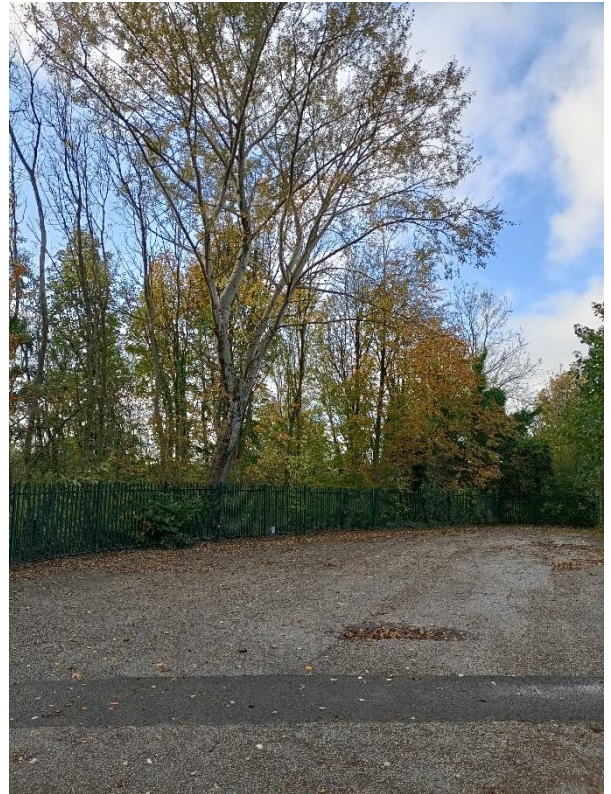
Figure 2.4: Linear patching of the tarmac car park surface indicating buried utilities.

| Item | Brief Description |
|---|---|
| Present land use | The site is presently covered by hardstanding and utilised as car parking. Visible linear scarring of the tarmacadam surface can be observed which indicates the presence of potential utilities buried within this area (assumed to be a gas main, although pressure is unknown). There is a lighting pole and small cabin (associated with utilities) in the north. There is visible patching across the car park and the surface is in a general poor condition. |

During the field reconnaissance bituminous bound pavement hardstanding was noted covering 100% of the car park site and noted to be in poor condition, including service trench scars and repair patching. In the areas outside of the development area, i.e. on the slopes between car parks where the hand pits were due to be progressed, the surface comprised vegetated and bare earth.

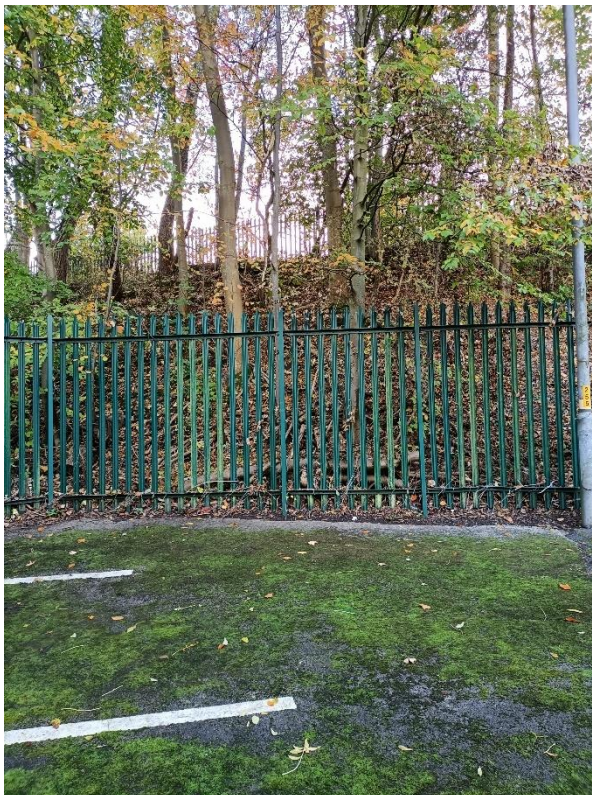
Figure 2.5: Slope adjacent to the eastern car park.

Sloping ground is present to the east of the site, onsite observation found the trees at the crest of the slope to generally be straight and there were no obvious signs of cracking of the hardstanding across the car park running parallel to the crest of the slope. However, as part of the ground investigation and more detailed design the stability of the slope will require assessment to ensure that loading of the slope by proposed site structures will not lead to future instability or failure.

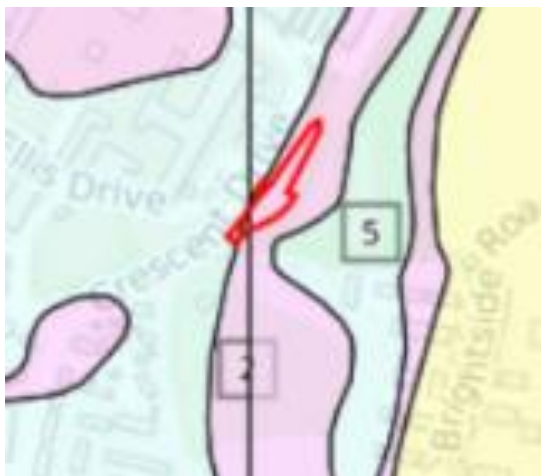
Figure 2.7: Superficial deposits.  
(Reproduced with permission from Groundsure)

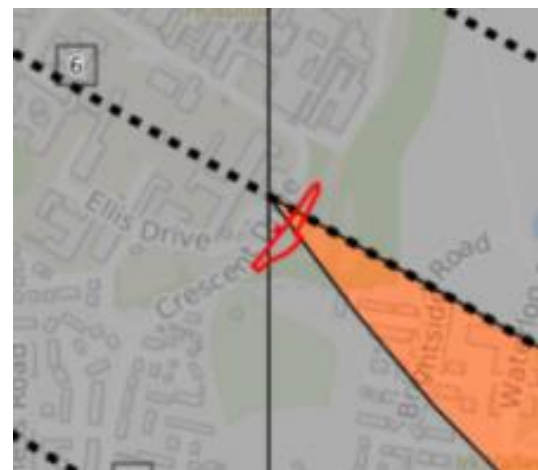
Figure 2.8: Solid geology.  
(Reproduced with permission from Groundsure)

A fault indicated by the dashed line in Figure 2.8 intersects the site in a north-west to south-east trend and is shown on the BGS sheet map 85 (1:50,000 Manchester) with downthrow to the east. The BGS mapping indicates that at least 10.0m of superficial coverage will overly the bedrock, with the toe of the slope likely sat upon the deeper Glacial Till. Therefore, fault surfaces associated with the recorded fault is not anticipated to pose a significant geotechnical risk to currently proposed end use.
