**Lower Campfield, Manchester**  
Lower Byrom Street, M3 4FP

**Listed Building Consent Application Condition 09**

*Lower Campfield, Manchester - Listed Building Consent Planning Application - Condition 09*

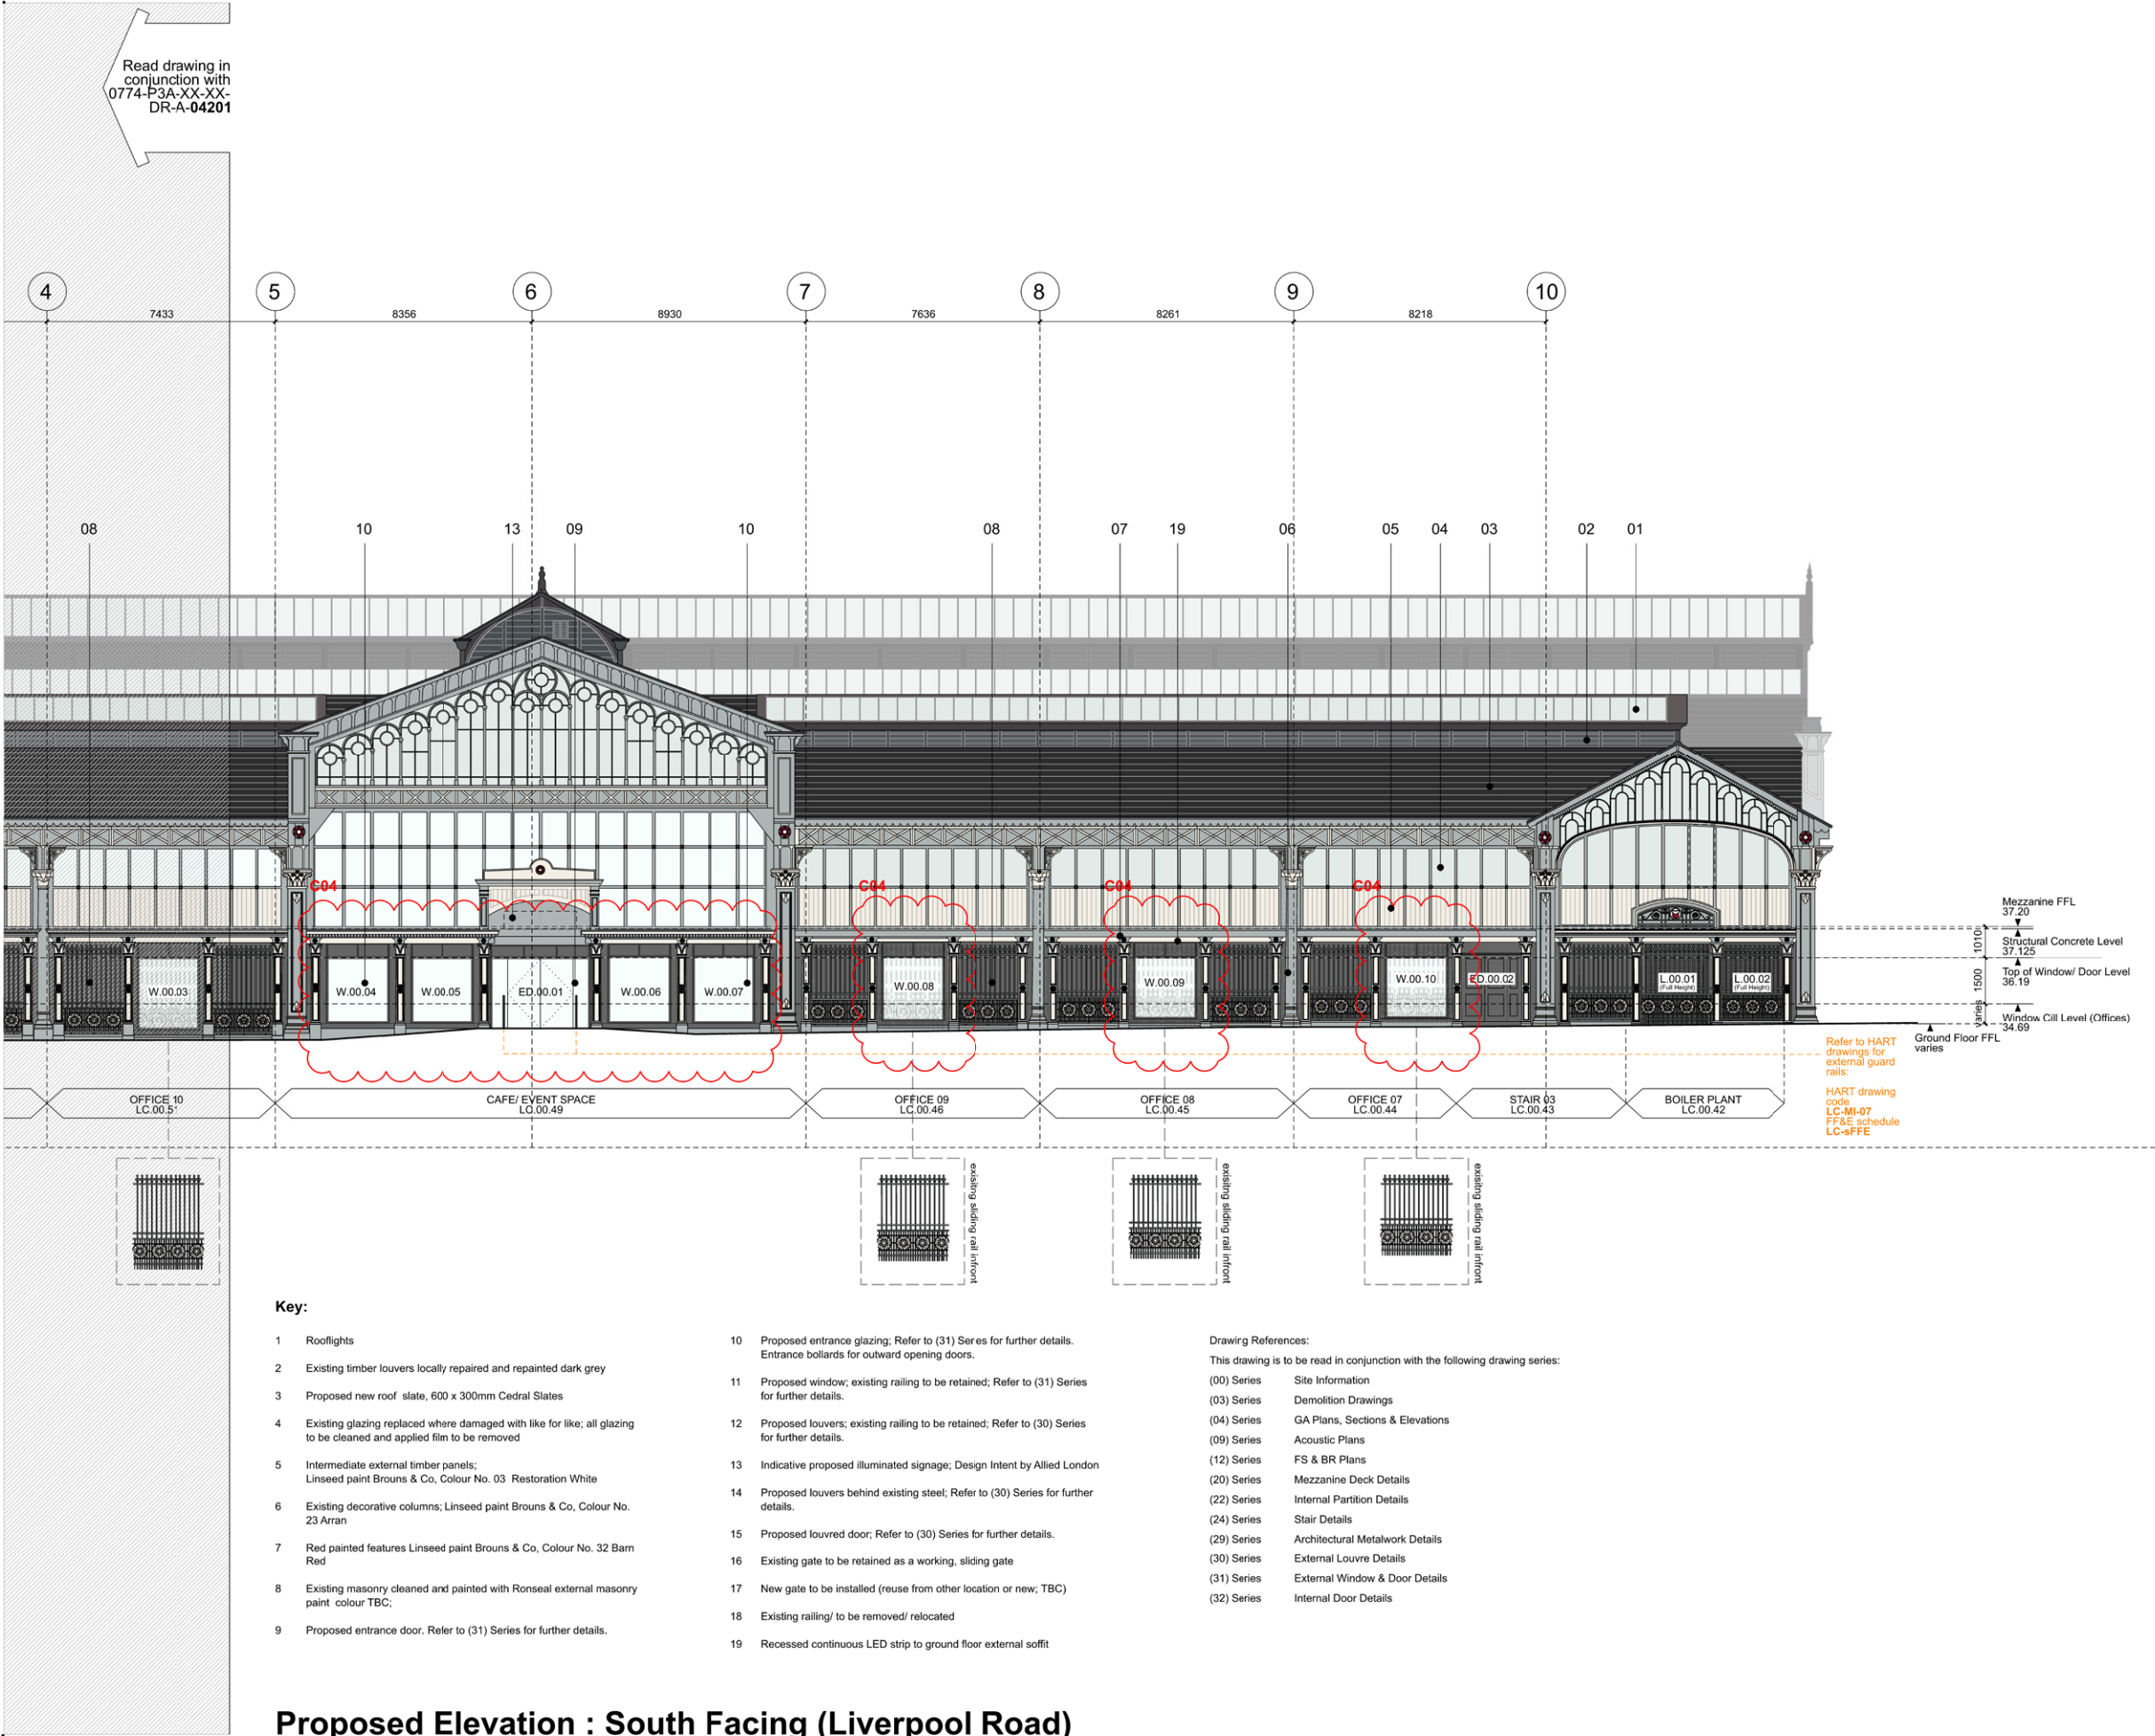
Project:  
Lower Campfield  
Liverpool Rd, Manchester  
Title:  
Proposed GA Elevations  
South Facing (Sheet 2 of 2)  
Status:  
CONSTRUCTION  
Scale @ ISO A1:  
1:100  
Drawing Number:  
0774-P3A-XX-XX-DR-A-04202  
Revision:  
C04

- 1 Rooflights
- 2 Existing timber louvers locally repaired and repainted dark grey
- 3 Proposed new roof slate, 600 x 300mm Cedral Slates
- 4 Existing glazing replaced where damaged with like for like; all glazing to be cleaned and applied film to be removed
- 5 Intermediate external timber panels;  
Linseed paint Brouns & Co, Colour No. 03 Restoration White
- 6 Existing decorative columns; Linseed paint Brouns & Co, Colour No. 23 Arran
- 7 Red painted features Linseed paint Brouns & Co, Colour No. 32 Barn Red
- 8 Existing masonry cleaned and painted with Ronseal external masonry paint colour TBC;
- 9 Proposed entrance door. Refer to (31) Series for further details.

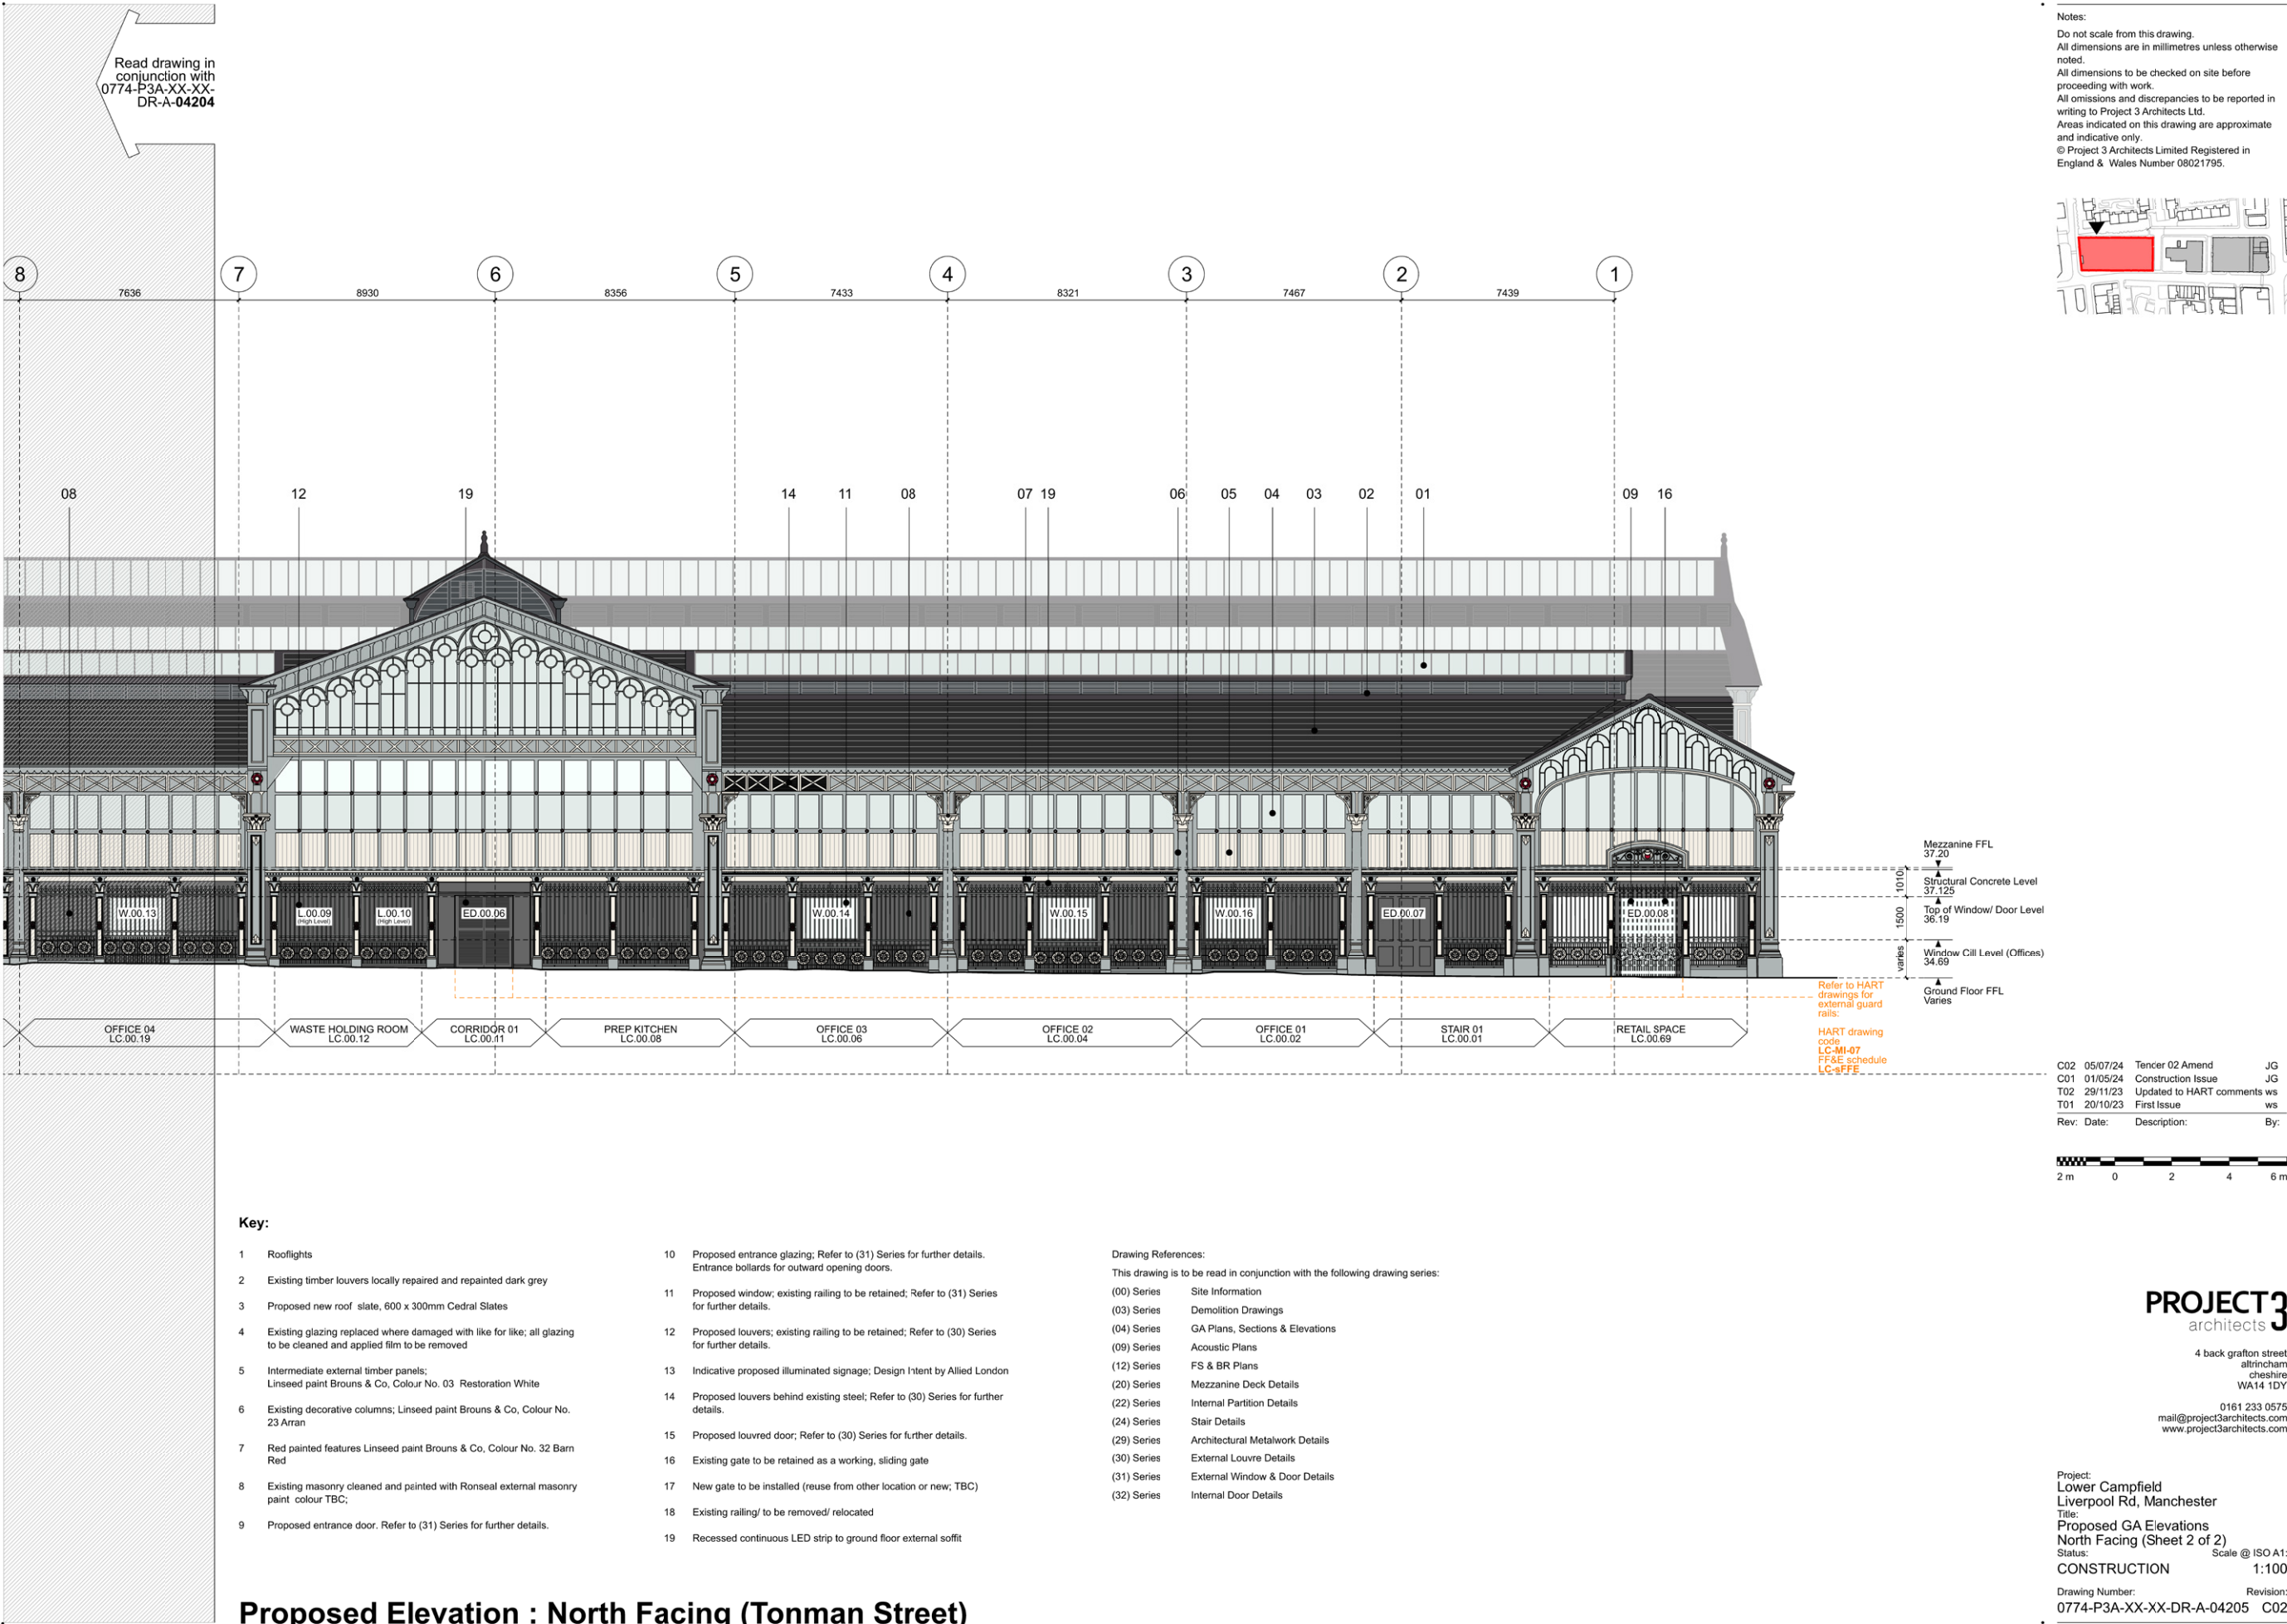
Project:  
Lower Campfield  
Liverpool Rd, Manchester  
Title:  
Proposed GA Elevations  
North Facing (Sheet 1 of 2)  
Status: Scale @ ISO A1:  
CONSTRUCTION 1:100  
Drawing Number: Revision:  
0774-P3A-XX-XX-DR-A-04204 C02

- Key:**
- 1 Rooflights
  - 2 Existing timber louvers locally repaired and repainted dark grey
  - 3 Proposed new roof slate, 600 x 300mm Cedral Slates
  - 4 Existing glazing replaced where damaged with like for like; all glazing to be cleaned and applied film to be removed

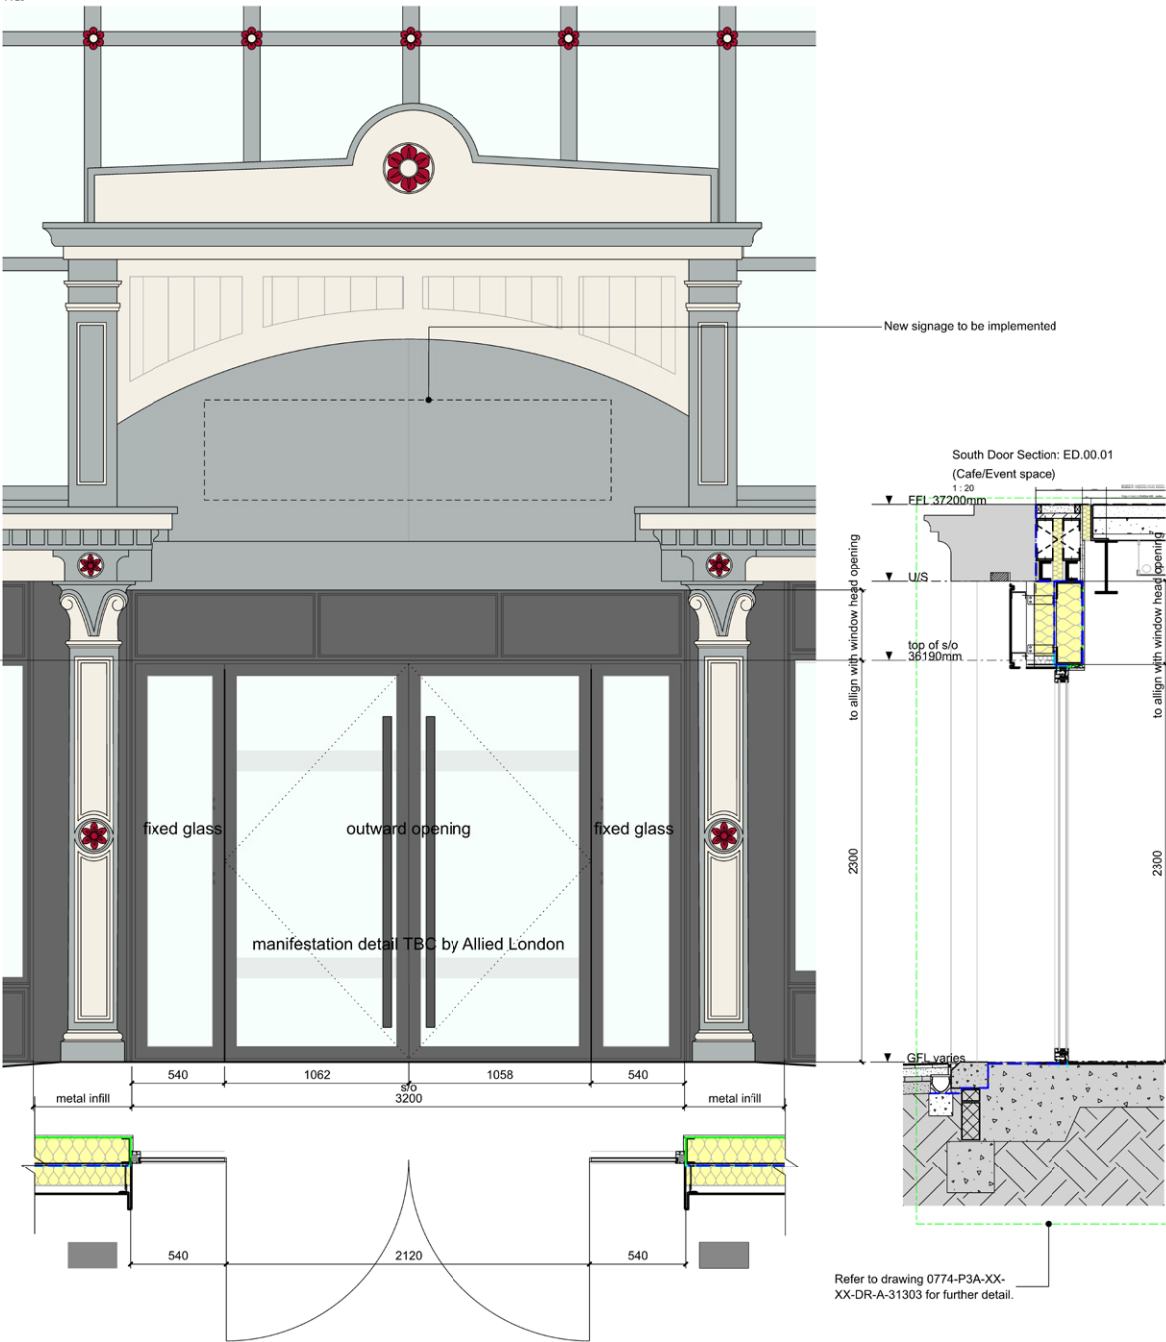
South Door: ED.00.01 (Cafe/ Event Space)  
1:20

Proposed aluminium cladding system. Design intent to Architect detailed design to specialist subcontractor. Colour REF: RAL 7016. Finish PPC

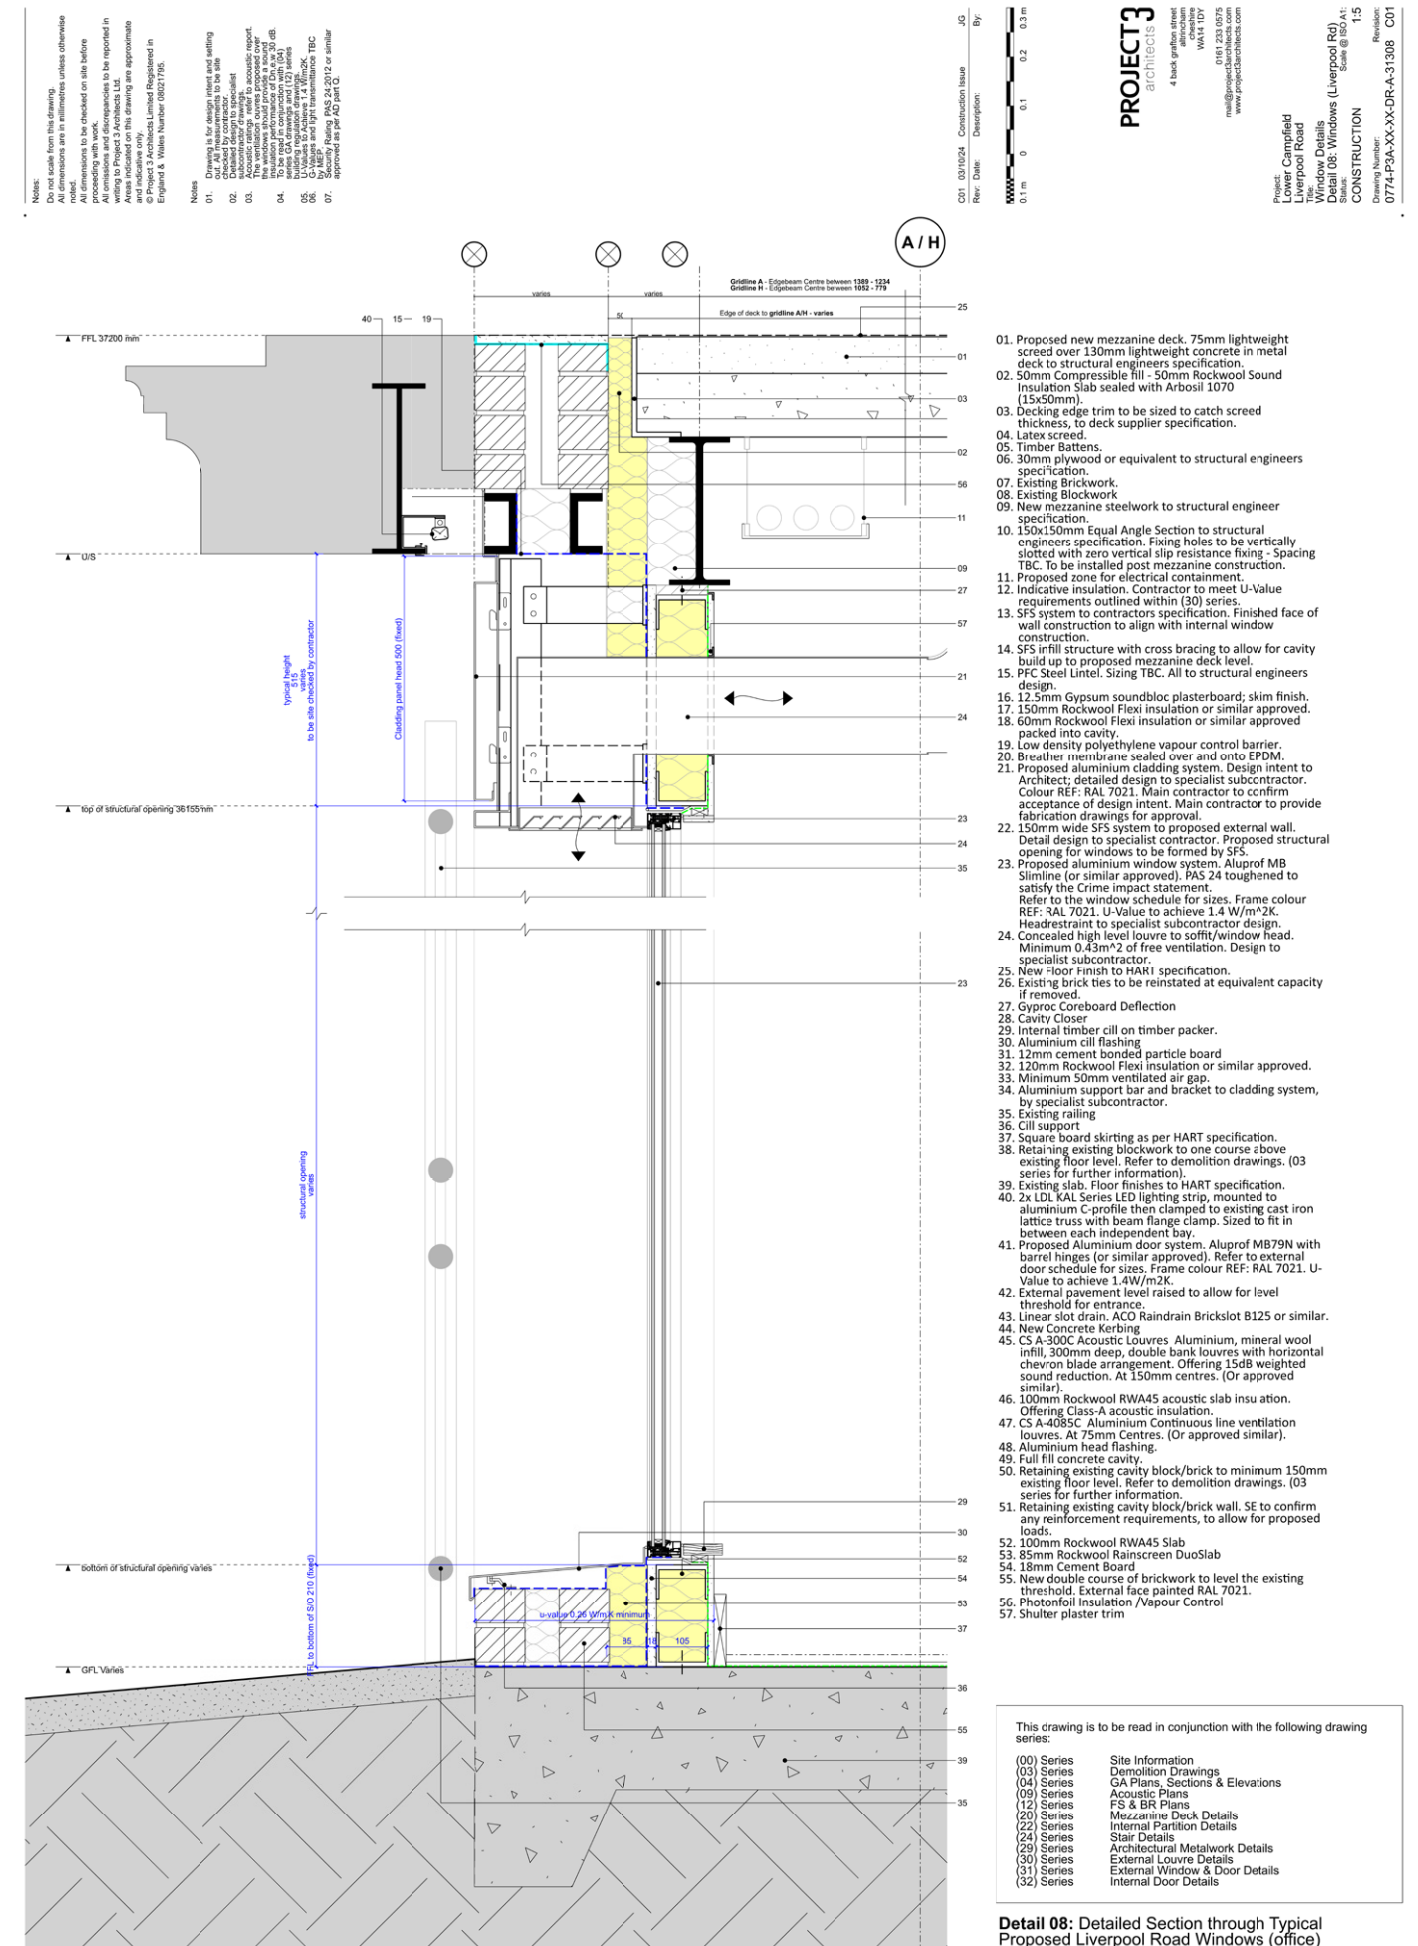
**Detail 08:** Detailed Section through Typical Proposed Liverpool Road Windows (office)

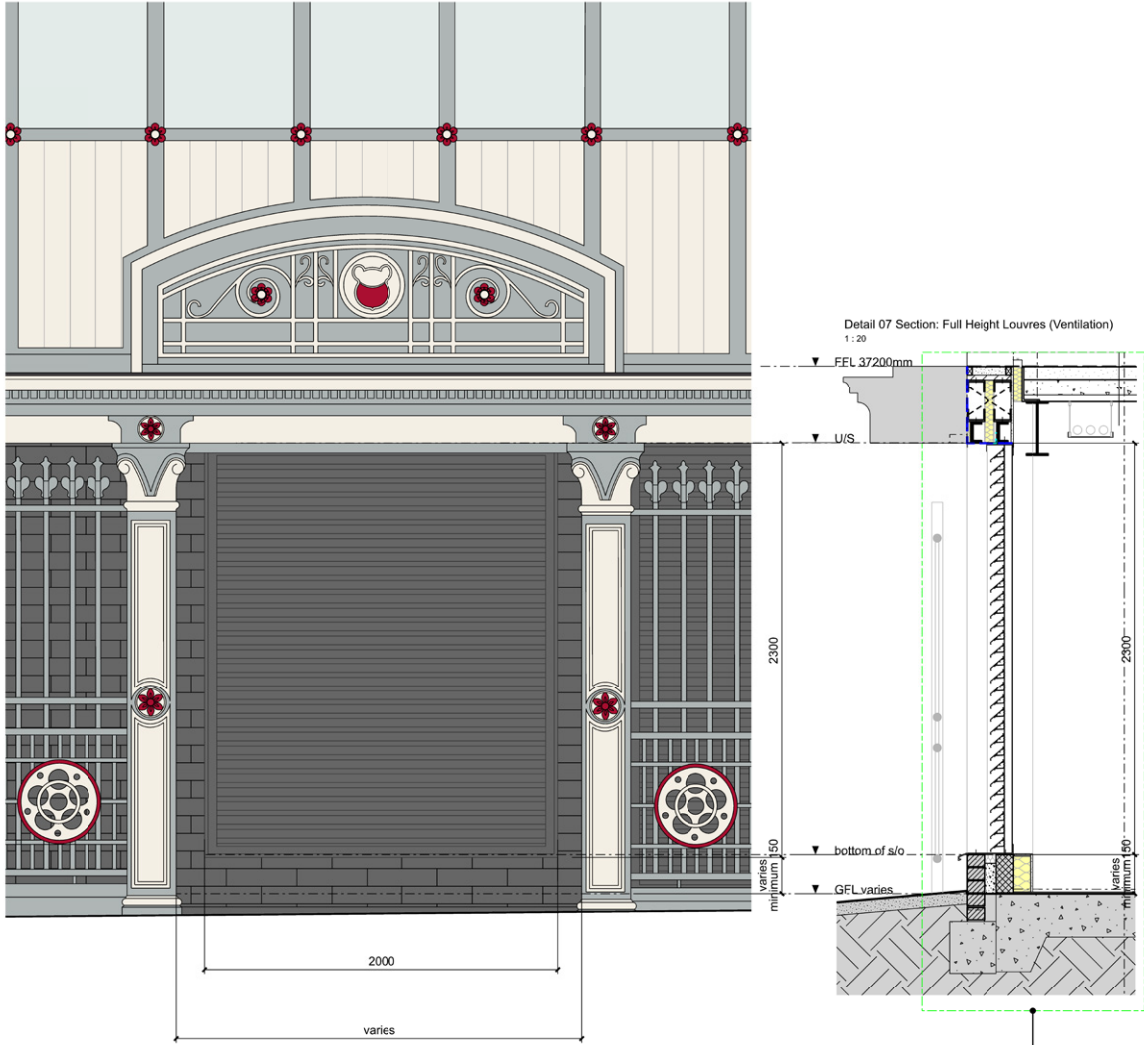
Detail 07: Full Height Louvres (Ventilation)  
1:20

Refer to drawing 0774-P3A-XX-XX-DR-A-31302 for further detail.

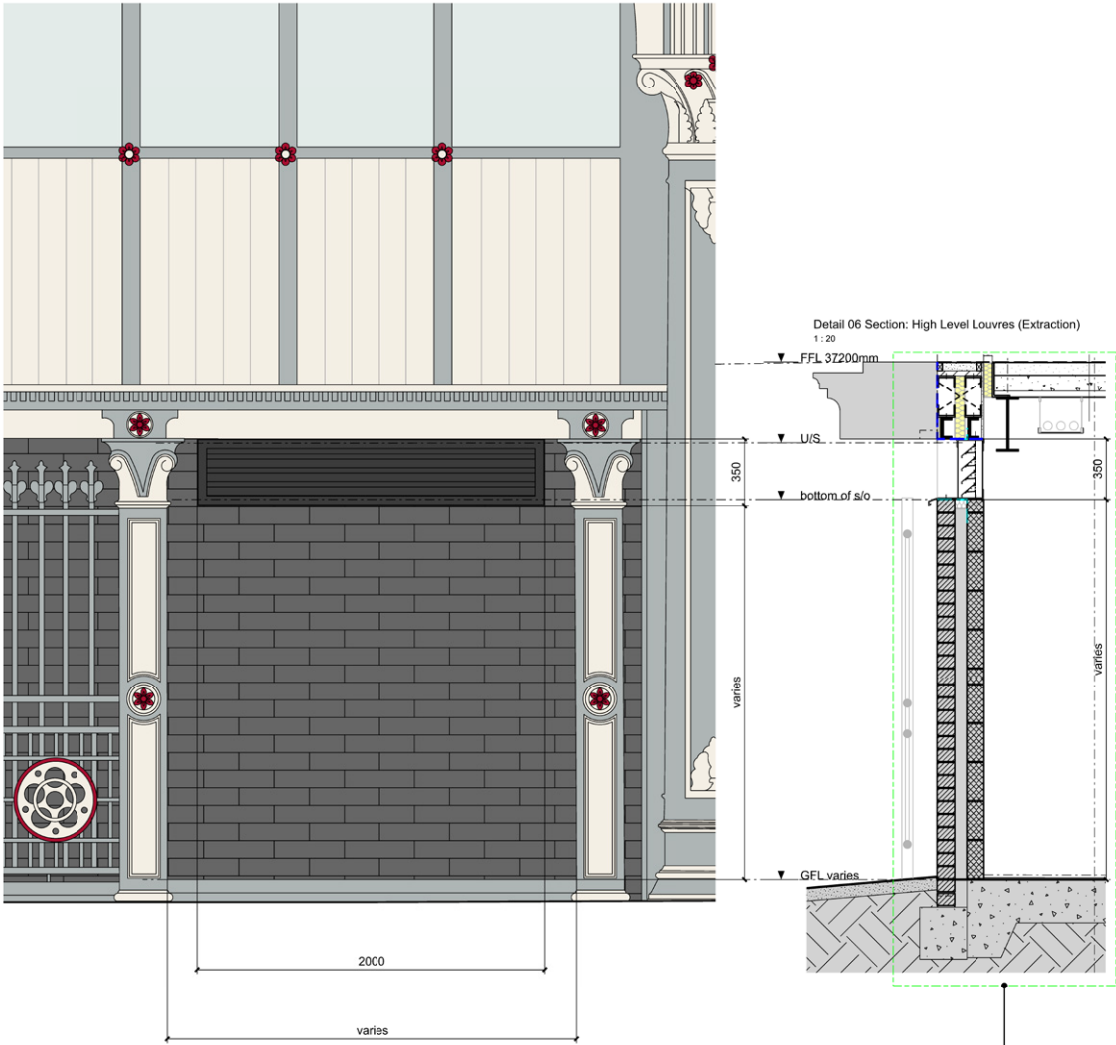
Detail 06: High Level Louvres (Extraction)  
1:20

Refer to drawing 0774-P3A-XX-XX-DR-A-31302 for further detail.

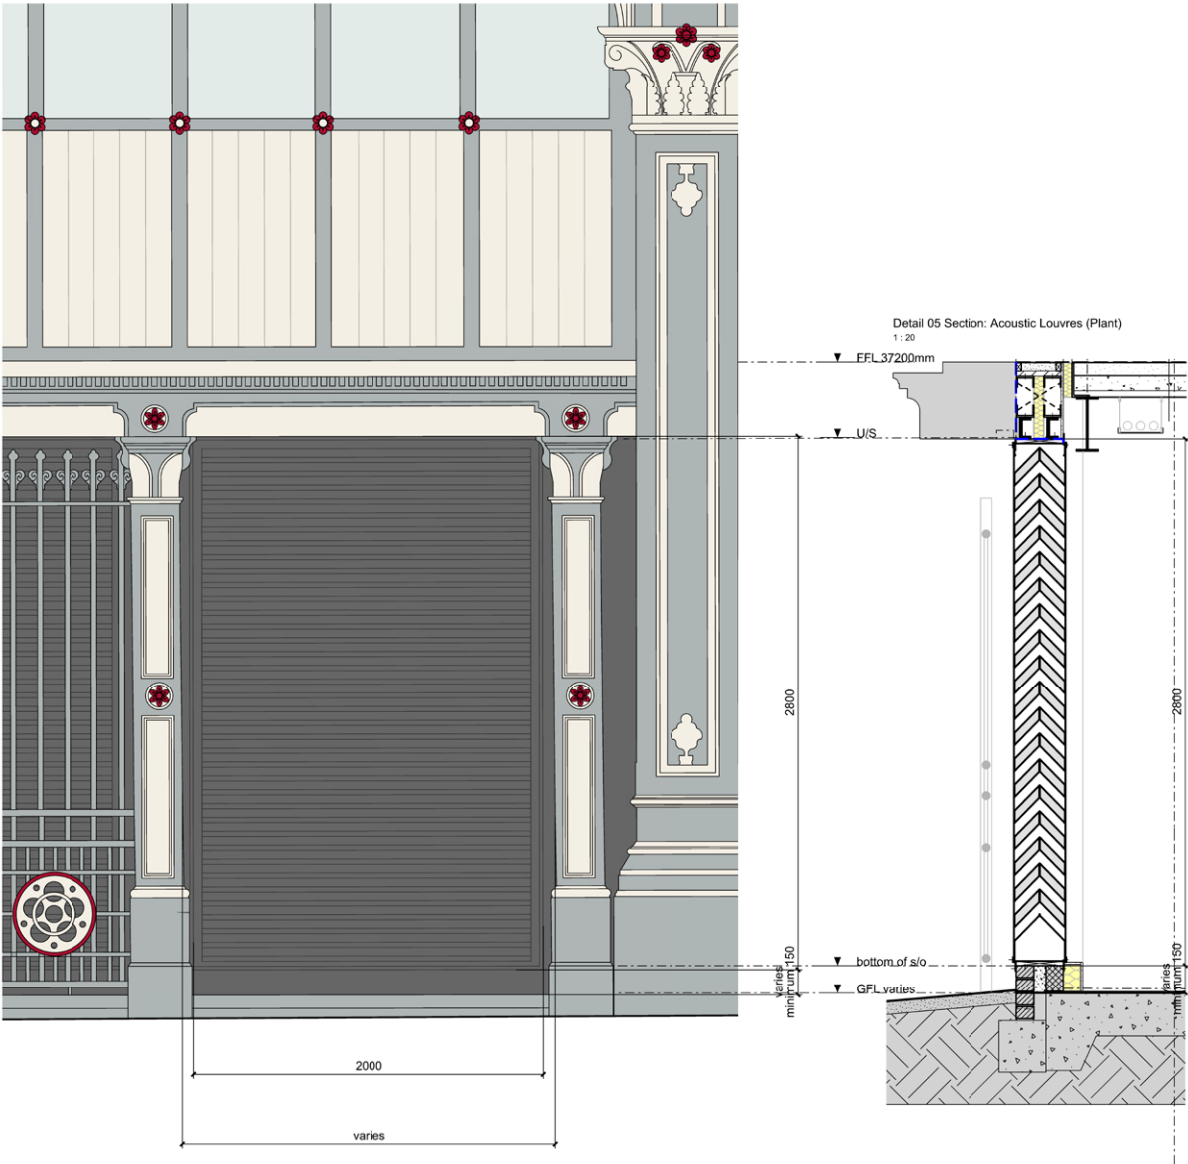
Detail 05: Acoustic Louvres (Plant)  
1 : 20

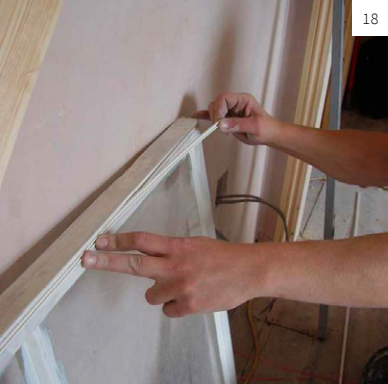
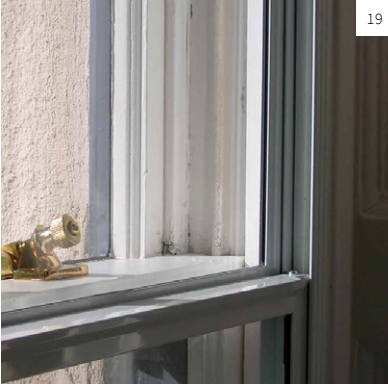
Images 18 and 19  
The thermal performance of single glazed traditional windows can be improved significantly by draught-proofing or secondary glazing.

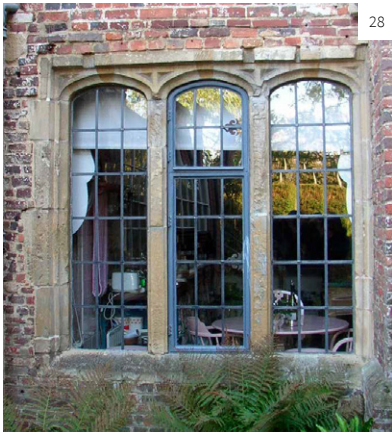
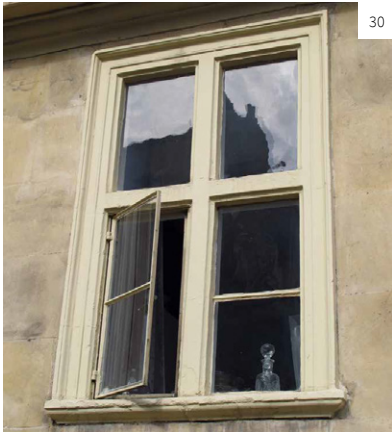
Images 28-31

28. Leaded glazing set within stone mullions with a later steel casement to the central bay.

29. Late 17th or early 18th-century oak framed window with an opening side hung iron casement.

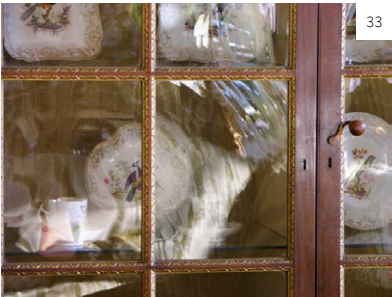
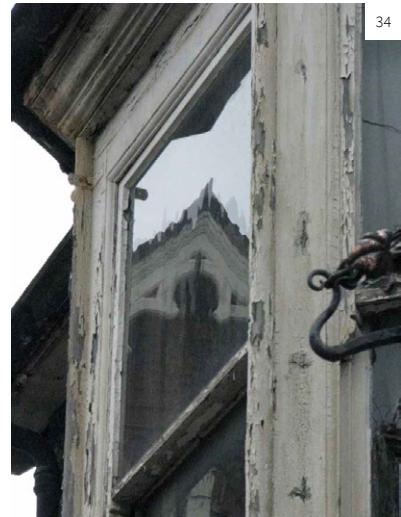
Images 33 and 34

33. An example of crown glass which is now very rare but was widely used for windows until the mid 19th century.

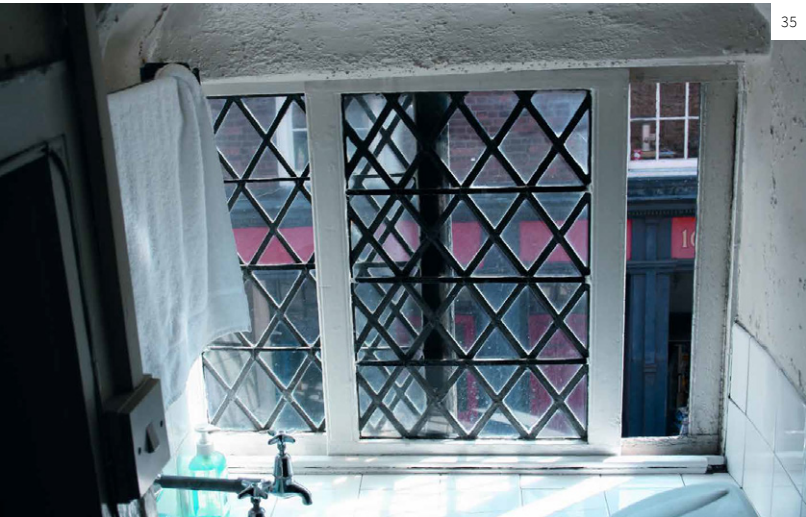
Image 35

Windows with horizontally sliding sashes are often called Yorkshire' sliding sashes though they were used widely.

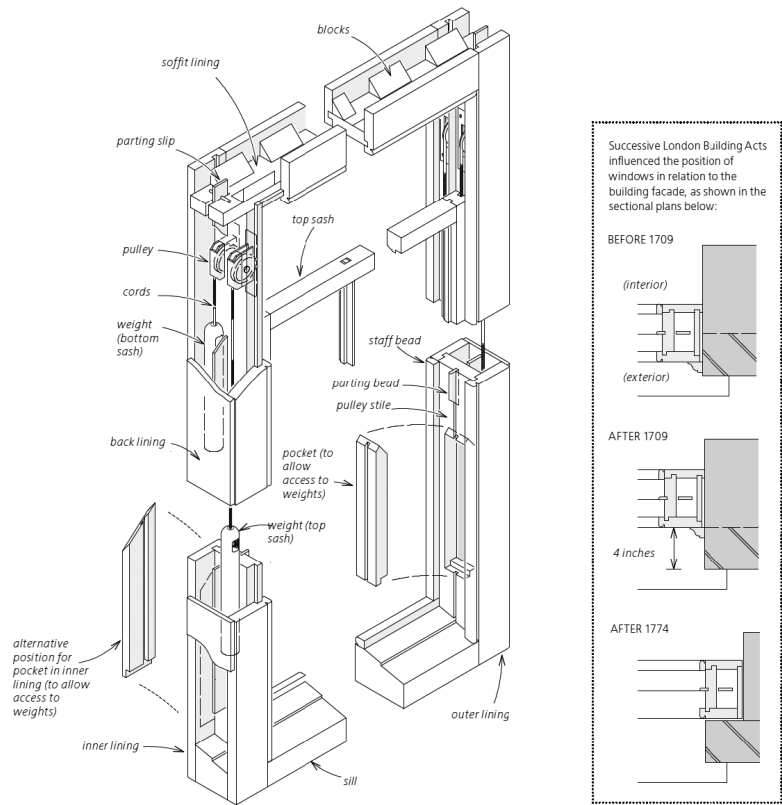
**Image 36**  
Typical details of sliding sash window with cased frame.

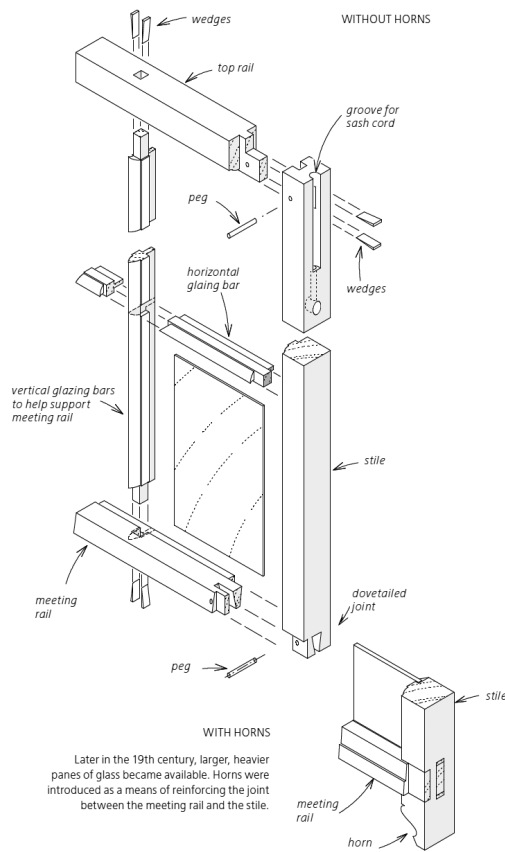
**Image 37**  
A. Sliding sash windows: typical top sash.

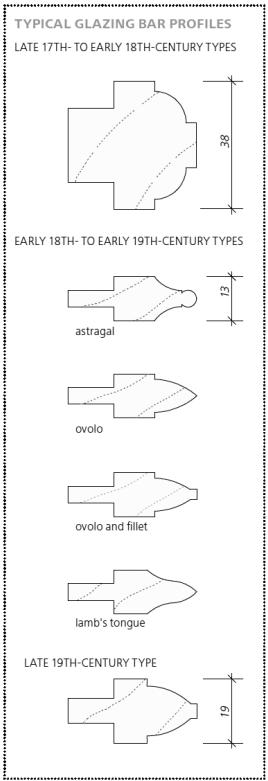
B. Typical glazing bar profiles (dimensions in millimetres) showing the early ovolo profile (top)

Early glazing bars were thick and robust, usually made of native oak or a similar hardwood. They were often almost 40mm thick to support and protect the fragile glass. However, the increasing use of oak for shipbuilding coincided with the growing availability of cheaper softwoods from Scotland, the Baltic States and Scandinavia. Most late 17th and early 18th-century glazing bars were based on the ovolo, or quarter-circle moulding and used 'deal', a generic term for pine or fir softwood. Crown glass was used for glazing; being lighter it lent itself to larger sashes. Thinner, finer glazing bars, with pointed (gothic)

and lamb's tongue mouldings became popular. By the early 19th century some glazing bars were only 12mm wide (although, to provide lateral strength, they could be up to 38mm deep).

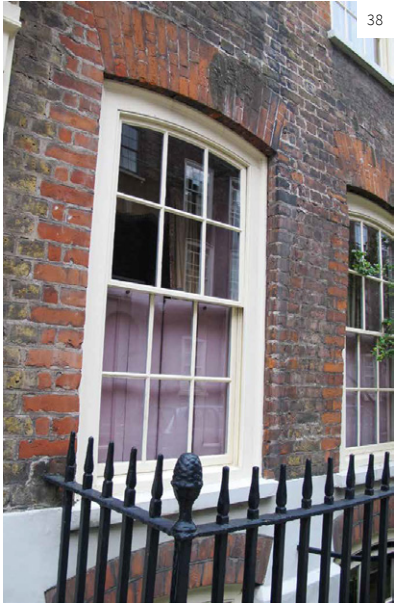
**Images 38 and 39**  
38. In the cities of London and Westminster, legislation came into force in 1709 which required window frames to be set back from behind the wall face.

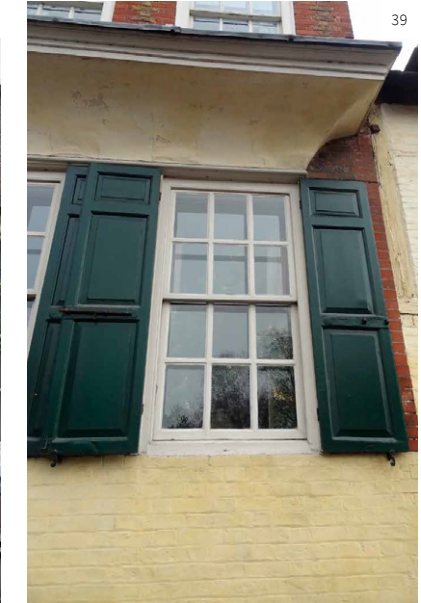
39. Late 17th to early 18th-century glazing bars were considerably thicker than later profiles.

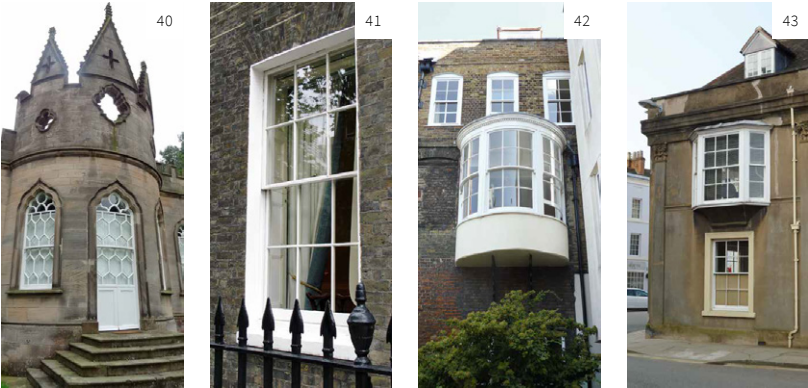
Images 40-43  
40. Elaborate mid-18th-century ‘Gothick’ windows.  
41. In 1774, further legislation in London led to sash boxes being hidden within a rebate formed in the brickwork surrounding the window opening. This, combined with very slender glazing bars gave windows a much lighter and more delicate appearance.

42. Bow windows are curved rather than polygonal in plan.  
43. Oriel windows are confined to the upper storeys so that they jut out from the wall.

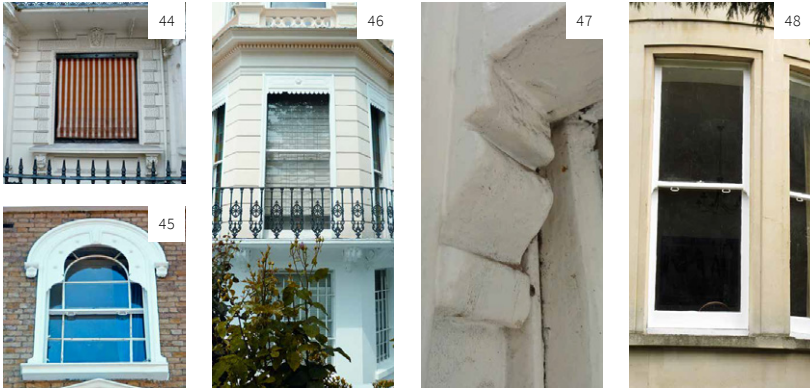
Images 44-48  
44. A rare surviving awning.  
45. Remains of cases for external blinds and awnings still exist on some Victorian buildings.  
46. Bay windows have foundations and may be one or several storeys high.  
47 & 48. In the late 19th-century vertically sliding sash windows began to make use of larger and heavier panes of glass. The weight of the glass, coupled with the disappearance of the glazing bars that had given support to the horizontal meeting rails, led to the development of ‘horns’ which strengthened the joint between the meeting rail and the stiles.

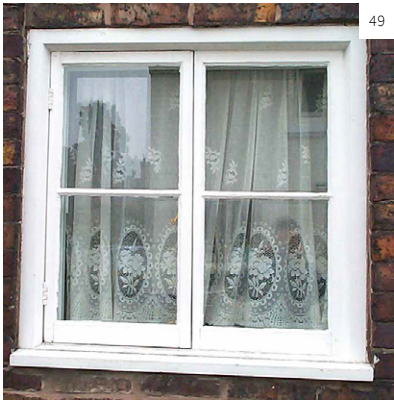
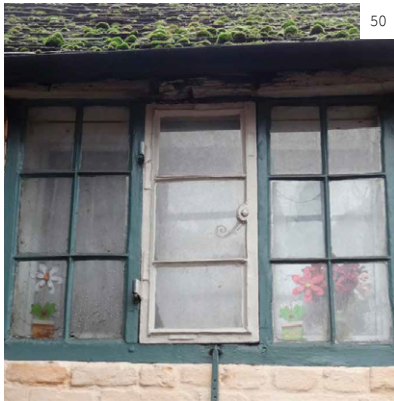
Images 49 and 50  
49. A simple 19th-century timber side-hung casement window. The uniformity of the frame proportions is maintained by the split mullion.

50. An early 19th-century casement with a later steel metal casement central light.

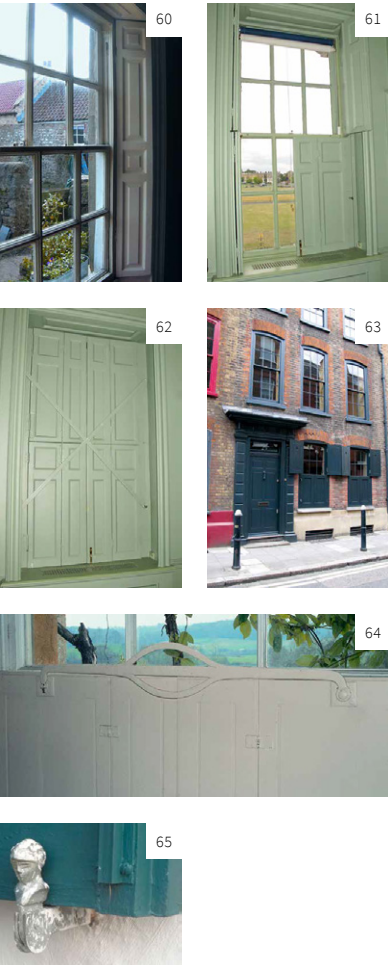
60-62. Double hung sash windows with internal shutters which fold into recesses on each side of the window. When fully closed the shutters are secured tightly with iron shutter bars.

63. External shutters from the 18th -century divided into upper and lower leaves to give greater flexibility in balancing requirements for light, ventilation and security.

From the 17th century, frame and panel construction was also used for internal window shutters and their housings or shutter boxes. The shutters usually consisted of a series of narrow leaves, which were hinged together so as to fold into the shutter box. The outermost segment, the 'back-flap', was sometimes a plain board, which could be easily cut to the exact width required on site. Counterbalanced internal shutters that slid vertically into a housing below the window cill were sometimes installed but are a comparative rarity. They can also be difficult to recognise as a result of having been sealed up.

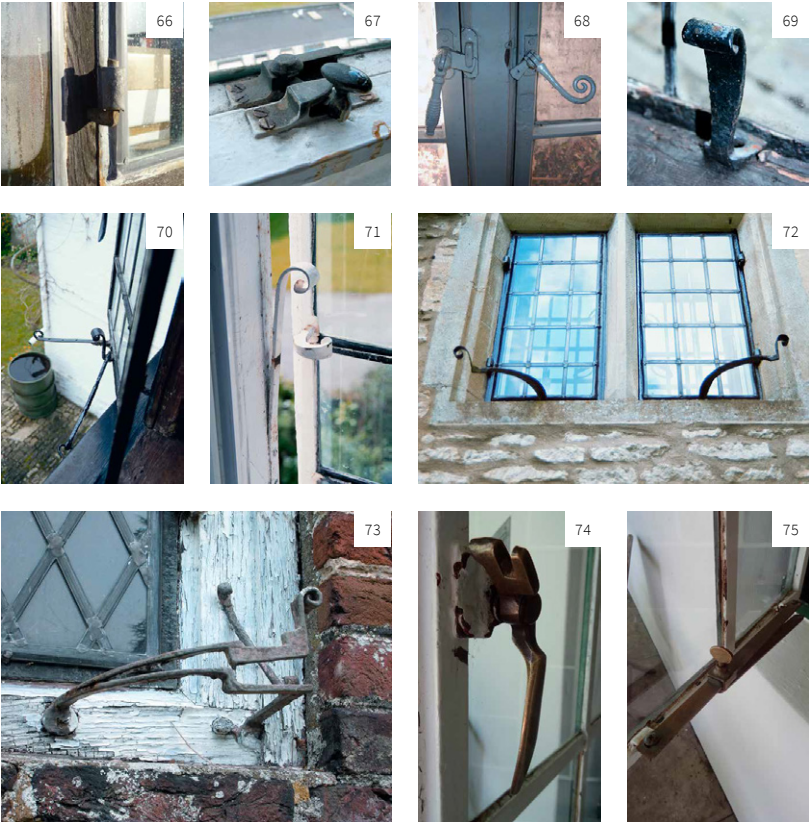
**Images 66-75**

66. A window hinge made up of a pintle and gudgeon.  
67. A 19th-century lever catch for a sash window.  
68. A cockspur catch consisting of a piece of metal bent at right angles to form a flat latch and a handle.  
69 & 70. The loop to fasten the stay which was usually on the handle. Early hook stays were attached to the frame.  
71. A spring catch which has a notch to take a bar of sprung wrought iron fixed to the frame, which will hold the window shut.  
72. Simple quadrants could only secure the window fully open.  
73. A sprung quadrant can hold a window open in almost any position.  
74 & 75: Brass fastener and adjustable stay to a 1930s steel casement.
