**Lower Campfield, Manchester**  
Lower Byrom Street, M3 4FP

**Listed Building Consent Application Condition 09**

*Lower Campfield, Manchester - Listed Building Consent Planning Application - Condition 09*

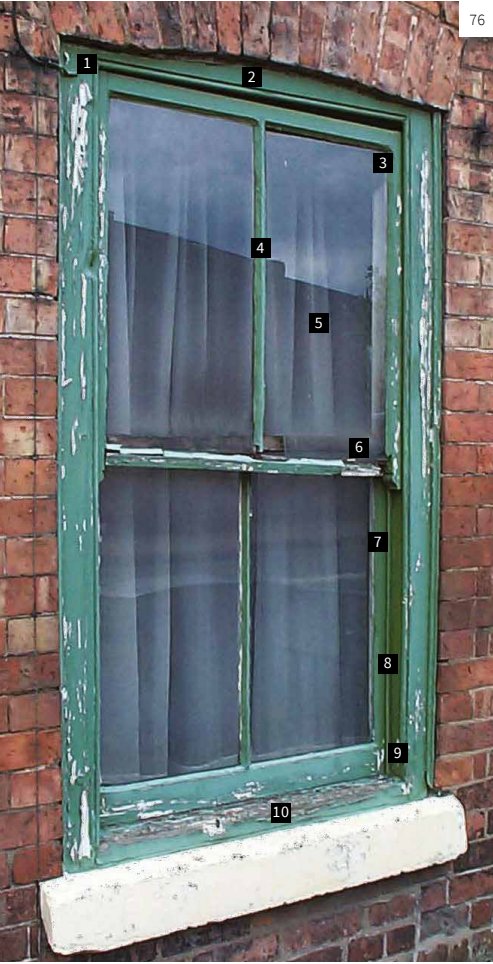
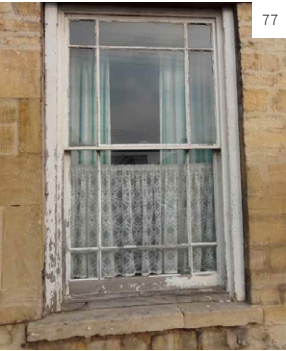
**Key to Image 76**

1. Holes drilled in frame for cable entry may admit water and cause decay.  
2. Deformation of window caused by structural movement in wall; sashes no longer fit or slide properly.  
3. Broken sash cords.  
4. Breakdown of paint and putty caused by lack of regular maintenance; this allows water to penetrate and become trapped, causing decay.  
5. Glass displaced or broken due to deformation of sash.  
6. Failure of joints, caused by timber decay due to water penetration.  
7. Opening parts of window jammed due to accumulation of paint.  
8. Worn or damaged beads, causing rattles and draughts.  
9. Decay of stile (or jamb) and outer lining at junction with cill due to water penetration.  
10. Decay of cill caused by water penetration after breakdown of paint. Water may also creep into the joint between the timber cill and the masonry sub-cill.

**Images 76-78**

76. Some of the problems to look out for when inspecting older windows.  
77. A double hung sash window lacking maintenance but still easily capable of being overhauled.  
78. Lack of maintenance has resulted in lost putties to glazing and rot at the base of the window frames all capable of repair. Cables fed through the base of the frame have allowed water to enter and contribute to the rot.

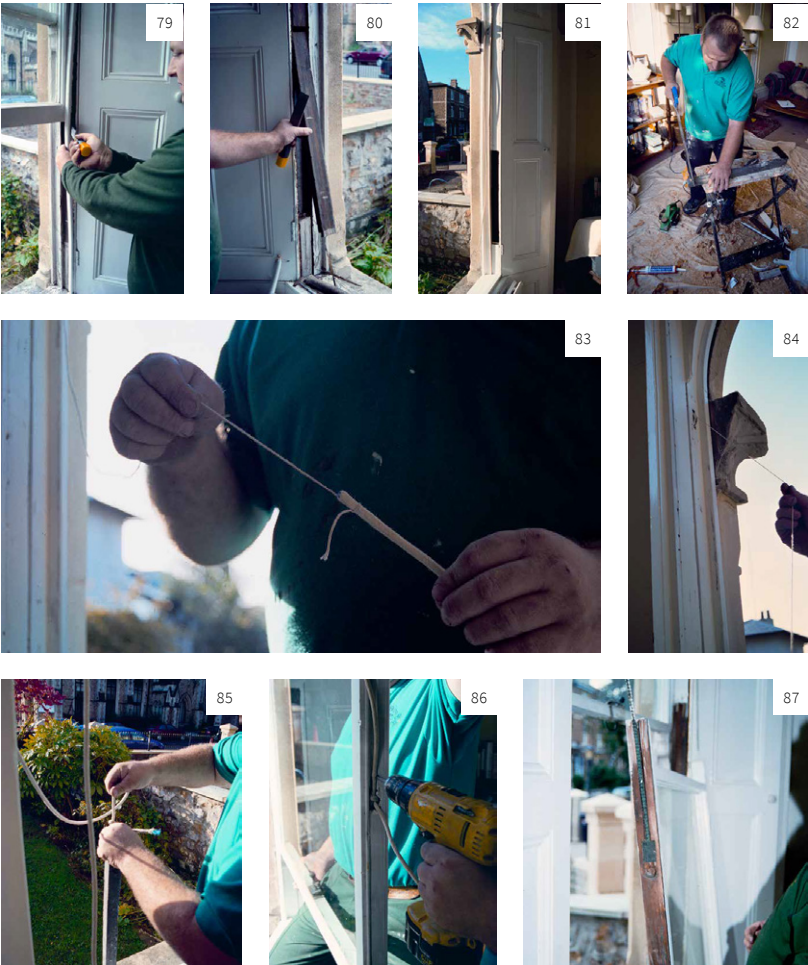
**Images 79-87 Replacing a sash cord and adjusting window operation.**  
79. Removing the staff bead to free the lower sash.  
80. Opening the sash pocket.  
81. Accessing the weights.  
82. Adjusting the weight as necessary to balance the sash.  
83. Tying a lead 'mouse' and string to the new sash cord.  
84. Running the mouse over the pulley into the weight box.  
85. Knotting the weight to the new sash cord.  
86. Fixing the cords to the grooves in the sides of the sash.  
87. Chains are replaced in much the same way being screwed into the special fitting in the sash.

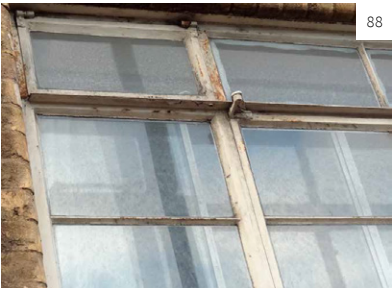
88

88. A steel window showing signs of corrosion with paint blistering.

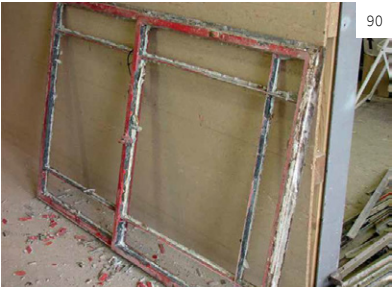
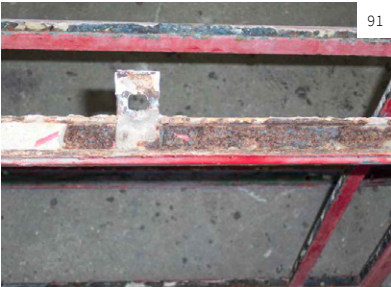
90

90-91. Preparation of a steel window for repainting- all loose paint must be removed along with any corrosion such as rust. Deep losses should be filled to stop water collecting leading to corrosion.

On ferrous metal frames, active corrosion products such as rust should be removed as completely as possible using mechanical methods.

The areas to be painted should then be cleaned with sugar soap as this improves the key. A thorough rinsing and drying is essential, particularly for frames made of ferrous metal; these should be primed to prevent flash rusting.

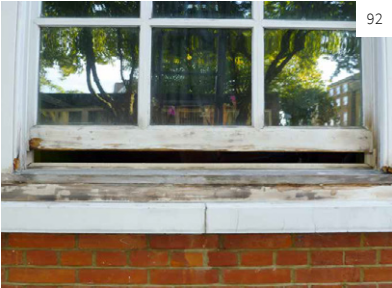
92

92. If paintwork is allowed to deteriorate on timber windows this can lead to decay of the timber as shown here to the lower more vulnerable parts of the window.

Decay in timber windows resulting from moisture penetration can be prevented by thorough painting, regular maintenance and prompt repairs. Wet rot in windows is recognisable by cracked and wavy paintwork, the timber beneath having become very soft. Replacement sections can be scarfed or pieced-in, taking care that the original profile is accurately reproduced. At the same time it is essential to remedy the cause of the dampness.

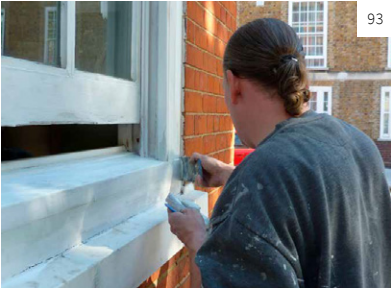
93

93. The decayed parts of the window being filled and primed ready for repainting.

Cracks and other irregularities can trap water and need to be filled before painting. Fillers need to

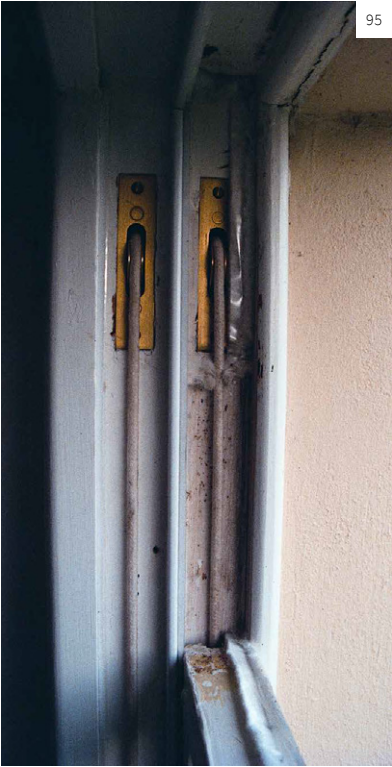
**Images 95 and 96**  
95. In a double hung sliding sash window each sash has its own pulley and cord. The parting bead separates the sashes and holds them in position. The cord and pulley need to be kept in good working order.  
96. A Fitch pattern sash fastener.

Sash cords can be cotton, jute or nylon, although sashes from the later 19th century may have a metal chain instead. The cord or chain must be taut. Waxing keeps cords flexible and prevents them from rotting. New cord is fed over the pulley wheel by attaching it to a piece of string (with a small weight at one end) which is guided over first. A sash may sometimes not work properly because the pulley has broken or has been blocked with paint, or rubbish has accumulated under the weights.

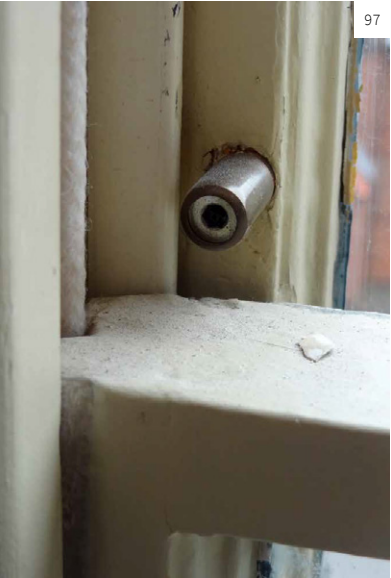
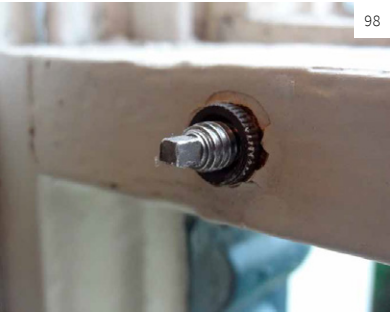
**Images 97 and 98**  
97. Height restrainers allow a degree of ventilation without compromising security.  
98. Bolts inserted into the meeting rails of a sash window keep the two sashes firmly locked in place.

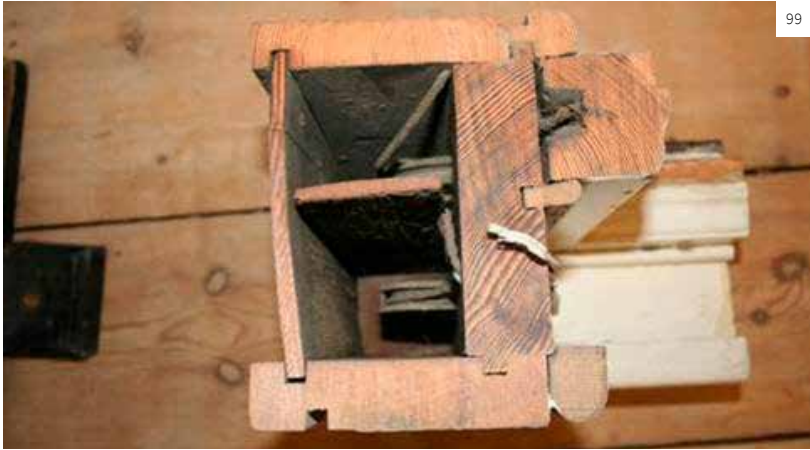
Image 99  
This section through a sash box shows the high quality of the timber used during the 19th century.

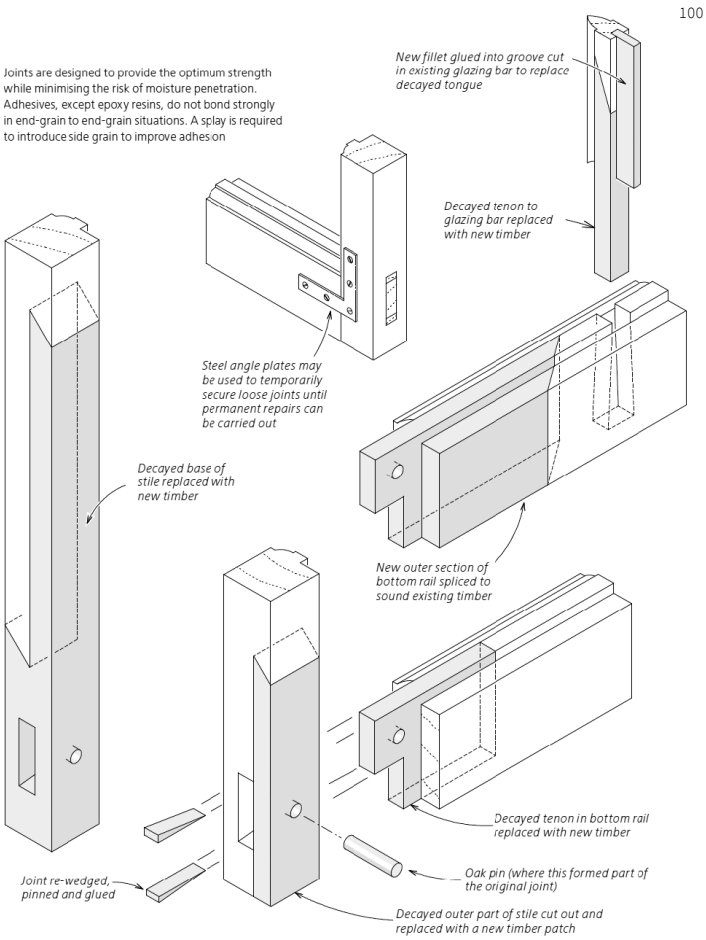
Image 100  
Typical timber-to-timber repairs to sash and casement components.

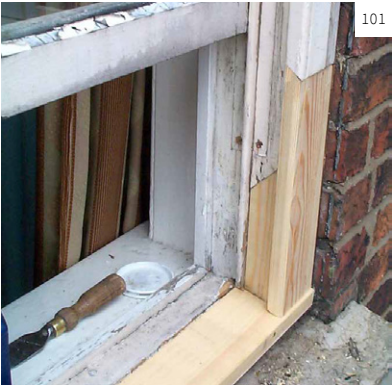
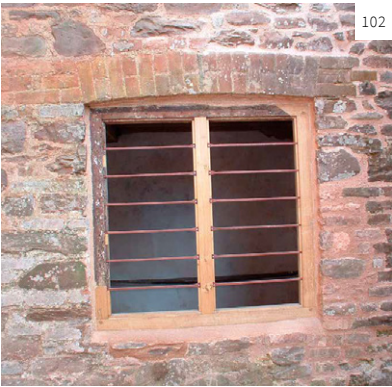
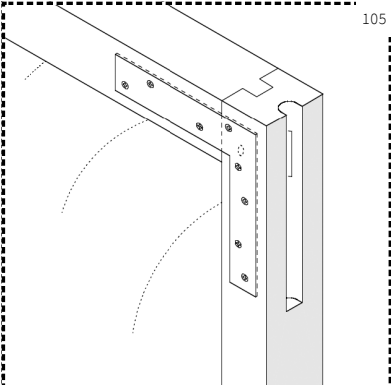
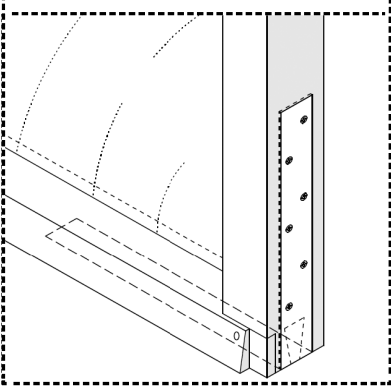
Images 101-105

101. Decayed timber at the base of the pulley stile, the outer lining and the exterior of the cill has been cut out and new timber inserts have been pieced in.
102. Careful piecing in of new timber has saved this window whilst retaining as much historic fabric as possible.
103. Splicing in new timber
104. An example of skilled joinery repair in the workshop where the central mullion and cill have been replaced.
105. Metal angle brackets are one of the least invasive ways of reinforcing damaged timber casements and sashes. They are more obtrusive than carpentry repairs, and should therefore be positioned on the interior of the frame, but they have the great advantage that the glass does not need to be removed to make the repair.

Spliced repairs should be made by cutting out rotten wood and splicing or scarfing-in timber inserts which are shaped to obtain the maximum strength and to match the existing profiles. The new timber should always be worked to the line of the existing and should follow any existing deformations in the line of the window. Excessive trimming of the existing timber should be avoided. Spliced repairs should be designed so that water is directed towards the outer face of the timber and cannot lie on or enter the repair joint. Inserts should be made from good-quality wood similar in species and moisture content to the parent timber. They should be fitted with the grain orientated to match the existing. This reduces the risk of the insert and the parent timber moving at different rates during damp and dry conditions, which could in turn cause the repaired joint to fail by splitting. Just as for any other joinery work, timber with defects such as shakes, resin pockets, knots or sapwood should be avoided for use in repairs. Modern softwood has poor resistance to decay and should be double-vacuum impregnated with preservative by the supplier.

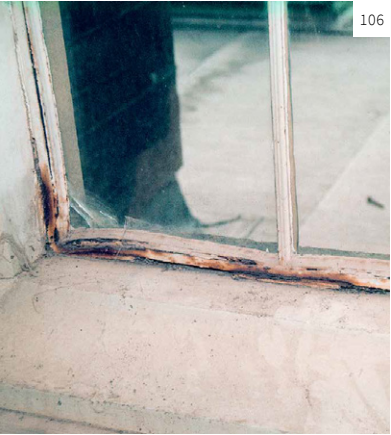
**Image 106**  
Steel window showing severe corrosion to the bottom rail of the frame and distortion from 'rust jacking' which has cracked the glass.

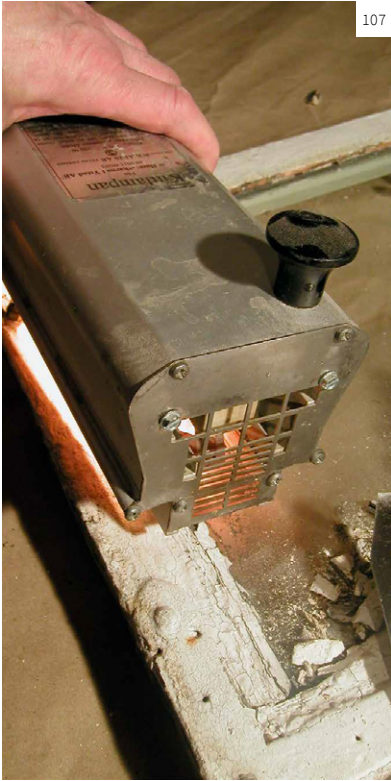
**Image 107**  
A putty lamp should be used where old putty needs to be renewed as this reduces the risk of cracking the glass.

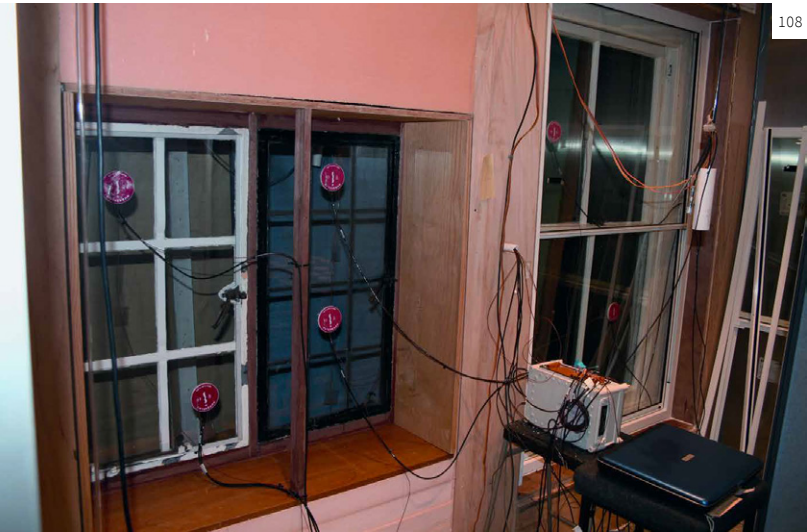
**Image 108**  
Testing windows in the climate chamber at Glasgow Caledonian University.

The heat loss from windows can vary considerably, depending on the size of the windows and their ratio to the external wall area. Heat is exchanged through windows in a number of ways: by *conduction* through the glass and materials of the frame, by *convection* through gaps and openings, and by *radiation* from the surfaces. All of these are important for thermal comfort; draughts will replace warm indoor air with cool air from the exterior, and radiant heat loss can make people within a room with large windows uncomfortably cold, even if the windows are completely sealed. A brisk winter breeze cooling the exterior glass can set up convection currents that make the room feel draughty, even if there is no exchange with the exterior.

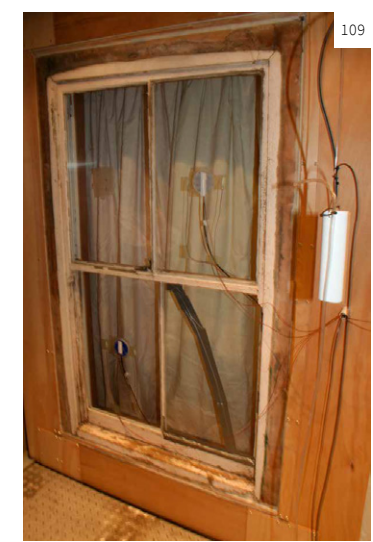
**Image 109**  
Testing windows in the climate chamber at Glasgow Caledonian University.

Where a window is clearly 'leaky' (with gaps around the frame and rails where sash windows meet) research has shown that repairing and draught proofing it can reduce air infiltration by over 80%. Further benefits can be gained simply by closing curtains, blinds and shutters and these can produce the same heat savings as double glazing. The addition of secondary glazing can also reduce heat loss by nearly 60% (and is also effective in reducing sound transmission). In multi-paned windows, secondary glazing will generally be more thermally efficient than replacing the existing glass with double glazing due to thermal bridging through the frame and glazing bars. It is also usually less expensive. Some of these measures enable buildings that retain historic windows to be *more* energy efficient than buildings whose windows are simply replaced with double glazed units.

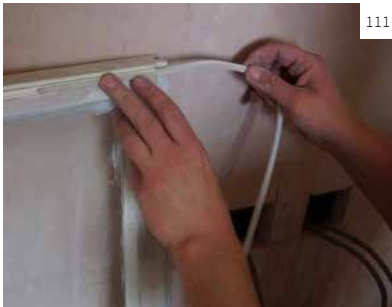
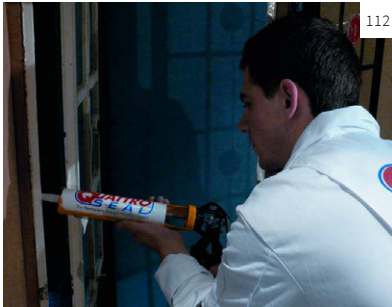
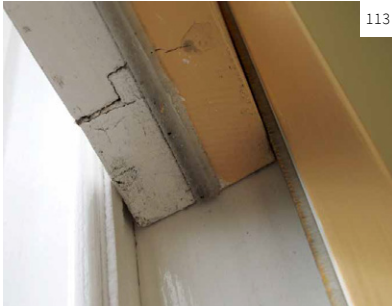
Images 111-113

111. Nylon brushes being inserted into the sash as draught-proofing.
112. Silicone being injected into gaps between the frame and casement to exclude draughts. The casement is first painted with a releasing agent.

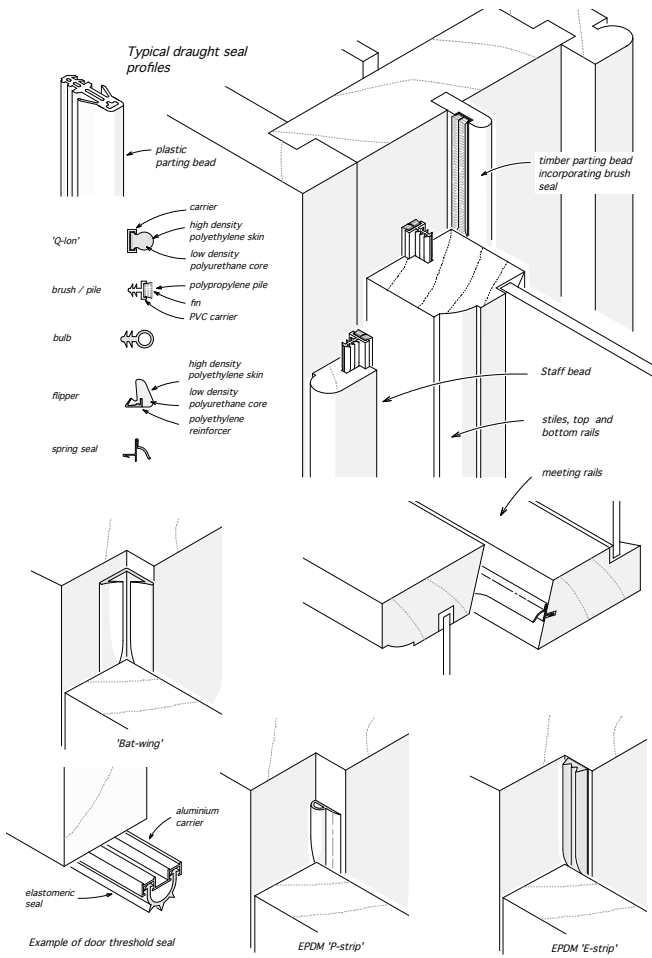
Image 114

- A. Example of draughtproofing for sash windows.
- B. Examples of draughtproofing for casements or doors.

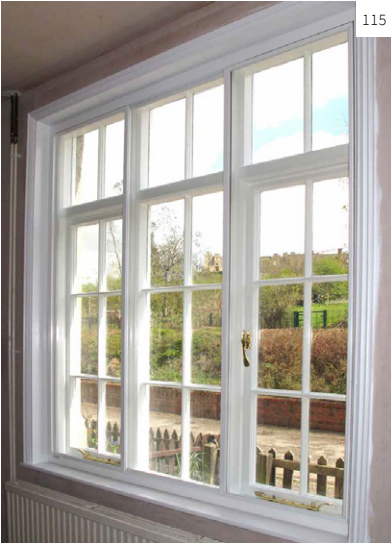
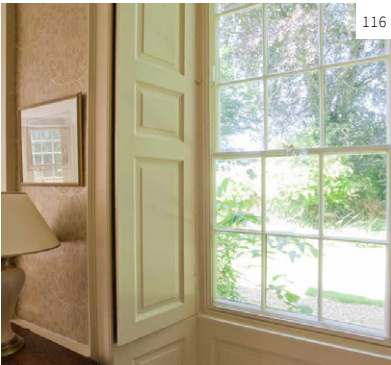
Images 115 and 116

115. Failing plastic coated aluminium double glazed windows to this listed terraced house were replaced with single glazed timber casements to the correct historic pattern with secondary glazing incorporating Low E glazing giving a centre pane U-value of 1.6w/m²K.
116. A very thin secondary glazing unit fitted alongside working timber shutters.

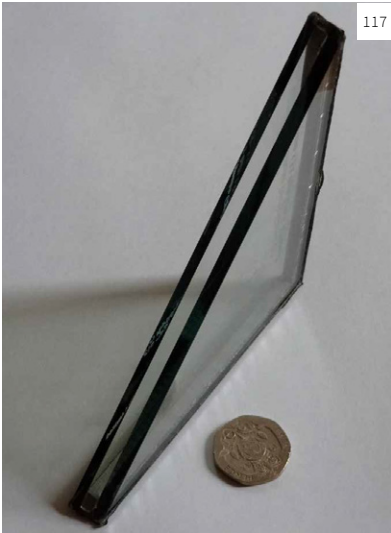
Image 117  
This slim profile IGU comprises 3mm outer glazing a 3mm gas filled cavity and 4mm Low-E inner glazing giving a total thickness of 10mm.

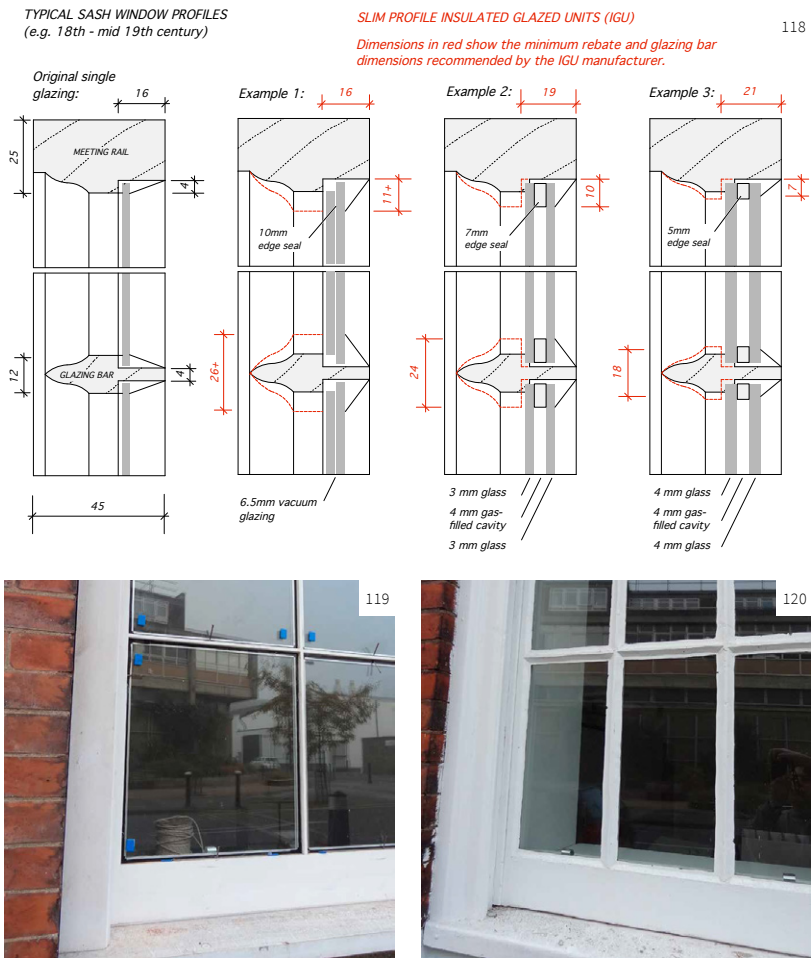
**Images 118-120**  
 118. This drawing shows the different thicknesses of insulated glass units currently available when applied to a window with slim glazing bars (Dimensions shown are in millimetres).  
 119-120. These existing windows had IGUs fitted but the width of the edge seals necessitated the painting of the glazing bars to be extended over the glass so that the seals are not visible.

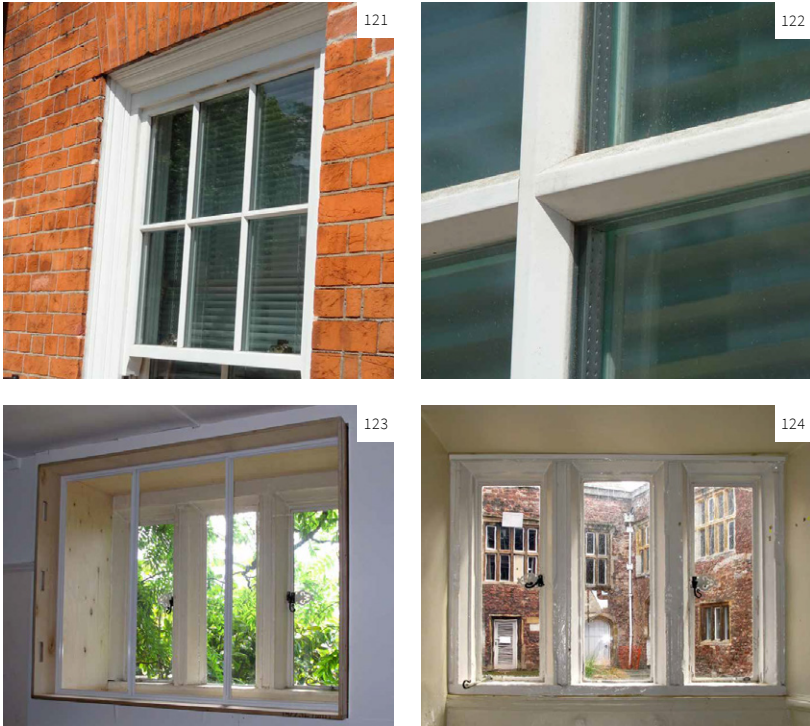
**Images 121-124**  
 121-122. All the double hung sash windows to this Victorian tenement were completely renewed with replica sash windows incorporating IGUs. The timber glazing bars have been applied onto the IGU. Although the workmanship is of a good standard the overall appearance lacks character.  
 123-124. Following a mock-up of secondary glazing units these steel windows in an older stone frame were fitted with slim IGUs as this solution had less impact on the significance of the window. There was no historic glass and the steel sections were able to accommodate the thickness of the IGUs.

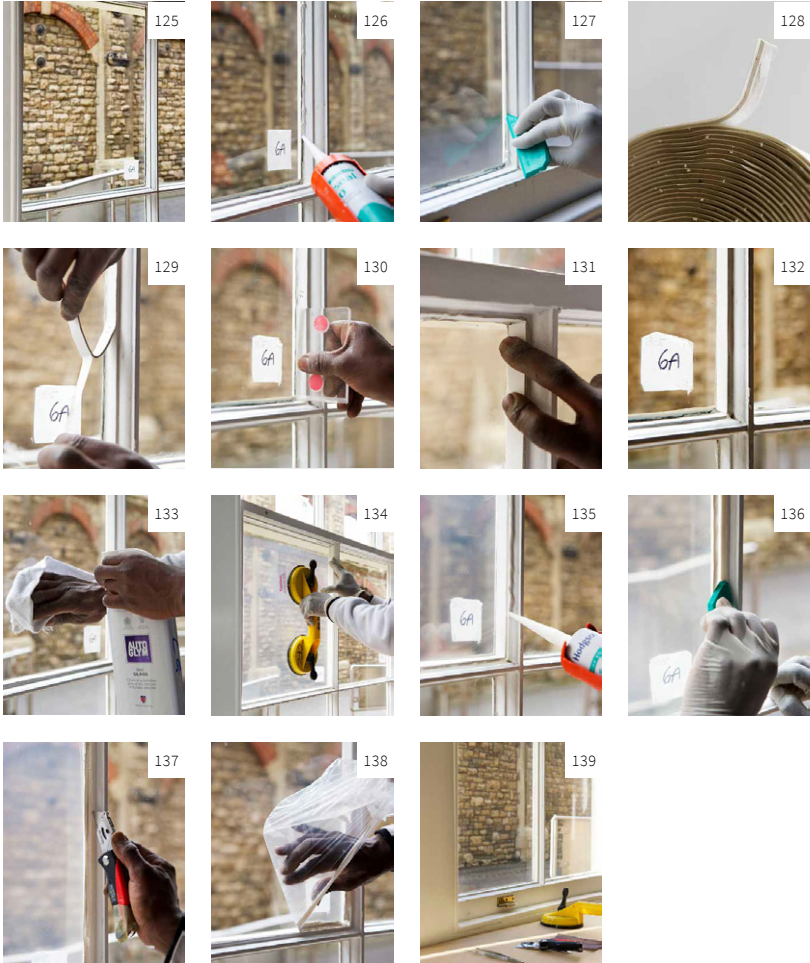
**Images 125-139**  
 125-139. This sequence shows the addition of precision cut acrylic glazing to small paned windows. This allows the existing glazing to remain in place  
 The edges need to be carefully sealed to prevent moisture entering the cavity. This is backed up with a specially developed dessicant material inserted in the cavity to prevent condensation.

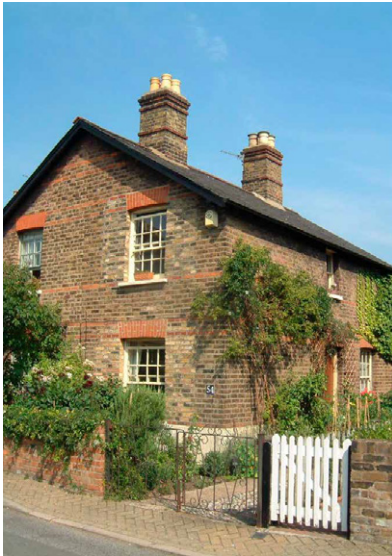
**Image 140**  
Windows of the original size and pattern have been reinstated in this south London conservation area which has involved reinstating the original masonry openings.

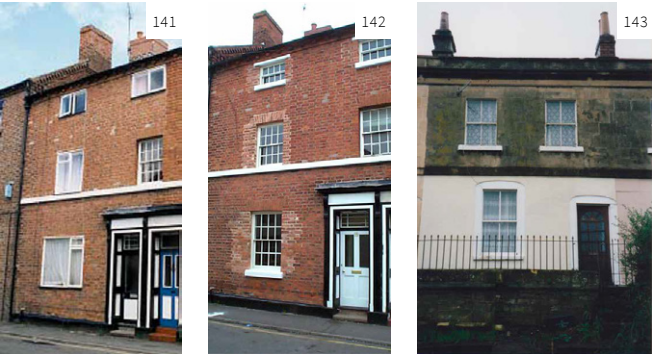
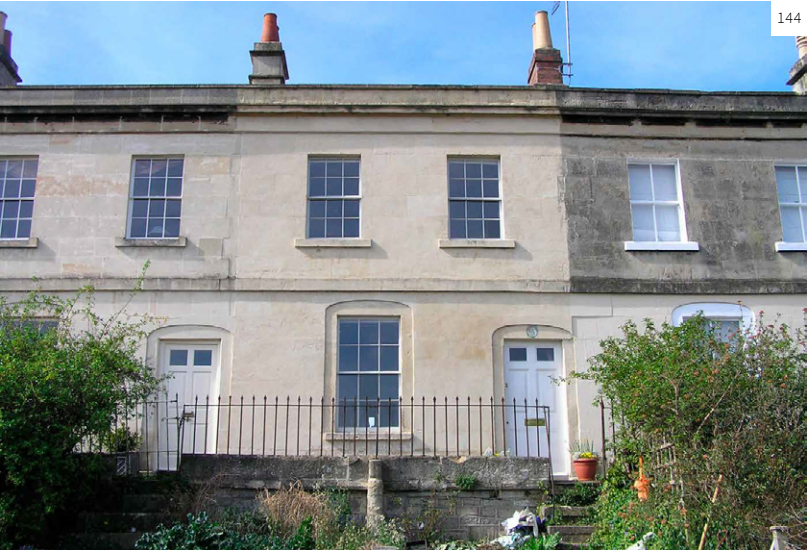
**Images 141-144**

141. Historically inappropriate windows in an early 19th century terraced house.  
142. Windows of the correct pattern reinstated along with adjusted masonry openings. The window patterns were obtained from surviving examples in the same terrace.  
143-144: The repairs and restoration works to this listed terraced house have included the accurate reinstatement of the 6-over-6 glazing pattern but
