# Proposed Alterations at The Brunswick, 97 Piccadilly, Manchester M1 2DB

## Heritage Statement

January 2024

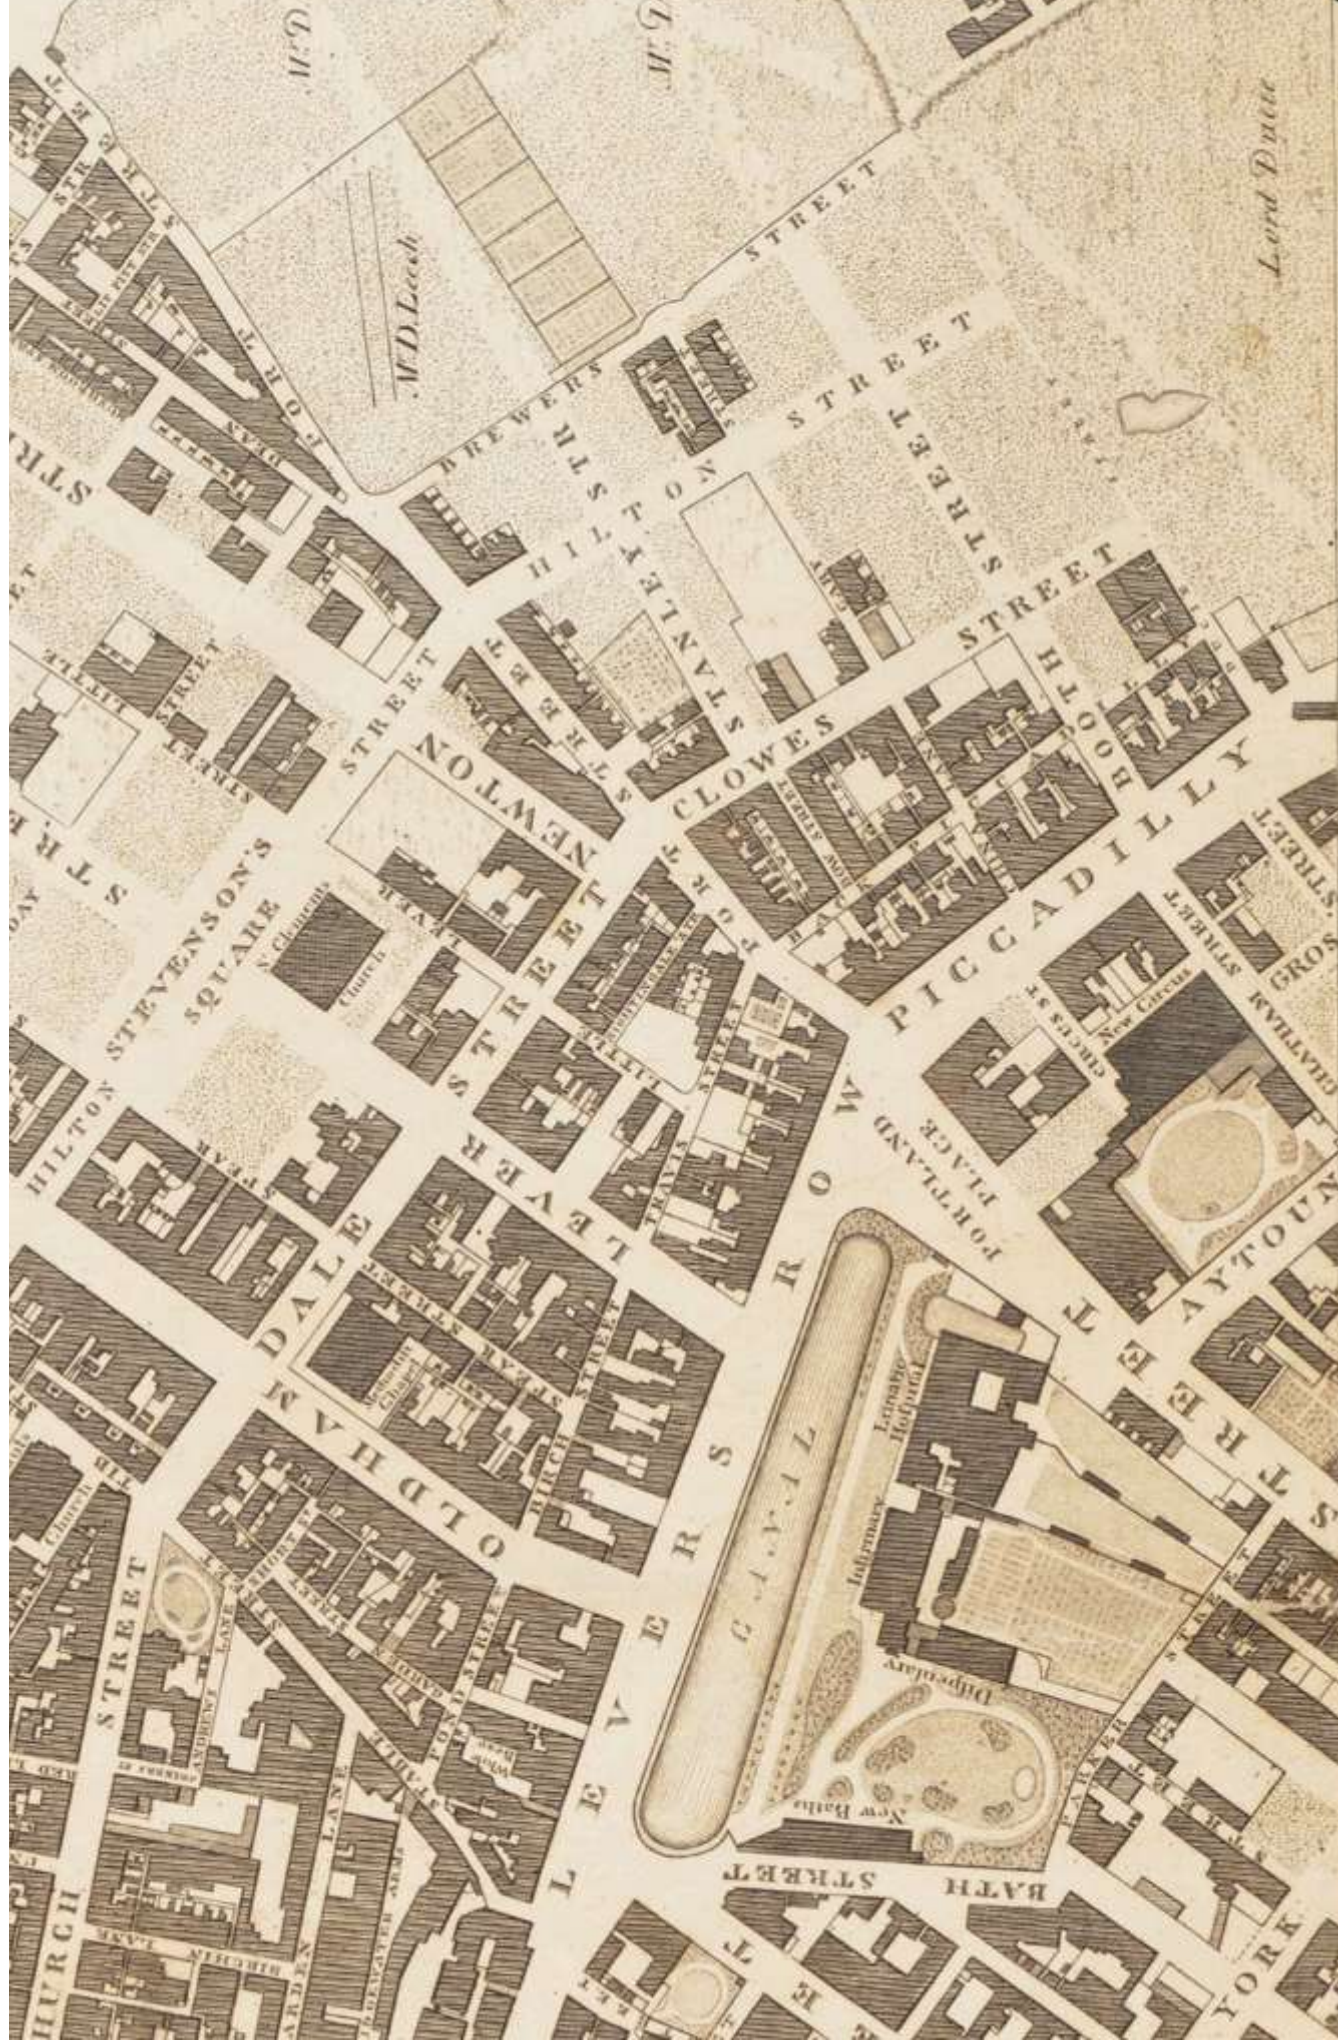
**Figure 3.** William Green's map of 1794. Paton Street was then known as Booth Street, and the building now known as the Brunswick is shown. This is evidence that it is a late 18<sup>th</sup> rather than an early 19<sup>th</sup> century building.

The building (The Brunswick Hotel and 2 & 4 Paton Street) was Listed Grade II in 1974. The List description states that it is early nineteenth century, but it is shown on William Green's map of 1794 (Figures 3 & 7) but not on a plan of Manchester dated 1772, and so must date from the late eighteenth century and probably from shortly before 1794. The description simply states 'Interior altered'.

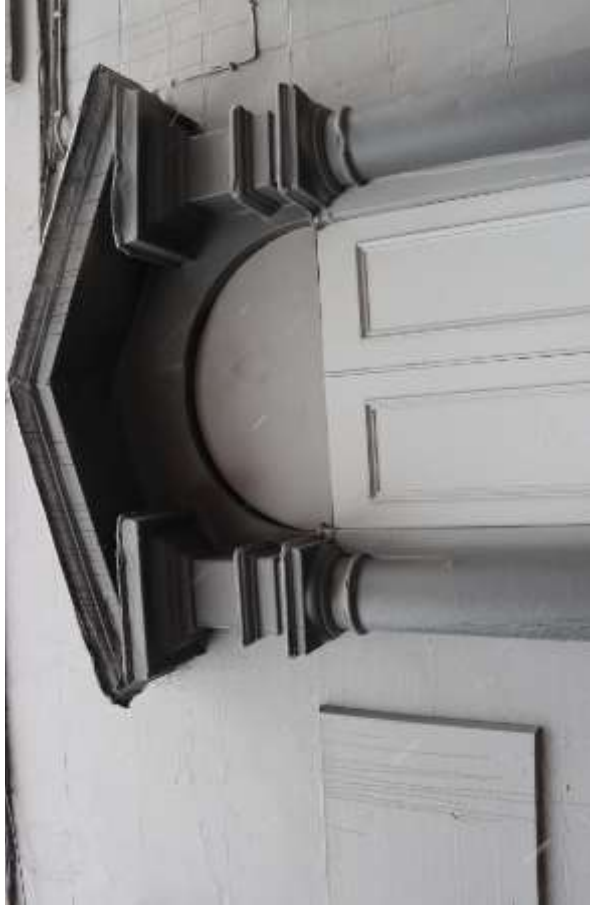
**Photograph 11.** The left-hand doorcase on the Paton Street elevation.

The stucco facade to Paton Street must post-date the 1840s conversion works, with the lesser window heights to the two left-hand bays perhaps indicating that this part of the building has been converted from the late 18<sup>th</sup> century building on the corner with Back Piccadilly. The Tuscan doorcases could date from the 1790s, but their positions in the rebuilt facade make it more likely that they date from the 1840s, perhaps replicating an earlier doorcase at the front of the building. Around 1840 there is an overlap between late Georgian and early

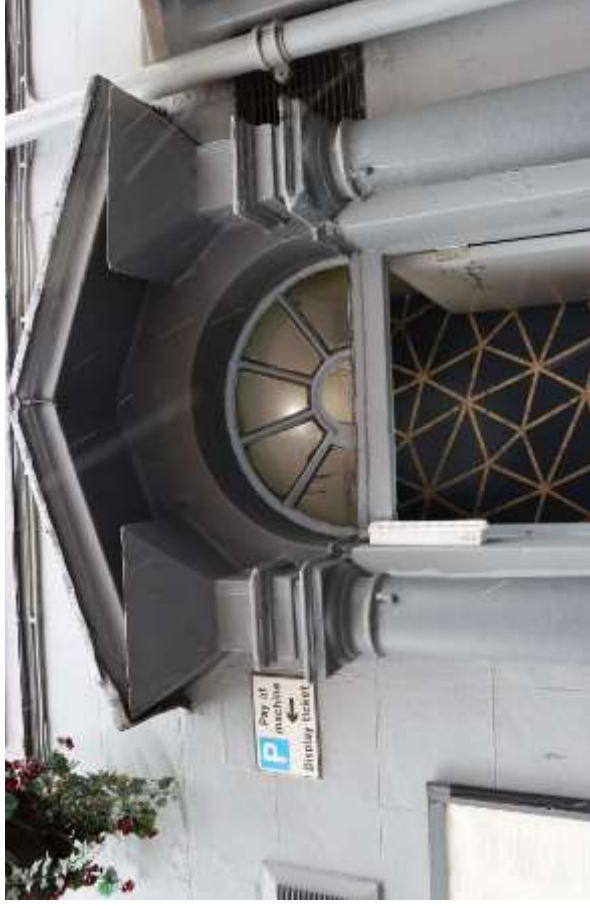
**Photograph 12.** The middle doorcase on the Paton Street elevation.

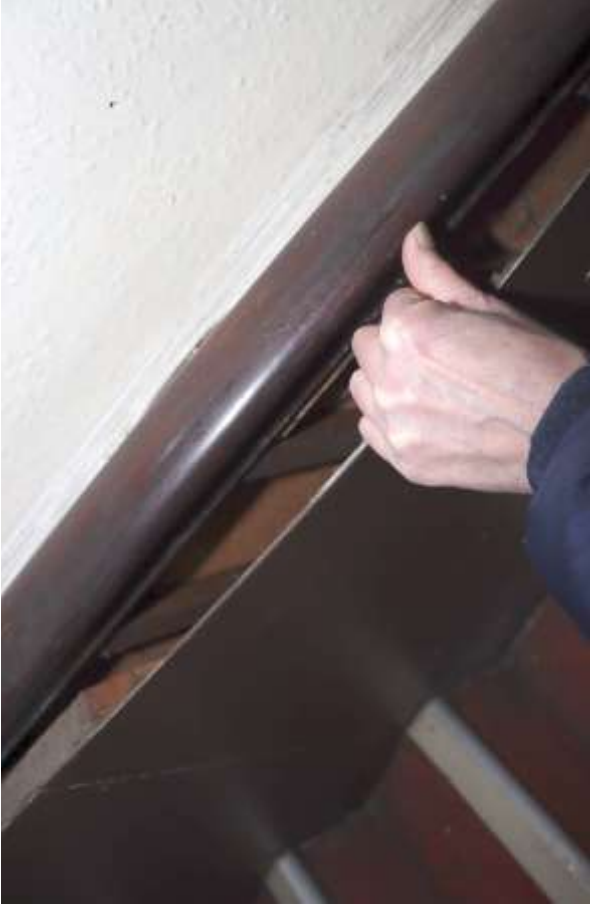
**Photograph 22.** The balustrade to the staircase that leads from behind the bar in the pub to the first floor.

The only internal evidence of a late eighteenth century origin for the building visible on the ground floor is a balustrade to the staircase that is now accessed from behind the bar area. This leads up to the first floor and has a stick balustrade that is now covered with plywood (Photographs 22 & 23) and has a newel treated as a modified version of a Tuscan column. The lobby at the bottom of the staircase is much altered, but has part of a moulded plaster cornice remaining.

A staircase that rises from the ground to the first floor behind the bar area probably dates from the 1790s and so is one of the few surviving original features. It is almost unrecognisable now because the balustrade is covered

with a plywood panel and treads are covered with vinyl with aluminium nosing. An octagonal newel remains. Its retention and restoration would enhance the historic character of the building.

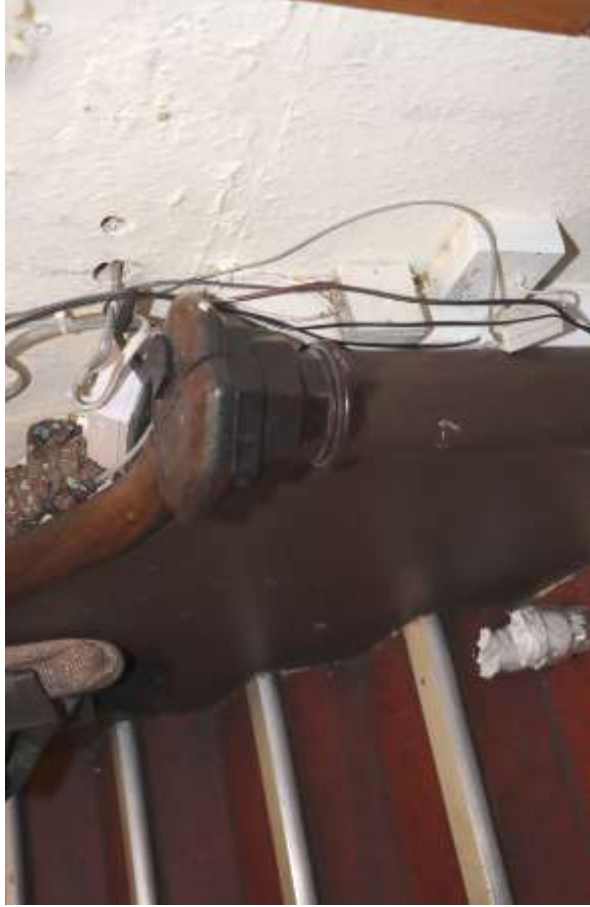
**Photograph 23.** The newel post to the staircase that leads from behind the bar in the pub to the first floor.

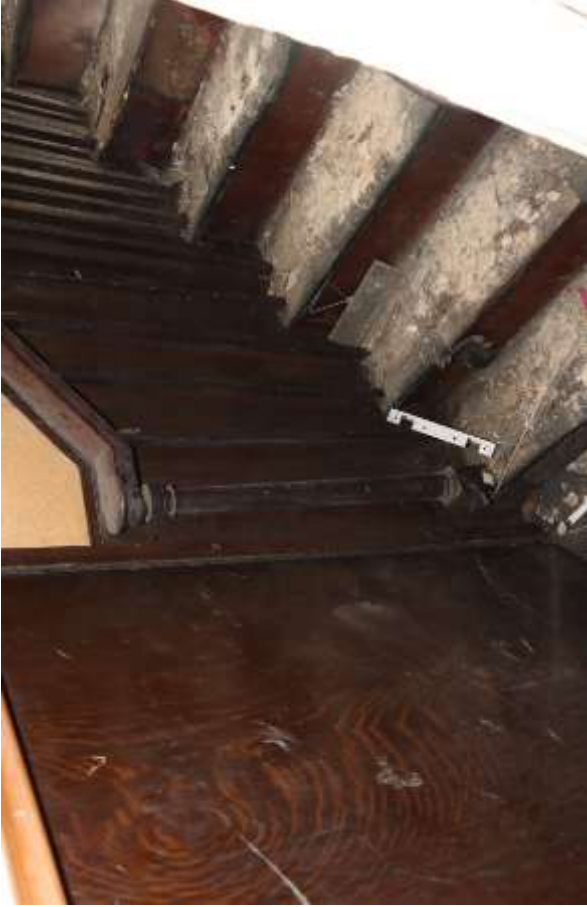
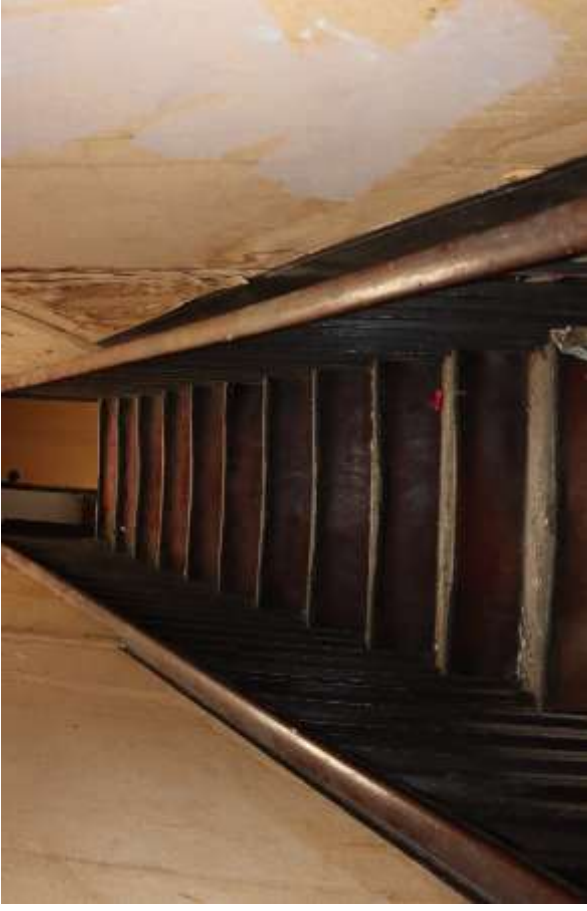
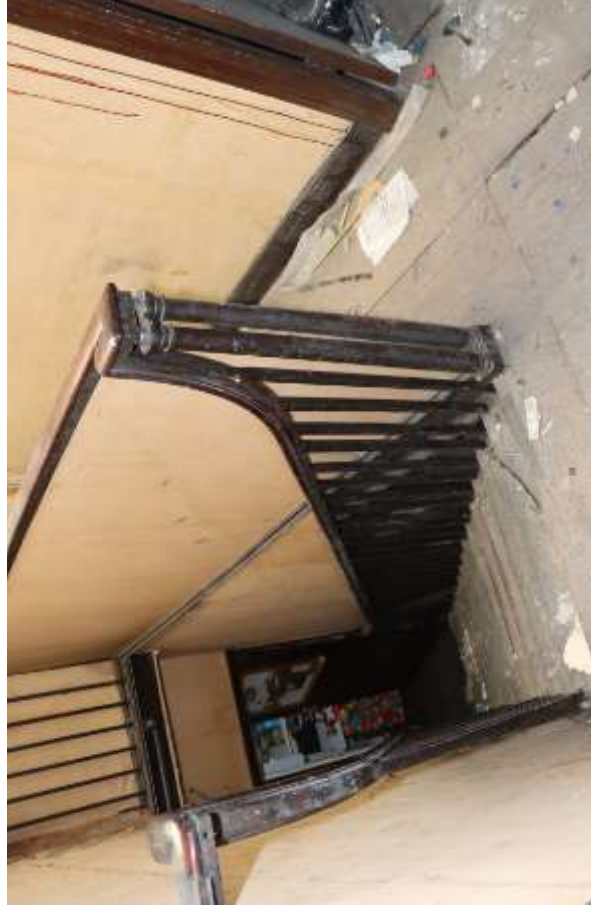
**Photograph 25.** The staircase from the first to the second floor in the front part of the building.

**Photograph 26.** The staircase from the first to the second floor in the front part of the building.

**Photograph 27.** The staircase from the first to the second floor in the front part of the building.

The staircase from the first to the second floor is of more interest (Photographs 25, 26 & 27), as it has stick balusters, ramped mahogany handrails, Tuscan columns as newels, and a second floor landing balustrade.

It is no longer proposed to remove the upper staircase at the front of the building, linking the 1<sup>st</sup> and 2<sup>nd</sup> floors. Although it is a common type of staircase with stick balusters and not of outstanding quality, it is one of the few remaining original internal features.

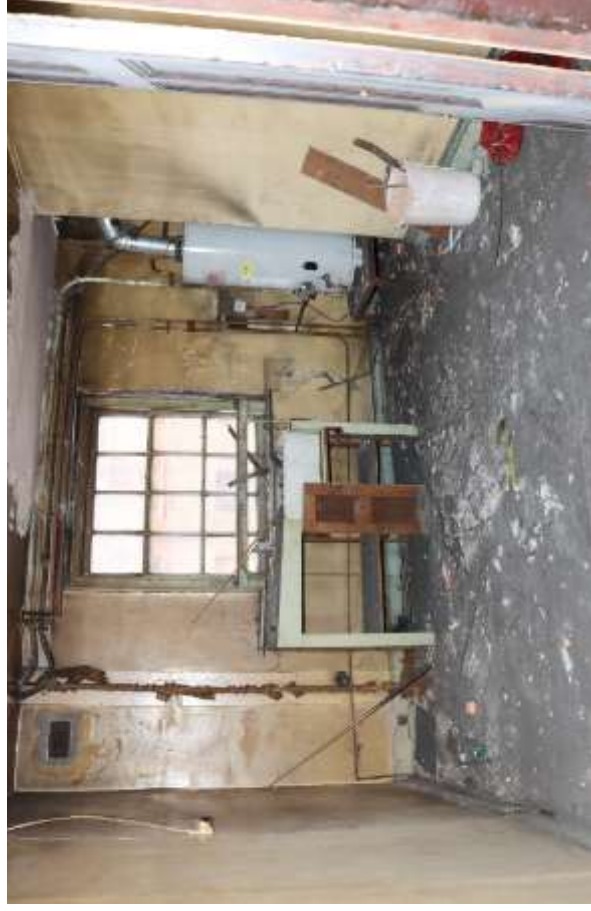
**Photograph 28.** A second floor room, with a 4 over 8 sash window on the Paton Street elevation.

On both floors the remaining sash windows have simple architraves. The sashes themselves and the external appearance will be unaffected, and matching architraves will be provided to the internal secondary glazing.

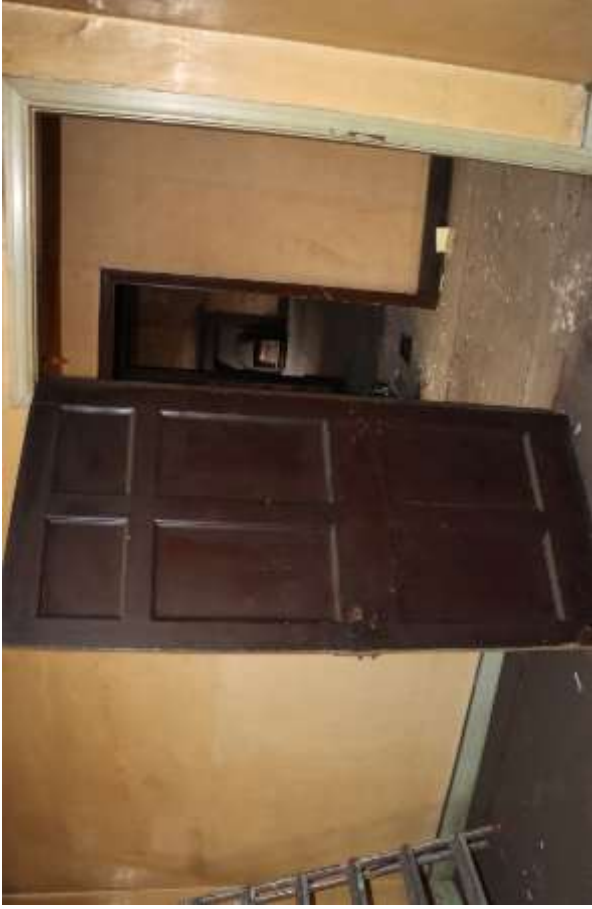
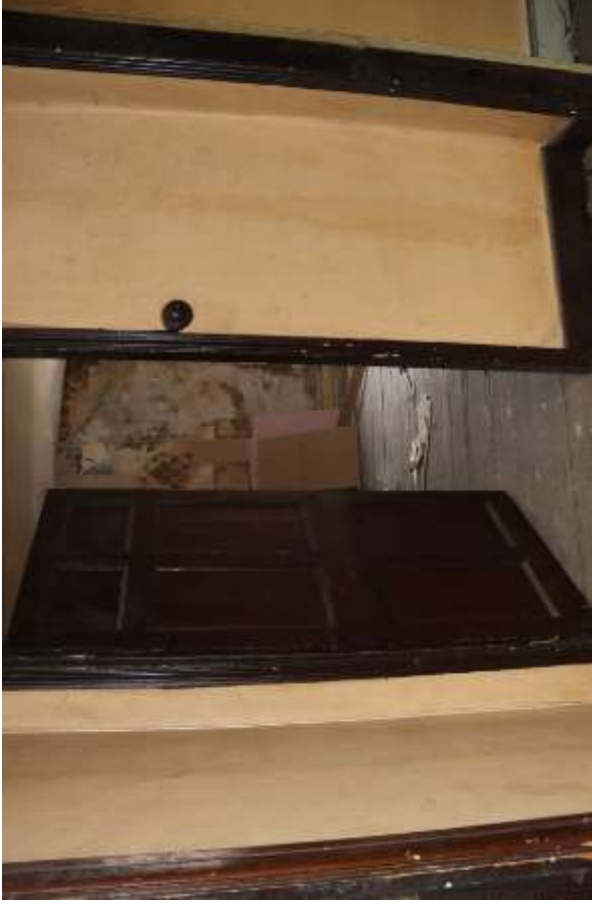
**Photograph 29.** A 6-panel door on the second floor.

**Photograph 30.** A 6-panel door on the second floor.

The second floor to this part of the building has been disused for a long time. Two six-panel doors and a fireplace that has a hob grate are probably original, as is a second fireplace that now has its grate concealed. The locations of these are shown on the plan (Figure 15). The original room layout is more recognisable at the front of the building at this level, but has also been altered by the addition of lobbies giving access to an external fire escape and by a WC extension. It is probable that the late eighteenth century layout included front and back bedrooms on the south side of the building, a front bedroom on the north side, a staircase landing, and two rooms on the north side of the landing.

The second floor has also been altered greatly and is now partly semi-detached. It does retain two fireplaces in the front part of the building that probably date from the 1790s, and these will be retained and repaired. Two six-panelled doors also remain. These are unremarkable but are evidence of the pre-Victorian origins of the building and will be retained with their fire resistance upgraded by covering their plain sides.

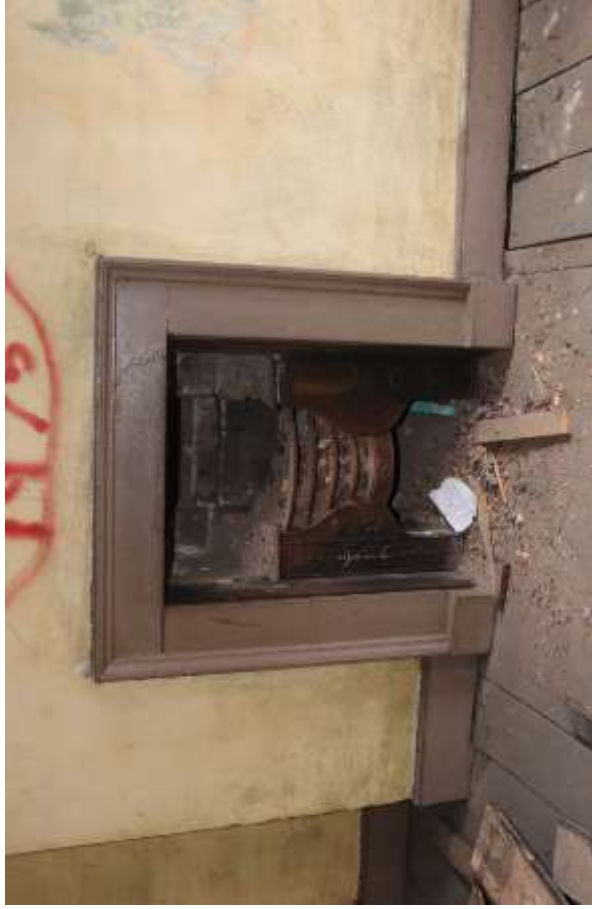
**Photograph 31.** A fireplace with a hob grate, in the southern second-floor room on the Piccadilly elevation.

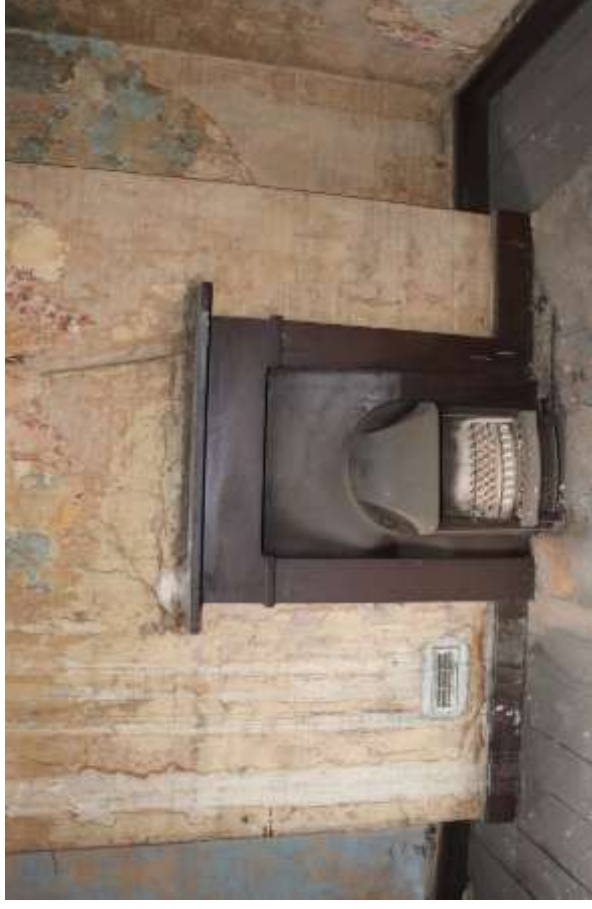
**Photograph 32.** A fireplace in the southern second-floor rear room.
