## Heritage Design & Access – William Kay House

February 2025

This Heritage Statement is intended to support an application for a Listed Building Consent made by Halliday Meecham Architects on behalf of our Client, The University of Manchester, for consent to refurbish William Kay House on Oxford Road.

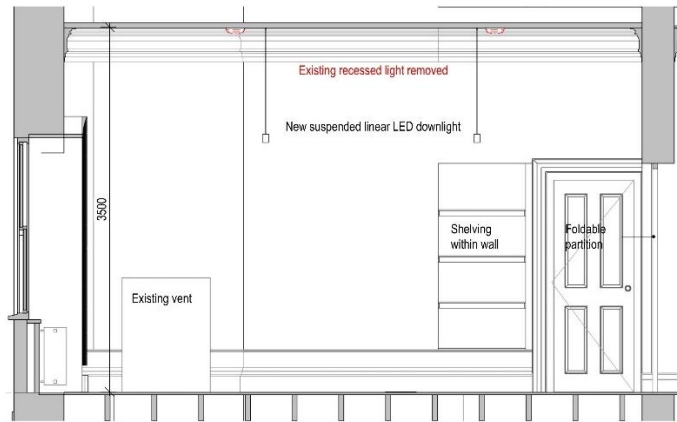
G.007a Hotdesk - Elevation A

- Localised repairs to cornices, walls, ceiling where required to make good. See Figures 14 and 16 for example of cornicing.
- Walls and ceilings to be painted in line with suitable heritage colourways. Colour TBC by Architect and Client
- Cleaning of doors, woodwork and mouldings. Localised spot decoration where required to ensure that existing detail is retained. See Figure 22 for example of shuttering to windows
- Removal of existing hooks and associated making good of the walls.
- New flooring to be laid with protective underlayer to ensure existing floorboard condition is retained.

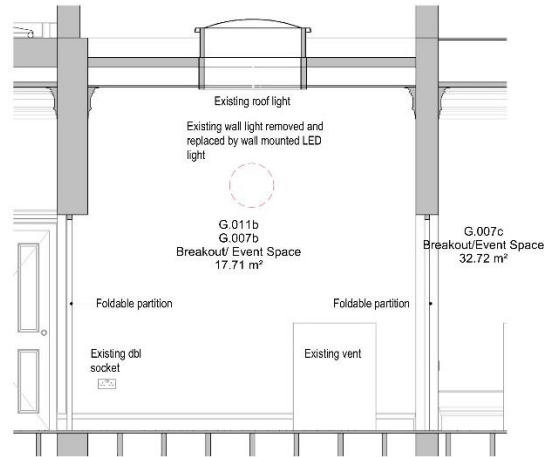
G.007b Breakout - Elevation A

- Localised repairs to cornices, walls, ceiling where required to make good. See figure 27
- Walls and ceilings to be painted in line with suitable heritage colourways. Colour TBC by Architect and Client
- Cleaning of doors, woodwork and mouldings. Localised spot decoration where required to ensure that existing detail is retained
- New flooring to be laid with protective underlayer to ensure existing floorboard condition is retained.

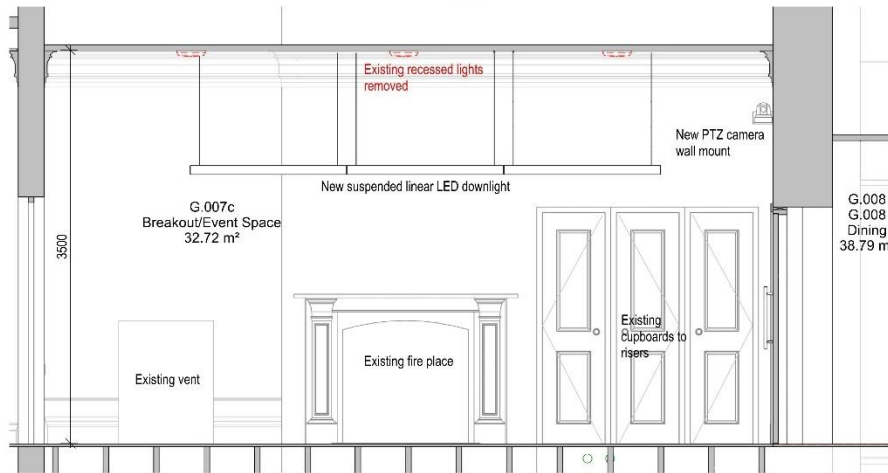
G.007c Breakout - Elevation A

- Localised repairs to cornices, walls, ceiling where required to make good.
- Walls and ceilings to be painted in line with suitable heritage colourways. Colour TBC by Architect and Client
- Cleaning of doors, woodwork and mouldings. Localised spot decoration where required to ensure that existing detail is retained
- New flooring to be laid with protective underlayer to ensure existing floorboard condition is retained.

In person and hybrid event and seminar space with dedicated PC, Solstice wireless and cabled laptop connectivity to large format display screen and speakers. 2x pan, tilt, Zoom (PTZ) cameras for hybrid events and live streaming via Zoom and MS Teams 2x handheld and 2x lapel wireless microphones for voice reinforcement in the room and for hybrid/live streaming.

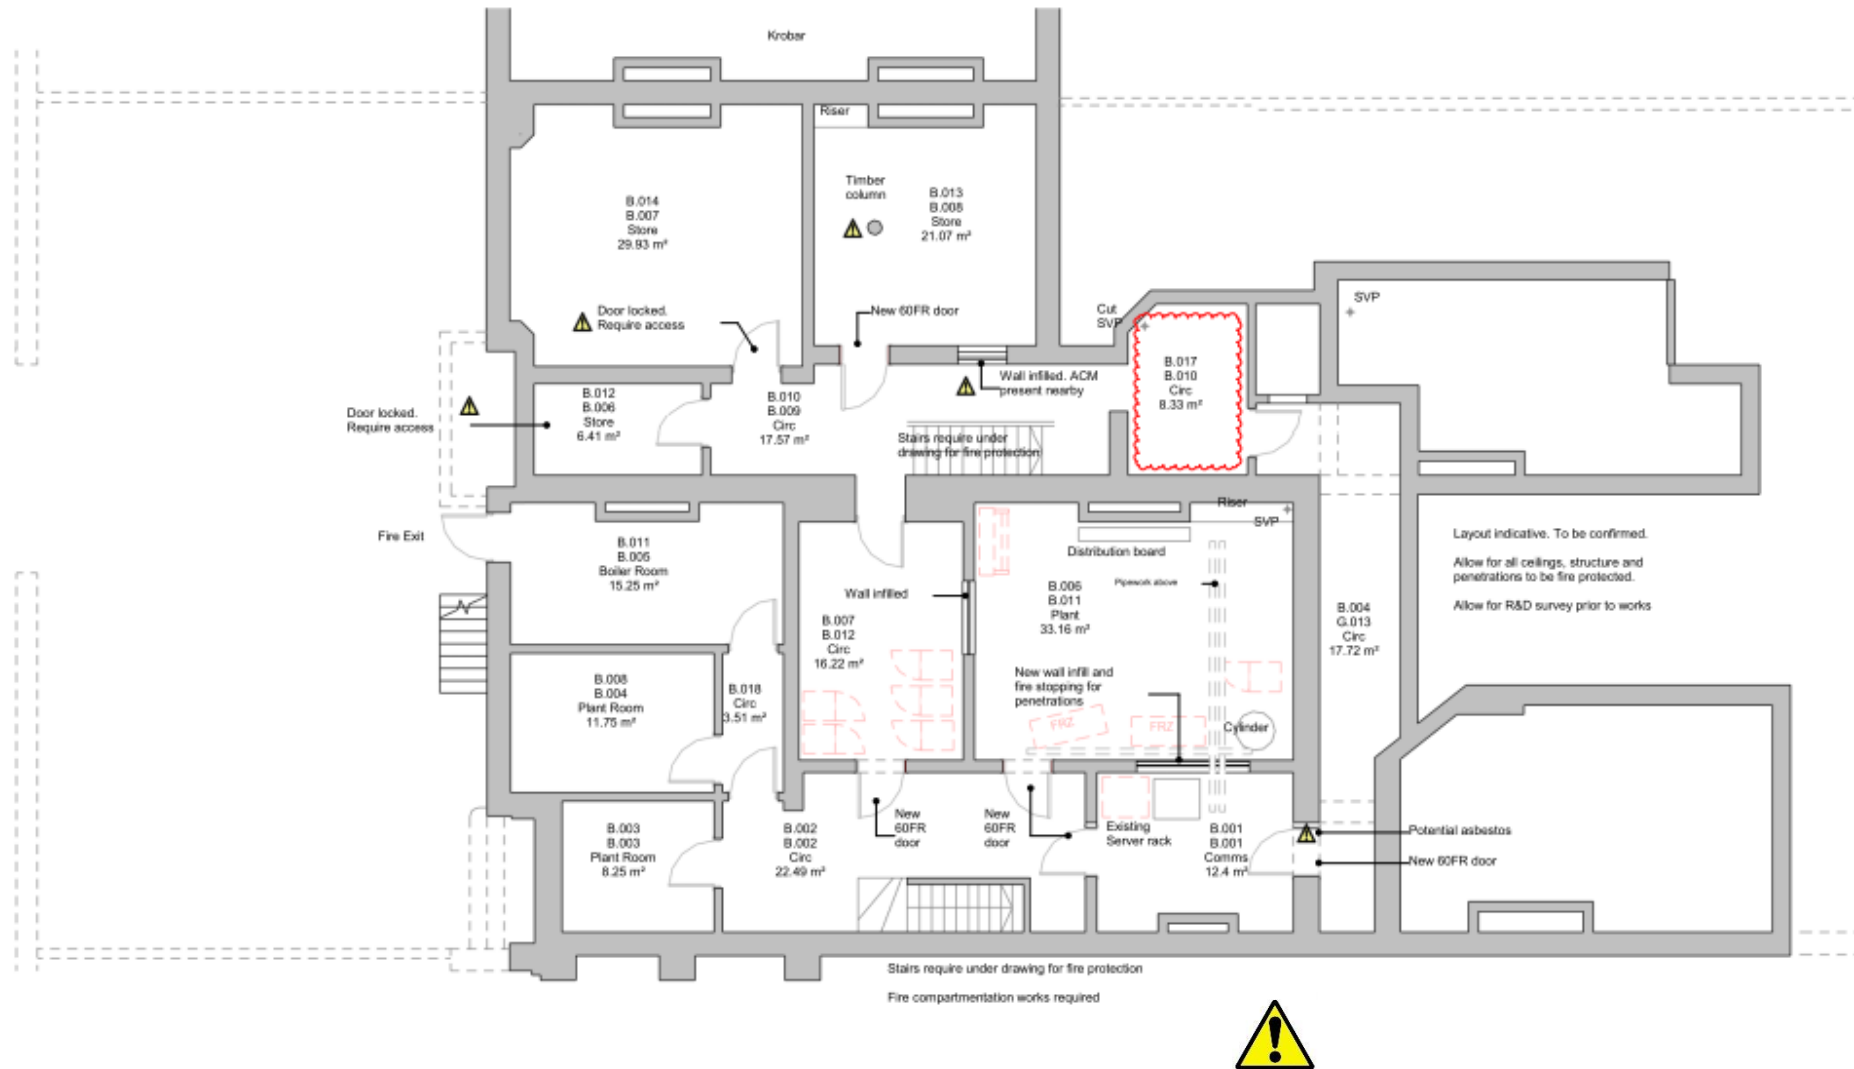
### Level -01

Wall infills and fire stopping required for penetrations of mechanical or electrical equipment.

Extent of works in relation to Fire Compartmentation subject to Stage 4 design process, review with Building Control, review with UoM Fire Officer, and Fire Consultant if required

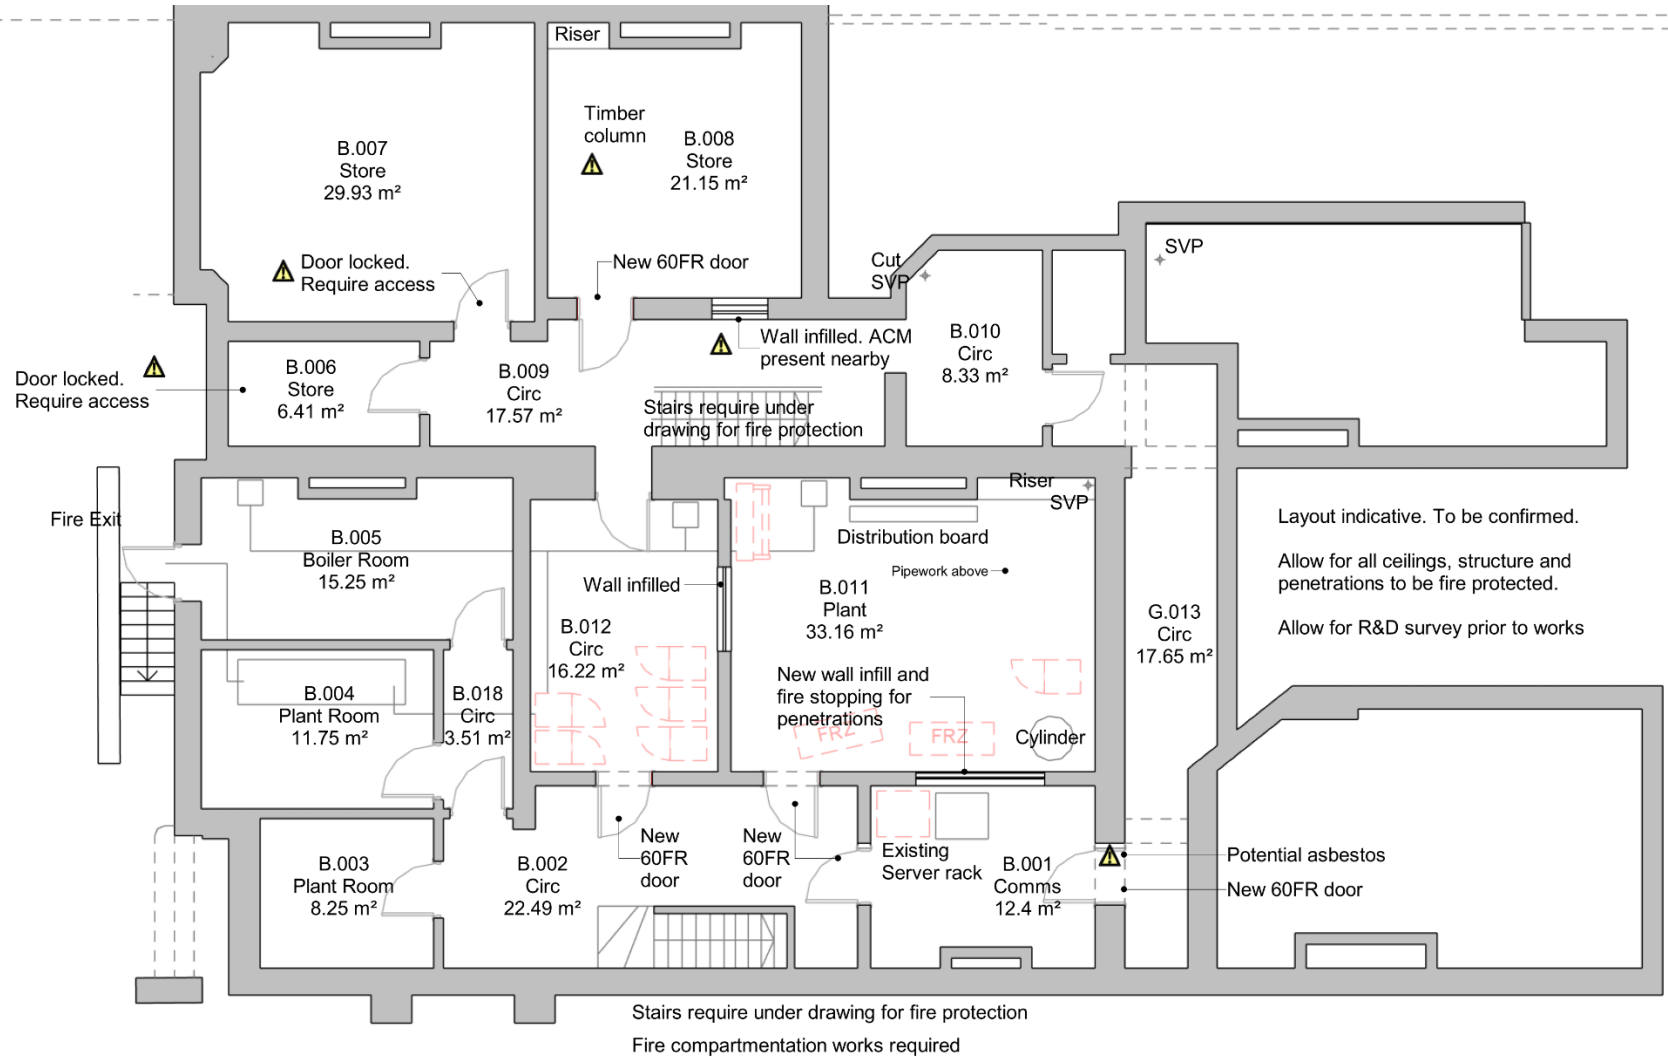
## Basement Works

Fire remedial and compartmentation works required. A new compartmented commas room is to be provided. All items have now been removed to reduce fire and access risk.

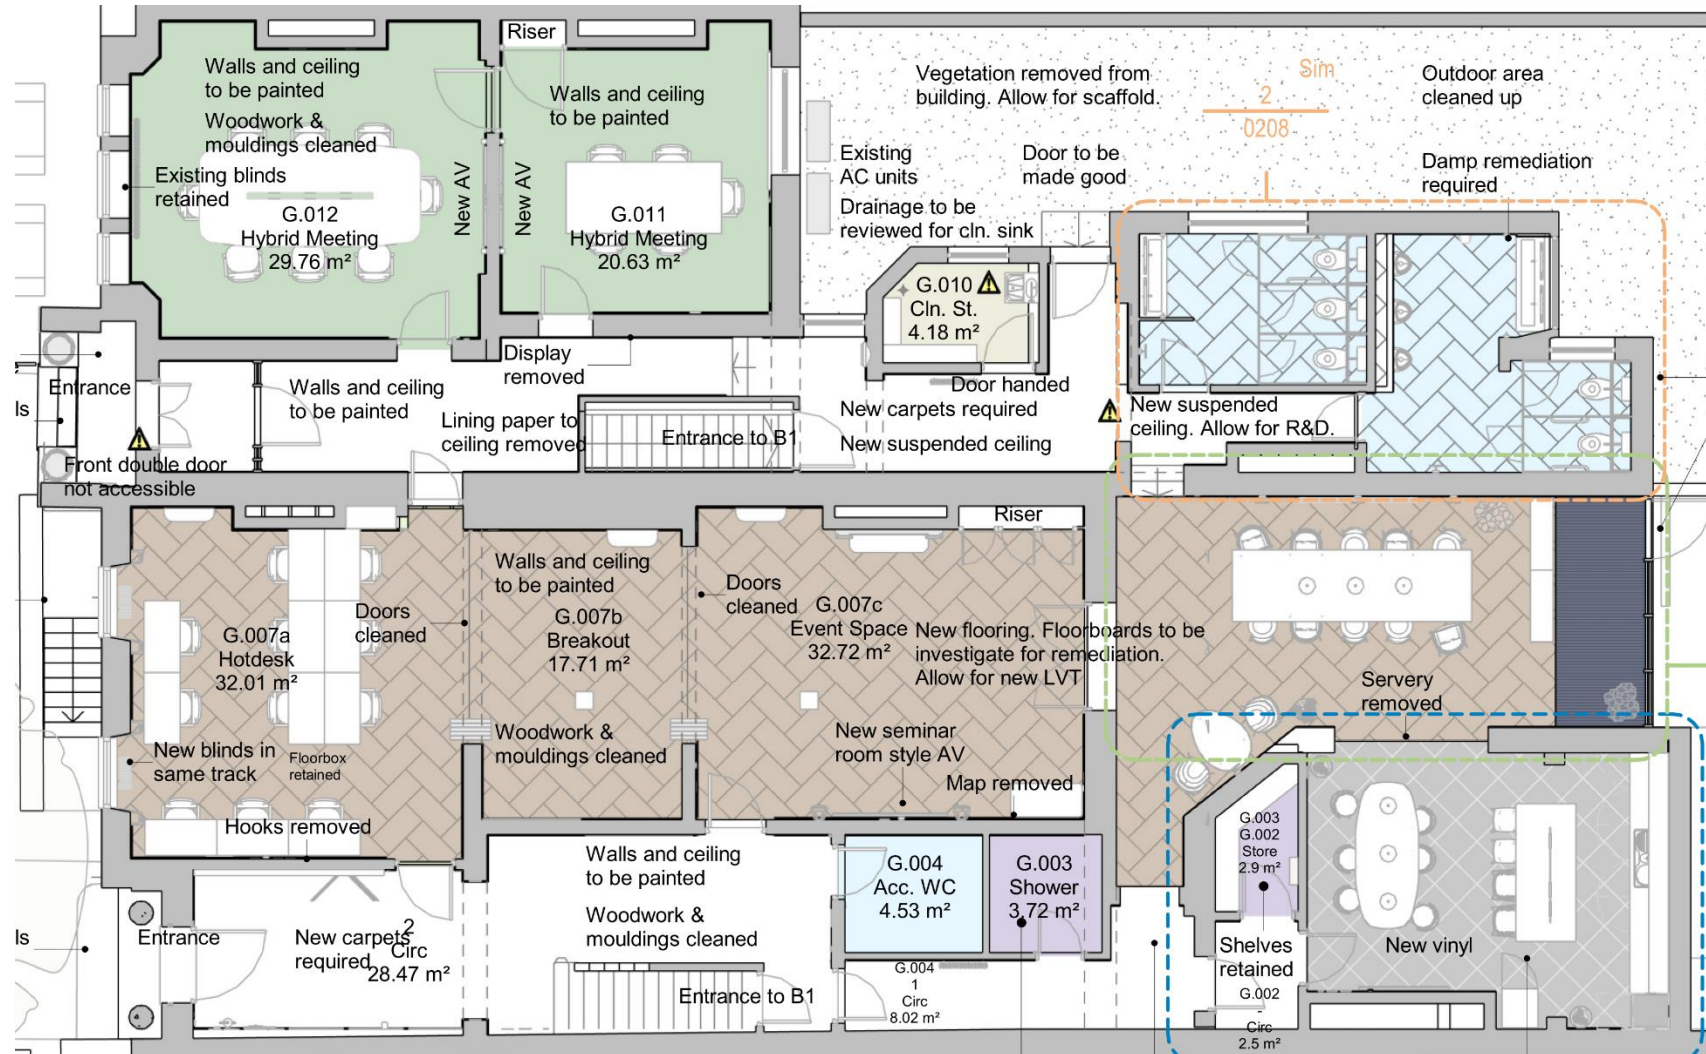
## Level 0 (Ground Floor) Works

The ground floor is proposed for communal spaces comprising of meeting rooms, hot desking, dining, WCs, kitchen and a new shower. The end users have confirmed their requirements for new AV and preferred floor finishes for the main spaces.

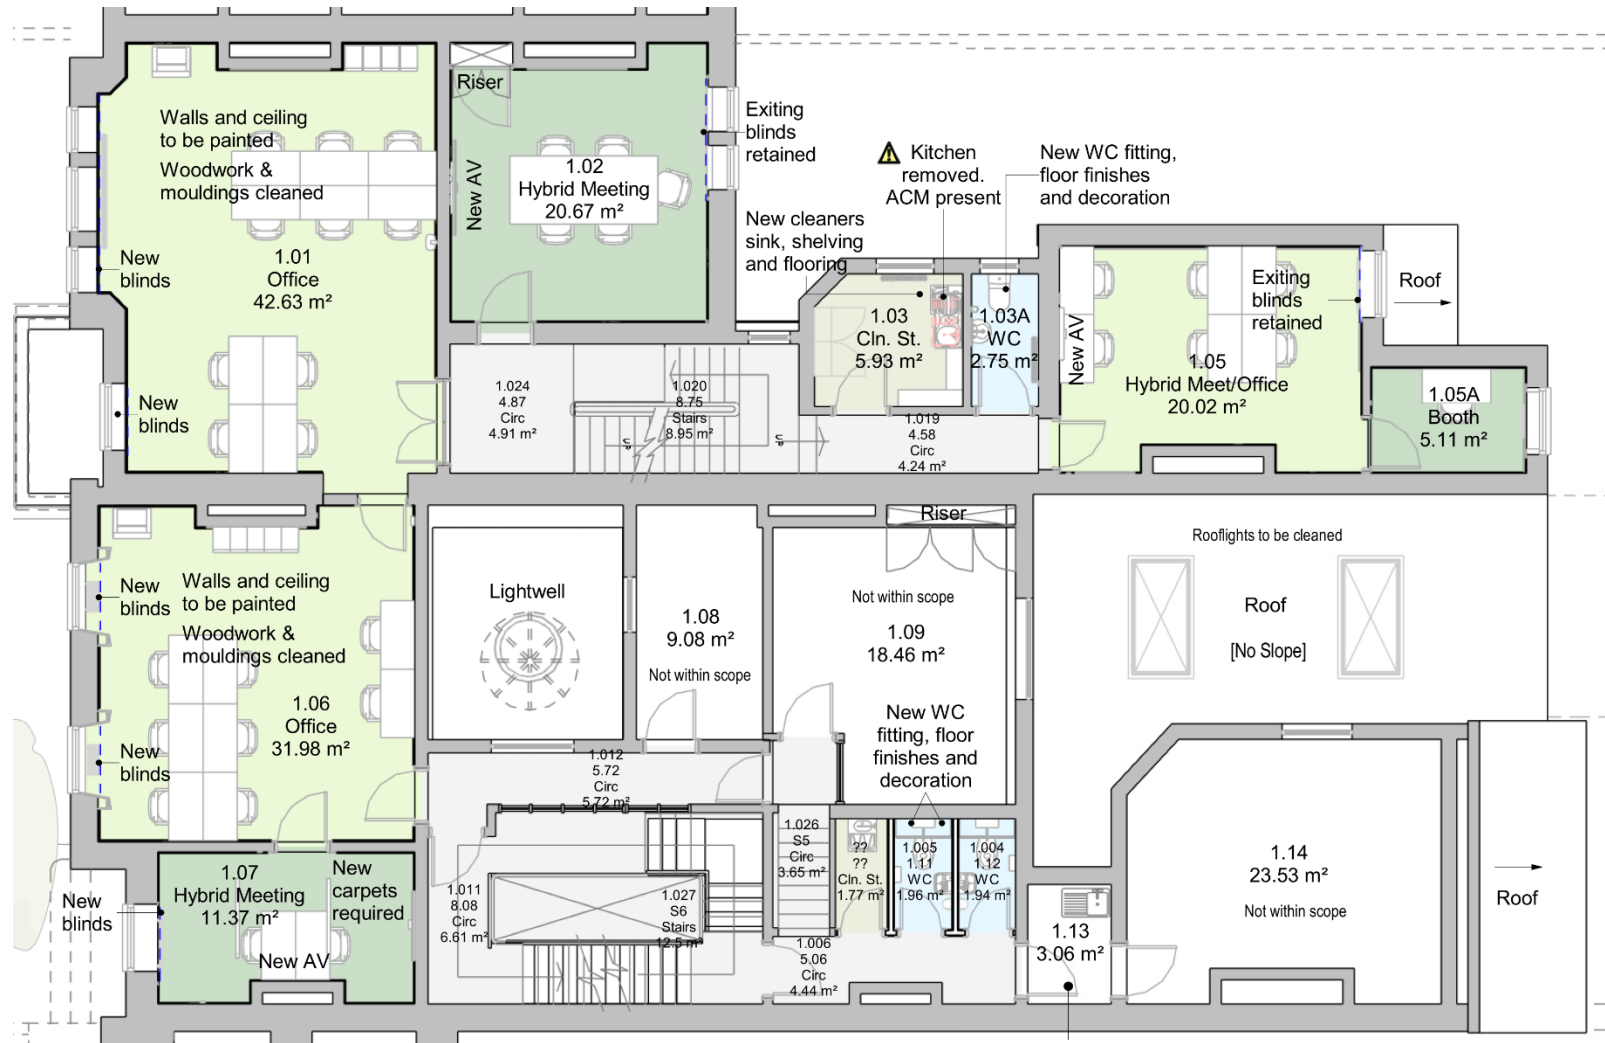
## Level 1 (First Floor) Works

The first floor is for office staff. Rooms will receive new decoration, lighting and floor finishes. The end users have specified which rooms they would like as meeting rooms. House Services requested cleaner's sinks to both sides of the building as there are flights between them. This has led to WC remodel on the southern side of the building. However, the FMC report advised all WCs require refurbishment.

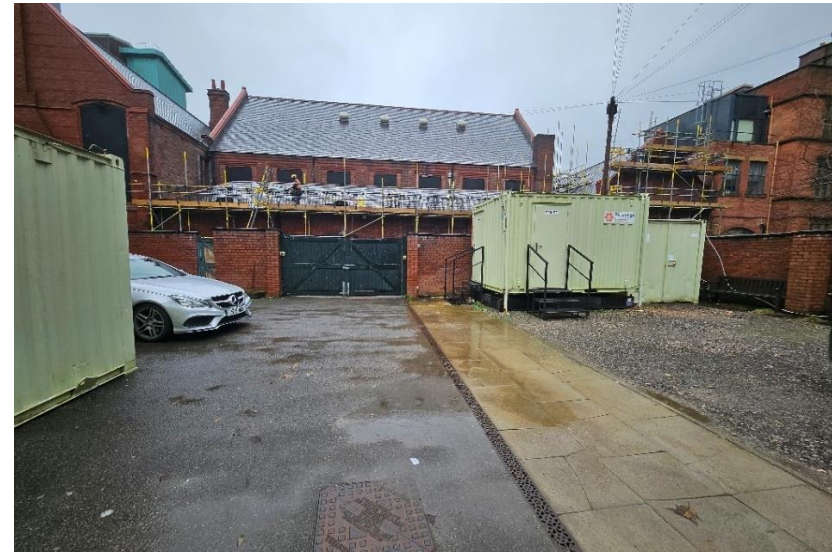
It has been confirmed that the rear ramp is not compliant for wheelchair users.

*Rear access of the site*

The cabins to the rear of the site are to be removed with all cracked flags to be remediated and reinstatement of the grass where gravel is currently. Vegetation to the building and site will be removed.
