## LANDSCAPING VALIDATION LETTER THOMPSON / BENDIX STREET

| <b>Project Name:</b> | Thompson Street |
| <b>Project Number:</b> | 12-729 |

## POS (Public Open Space) Cover System Validation

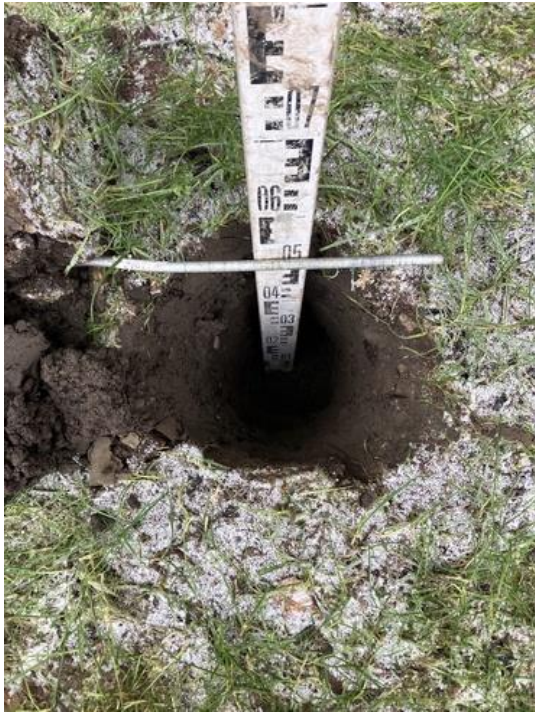
Photo 1

| <b>Depth of Cover System Materials (record the depth and support with Photo down the hole)</b> | | 500 |
| <b>Depth of Topsoil (mm)</b> | | 500 |
| <b>Depth of Subsoil (mm)</b> | | 0 |

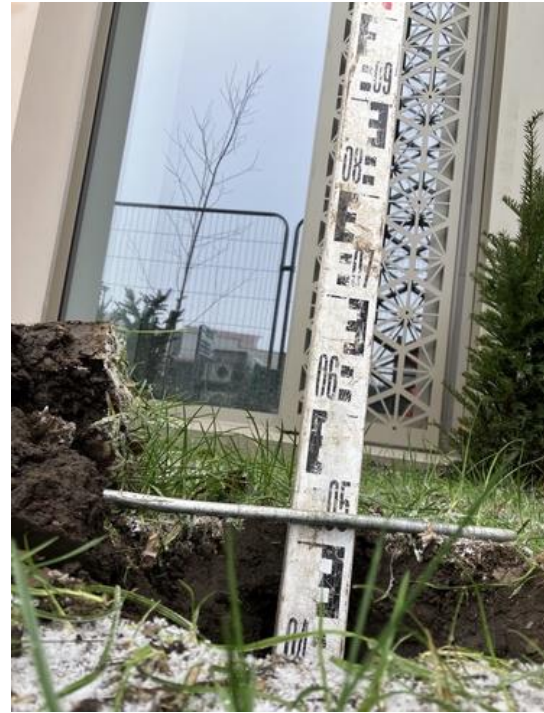
Photo 2

| <b>Depth of Cover System at Ground Level (Photo)</b> | | <input checked="" type="checkbox"/> |

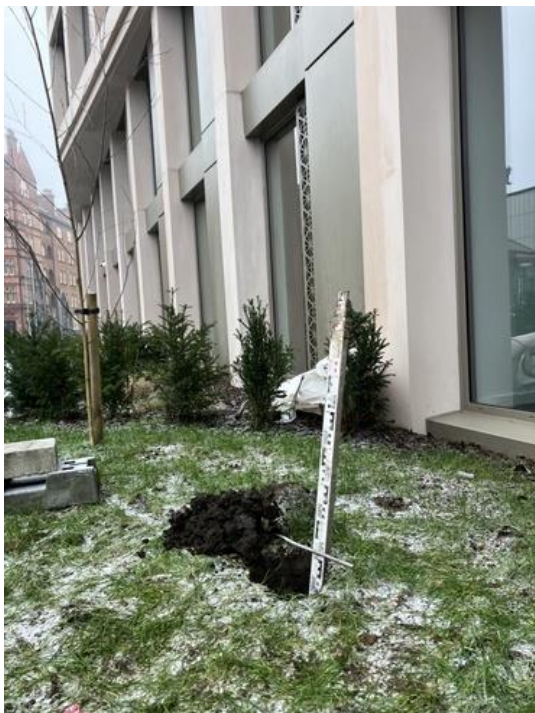
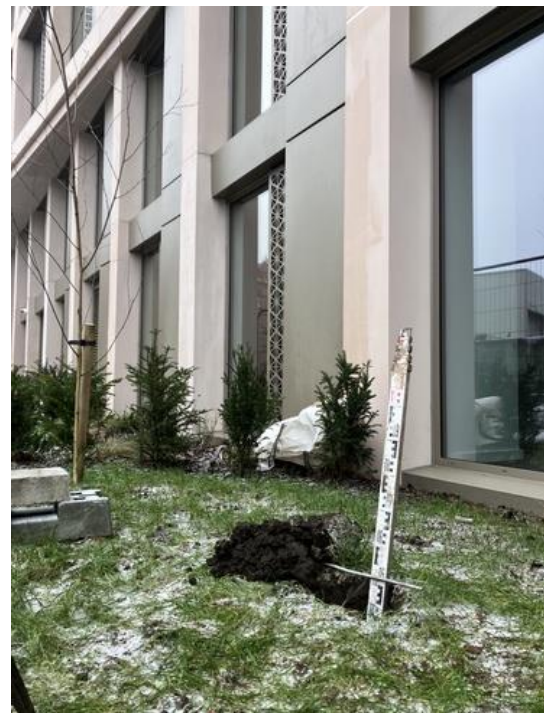
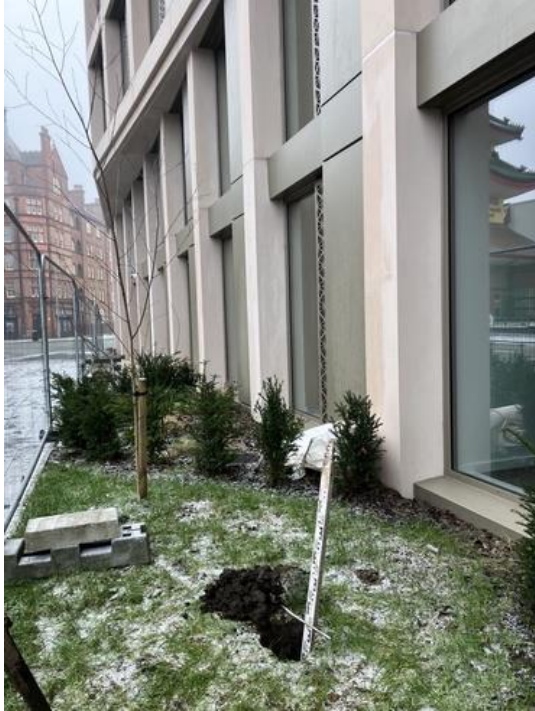
| <b>Depth of Cover System in Relation to Plot (Ensure the whole plot can be seen in the photo)</b> | | <input checked="" type="checkbox"/> |

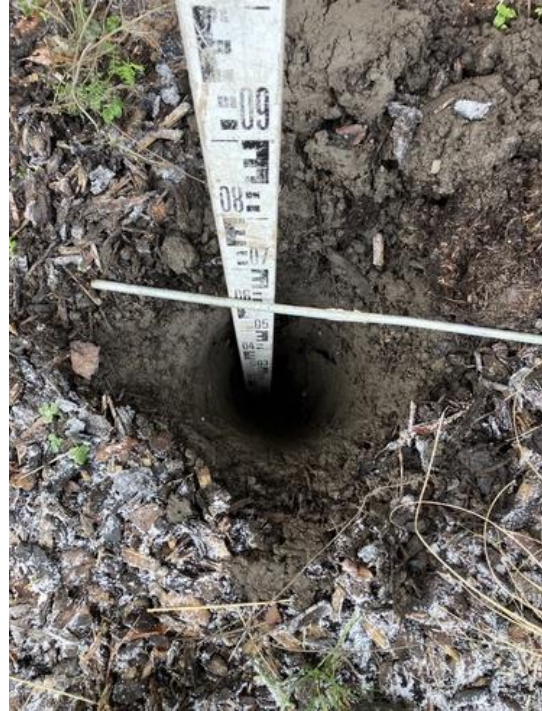
Photo 6

Depth of Cover System Materials (record the depth and support with Photo down the hole)

600

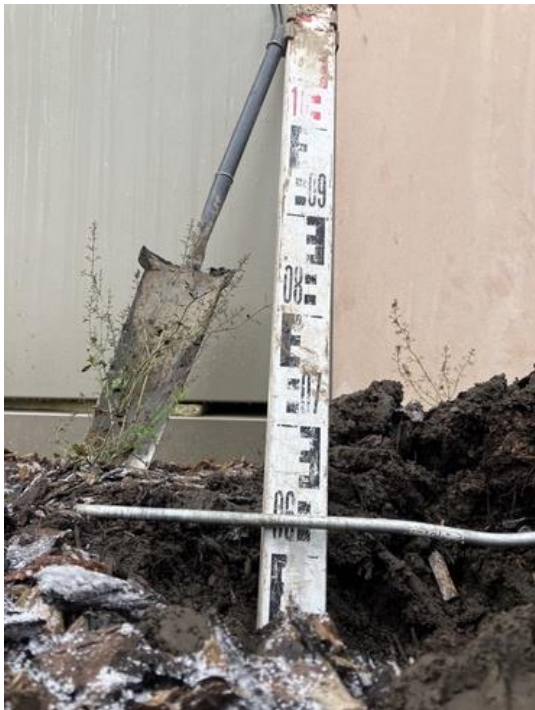
Photo 7

Depth of Cover System at Ground Level (Photo)

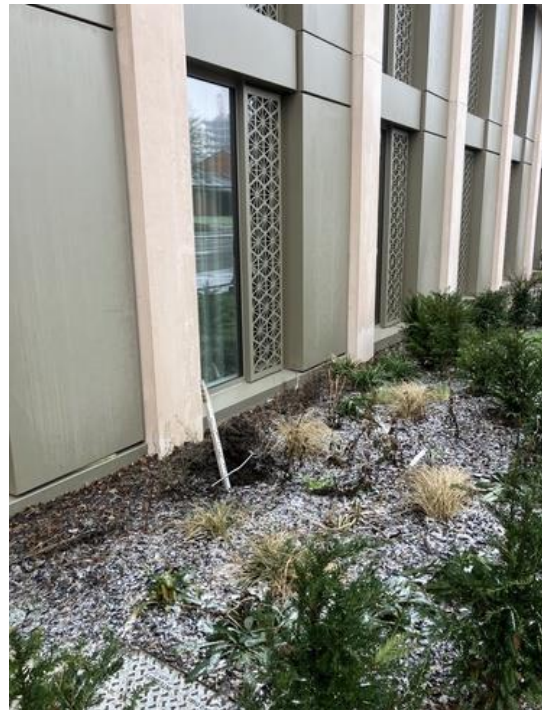
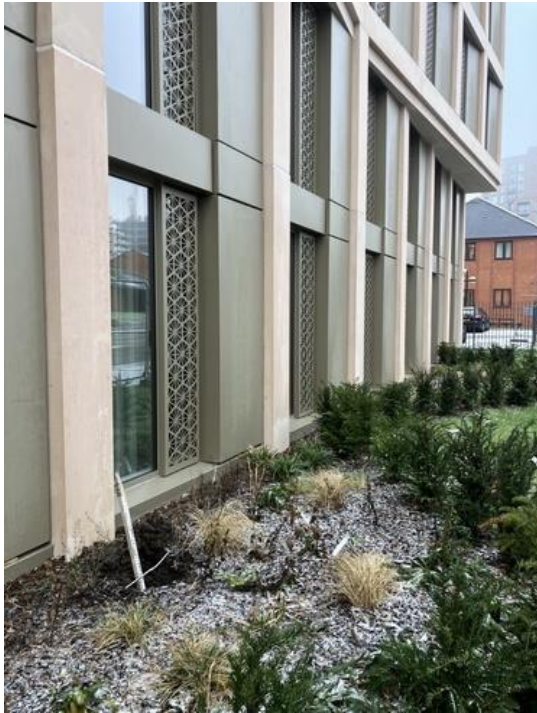
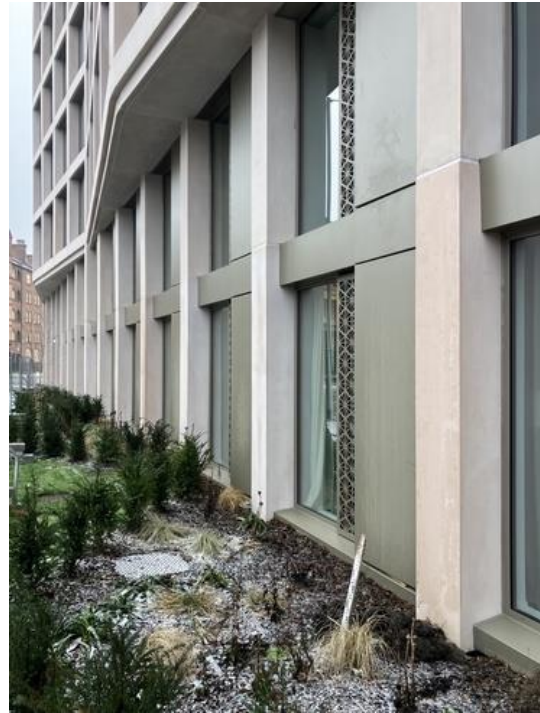
Depth of Cover System in Relation to Plot (Ensure the whole plot can be seen in the photo)

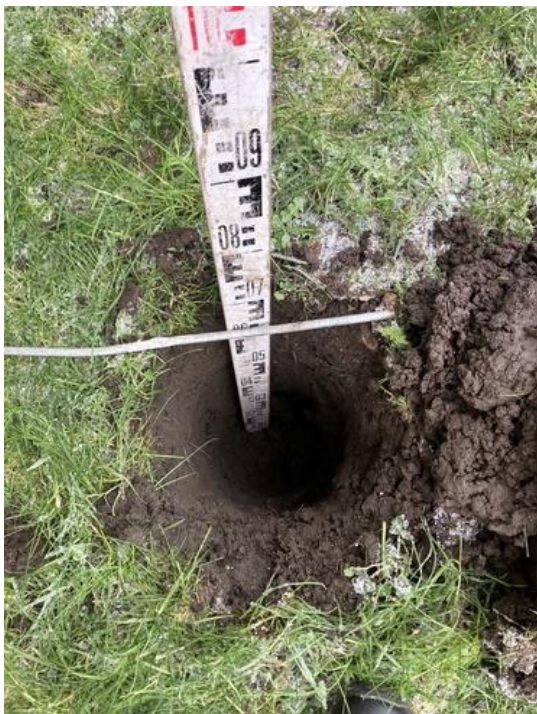
Photo 11

| <b>Depth of Cover System Materials (record the depth and support with Photo down the hole)</b> | | 600 |
| <b>Depth of Topsoil (mm)</b> | | 600 |
| <b>Depth of Subsoil (mm)</b> | | 0 |

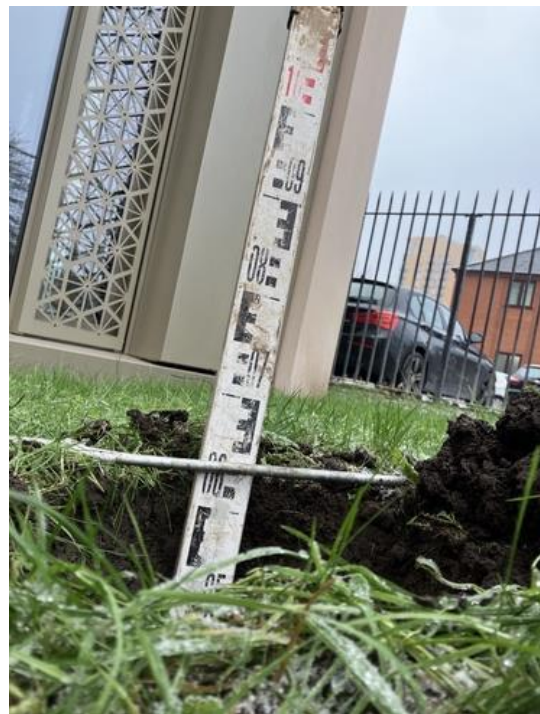
Photo 12

| <b>Depth of Cover System at Ground Level (Photo)</b> | | <input checked="" type="checkbox"/> |

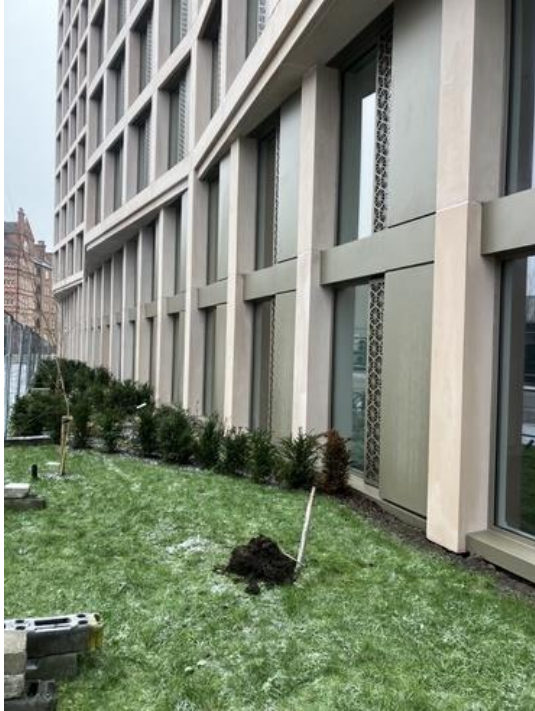
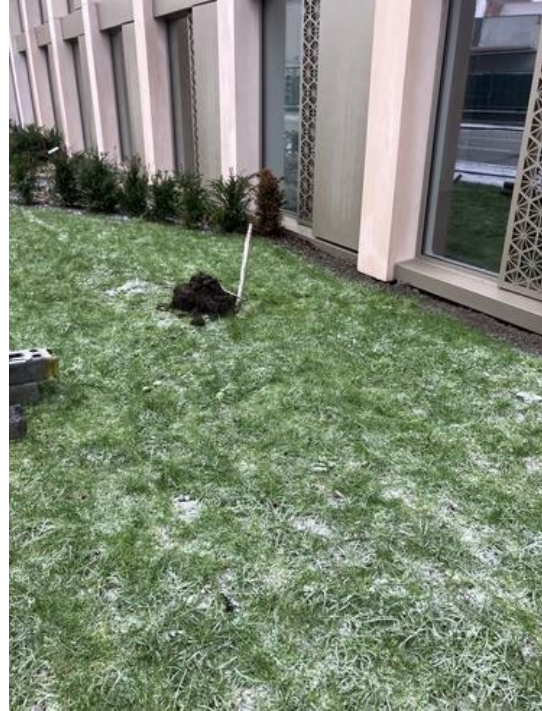
| <b>Depth of Cover System in Relation to Plot (Ensure the whole plot can be seen in the photo)</b> | | <input checked="" type="checkbox"/> |

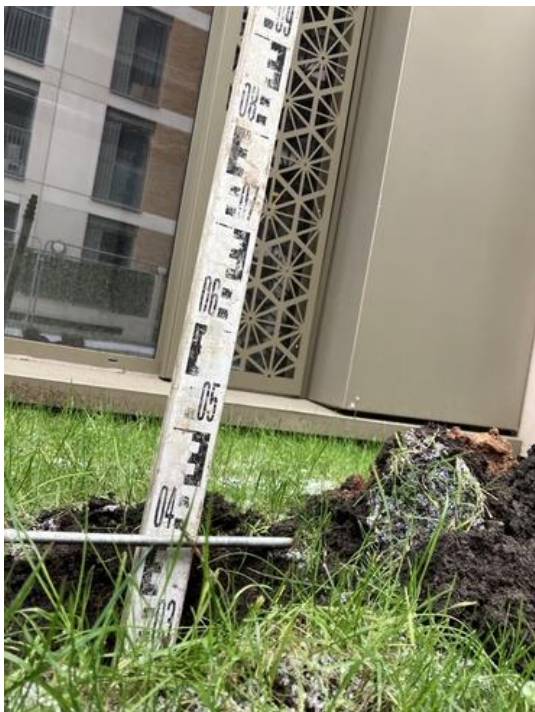
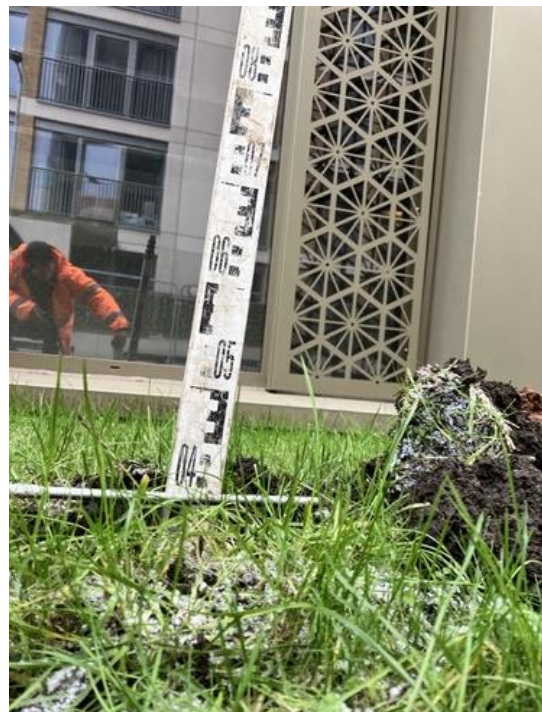
Depth of Cover System Materials (record the depth and support with Photo down the hole)

400

150

250

Depth of Cover System at Ground Level (Photo)

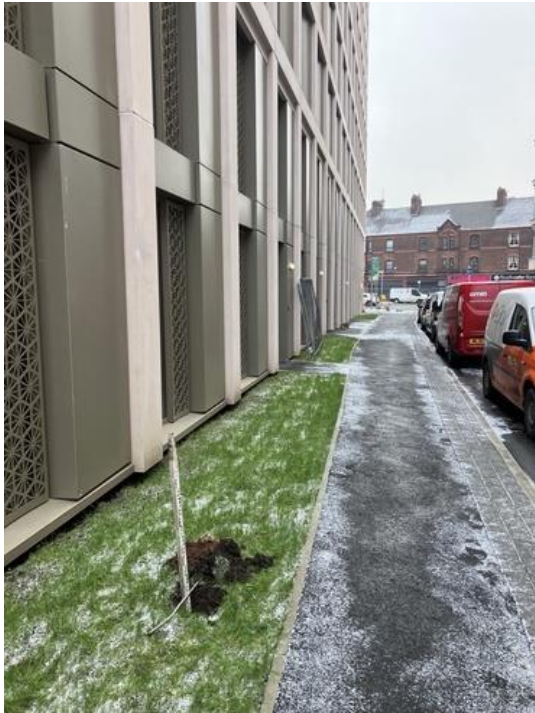
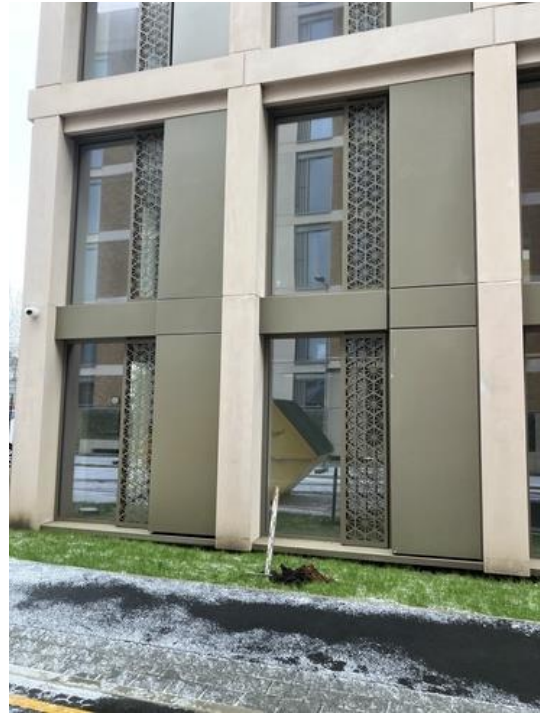
Depth of Cover System in Relation to Plot (Ensure the whole plot can be seen in the photo)

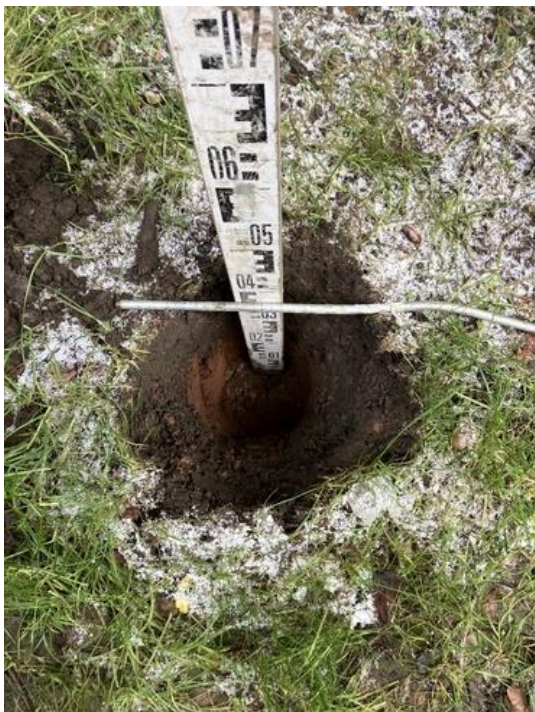
Photo 19

| <b>Depth of Cover System Materials (record the depth and support with Photo down the hole)</b> | | 350 |
| <b>Depth of Topsoil (mm)</b> | | 150 |
| <b>Depth of Subsoil (mm)</b> | | 200 |

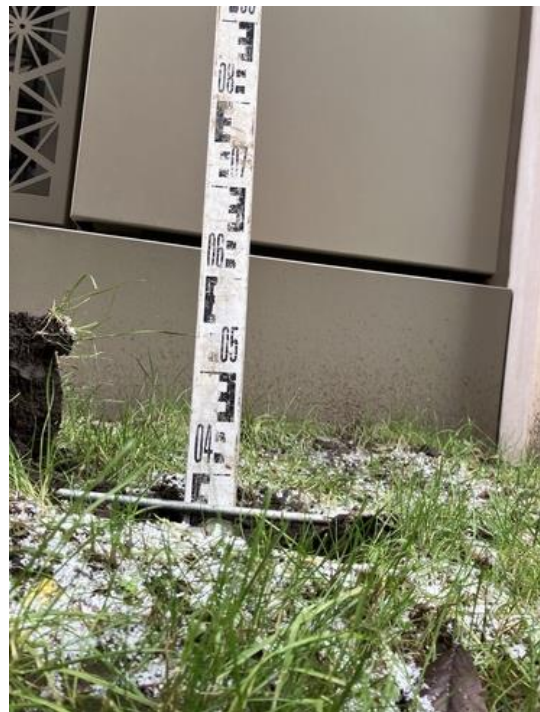
Photo 20

| <b>Depth of Cover System at Ground Level (Photo)</b> | | <input type="checkbox"/> |

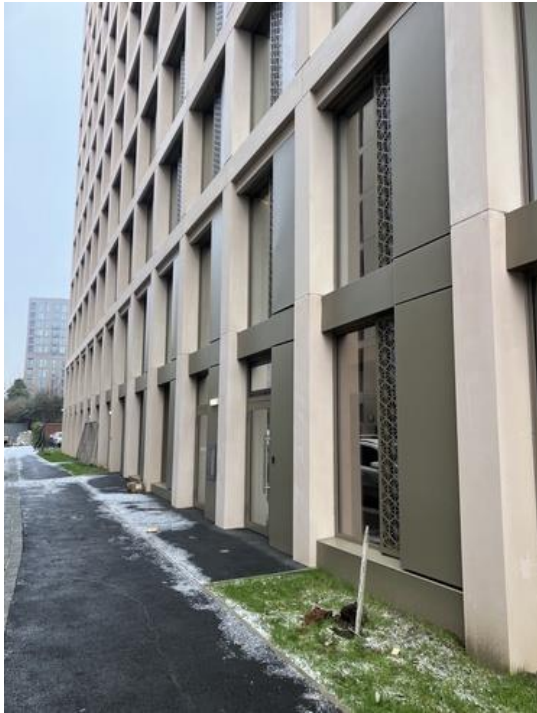
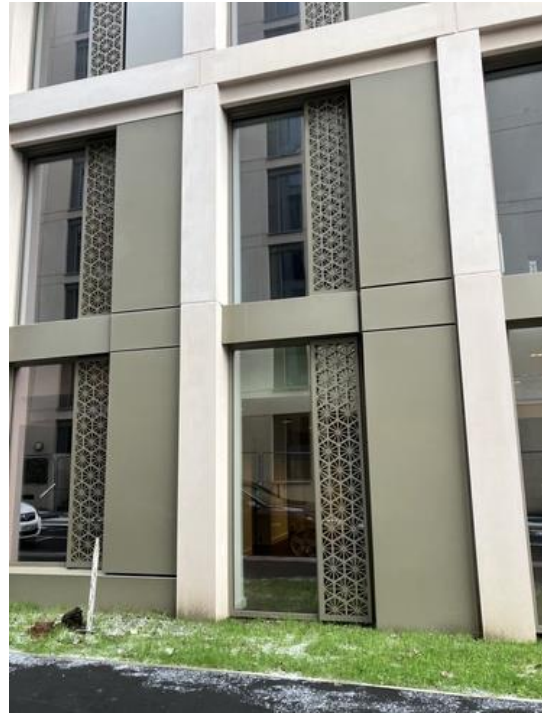
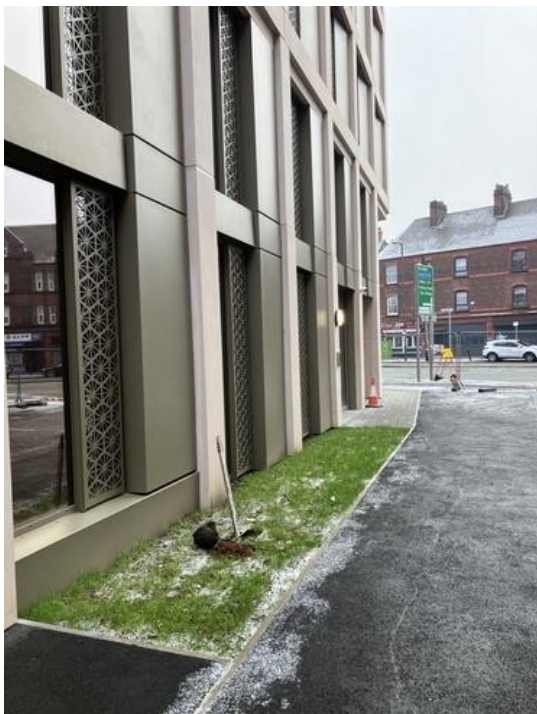
| <b>Depth of Cover System in Relation to Plot (Ensure the whole plot can be seen in the photo)</b> | | <input type="checkbox"/> |
