197 Palatine Road  
Didsbury, Manchester

Bat Scoping Assessment

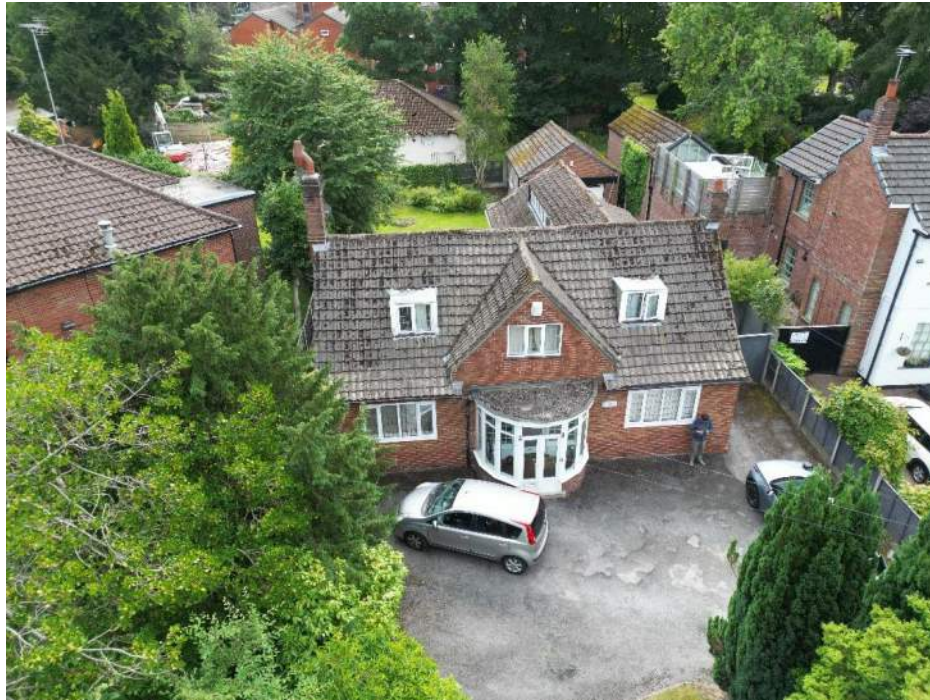
*Photograph 1- Front of the of the bungalow*

Externally, the building has a pitched roof with gables at its front and side elevations. The rear elevation has a hipped roof. The roof is clad in interlocking concrete tiles. The ridge and hips are well mortared in place, and mortar is also intact at the gable verges. The building has tightly fitted soffit boxes running around the perimeter

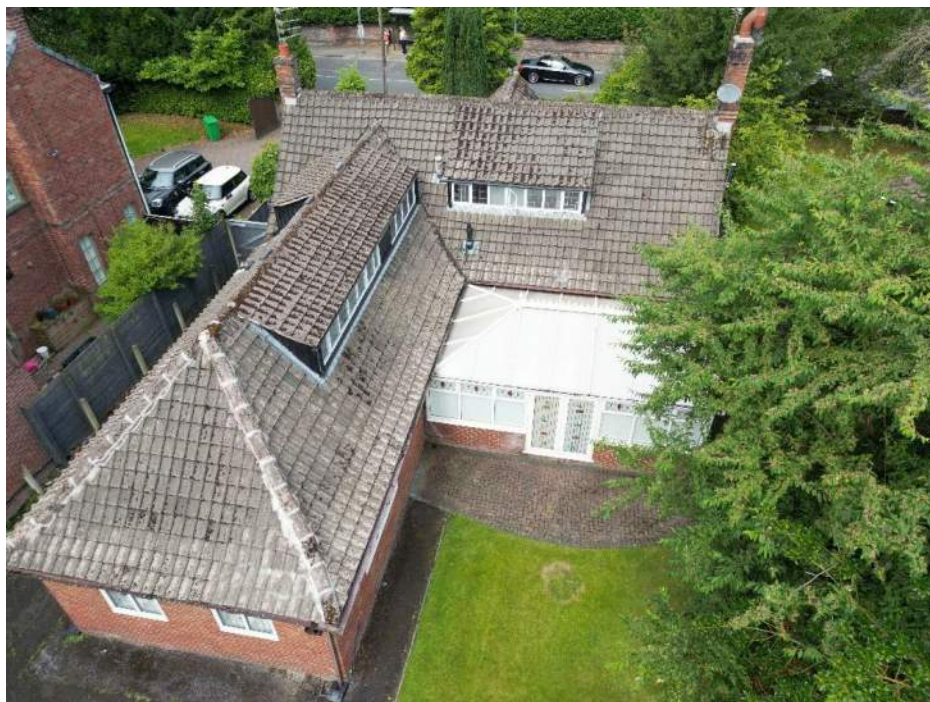
*Photograph 2 - Rear face of the bungalow*

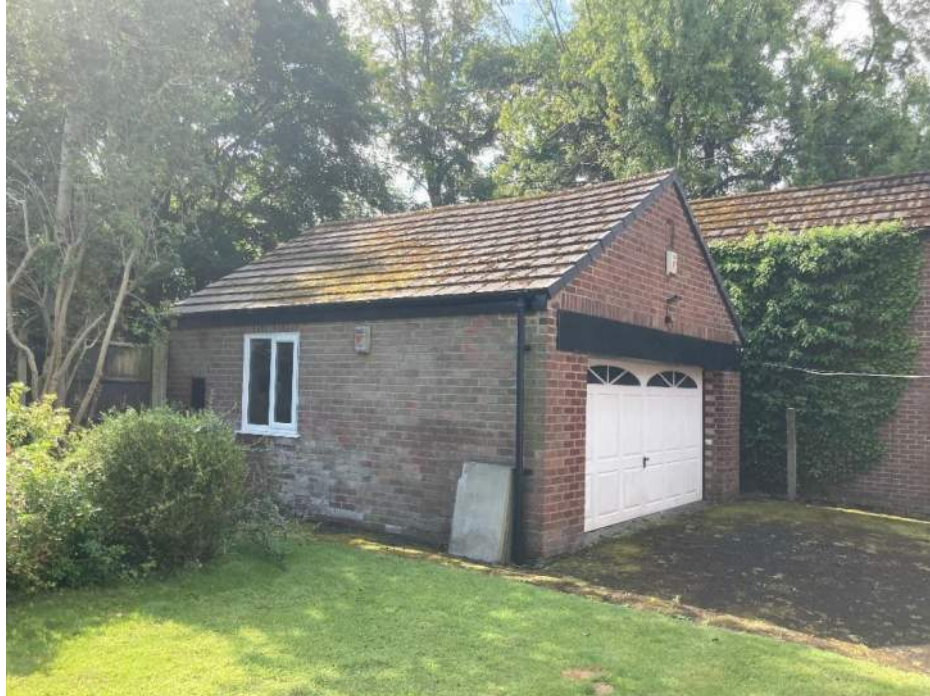
*Photograph 3 - Detached garage building*

There is a detached garage to the rear of the house. The garage is of late 20th-century origin and has a pitched roof clad in tightly fitted, interlocking concrete tiles. The verges are sealed with UPVC capping. No potential bat roosting features or potential bat access points to the interior of the garage were identified.

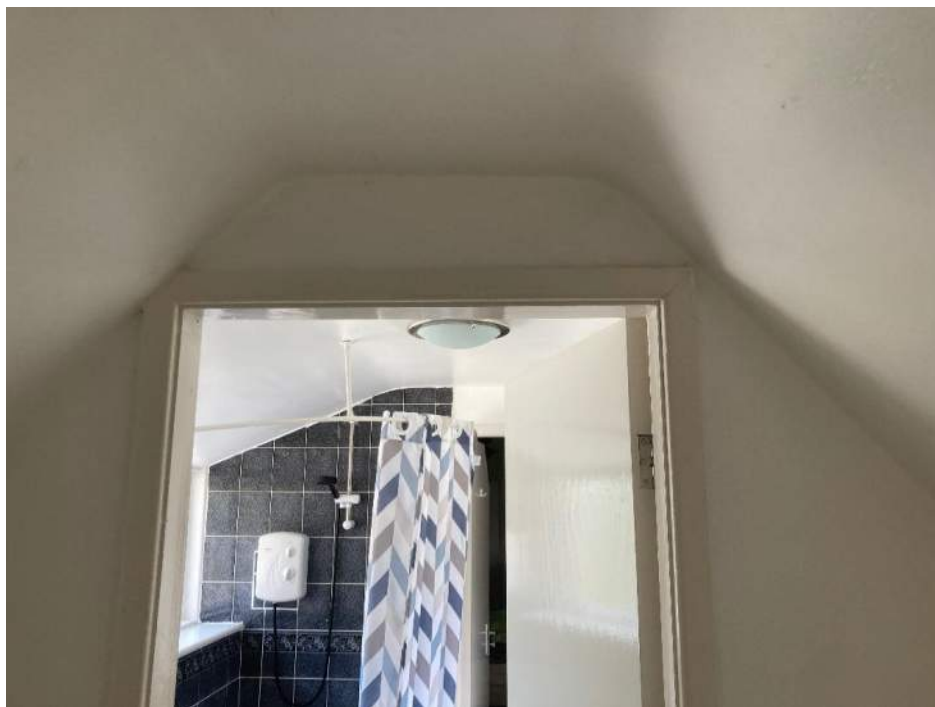
*Photograph 4 - Interior of the house*

The main dwelling comprises of an L-shaped bungalow with a detached garage to the rear. The upper floor rooms of the bungalow extend into the roof void space; therefore, the building does not have a separate loft space. Internally, the building is considered to be entirely unsuitable for roosting bats.

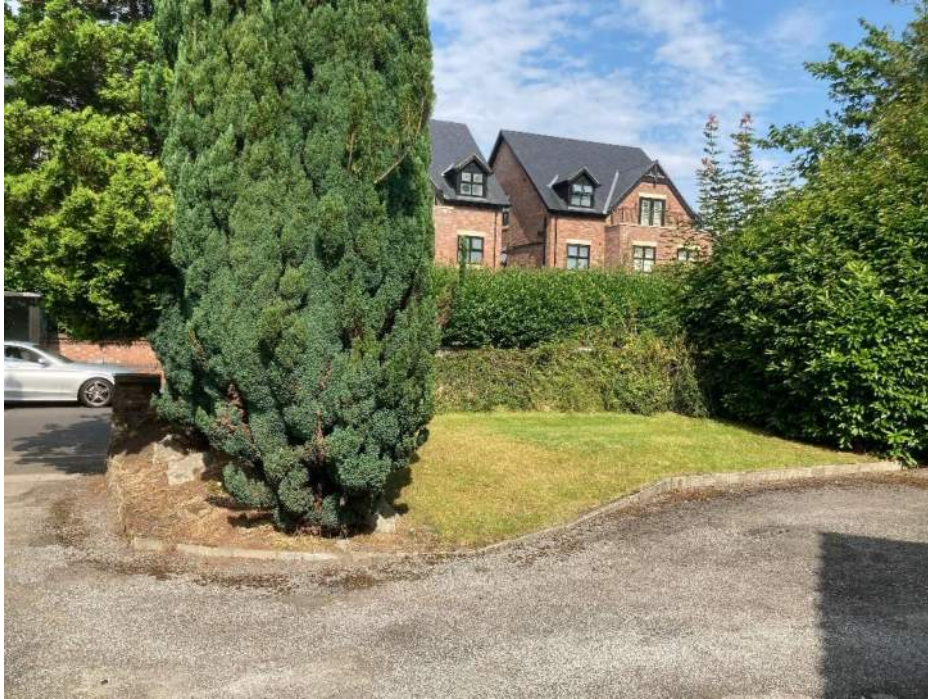
*Photograph 5 - Small front garden*

The front garden supports a further area of lawn which comprises principally of red fescue and Yorkshire fog, with mouse-ear chickweed, white clover, and springy turf moss. The grassland is species-poor with approximately five species per square meter. There are areas of ornamental shrubbery and ornamental trees located around the lawn, including a small yew and three small cypresses. Other shrubbery present includes rhododendron, holly, and hazel. There is a large hardstanding parking area in front of the house.

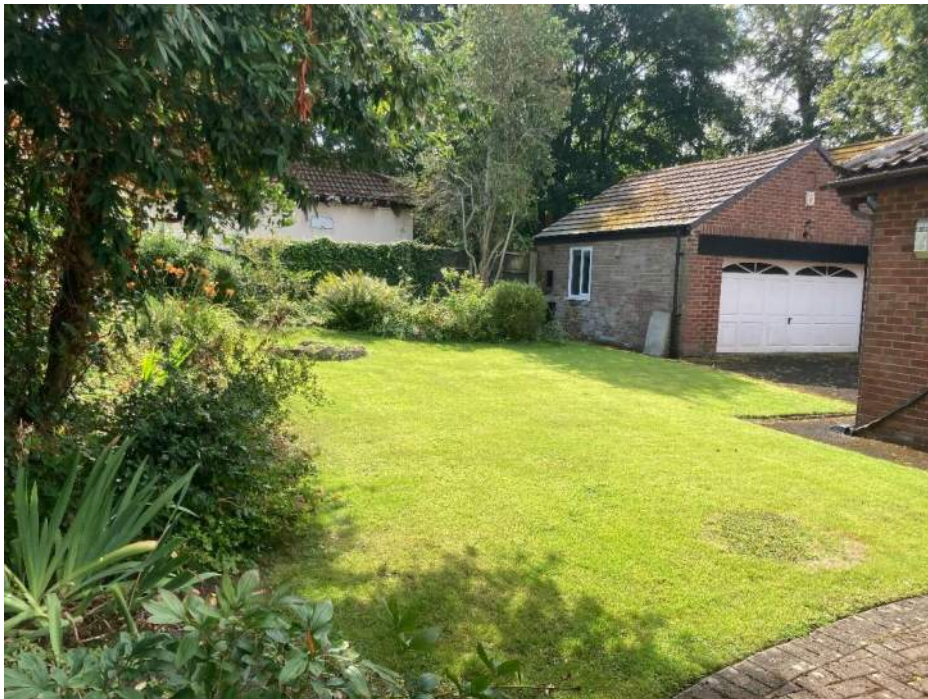
*Photograph 6 - Rear garden with modified, mown lawn.*

Habitats within the rear garden of the site comprise of an area of modified, mown lawn. Plant species present include selfheal, cat's ear, creeping buttercup, greater plantain, daisy, and grasses such as Yorkshire fog, perennial ryegrass, toad rush, and red fescue. The grass is cut short and supports approximately six species per square meter.
