**401 Wilbraham Road,  
Chorlton,  
Manchester,  
M21 0UT**

**Preliminary Ecological Appraisal  
in respect of Bat Species and Nesting Birds.**

**28<sup>th</sup> February 2025**

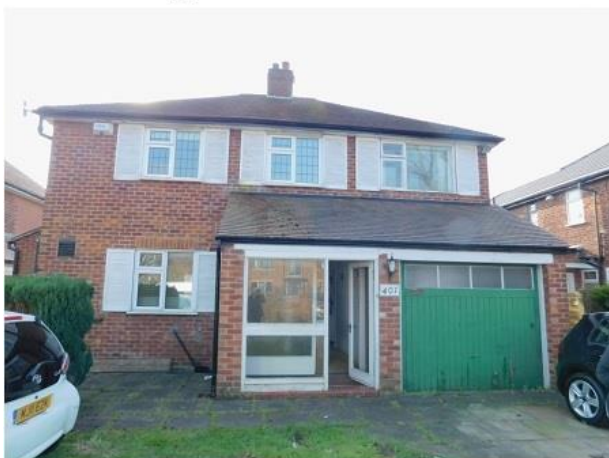
**PHOTO 3**  
**Northern Elevation**

- Each of the windows in the northern elevation, both at ground floor and first floor levels, had adjacent timber window shutters, and all of these were surveyed using both sight and close focus binoculars, and out of them all, only the upper north-western shutter had a narrow gap between the underside of the timber, and the dwelling wall. But neither bat droppings or any fur grease staining were seen. Also, where possible the gap interior was searched using an endoscope, but no other evidence of bat usage was found. A survey of all of the shutters and the areas around them, in the ultraviolet light from the Darkbeam LED ultraviolet flashlight, found no indication of any bat urine staining, and therefore they were all deemed to offer very low bat suitability, (refer to **figs 3, 4, and 5**, and **photos 1 to 4, 10 and 11**).

- Positioned at the north-eastern corner of the dwelling was a square metal grill, and a close inspection of this found it be the front of a fan housing, containing a large fan. Although the gaps between the metal mesh were quite large, no signs of bat droppings, either invertebrate or lepidopteran remains were seen, nor was any fur grease staining found on the mesh which would have indicated the passage of a bat through the mesh, and also, as no urine staining was observed in the infrared torch light, either on the fan, the mesh, or the surrounding wall, it was felt that bats do not use the fan housing, and was of low bat suitability, (refer to **figs 3, 4, and 5**, and **photos 3 and 10**).

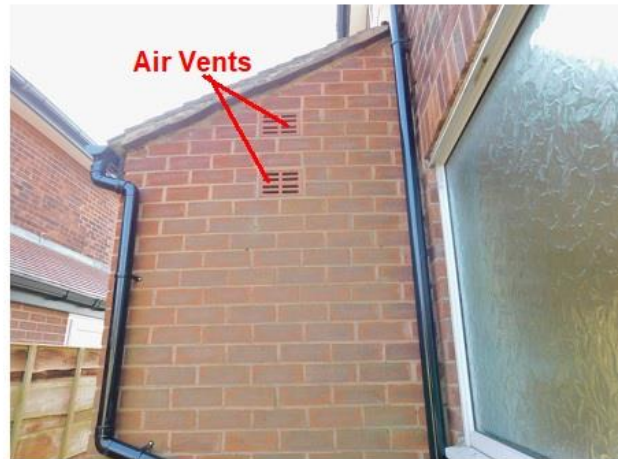
**PHOTO 12**  
**Northern Elevation of WC Extension**

void. and again, this was well sealed and in an excellent condition, with no internal sign of any bat droppings, invertebrate prey remains, nor of any urine or fur grease staining, and therefore the WC extension was judged to offer low bat roosting suitability, (refer to **figs 3, 4, and 5, and photos 12 to 17**).

- There were two air vents in the northern elevation of the WC, and another in the southern elevation, and an inspection of all these and the walls and floor beneath them, internally and externally, found neither bat droppings, no invertebrate prey remains, nor any sign of bat urine or grease fur staining, and therefore all three vents were of negligible bat roosting potential, (refer to **figs 3, 4, and 5, and photos 12 to 17**).

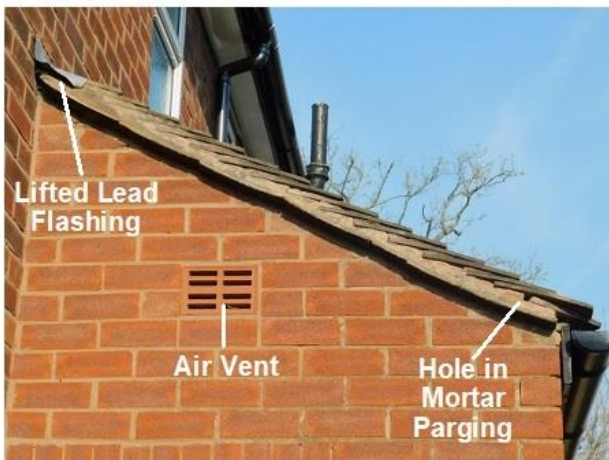
**PHOTO 15**  
**Upper Southern Elevation of WC Extension**

- A small area of lead flashing had lifted at the upper north-western corner of the southern WC elevation, and a small hole was found at the same elevation, where part of the mortar parging was missing. Both of these areas were searched using the Darkbeam LED flashlight but no urine staining was found. The same areas were searched using an endoscope but neither bat droppings or any other sign of bat occupation was discovered, and therefore both of these opportunities were thought to have very low roosting suitability, (refer to **figs 3, 4, and 5, and photos 15 to 17**).

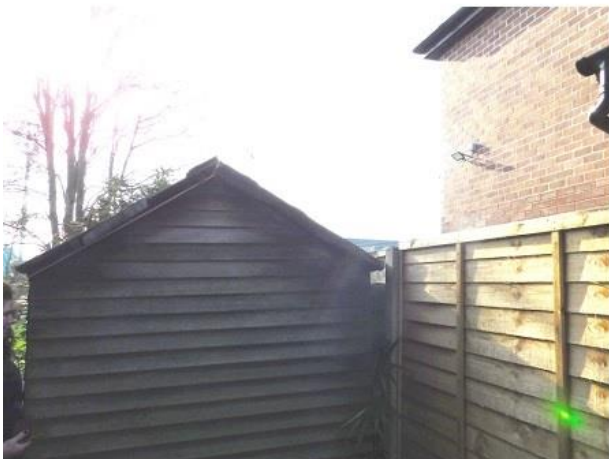
**PHOTO 23**  
**Northern Elevation of Shed**

Due to its overall rundown condition as a result of poor maintenance, all parts of shed were damp, and would be draughty and cold throughout most of the year, and therefore it was deemed unsuitable for either daytime roosting bats, or breeding bats, and as frost and inclement bad weather were very likely to penetrate the interior of the shed in the colder months, it did not offer the optimum humidity, and constant low temperatures that are required for hibernating bats, and therefore the shed was judged to offer low bat roost suitability, (refer to **figs 3, 4, 5 and 6,, and photos 23 to 29**).

- There was lifted and missing felt at both the upper north-western and north-eastern corners, and also, along the eastern edge of the roof, also, there were holes in the timber at the north-western, corner, together with missing timber and a gap behind the soffit, along the southern edge of the roof. All of these opportunities were closely inspected by sight, and by using a bright torch and an endoscope, but neither bat droppings, any invertebrate or lepidopteran prey remains, or were any grease fur staining found, nor was any bat urine staining found in the light produced from the LED UV flashlight, and therefore the shed was judged to offer very low bat roost suitability, (refer to **figs 3, 4, and 5, and photos 23 to 29**).

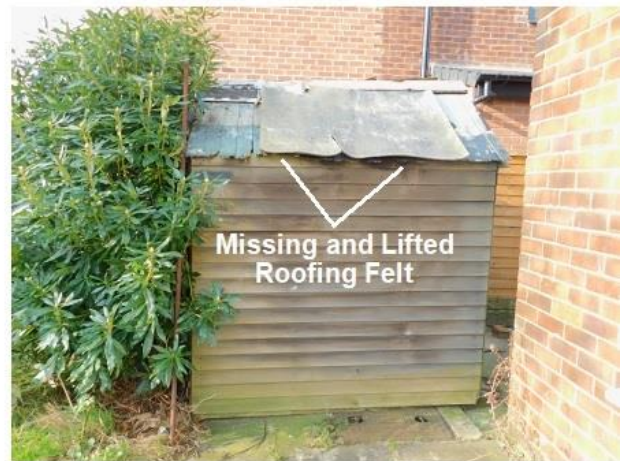
**PHOTO 26**  
**Eastern Elevation of Shed**

Particular attention was given to the bush growing at the south-eastern corner of the dwelling, where it blocked the doorway into the wooden shed. It was thought probable that this would be felled during the upcoming development, but a careful inspection of all parts of the bush, found neither droppings or any other kind of evidence of bat usage, nor were any signs of the bush being used by nesting birds either currently or historically, (refer to **figs 3, 4, and 5, and photos 26 to 28**).
