## Ground Investigation Report

Proposed LED Floodlit Tarmacadam PlayZone Pitch

Unity Primary School, Manchester

Document no.: STV6309-R01 Rev A

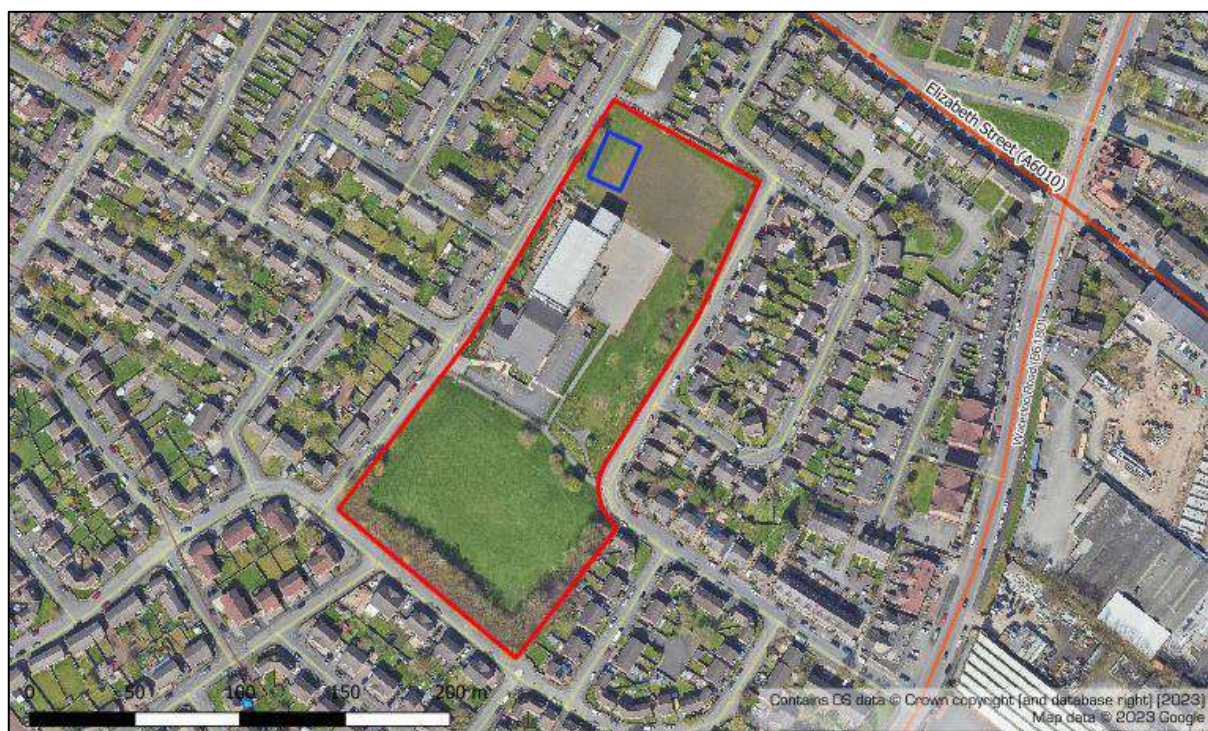
Figure 2-A: Aerial photograph of site boundary (red) and PlayZone footprint (blue)

2.2.2 An aerial image showing the approximate site boundary and approximate development footprint is presented below, followed by a table summarising the key site features and a series of site photographs. A site plan is provided within Appendix A.

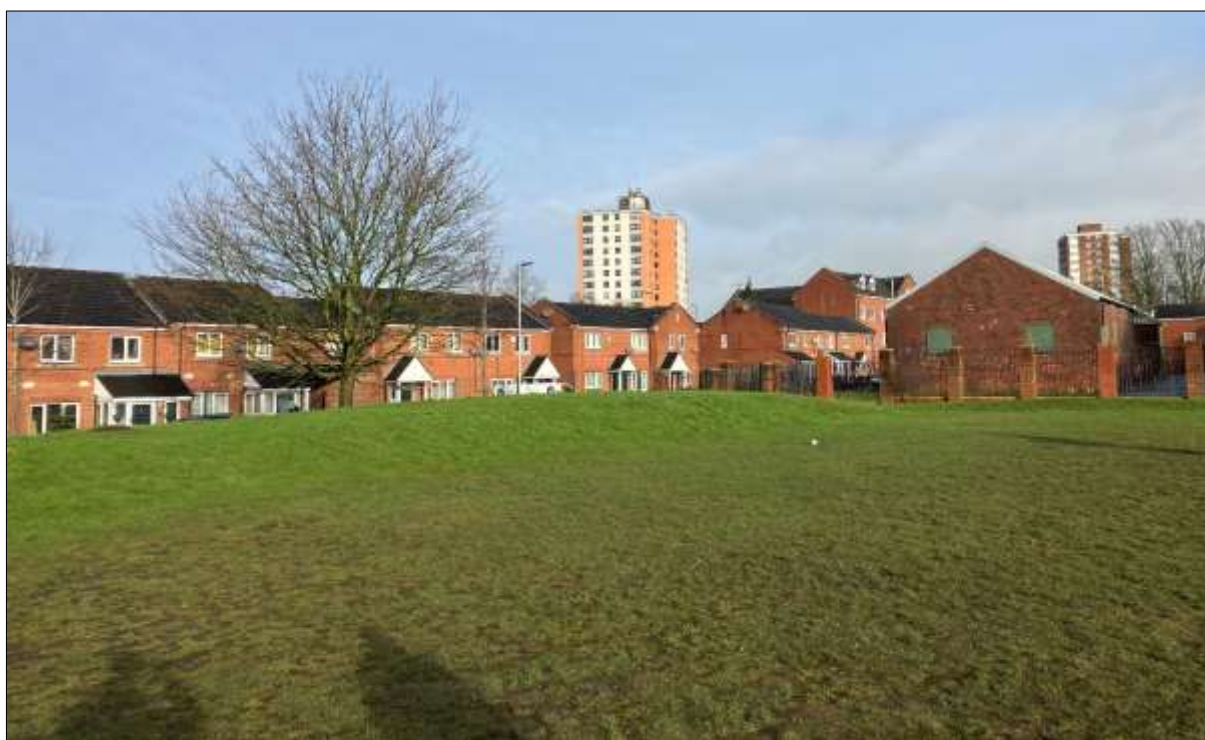
*Figure 2-C: Photograph looking towards the northwest corner of the site and grass embankment*

| Theme | Feature |
|---|---|
| Topography | Surface levels fall marginally from northwest to southeast across the proposed PlayZone pitch. A 1-1.5m high grassed embankment is noted along the western boundary of the proposed PlayZone, see Figure 2-C below. |

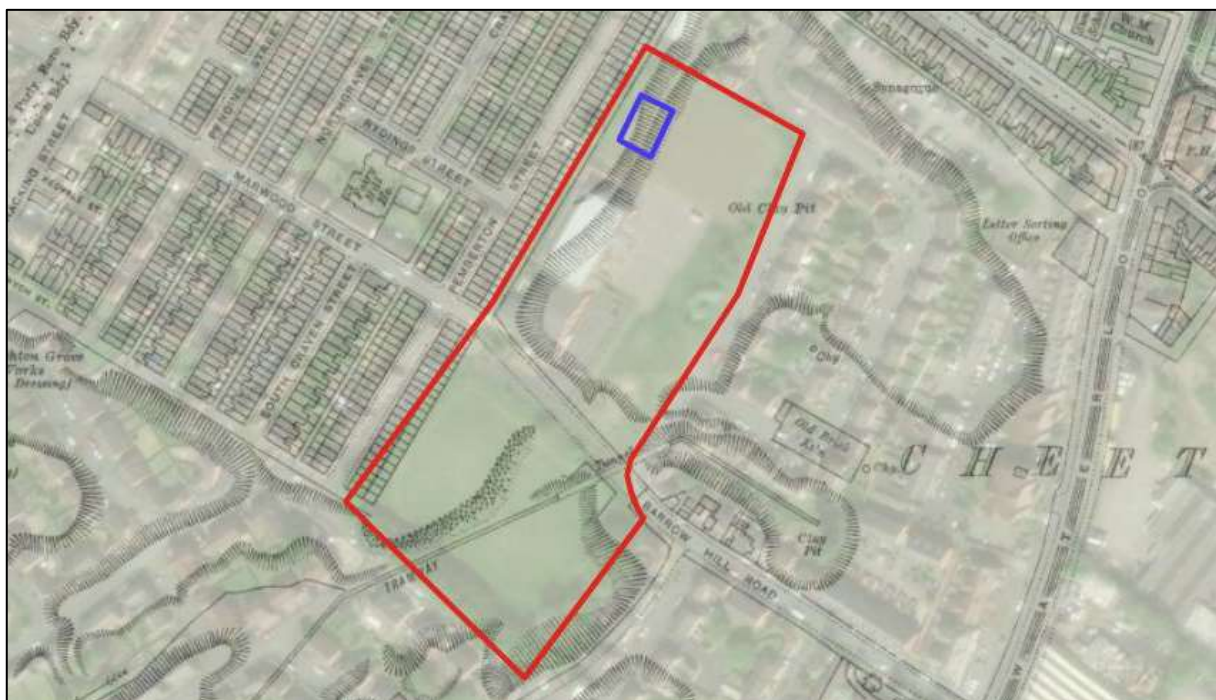
Figure 2-E: 1892-1914 Historical map extract overlay showing the site boundary (red) and proposed PlayZone (blue)

| Date | On-site | Off-site |
|---|---|---|
| Late-1800s | The PlayZone location is noted to have been situated on the western high wall of an old clay pit associated with a brickworks to the southwest of the site (see Figure 2-E). | Adjacent land uses are noted to have comprised residential properties to the north and west, with the brick works/pit extending off site to the south and east. |

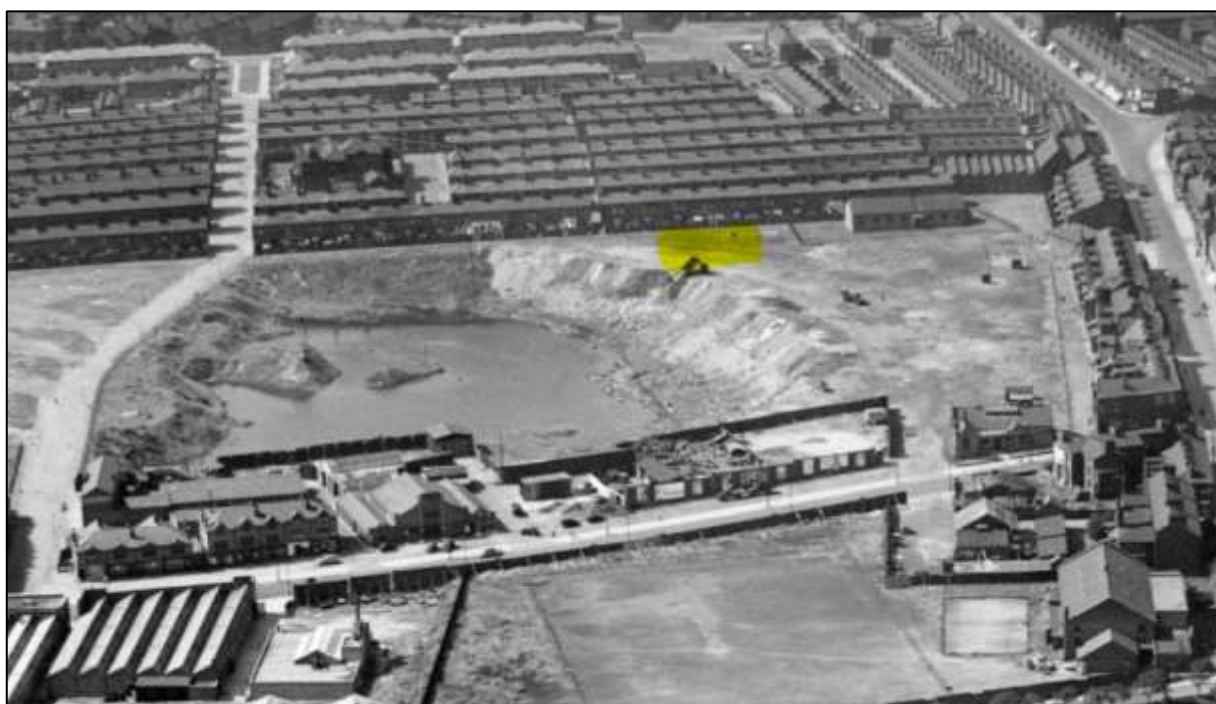
Figure 2-F: 1933 aerial image showing infilling of the former clay pit. Approximate location of PlayZone shown in area highlighted yellow (note truck on south of highlighted area tipping waste into the excavation).

| Date | On-site | Off-site |
|---|---|---|
| Early 1900s | Historic aerial imagery dated 1933, shows the PlayZone location in relation to the clay pit, see Figure 2-F below. The old clay pit beneath the proposed PlayZone area was infilled at this time. | Residential properties are noted to the north and west of the wider site. |

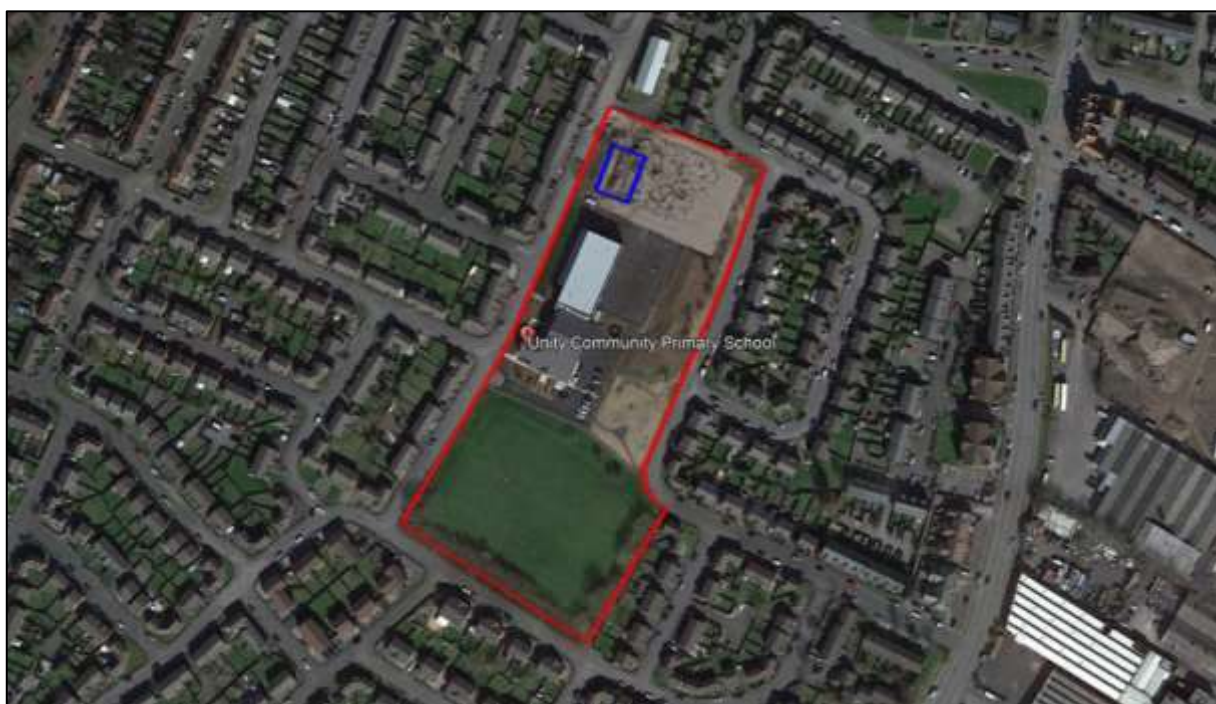
Figure 2-H: Aerial imagery dated 2017 showing stockpiling of soils in the PlayZone area (blue)

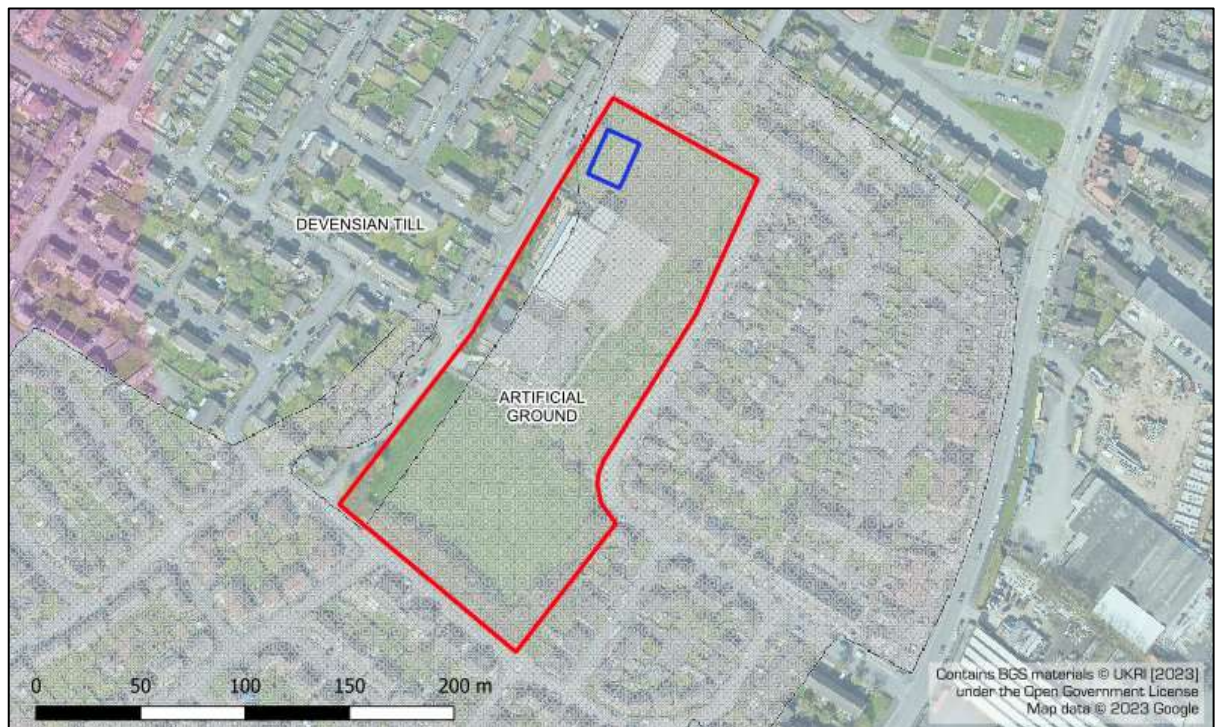
Figure 2-I: Extract from BGS showing superficial geology at the site

- 2.4.1 Based on a review of available records, the site is anticipated to be underlain by superficial deposits of Devensian Till (refer to Figure 2-I below). The site is observed to be within an area of superficial thickening associated with a hidden valley, extending to anticipated depths of 10m to 20m bgl.
- 2.4.2 Artificial ground is noted across the wider site footprint, likely associated with backfilling of the former clay pit.

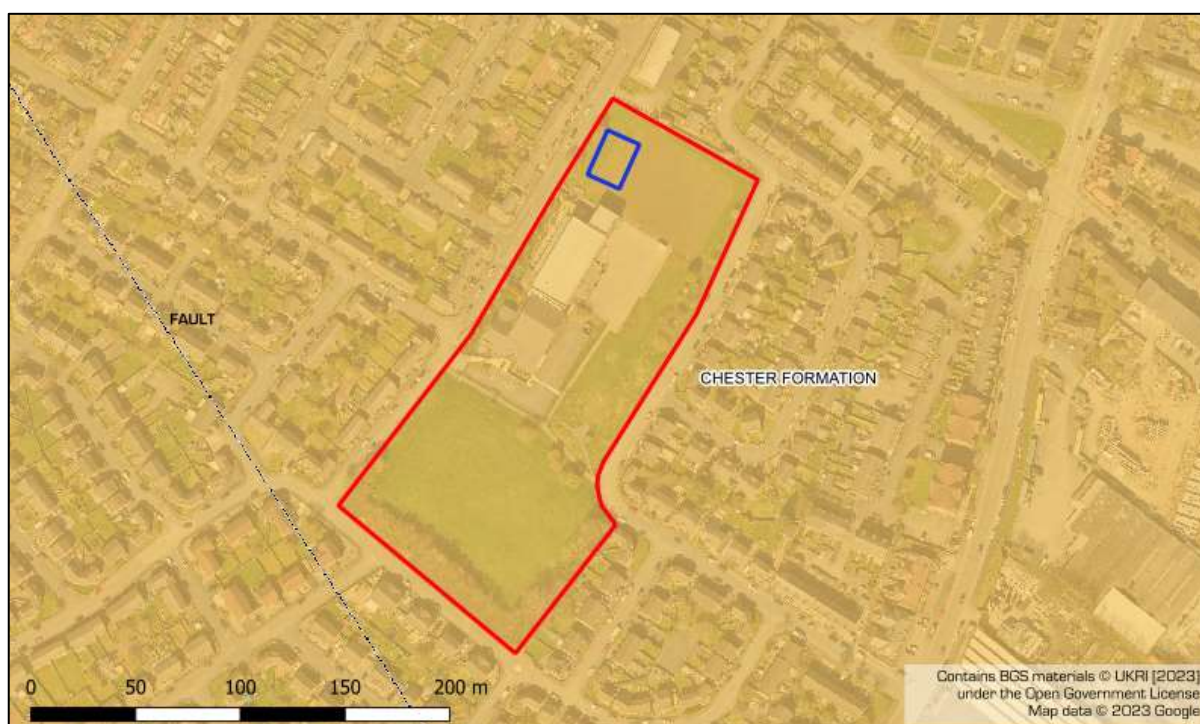
Figure 2-J: Extract from BGS showing bedrock geology at the site

- 2.4.3 Review of a Phase 1 desk study report produced for the Unity Community Primary School by Integra Consulting Environmental Ltd in August 2015, provides historical ground investigation data for the redline site under consideration. Borehole data indicated at least 6-10m of Made Ground, comprising dark brown firm clay with coarse and fine brick, concrete and asphalt fragments or crushed hardcore and asphalt as well as possible ash.
- 2.4.4 Testing of soils indicated the presence of quantifiable Chrysotile asbestos fibre bundles and free fibres within 6 No. of 12 No. samples tested (4 No. of 9No. 'shallow' samples).
- 2.4.5 The underlying bedrock is recorded as the Chester Formation across the entirety of the site, comprising mudstone (refer to Figure 2-J below).

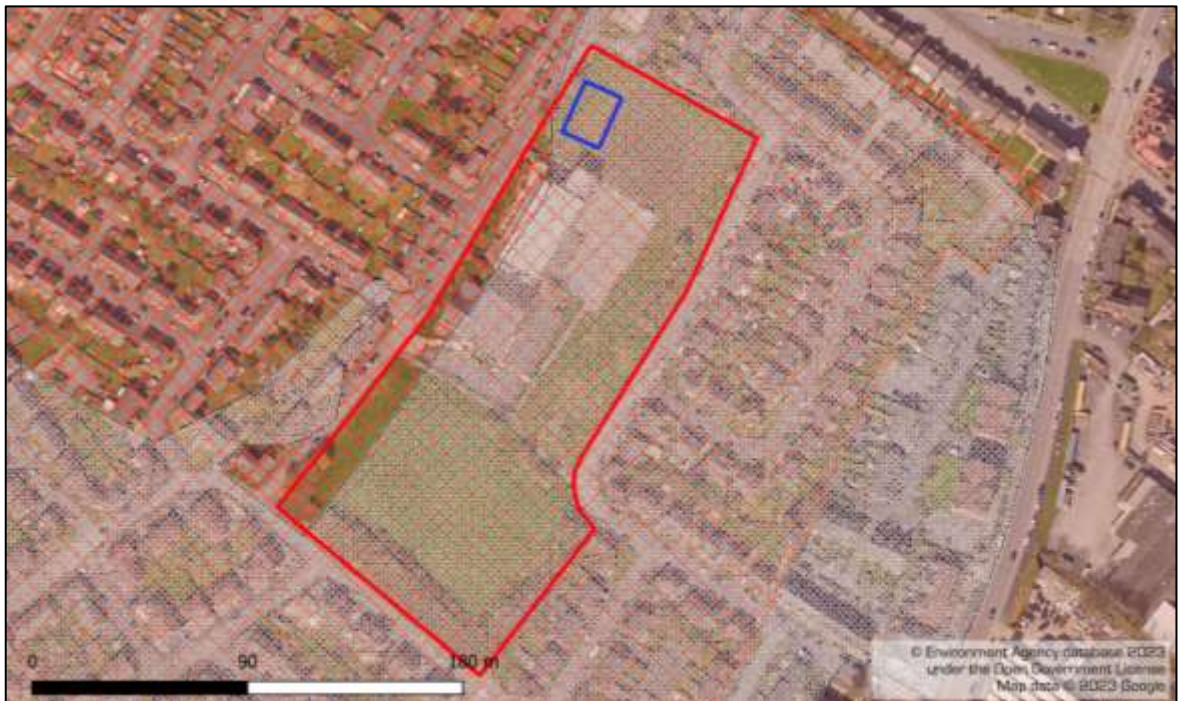
Figure 2-K: Extract from EA showing proximity of the site to landfills.

- 2.7.1 Open-source Environment Agency landfill mapping data indicates the proposed development lies within a historic landfill site, associated with the historic clay pit (refer to Figure 2-K below). The landfill is noted to comprise commercial and household waste. 6-10m of Made Ground has been recorded beneath the wider site during previous investigation, however, landfill materials were recorded as being dominantly inert demolition materials, rather than household waste.
- 2.7.2 Based on the above and anticipated ground conditions on site, whilst there is a potential for elevated ground gases beneath the site, the risk to the PlayZone is considered to be low due to the nature of the development (open air pitch and floodlighting).

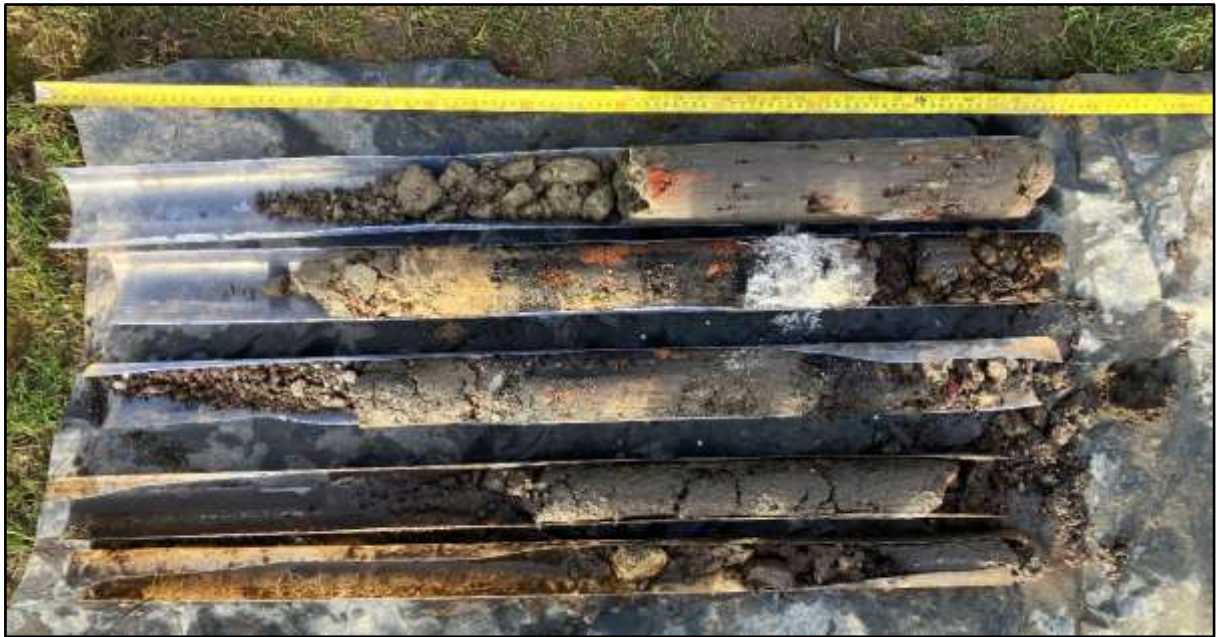
5.3.2 Made Ground was observed as dominantly granular soils typically observed to be very gravelly silty sand with demolition type materials. On the western side of the site (WS03 & WS04) clay fill was present, comprising reworked natural soils, and at depth in WS02 in the northeast of the site.

Figure 5-A: Made Ground encountered in WS01

5.3.3 A photograph of the Made Ground encountered is shown below in Figure 5-A.

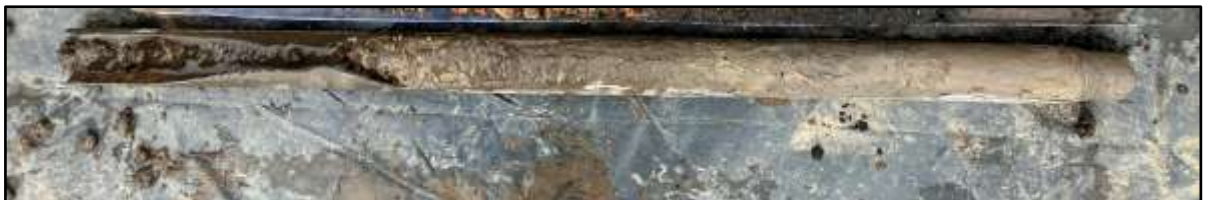
Figure 5-B: Devensian Till encountered in WS04

5.4.2 A photograph of the Devensian Till can be seen below in Figure 5-B.
