## Remediation Strategy

Stockport Road

Manchester

**Report A2951/24/RMS/V**

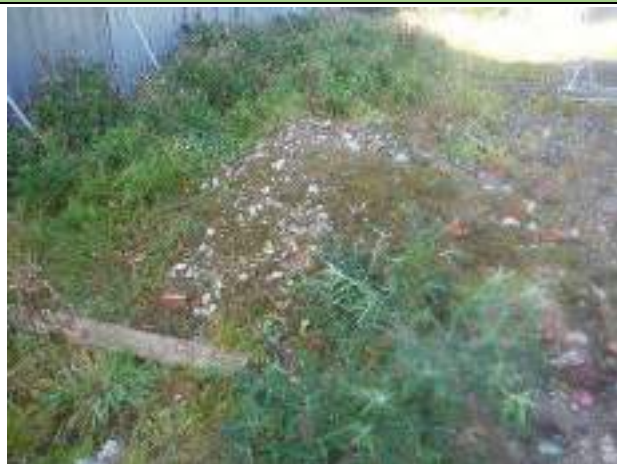
**P8:** A number of small stockpiles of soils with occasional brick and concrete were noted in the south-east of the site

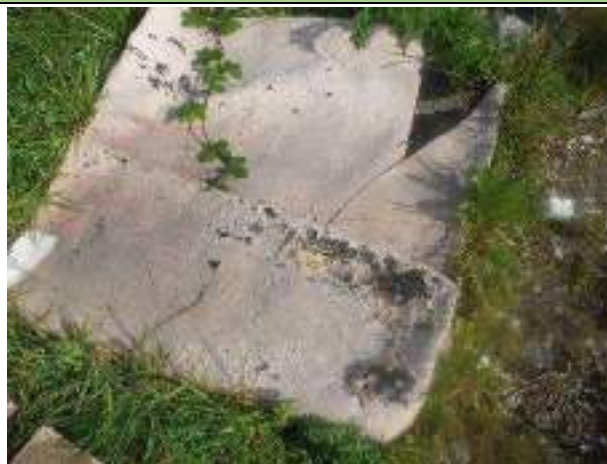
**P9:** A number of small stockpiles of soils with occasional brick and concrete were noted in the south-east of the site

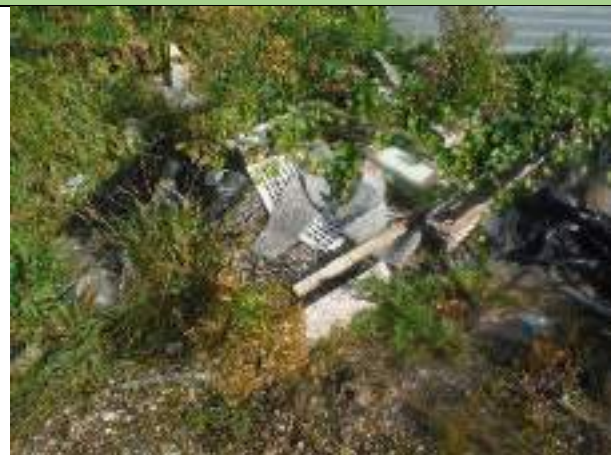
**P10:** Flytipped Mattress located in the south-west
