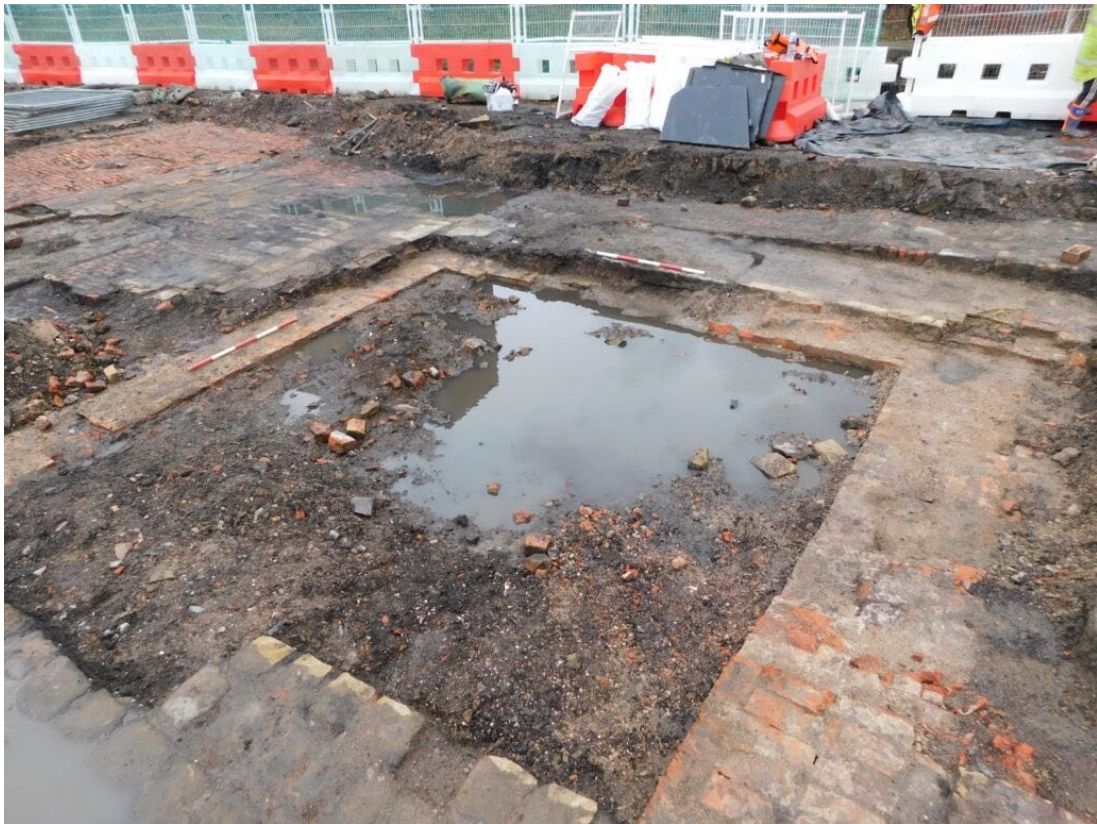
*Plate 25: The walls of the extended engine house [2054] facing east, 1m and 1m scale*

- 6.11.1 The mid-19<sup>th</sup> century mapping indicates further extensions to the main mill, labelled as an 'engine' and 'boiler' on the 60-inch to 1-mile OS Town Plan of 1850.
- 6.11.2 The walls of the extended engine house Group [2054] were found to the south of wall [255] and survived as a rectilinear wall constructed from handmade brick, measuring 7.72m north-west/south-east and was 5.28m north-east/south-west (Plate 25). The engine house [2054] was not excavated to its

full depth due to the ingress of water, however it was clear that the majority if not all of the stone mounting blocks had been repurposed within a later stair tower [2052] located to the north-east (Phase 4).

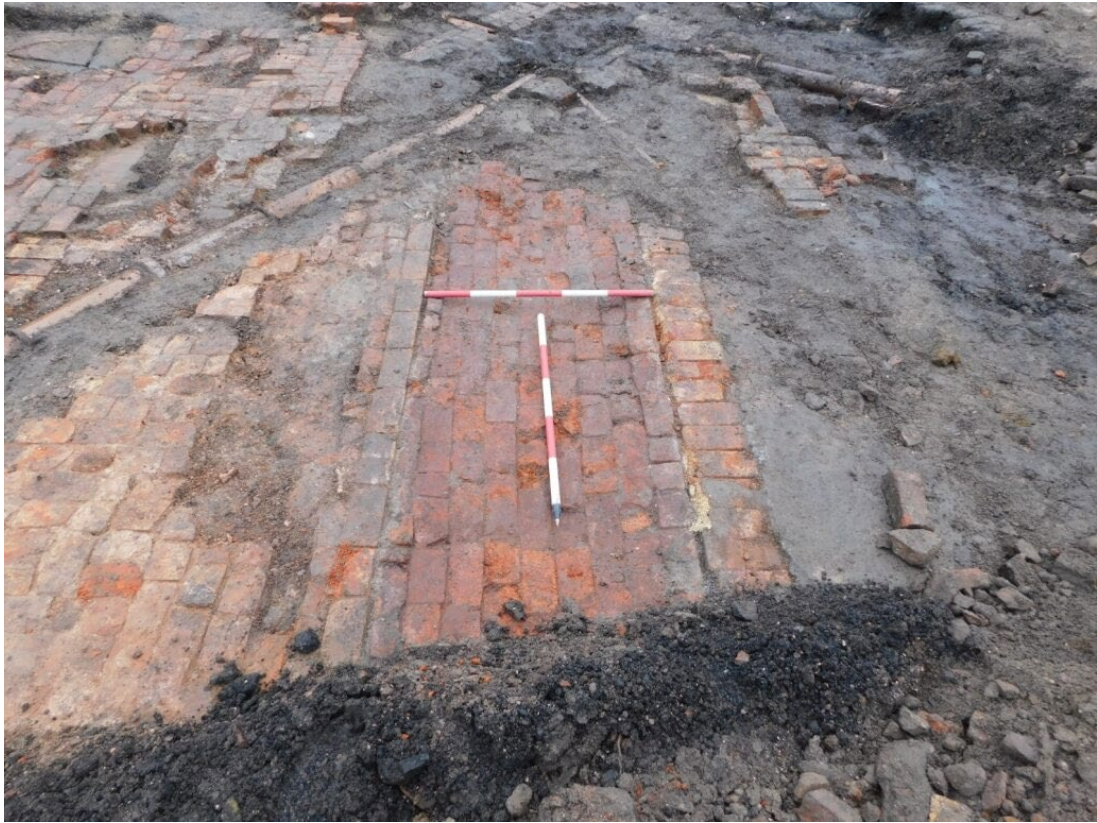
*Plate 27: Boiler bed [2086]/[2084] facing south-east, 1m and 1m scale*

6.11.5 A rectilinear wall [2088] appeared to delineate one side of the firing end of the boiler bed. The south-western boiler bed comprised two rows of bricks [2084] forming the sides of a 0.95m-wide bottom flue and a heat-affected surface

[2086]. The flue surface [2086] survived to a maximum length of 2.80m (Plate 27).

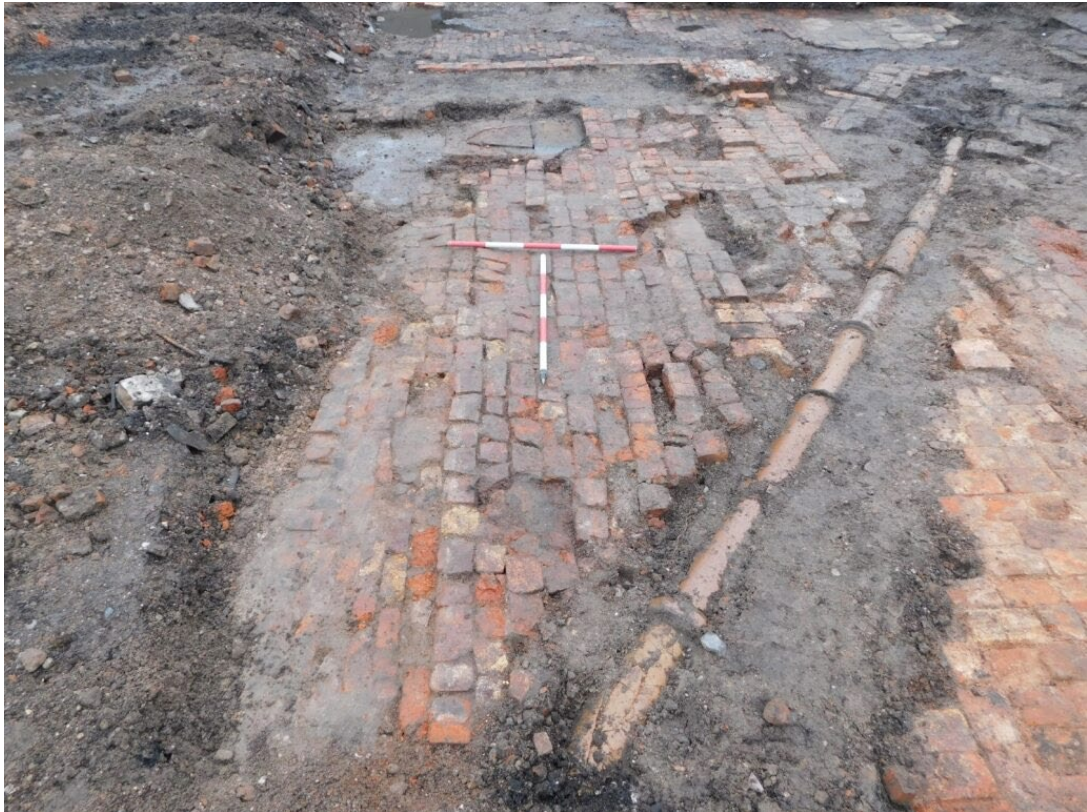
*Plate 28: Boiler bed [2082] truncated by drain [2085] facing sout-heast, 1m and 1m scale*

6.11.6 To the north-east lay an additional brick foundation [2082] constituting the north-easternmost boiler bed (Plate 28). This survived to 5.25m long, 3.60m wide and was at least one brick thick. More of the structure survived overall, enough to extrapolate the boiler bed's T-shaped plan. Sunken flagstones at the south-western end of the boiler setting likely denote the position of the boiler's blow-off valve. A brick column base [2081] and abutting L-shaped wall demarcate the firing floor. Floor surfaces [2070]/[2076]/[2089] to the south-west probably served as the floors of a coal store, although this part of the building is indicated as 'Boiler' on the 60-inch to 1-mile Town Plan, and could have been the location of the third boiler referenced in 1852. The surface [2070] was constructed from handmade bricks and occasional firebrick, extending over an area of 5.02m by 1.50m.

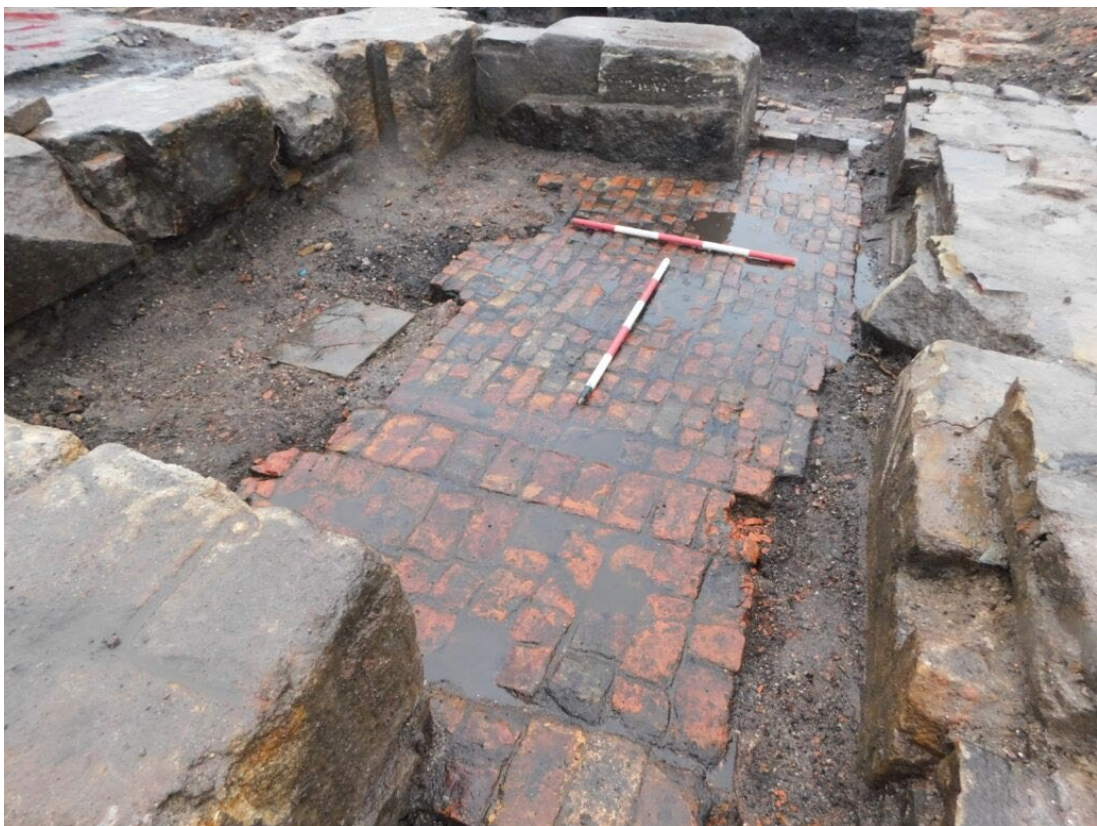
*Plate 29: Surface [2070], facing southwest, 1m and 1m scale*

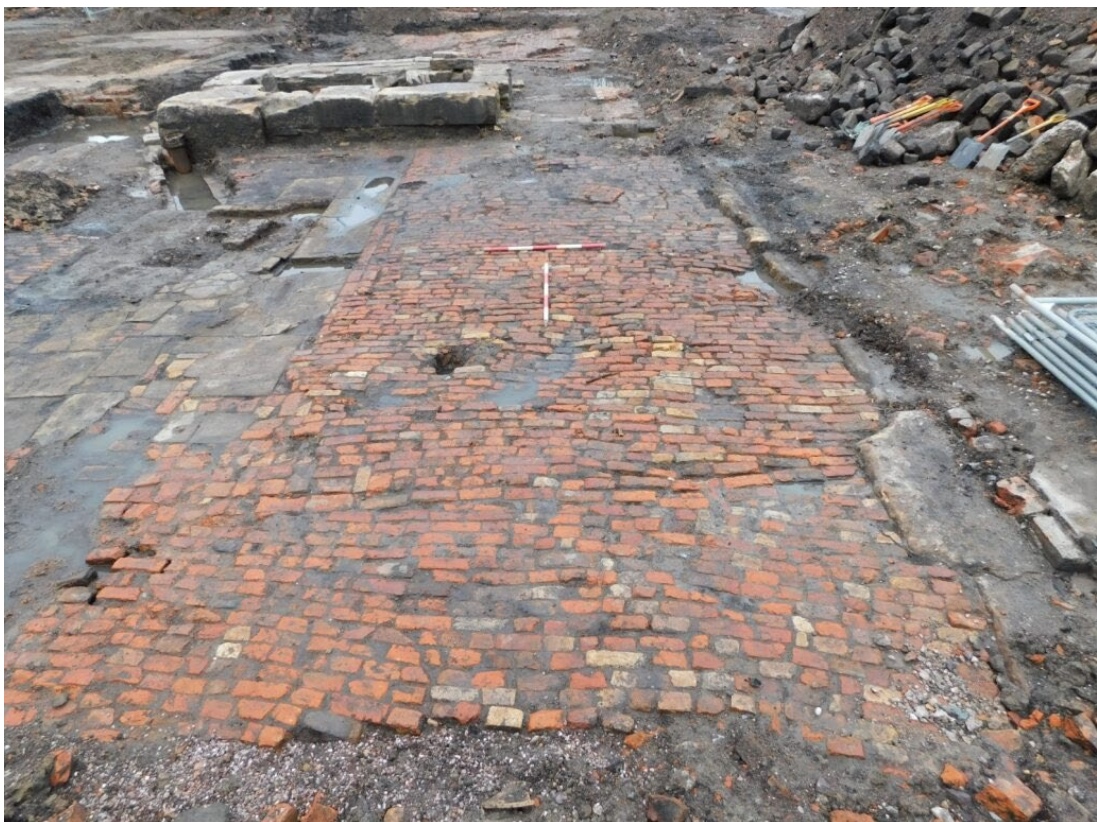
*Plate 30: Brick floor surface [2066] facing northwest, 1m and 1m scale*

6.11.7 To the south-east of [2082] at the limit of excavation and abutting the coping stones of the presumed canal arm wall [2077] was surface a [2066] constructed from red handmade brick and occasional firebrick (brick dimensions: 225mm [l] x 112mm [w]) (Plate 30). The surface [2066] measured 8.84m long and 7.27m wide and was one brick thick. The surface [2066] lay within the footprint of a 4.45m-wide building shown on the 60-inch to 1-mile Town Plan of 1851. A break in the pattern of the brick floor corresponds to a dividing or end wall of the building, as depicted on the historic mapping. The building may have functioned as a store or warehouse.

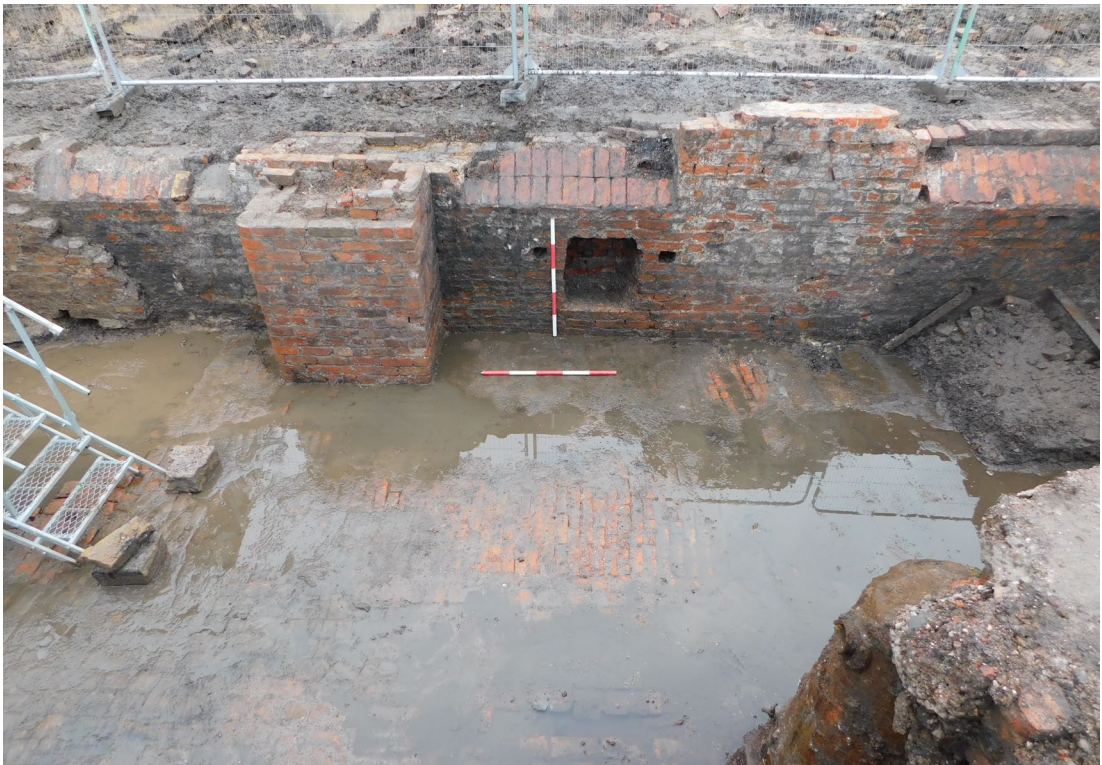
*Plate 31: South-western wall of the cellar showing the inserted cellar lights [242] and openings (2 x 1m scales)*

- 6.12.3 **Wall 241:** three cellar lights, Group [242], and a possible cut-out for a bearing box in the mill cellar's south-western wall [241] were seen as evidence for modifications made to the cellar made during this period (Plate 31).

- 6.12.4 The cellar lights [242] were first depicted on the 1:500 OS Town Plan of 1891 and clearly correspond to three c.1.50m-wide openings within the cellar's south-western wall [241]. The openings were splayed and had sloping sills. The finish of the bricks and pointing were noticeably different from the fabric of the mill wall [241].

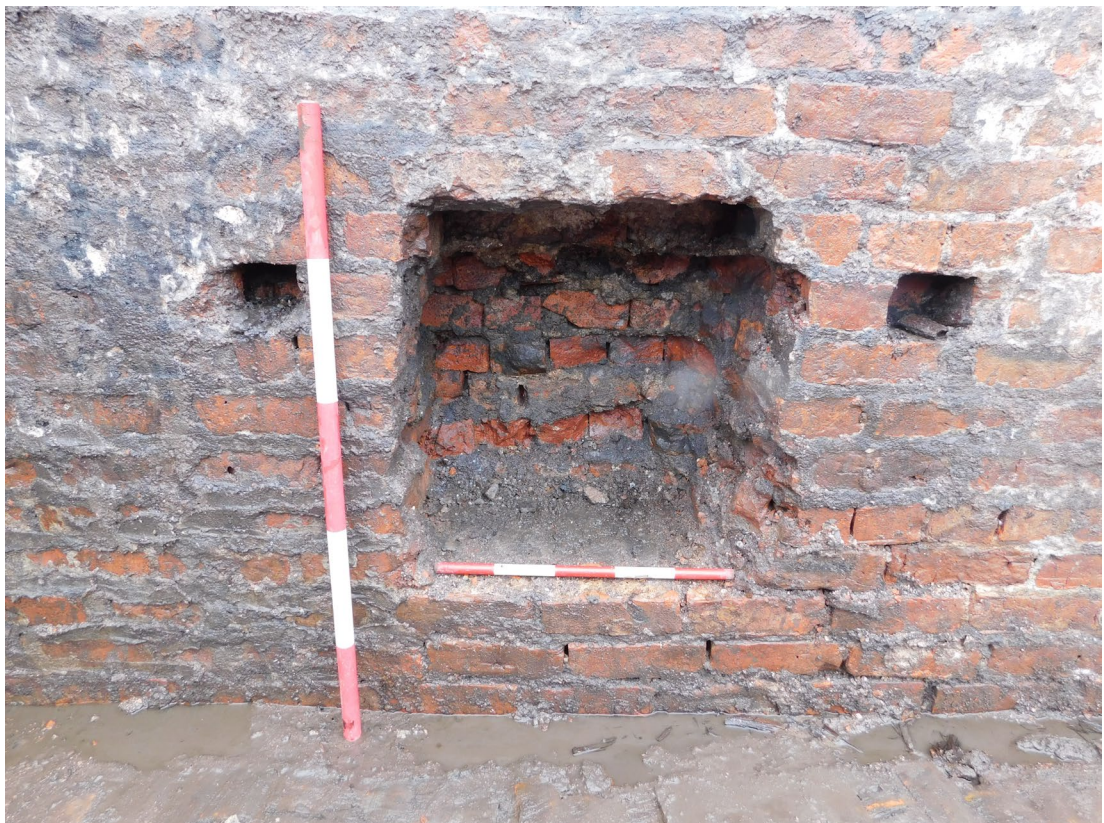
*Plate 32: Cut-outs within wall [241] scales: 1m, 0.50m*

- 6.12.5 A rectangular opening was made within the face of wall [241] (Plate 32). The opening was clearly a later addition to the wall and its situation immediately beneath the central cellar light suggests this post-dated the insertion of the cellar lights. Two holes were made in the wall either side of the large opening by the removal of half-bricks. Two corresponding sockets were identified in the

opposing wall [253] face. The position of the large cut-out and smaller sockets aligns reasonably well with the south-eastern row of columns on the mill floor and supposed position of the line shaft, as extrapolated from the engine mounting block [2097] at the north-eastern end of the mill. It is therefore possible that the cut-out within the wall [241] housed a bearing box associated with power transmission at this end of the mill.

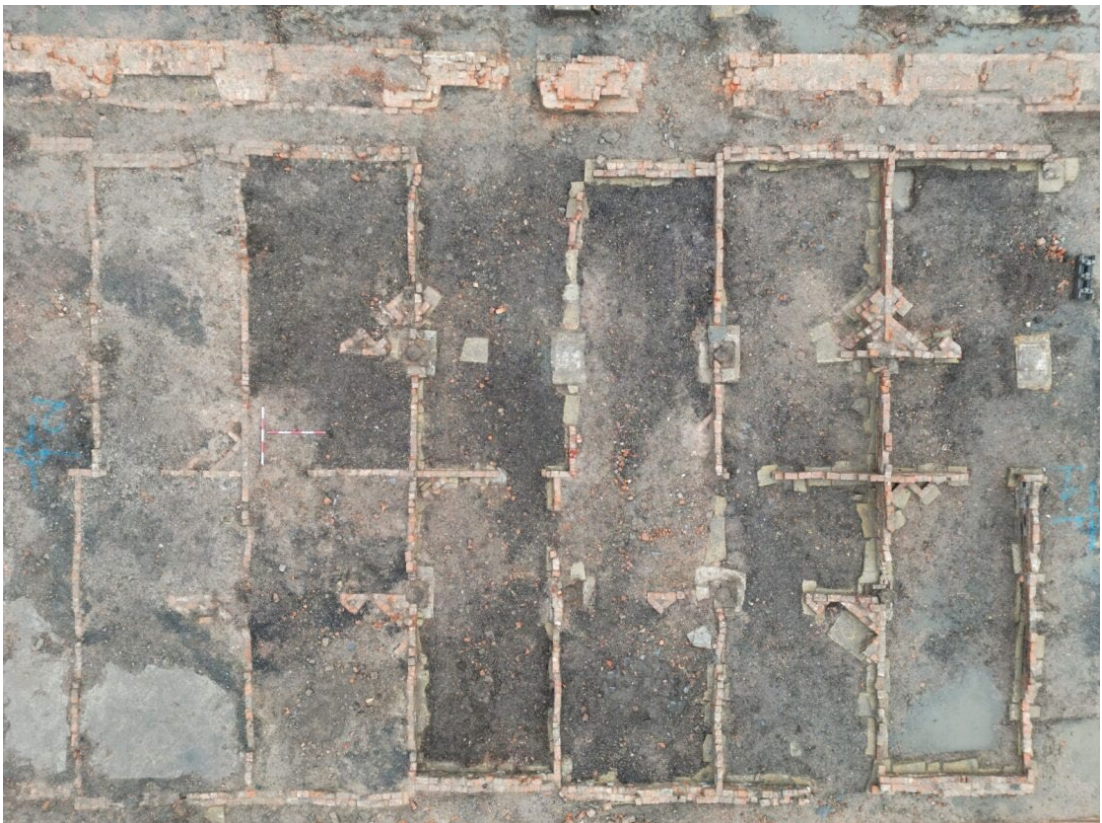
*Plate 34: Close-up of the partitioned mill floor and arrangement of rooms and fireplaces (north to top)*

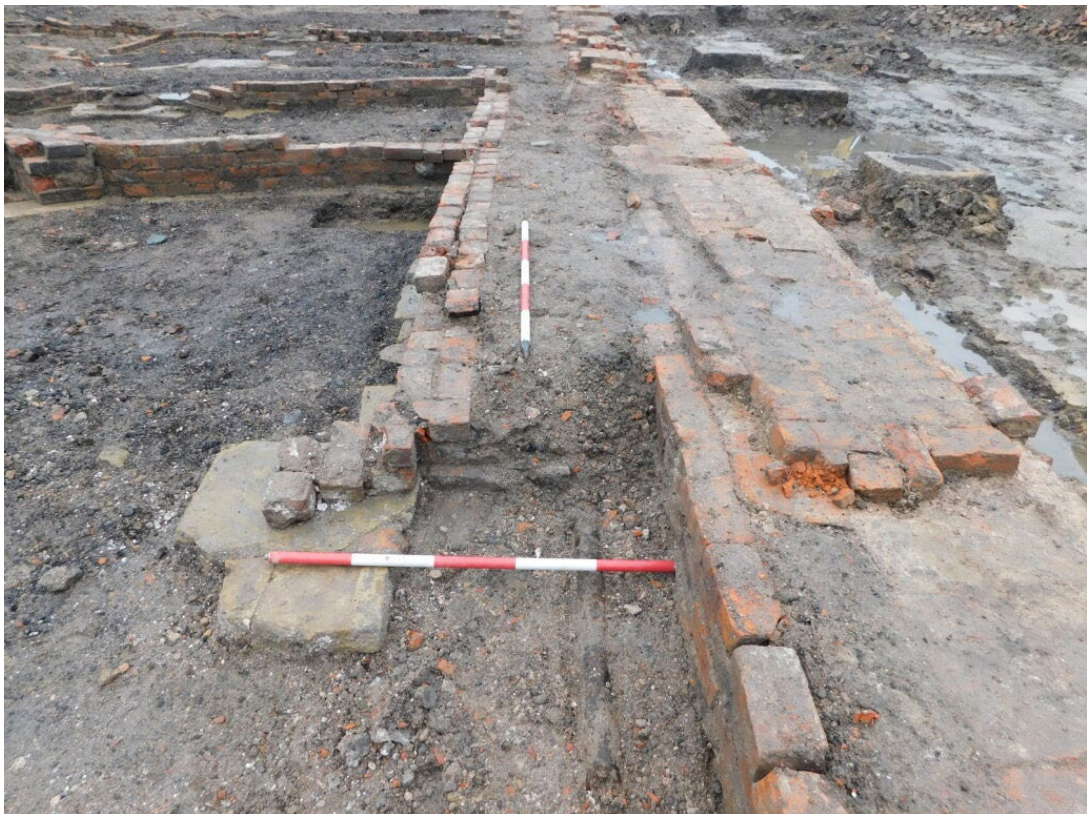
*Plate 35: Walls [256] right and [257] left, forming a narrow corridor along the south-eastern side of the principal mill, looking north-east. 2 x 1m scales*

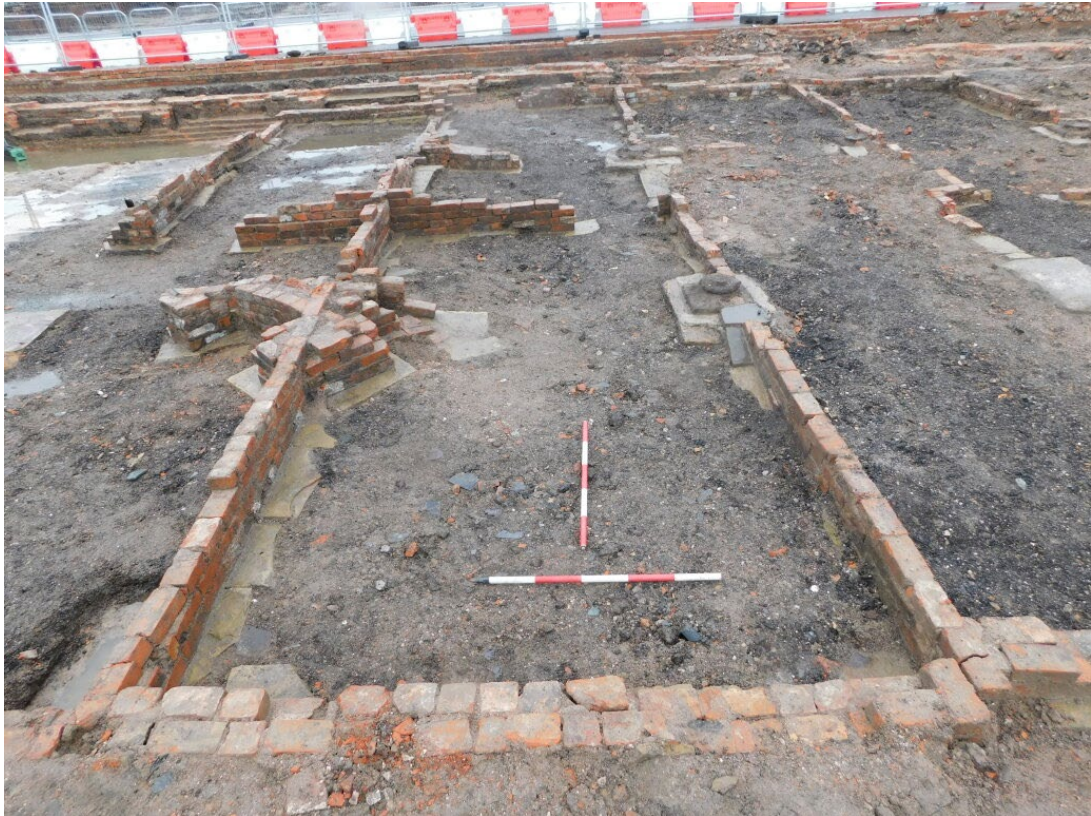
*Plate 36: Rooms 5 and 6 facing northwest, 1m and 1m scale*

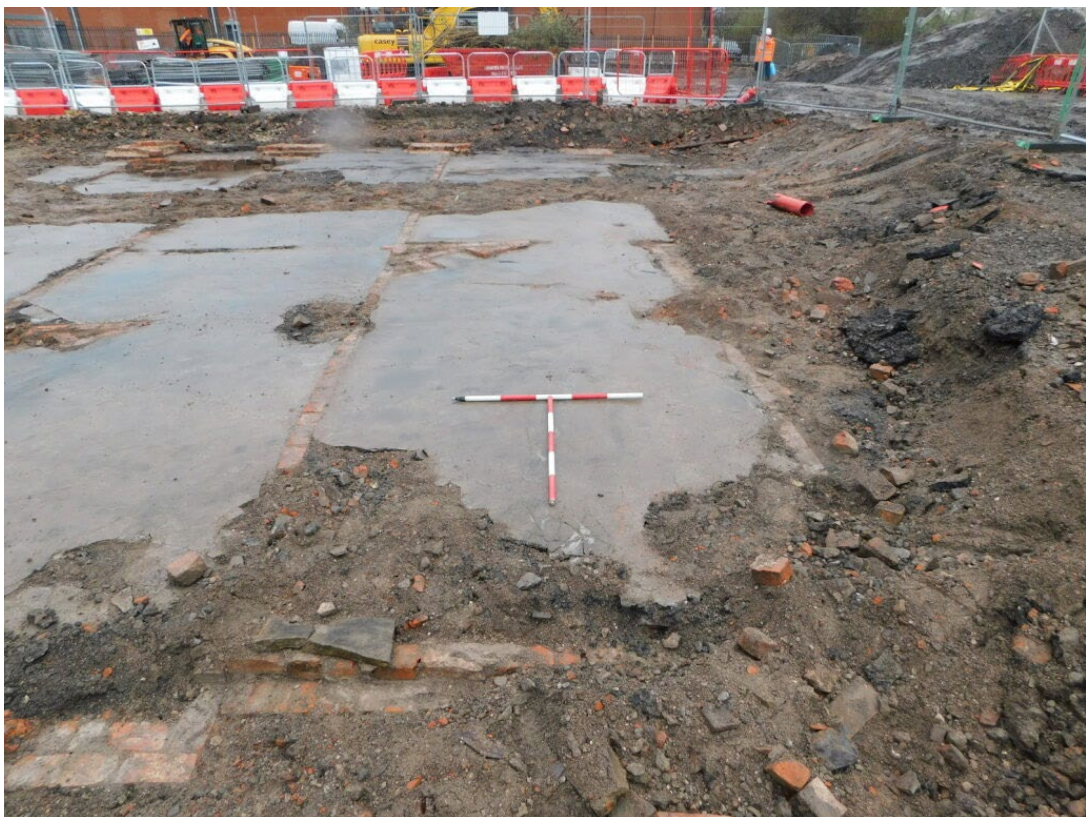
*Plate 37: Single concrete surface [2037] truncated by modern service, facing northwest, 1m and 1m scale*

- 6.14.1 During the excavation only vestiges of original flooring were encountered. Sandstone flags, presumably from the original mill been retained as footings to spread the load of the new partition walls between the dwellings; it was unclear if all were *in-situ* or whether they had been re-laid. Most of the original surfaces had been lifted and were replaced with concrete (Plate 37).

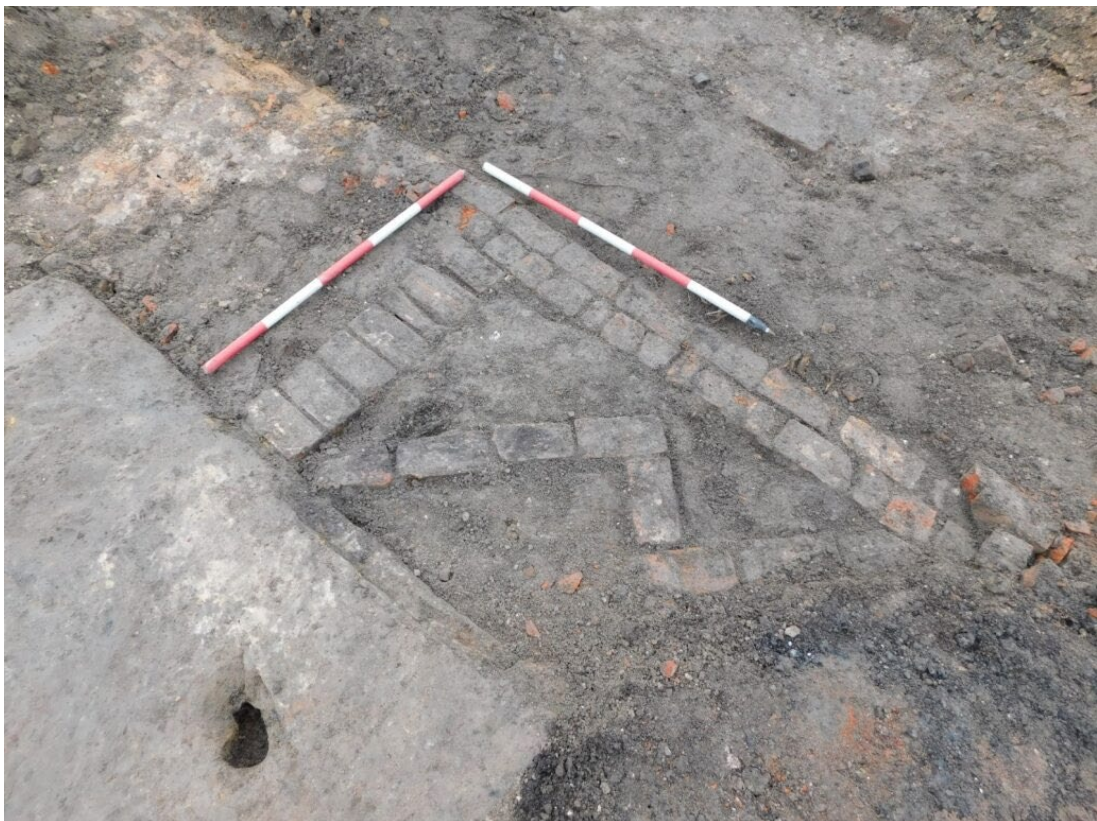
*Plate 38: Fireplace [2096] and engine bed [2097] facing south, 1m and 1m scale*

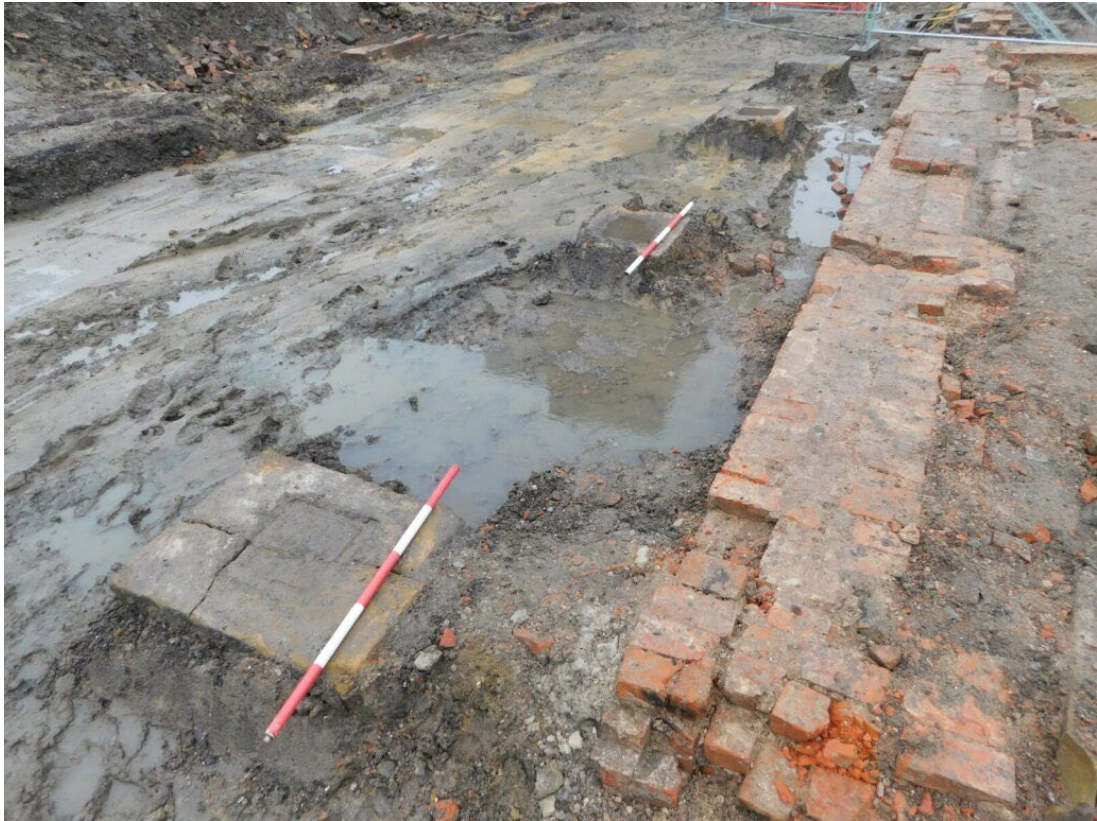
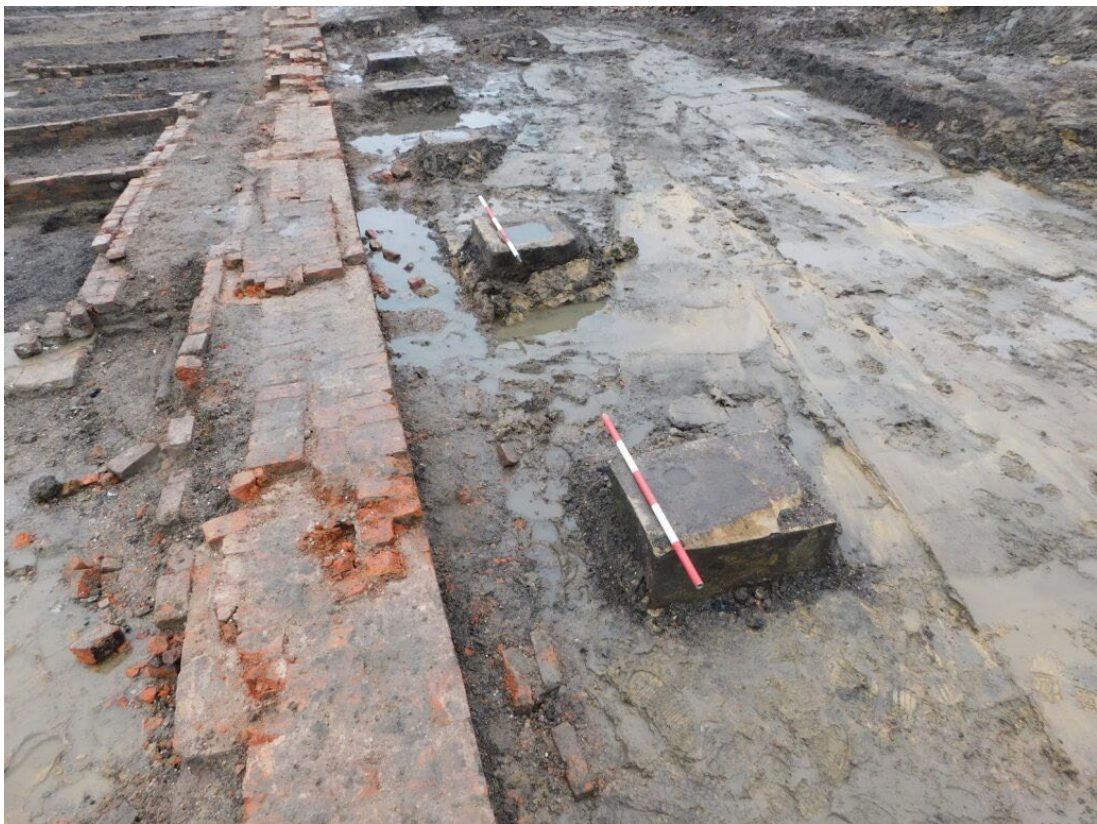
*Plate 39: Stone settings [275] facing south, 1m and 1m scale*

*Plate 40: [275] facing east, 1m and 1m scale*

- 6.14.8 **Balconies:** Along the south-eastern side of the mill were a series of eight reused column bases (Plates 39-40). The south-western blocks of stone were placed at regular intervals of 2.15m and were evidently intended to form pads for the ironwork of the balconies / gangways, which gave access to the tenements at each floor level. A similar arrangement was recorded along the south-western side of the small mill (see below).

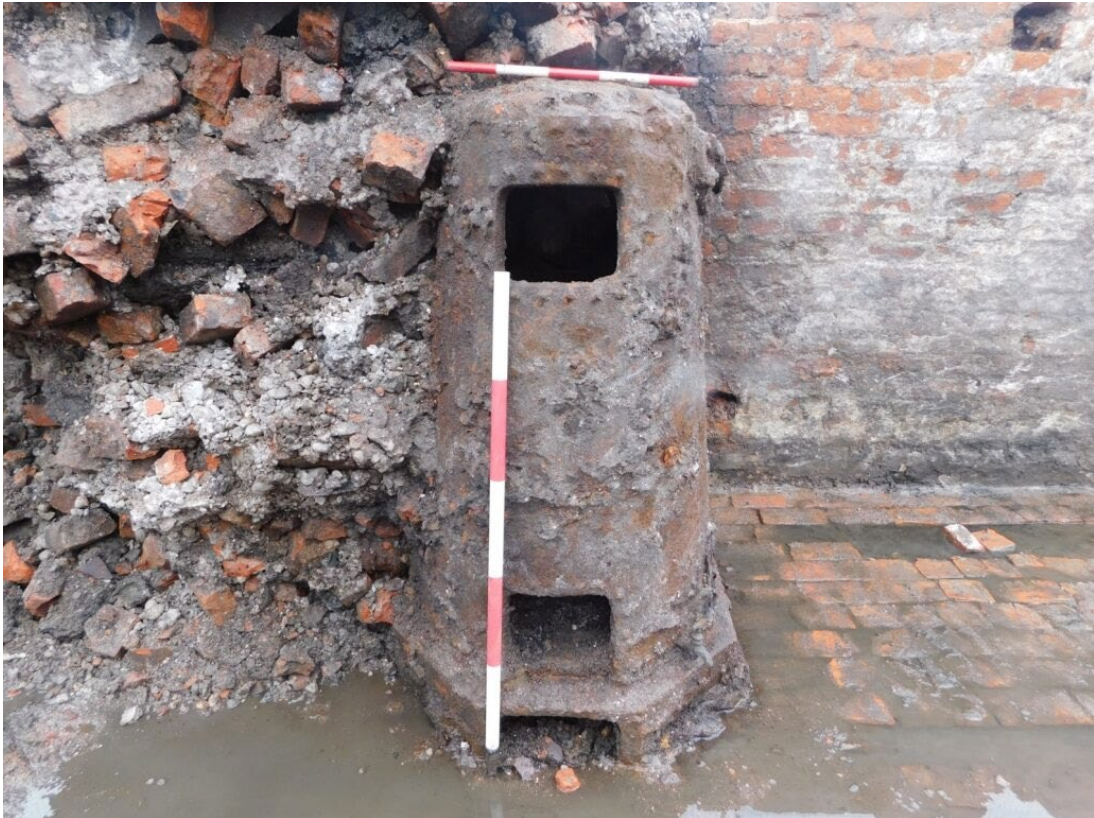
*Plate 41: Boiler [249], 1m scale and 0.50m scale*

- 6.15.6 On the opposite side of the cellared room to the ash pits, occupying a central position alongside the cellar's north-eastern wall [253], was a cast-iron boiler (Plate 41). The boiler [249] stood above the cellar floor [248] offset slightly from wall [253]. The boiler [249] was an upright boiler; it had elongated trapezoidal shape with an octagonal base and rectangular openings at the top and bottom (Plate 41). It measured a maximum of 0.85m wide at its base, narrowing to 0.44m at its top and stood to a maximum height of 1.36m.

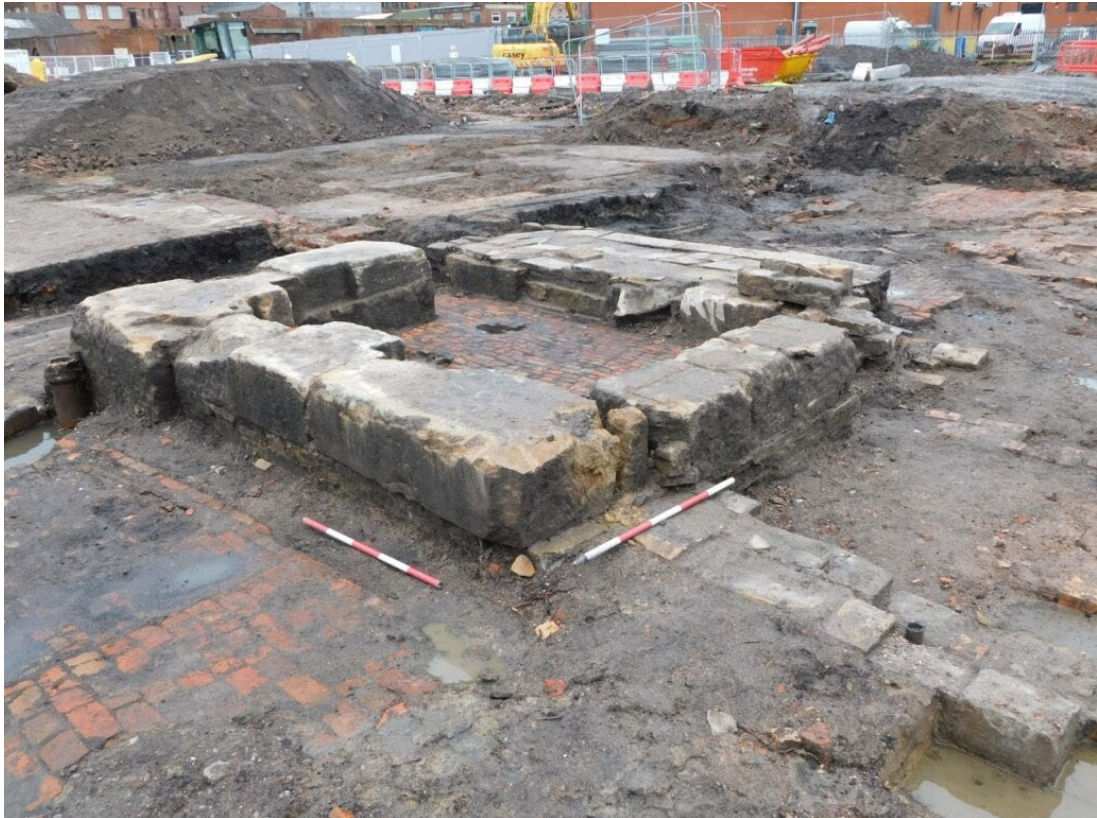
*Plate 42: [2052], facing west, 1m and 1m scale*

- 6.17.1 A rectangular stair tower [2052] providing access to the dwellings' balconies was constructed atop the early- to mid-19<sup>th</sup>-century boiler house. This measured 4.52 x 4.11m (Plate 42). The foundations of the tower consisted of large stone blocks, some of which were evidently reused from one of the mill's engine settings. Several of the blocks had perforations in their upper surfaces consistent with those found in engine mounting blocks, used for holding-down bolts.

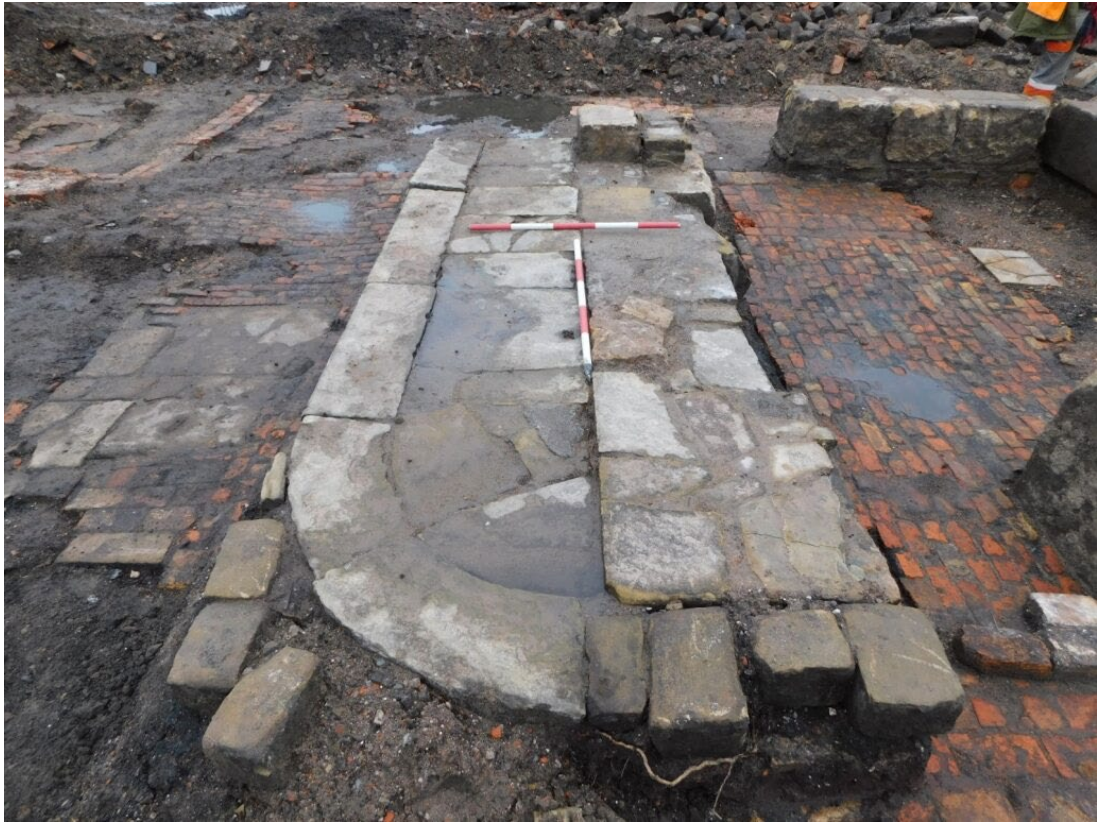
*Plate 43: [2075] facing west, 1m and 1m scale*

- 6.17.3 A surface [2075] bordered with a curvilinear stone curb likely formed the first level of the staircase (Plate 43). This measured 3.68m long by 0.59m wide and 0.74m high. The foundations stood to a height of 0.85m above the earlier floor

surfaces [2070]/[2089]. This was constructed from repurposed blocks of cut stone masonry.

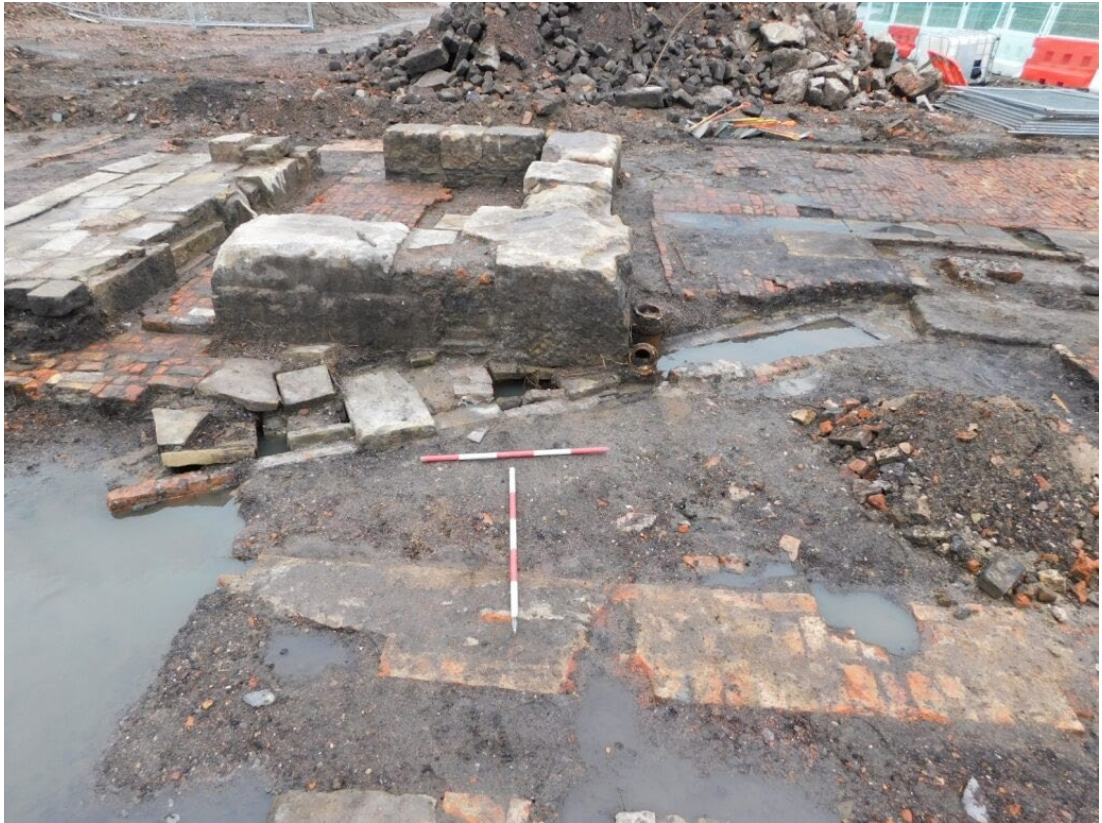
*Plate 44: [2053] facing northeast, 1m and 1m scale*

- 6.18.1 To the northeast of the principal mill's external wall [2090], there were a series of drains and manholes [2057]/[2085]/[2053] truncating the earlier mill remains within the early boiler house and extended engine house [2082], [2084].
- 6.18.2 Post-dating the extended engine house [2054] was a drain [2053] constructed from two walls of red handmade brick surmounted by sandstone flags (Plate 44). The drain [2053] measured 3.27m long, 0.75m wide with an excavated height of 0.40m.
- 6.18.3 Another connected drain [2057] was orientated north / south. This contained a ceramic pipe [2058] and measured 23.10m long and 0.90m wide. This truncated engine house [2054] and house brick and stone capped drain [2054].
- 6.18.4 Sealing all earlier deposits and drains was surface [2056], a cobbled external yard surface 15m long by 10m wide.
