### **DESIGN COMPLIANCE STATEMENT – SMITHFIELD MARKET, MANCHESTER**

NEW SMITHFIELD MARKET  
PROPOSED DRAINAGE

# Inspection Report

Project Name: New Smithfield Market 041124  
Start Date: 04/11/2024  
Client: Barnfield Construction Ltd  
8 Kenyon Road, Lomeshaye Industrial Estate  
Nelson

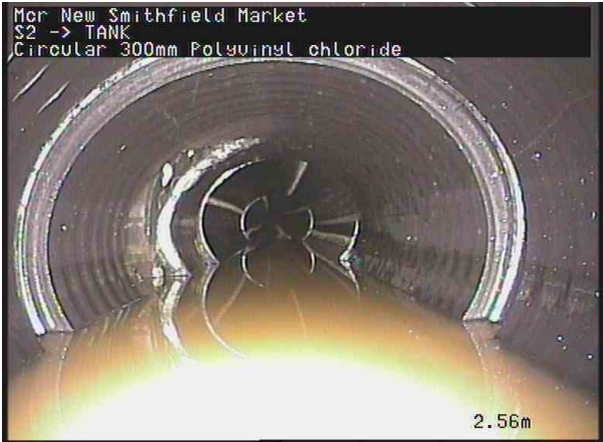
| Scale: | 1:236 | Position [m] | Code | Observation | MPEG | Photo | Grade |
|---|---|---|---|---|---|---|---|
| | | 2.56 | OJM | Open joint, medium | 00:00:20 | S2X_a6d1<br>3c1d-3f1f-<br>4086-8546 | 1 |

S2X\_a6d13c1d-3f1f-4086-8546-778b02011d1c\_20241104\_092  
512\_015.jpg, 00:00:20, 2.56 m  
Open joint, medium

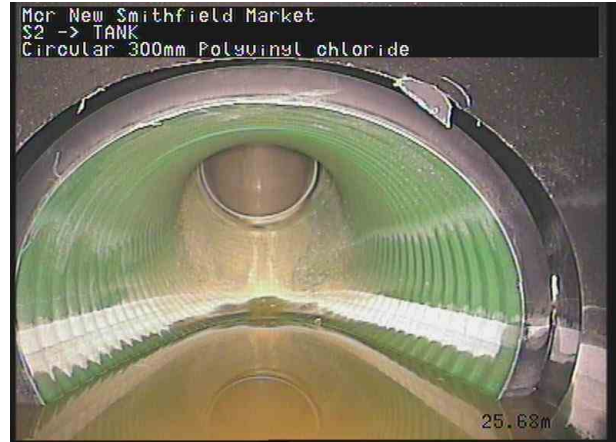
| Scale: | 1:236 | Position [m] | Code | Observation | MPEG | Photo | Grade |
|---|---|---|---|---|---|---|---|
| | | 25.68 | OJM | Open joint, medium | 00:04:14 | S2X_f7222<br>f66-3294-4<br>dcc-8600- | 1 |

S2X\_f7222f66-3294-4dcc-8600-5484e84aa56d\_20241104\_092  
943\_480.jpg, 00:04:14, 25.68 m  
Open joint, medium

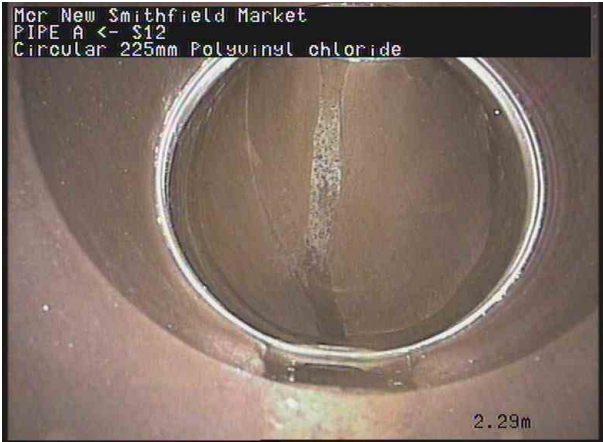
AX\_f6dae6dc-38bd-4364-afa4-7698d6535c87\_20241105\_1434  
06\_868.jpg, 00:00:26, 2.29 m  
Pipe size changes, new size(s), 150mm high
