Remediation Strategy

Stockport Road

Manchester

**Report A2951/24/RMS/V4**

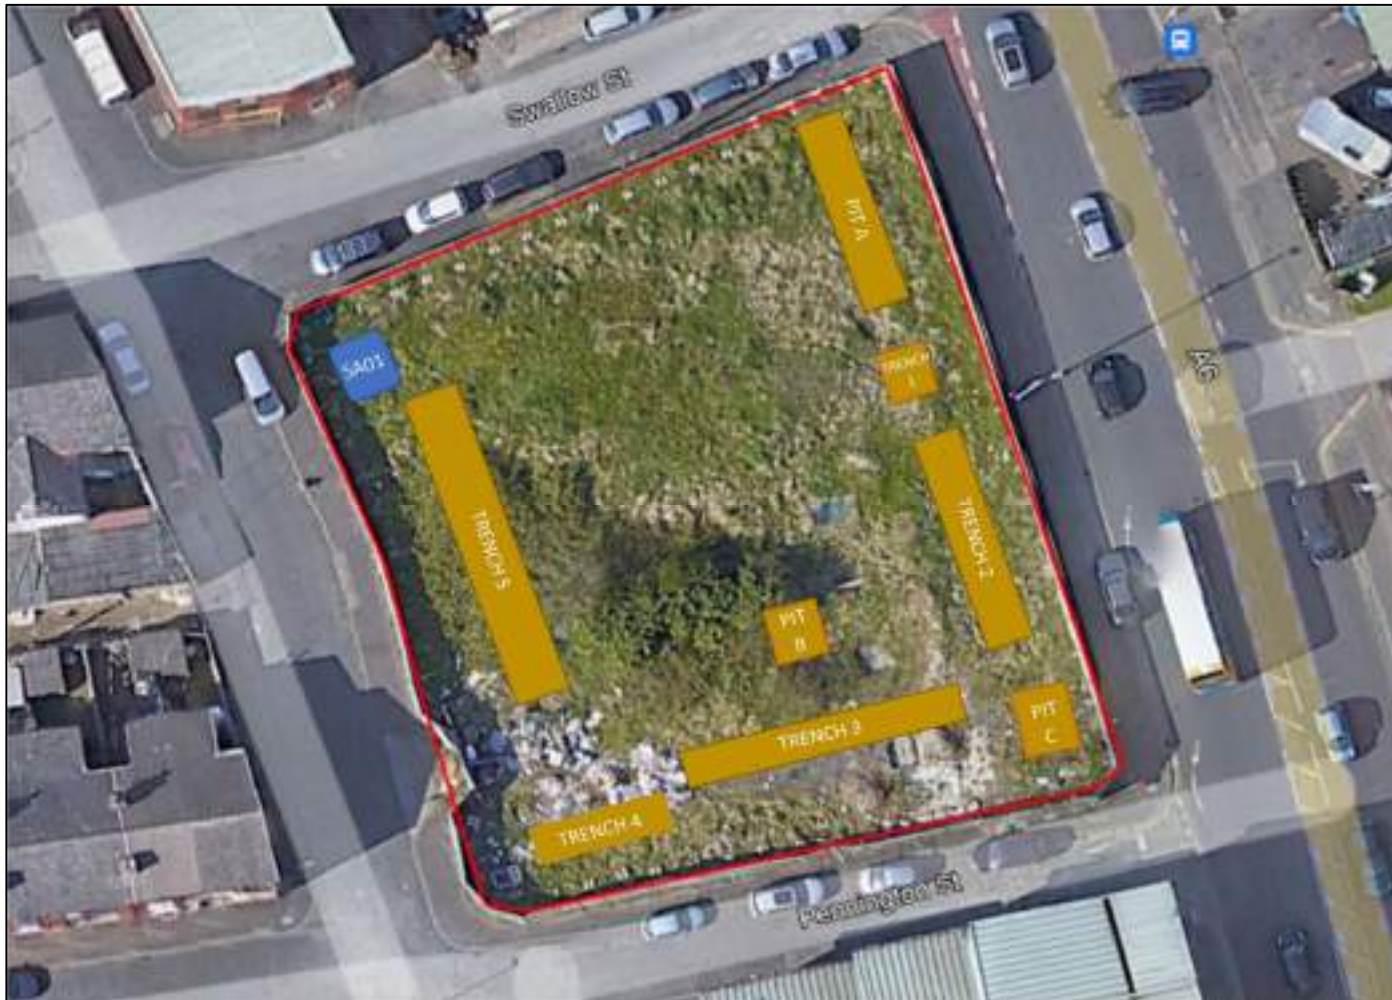
**Figure 4: Exploratory Hole Location Plan (Trenching SI)**

Trench 1 – The top of the natural clay layer at the base of this trench was found to slope from 1.00m depth to 1.80m depth from north to south.

Details of the trenching carried out in the additional investigation can be found within Table 1 overleaf. Further details, where necessary, are provided below.

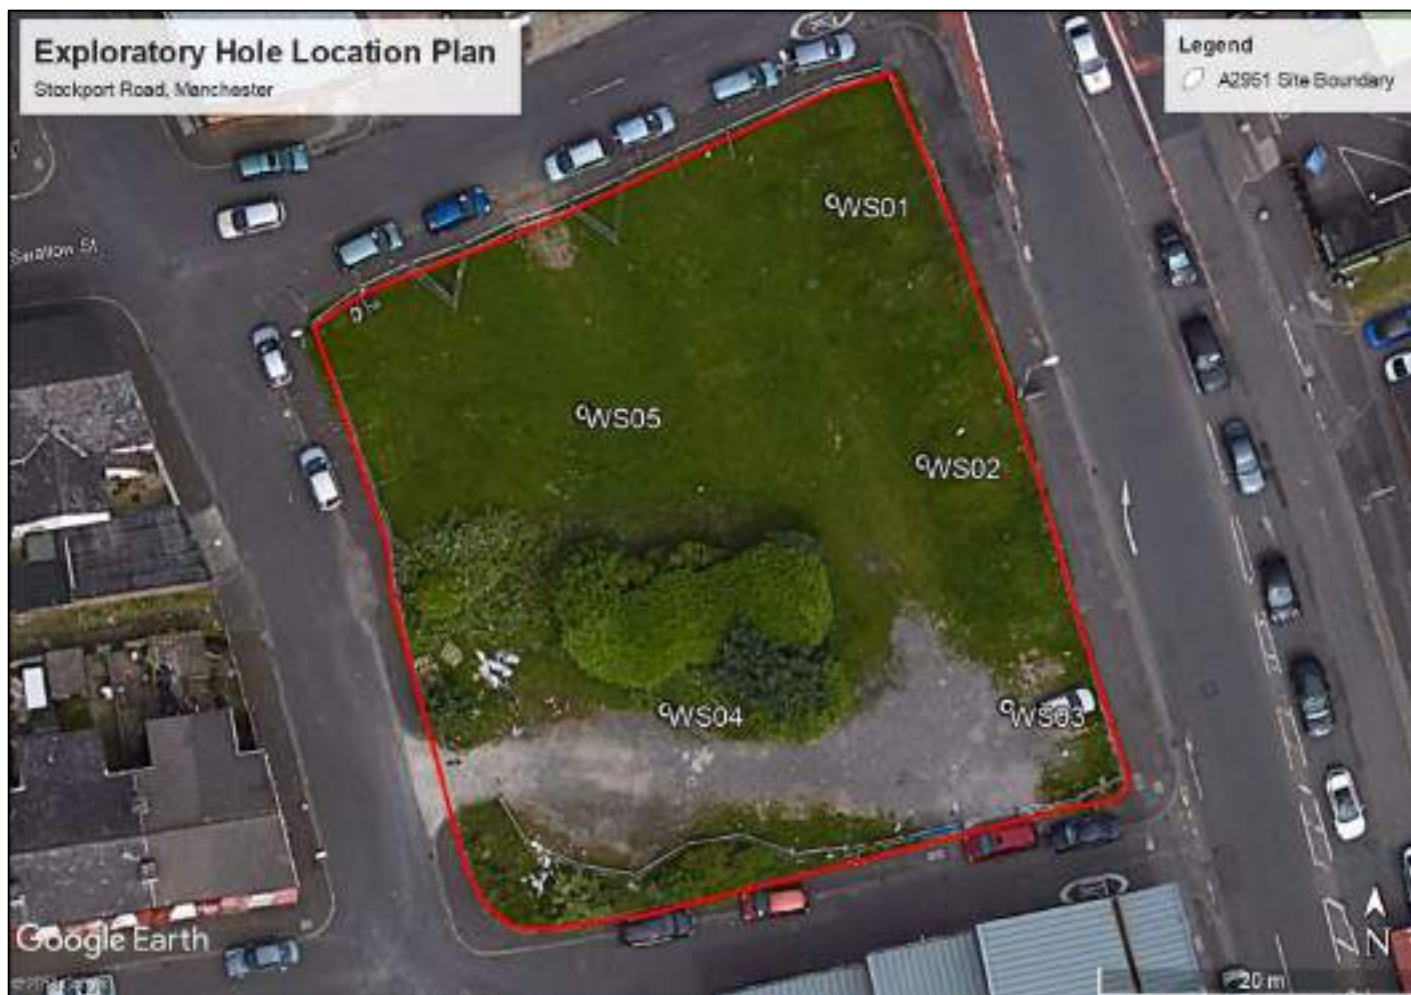
Figure 7: Exploratory Hole Location Plan (Window Sampling SI)

Each exploratory location was scanned using a Cable Avoidance Tool (CAT) in order to locate unrecorded underground services, and the exploratory locations were repositioned if necessary.

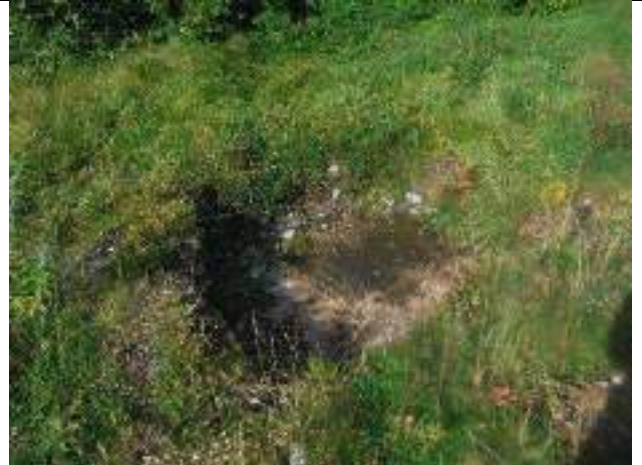
**P5:** Long grasses and sporadic weeds occupy the north and eastern parts of the site

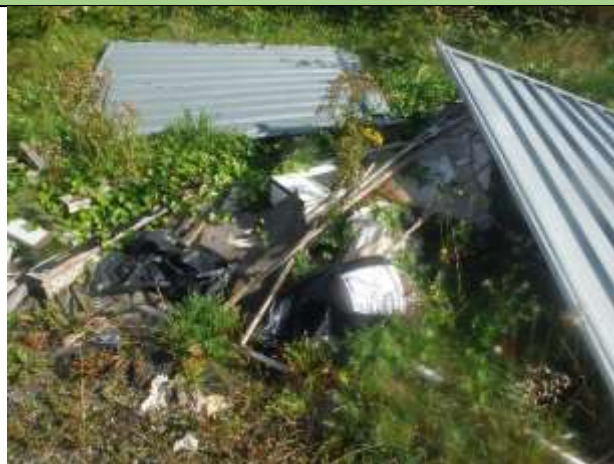
**P11:** Flytipped rubbish noted in the south-west of the site
