**PHASE II SITE INVESTIGATION REPORT  
OF LAND AT  
PLANT HILL ROAD  
MANCHESTER**

**January 2025  
Ref: GSI 1941 MP PII Report V3**

| Quality Assurance | |
|---|---|
| Project Name | Plant Hill Road, Manchester |
| Report Type | Phase II Site Investigation |

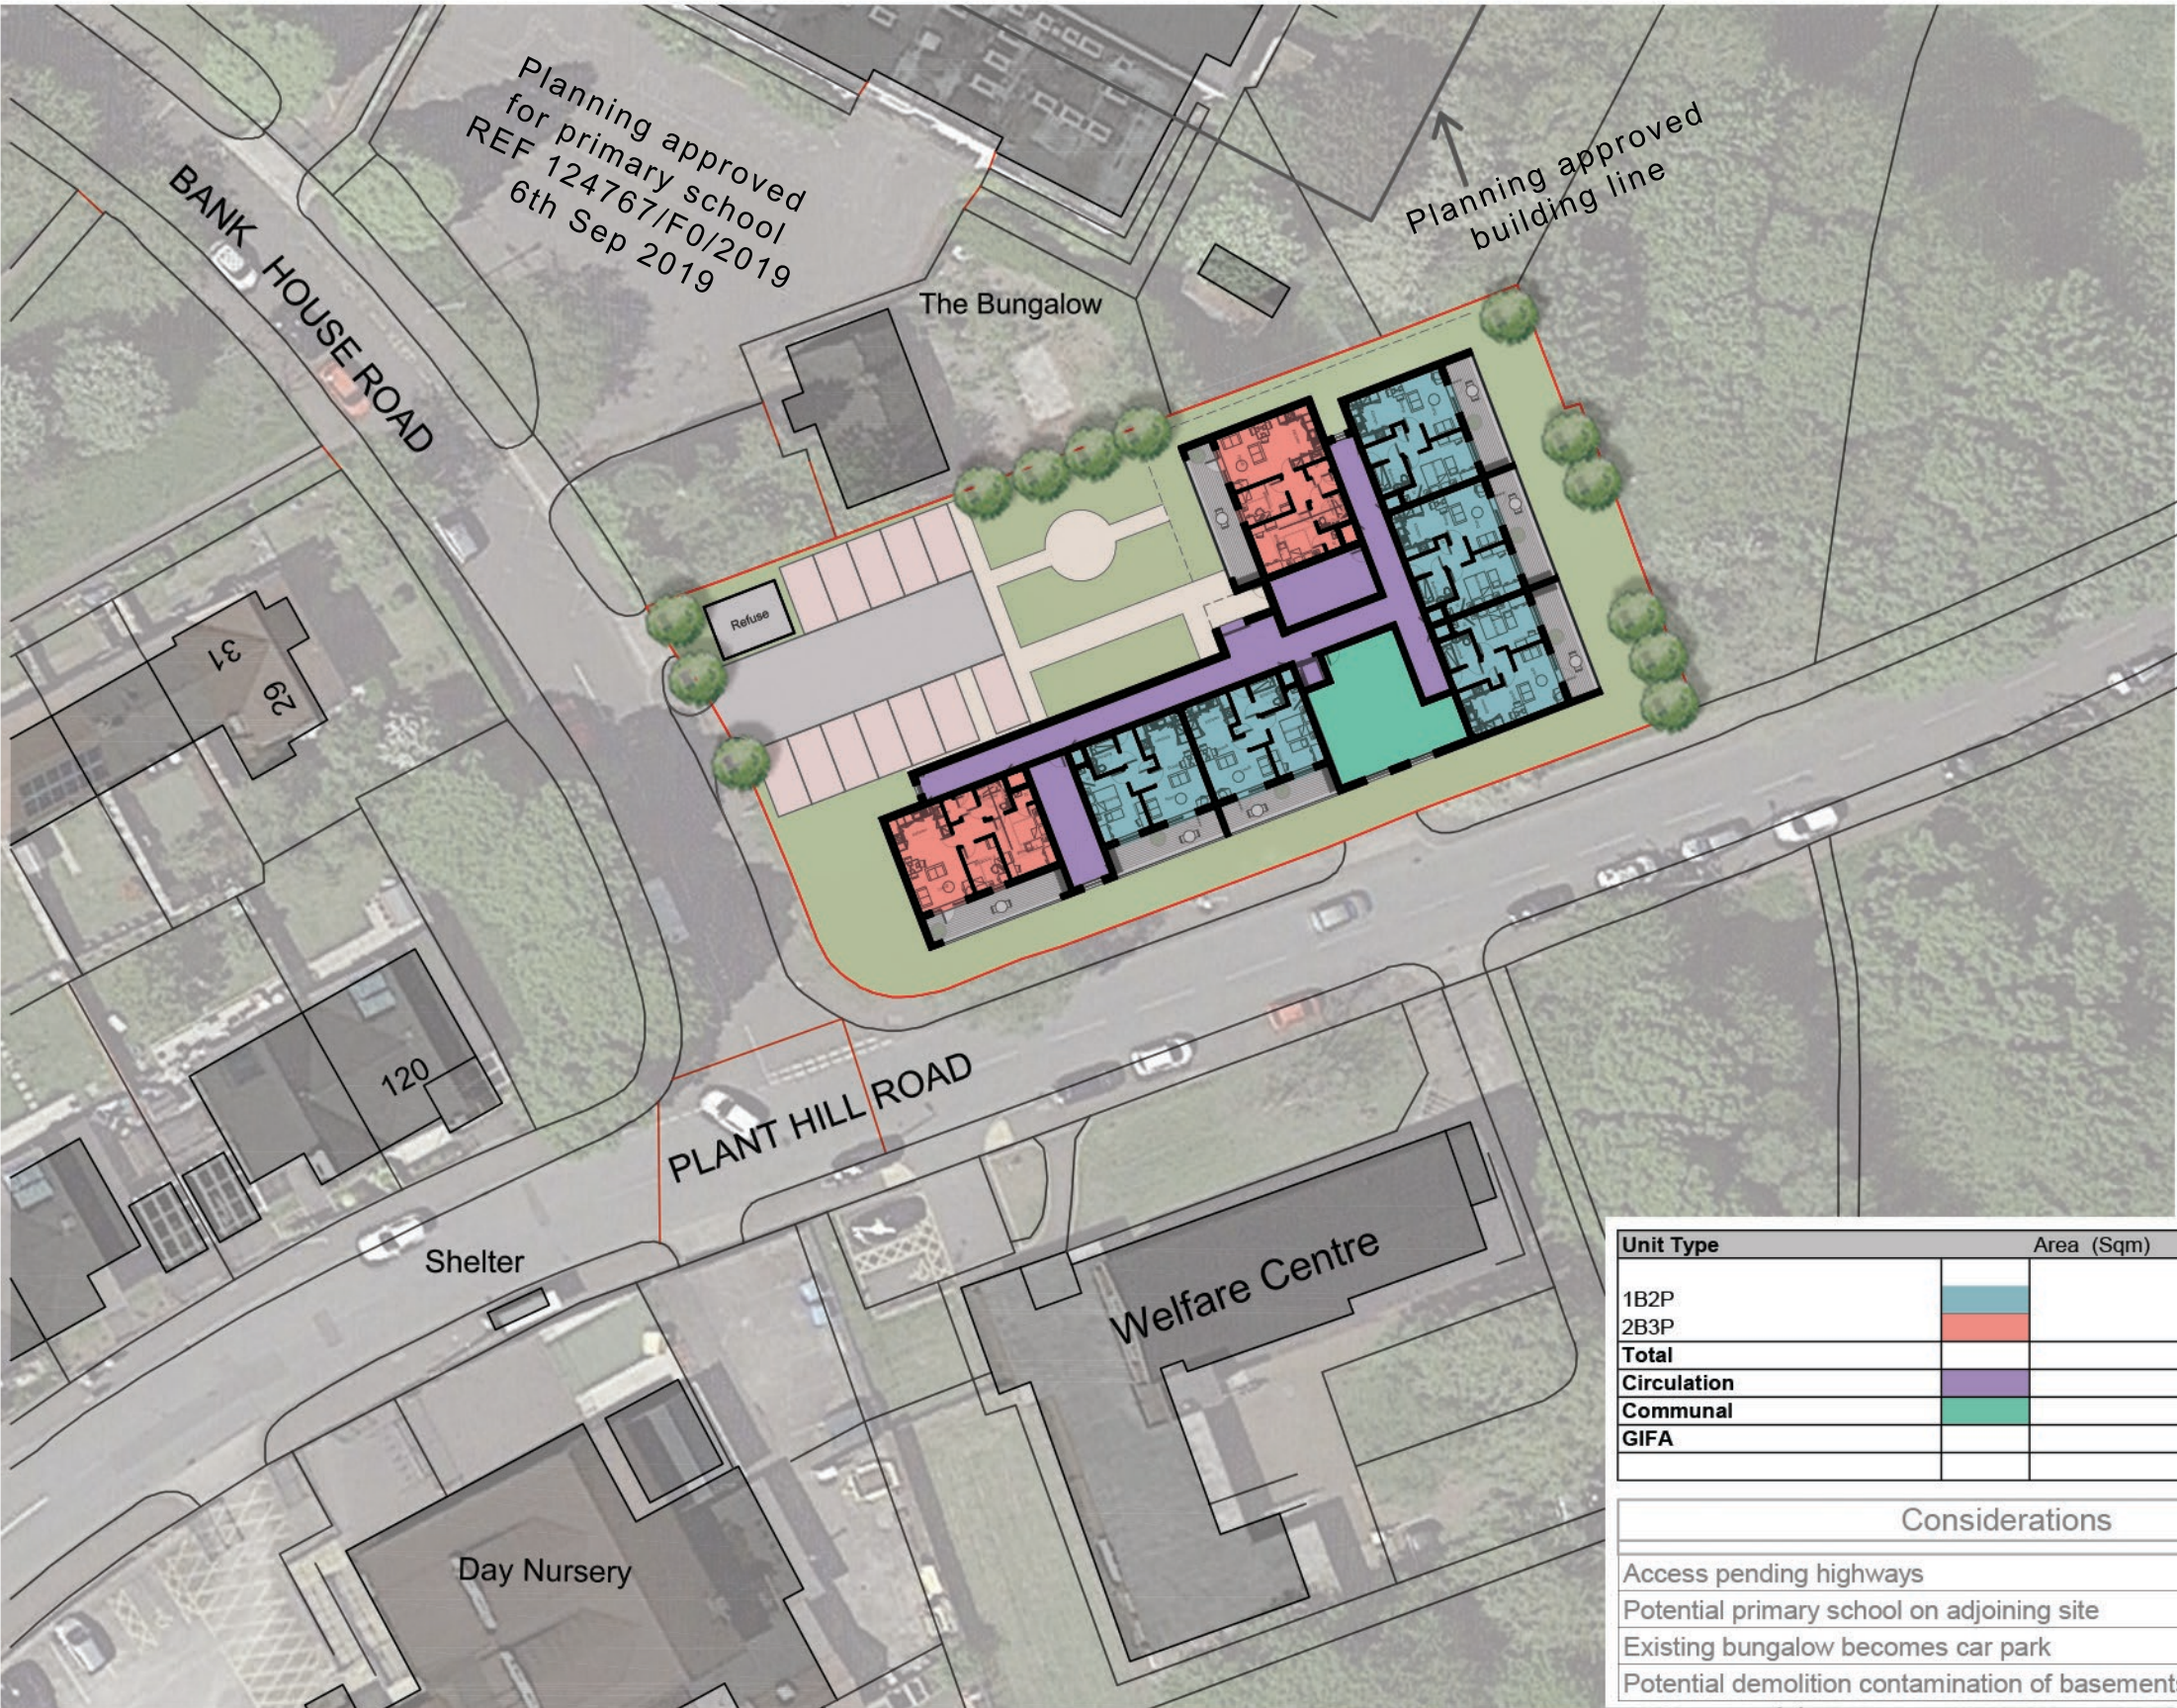
| | GeoCon Site Investigations Ltd<br>Suite 2 Marple House,<br>39 Stockport Road,<br>Marple,<br>Stockport,<br>SK6 6BD.<br>Tel: 0844 504 3901, Fax: 0844 504 3902,<br>Email: <a href="mailto:info@geoconsiteinvestigations.com">info@geoconsiteinvestigations.com</a><br>Web: <a href="http://www.geoconsiteinvestigations.com">www.geoconsiteinvestigations.com</a> | <b>PROJECT ID</b><br>GSI 1941 Plant Hill, Manchester | <b>DRAWING NUMBER</b><br>GSI 1941/02 | <b>SCALE</b><br>N.T.S |

- 8.2.1 Ten dynamic sample boreholes were advanced across the site on a basis of targeting proposed structures and as a general coverage assessment of the site as a whole.
- 8.2.2 The ground conditions encountered within the exploratory holes are summarised below in **Table 8.1: Summary of Ground Conditions**

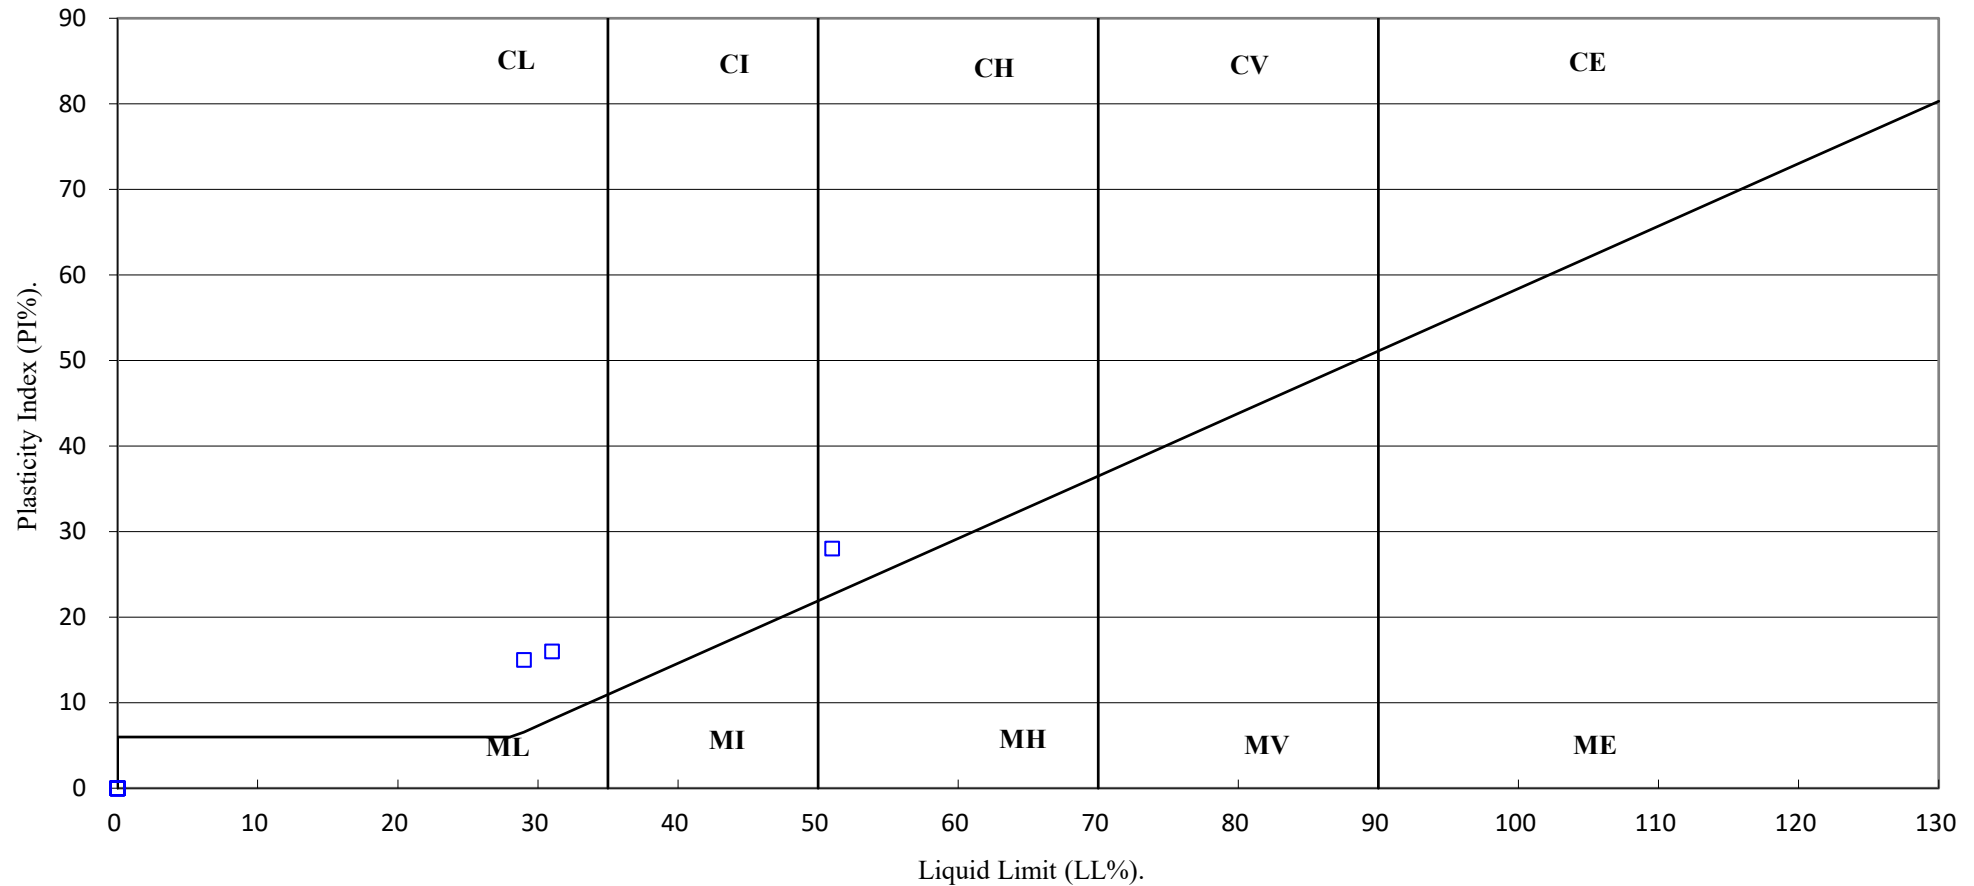
# PLASTICITY CHART FOR CASAGRANDE CLASSIFICATION.

Plant Hill, Manchester

| Stratum | Depth Range to Base of Stratum (mbgl)<br>(Thickness Range) | Relative Density / Undrained Shear Strength | Notes |
|---|---|---|---|
| Cohesive Soils | 3.60 to 5.45m+<br>(0.40 to 4.95m+) | <u>Strength from Field Description</u><br>Soft to very stiff<br><u>Strength from In-situ Field Testing</u><br>1.20: N = 6-16<br>2.00: N = 10-17<br>3.00: N = 12-30<br>4.00: N = 19-50<br>5.00: N = 15-26 | Clay / silt was encountered in DS01, DS03-DS10 holes directly beneath the Made Ground and other granular deposits generally comprising sandy gravelly clay.<br>Moisture Contents: 20 – 23%<br>Liquid Limits: 29 – 51%<br>Plastic Limits: 14 – 23%<br>Plasticity Indices*: 15 – 28%<br>Consistency Index: 0.5 – 1.0<br>The Atterberg Limit tests indicate that the cohesive soil is of low to high plasticity, of low to medium volume change potential (NHBC classification), and on the basis of the consistency index is firm to stiff. |
