4307-02/AL

## DOMETT STREET– SOIL INFILTRATION TEST LETTER REPORT

IGE Consulting were instructed in January 2025 to undertake soil infiltration tests at a site off Domett Street, Manchester for John Southworth Builders Ltd.

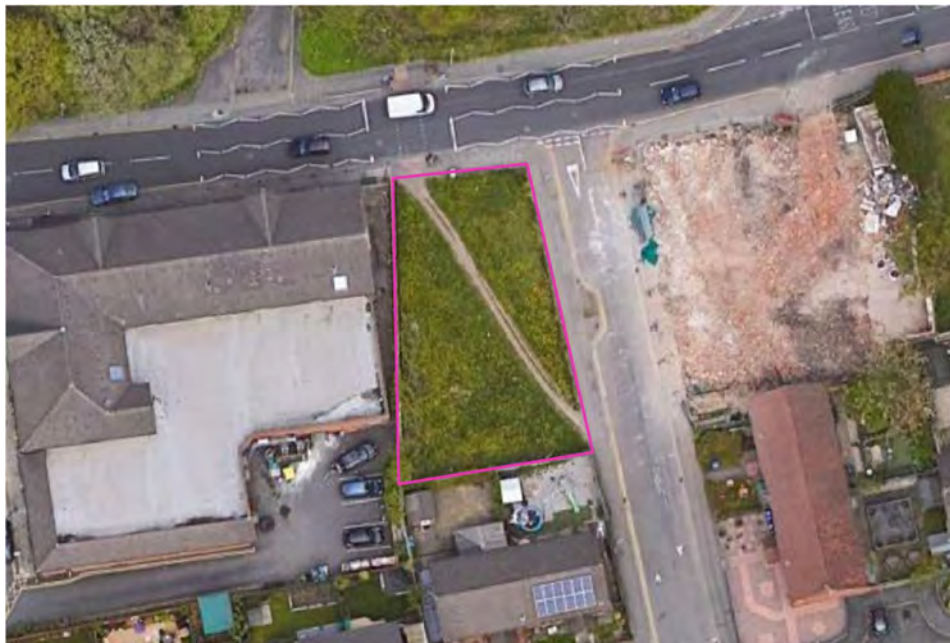
Figure 1: Aerial image of the site dated July 2021. The approximate site boundary is highlighted in magenta.

The site is bound by Domett Street to the east, residential dwellings to the south, mixed use retail and residential premises to the west and Old Market Street to the north. The approximate site boundary is shown on the below aerial photograph, highlighted in magenta. A site location plan is contained in Appendix 2.

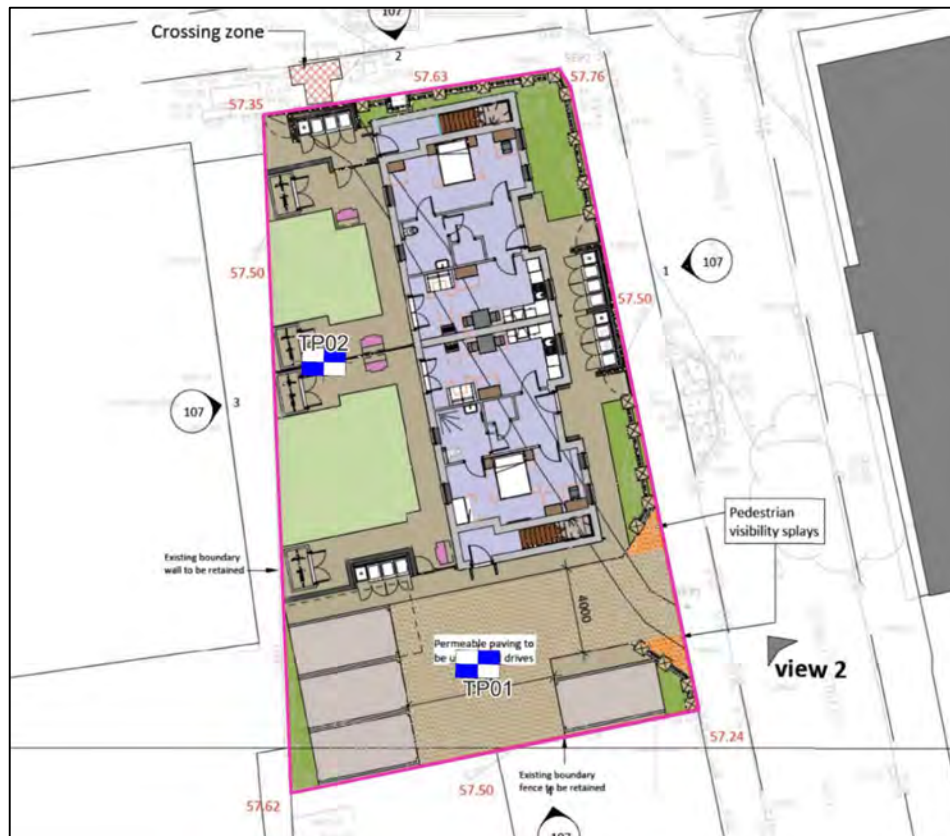
Figure 2: Proposed development plan and trial pit locations.

It is the client's intention to develop the site into a low-rise residential development comprising 4 No. apartments with associated areas of soft landscaping and hardstanding. The hole location plan in relation to the proposed development is shown below:

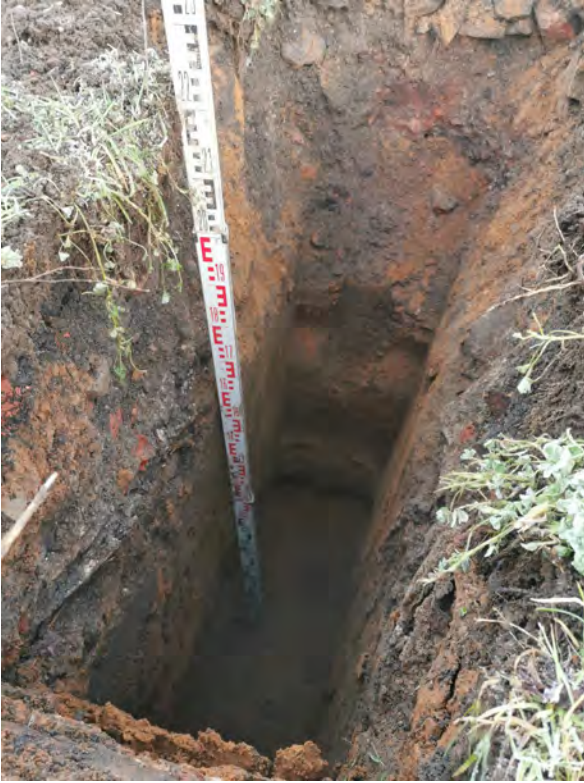
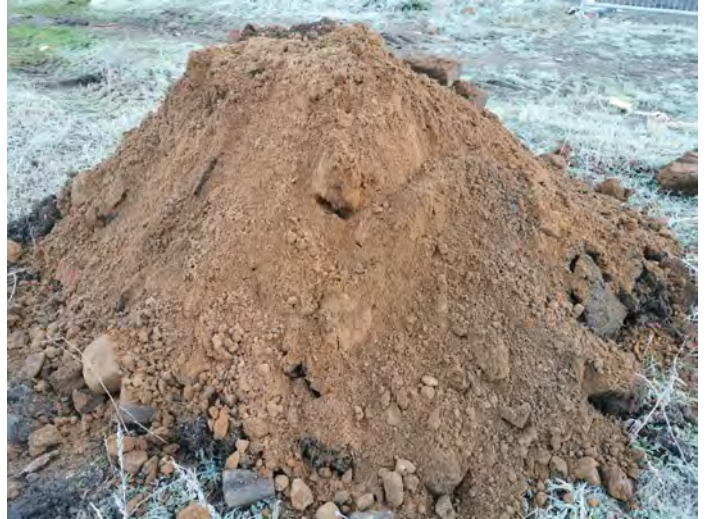
Terminated at target depth

0.00 - 2.00m TP JCB 3CX

Stable

- **Made Ground** comprising dark brown, very gravelly, slightly clayey, fine to coarse SAND and soft to firm, brown, mottled orangish brown, slightly gravelly, sandy CLAY to a depth of between 0.60m to 0.90m bgl (57.20m to 56.70m AOD), underlain by:
- **Glacial Fluvial Sheet Deposits** comprising orangish brown, gravelly, silty, fine to coarse SAND to a depth of at least 2.20m bgl (55.40m AOD).

No water strikes or trial pit instability was observed in either trial pit. The trial pit logs and photographs are included in Appendix 3.

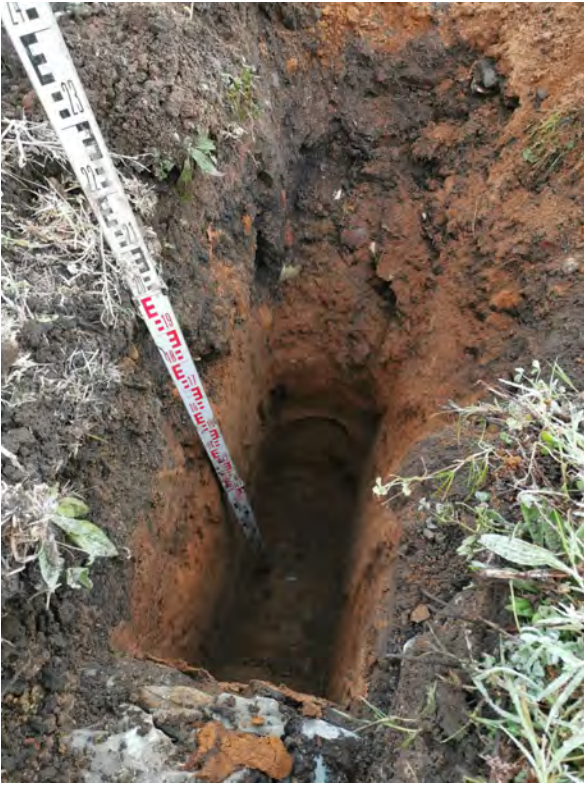
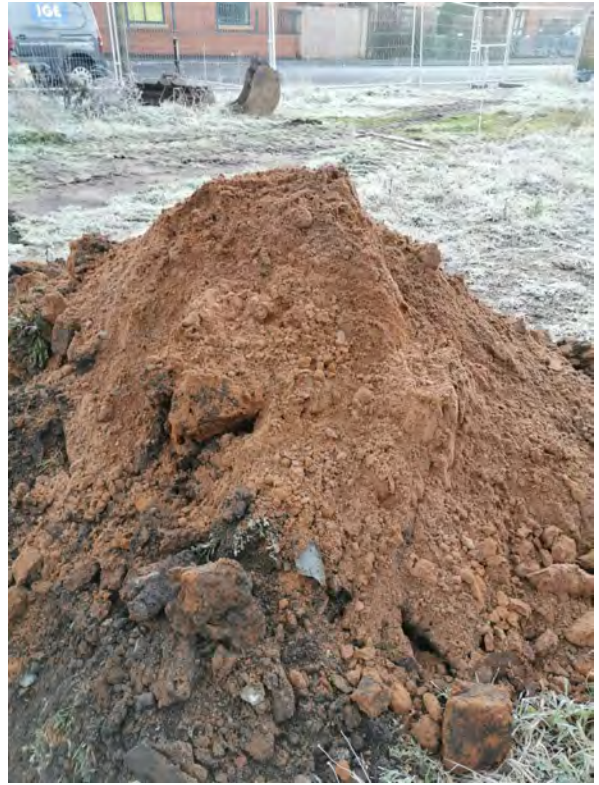
Terminated at target depth

0.00 - 2.20m TP JCB 3CX

Stable

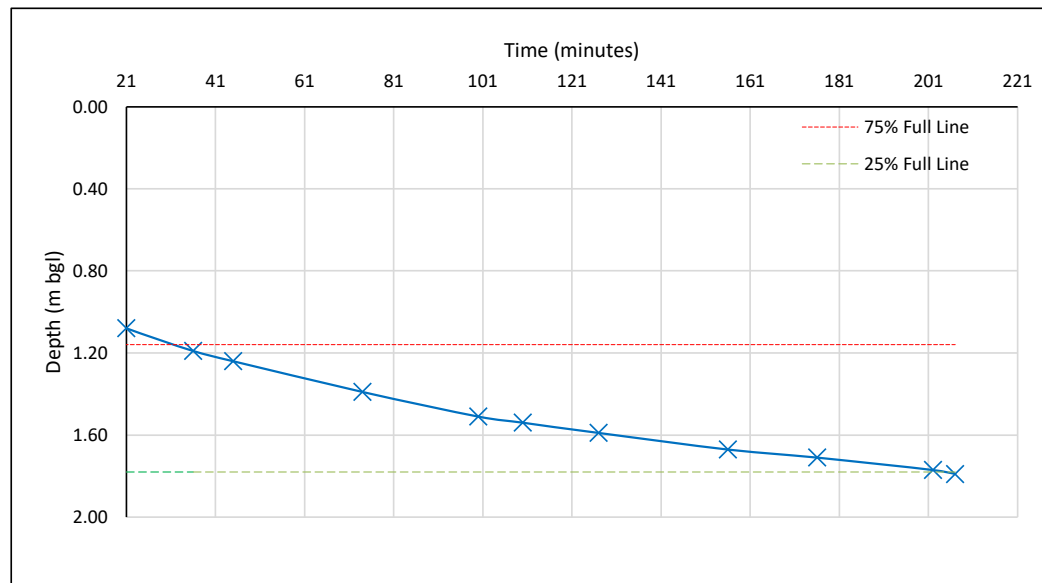
Site Name: Domett Street, Manchester  
 Job Number: 4307  
 Date: 20/01/25  
 Exploratory Hole: TP02 Run 2

| <b>f (m/s) =</b> | <b>1.365E-05</b> |

Calculations carried out in accordance with  
 BRE 365 Soil Infiltration Test Pits

100 - calculated using extrapolation
