**PHASE 2 GROUND INVESTIGATION:  
THE SHAMROCK PUB, BENGAL  
STREET**

**GSL3127**

**16 AUGUST 2024**

John Dixon & Associates LTD

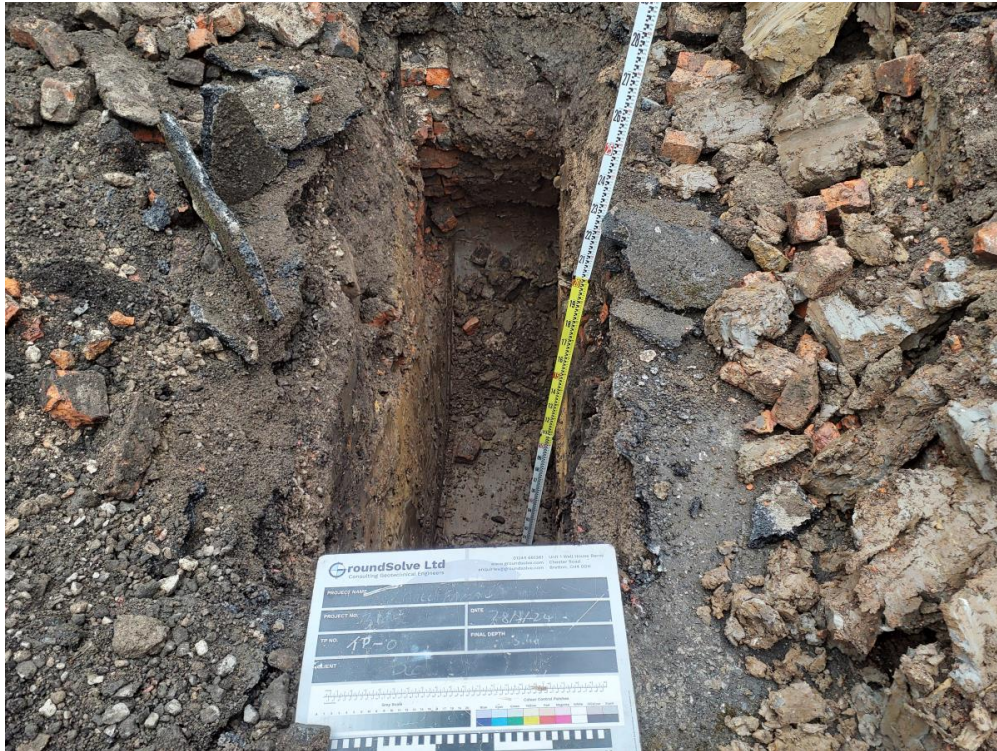
**TP01**

| Encountered concrete slab. Difficulty progressing beyond 2.25m bgl. Hot water tank recovered at 2.00m along with pipe. | |

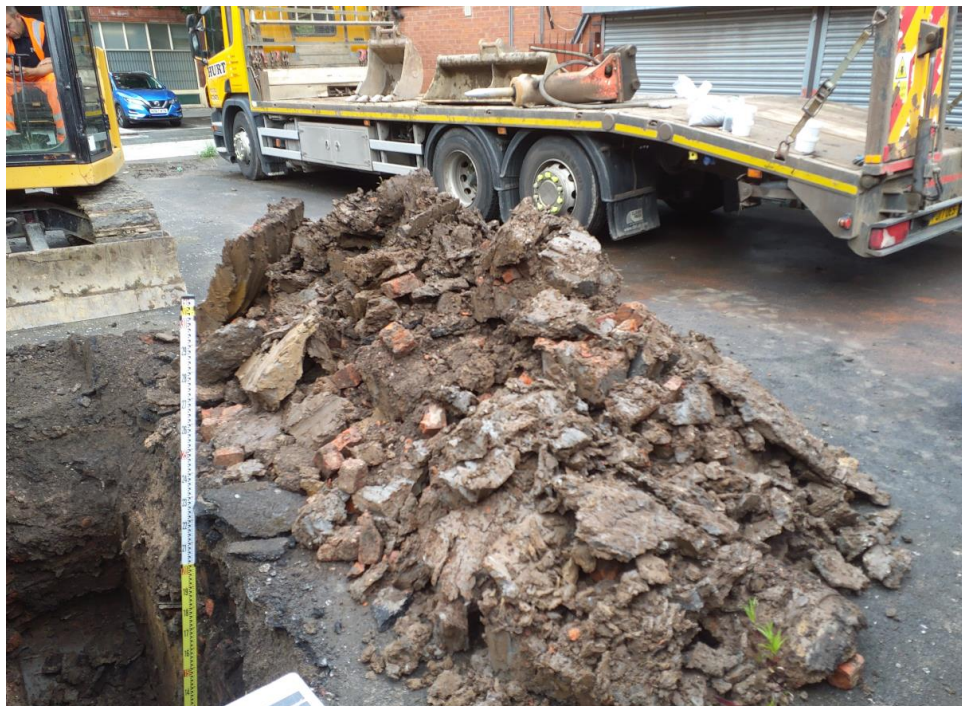
**TP01 Arisings**

| Backfill/<br>Instal'n | Water<br>Strikes | Sample and In Situ Testing | | | Depth<br>(m) | Level<br>(m) | Legend | Stratum Description | |
|---|---|---|---|---|---|---|---|---|---|
| | | | | | 0.35 | | | Loose grey slightly silty sandy subangular to angular fine to coarse GRAVEL of bituminous material, limestone and red brick<br>(MADE GROUND)<br>Loose angular red brick COBBLES<br>(MADE GROUND) | |

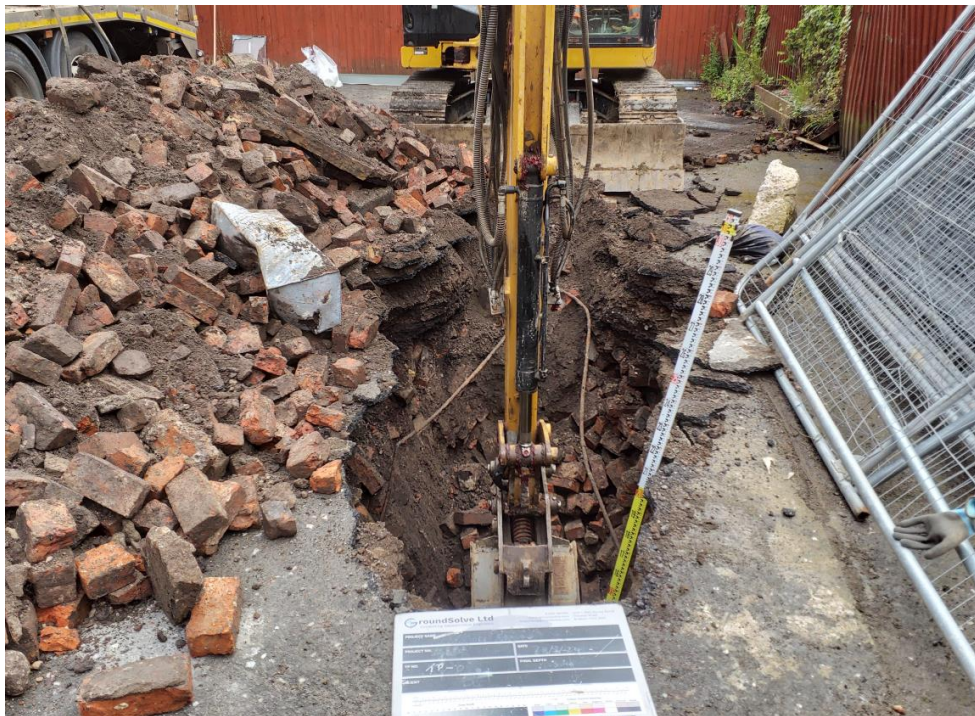
**TP02**

| Encountered concrete slab. Difficulty progressing beyond 2.30m bgl | |

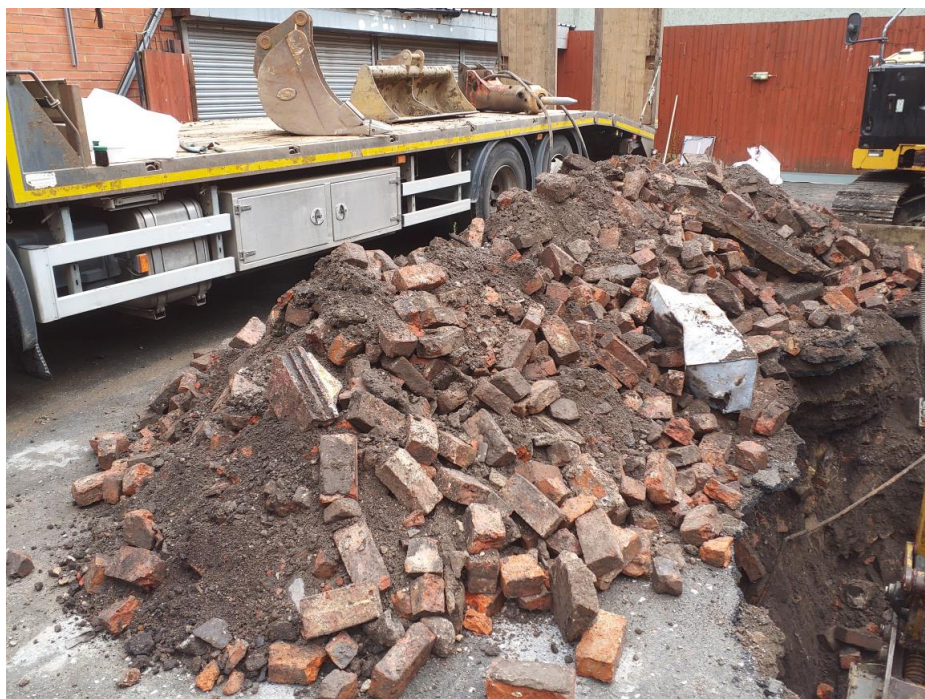
**TP02 - Arisings**

| Backfill/<br>Instal'n | Water<br>Strikes | Sample and In Situ Testing | | | Depth<br>(m) | Level<br>(m) | Legend | Stratum Description | |
|---|---|---|---|---|---|---|---|---|---|
| | | 0.40<br>0.40 - 0.70 | ES<br>B | | 0.05 | | | Bituminous slab<br>(MADE GROUND)<br>Loose grey slightly silty sandy subangular to angular fine to coarse GRAVEL of bituminous material, limestone and red brick<br>(MADE GROUND) | 1 |
| | | | | | 0.85 | | | Loose angular red brick COBBLES<br>(MADE GROUND) | |

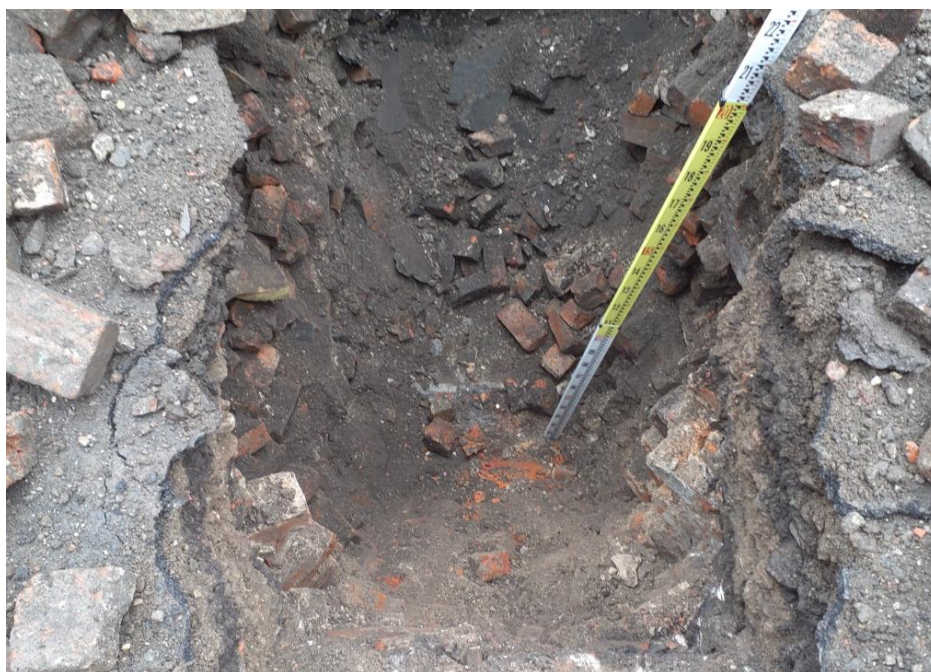
**TP03 – Concrete Slab**

The shallow ground conditions predominantly comprise loose grey silty sandy gravel of bituminous fragments, limestone and red brick varying in thickness from 0.35m to 0.85m. This material typically overlies loose red brick cobbles which extend to a maximum proven depth of 2.20m bgl and 2.10m bgl in TP02 and TP03 respectively, where excavations encountered concrete obstructions anticipated to be basement floor slabs.

Given the absence of any details as to the age, composition and strength of the relict basement slabs it is recommended these are removed prior to the construction of the new development, likewise any, relict walls and foundations. These materials could then be screened, crushed and reused as a suitably engineered backfill. The development could then be constructed on a conventional reinforced concrete raft designed based on an allowable bearing capacity of  $50\text{kN/m}^2$
