# Phase II Geoenvironmental Site Assessment

Site: Greenbrow Social Club, Wythenshawe, Manchester

Reference: 17-305-R1-2

Date: July 24

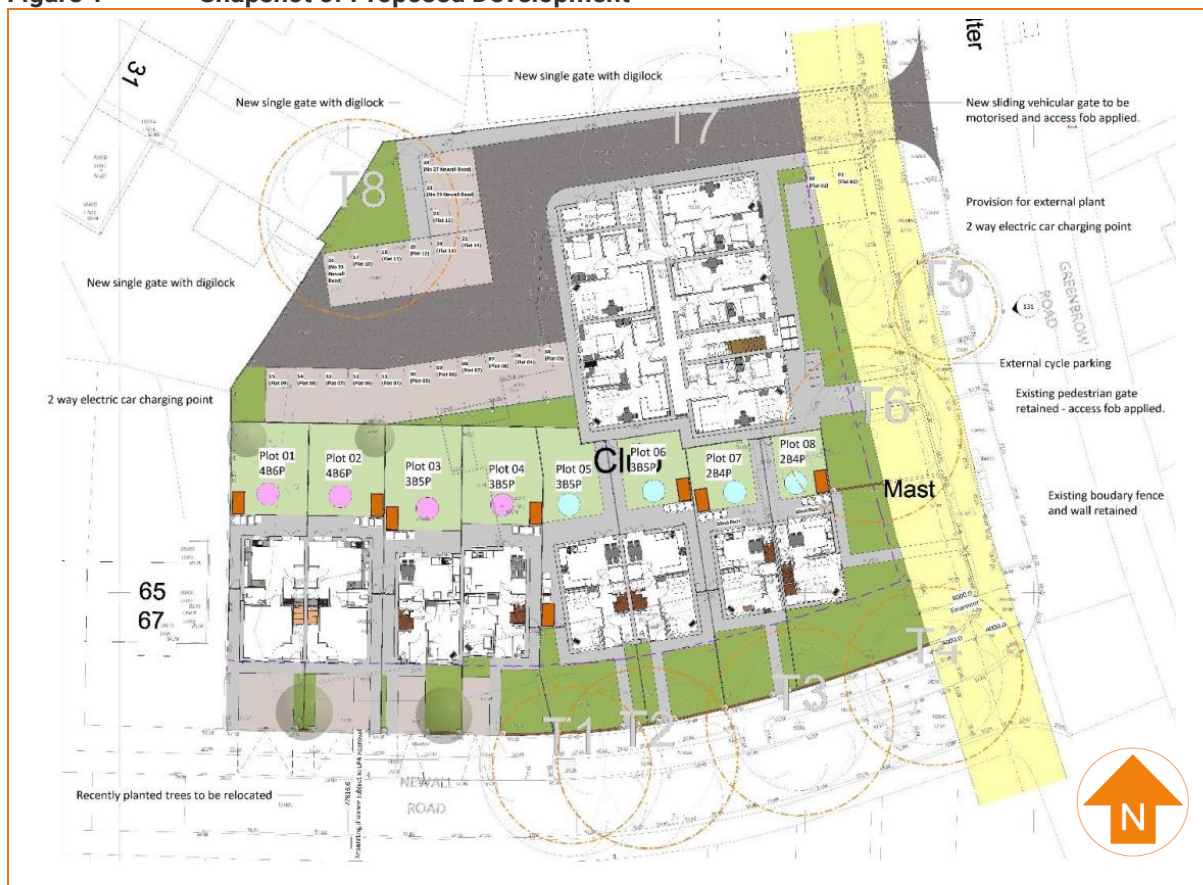
**Figure 1** Snapshot of Proposed Development

A snapshot of the Proposed Development Layout is indicated in Figure 1 below and Drawing 17-305-002 (APPENDIX IV).

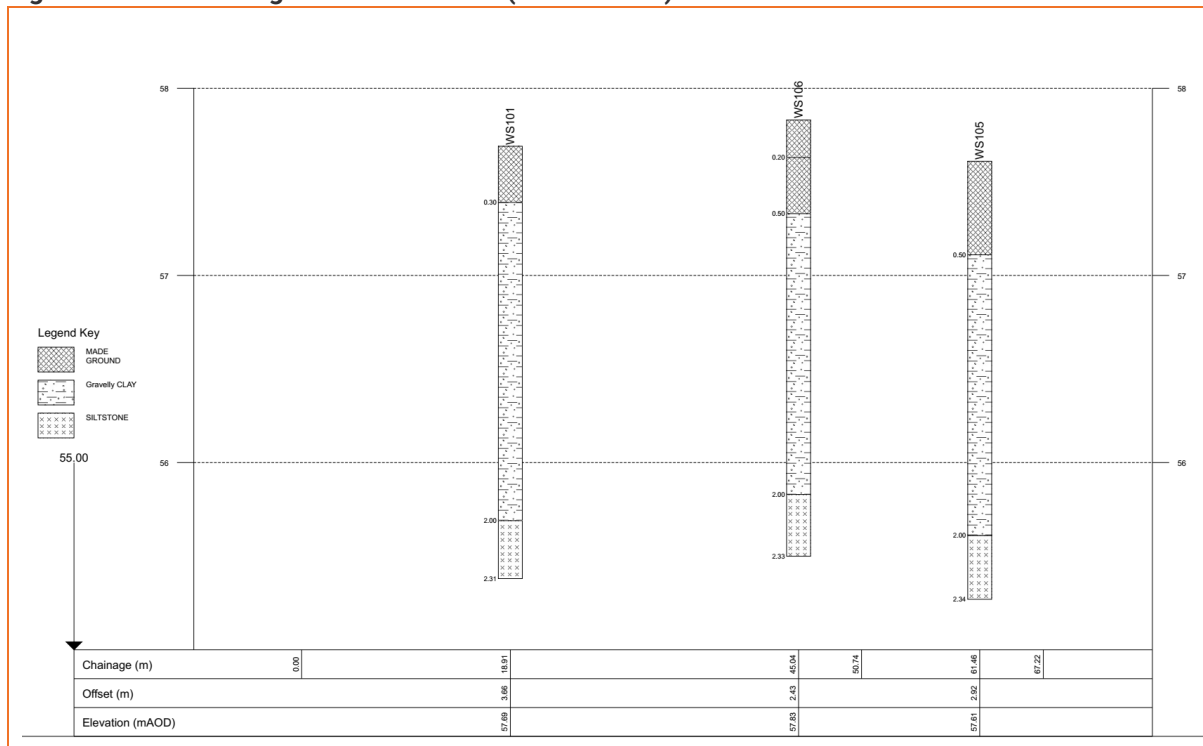
**Figure 2 Geological Cross Section (North-South)**

A geological cross section is included in APPENDIX IV, and a snapshot is shown below in Figure 2.

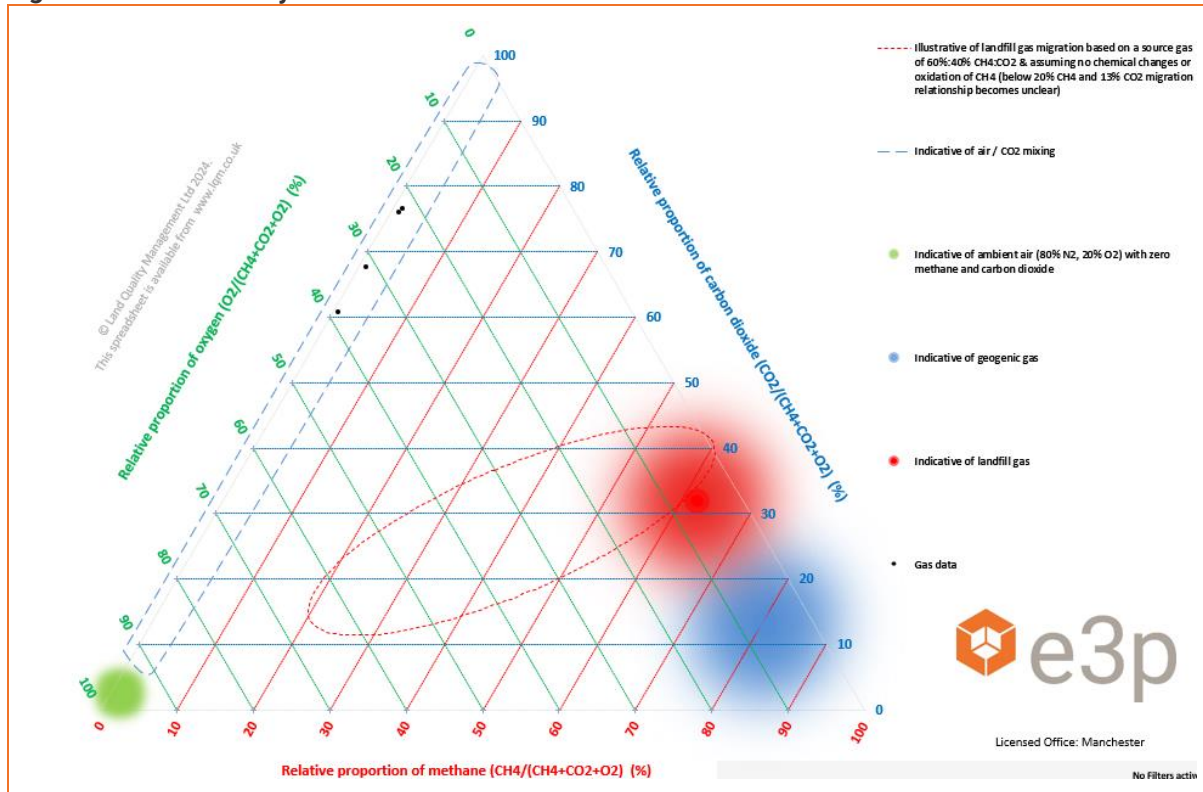
**Figure 4 Ternary Plot**

ternary plot has been used as an assessment tool for the gas monitoring data to identify if there is a true risk. Figure 4 shows the ternary gas plot for the gas monitoring data.

The ternary plot indicates that the results are indicative of air/CO2 mixing.

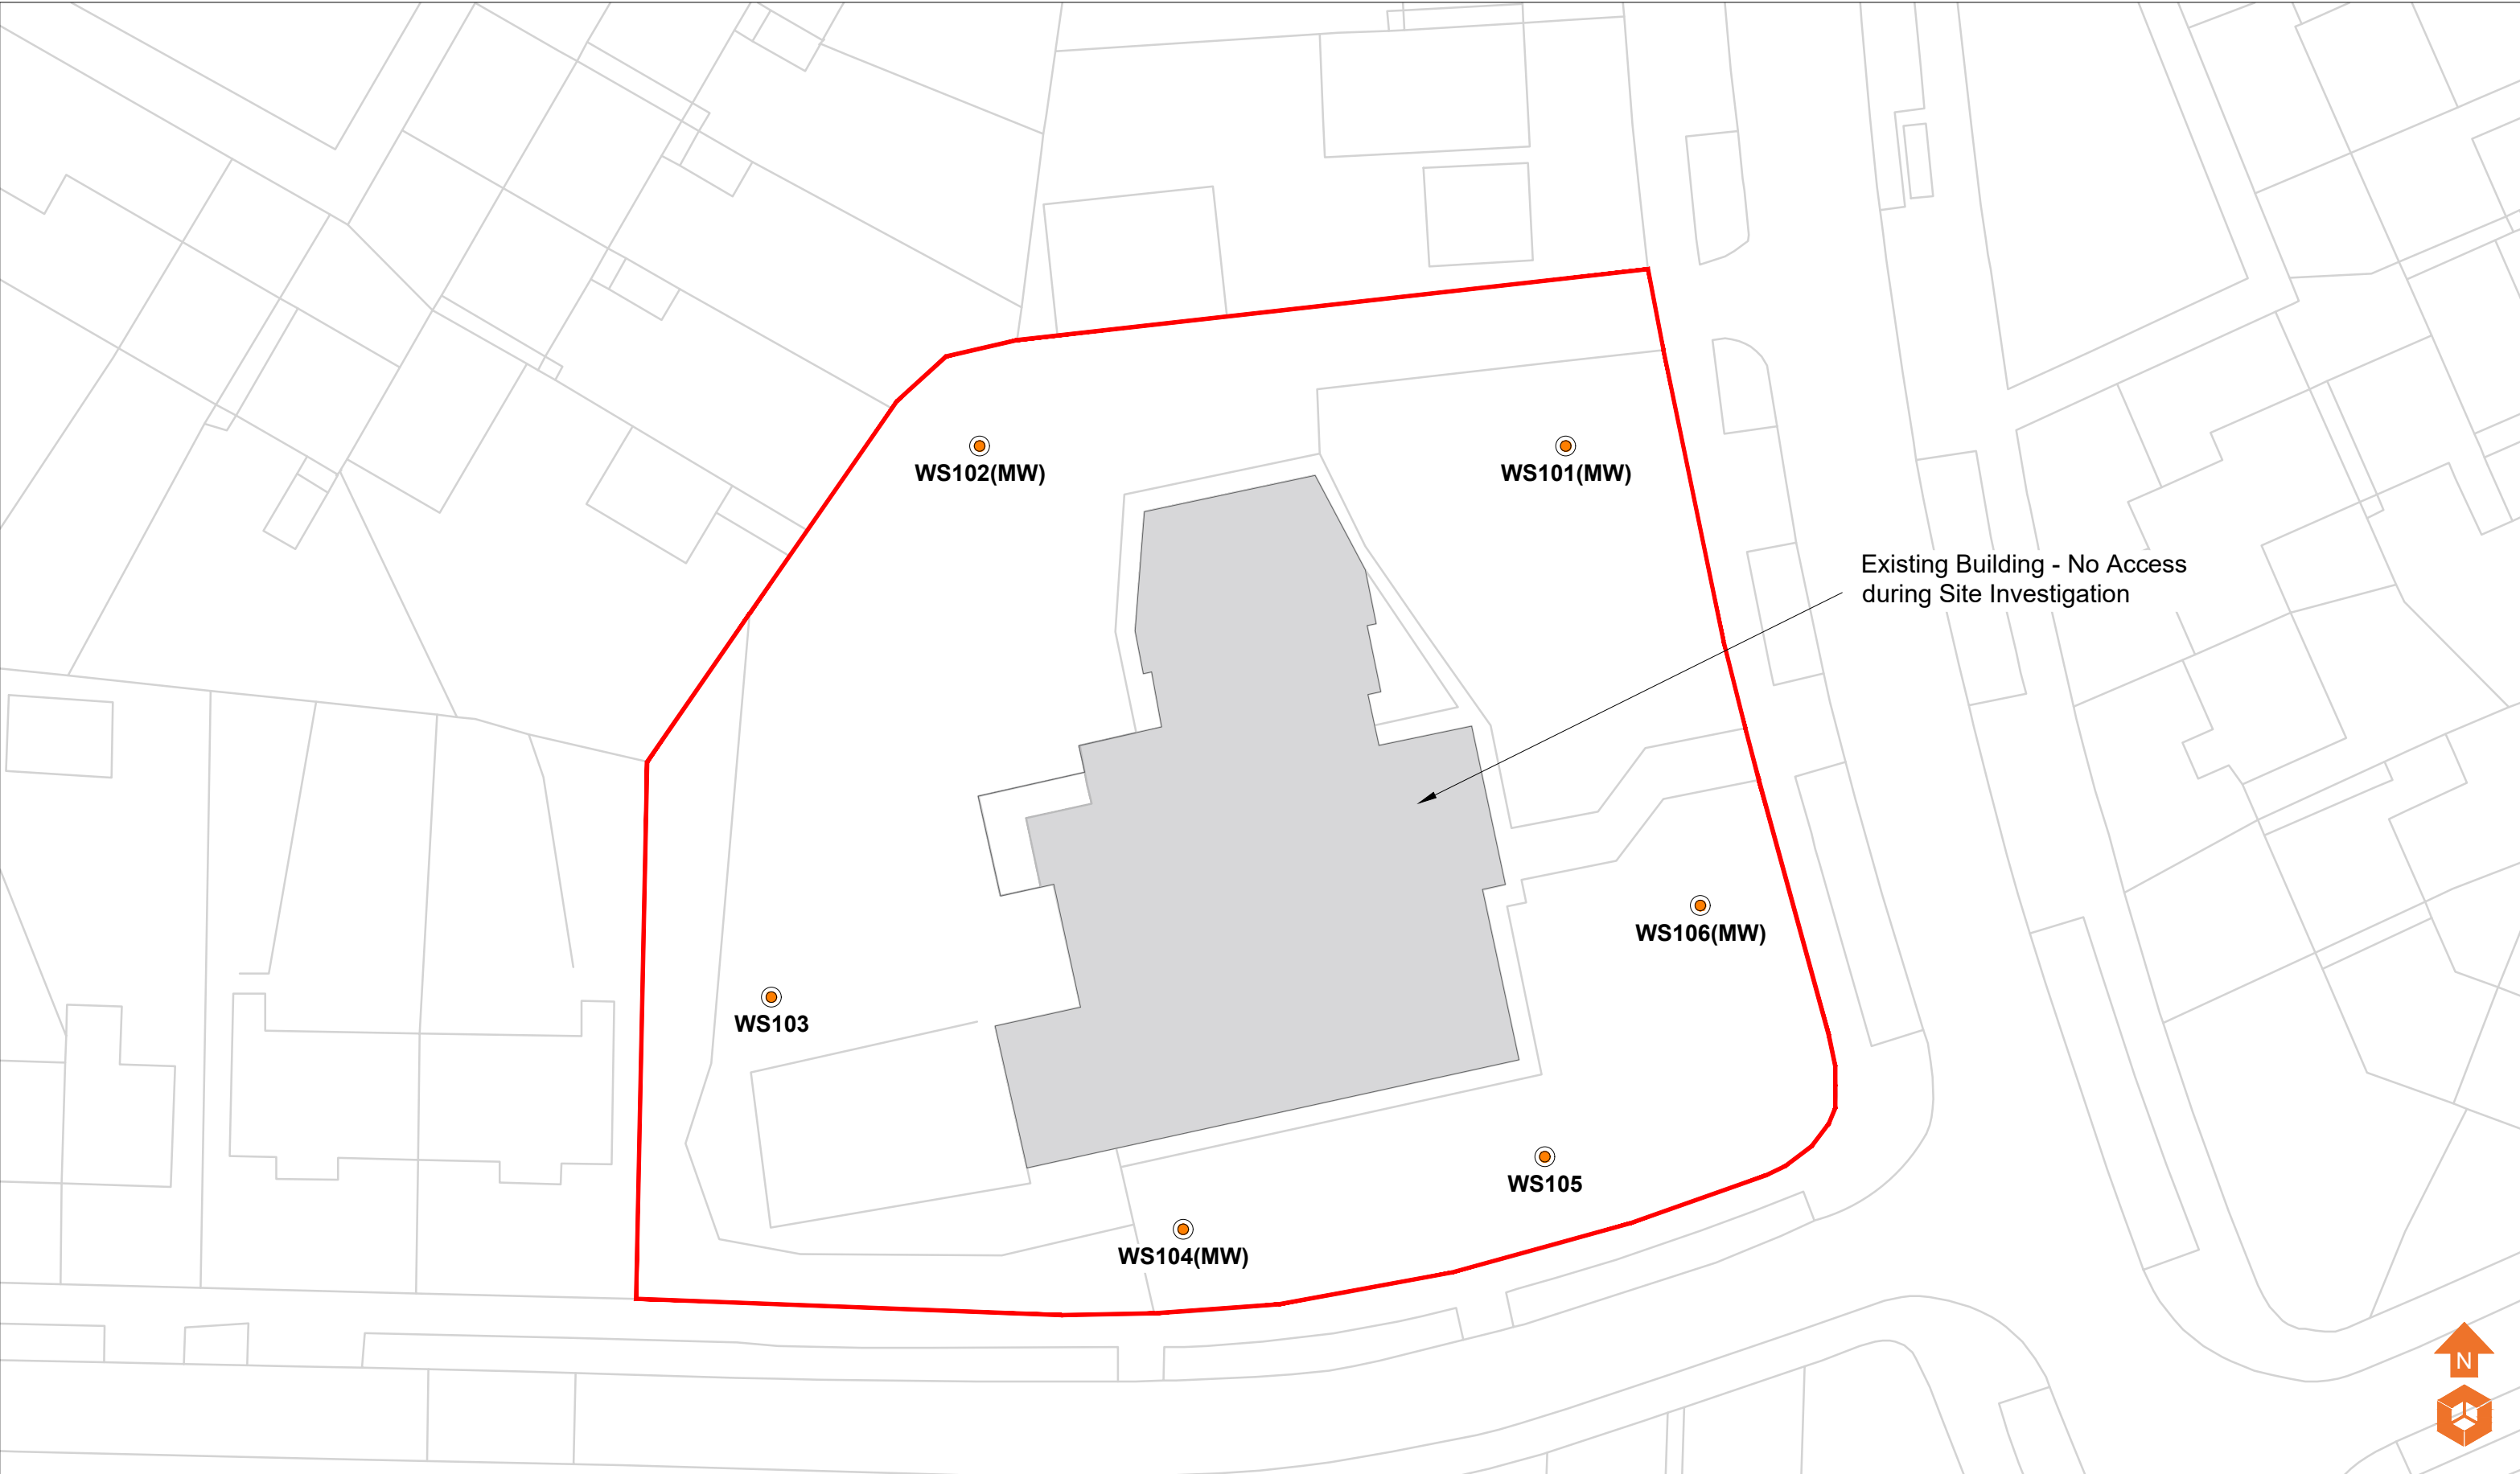
**Location Symbols**

- Approximate Window Sample Probehole Location (E3P Location February 2024)
- Approximate Window Sample Probehole Location with Install (E3P Location February 2024)
- Existing Building - No Access

The sampling locations are illustrated in Drawing 17-305-005 (APPENDIX IV). The ground conditions encountered are indicated on the logs, which are provided in APPENDIX VI.

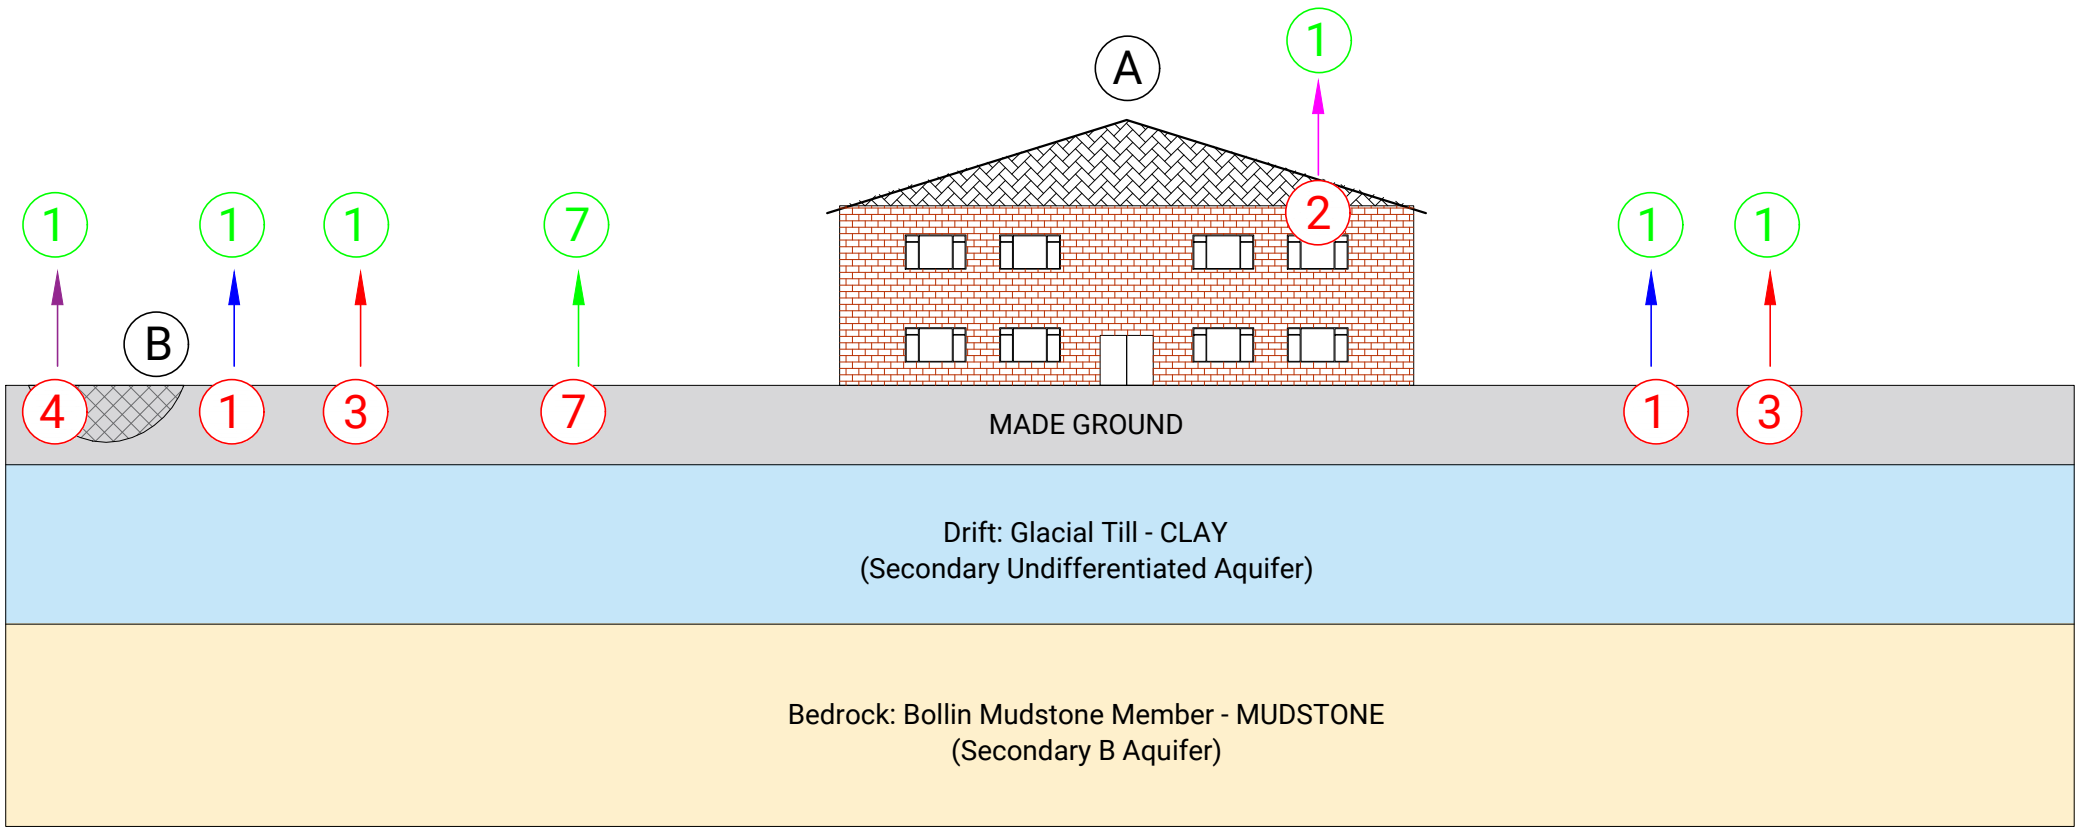
**Geology Key**

- Made Ground
- Drift: Glacial Till - CLAY
- Bedrock: Bollin Mudstone Member - MUDSTONE

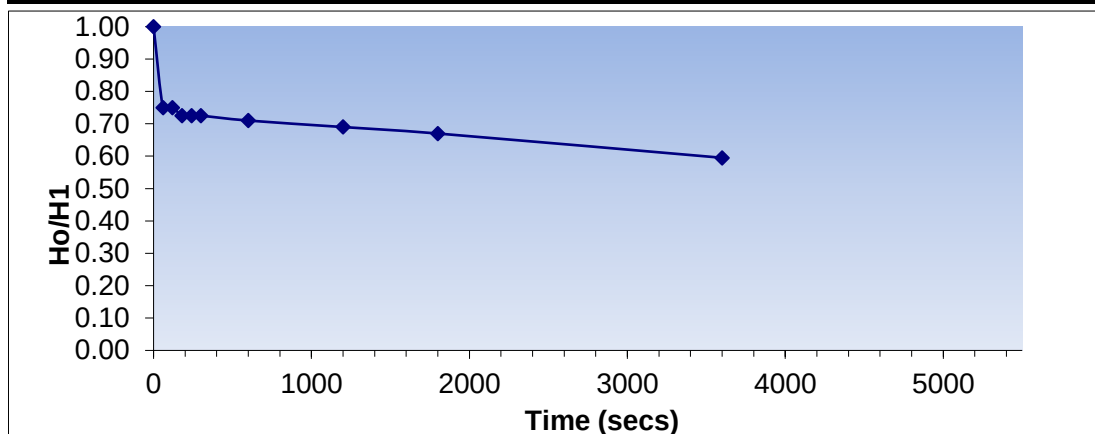
General Approach

$$k = \frac{A}{F(t_2 - t_1)} \log_e \frac{H_1}{H_2}$$

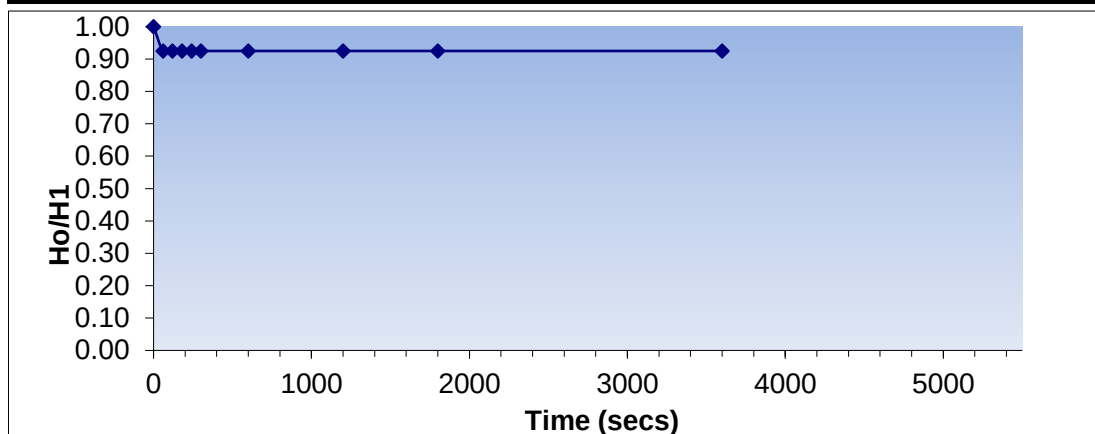
General Approach

$$k = \frac{A}{F(t_2 - t_1)} \log_e \frac{H_1}{H_2}$$
