# CLAYTON HALL, CLAYTON, MANCHESTER

## Archaeological Trial Pitting

Matrix Archaeology

Report No. 2024-10  
(Project Code: MA866)

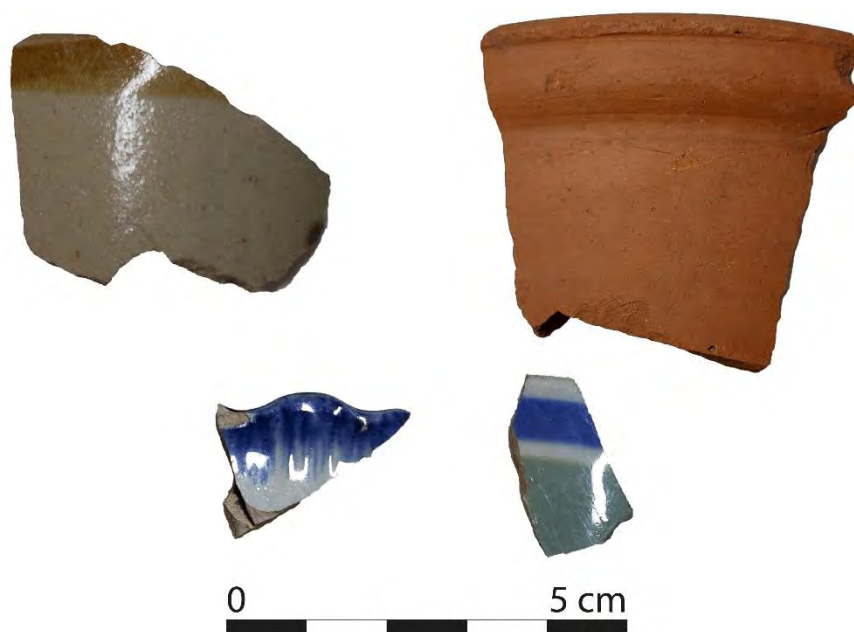
Fragments of two stoneware vessels were also recovered from Trial Pits 2 and 3. A bottle or jar fragment (FN3; *Plate 1*) displays a Bristol glaze, that is a feldspathic glaze introduced in London in c 1831, but more famously 'introduced' in Bristol in 1835 (Green 1999, 159). Again, this type of decoration is part of a long-lived tradition with some examples dating to the 1920s (Askey 1981, 121). A small rim fragment from a grey stoneware jar with vertical fluting probably once held jam or marmalade, with similar jars being produced from c 1870 until the end of the 1920s (Will *et al* 2017, 10).

*Plate 1: Top row left to right, FN3 stoneware jar or bottle, plant or flower pot with thickened rim (FN5), bottom row left to right, shell edge plate (FN12) and industrial slipware (FN11).*

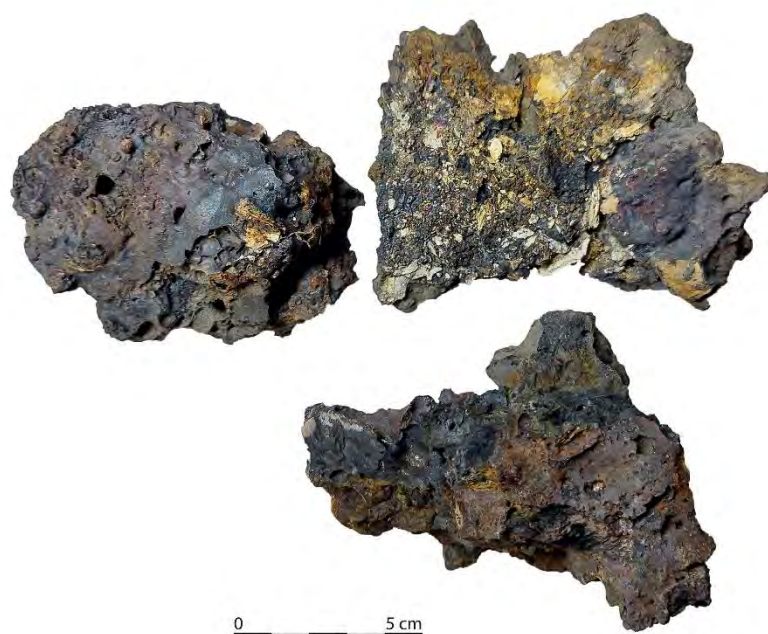
Five fragments of industrial waste were found in Trial Pits 1 and 3 (*Plate 2*). All the fragments are non-magnetic and versicular in appearance. They are likely to be vitrified coal ash or clinker rather than metal working slags. Such material can be produced by a number of industrial processes such as metallurgy or glass making where coal is used as a heat source. However, it can also be formed in other contexts such heating steam engines (Historic England 2015, 59-60, fig 55). A possible source for this material is the former brickworks that lay 0.3km to the east of Clayton Hall (OS 1909), where coal would have been used to fire the kilns and potentially provide fuel or any steam engines used at the works. Cinders and other by products from potteries, for instance, are recorded as being sold to local farmers for roadmaking (McGarva 2000, 111). In this instance they would have provided suitable drainage material used in the French drain [05].

*Plate 2: vitrified coal ash or clinker found the fill of French drain [05] in Trial Pit 3.*

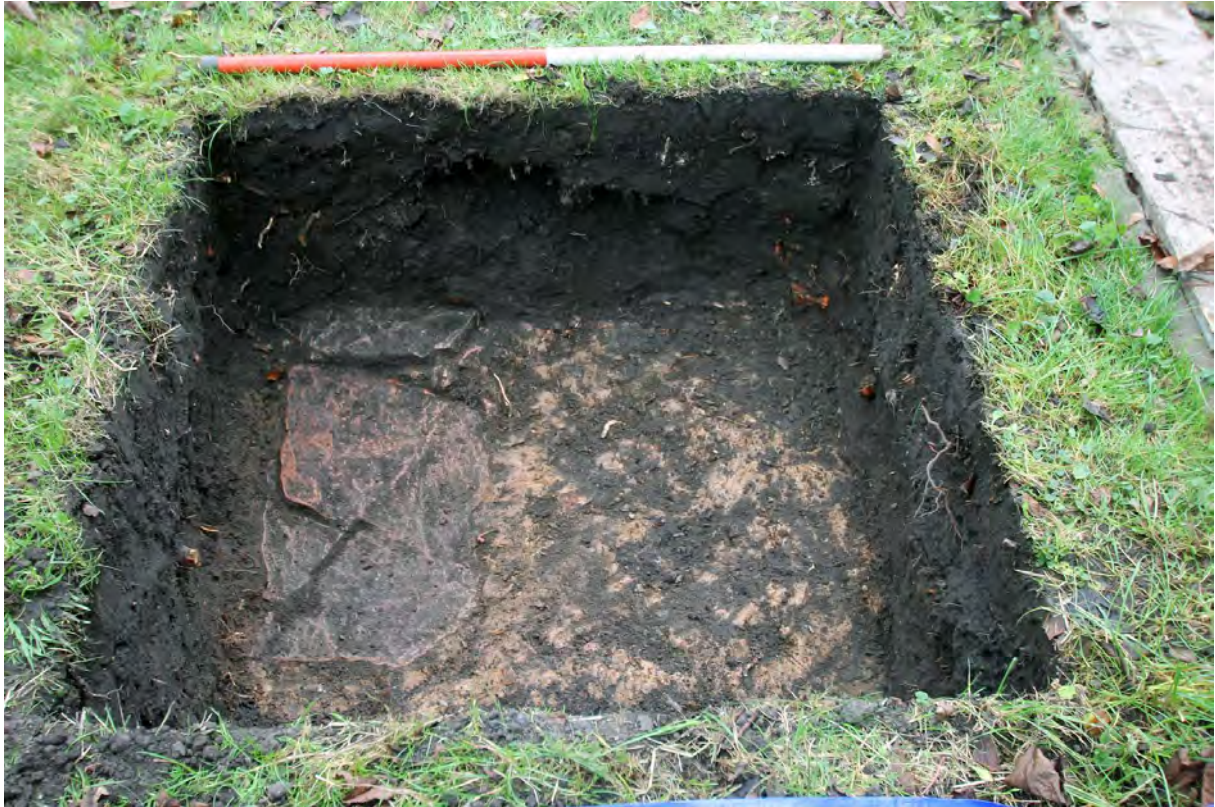
The earliest recorded feature was probably east-west wall footing (04), within Trial Pit 1. It was clear that this feature represented the surviving lowermost course of a wall, the upper courses of which had probably been truncated. The truncation level was represented by the top of the natural glacial clay, at about 78.00m AOD, at a trial pit depth of 0.45m. Given that the existing ground level at TP1 is slightly lower than the internal floor level of the Hall, this implies that any late medieval or early post-medieval building floor levels within the area of Trial Pits 1 to 3 would have been significantly truncated by late post-medieval garden activity.

The wall footing did not seem substantial enough even for the cill of an external wall of a timber-framed structure; although it could conceivably represent the footing for an internal timber-framed partition. Alternatively, it may represent the remnant of a garden feature, such as a low revetment wall. Any further speculation as to function seems premature.

Plate 7. Trial Pit 1, viewed from east, wall footing (04), visible to left.

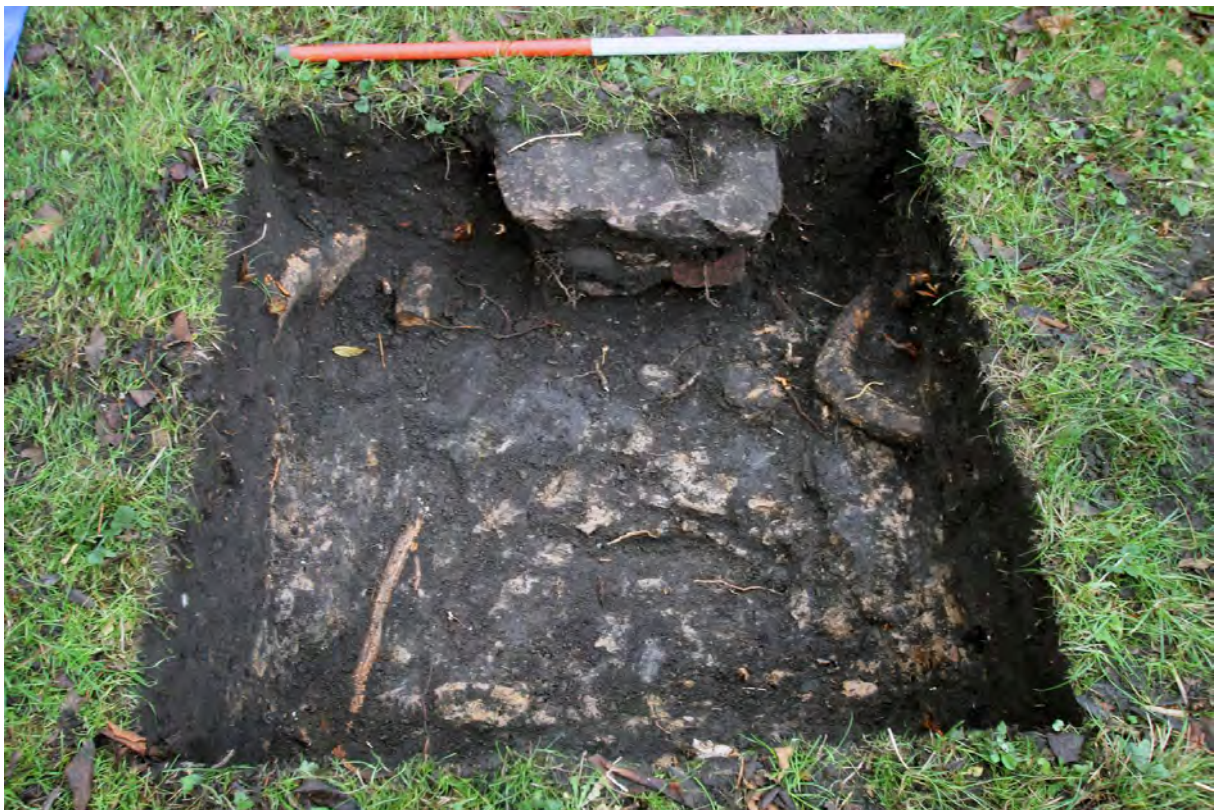
All other deposits and features noted within the trial pits could be attributed to 19th or 20th century activity. The mass concrete block (02), with cut off iron post, noted within Trial Pit 2 was probably an original component of the fence line which is visible in the centre of Plate 5, which originally extended from north to south across the site.

Plate 10. Trial Pit 2, viewed from north, mass concrete post base (02) visible.

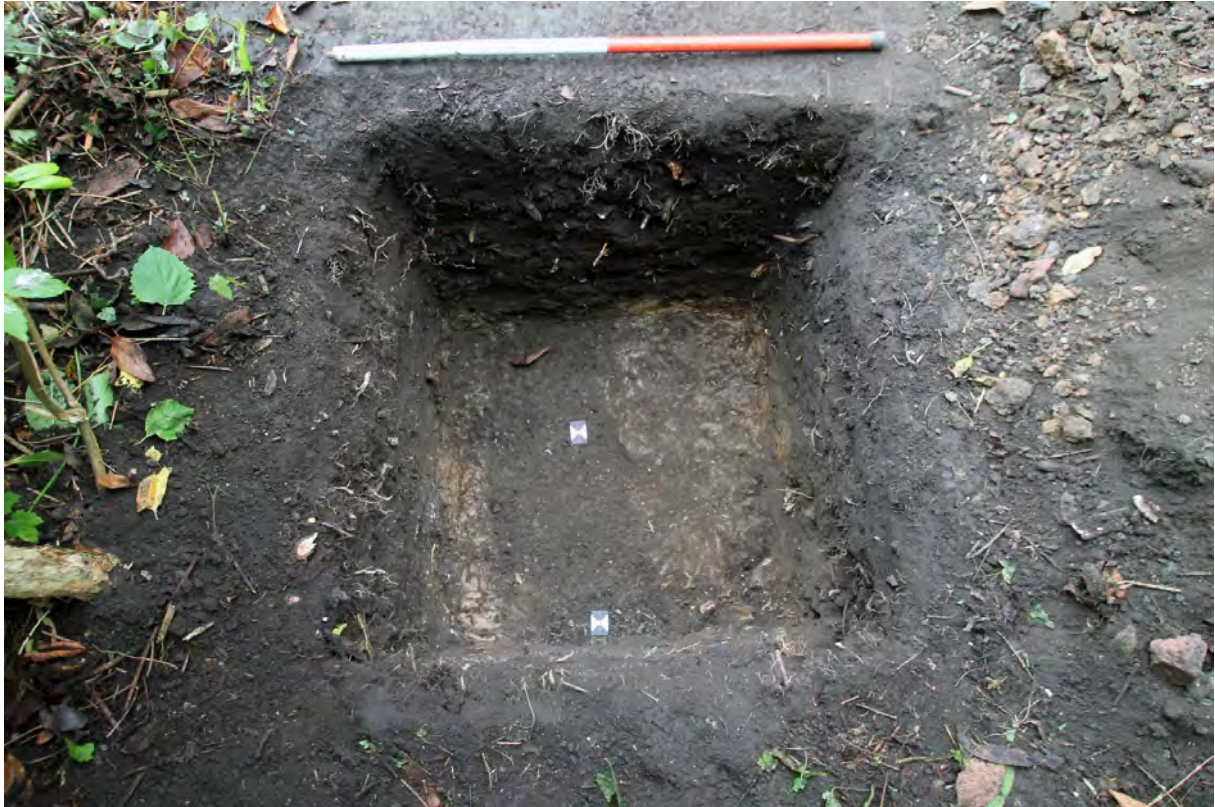
Contexts (04) and [05] in Trial Pit 3 appear to represent a French drain dug into the natural, which has been subsequently truncated by garden activity. The use of iron slag as a fill suggests a desire to create a channel which drains easily, into the open moat cut.

Plate 13. Trial Pit 3, viewed from south, north-south drainage feature (04) visible.

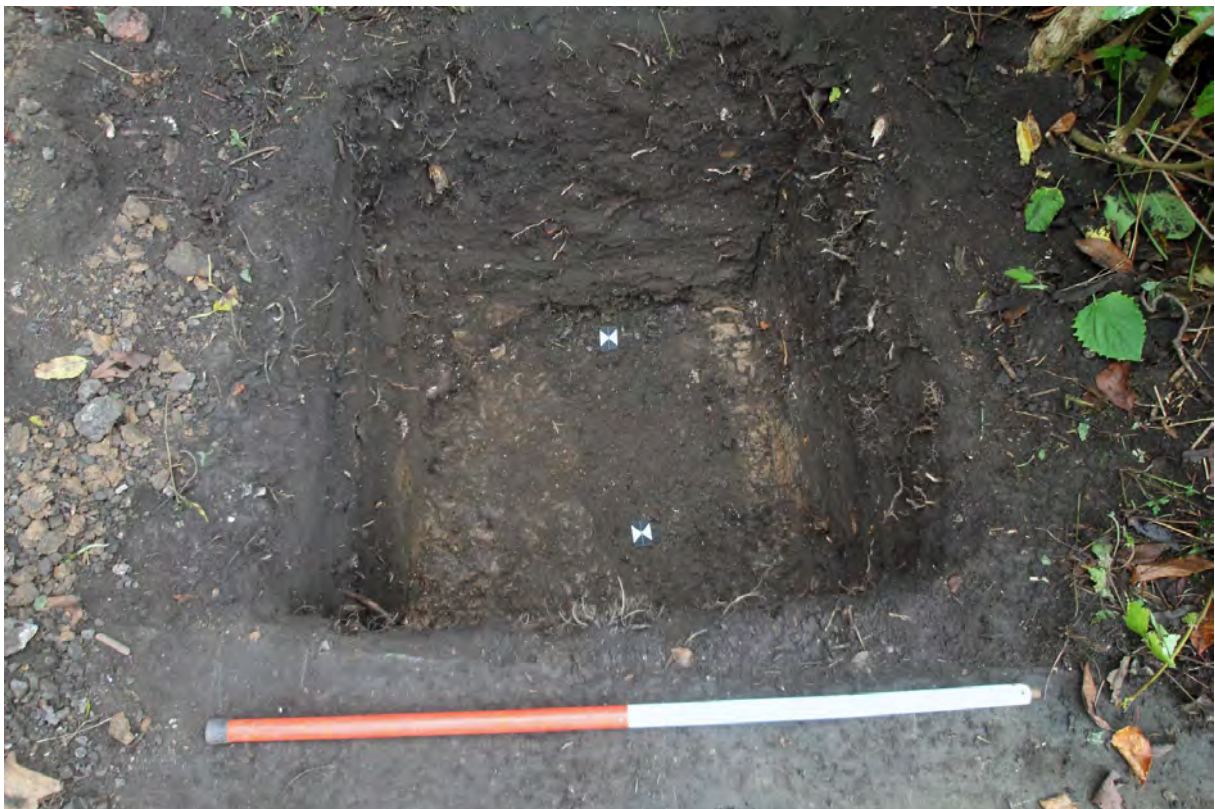
Plate 14. Trial Pit 3, viewed from north, north-south drainage feature (04) visible.
