## Ground Investigation Report

Proposed LED Floodlit Tarmacadam PlayZone Pitch

Procter Young Peoples Centre, Manchester

Document no.: STV6311-R01 Rev A

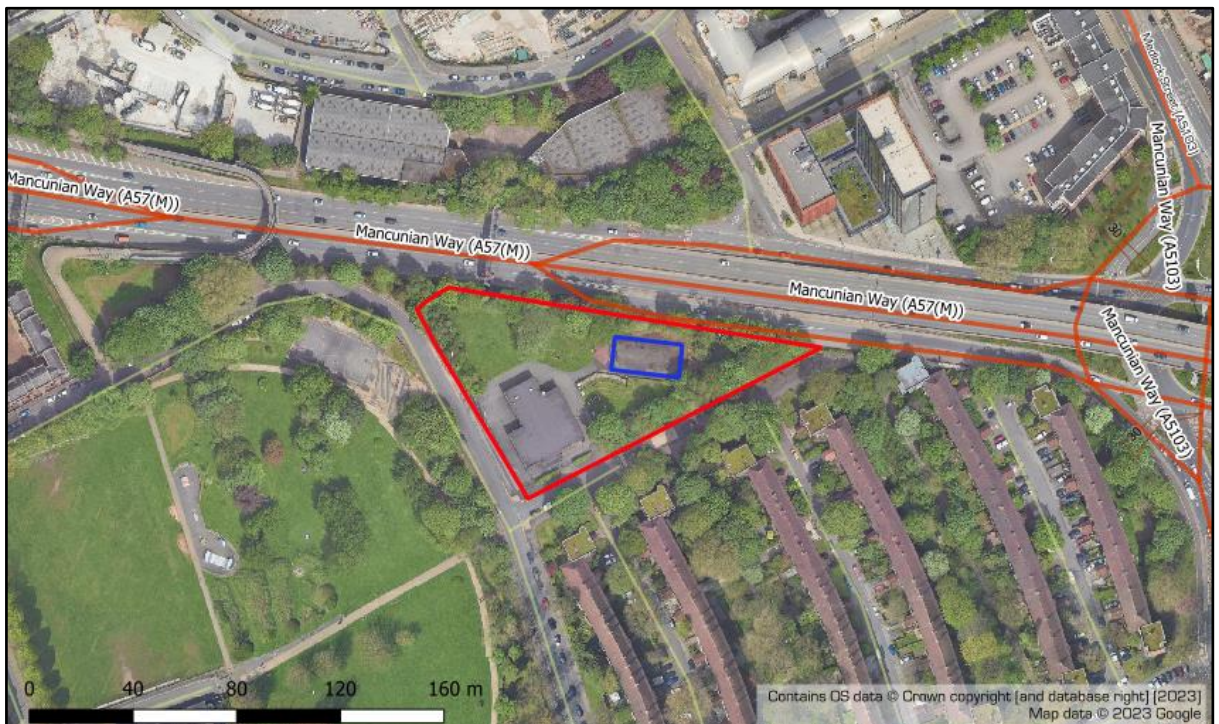
Figure 2-A: Aerial photograph showing site boundary (red) and proposed PlayZone area (blue)

2.2.2 An aerial image showing the approximate site boundary and approximate development footprint is presented below, followed by a table summarising the key site features and a series of site photographs. A site plan is provided within Appendix A.

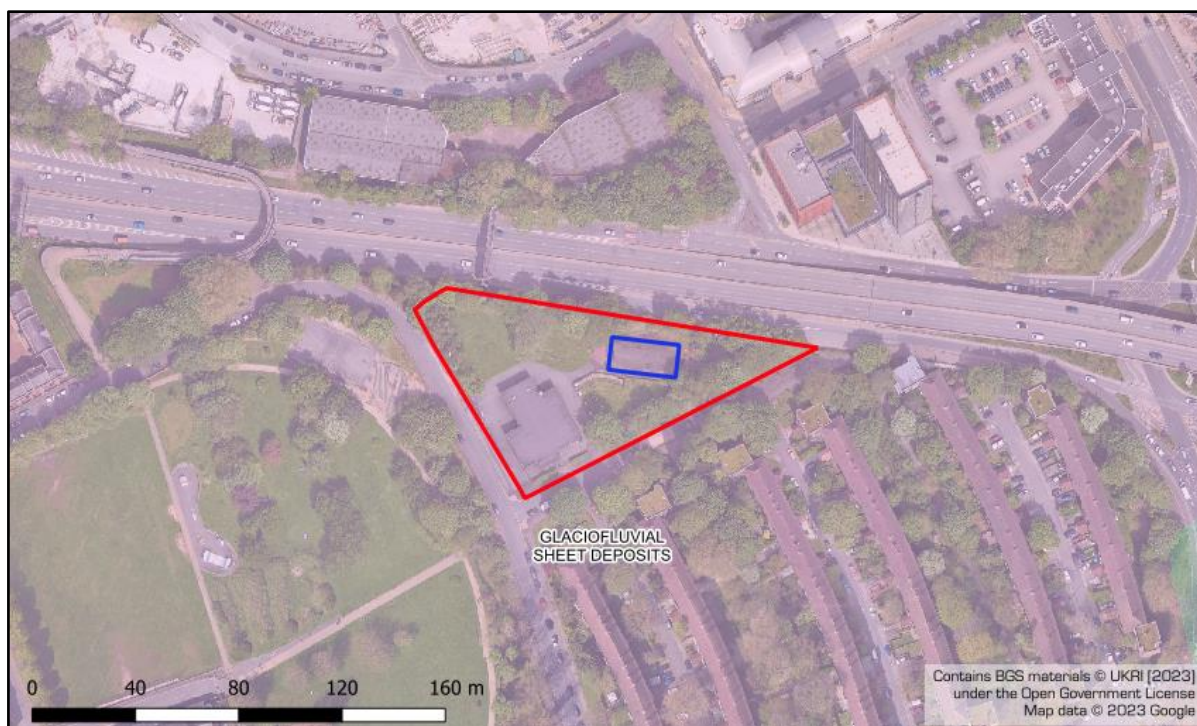
Figure 2-E: Extract from BGS showing superficial geology at the site

- 2.4.1 Based on a review of available records, the site is anticipated to be underlain by superficial Glaciofluvial Sheet Deposits to underly the site comprising sands and gravels (refer to Figure 2-E below), with Devensian Till below (clays).
- 2.4.2 Made Ground is anticipated to be present, given the site's previous development phases, potentially deepened in the area of former basements/cellars to terraced housing.
- 2.4.3 The underlying bedrock is recorded as the Chester Formation across the entirety of the site, comprising mudstone (refer to Figure 2-F below).

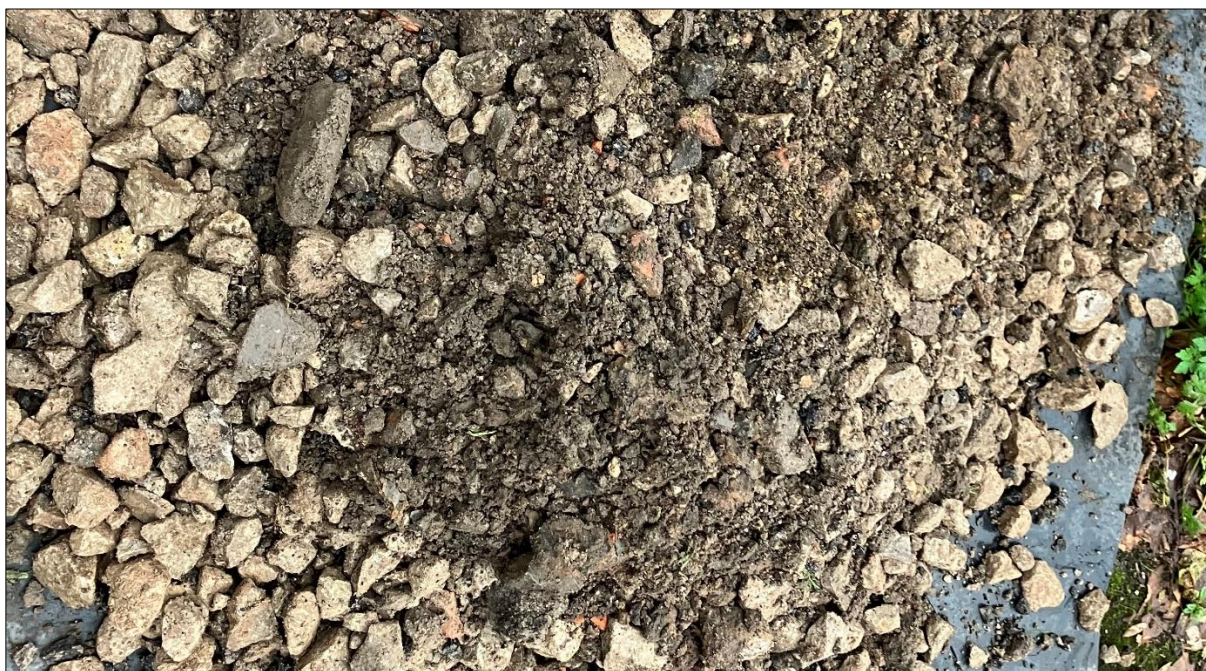
*Figure 5-A: Subbase observed within TP02*

5.3.1 A layer of limestone gravel subbase was encountered at every position underlying asphalt. The thickness of the subbase varied between 0.15m and 0.25m.

5.3.2 The subbase comprised a clayey sandy gravel of limestone. A typical photograph of the subbase soils encountered is presented below.

- 7.3.1 It is anticipated that the proposed PlayZone will be located at or about existing ground levels, with the formation located Made Ground soils. It is assumed that the subbase to the existing MUGA will be reused where possible. It should be noted however, the subbase contained a fair proportion of fines and may not be considered suitable for reuse.

- 7.3.5 It is recommended that the formation level is trimmed and rolled following the requirements outlined in the Specification for Highway Works Series 600. Such a process will identify any soft/loose areas, which should either be excavated out and backfilled with a suitable well compacted material similar to those exposed in the sides of the resulting excavation, or large cobbles of a good quality stone rolled into the formation to stabilise the 'soft/loose' area.

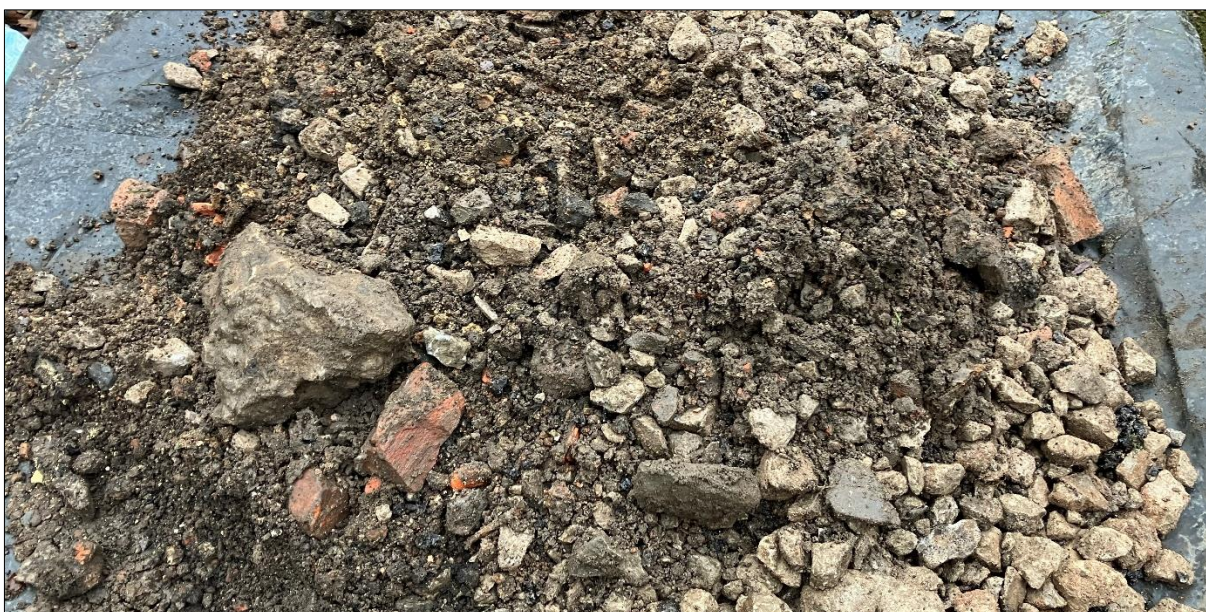
*Figure 5-B: Made Ground soils encountered within TP03*

- 5.4.1 Made Ground was encountered at every position underlying the gravel subbase. The base of the unit was not proven within any of the exploratory positions.
- 5.4.2 Made ground was observed mainly as granular gravelly silty sand with gravels of brick, clinker and ceramic, with limestone and coal also.
- 5.4.3 A typical photograph of the Made Ground soils encountered is presented below.

- 7.3.6 Due to the composition, variable density/strength and thickness of Made Ground at the site, it is recommended such soils present at and below formation levels are appropriately conditioned to achieve a more uniform level of compaction and minimise levels of differential settlement which could otherwise manifest across the PlayZone surfacing.

- 7.3.9 The Made Ground soils are considered frost susceptible, and this may override the CBR criteria for pavement foundation design purposes.
- 7.3.10 The silty nature of the Made Ground soils will render them moisture susceptible with small increases in moisture content giving rise to a rapid loss of support to construction plant. It is therefore recommended that the sub-base is laid as soon as practicable following establishment of formation.
