# Wythenshawe Town Centre Regeneration

## Preliminary Ecological Assessment

Prepared For: Kier Construction

Document Reference: 10890.002

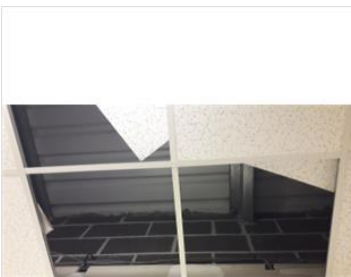
| | Description of Interior: | False suspended ceiling below flat roof. The flat roof was metal panelled internally. Panels missing throughout the shop floor. Gap between ceiling and roof was inspected through the missing panels which allowed full coverage of the ceiling. No signs of bat activity were found (bats/droppings/urine staining/fur rubbing). No suitable roost crevices were identified in the area. To the rear of this unit is a kitchen area where mouse droppings were found on the suspended ceiling above the cupboard. | | | |
| Categorisation of Potential Bat Roost Habitat Suitability | | Negligible | | | |
