Preliminary Roost Assessment

The Shamrock, Bengal Street

Reference: 81-659-R1-1

Date: February 2024

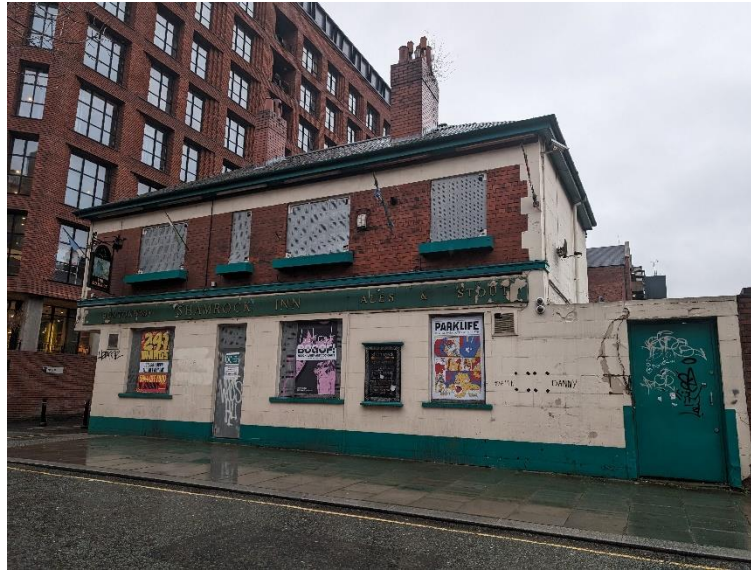
PLATE 1      SHOWING SOUTH-WEST ASPECT OF BUILDING

The on-site building was a disused detached two-storey pub building, comprising render on the ground floor and red brick walls on the second floor with a cross-hipped slate tiled roof. Three redbrick chimneys were present on the building. No evidence of bat droppings or staining was identified throughout the entire building, both internally and externally.

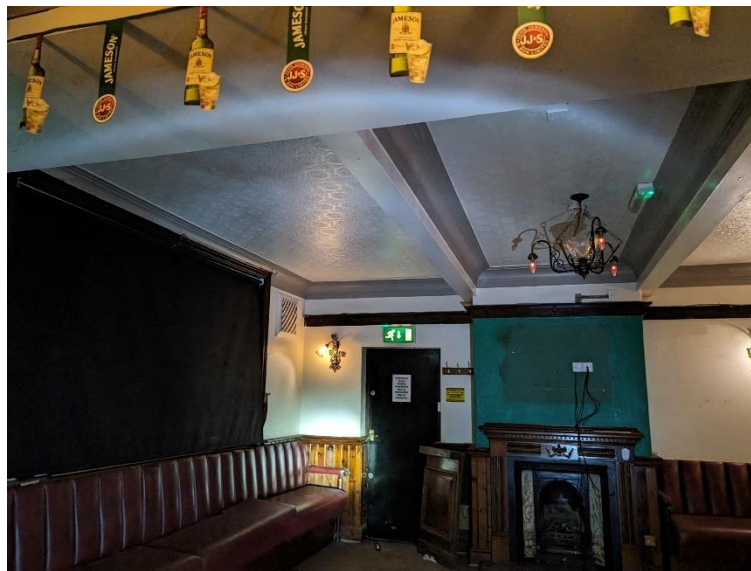
PLATE 2      SHOWING THE BUILDING INTERNALLY

An internal inspection of the building was undertaken. The building was well-sealed internally, with no obvious access points that could be utilised by bats. No evidence of bats were identified. It was determined that no suitable bat roost features were located internally within the two storeys of the building.

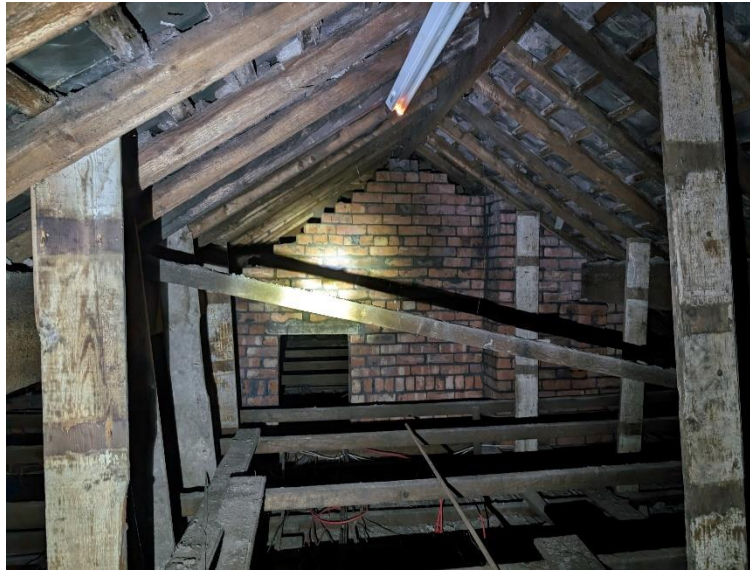
PLATE 3      SHOWING THE LOFT VOID

Internally, a loft void was present extending along the whole building. The approximate dimensions of the loft void were 14 long, 12 m wide, and 1.6 m high. The internal of the loft void was in good condition with no crevices or gaps within the brickwork. The wooden supporting beams were tight to the roof felting, as such, no gaps were present providing opportunities for roosting bats.

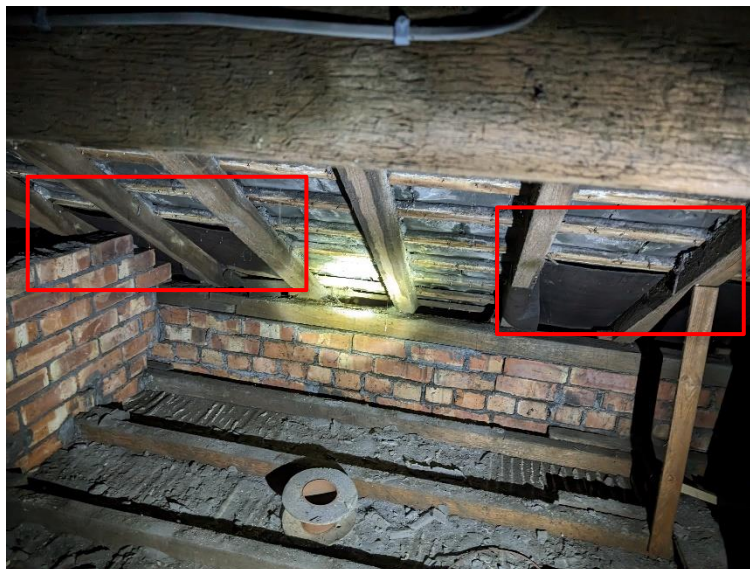
PLATE 4      SHOWING AREA OF LIFTED FELT

Two areas of lifted felt (PRF4) were present near the entrance to the loft void along the northern aspect of the building. These lifted areas could provide a small number of crevice-dwelling bats roosting opportunities on an occasional basis.

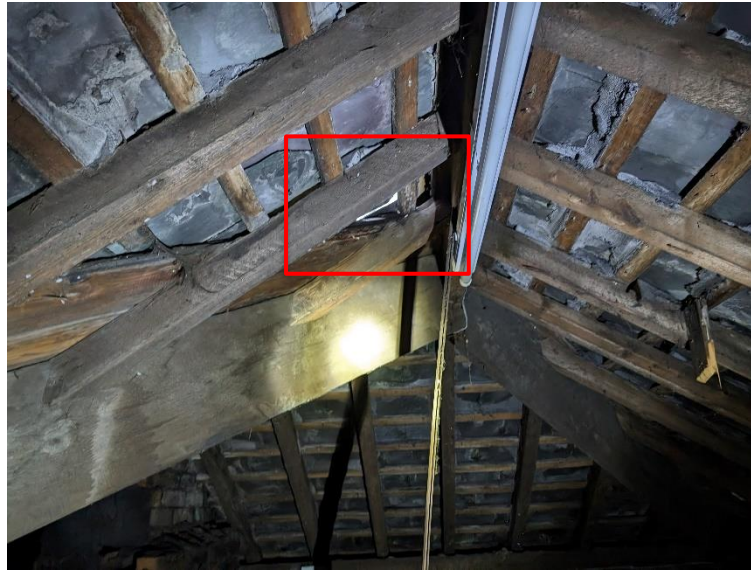
PLATE 5      SHOWING SLIPPED TILE

An access point – Access Point 1 (AP1) into the loft void was provided by a slipped tile along the ridge of the roof on the northern aspect. This would provide access into the loft void and access to the potential roosting features within the loft void. However, as there were only two small crevices present within the loft void, it was assessed as being unsuitable to support a large number of bats such as a maternity colony.

Furthermore, due to health and safety issues regarding the damage to the roof, roof works could be undertaken under a method statement and supervision of an ecologist to avoid any future delays. However, if the application is reviewed by the Local Planning Authority after May, it is likely further surveys would be requested.

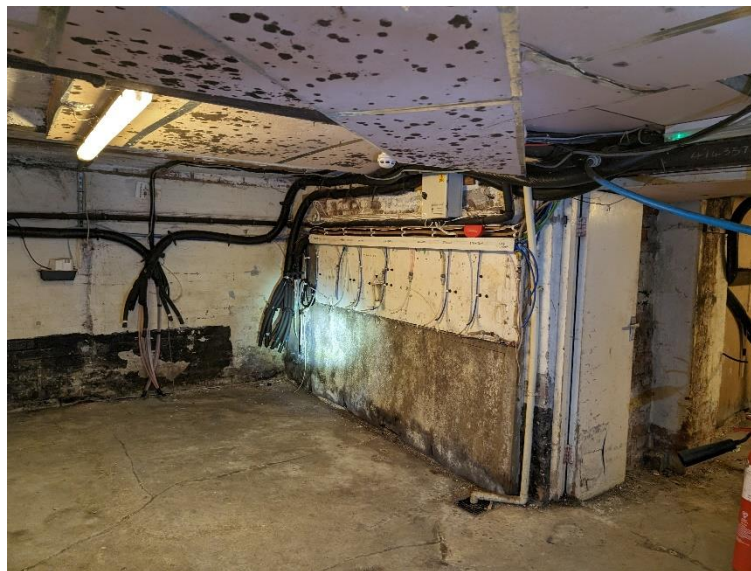
PLATE 6      SHOWING THE BASEMENT

A basement was present within the building that spanned the whole of the underneath of the building. The approximate dimensions of the basement were 14 m long, 7 m wide, and 2 m high. The walls comprised painted brickwork with a concrete ceiling that was painted in areas. All of the brickwork was well sealed with no crevices or gaps present that could provide opportunities for roosting bats. Furthermore, no access points were present internally and externally and as such, bats would not be able to gain access to the basement. As such, the basement was assessed as being unsuitable to support a hibernation roost due to no access into the basement and no potential roost features present.

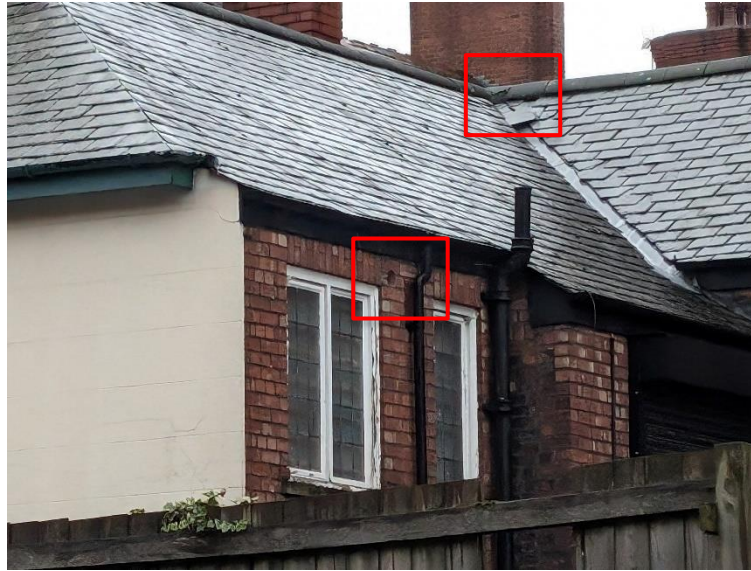
PLATE 7      SHOWING HOLE INTO WALL ON EASTERN ASPECT

Externally, the majority of the brickwork was in good condition on all aspects of the building; however, a hole was on the southern (Access Point 3) and eastern (Access Point 2) aspects of the building. These holes could provide access into the cavity wall of the building and further concealed potential roosting features. However, as there is a limited of suitable foraging and commuting habitats within the close area surrounding the building these features were downgraded and assessed as providing only Low bat roosting potential.

The loft void, gaps into the wall cavities and tops of the chimney breasts as shown within Section 3.4 were assessed as having nesting bird potential. As such, if any works are required that will affect the loft void, gaps into the wall cavities and/or chimney breasts, the works should be undertaken outside of the breeding bird season. If this is not possible, a suitably qualified ecologist should undertake a nesting bird check up to 24 hours before works commence. If a nest, or nest construction is located, then a stand-off distance should be maintained until the young have fledged.

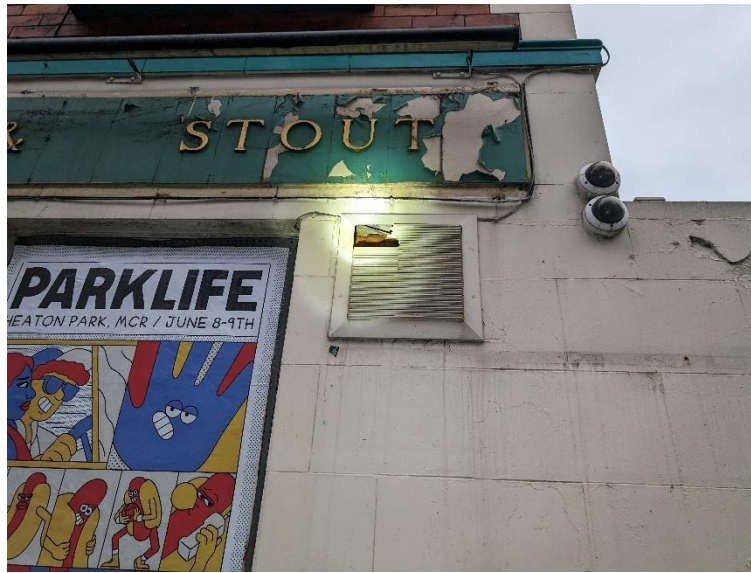
PLATE 8      SHOWING BROKEN VENT

Furthermore, a broken vent (Access Point 4) was present on the western aspect of the building. This broken vent could provide access into the cavity wall of the building and further concealed potential roosting features. However, as there is a limited of suitable foraging and commuting habitats within the close area surrounding the building, this feature was downgraded and assessed as providing only Low bat roosting potential.

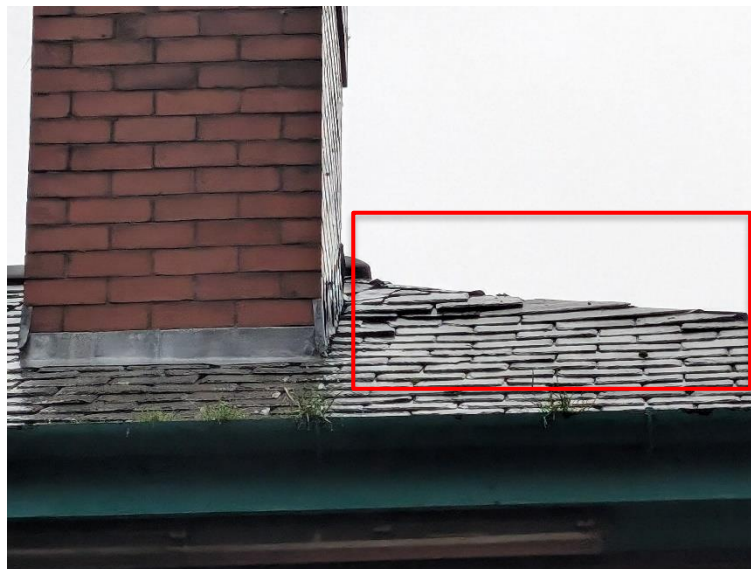
PLATE 9      SHOWING DAMAGED AND LIFTED TILES

Areas of damaged and lifted tiles were present on the western (PRF1) and southern (PRF2) aspects of the building. These damaged and lifted tiles could provide crevices and gaps that opportunistic crevice-dwelling bat species could roost within on an occasional basis.

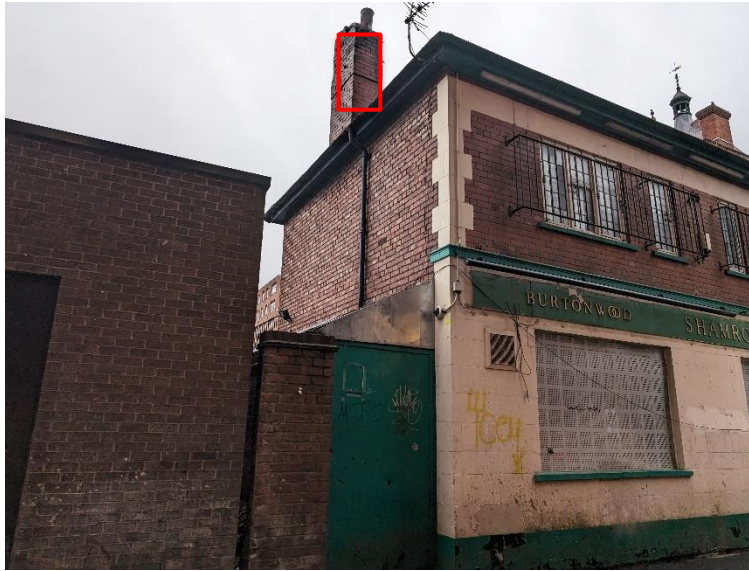
PLATE 10      SHOWING DAMAGED BRICKWORK ON CHIMNEY BREAST

The chimney breast on the northern aspect of the building had an area of damaged brickwork (PRF3). This damaged brickwork could provide crevices and gaps that opportunistic crevice-dwelling bat species could roost within on an occasional basis.

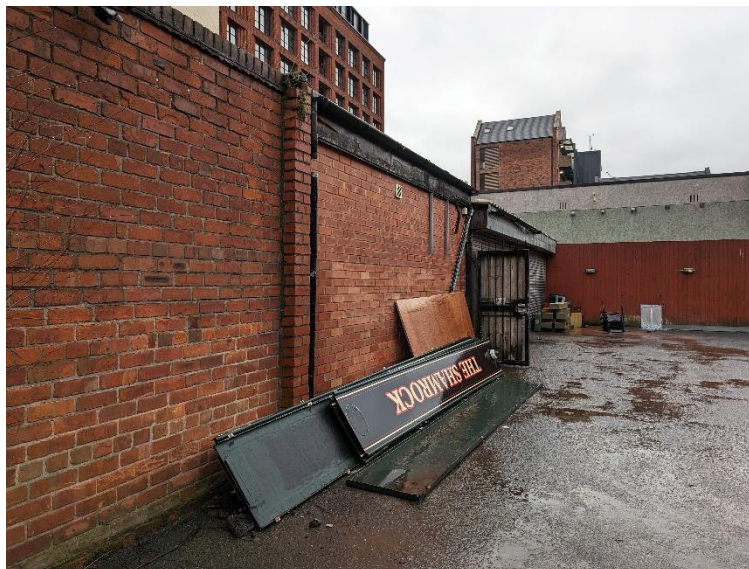
PLATE 11      SHOWING YARD/BEER GARDEN

It should be noted that the building on the southern aspect was adjacent to a covered beer garden with sheet metal and roller shutter doors, and therefore it is considered unlikely bats would be able to gain access to any suitable bat features on the building, such as brickwork crevices.

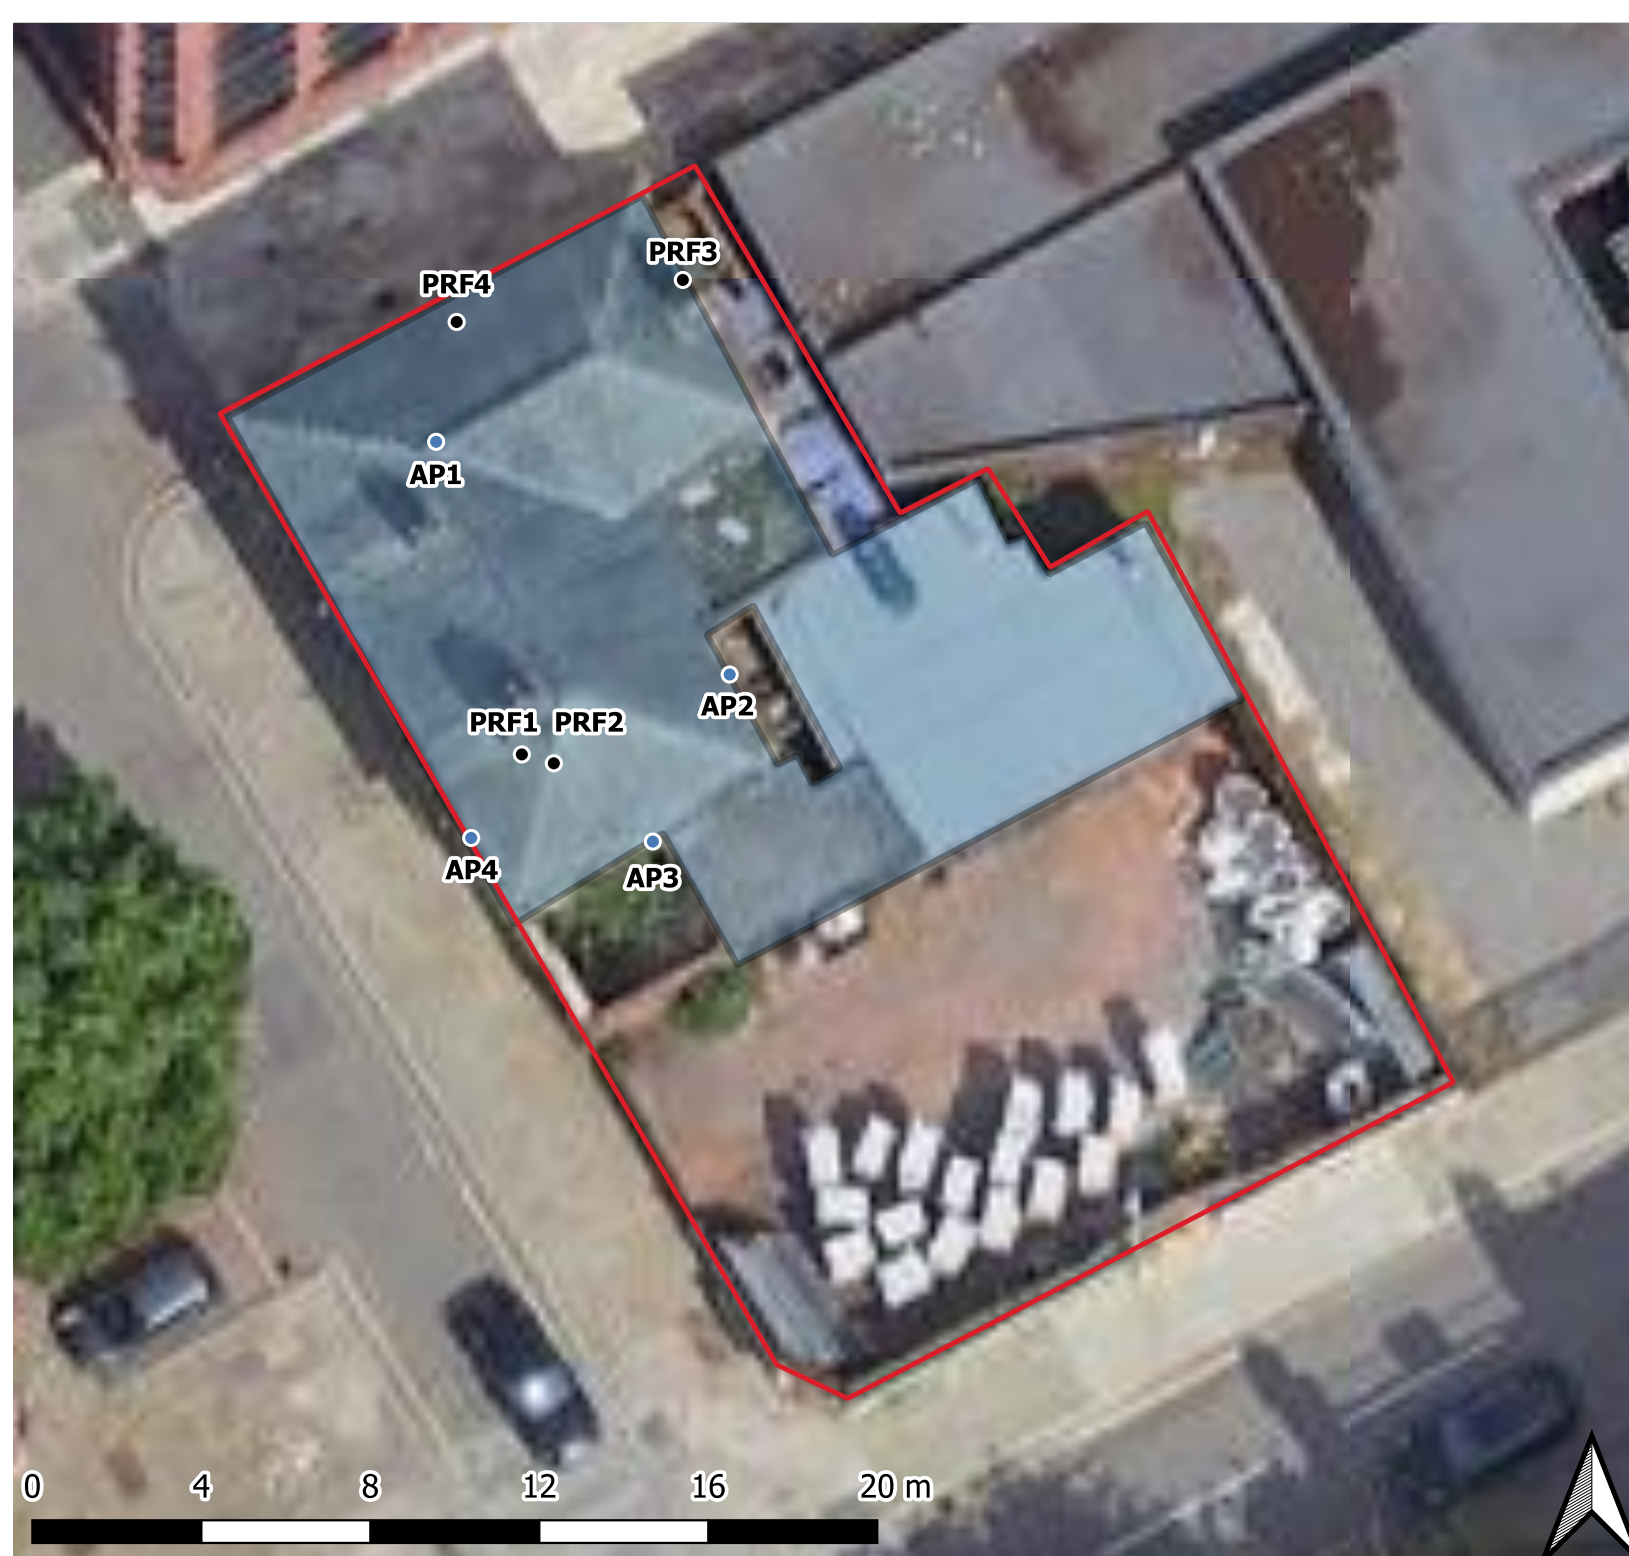
## **POTENTIAL ROOST FEATURE LOCATIONS**

A PRA was undertaken on the on-site building; no other buildings, structures or trees were present within the site boundary. Please see Table 3.2 for the descriptions of the potential roost features (PRFs) and Appendix I for the locations of the potential bat roost features.
