## Appendix 5.2: Biodiversity Figures

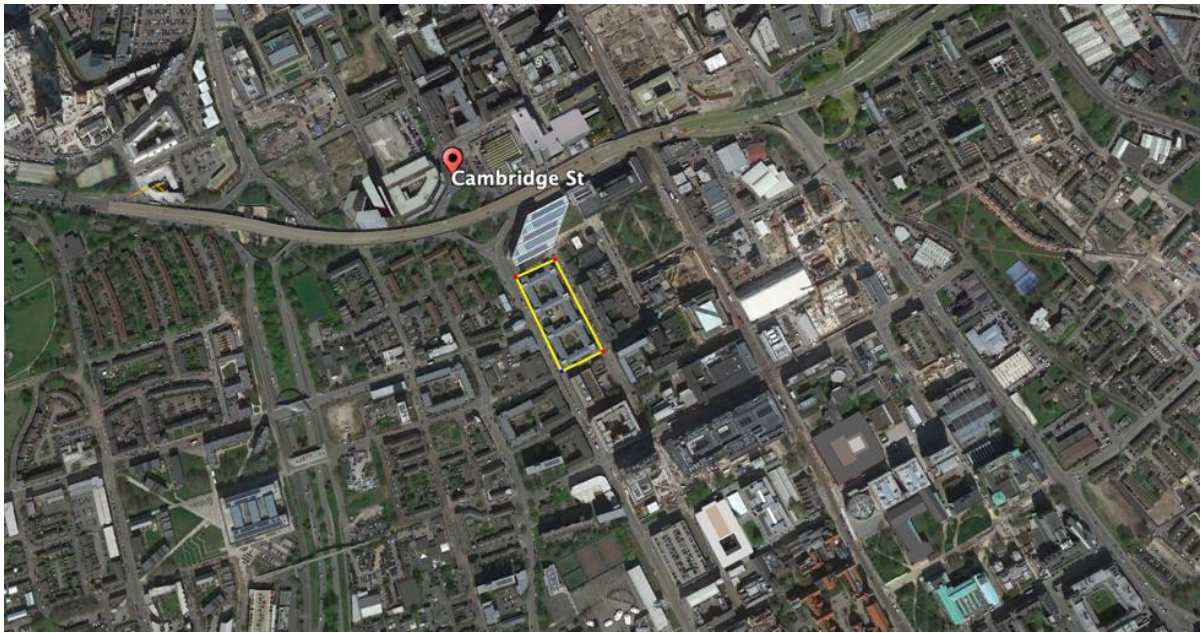
Location and Context of Cambridge Halls, Lack of any Semi-natural Habitats and Significant Fragmentation of Small Areas of Urban Planting As a Result of Dense Mixed Use Development.  
Image Courtesy of Google Earth.

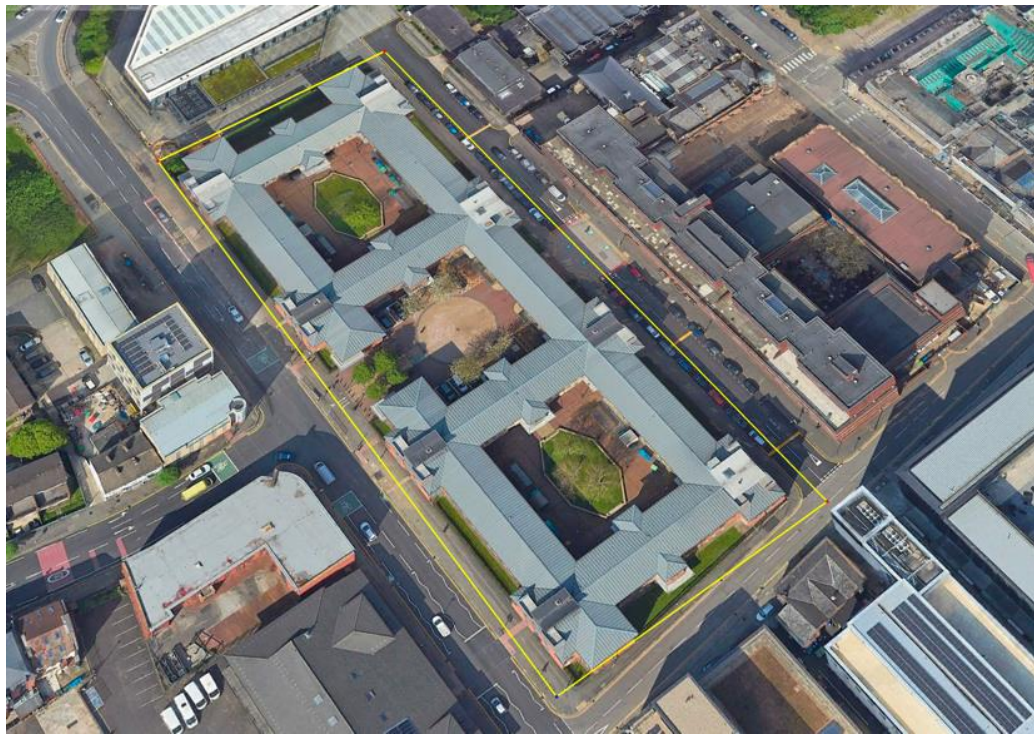
Closer Perspective Showing Modern Building Construction, Isolation of Small Areas of Planting Within and Without of Cambridge Halls. Image Courtesy of Google Earth.

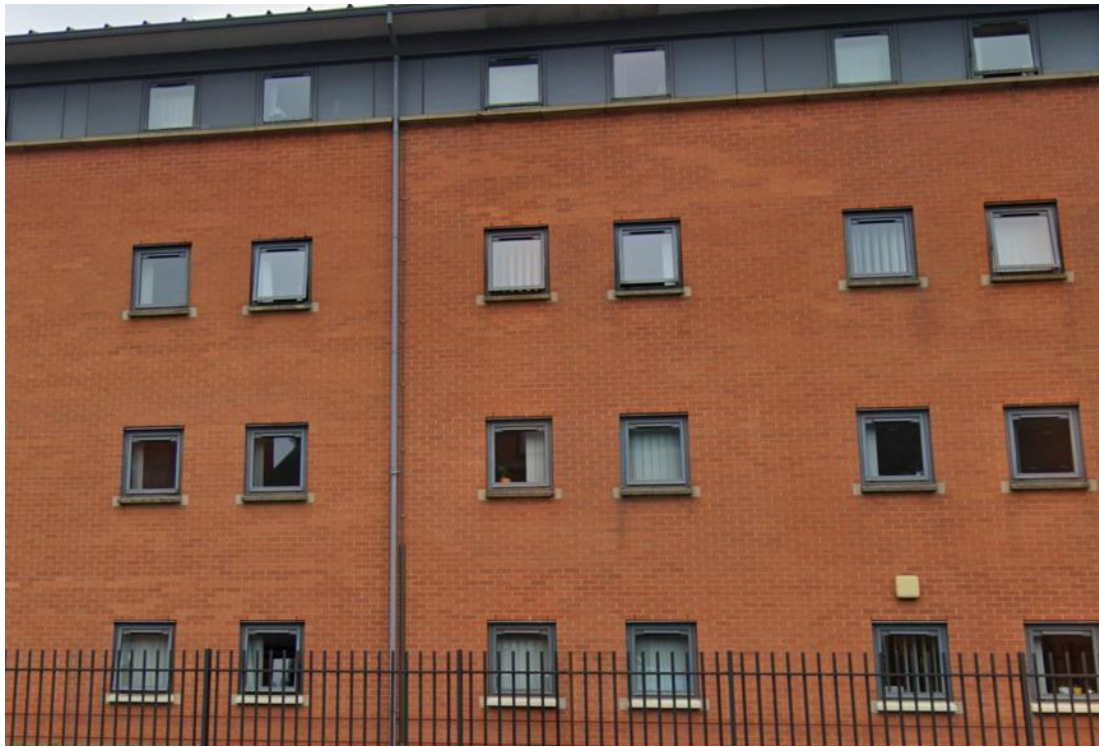
Representative view from Upper Cambridge Street. All brick work, windows, cladding and other features are tight with no visible gaps or cavities. No bat potential roost features were observed.

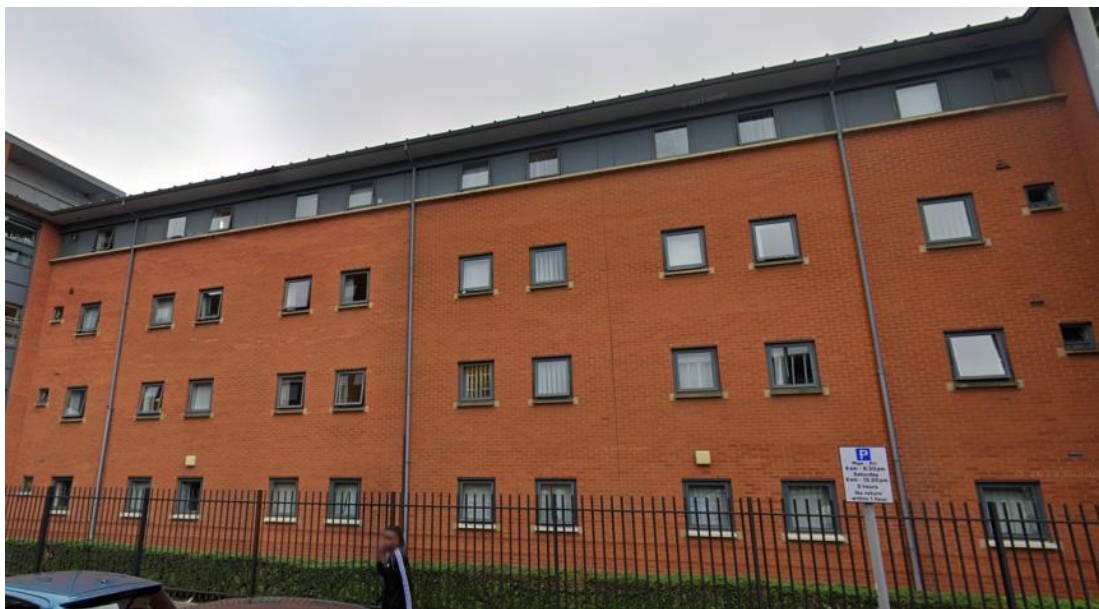
Representative view from Lower Chatham Street. All brick work, windows, cladding and other features are tight with no visible gaps or cavities. No bat potential roost features were observed.
