## METHODOLOGY

## ARCHAEOLOGICAL SEQUENCE

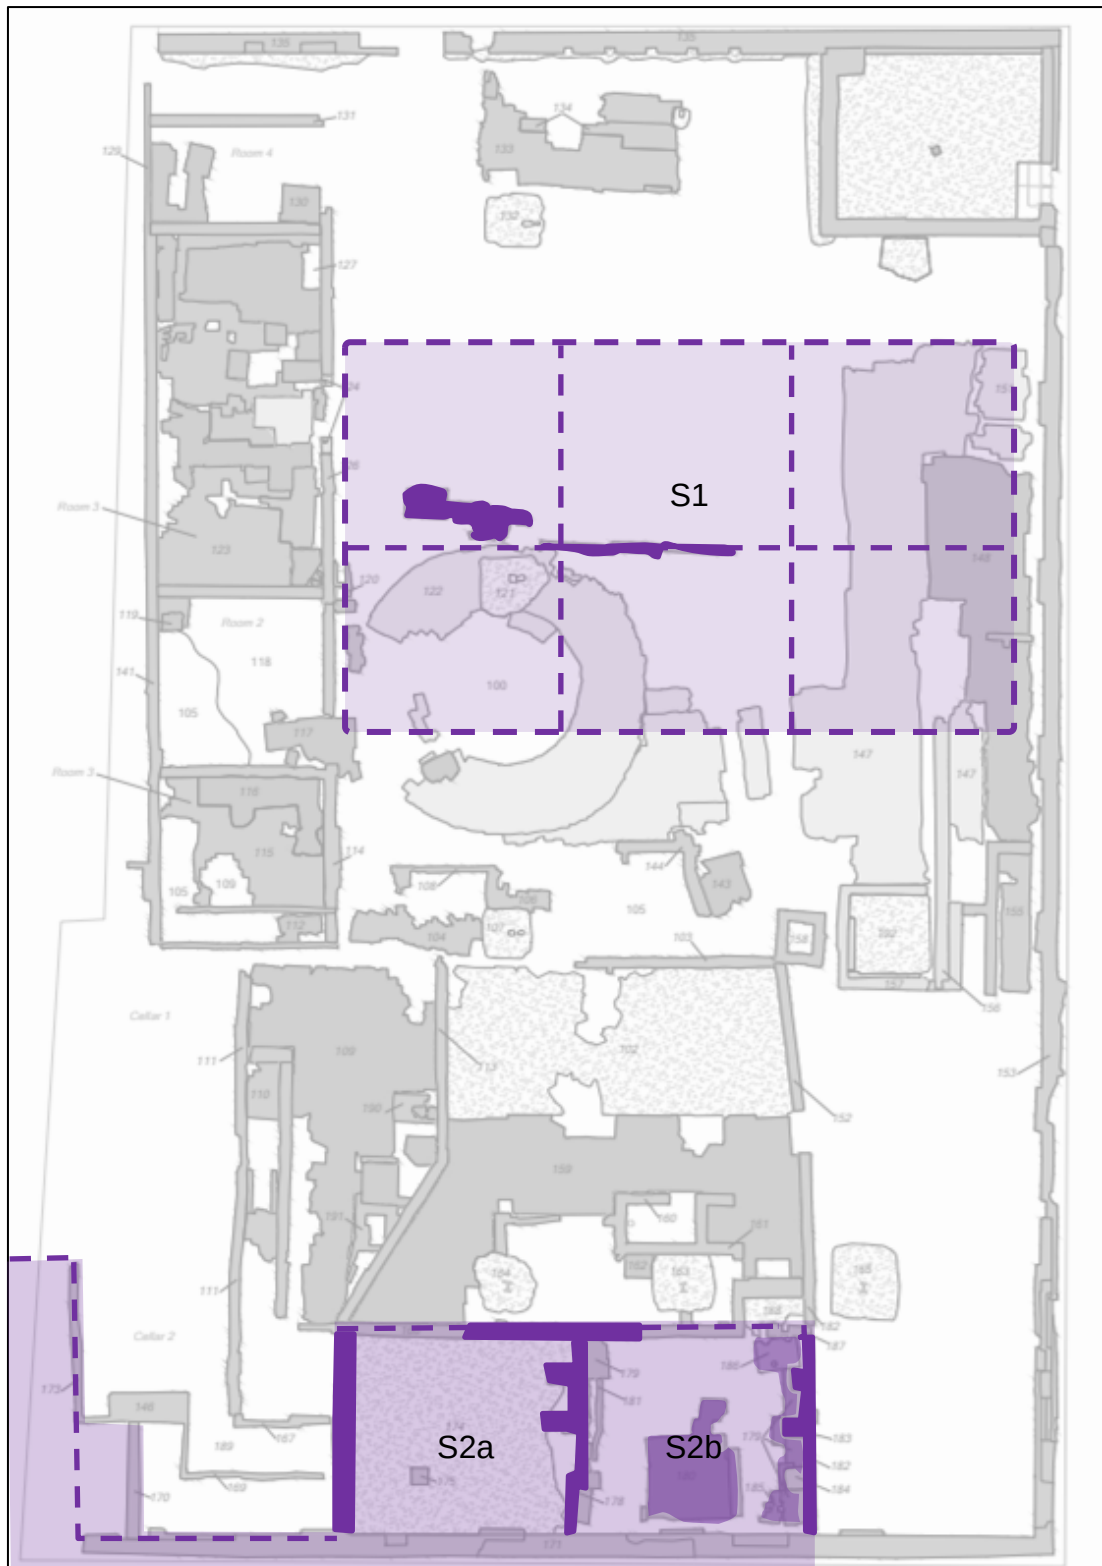
*Plate 21: Phase 1 walls and surfaces (solid purple) shown within the excavated footprint of known 18<sup>th</sup>-century buildings (shaded purple; outlined with dashed lines)*

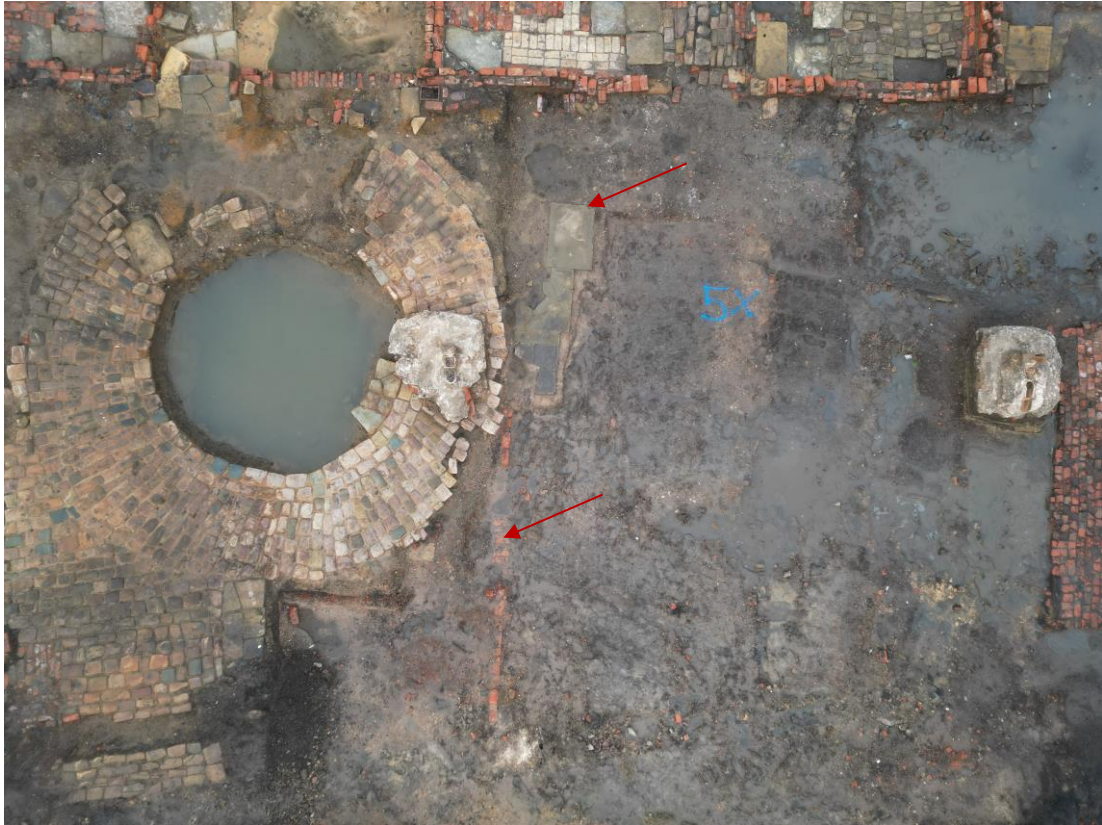
*Plate 22: S1 - wall [200] and floor surface [128]*

A row of houses was constructed in the north-western half of the site in the late 18<sup>th</sup> century. Most of the walls and floors of the house had been truncated by later activity, leaving only traces of a single-skin internal wall [200] and an associated floor [128], which survived beneath the yard surfaces [122] of the 19<sup>th</sup>-century coal wharf. The 0.11m-wide wall [200] was oriented north-east/south-west and survived to a maximum length of 4.18m. A floor surface [128] had been laid up to the wall on its north-western side. The floor surface comprised three 60mm-thick pale yellow / yellowish grey sandstone flags, which covered an area of 2.70 x 0.80m.

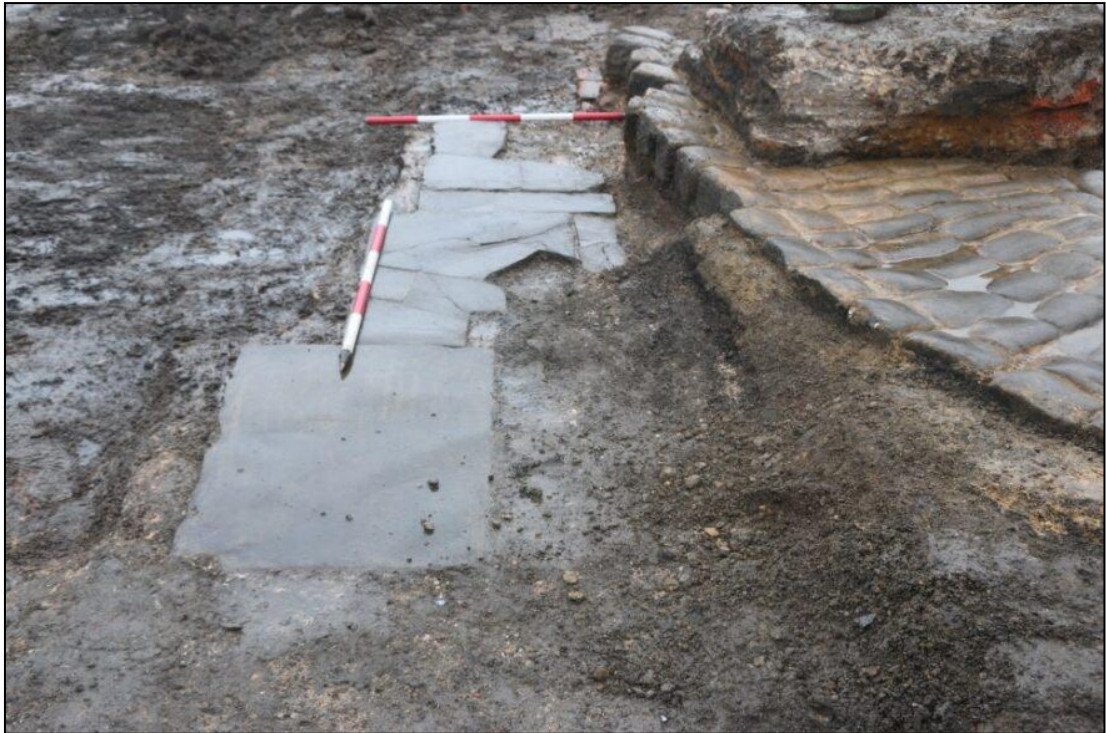
*Plate 23: Flagstone floor [128]; looking north-east. Scales 2x1m*

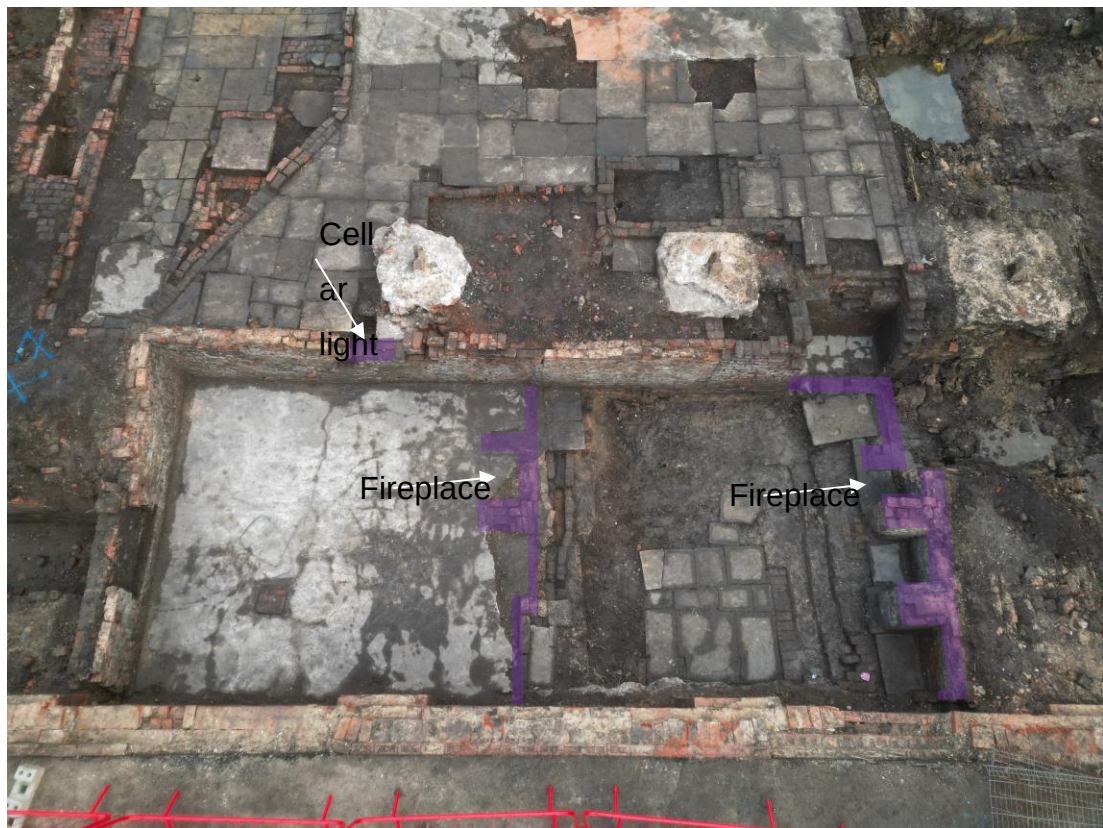
*Plate 24: Cellars S2a/S2b looking north-west*

Two houses were constructed along Jersey Street in the south-eastern part of the site in the late 18<sup>th</sup> century. Two partially exposed cellars (structure numbers: S2a and S2b) represent the rear cellar rooms of the properties. These cellars both had an internal footprint of 4.89m (NE/SW) by 4.55m+ (NW/SE).

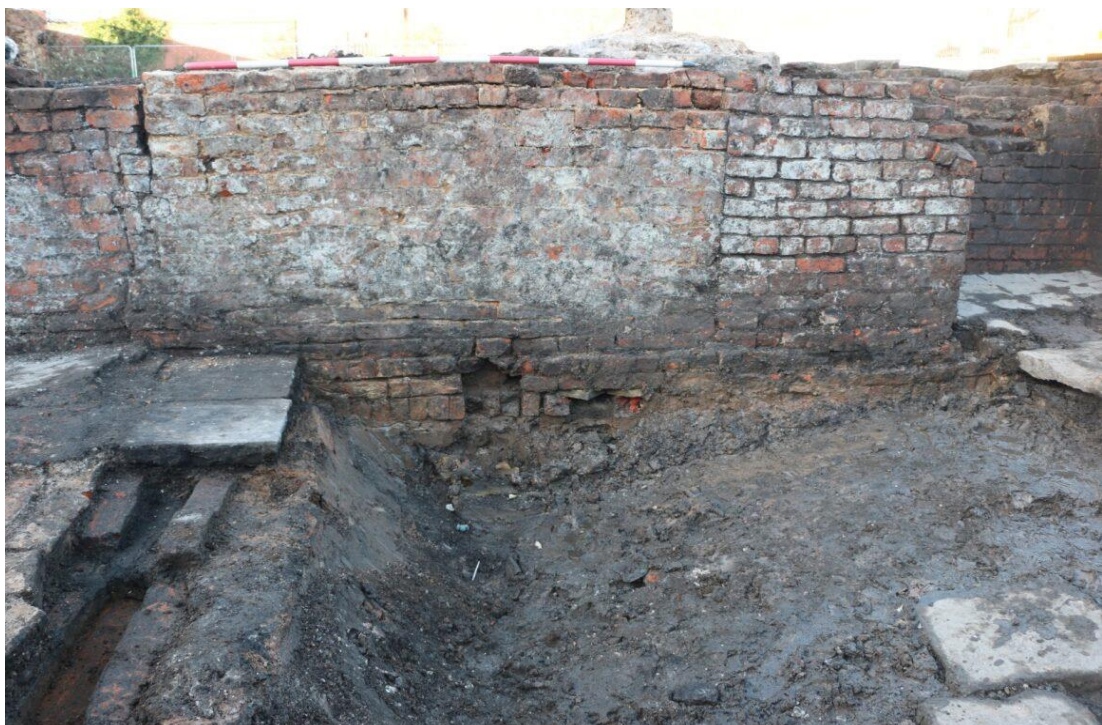
*Plate 35: Original elements of the rear, north-western wall [166] left of shot, [166], looking north-west. Note the vertical phase break with remodelled wall [196] beyond. (scale: 2m)*

could be traced in plan, returning to the south-east. A vertical phase break between the original wall [166] and the remodelled north-east corner [196] may denote the position of a doorway.

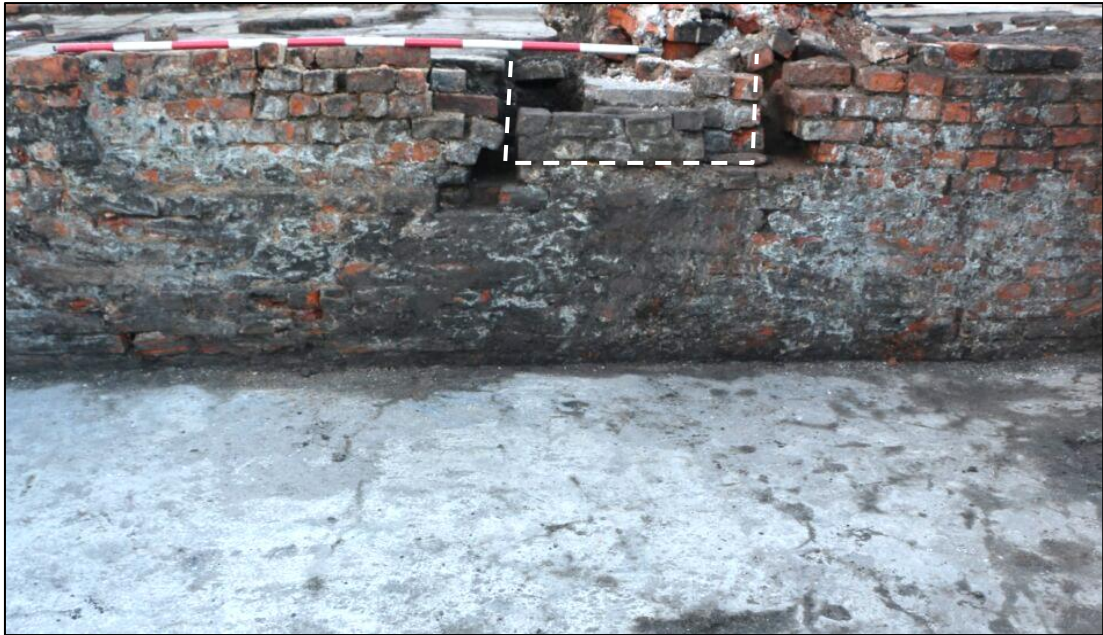
*Plate 36: Rear wall [166] of cellar S2a with blocked cellar light [201]; looking north-west.  
(scale: 2m)*

This cellar was lit by means of a cellar light [201] built into the north-western wall [166]. The window aperture was 0.86m wide. It had been blocked-up in the late 19<sup>th</sup> century, however vertical recesses either side of the blocking [194] mark the position of the original timber jambs, which had since rotted away.

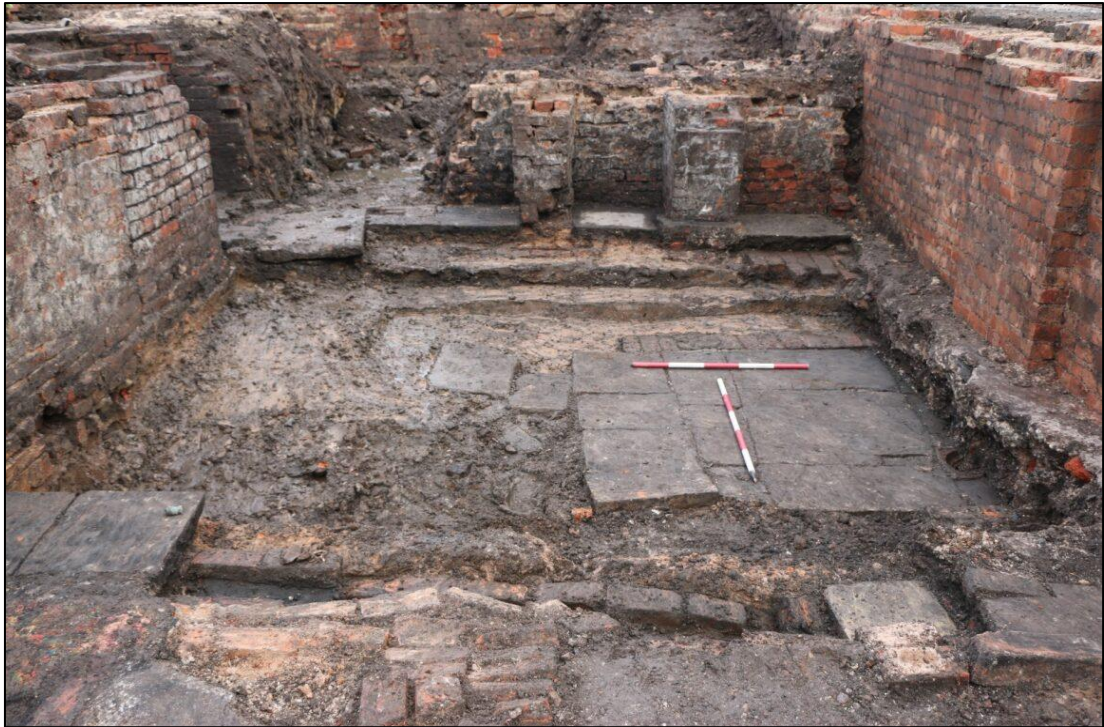
*Plate 37: Cellar S2b, looking north-east showing the drain [178] in the foreground (scales: 1m)*

A stone-capped drain [181]/[178] was constructed alongside the party wall [177] within the north-eastern cellar (S2b) (Plate 37). The side walls and base of the drain were constructed of handmade brick; it was capped with sandstone flags. The drain [178] was 3.10m long, 0.54m wide and a maximum depth of 0.34m.

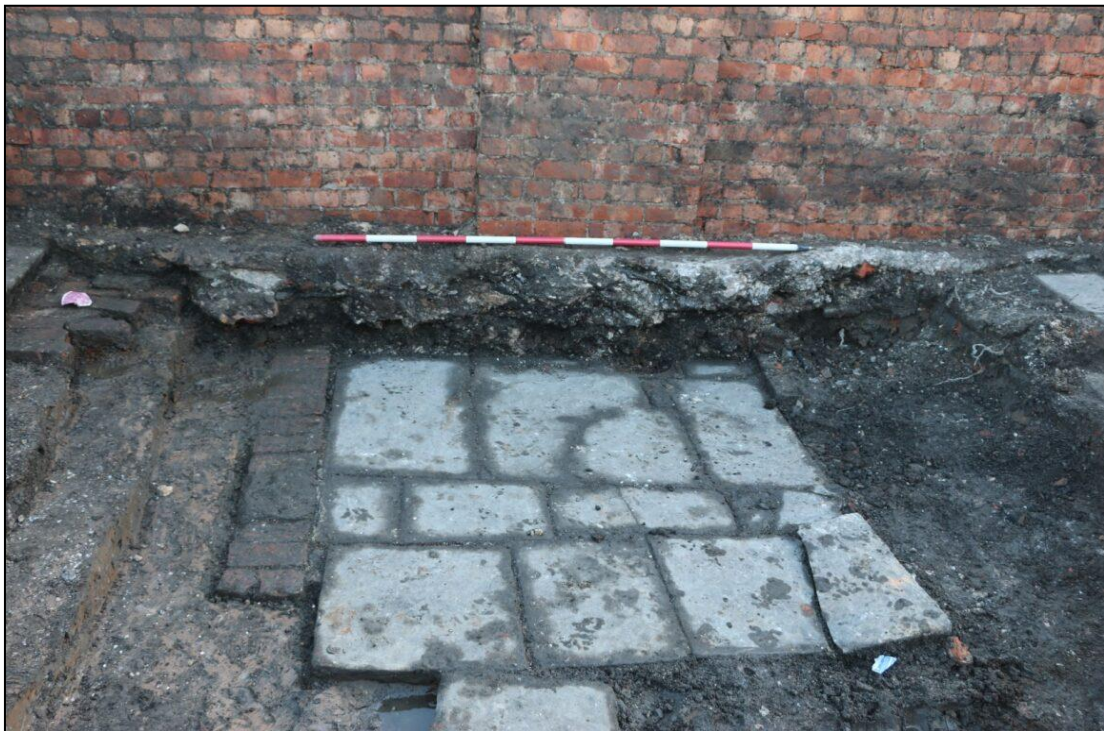
*Plate 38: Floor surfaces [179]/[180] within cellar S2b looking south-east. Scale: 2m*

The north-western cellar retained elements of its original floor surfaces, comprising both handmade brick [185] and sandstone flags [180]. Flags [186]/[179] arranged along the north-east wall [166] were laid at a slightly higher level.

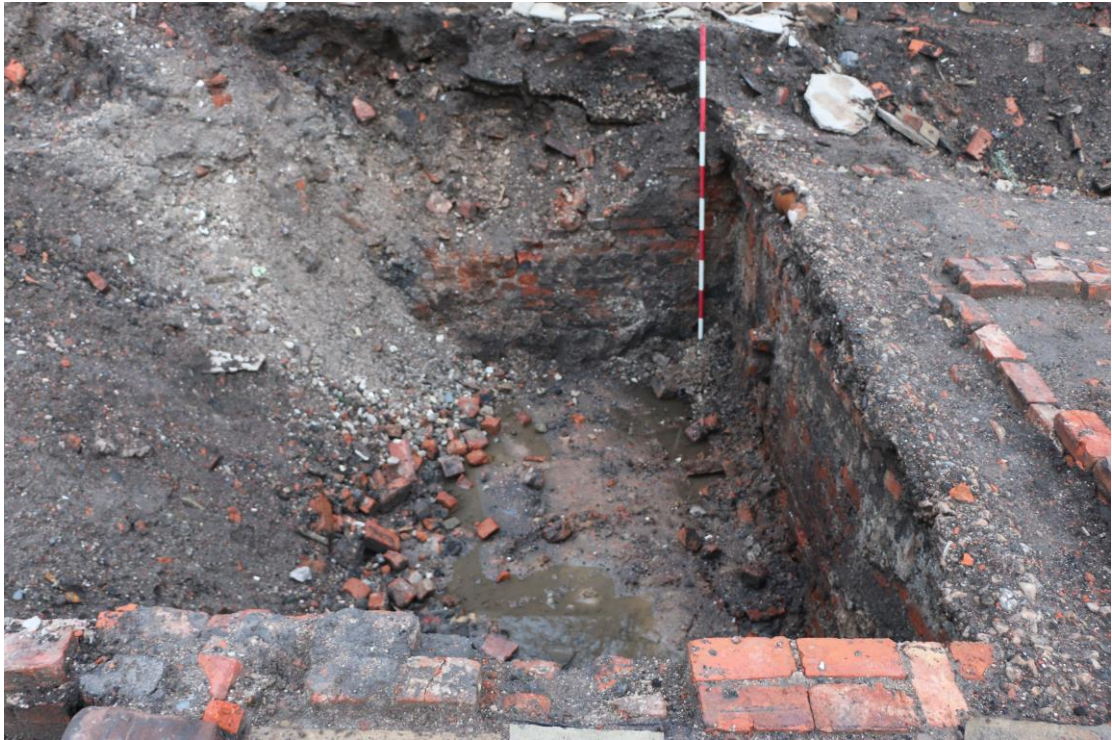
*Plate 40: Partially excavated cellar (S3) looking south-west. Note the blocked cellar light [205] in the foreground (scale: 2m)*

Three sides to a cellared room (S3) were exposed within the excavation. The cellared room measured 3.89m (north-east/south-west) by c.4.77m.

The exposed walls [202]/[203]/[204] were all built from handmade brick bonded with lime-based mortar. An aperture [205] within the north-western cellar wall [202] was interpreted as a cellar light.

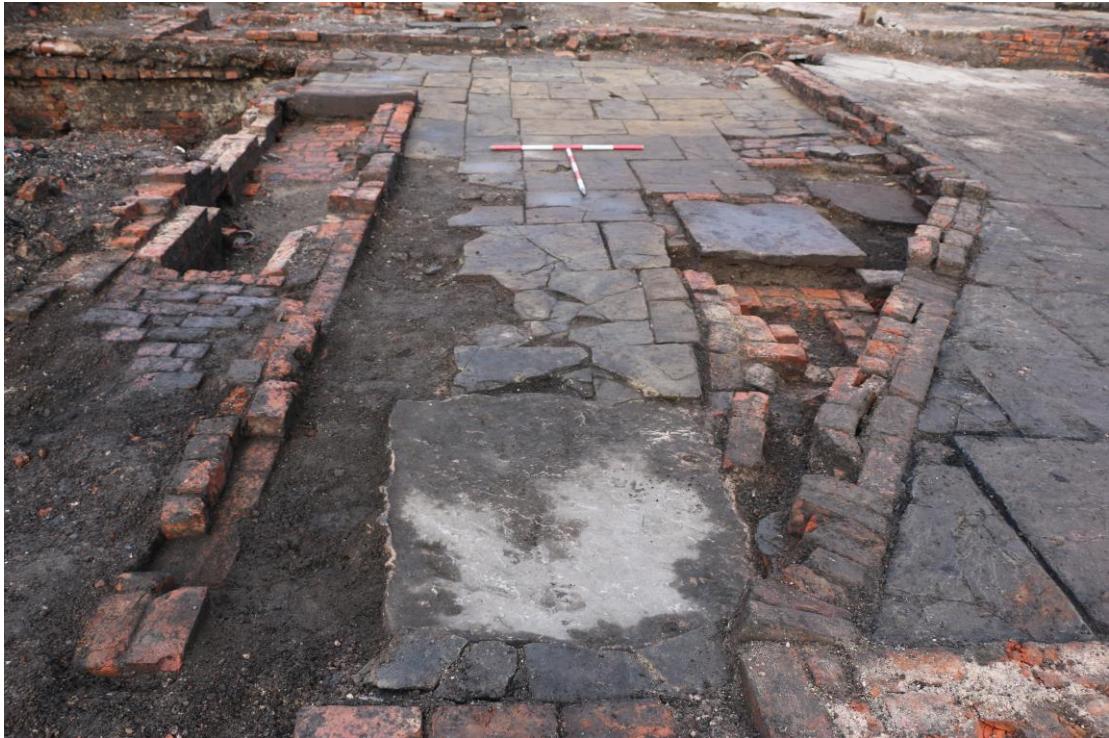
*Plate 41: Yard surface [109]*

A yard surface [109] was laid out to the south-west of the kinked wall [113]. The surface may have once continued further to the south-east. The surviving surface [109] was formed of rectangular sandstone flags, recorded over an area of 4.47m x 4.05m.

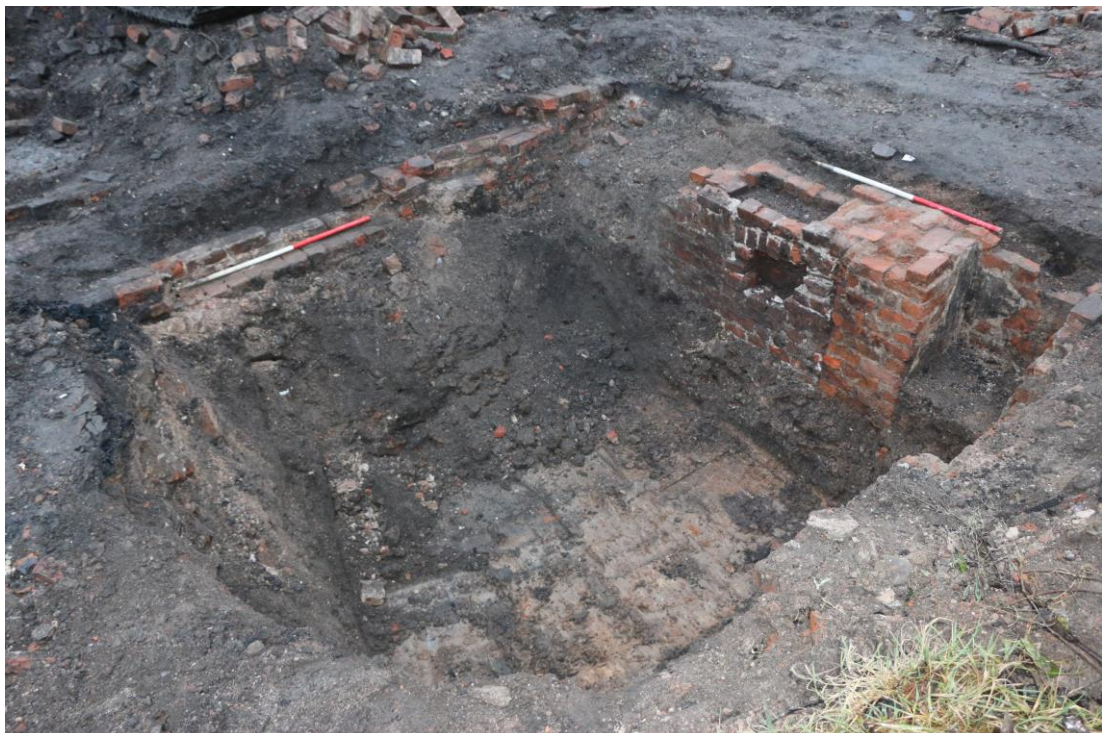
*Plate 44: Initial exposure of cellar (S4) forming Saxon's Court, looking south-west (scale: 2m)*

The cellar was defined by three walls [111]/[146]/[173] constructed from handmade brick and lime-based mortar. The north-eastern and south-western walls [111]/[173] were 0.25m wide. The wall [146] to the south-east was formed of a single skin of brick (0.11m wide). The walls retained traces of a sandy render and limewash.

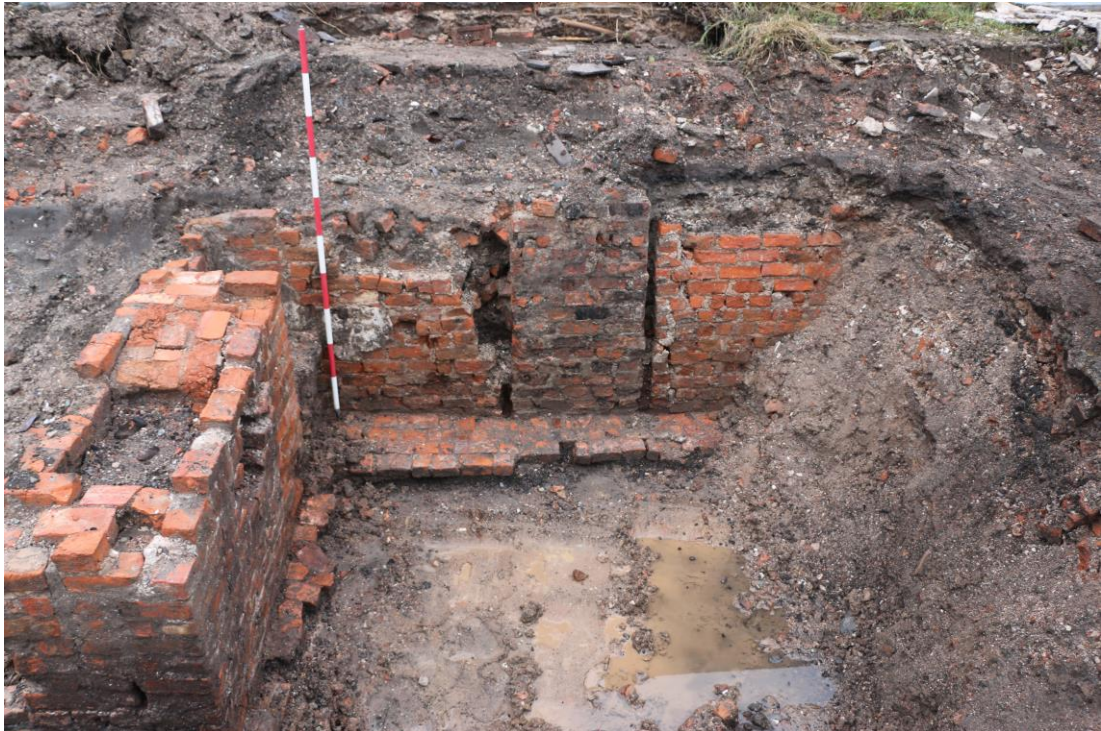
*Plate 45: Rear cellar of Saxon's Court (S4) looking south-west (scale: 2m)*

A fireplace was built into the south-eastern wall [146]; it measured 1.78m (north-east/south-west) by 0.66m (north-west/south-east). The jambs were 0.33m and 0.48m wide and the recess for the hearth was 0.79m wide.

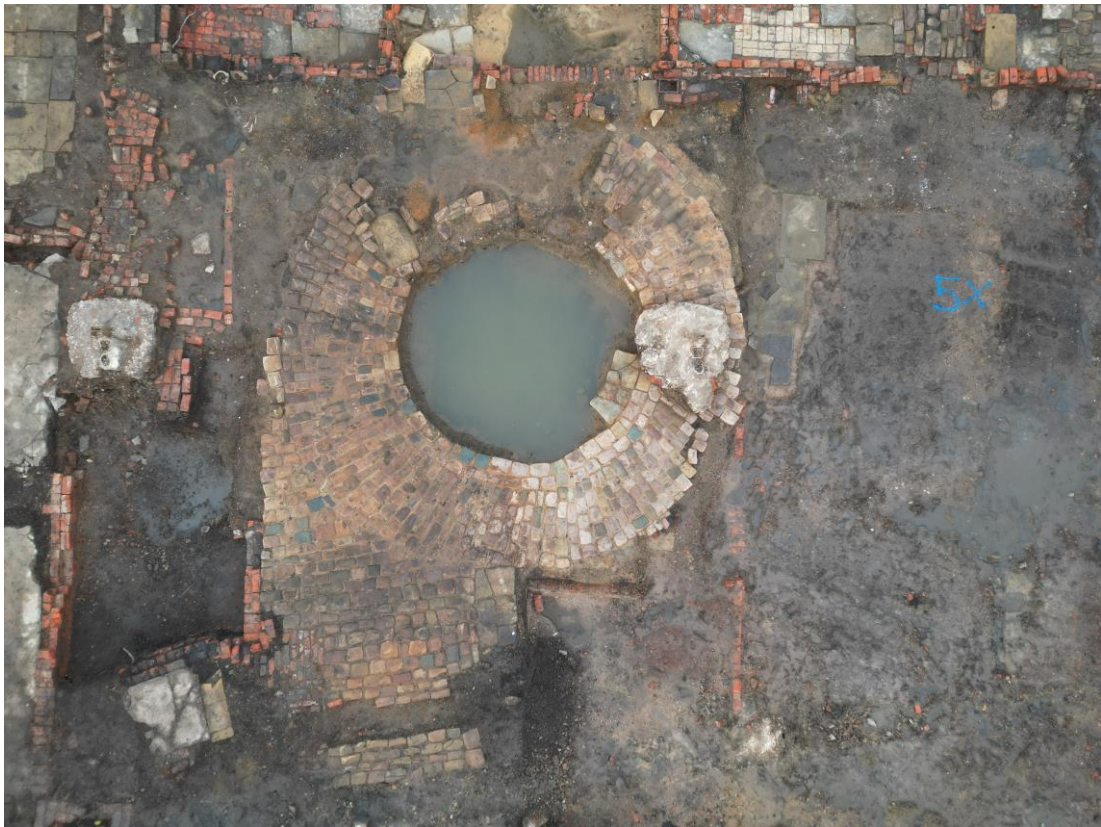
*Plate 45: Aerial view of surface [122] with circular aperture possibly denoting the position of a crane or jib (S6)*

An unusual feature within the coal wharf was an arrangement of setts [122], forming an annular shape in plan. These had evidently been laid around a structure or mechanism, which had since been removed. One possibility is this could have been the location of a rotating crane or jib (S6). The extrapolated external diameter of the surface [122] was 6.56m.

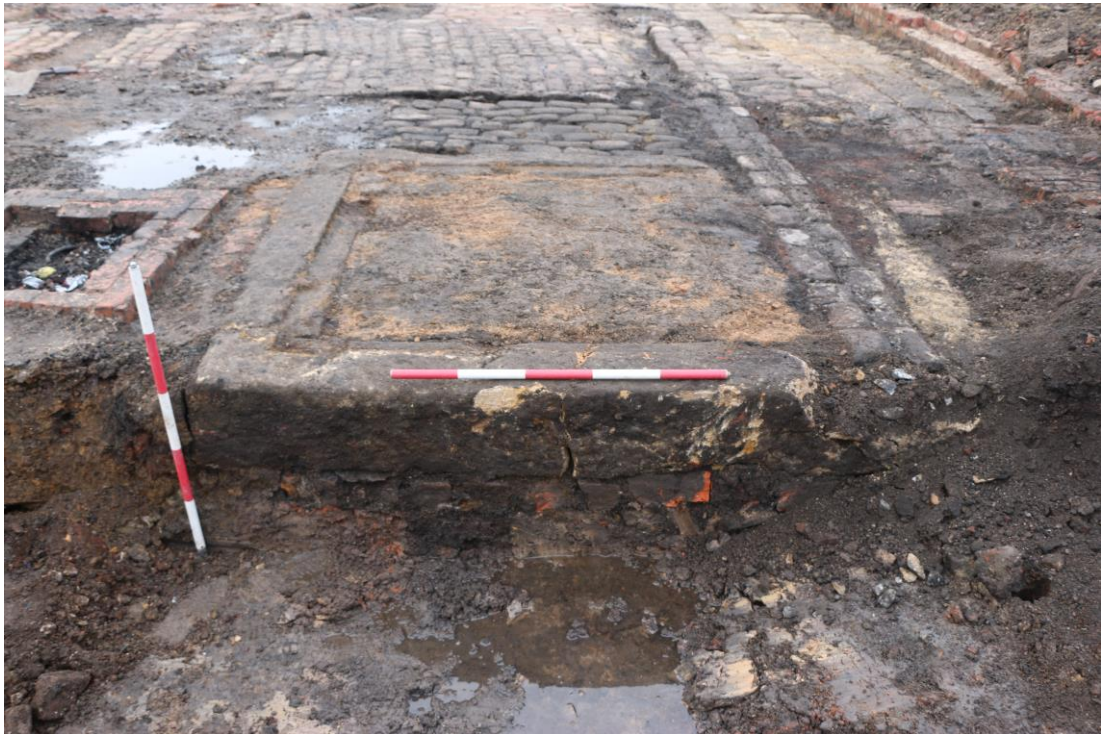
*Plate 46: Weighing machine (S7) scales: 1m*

Another structure (S7) easily attributed to this phase of the site's use was a rectangular weighing machine [157]. This was constructed at the entrance to the wharf and was formed of rectangular rough-faced sandstone laid atop a

brick base. The structure measured 2.00m x 2.20m and was approximately 0.35m deep.

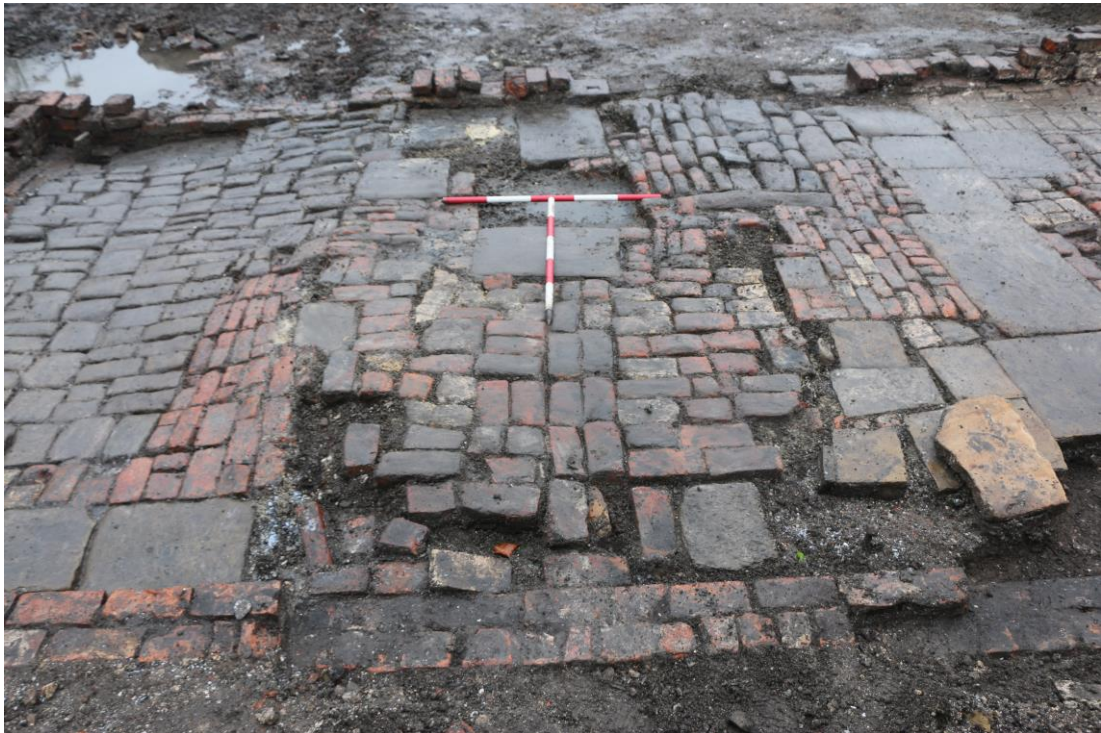
*Plate 48: Example of the floor surfaces within the Poland Street Houses (S9, Room 4)*

The size and shape of the Poland Street houses correspond closely with the reconfigured properties, as shown on the 1891 Town Plan. Five ground floor rooms were identified. The exposed walls [114]/[141]/[131]/[127] were constructed using a mixture of handmade and wire-cut bricks, which were bonded with black ash mortar. Internally, the rooms were floored with an assortment of brick, firebrick, sandstone flags (contexts: [130]/[123]/[117]/[116]/[115]/[119]. Of particular note were the use of large blocks of refractory brick to form the foundation of a step in the corner of Room 2. Two sandstone blocks [124] with sockets for door jambs were constructed into the walls of Rooms 3/4.

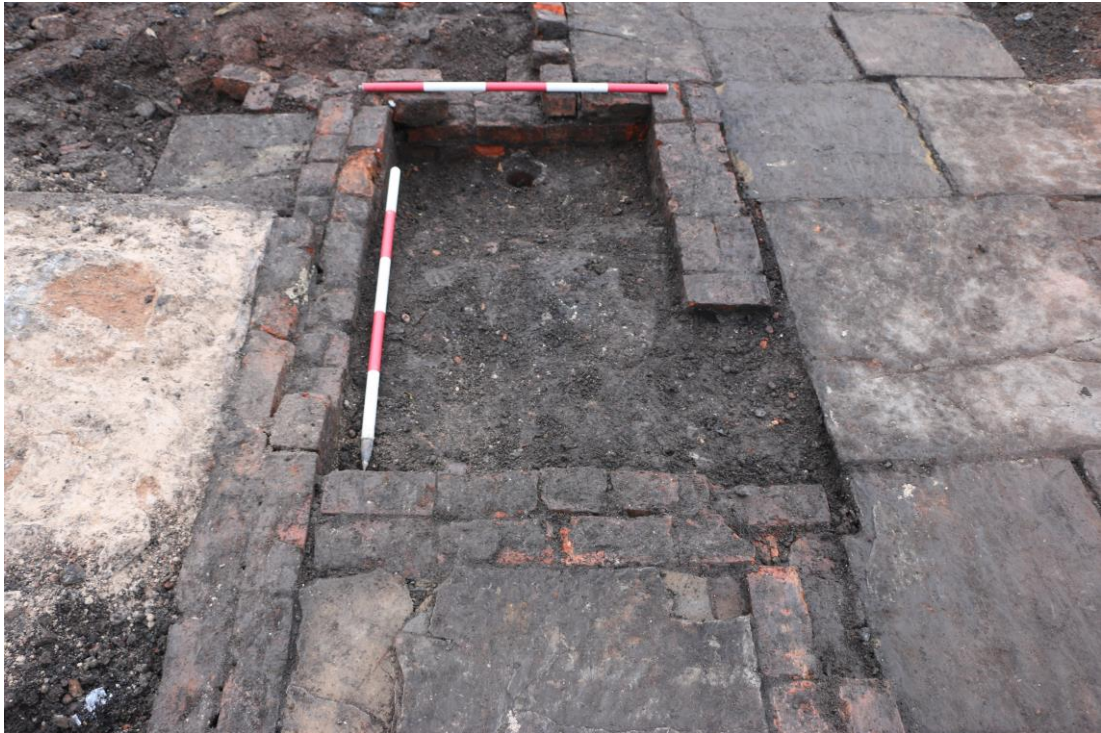
*Plate 51: Privy to the rear of the Jersey Street Houses, part of structure [160]*

A block [160] was constructed to the rear of the Jersey Street properties in the late 19<sup>th</sup> century. This comprised one large room and three smaller cubicles. The structure likely functioned as a washhouse with the adjoining smaller rooms functioning as privies. A small vestige of floor survived in one of the rooms [162].
