# LAND AT GREENBROW SOCIAL CLUB, WYTHENSHAW, MANCHESTER

## Remediation & Enabling Works Strategy

Report Ref: BEK-24100-1 (Rev A)

October 2024

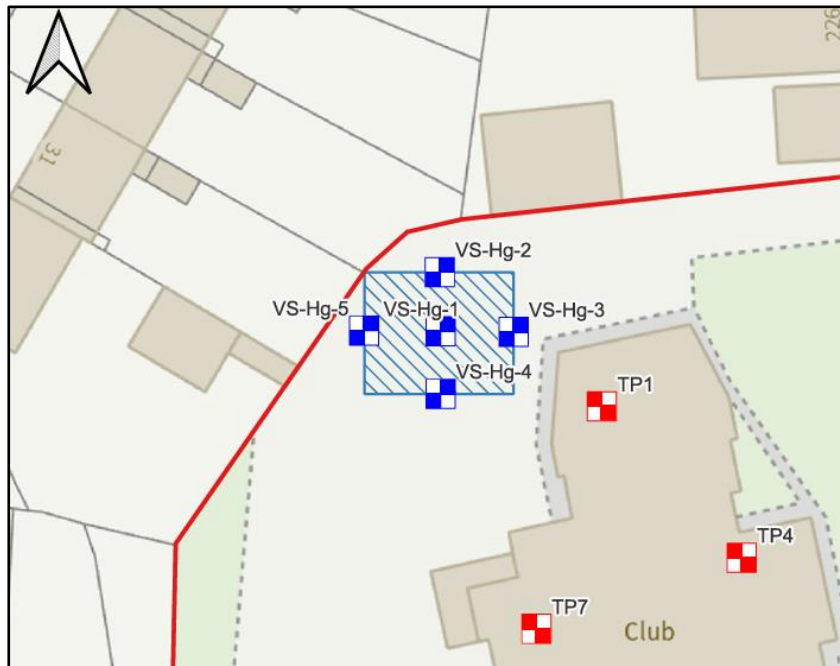
**Figure 1:** Extract from BEK Drawing No 24100-1

- 3.3.3 Given that the made ground at the location of borehole WS102 has been removed off-site, BEK considered it prudent to undertake validation sampling around the excavation. This comprised the excavation of 5No. shallow trial pits in the base and along the edges of the excavation in order to sample the material remaining in-situ. The locations of the trial pits can be seen on BEK Drawing No 24100-1, a copy of which is presented in Appendix F and an extract of which can be seen below as Figure 2.

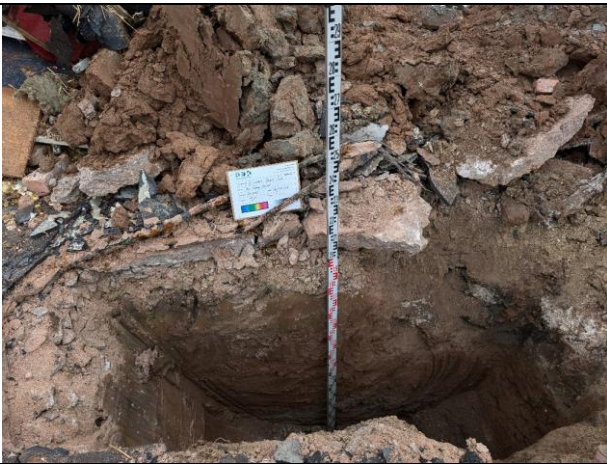
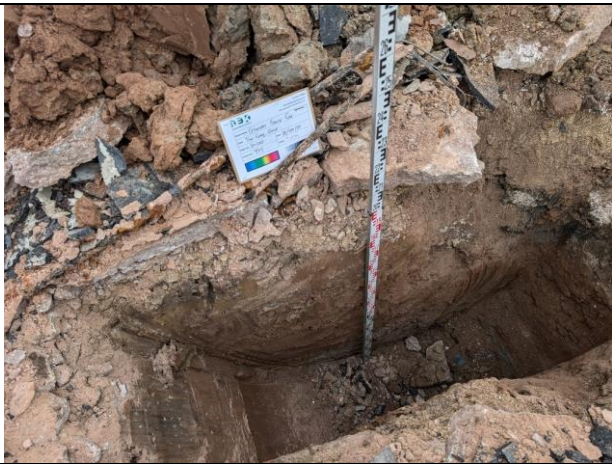
- 3.2.1 7No. trial pits were machine excavated to a maximum depth of 3.1 m, with in-situ testing (hand/shear vane) carried out in the trial pits where appropriate.
- 3.2.2 The ground conditions were recorded by an engineer from BEK and copies of the trial pits records are presented in Appendix A. A series of photographs showing the trial pits can be seen in Appendix B.

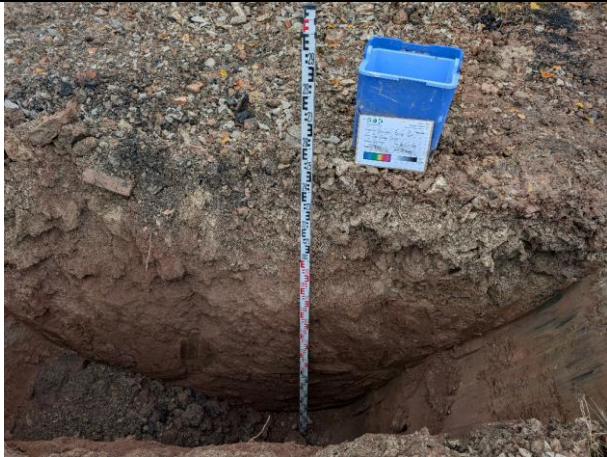
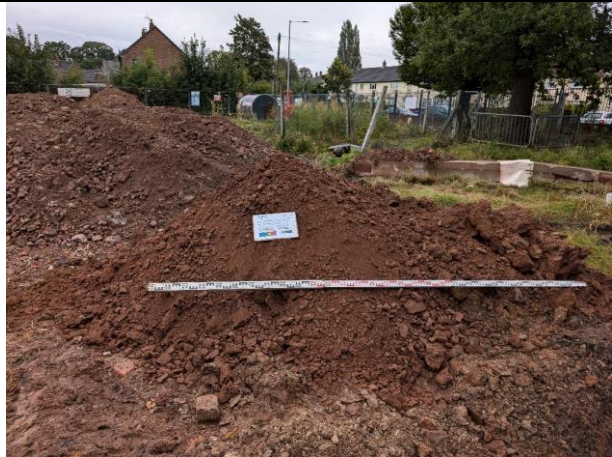
'Grey slightly clayey very sandy fine to coarse GRAVEL of angular limestone and brick. Sand is fine to coarse. Low cobble content of angular limestone and whole/broken brick' – This strata was encountered at the surface of TP2 to a depth of 0.3 m.

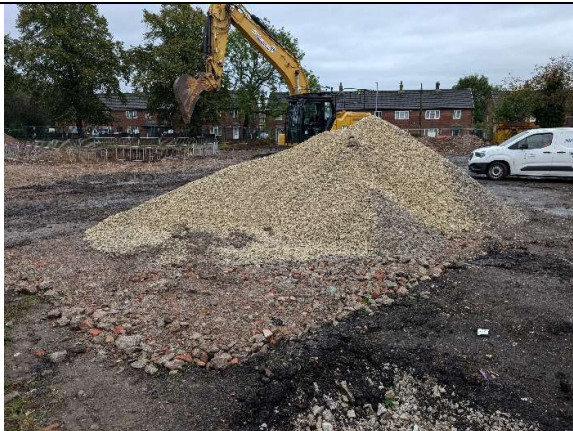
| P1: General view of excavation | P2: Trial pit in the centre of the excavation (to base) |

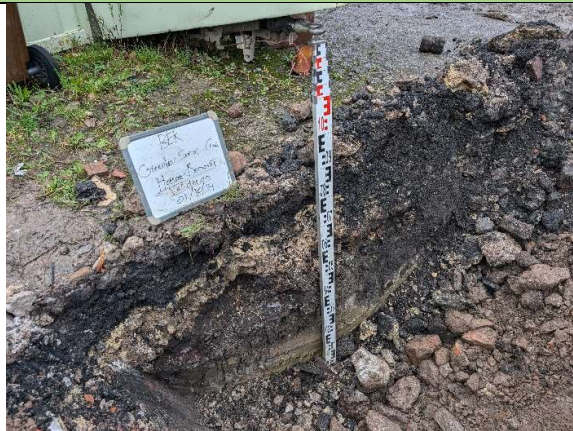
| P3: Trial pit on the northern edge of excavation | P4: Trial pit on the eastern edge of excavation |

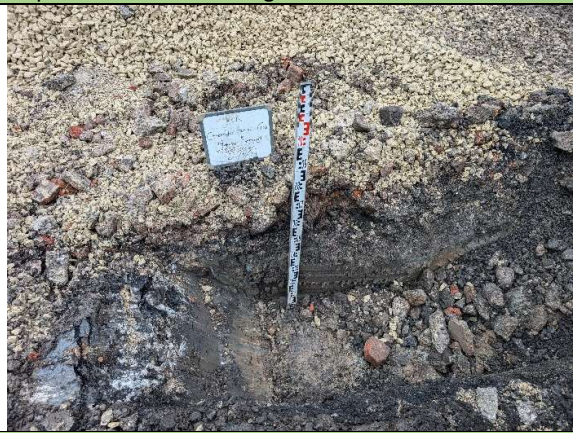
| P5: Trial pit on the southern edge of excavation | P6: Trial pit on the western edge of excavation |

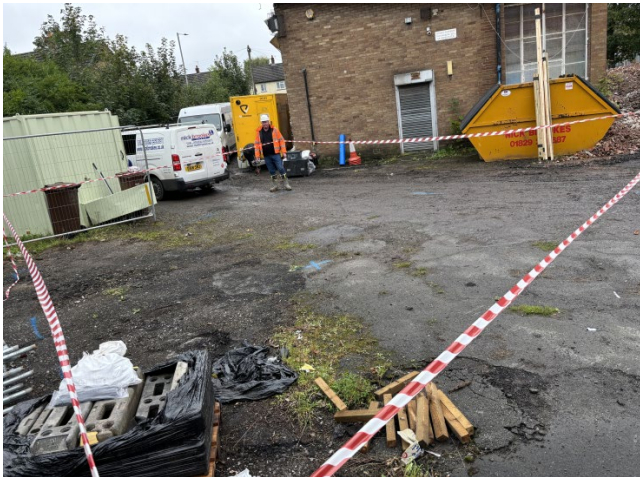
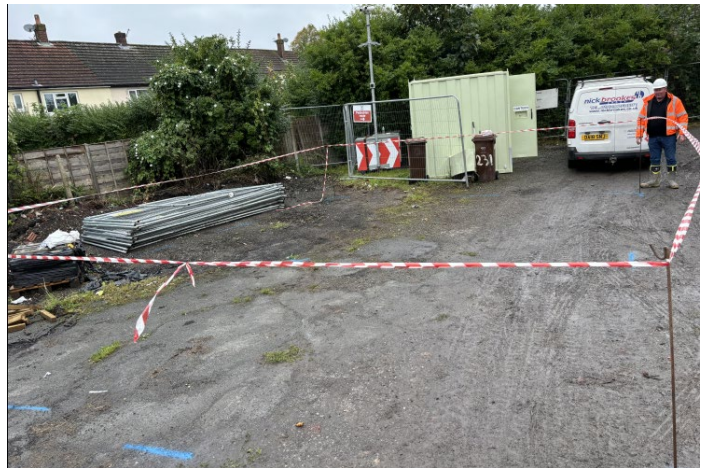
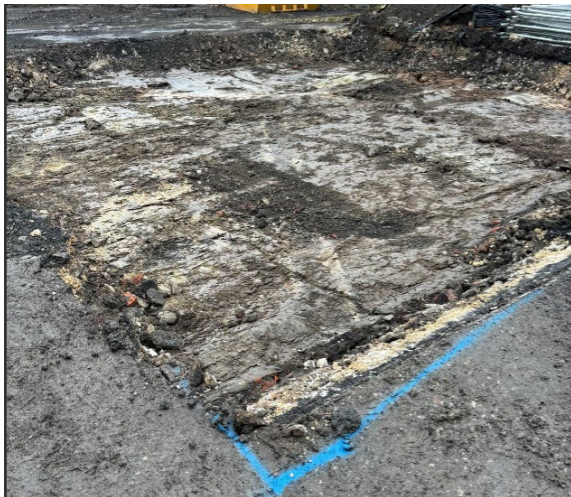
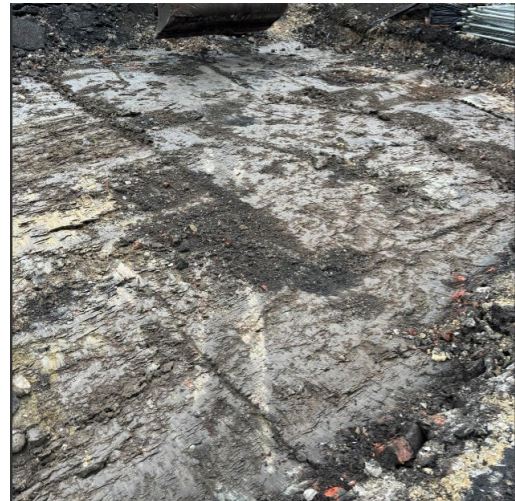
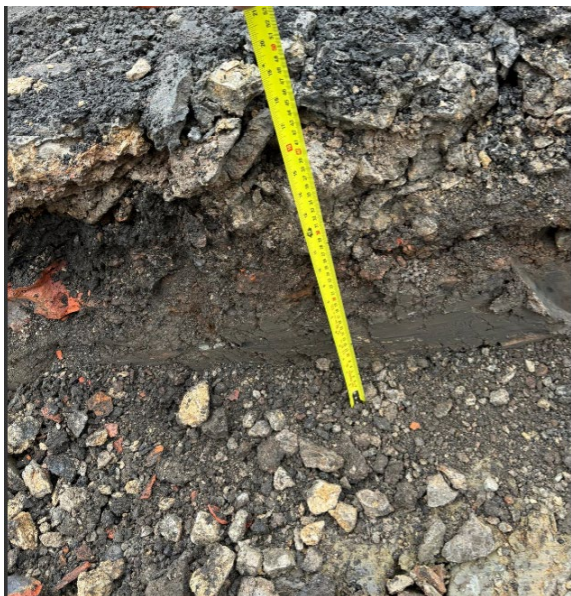
**Segregation images:**

**Location WS102 was chemically classified as Non-Hazardous due to elevations in Metals Concentrations as identified within Phase 2 Geoenvironmental Site Assessment Report reference: 17-305-R1-1.**

**3 x loads were removed from site to Booth Ventures – Harwood quarry for disposal as Non Hazardous soils under permit reference: BV8741IL – Waste Transfer note reference: DHI/00-2229 listed below.**

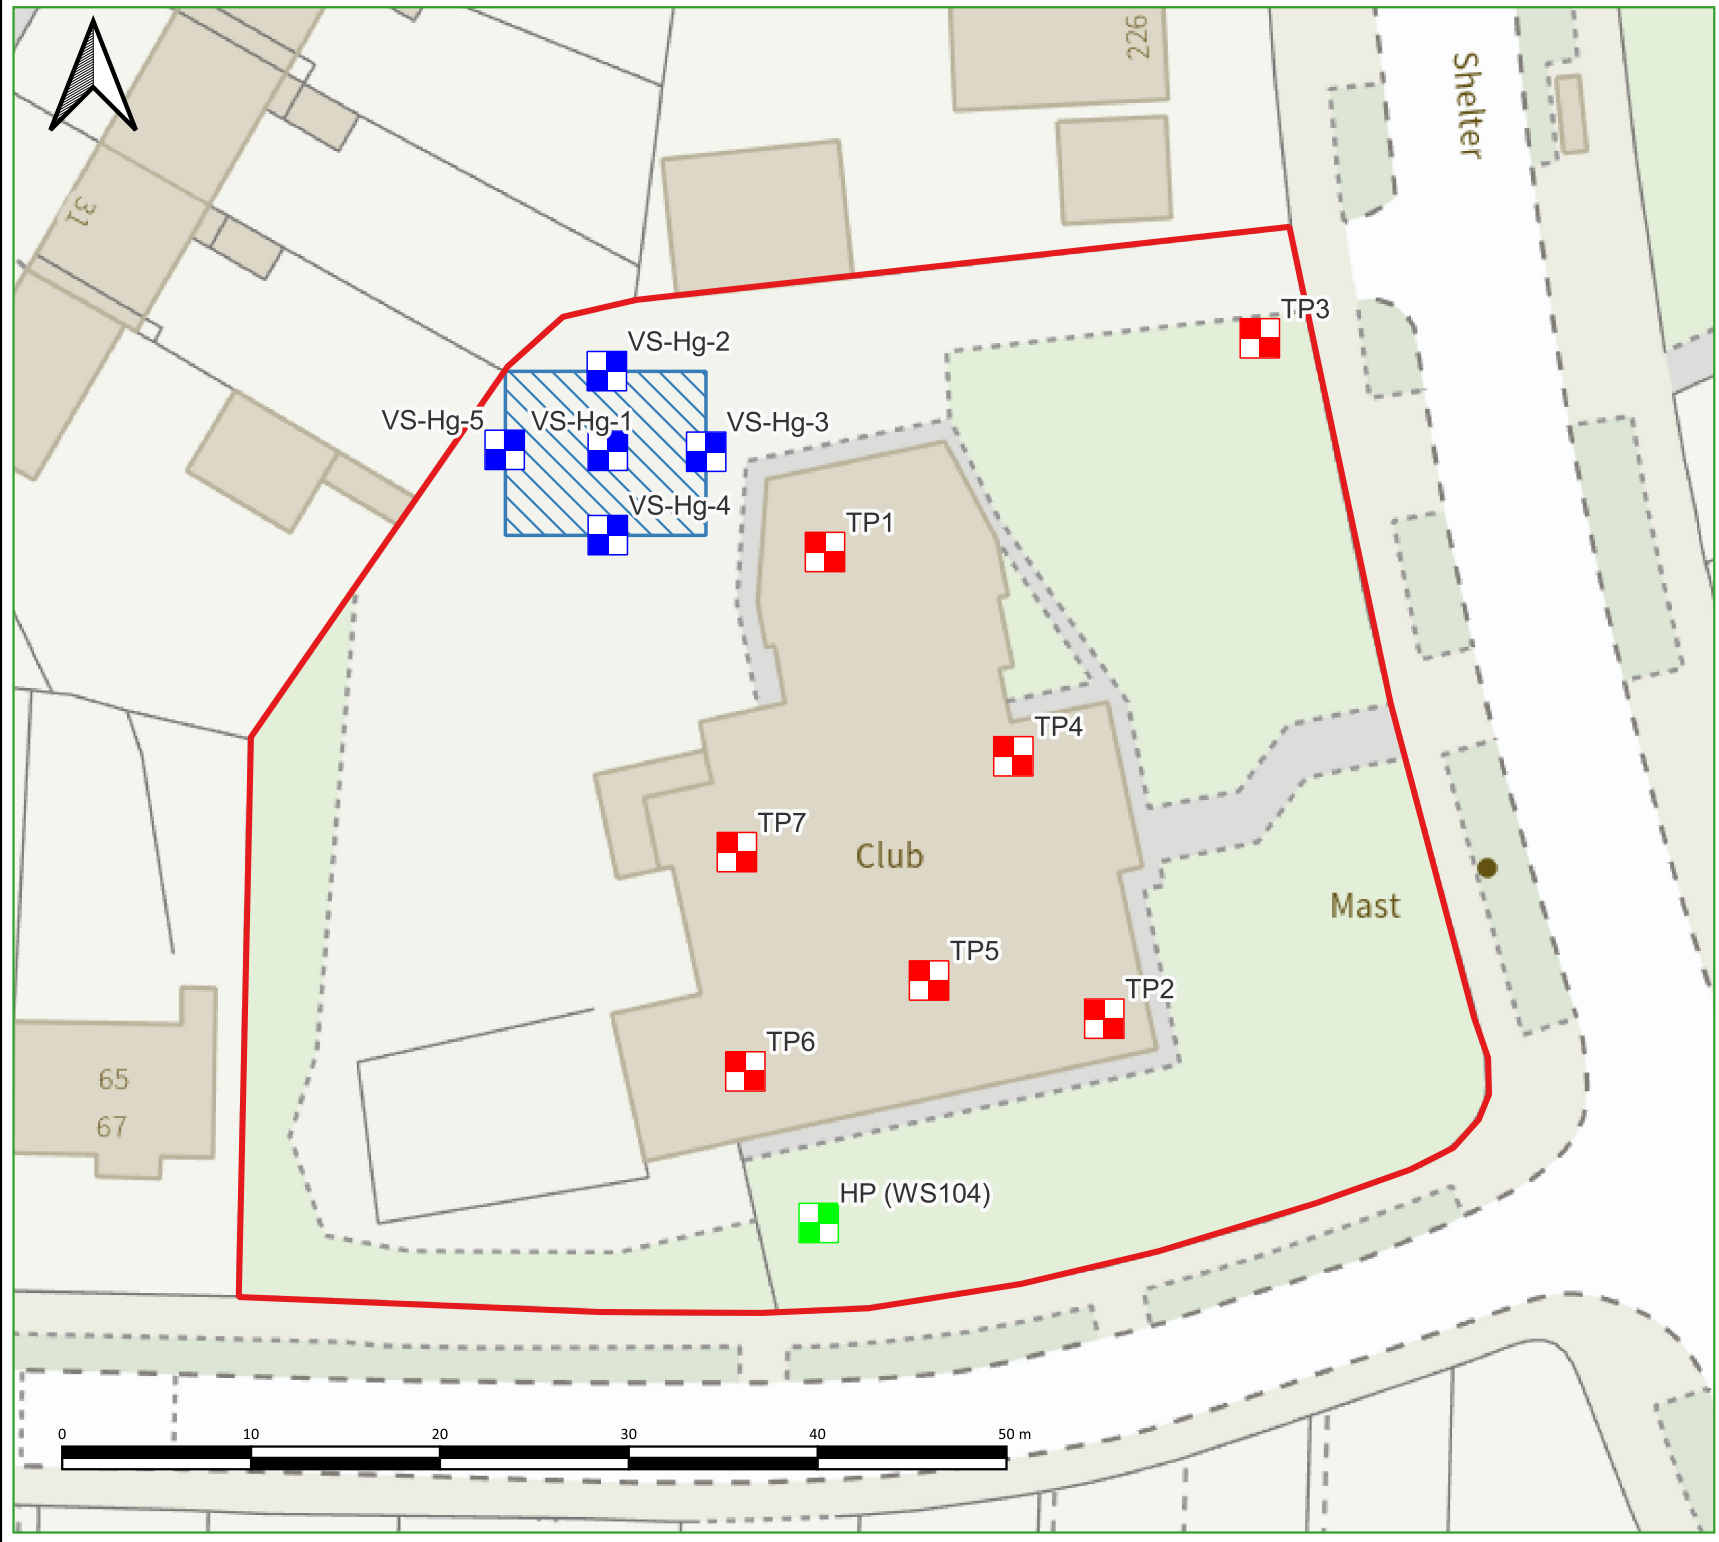
- Red Line Boundary
- Hotspot Removal (Undertaken by DHI)
- TP Locations
- Hotspot Validation Samples Speciated
- Mercury Sample
