## **GROUND INVESTIGATION REPORT**

**FOR  
EVERY STREET,  
MANCHESTER,  
M4 7DQ**

**PREPARED FOR  
McCAUL DEVELOPMENTS LIMITED**

**REPORT NO. 7741A  
JANUARY 2024**

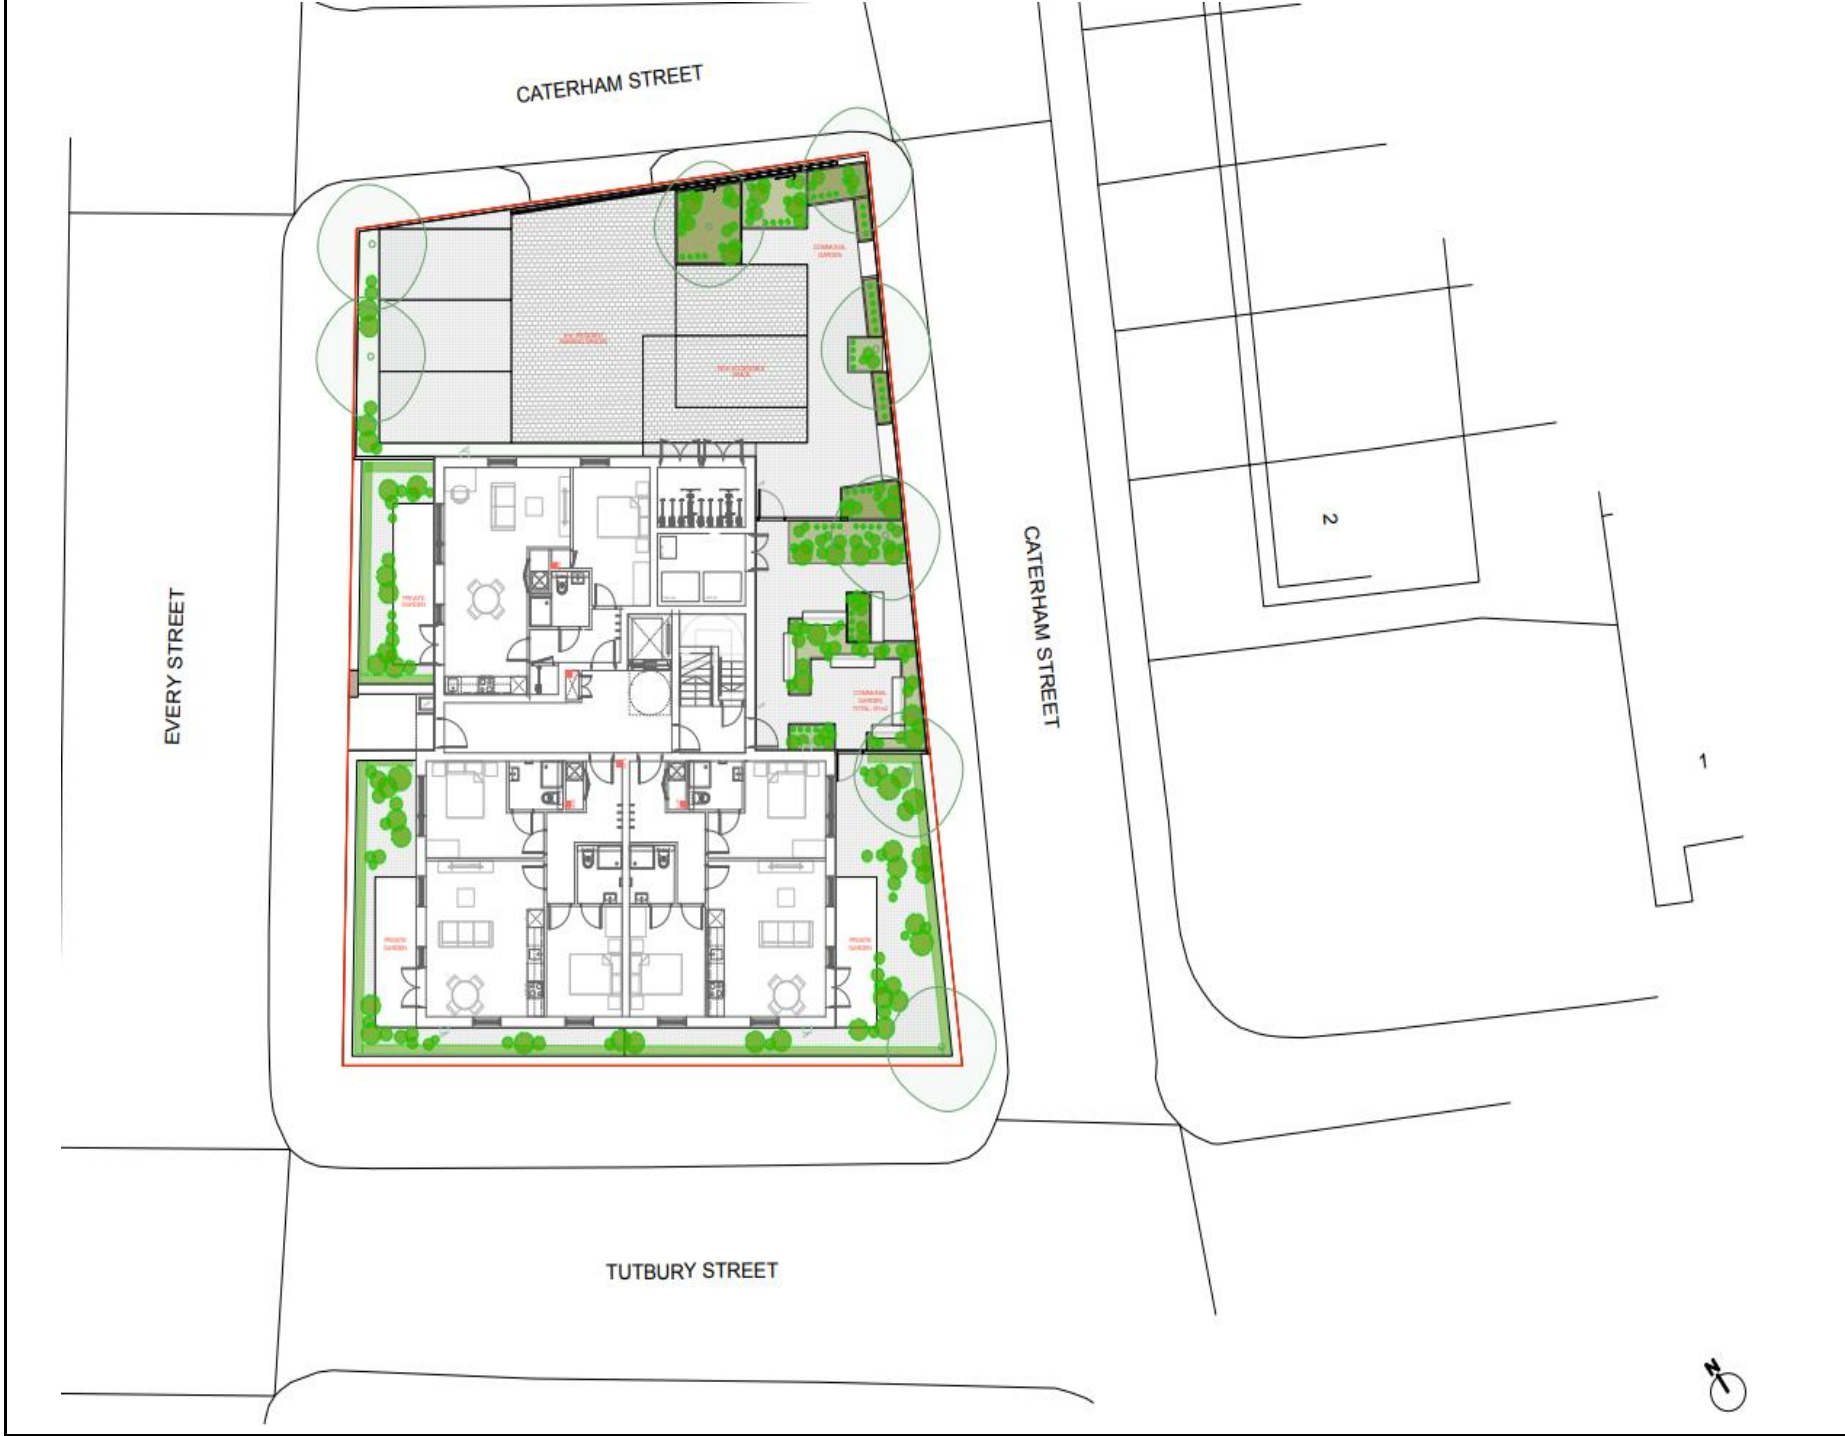
We understand that it is proposed to construct a block of residential units with communal and private garden areas and a residents car park, as shown on Figure 2. At the time of the investigation construction was underway at floor slab level.

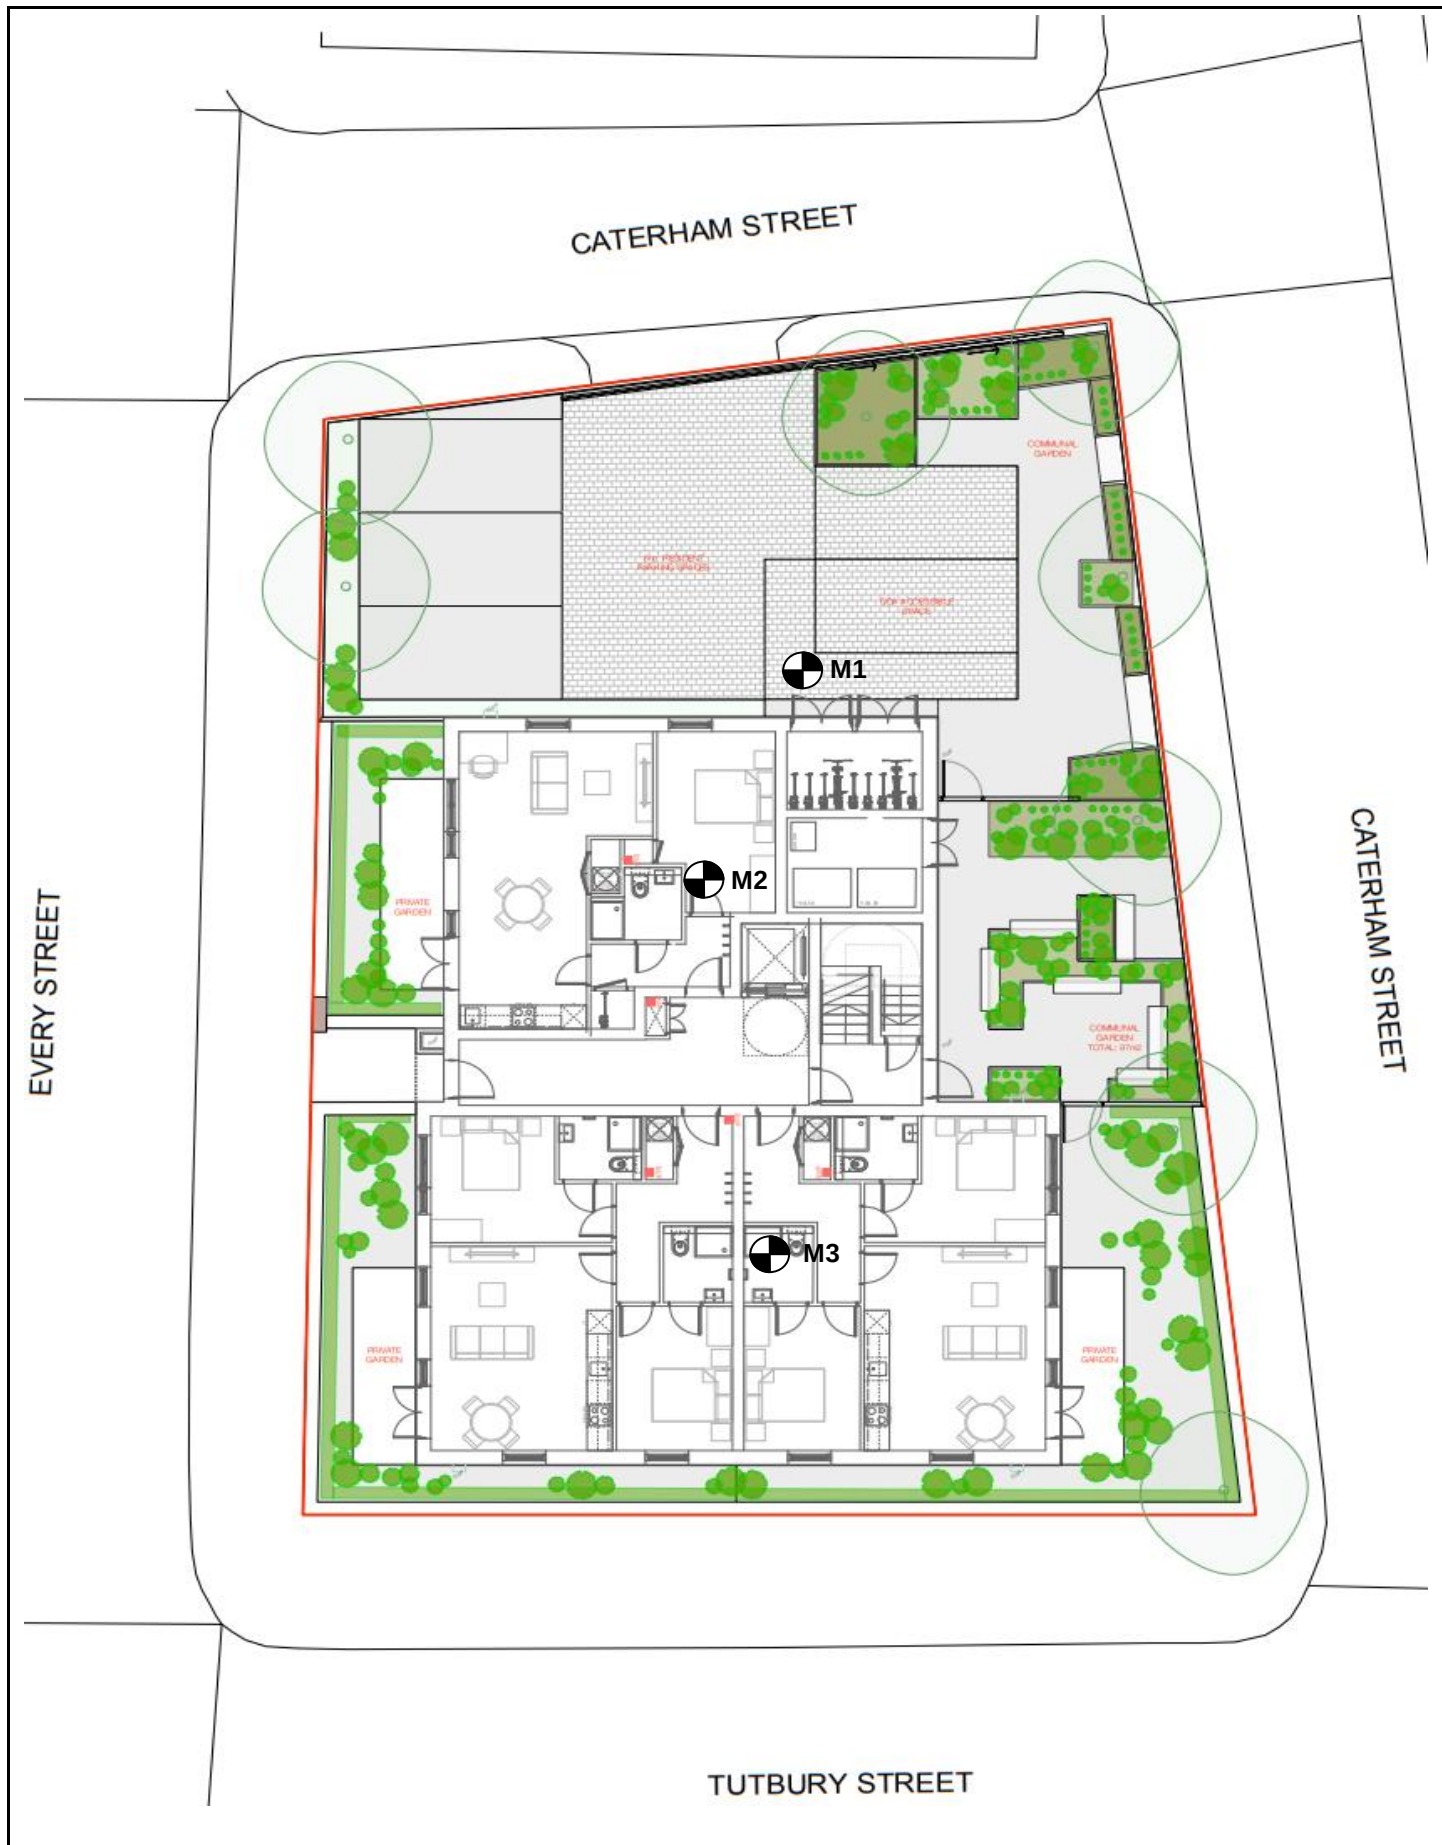
Three mini boreholes were put down to a depth of 3.00 metres using a Dart Mini Sampling Rig fitted with windowless sample tubes of 86mm to 64mm diameter at the positions determined and set out by Sub Surface North West Limited, as shown on Figure 3. The samples were subsequently logged in accordance with BS.5930:2015+A1:2020 and the resulting Mini Borehole Records are appended. On completion the mini boreholes were backfilled with gravel as no installations were required.
