**BEK Geo-Environmental Consulting**

Our Ref: BEK-240926-24072-SAAL

**Land at Wythenshawe Town FC, Timpson Road, Wythenshawe - Ground Gas Risk Assessment**

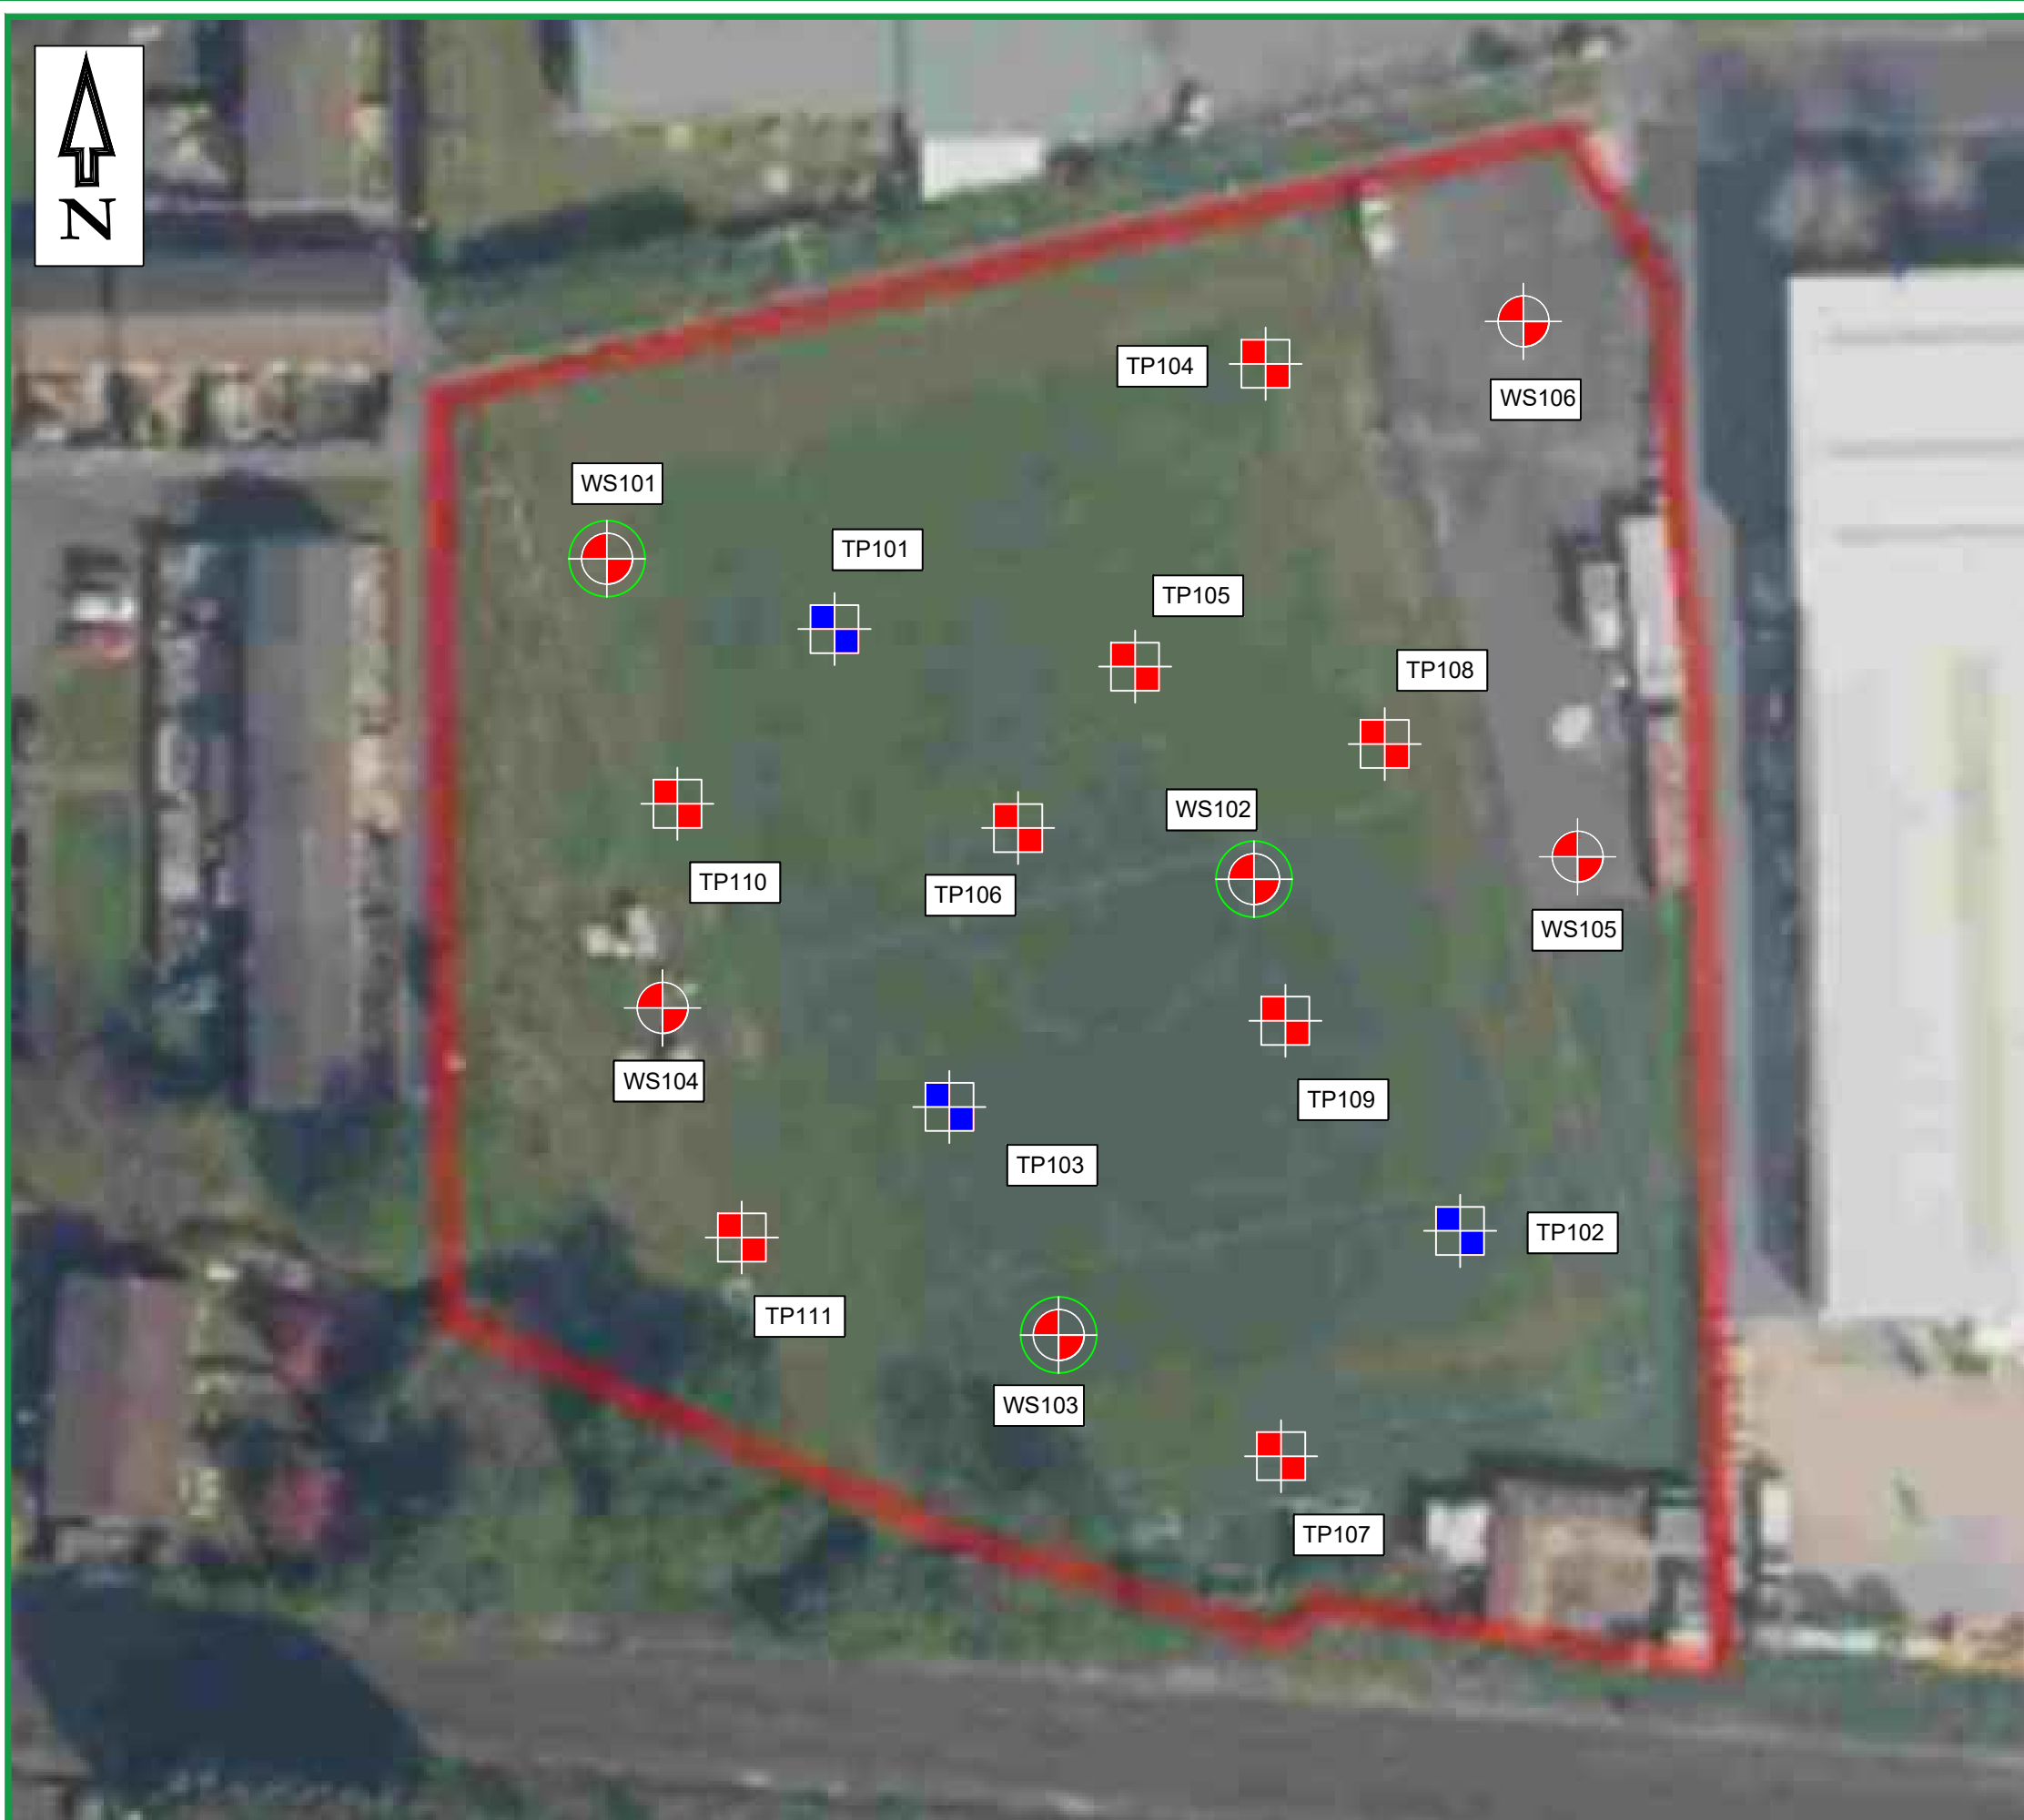
| DRAWING No.<br>24072-3 | REV.<br>- | | |

To characterise the shallow ground conditions and facilitate the assessment of potential risks associated with contamination and ground gas as well as provide geotechnical information to support foundation design, BEK carried out site investigation work which included the drilling of six window sample boreholes drilled to a maximum depth of 5.45 m bgl and the excavation of eleven trial pits. The exploratory locations are presented on BEK Drawing No 24072-3, a copy of which is presented in Annex C.
