**Site:** St James Park, Former MMU Campus, Didsbury  
**Plots:** 10 to 17  
**Date:** 17th October 2017  
**NHBC Ref:** Phase A – 517456

LK Consult (LKC) has been appointed by PJ Livesey Holdings Ltd to validate the depth of the garden capping layer laid down at the development at St James Park, Former MMU Campus, Didsbury.

This validation report concerns Plots 10 to 17. These plots consist of a rear garden and a small area of landscaping to the front.

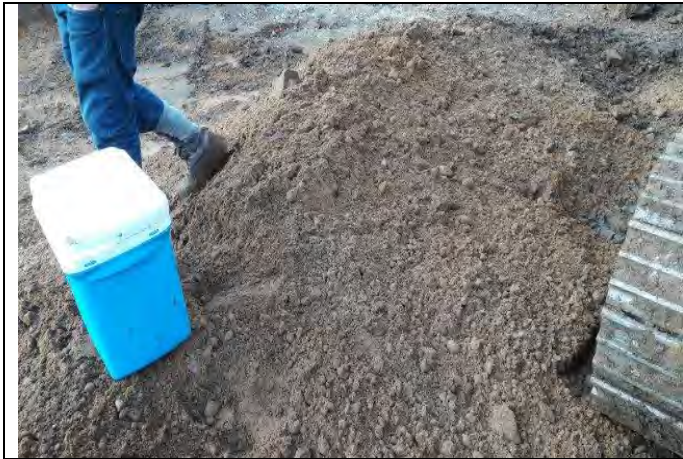
| | <p><b>Photograph 1:</b><br/>Stockpiles of site won sand excavated from site.</p> |

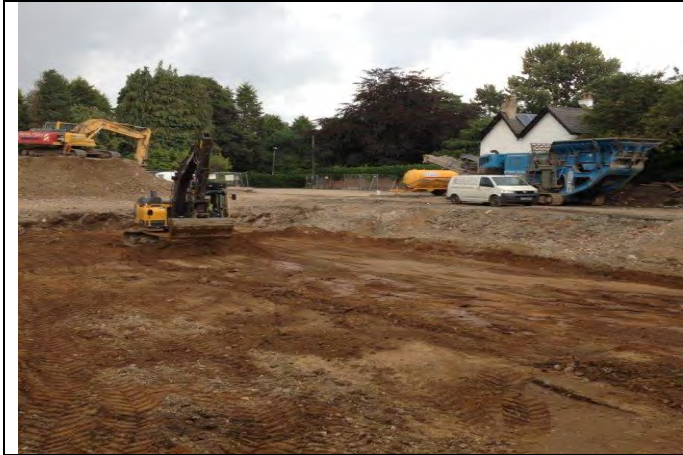
| | <p><b>Photograph 2:</b><br/>View of site won sand excavated from site.</p> |

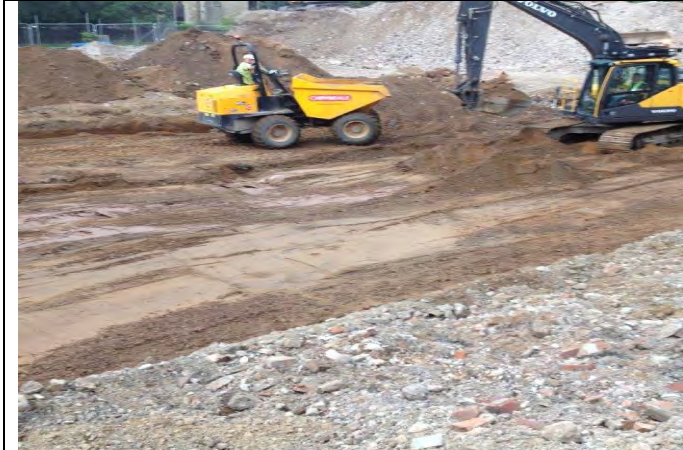
| | <p><b>Photograph 3:</b><br/>View of stockpiles to be reused as site won material on site.</p> |

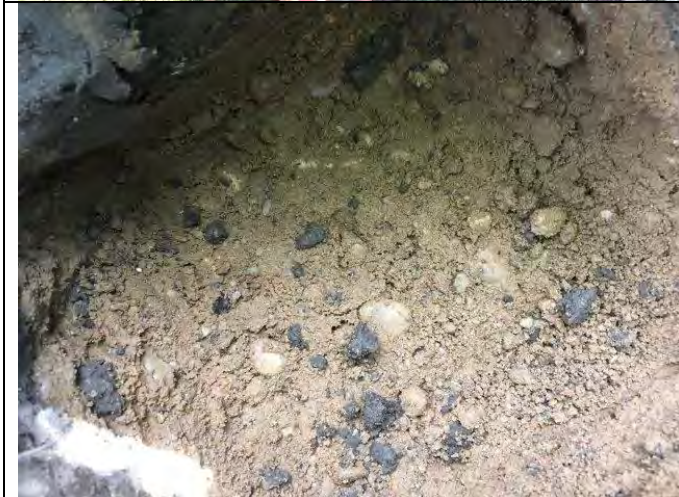
| Location | Topsoil Depth (mm) | Subsoil Depth (mm) | Membrane or 100mm MOT | Total Depth (mm) | Required Depth (mm) | Pass (✓) or Fail (x) |
|---|---|---|---|---|---|---|
| Plot 10 front | 250 | N/A | MOT | 350 | 300 | ✓ |

**Photograph 5:**  
View of soil in capping layer excavation in front garden of Plot 10 with MOT break layer visible.

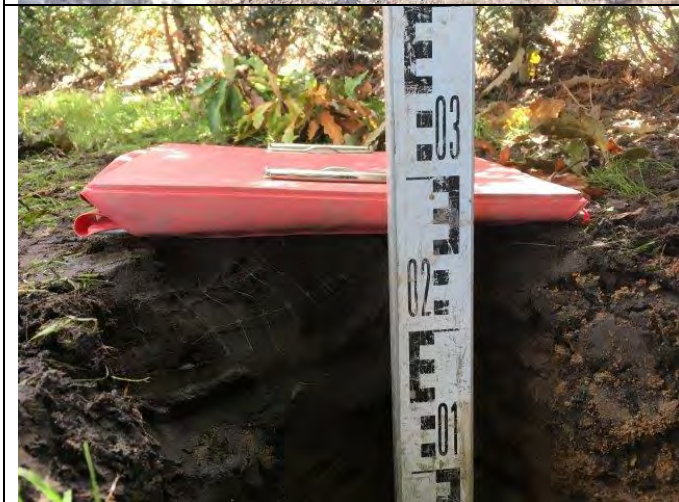
**Photograph 6:**  
Depth measurement in front garden of Plot 10.

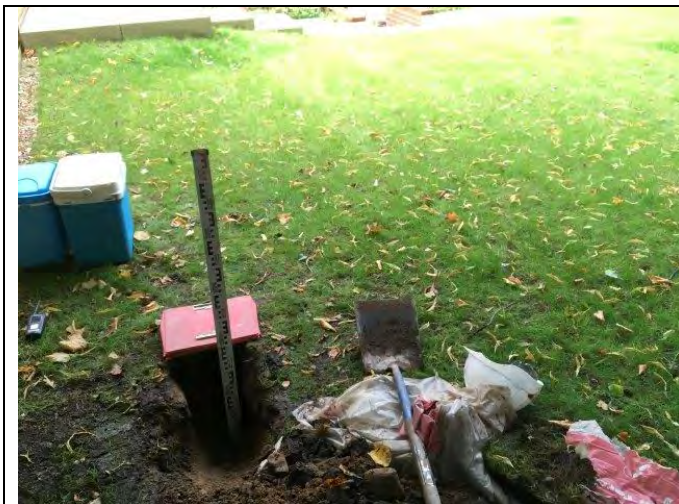
**Photograph 7:**

View of the upper level of the rear garden of Plot 10. Northern extent of photo shows the lower level (fully paved).

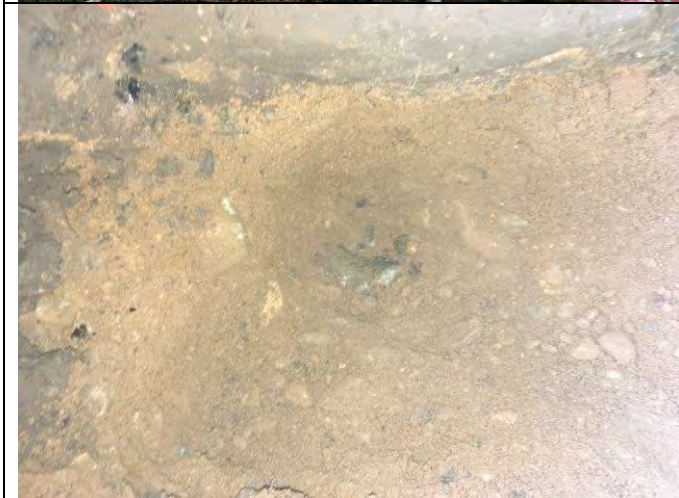
**Photograph 8:**

| Location | Topsoil Depth (mm) | Subsoil Depth (mm) | Membrane or 100mm MOT | Total Depth (mm) | Required Depth (mm) | Pass (✓) or Fail (x) |
|---|---|---|---|---|---|---|
| Plot 10 rear | 150 | 250 | Membrane | 400 | 450 | x |

View of soil in capping layer excavation in rear garden of Plot 10 with geotextile membrane visible.

Therefore, given the above, LKC consider the reduced capping layer provided to the rear of Plots 10 to 17 to be acceptable.

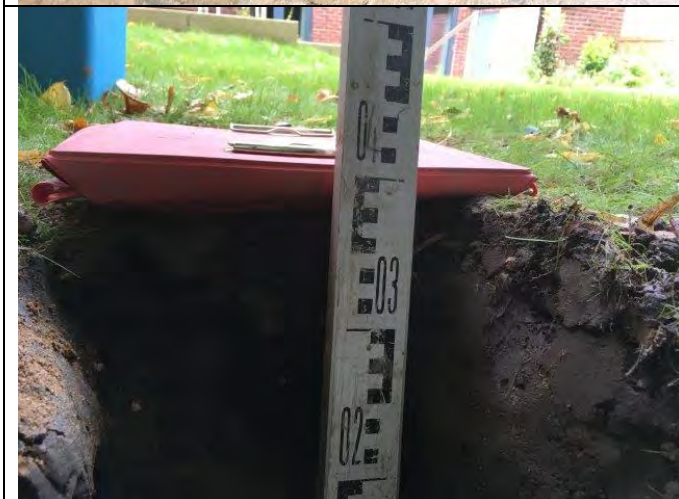
**Photograph 9:**

Depth measurement in rear garden of Plot 10.

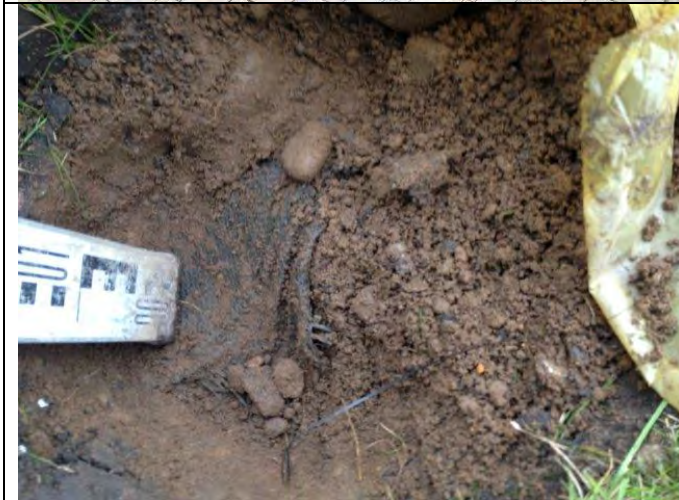
| Location | Topsoil Depth (mm) | Subsoil Depth (mm) | Membrane or 100mm MOT | Total Depth (mm) | Required Depth (mm) | Pass (✓) or Fail (x) |
|---|---|---|---|---|---|---|
| Plot 11 front | 250 | N/A | Membrane and MOT | 350 | 300 | ✓ |

**Photograph 11:**  
View of soil in capping layer excavation in front garden of Plot 11 with geotextile membrane visible.

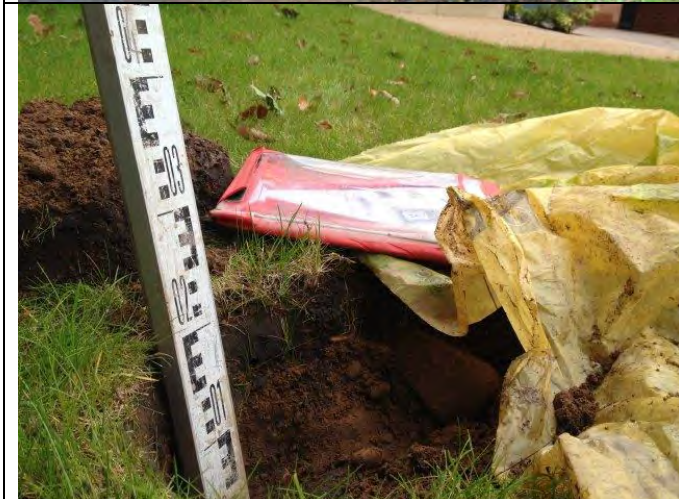
**Photograph 12:**  
Depth measurement in front garden of Plot 11.

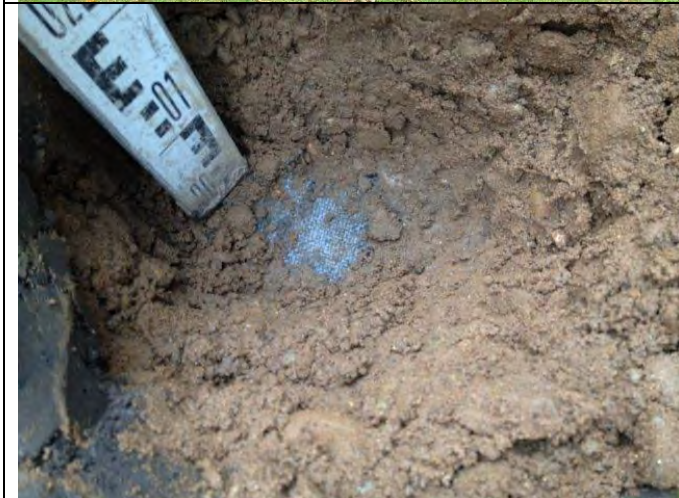
**Photograph 14:**

| Location | Topsoil Depth (mm) | Subsoil Depth (mm) | Membrane or 100mm MOT | Total Depth (mm) | Required Depth (mm) | Pass (✓) or Fail (x) |
|---|---|---|---|---|---|---|
| Plot 11 rear | 150 | 150 | Membrane | 300 | 450 | x |

View of soil in capping layer excavation in rear garden of Plot 11 with geotextile membrane visible.

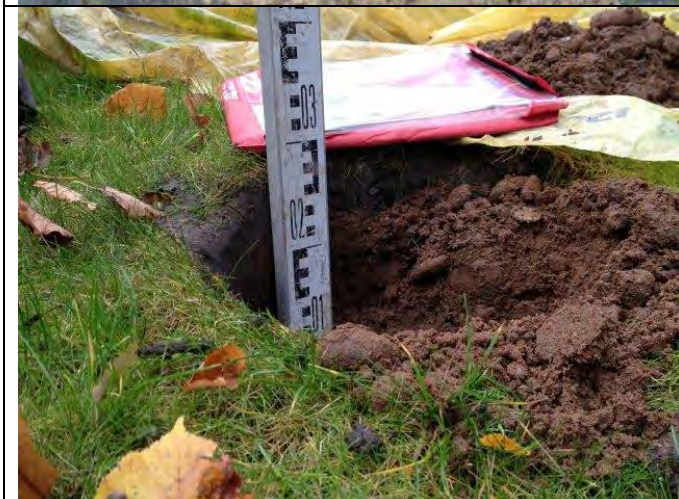
**Photograph 15:**

Depth measurement in rear garden of Plot 11.

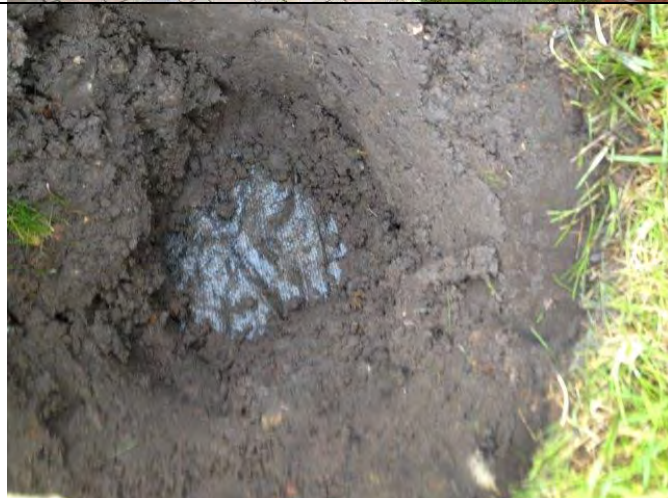
| Location | Topsoil Depth (mm) | Subsoil Depth (mm) | Membrane or 100mm MOT | Total Depth (mm) | Required Depth (mm) | Pass (✓) or Fail (x) |
|---|---|---|---|---|---|---|
| Plot 12 front | 350 | N/A | MOT | 450 | 300 | ✓ |

**Photograph 17:**  
View of soil in capping layer excavation in front garden of Plot 12 with geotextile membrane visible.

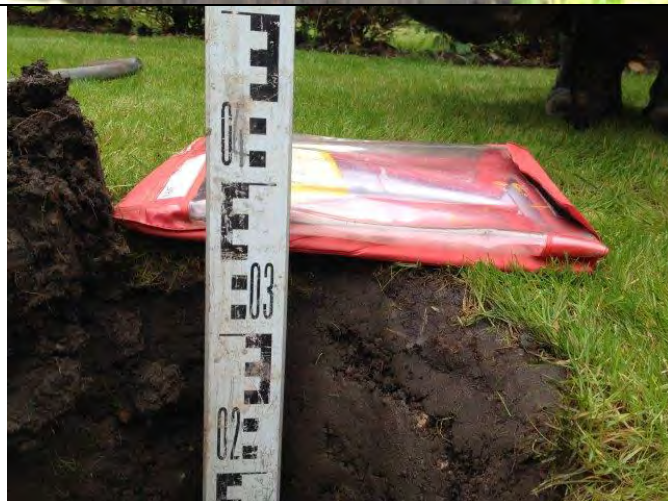
**Photograph 18:**  
Depth measurement in front garden of Plot 12.

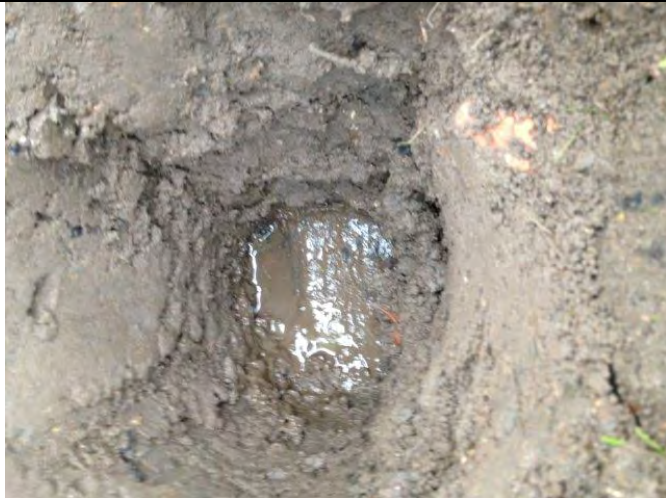
**Photograph 20:**

| Location | Topsoil Depth (mm) | Subsoil Depth (mm) | Membrane or 100mm MOT | Total Depth (mm) | Required Depth (mm) | Pass (✓) or Fail (x) |
|---|---|---|---|---|---|---|
| Plot 12 rear | 150 | 300 | Membrane | 450 | 450 | ✓ |

View of soil in capping layer excavation in rear garden of Plot 12 with geotextile membrane visible.

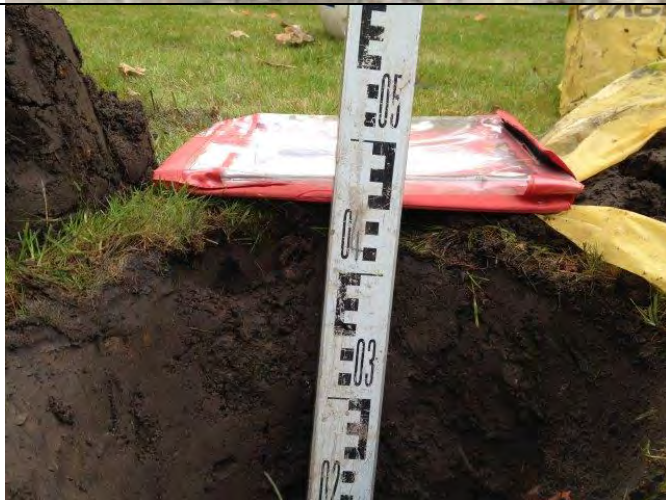
**Photograph 21:**

Depth measurement in rear garden of Plot 12.

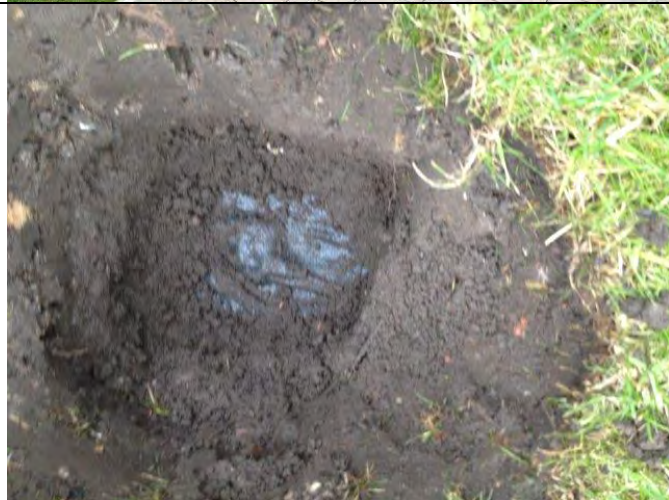
| Location | Topsoil Depth (mm) | Subsoil Depth (mm) | Membrane or 100mm MOT | Total Depth (mm) | Required Depth (mm) | Pass (✓) or Fail (x) |
|---|---|---|---|---|---|---|
| Plot 13 front | 300 | N/A | MOT | 400 | 300 | ✓ |

**Photograph 23:**  
View of soil in capping layer excavation in front garden of Plot 13 with geotextile membrane visible.

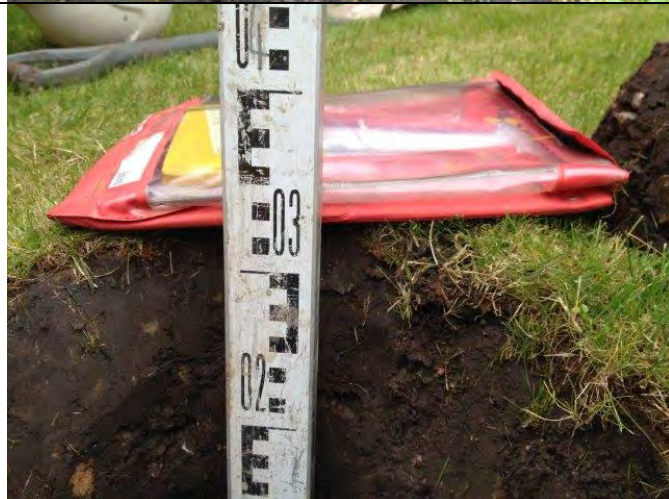
**Photograph 24:**  
Depth measurement in front garden of Plot 13.

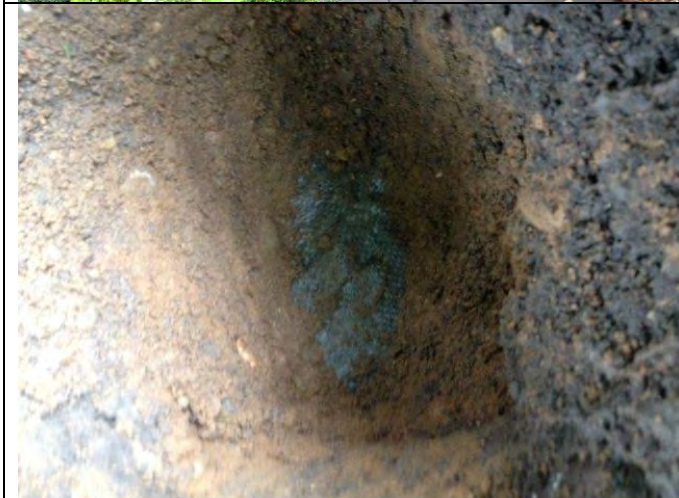
**Photograph 26:**

| Location | Topsoil Depth (mm) | Subsoil Depth (mm) | Membrane or 100mm MOT | Total Depth (mm) | Required Depth (mm) | Pass (✓) or Fail (x) |
|---|---|---|---|---|---|---|
| Plot 13 rear | 150 | 250 | Membrane | 400 | 450 | x |

View of soil in capping layer excavation in rear garden of Plot 13 with geotextile membrane visible.

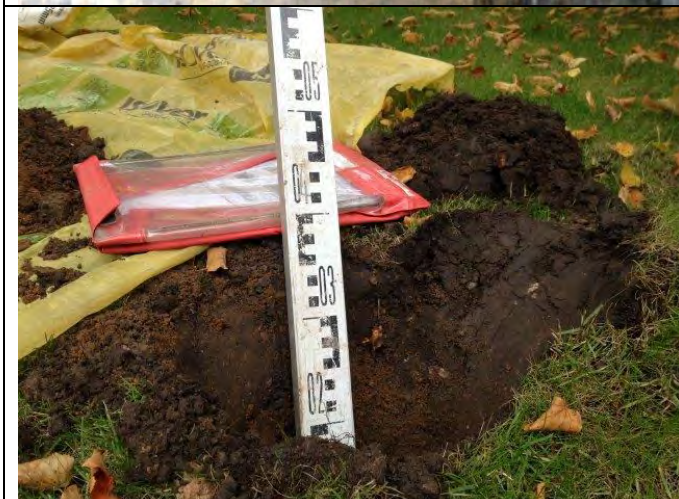
**Photograph 27:**

Depth measurement in rear garden of Plot 13.

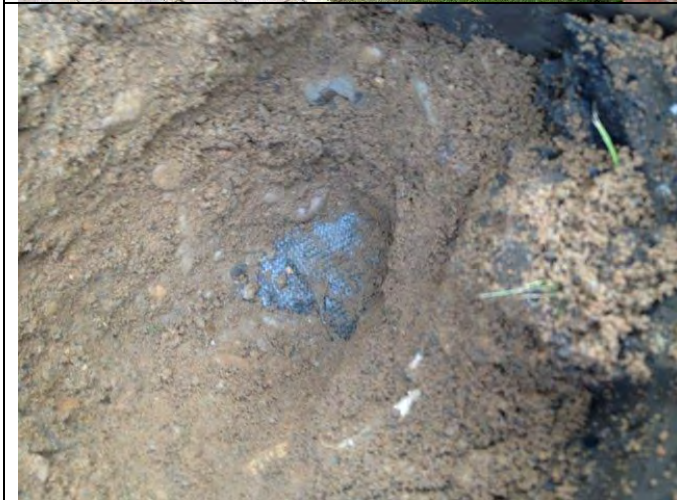
| Location | Topsoil Depth (mm) | Subsoil Depth (mm) | Membrane or 100mm MOT | Total Depth (mm) | Required Depth (mm) | Pass (✓) or Fail (x) |
|---|---|---|---|---|---|---|
| Plot 14 front | 400 | N/A | Membrane | 400 | 300 | ✓ |

**Photograph 29:**  
View of soil in capping layer excavation in front garden of Plot 14 with geotextile membrane visible.

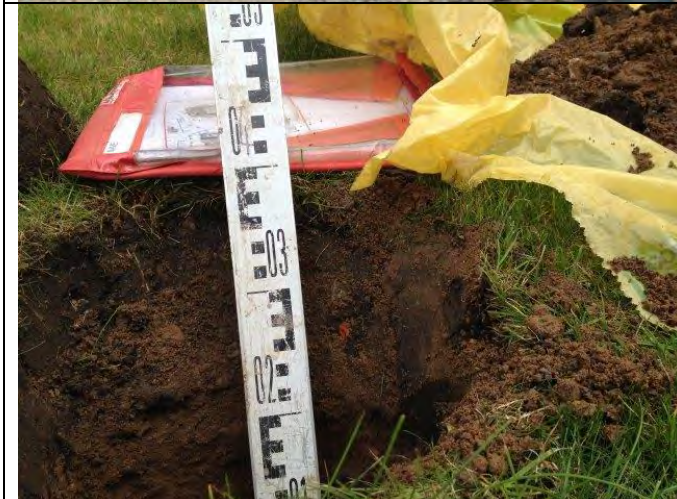
**Photograph 30:**  
Depth measurement in front garden of Plot 14.

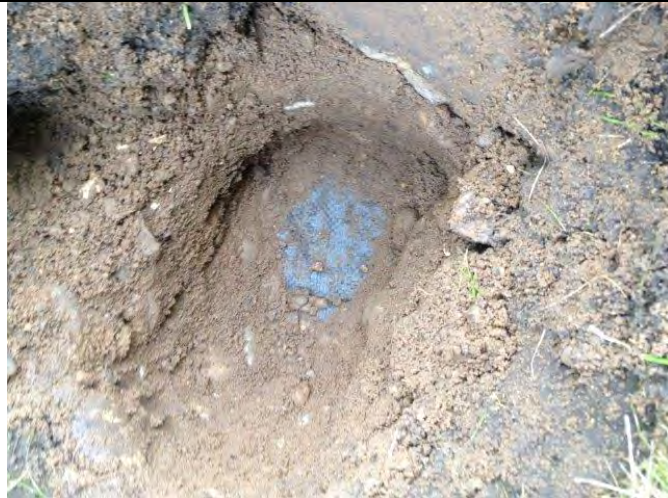
**Photograph 32:**

| Location | Topsoil Depth (mm) | Subsoil Depth (mm) | Membrane or 100mm MOT | Total Depth (mm) | Required Depth (mm) | Pass (✓) or Fail (x) |
|---|---|---|---|---|---|---|
| Plot 14 rear | 150 | 150 | Membrane | 300 | 450 | x |

View of soil in capping layer excavation in rear garden of Plot 14 with geotextile membrane visible.

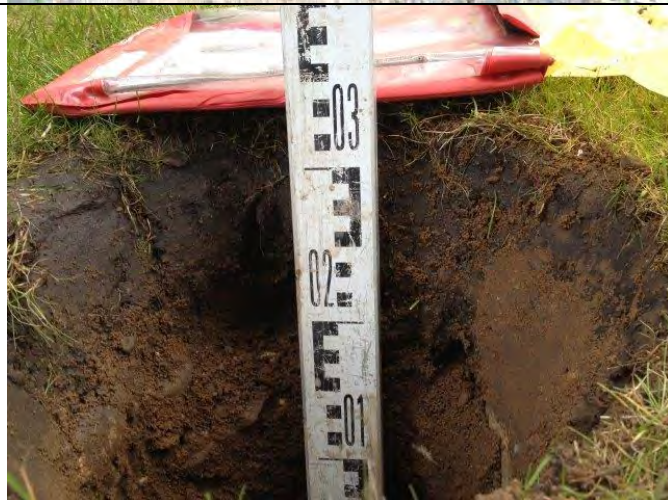
**Photograph 33:**

Depth measurement in rear garden of Plot 14.

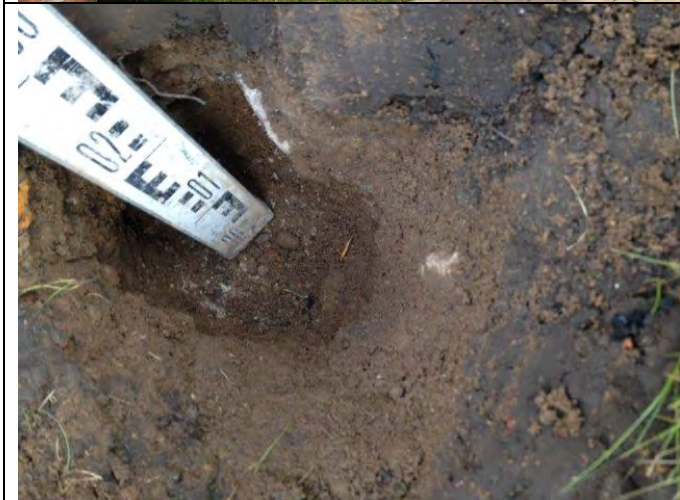
| Location | Topsoil Depth (mm) | Subsoil Depth (mm) | Membrane or 100mm MOT | Total Depth (mm) | Required Depth (mm) | Pass (✓) or Fail (x) |
|---|---|---|---|---|---|---|
| Plot 15 front | 450 | N/A | Membrane | 450 | 300 | ✓ |

**Photograph 35:**  
View of soil in capping layer excavation in front garden of Plot 15 with geotextile membrane visible.

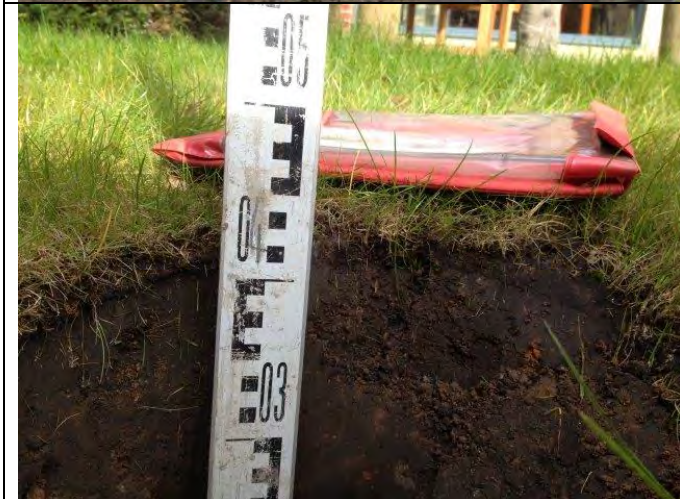
**Photograph 36:**  
Depth measurement in front garden of Plot 15.

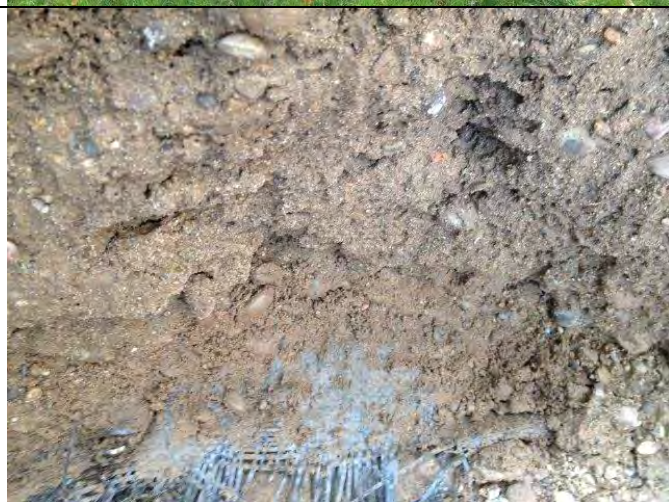
**Photograph 38:**

| Location | Topsoil Depth (mm) | Subsoil Depth (mm) | Membrane or 100mm MOT | Total Depth (mm) | Required Depth (mm) | Pass (✓) or Fail (x) |
|---|---|---|---|---|---|---|
| Plot 15 rear | 150 | 300 | Membrane | 450 | 450 | ✓ |

View of soil in capping layer excavation in rear garden of Plot 15 with geotextile membrane visible.

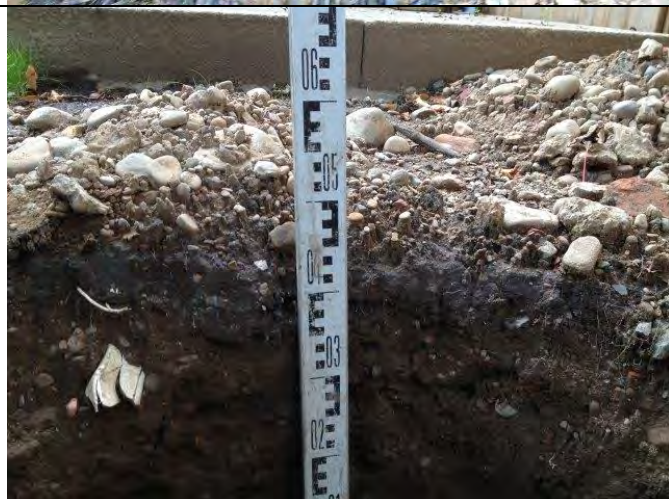
**Photograph 39:**

Depth measurement in rear garden of Plot 15.

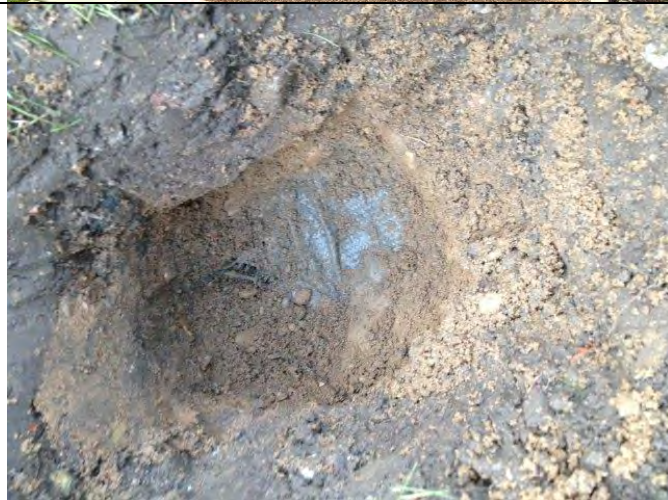
| Location | Topsoil Depth (mm) | Subsoil Depth (mm) | Membrane or 100mm MOT | Total Depth (mm) | Required Depth (mm) | Pass (✓) or Fail (x) |
|---|---|---|---|---|---|---|
| Plot 16 front | 350 | N/A | Membrane | 350 | 300 | ✓ |

**Photograph 41:**  
View of soil in capping layer excavation in front garden of Plot 16 with geotextile membrane visible.

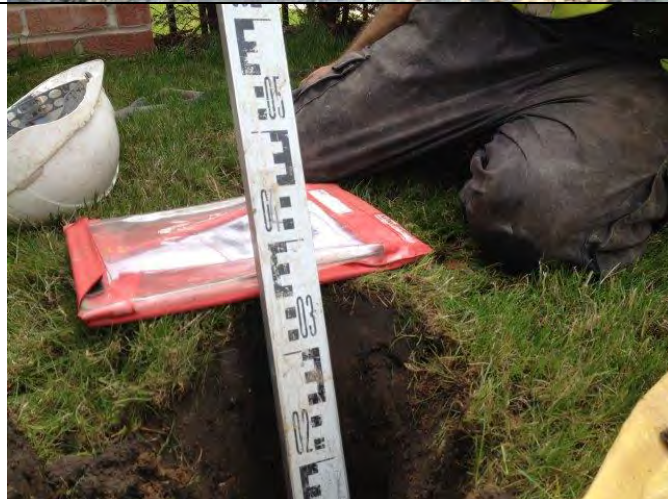
**Photograph 42:**  
Depth measurement in front garden of Plot 16.

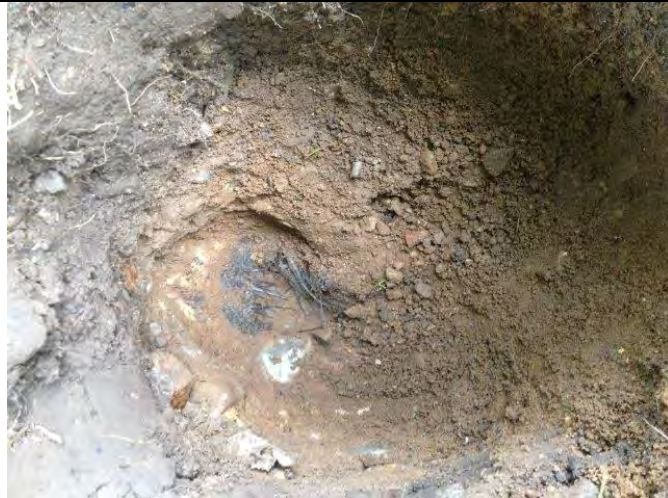
**Photograph 44:**

| Location | Topsoil Depth (mm) | Subsoil Depth (mm) | Membrane or 100mm MOT | Total Depth (mm) | Required Depth (mm) | Pass (✓) or Fail (x) |
|---|---|---|---|---|---|---|
| Plot 16 rear | 150 | 200 | Membrane | 350 | 450 | x |

View of soil in capping layer excavation in rear garden of Plot 16 with geotextile membrane visible.

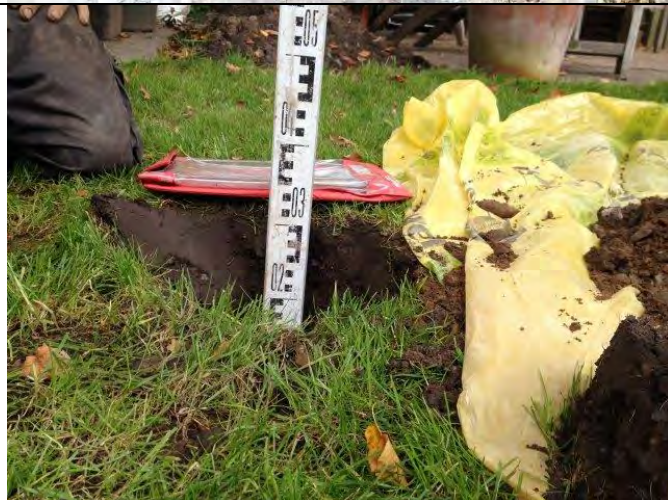
**Photograph 45:**

Depth measurement in rear garden of Plot 16.

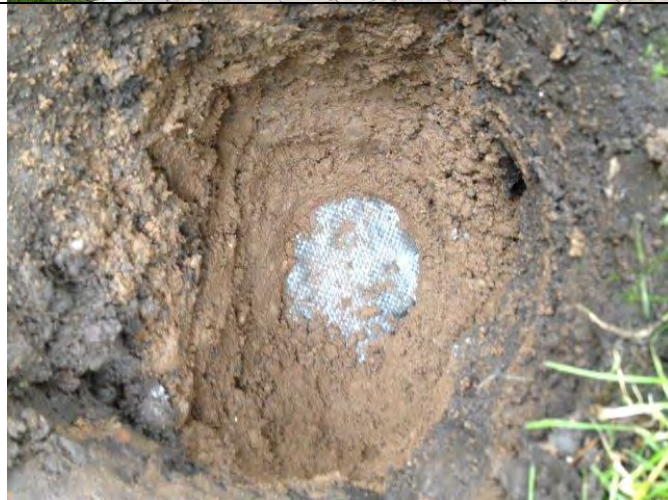
| Location | Topsoil Depth (mm) | Subsoil Depth (mm) | Membrane or 100mm MOT | Total Depth (mm) | Required Depth (mm) | Pass (✓) or Fail (x) |
|---|---|---|---|---|---|---|
| Plot 17 front | 350 | N/A | Membrane | 350 | 300 | ✓ |

**Photograph 47:**  
View of soil in capping layer excavation in front garden of Plot 17 with geotextile membrane visible.

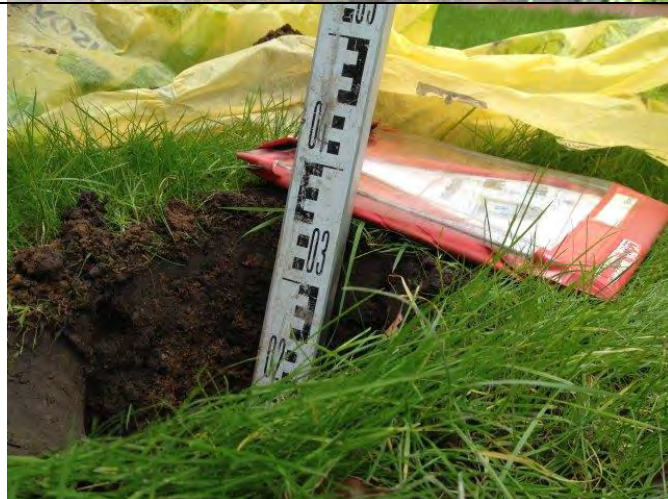
**Photograph 48:**  
Depth measurement in front garden of Plot 17.

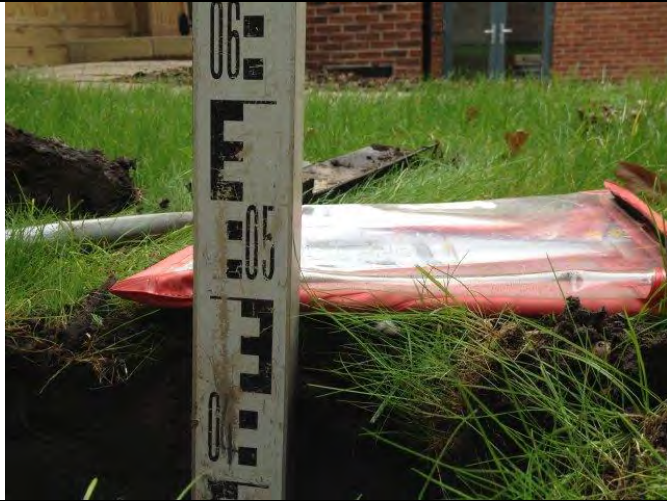
**Photograph 50:**

| Location | Topsoil Depth (mm) | Subsoil Depth (mm) | Membrane or 100mm MOT | Total Depth (mm) | Required Depth (mm) | Pass (✓) or Fail (x) |
|---|---|---|---|---|---|---|
| Plot 17 rear | 200 | 300 | Membrane | 500 | 450 | ✓ |

View of soil in capping layer excavation in rear garden of Plot 17 with geotextile membrane visible.

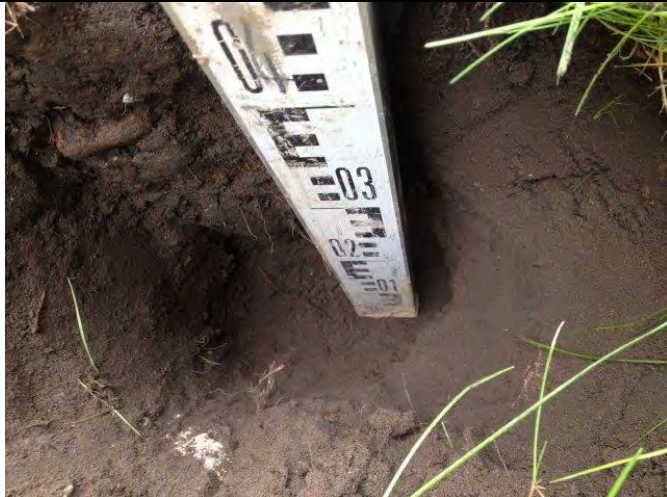
**Photograph 51:**

Depth measurement in rear garden of Plot 17.

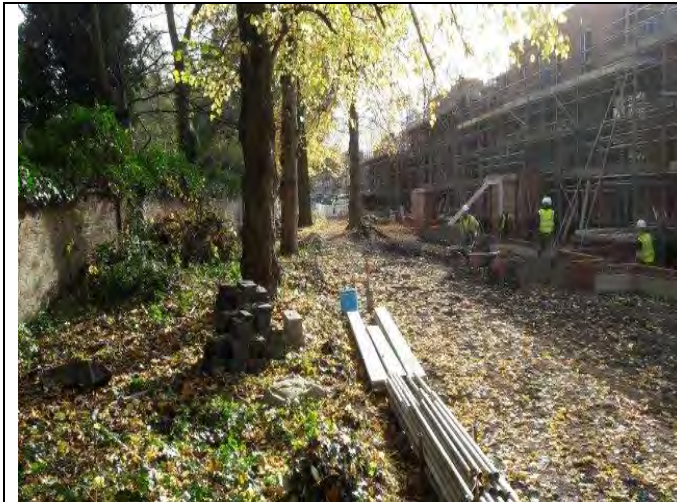
**Photograph 52:**

The rear gardens of Plots 10 to 17 have a stepped profile with the lower area flagged and the upper area grassed. The minimum 450mm capping layer was not achieved in the rear gardens of Plots 10, 11, 13, 14 and 16. The rear gardens of Plots 10 to 17 include mature trees towards the east which are part of the Didsbury St James Conservation Area. These

trees are protected by Tree Preservation Orders (TPOs) which limits the ground work which can be carried out within the tree's Root Protection Area (RPA).

Therefore, validation pits in the upper area of the rear gardens had limited depths due to the TPOs present in this area of the site.

View along the upper levels of the rear gardens of Plots 10 to 17 prior to remediation. Mature trees protected under TPOs are present in view.

To add a level of comfort, LKC undertook soil sampling from the made ground before the clean environmental cover system was installed in the upper areas of the rears of Plots 10 to 17. LKC attended site on 1<sup>st</sup> November 2016 and duly collected 5no. samples of the existing soil from the upper areas behind Plots 10 to 17 (ref P10T-P15T). Selected photographs of the rear gardens prior to remediation are presented in Appendix E

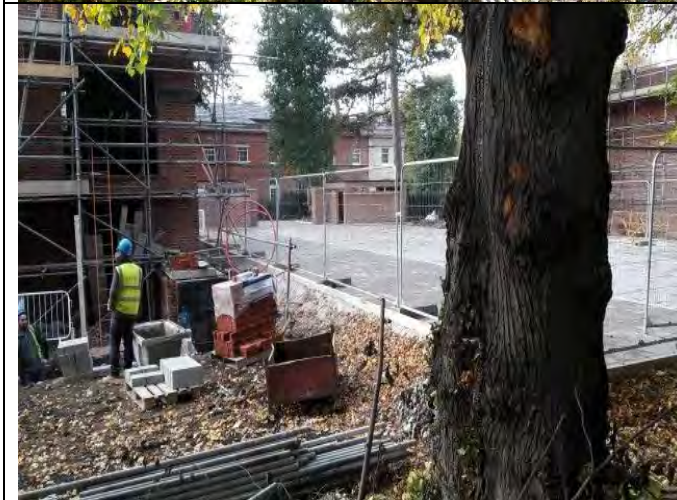
**Photograph 53:**

View of the upper level of the rear garden of Plot 10 with a mature tree under a TPO present in view.

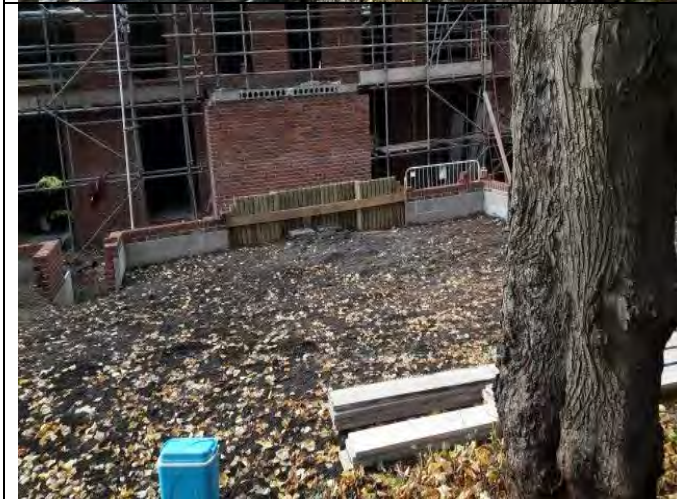
**Photograph 54:**

View of the upper level of the rear garden of Plot 11 with a mature tree under a TPO present in view.

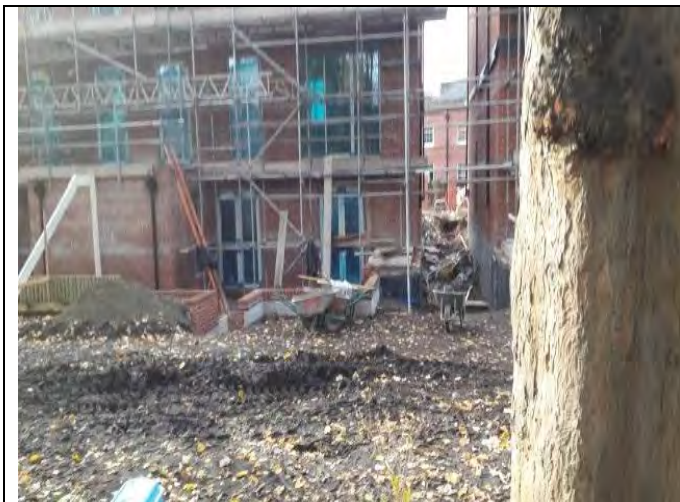
**Photograph 55:**

View of the upper level of the rear garden of Plot 12 with a mature tree under a TPO present in view.

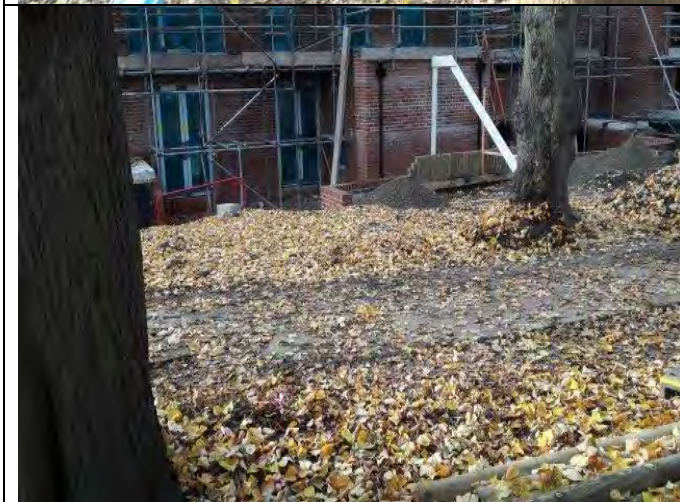
**Photograph 56:**

View of the upper levels of the rear gardens of Plots 13 and 14 with several mature trees under TPOs present in view.

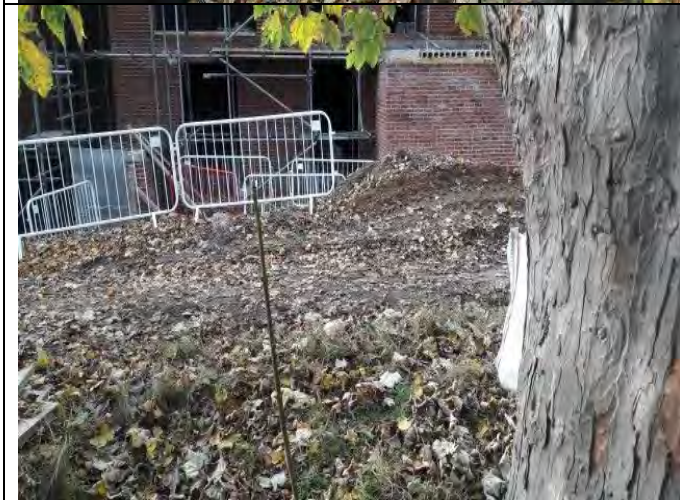
**Photograph 57:**

View of the upper level of the rear garden of Plot 15 with a mature tree under a TPO present in view.
