## Princedom Street, Manchester

### Remedial Strategy Report

For: John Southworth Builders Ltd

| <b>Report Reference:</b> | | <b>4048-01</b> |

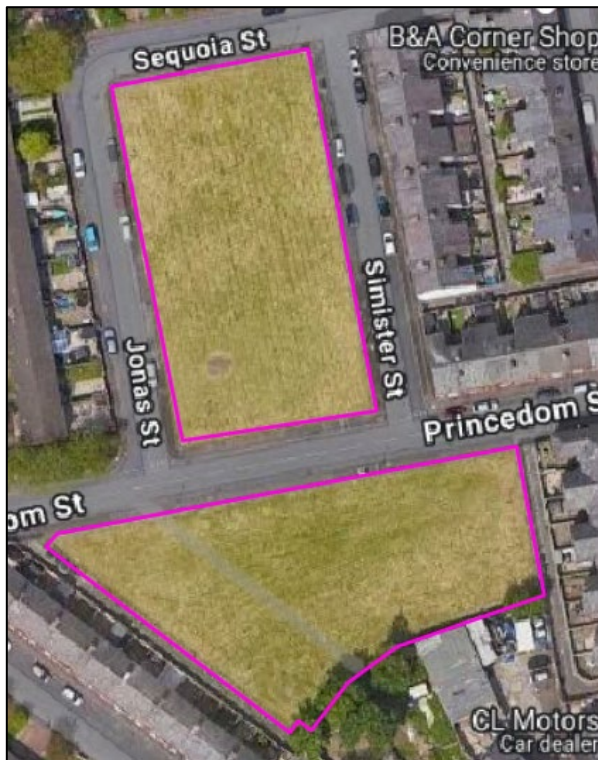
Figure 1: Aerial image of the site dated September 2024.

The site currently comprises 2 No. separate parcels of grassed, vacant land, bisected by Princedom Street. The southern site section is accessed via Princedom Street and the northern site section via Jonas Street. The northern site section is bound by Sequoia Street to the north, Jonas Street to the west, Simister Street to the east and Princedom Street to the south. The southern site section is bound by Princedom Street to the north and residential properties to the east, south and west. An aerial photo of the site is included below:

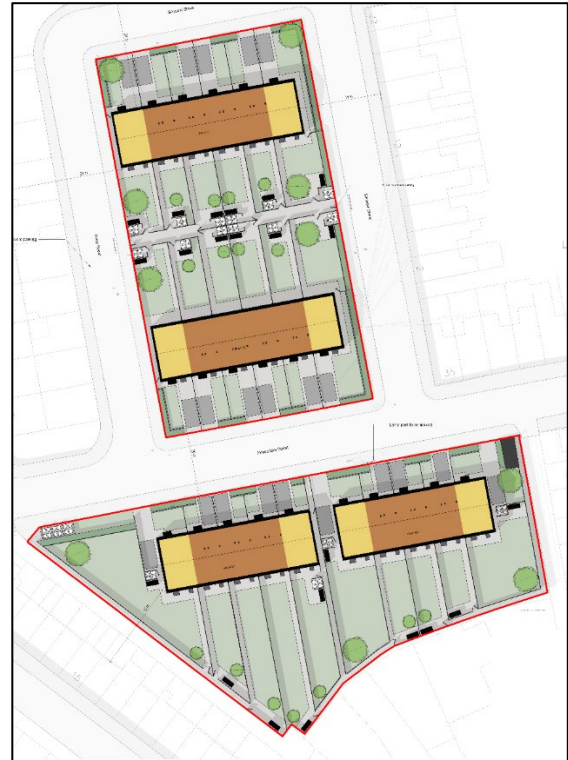
Figure 2: Extract of the Proposed Site Layout (July 2023).

This Remedial Strategy Report has been undertaken to determine the remedial requirements of the site based upon the existing site investigation works. It is the Client's intention to develop the site into a low-rise residential development comprising 22 No. dwellings with associated private gardens, soft landscaping and access roads. The proposed development plan is contained in Appendix 2. An extract of the proposed development plan is on Figure 2.

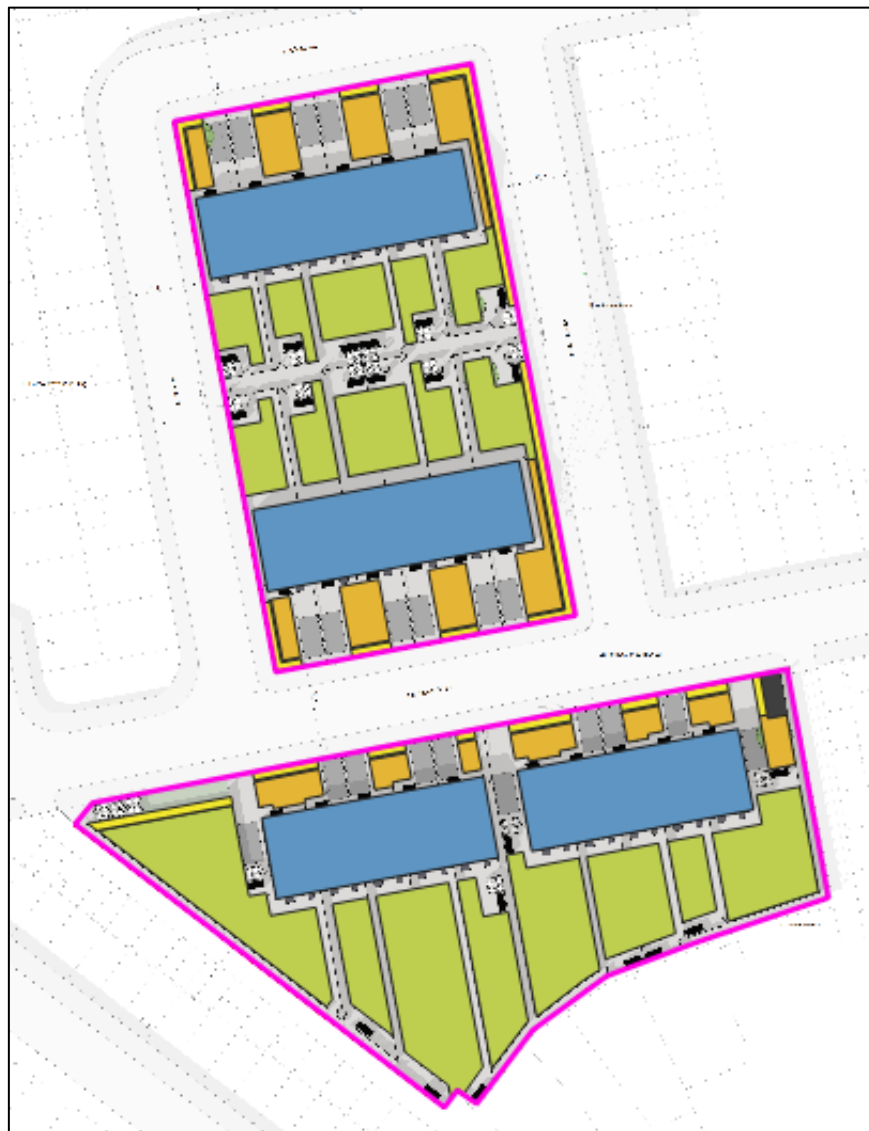
Figure 3: Extract of SI-02 Landscaping Plan (September 2024). Blue = proposed plots, green = proposed private rear gardens, orange = proposed front gardens, yellow = proposed soft landscaping.

The following Landscaping Plan shows the proposed plots (blue), private rear gardens (green), private front gardens (orange) and soft landscaping (yellow). The below remedial recommendations will refer to the landscaping designations detailed in the below extract.

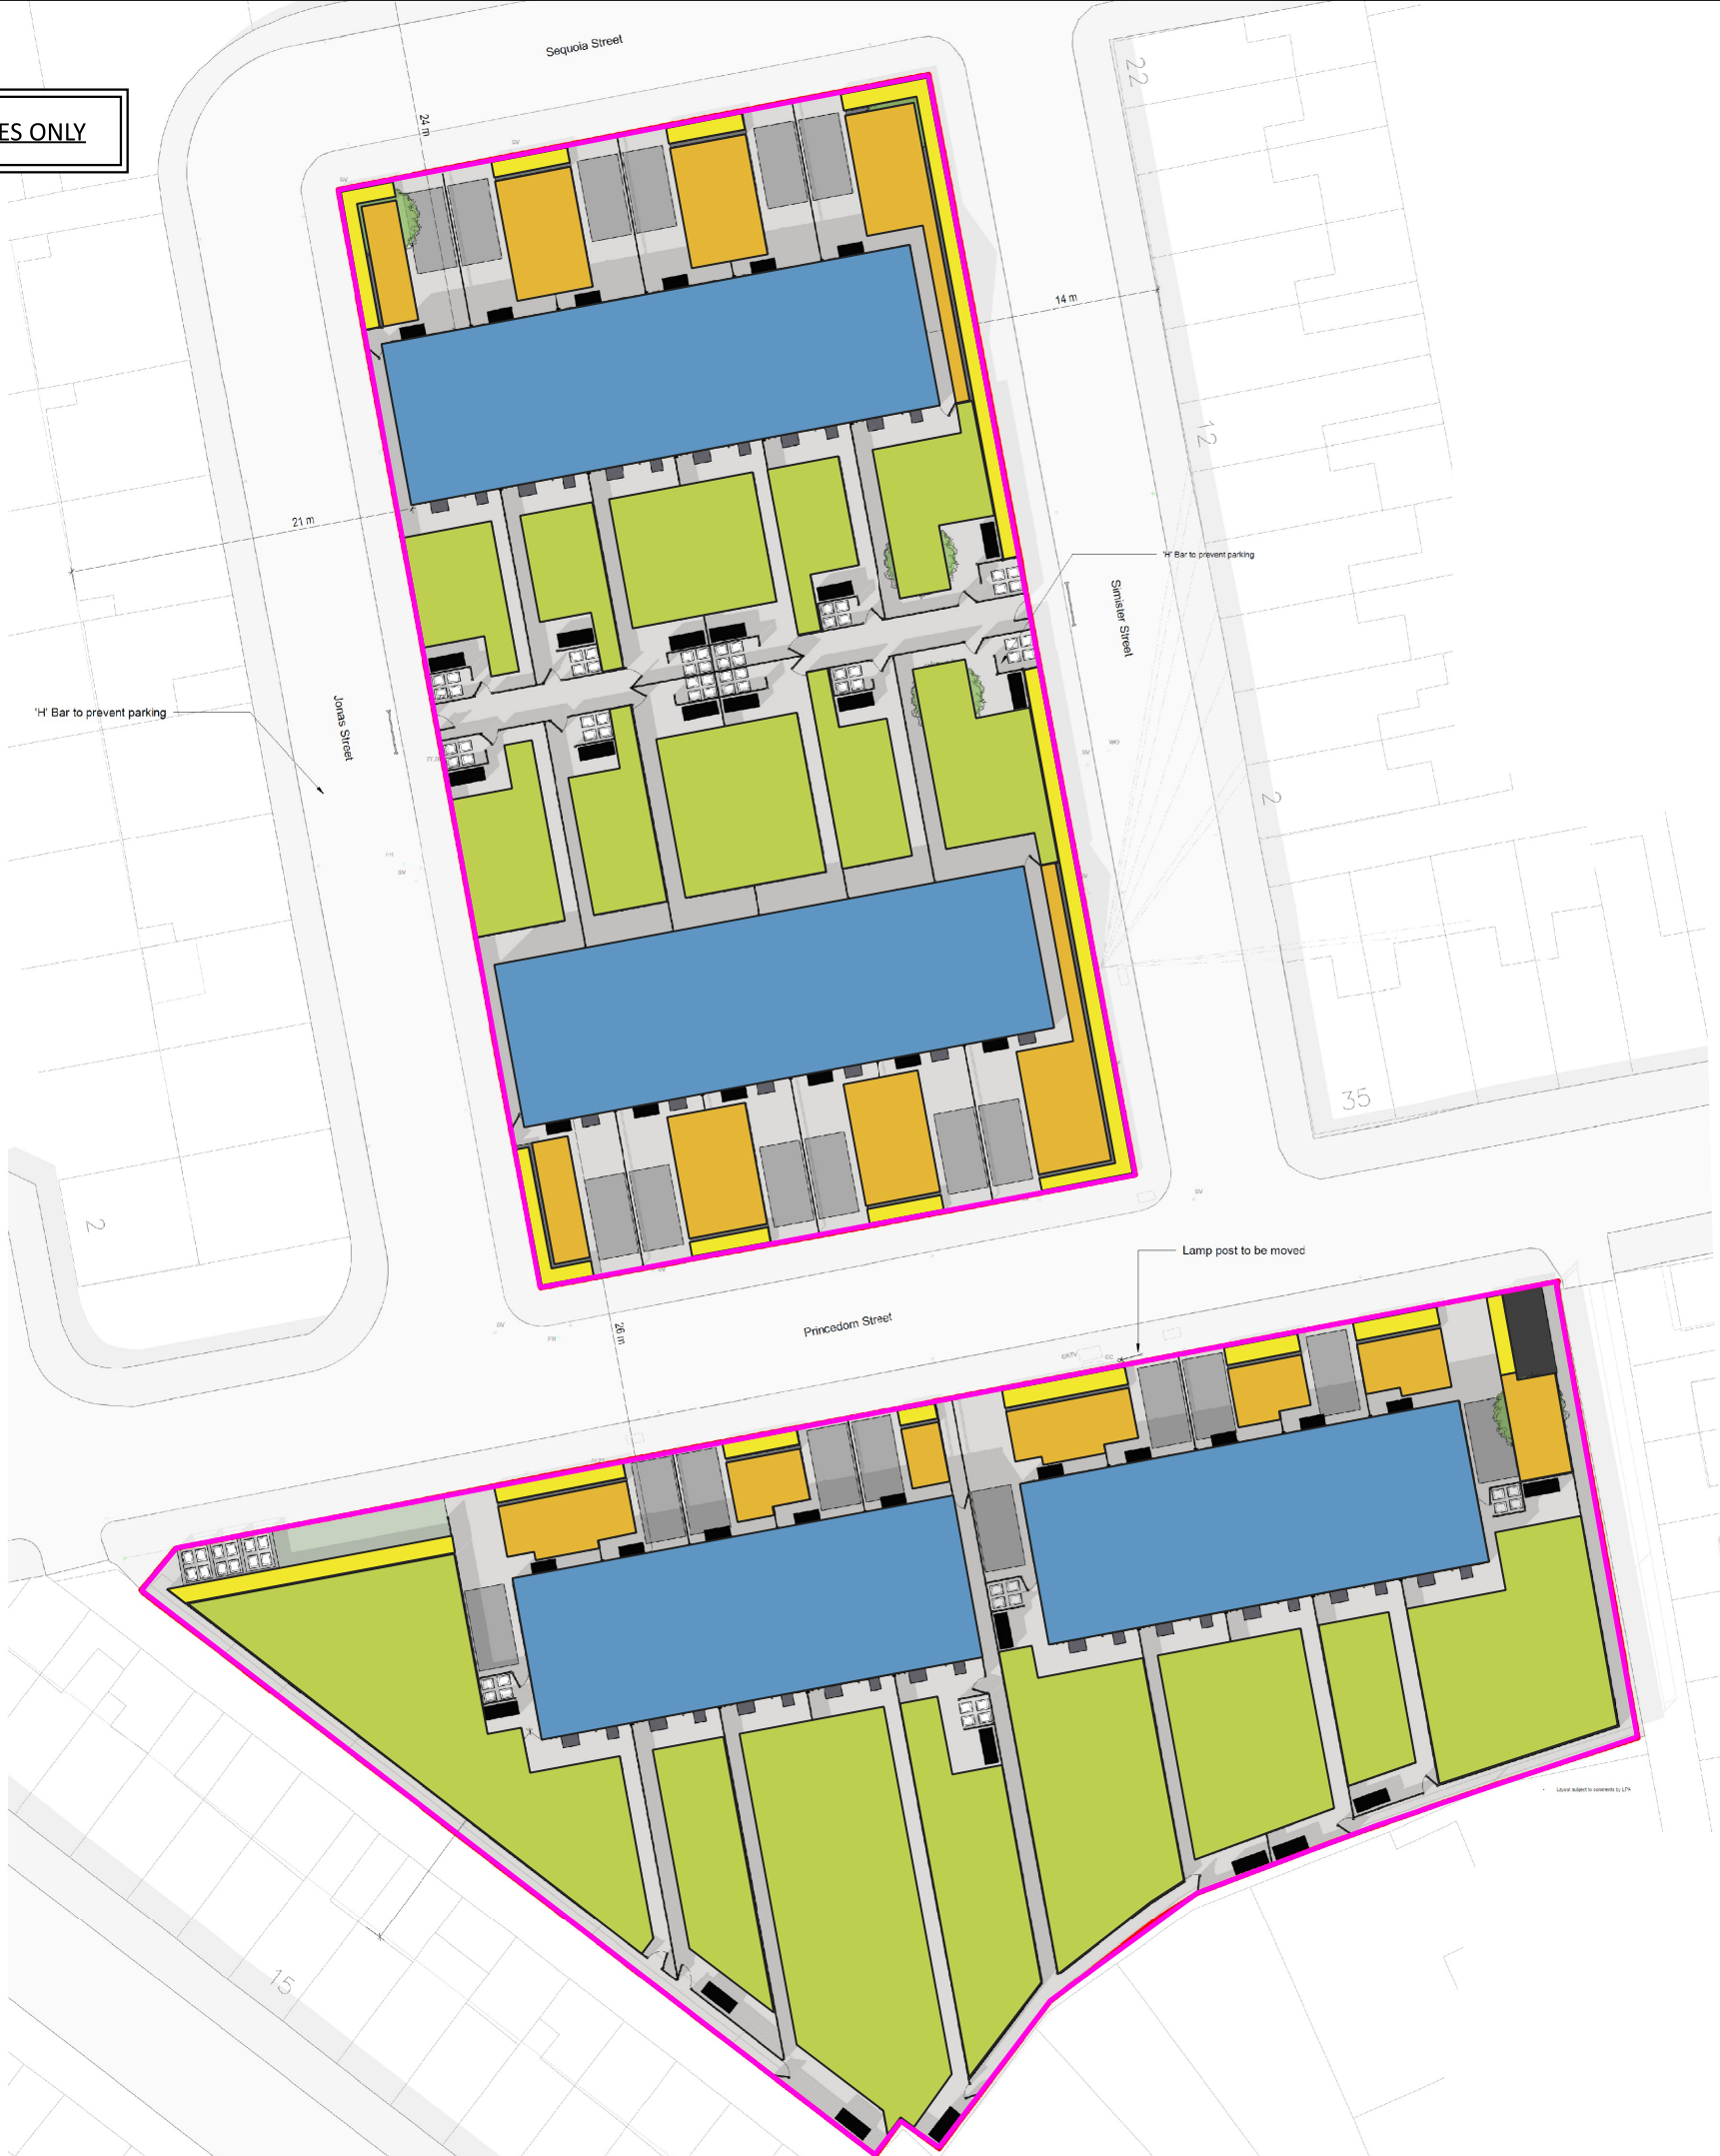
- Approximate Site Boundary
- Proposed Plots
- Proposed Rear Gardens
- Proposed Front Gardens
- Proposed Soft Landscaping

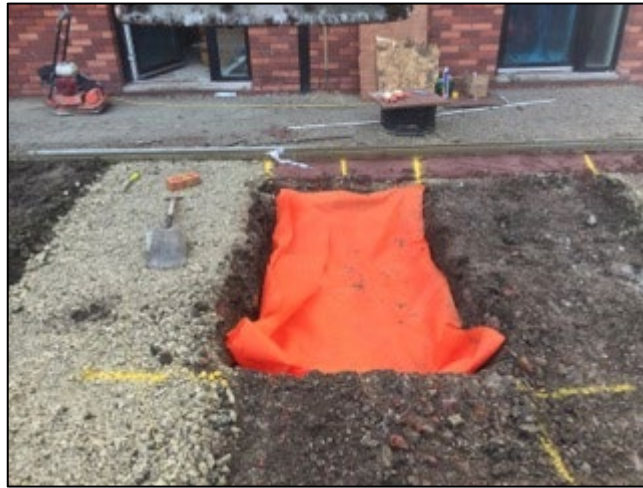
*Figure 1: First, the gardens are dug out to 600mm below FFL and lined with a hi-viz geotextile marker:*

It should be noted that most cover systems require **either** a gravel break layer **or** a hi-viz geotextile marker, but the below example uses both:

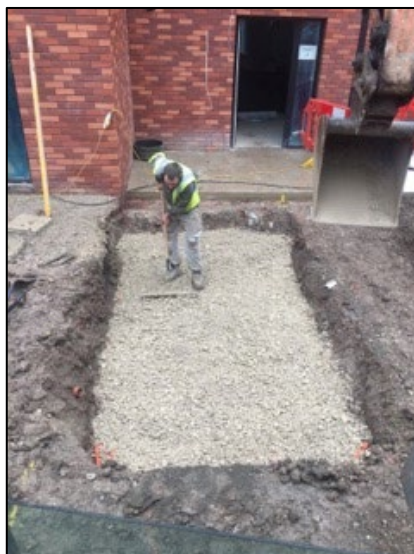
*Figure 2: The geotextile is overlain by a 150mm clean stone break layer.*

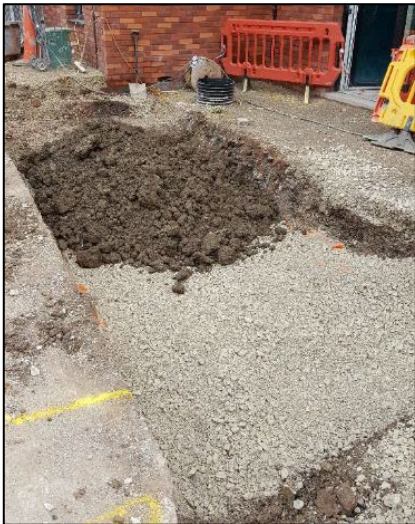
Figure 3: The break layer is overlain by 300mm sub-soil, seen here before spreading across the garden:

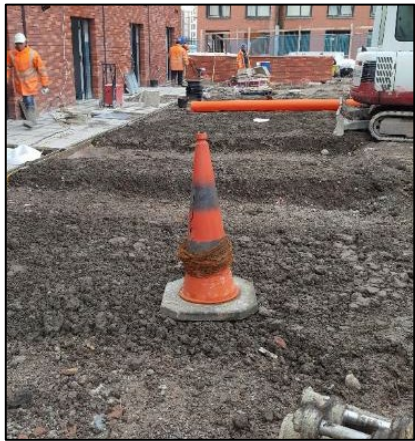
Figure 4: The sub-soil is overlain by 150mm topsoil to FFL:

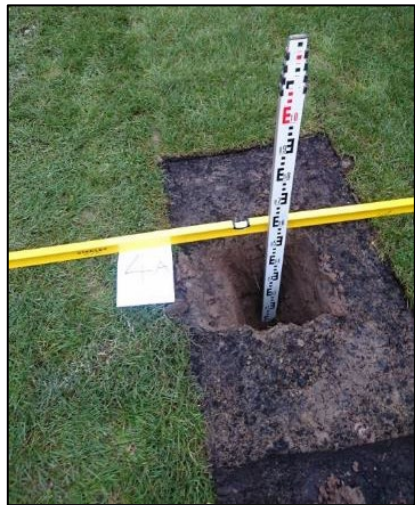
Figure 5: The gardens are finished with turf. The overall cover system depth is 600mm:

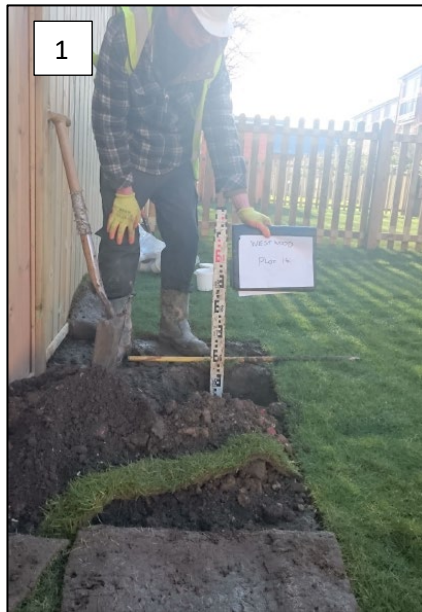
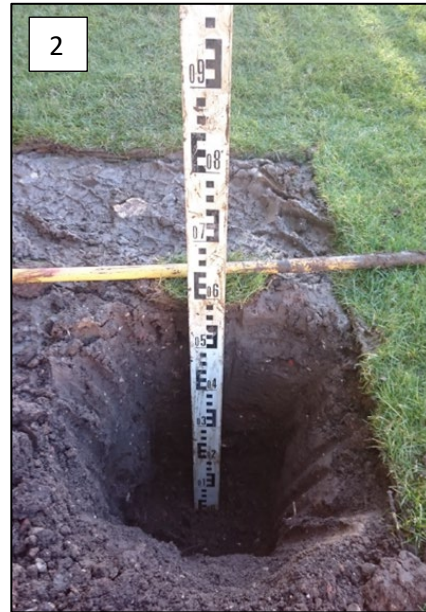
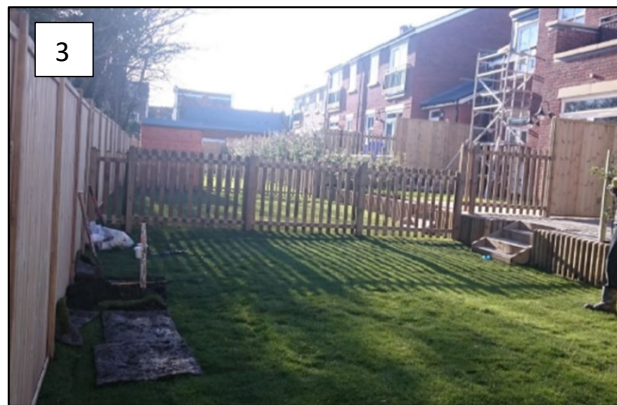
Photograph 1 – Identifies the plot number and shows the validation dig location in relation to the plot.

Photograph 2 – Shows the validation depth clearly, using a staff and a marker which crosses the hole. Shows the topsoil and subsoil, and the base of the hole.

Best practice requires three photos as follows:
